Reassessment of the development and hazard of the Rampac Grande landslide, Cordillera Negra, Peru

Vít Vilímek^{1*}, Jan Klimeš² and Marco Torres Zapata³

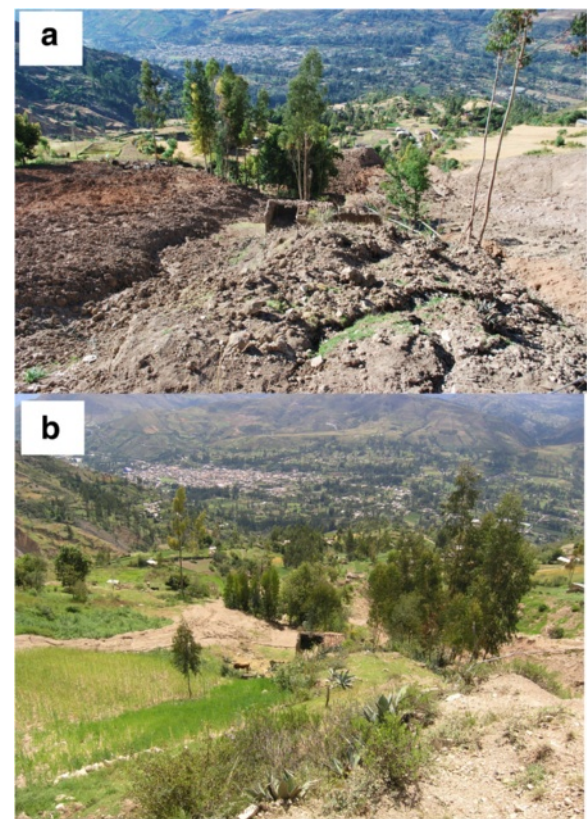
Fig. 3 a from 2009, b from 2014. A new flow accumulation was placed on the body of the complex landslide from 2009 – this time it arrived from a ravine located in the close vicinity of the complex landslide
