# PRELIMINARY STUDY ON SNOWPLOW SURVIVABILITY OF GUARDRAIL TERMINALS

**Prepared by: Zhongguo (John) Ma, Assistant Professor and  
Steven P. Mattingly, Assistant Professor  
Dept. of Civil and Environmental Engineering  
University of Alaska Fairbanks**

**Date: August 1, 2000**

FHWA-AK-RD-00-04

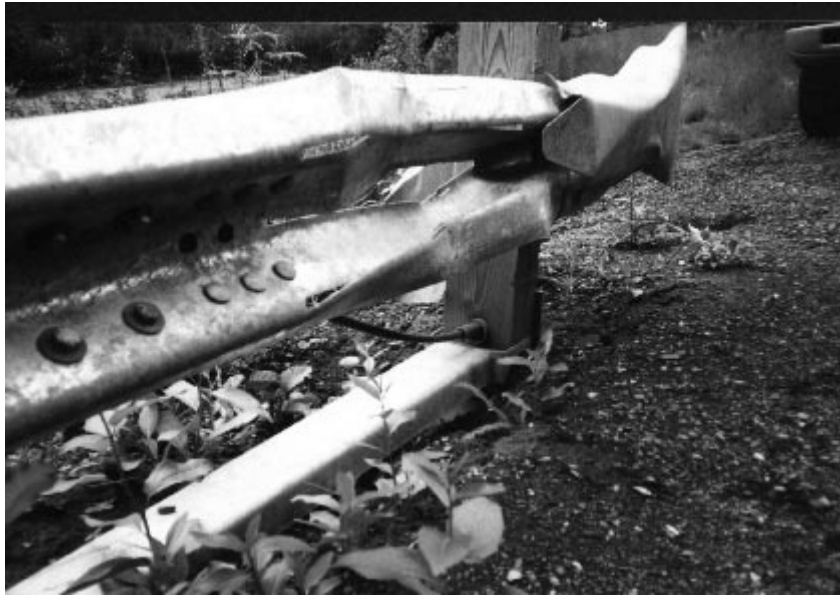
The Anchorage maintenance crews find the new slotted rail terminals (SRT-350s) fragile. The research team confirmed this statement through field visits. As an example, Fig. 1 shows the damage to the slotted area in the W-beam of SRT-350s. This type of damage could be caused by direct contact from the snowplow equipment or by snow-only contact, i.e. too much snow had been pushed against the slotted W-beam through snow removal operations parallel to the rail. The research team could not identify the exact cause of this damage. However, by comparing the slotted portion of the W-beam with the portion away from the slots shown in Fig. 1, it can be observed that the slotted portion has a lower bending resistance during snowplow operations.

**Fig. 1 Damage to the Slotted Area in W-beam of SRT-350s**

Although the maintenance crews did not know whether the damage shown in Fig. 1 was caused by the snow-only contact, they have observed significant damage due to routine winter maintenance in the Turnagain Pass region. In Valdez area, very heavy snow falls can be expected with at least 300 inches in the lower elevations and as much as 600 to 800 inches in Thompson Pass. The snow tends to be wet and heavy variety. Difting is a significant concern in many locations. The maintenance crews already attempt to operate three to four feet away from the terminal, but they are still observing damage to the new terminals.

2. There are two types of damage to the newly installed SRT-350s: (1) damage due to contact between the snow removal equipment and the terminal; and (2) damage resulting from the pressure of the snow (snow-only contact). The first type is the most likely damage observed in field visits. The damage due to snow-only contact can occur in heavy snow area.

1. Regardless whether snow-only damage can occur, damage that results from equipment collisions with the terminals seems more likely. The equipment operators need to increase their diligence in avoiding the terminals. The State of Minnesota recommendation for a video that emphasizes the damage and its cost may assist in this

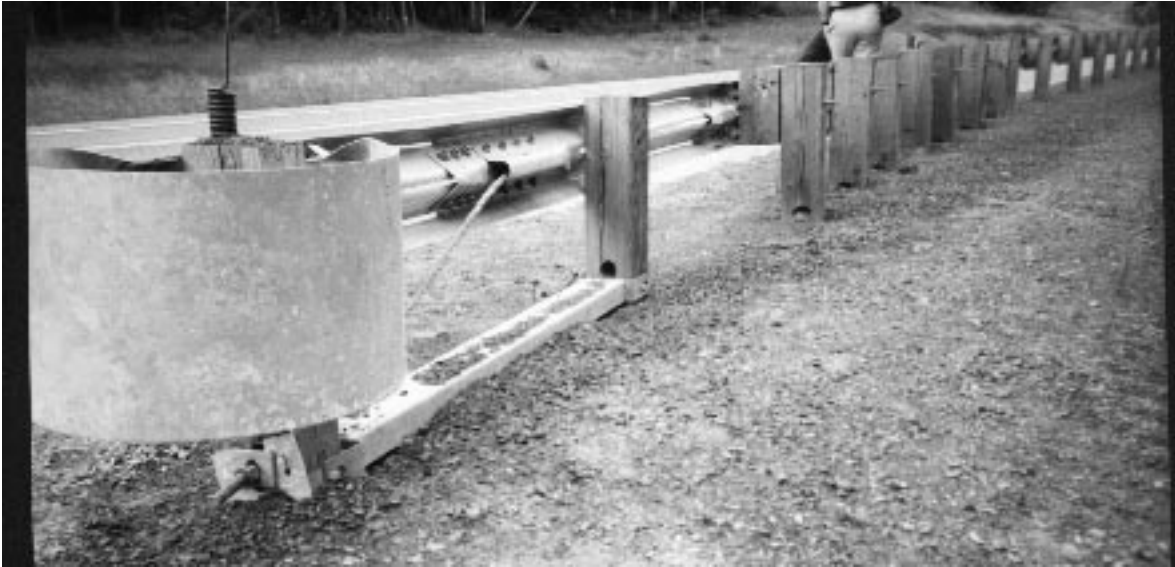
Another chief concern to these maintenance crews is the use of wooden posts for the terminal treatment that tend to shear away from its steel-tube base. It is important to point out that holes at the base of wooden posts (as shown in Fig. 2), similar in function to slots in the W-beam, intend to soften the new terminals during a vehicle collision. However, it does make them more fragile during the normal snowplow operations. After a post shears off its base, as shown in Fig. 3, the replacement effort is prohibitive because the base must be dug out of the ground.

**Fig. 2 Wooden Posts with Holes**

4. The maintenance crews in the Valdez area strongly support the investigation of both box-beam guardrails and the use of metal posts in the terminal as opposed to wooden posts. A careful research project may be designed to identify the ease of maintenance and likelihood of damage or failure associated with each post-type.

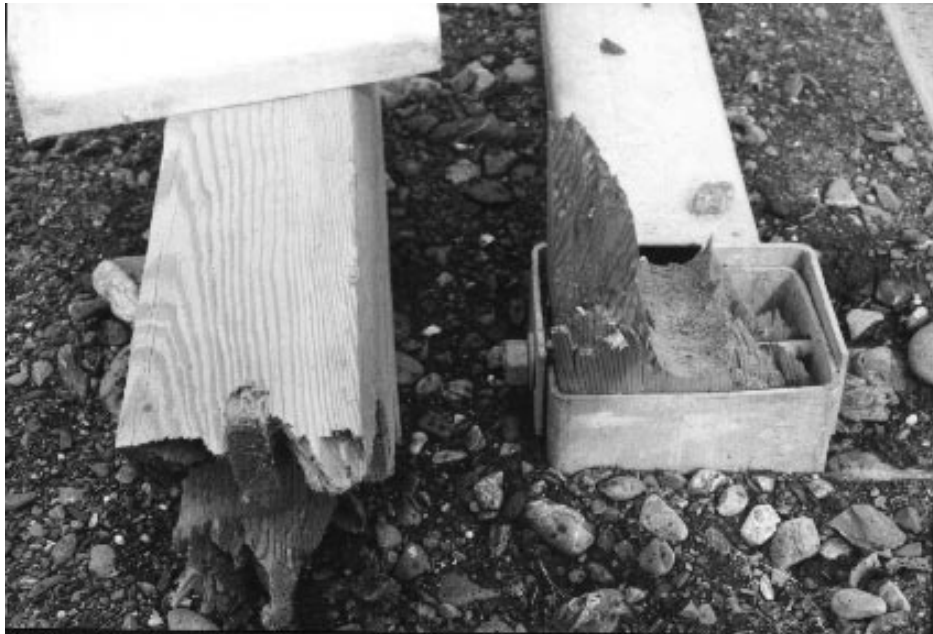
**Fig. 3 Wooden Post Broke away from Its Steel-Tube Base**

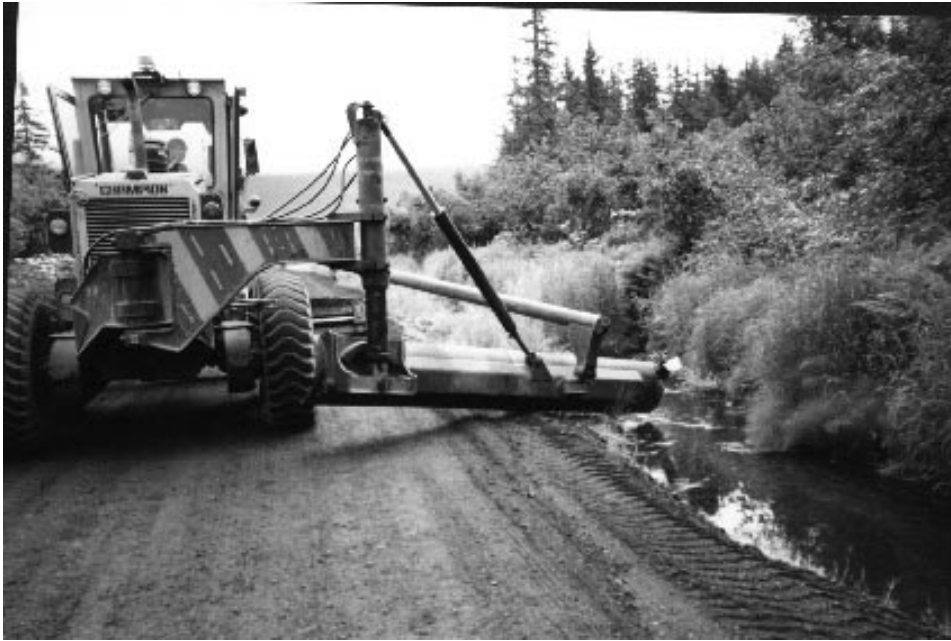
**Fig. 4 A Grader with a Sloper Attachment**

Similarly in Valdez area, the maintenance personnel also emphasize the vulnerability of the terminal when the grader operates in its vicinity. Specifically, the sloper attachment tends to catch on the posts and destroy the terminal.

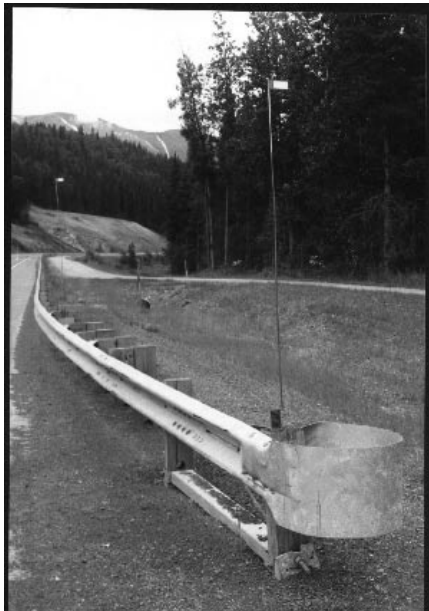
The new terminals in Turnagain Pass have been installed at the lower elevations, which only receives about a third (or approximately 130 in.) of the seasonal snowfall that is observed at the pass's peak. This region does not experience a large amount of drifting snow, but the heavy, wet snows seem to pose a special concern with regard to the terminal vulnerability. At this time, the terminal and guardrail ends in this section are marked with six-foot flexi-flags on spring steel, as shown in Fig. 6. This seems to be very effective and allows the operators to find these points throughout the winter. Additionally, the spring steel seems resistant to damage from winter maintenance activities.

**Fig. 6 Six-foot flexi-flags Marker on spring steel**

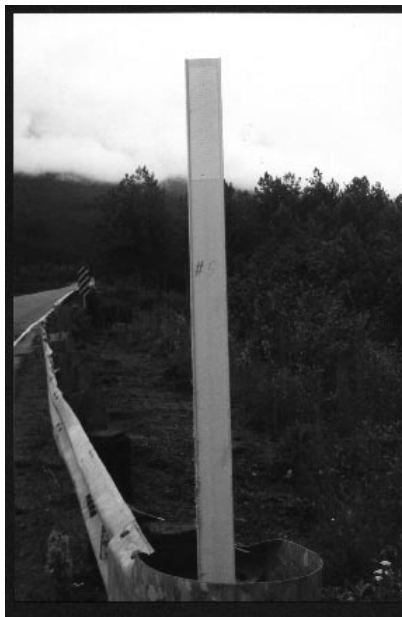
However, in Valdez area, only the terminal ends are marked with an eight-foot carsonite marker, as shown in Fig. 7. While the Valdez area crews are not sold on this marker, they believe it is the best they have found.

**Fig. 7 The Eight-foot Carsonite Marker**
