Durability and Waterproofing Investigations of the Building Envelope

Thesis

The University of Texas at Austin

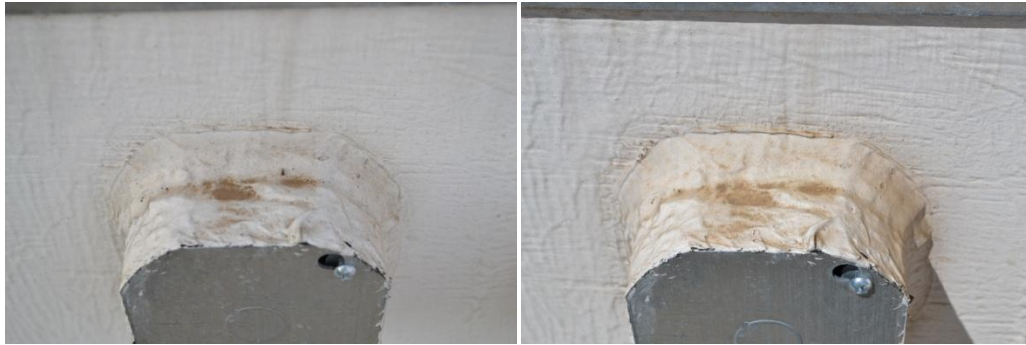
Nearly all of the WRBs are susceptible to dirtiness. It has been observed that most of the specimens with a significant accumulation of dirt, sand, or pollen, are liquid applied membranes. This accumulation can be seen after just a few months and has continued over the life of the product, as shown in Figures 7 and 8.

Figure 7: Dirtiness of Specimen DRP1009-11 After 4 Months (left) and After 1 Year and 3 Months (right)

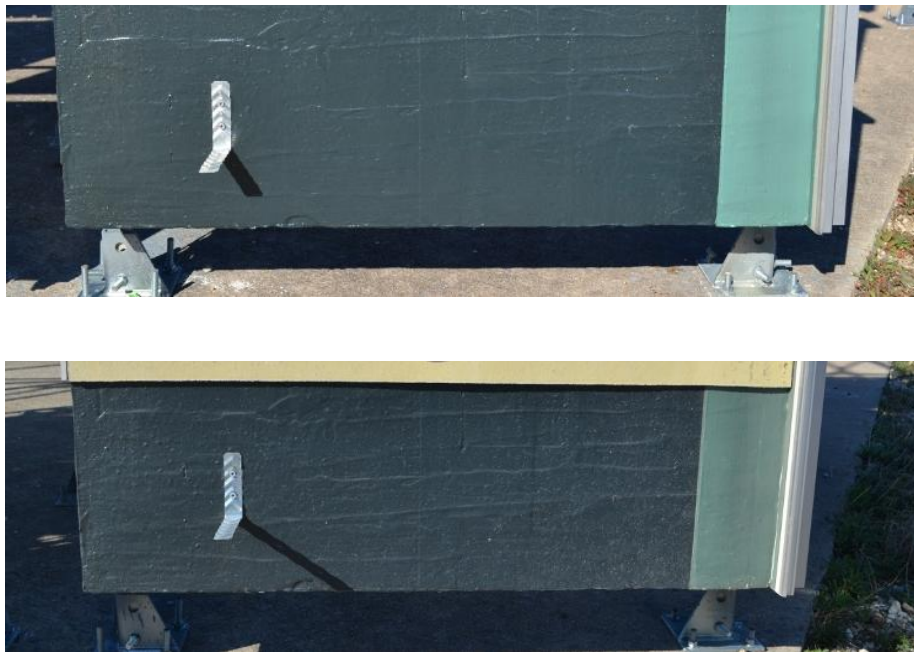
Figure 8: Dirtiness of Specimen DRP1009-07 at Installation (top) and After 1 Year and 3 Months (bottom)

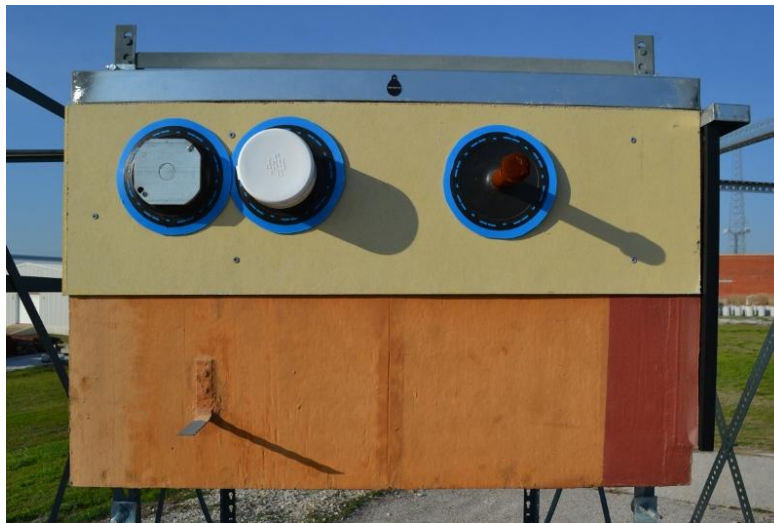
Just three months after being clad, the WRB in Figure 9 exhibited significant discoloration at the left edge, center joint, flashing at window flange, and miscellaneous locations throughout the field of the specimen. Some of the darker discoloration may be due to moisture intake, but the mechanism for the remaining discoloration is unknown.

Figure 9: Specimen DRP1009-03 with Significant Discoloration 3 Months After Cladding

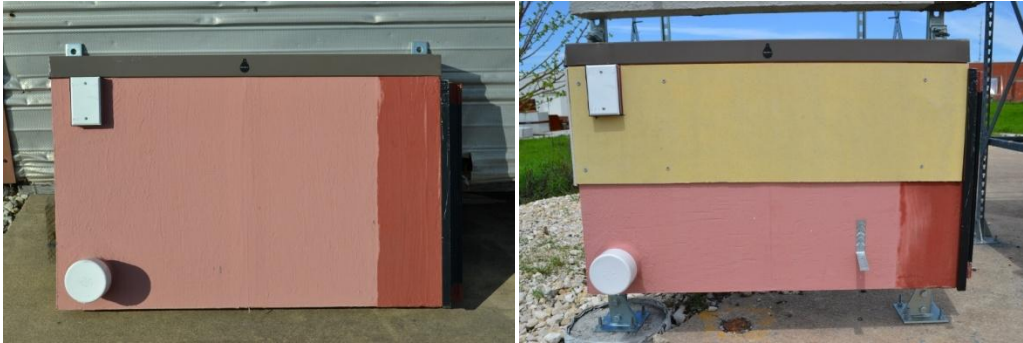
Figure 10 depicts the first trial mockup that was constructed. As can be seen, the layout of penetrations was later altered to better test the products. Due to being a trial specimen, during the first few months it was not facing directly south until the racks were completely assembled, but it has still provided useful observations. The photo on the left is the specimen right at its UV exposure limit, and the photo next to it is the same specimen after a year. It can be seen that the beginning of discoloration of the flashing product was starting at its cladding date, and it has since progressed significantly over the

course of one year. By the nature of the discoloration, it seems that the field product is reacting with the flashing product, resulting in the flashing product becoming the lighter pink color of the WRB. Further investigations and testing as the product is exposed further may be able to shed light on the mechanism of this reaction.

Figure 10: Specimen DRP1009-13 Comparison of Discoloration at 6 Months (left) and 1.5 Years (right)

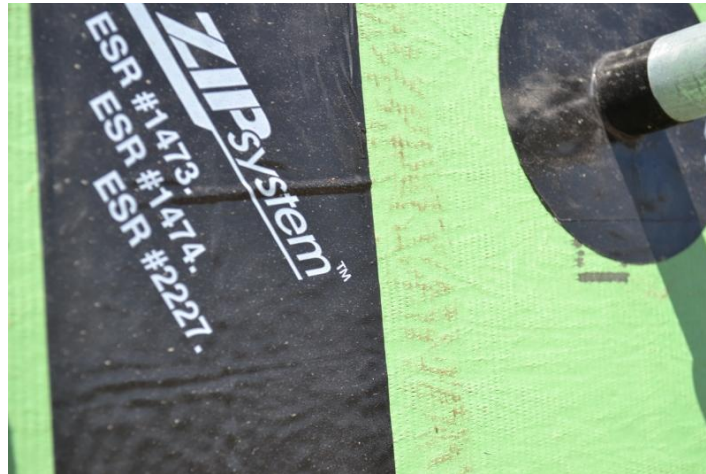
For most of these cases, as can be seen in Figures 11 to 14, with the exception of Figure 13, the fishmouthing occurred for each product before it had reached its UV exposure rating. Whether the resultant failure was due to slightly imperfect craftsmanship or simply deterioration of the product and adhesion, issues like these pose a large threat to buildings and can cause potential water intrusion failures. Although this testing has not proceeded sufficiently long enough to observe any significant damage as a result of these failures, it will be interesting to see how the products fare as the years progress.

Figure 11: Fishmouthing of Specimen DRP1009-10 Tape at Sheathing Joint After 2 Months—4 Months Before Required Cladding

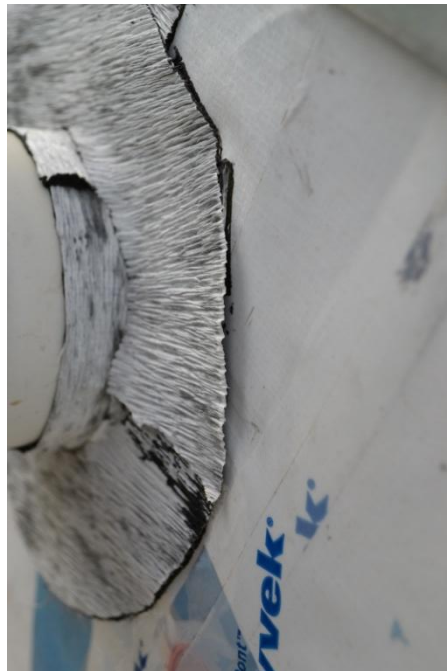
Figure 12: Delamination of Specimen DRP1009-02 Detailing at Large Pipe Penetration After 4 Months—Just Prior to Cladding

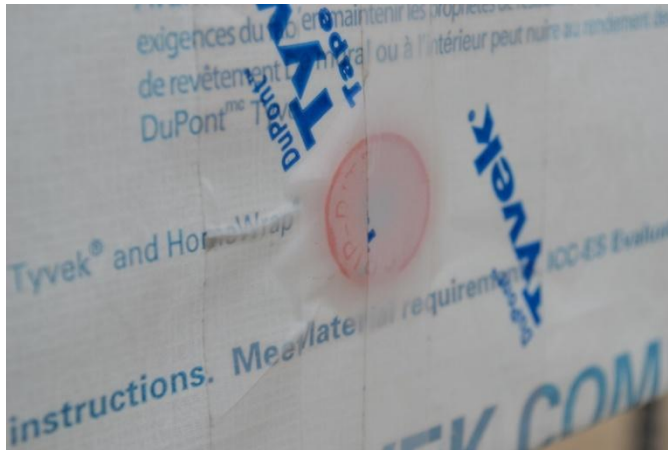
Figure 13: Fishmouthing of Specimen DRP1009-02 Tape at Joint After 6 Months—2 Months After Required Cladding

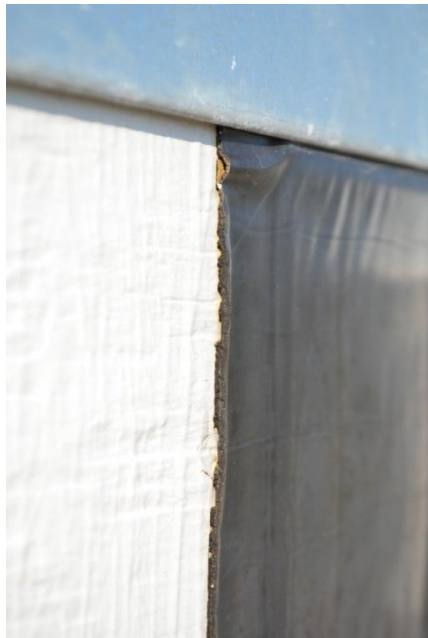
Figure 14: Fishmouthing, Delamination, and Cracking of Specimen DRP1009-05 at Flashing Edge After 10 Months—2 Months Before Required Cladding

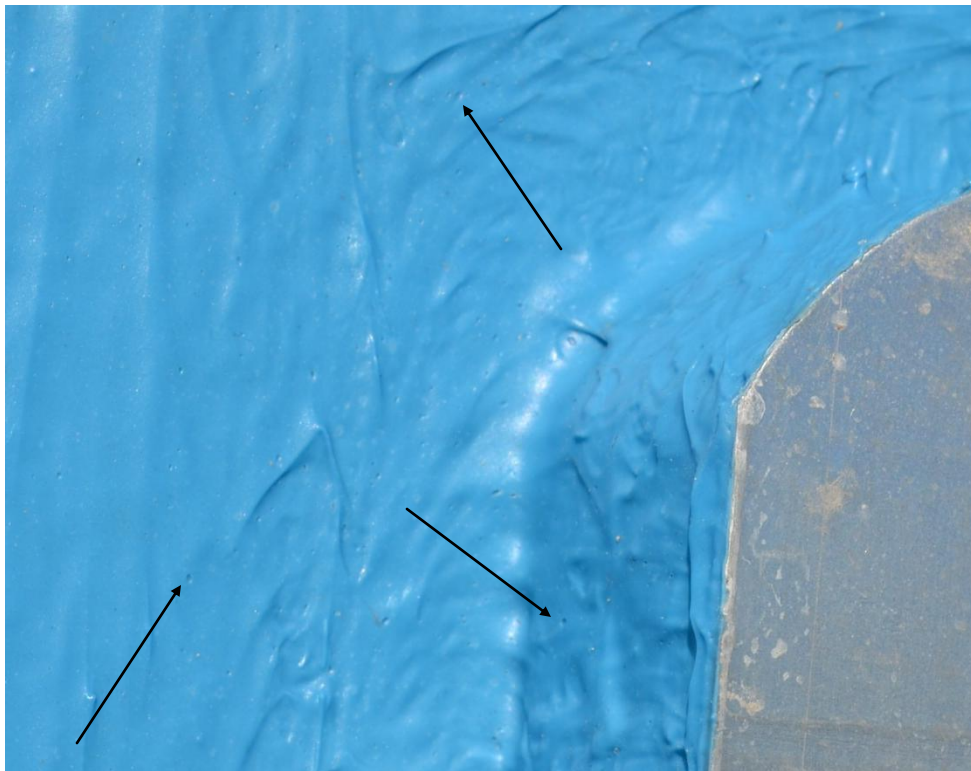
This phenomenon only occurs in liquid applied products. These imperfections have become present at installation, before the UV exposure limit, or after the UV exposure limit for nearly all of the liquid applied products. Sometimes these pinholes appear to be small divots in the field of the membrane as simple popped air bubbles after application, while others appear to have the potential to go all the way through the WRB and act as holes to allow water penetration (Figures 15 to 18).

Figure 15: Pinholes in Specimen DRP1009-08 Immediately After Installation on Racks

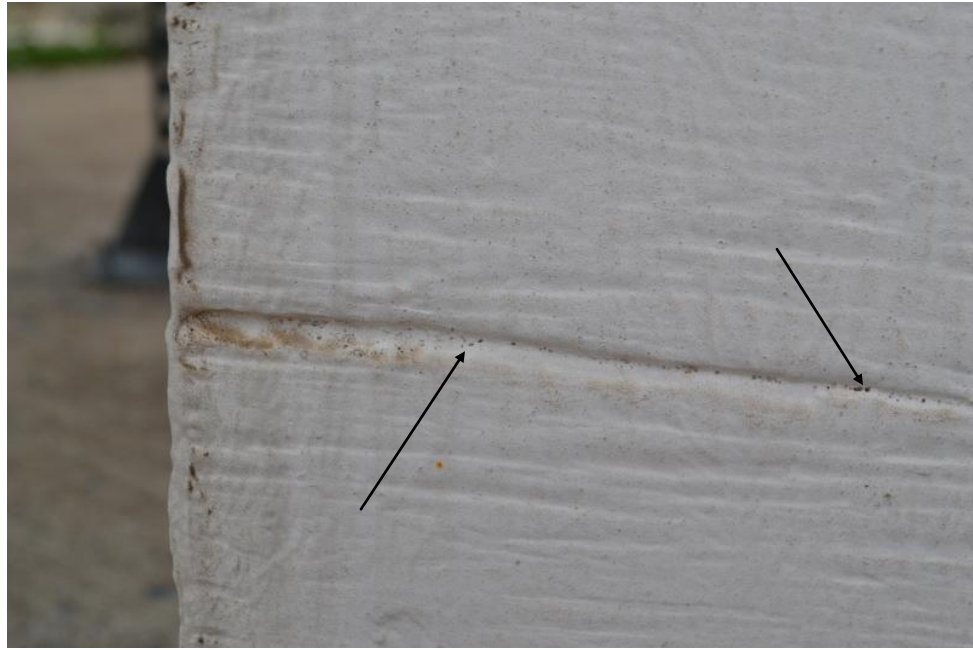
Figure 16: Pinholes in Deep Wood Grain of Specimen DRP1009-11 After 1 Year and 2 Months

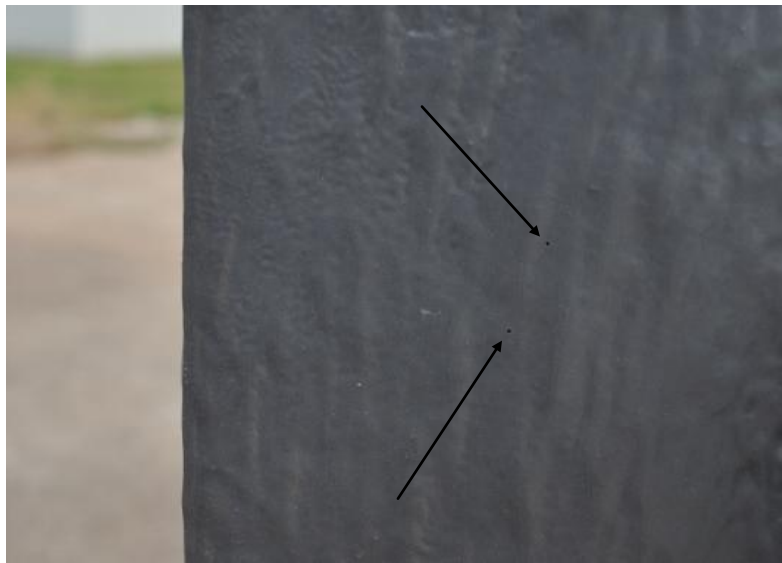
Figure 17: Pinholes in Specimen DRP1009-14 After 5 Months of Exposure

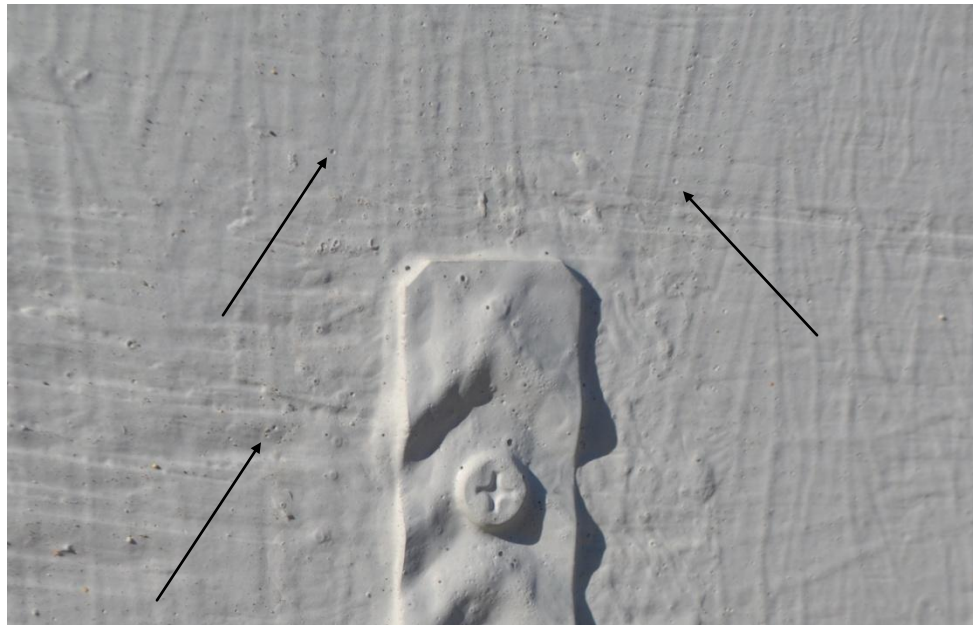
Figure 18: Pinholes Throughout Specimen DRP1009-05 After 1 Year and 3 Months—3 Months After Required Cladding

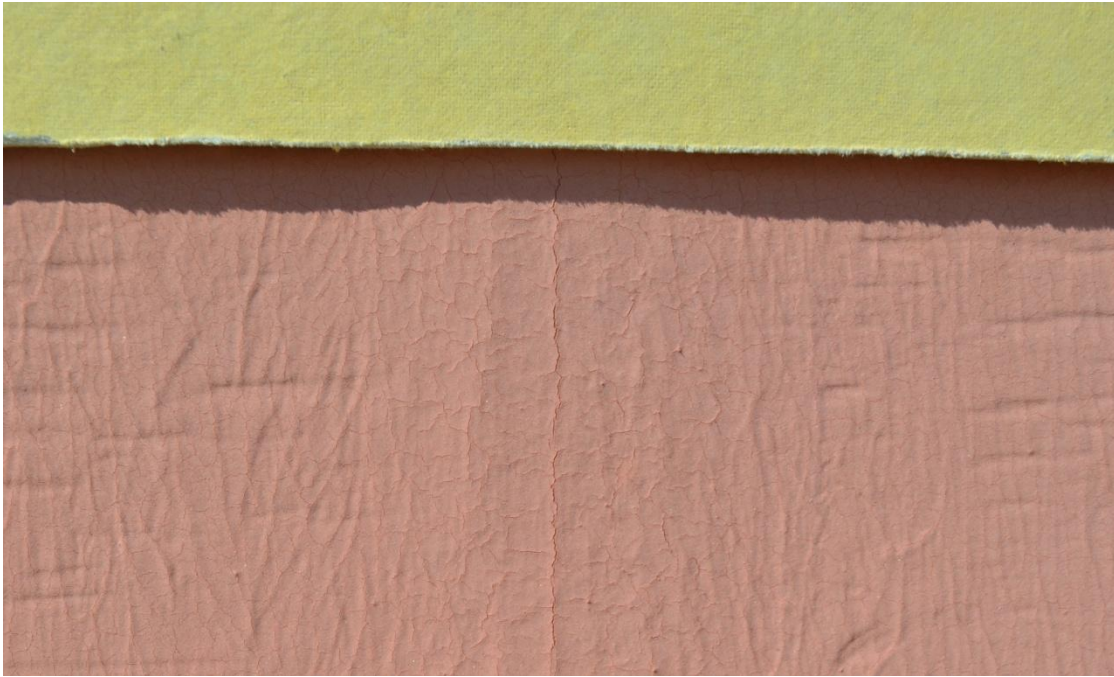
Some of the liquid applied products or accessories of felt products have been susceptible to significant cracking. Figures 19 to 23 show that some of the cracking of these products began before the product UV exposure limit, and others have occurred after the limit. Similar to all other observations thus far, the consequences of these failures have not developed yet, since durability issues may take years to fully manifest.

Figure 19: Crazing and Vertical Cracking at Center Joint of Specimen DRP1009-13 After 1 Year of Exposure

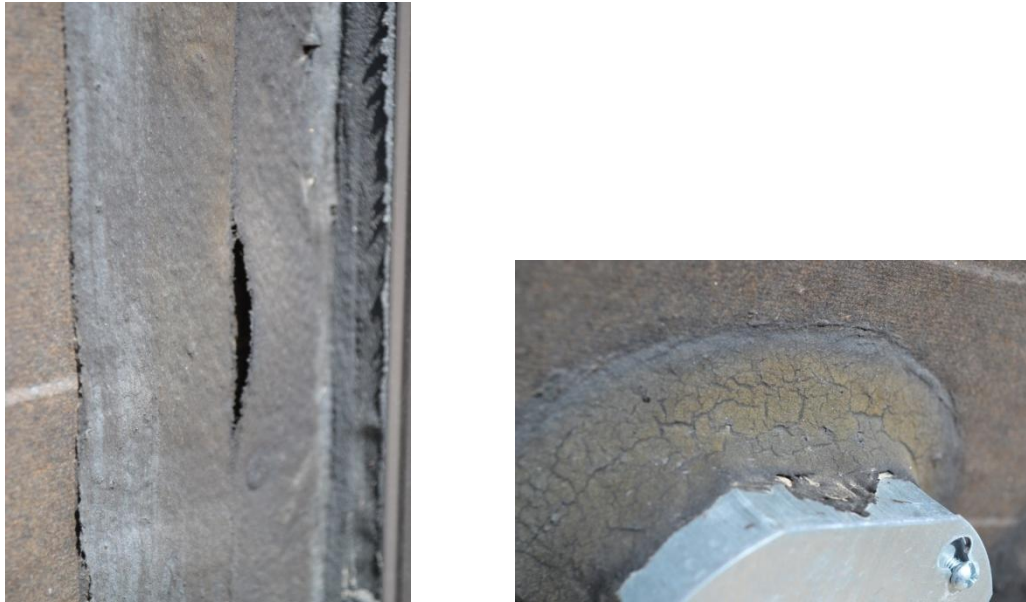
Figure 20 below shows the cracking of the auxiliary building cement product used to detail around the penetration on a felt WRB specimen. Cracking and failure of this product was noticeable after little exposure outside.

Figure 20: Specimen DRP1009-12 Flashing and Penetration Cracking After 2 Months Exposure

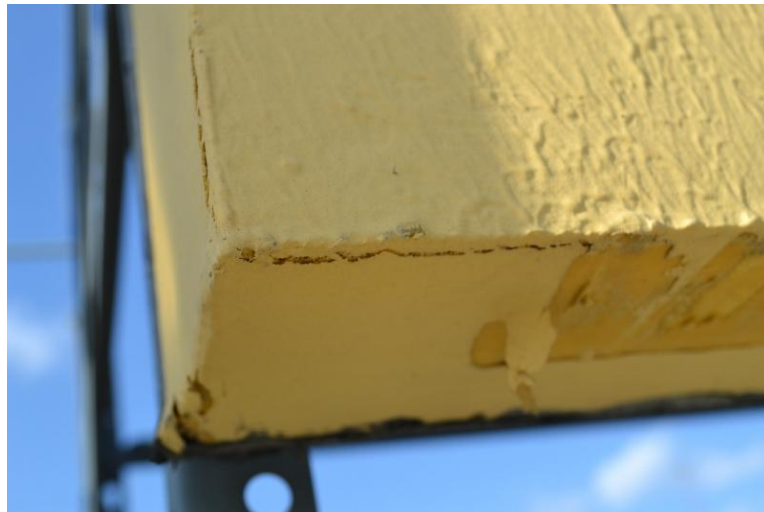
Figure 21: Specimen DRP1009-04 Edge Cracking After 3 Months Exposure

cracking has propagated almost along the entire length of the bottom edge of the specimen. As a result, there has been an increased amount of condensation accumulation on the rigid plastic backing, but no visible damage to the studs or sheathing has been observed yet. The manufacturers of this product stated that they have not seen a failure like this before, and they believe that it may be due to the imperfection on the right of the cracking. During installation, the specimen was still drying and accidentally touched another surface, causing the WRB to be pulled off.

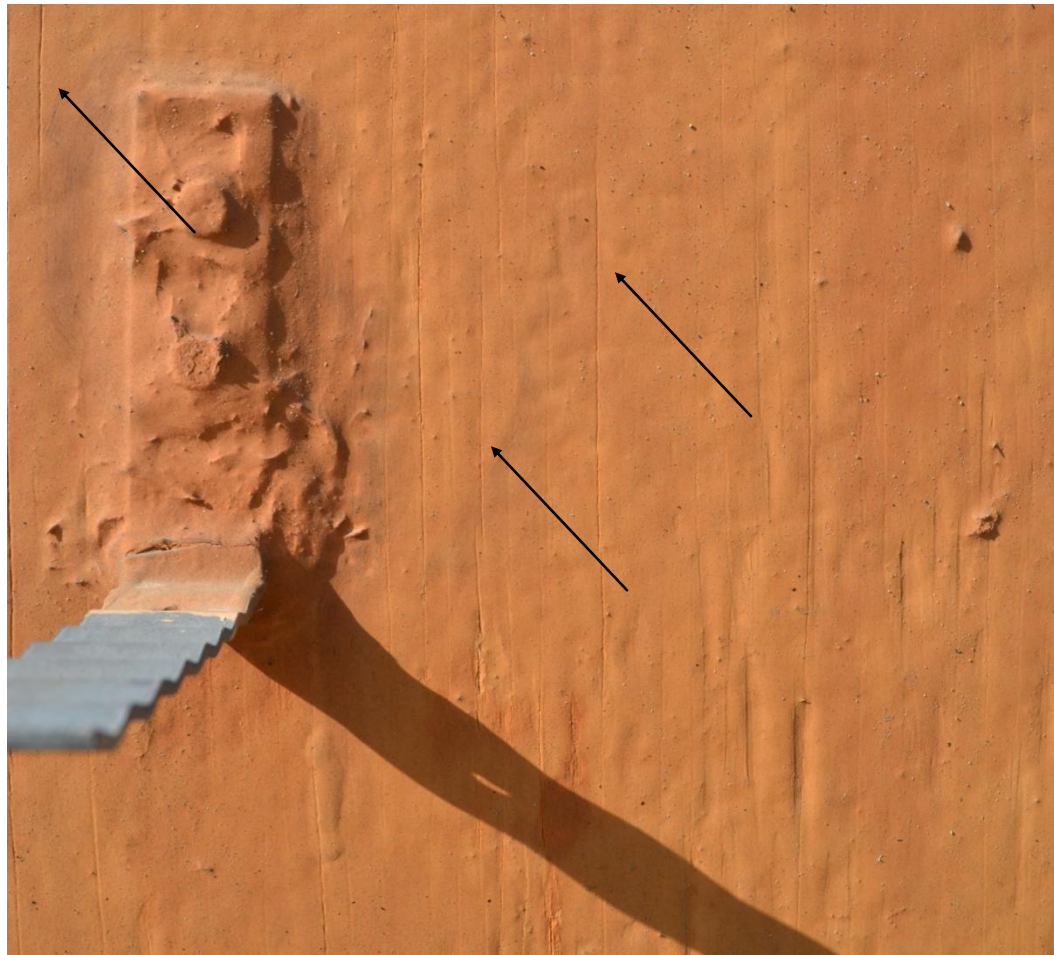
Figure 22: Specimen DRP1009-03 Vertical Cracking After 1 Year, Just Before Exposure Limit

In Figure 22, the vertical cracking had begun to propagate just one month after installation. Now this cracking has spread throughout the specimen, and is most severe on the left side near the electrical and large pipe penetrations and the brick tie. The manufacturers of the product have been notified of this cracking, and they are unfamiliar with such a failure before, and propose that it may be due to simply a bad batch of the material.

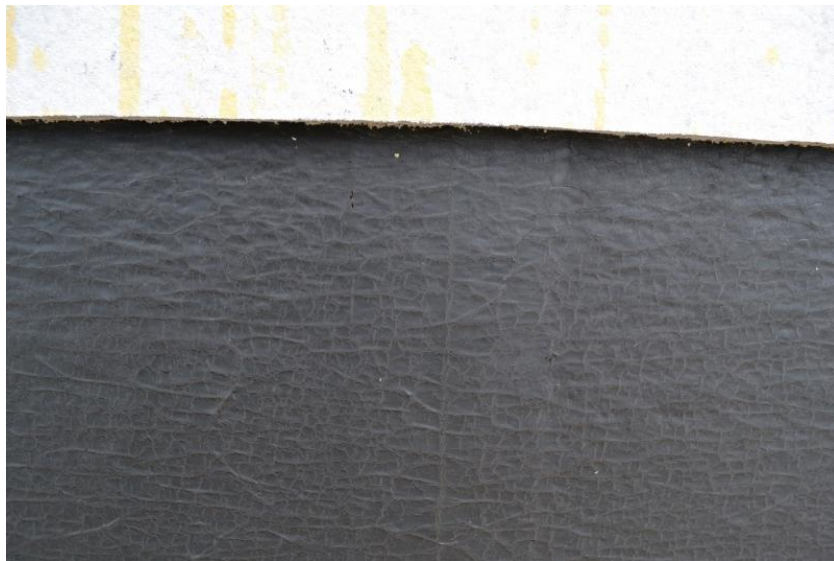
Figure 23: Specimen DRP1009-09 Crazing After 1 Year Exposure

of cracking that is seen here. This product is also the only WRB so far that has experienced blistering as well, which is described below.

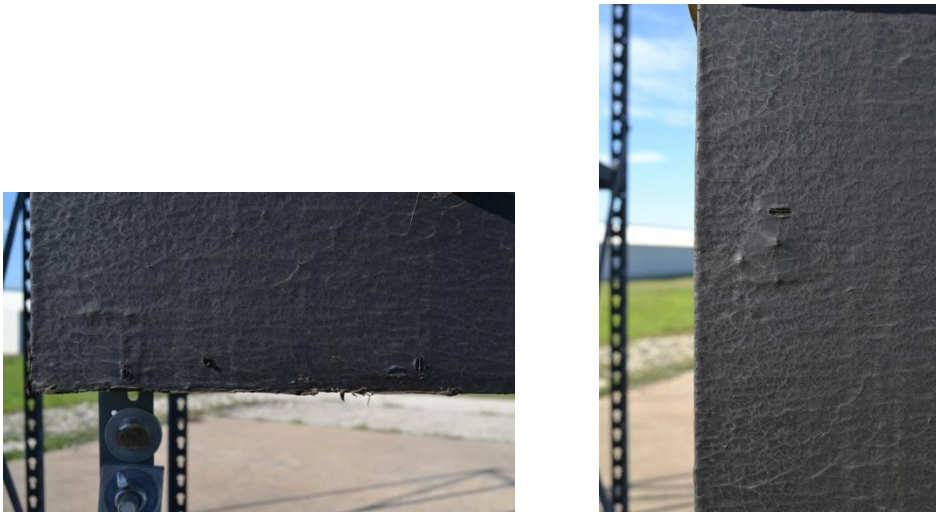
Blistering of products is a result of trapped water vapor behind the membrane and has only occurred on one tested specimen so far; it seemed to result after field crazing. This blistering began in the product after about 10 months, or one month after the substrate began to experience crazing (Figure 24).

Figure 24: Specimen DRP1009-09 Blistering After 1 Year and 3 Months Exposure

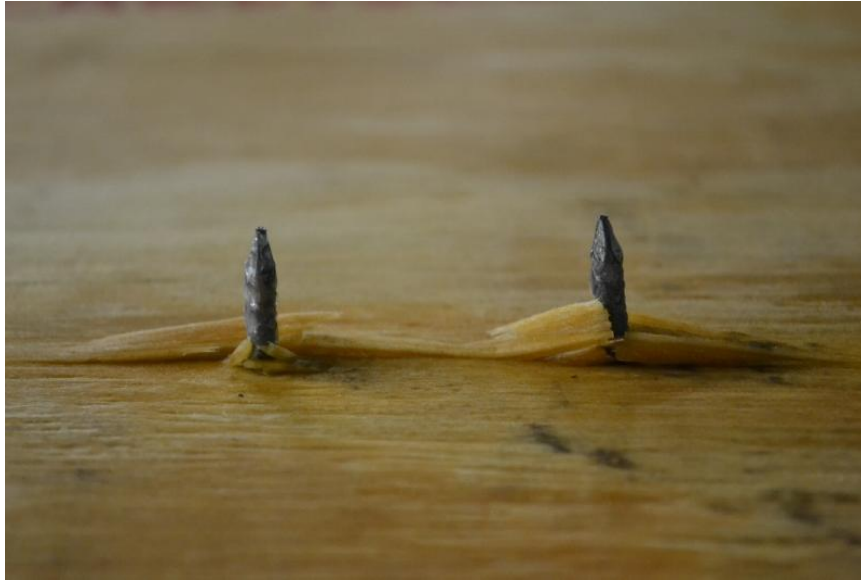
Figure 25: Visible Moisture Droplets on Nail Shanks of Specimen DRP1009-08-A

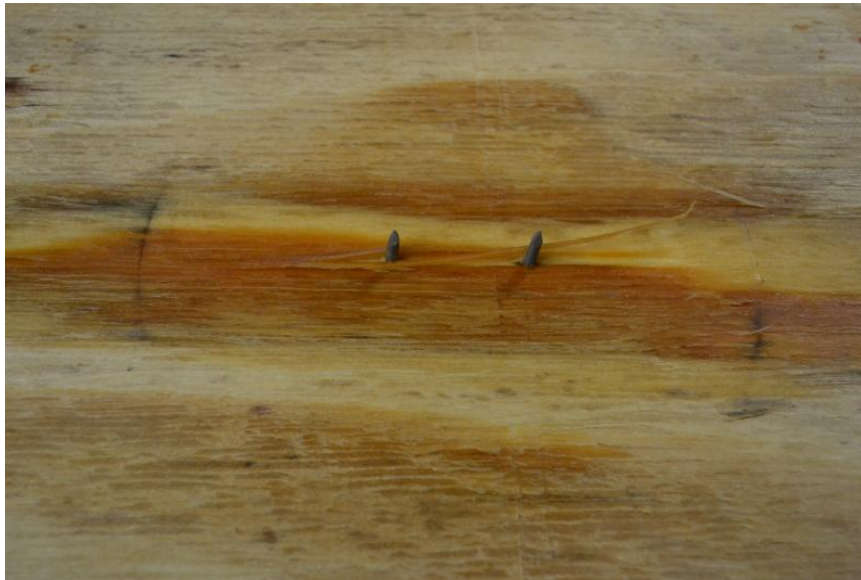
Figure 26: Significantly Saturated Underside of Plywood of Specimen DRP1009-03-A

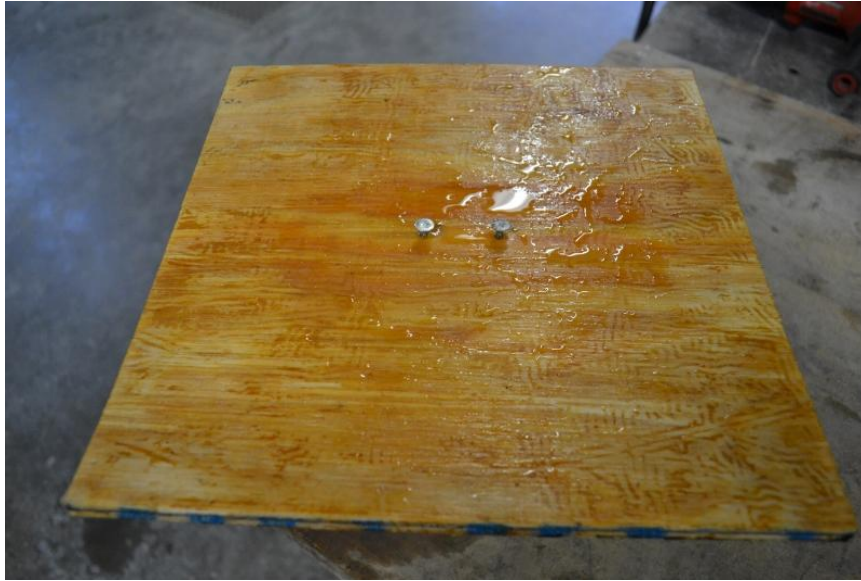
Figure 27: Significant Water Penetration Underneath Specimen DRP1009-06-B, a Self-adhered Membrane

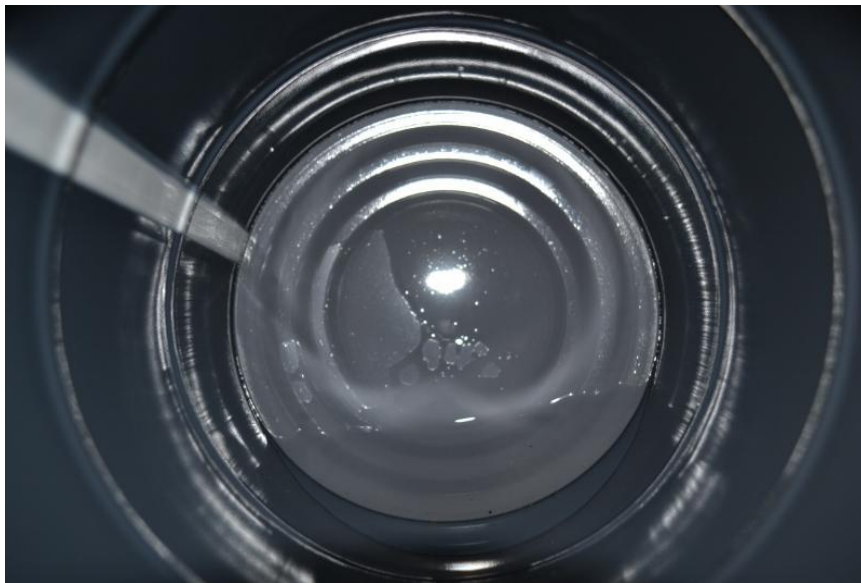
Figure 28: Water in Bottom Can of Specimen DRP1009-07-C

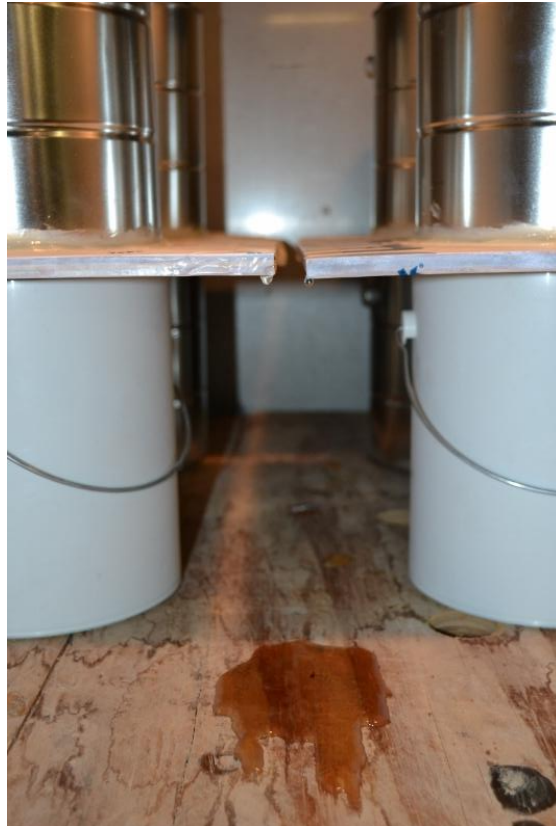
Figure 29: Water Leaking Out Corners of Specimen DRP1009-02-A and -B, Which are Wrap WRBs, Within Minutes of Placement in Environmental Chamber

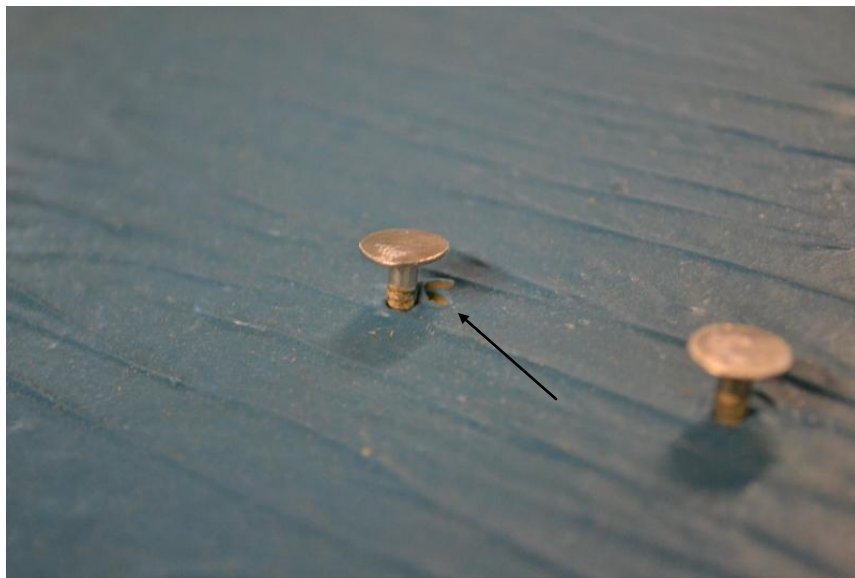
When testing the remaining seven products to the new ASTM standard, the results were remarkably different. Some of the specimens failed, and some passed, which makes the standard much more useful in terms of product comparison. A complete list of the pass and failed products for both the old and new test methods can be found in Appendix B. The biggest difference was the elimination of the requirement for the nails to be tapped back up. Many times, this caused the membrane to be ripped apart, as seen in Figure 30, making it very easy for water to penetrate.

Figure 30: Clear Distress of Specimen DRP1009-08-C After Nail Backed Out 0.25 in., According to Old ASTM D1970 Standard

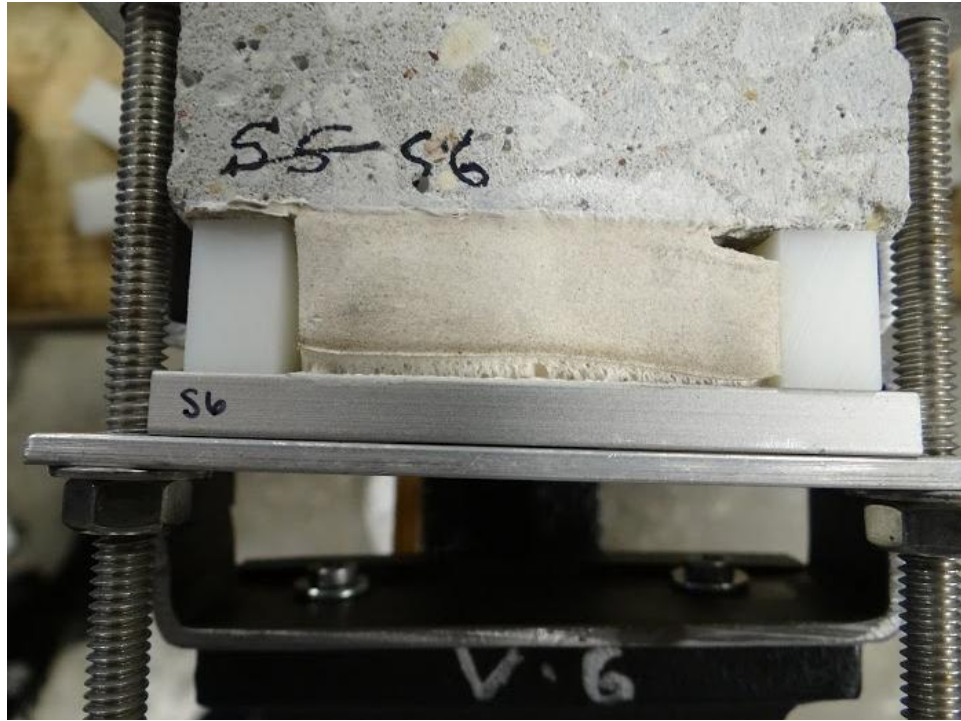
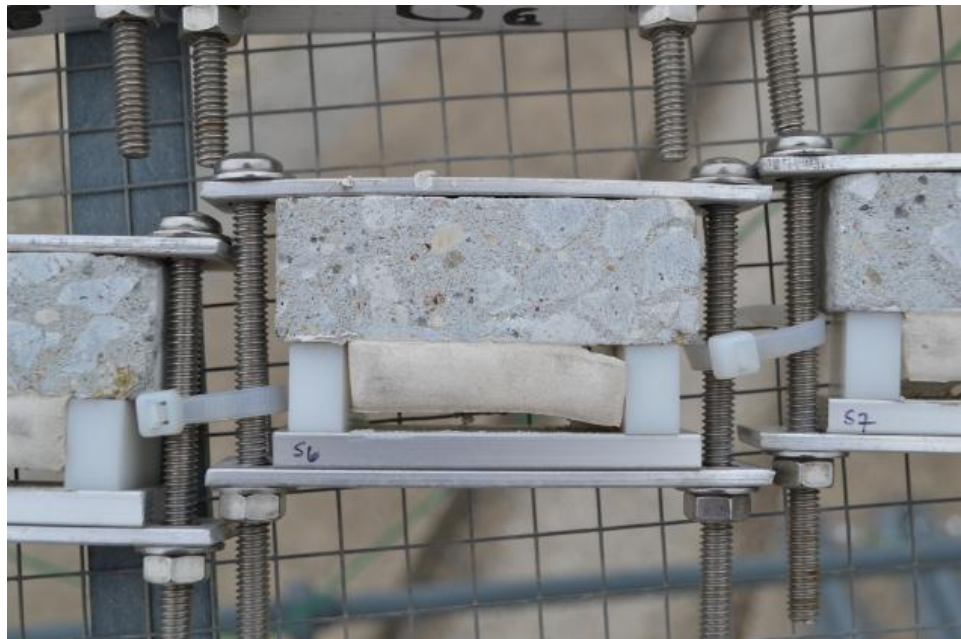
Figure 35: Sealant Specimen DRP1014-S6 (Urethane, Non-SWRI validated, Unprimed)
Immediately After (top) and 4 Months in Extension (bottom)

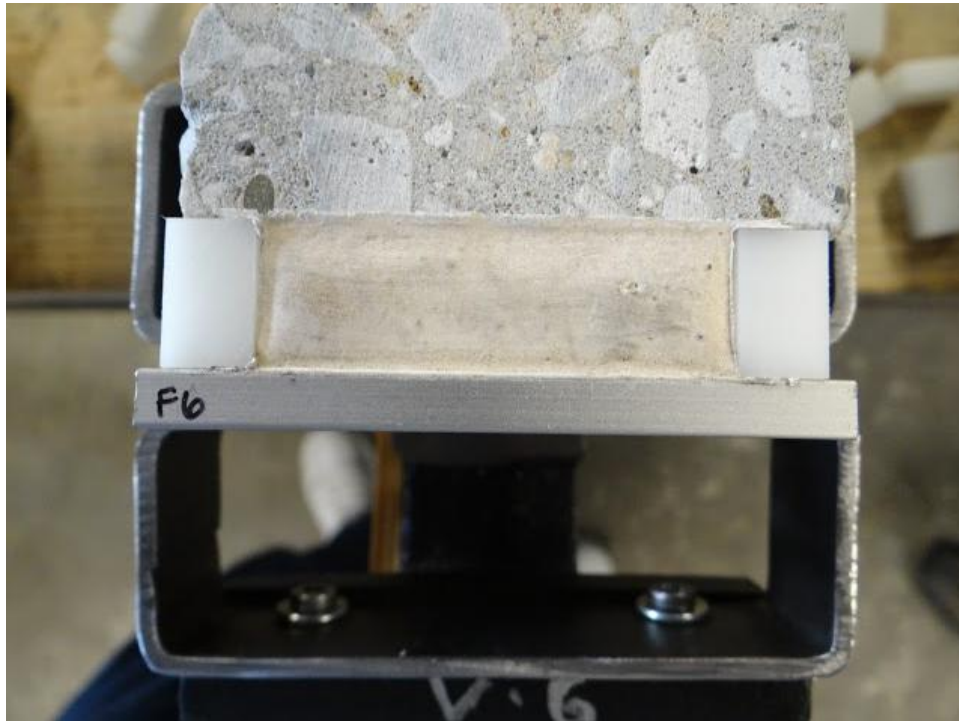
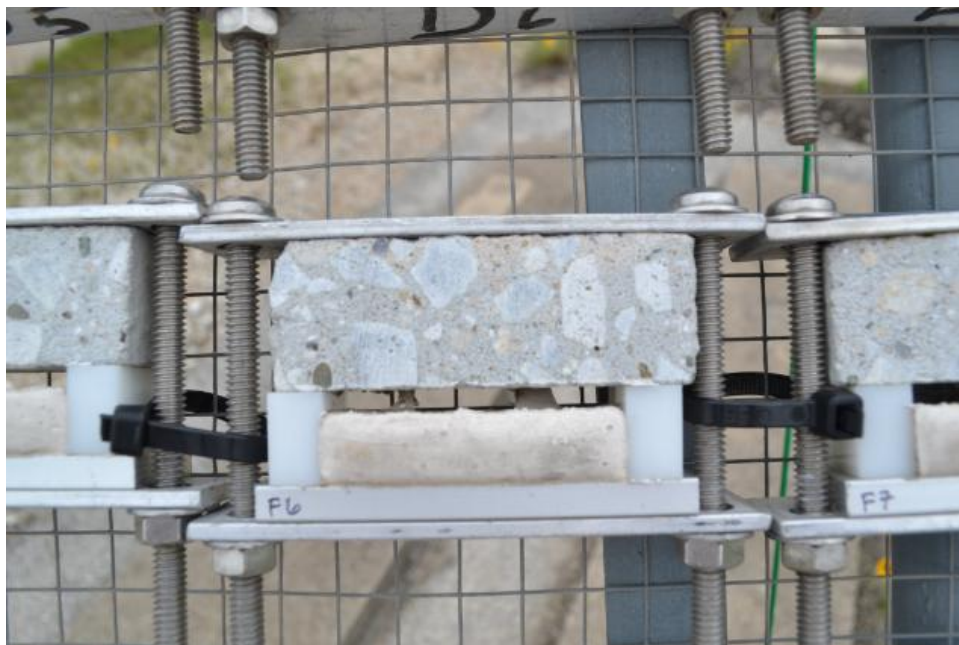
Figure 36: Sealant Specimen DRP1014-F6 (Urethane, Non-SWRI Validated, Unprimed) Immediately After (top) and Four 4 Months in Extension (bottom)

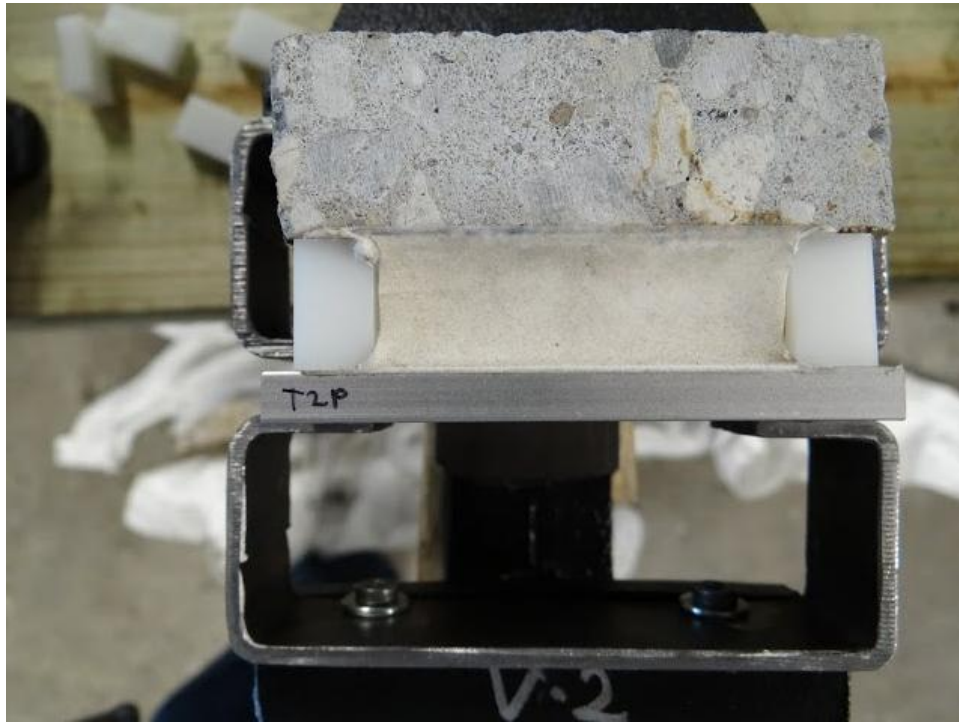
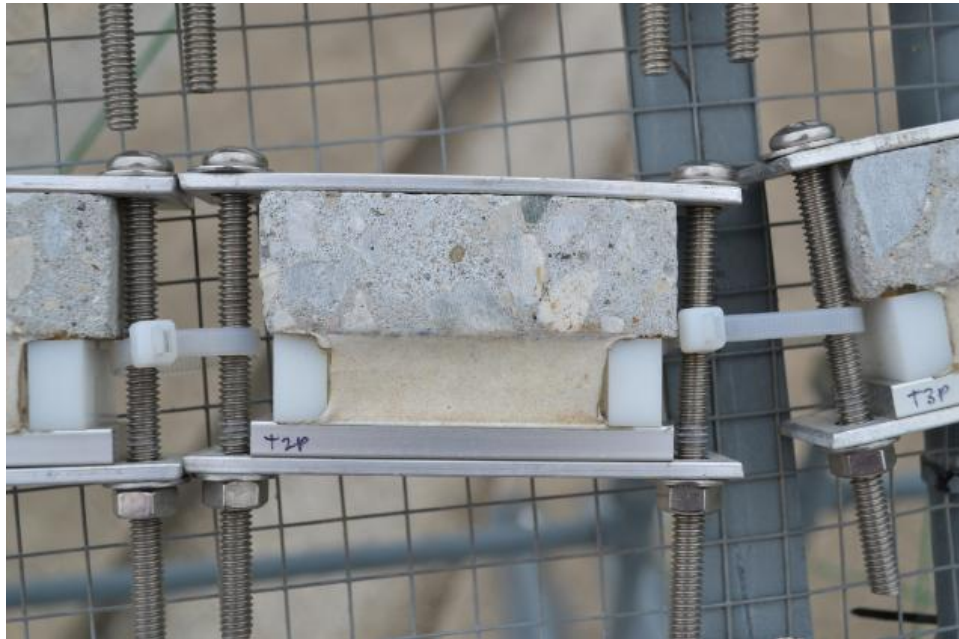
Figure 37: Sealant Specimen DRP1014-T2P (Silicone, SWRI Validated, Primed) Immediately After (top) and 4 Months in Extension (bottom)

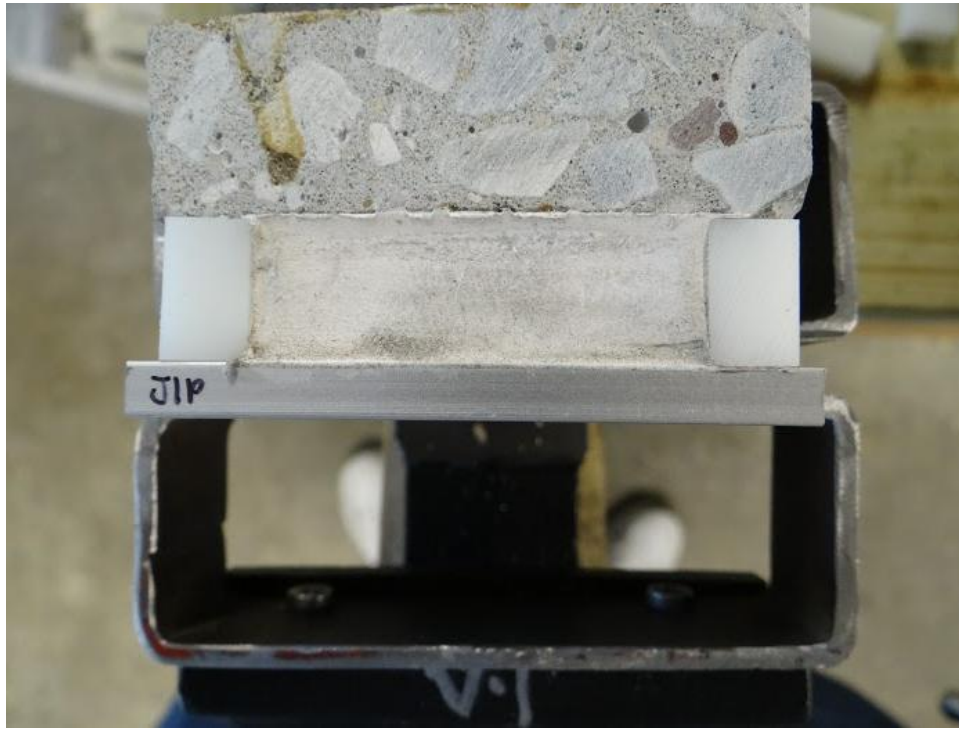
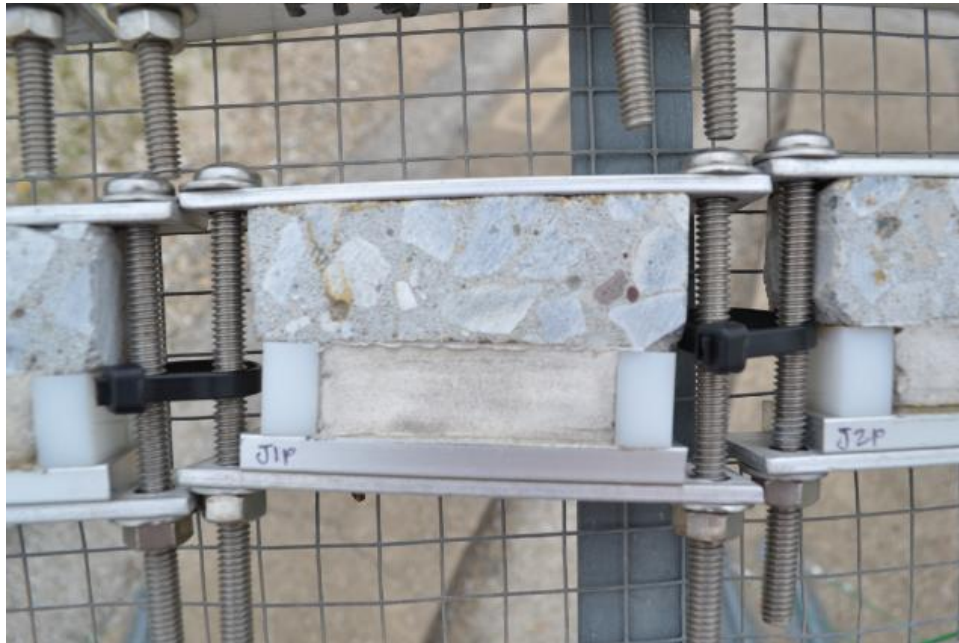
Figure 38: Sealant Specimen DRP1014-J1P (Urethane, SWRI Validated, Primed) Immediately After (top) and 4 Months in Extension (bottom)

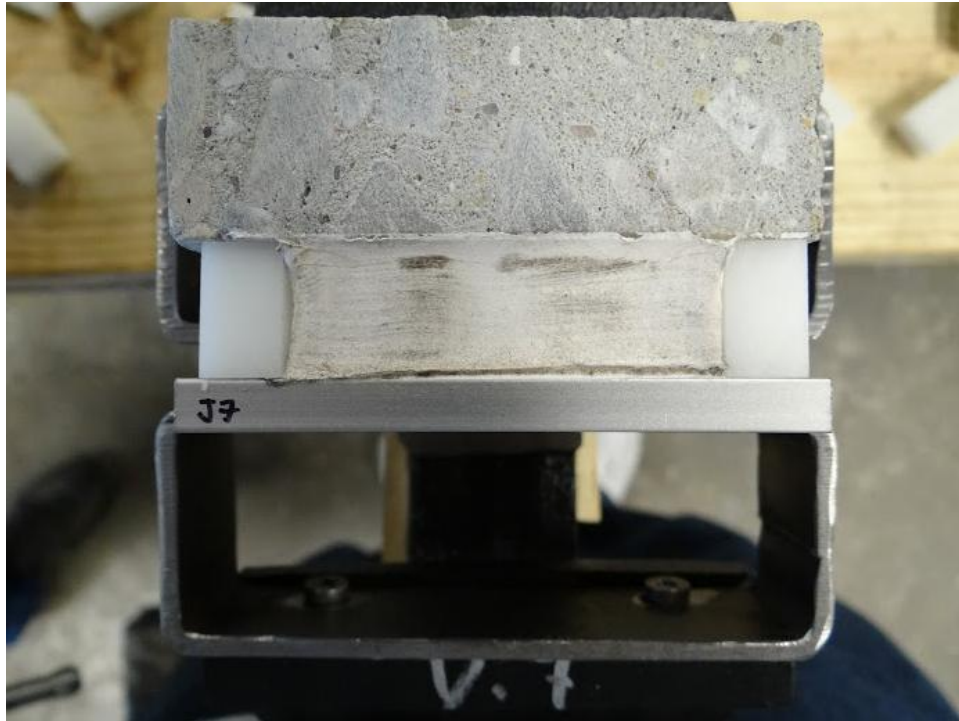
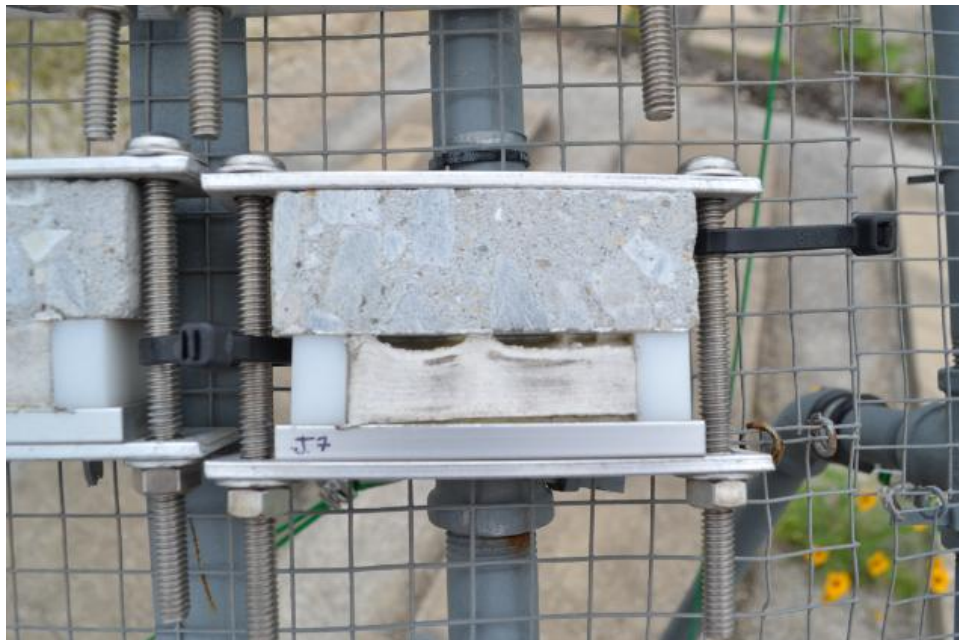
Figure 39: Sealant Specimen DRP1014-J7 (Urethane, SWRI Validated, Unprimed)
Immediately After (top) and 4 Months in Extension (bottom)

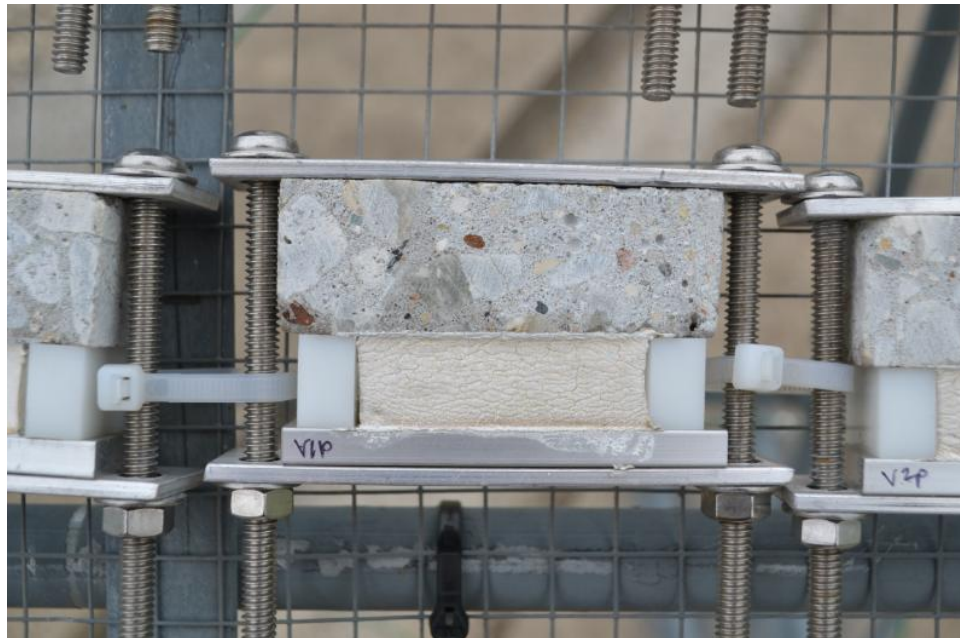
Figure 40: Specimen DRP1014-V1P Crazing After 4 Months in Extension

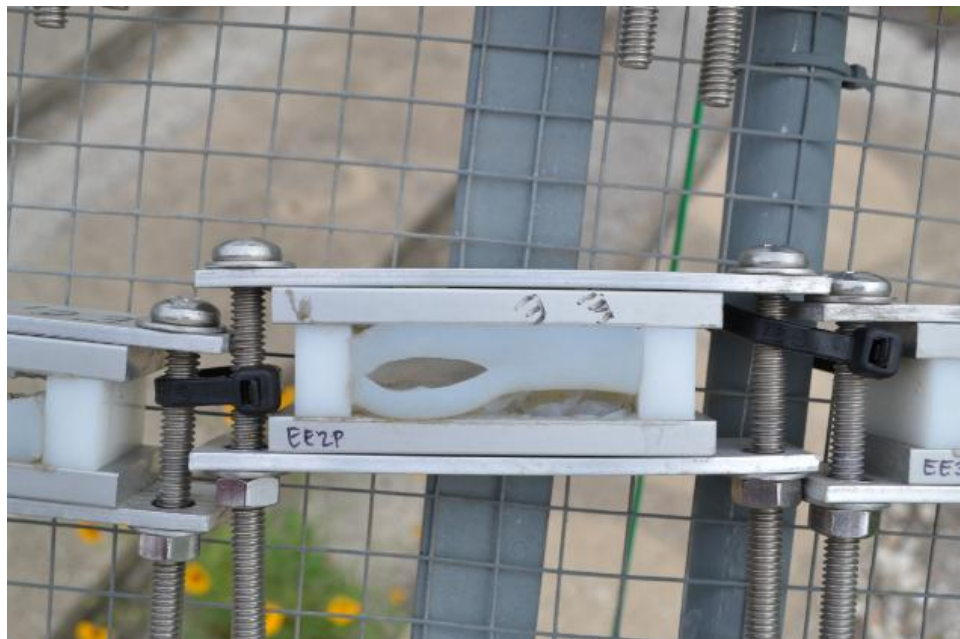
Figure 41: Specimen DRP1014-EE2P Partial Cohesive Failure After 4 Months in Extension

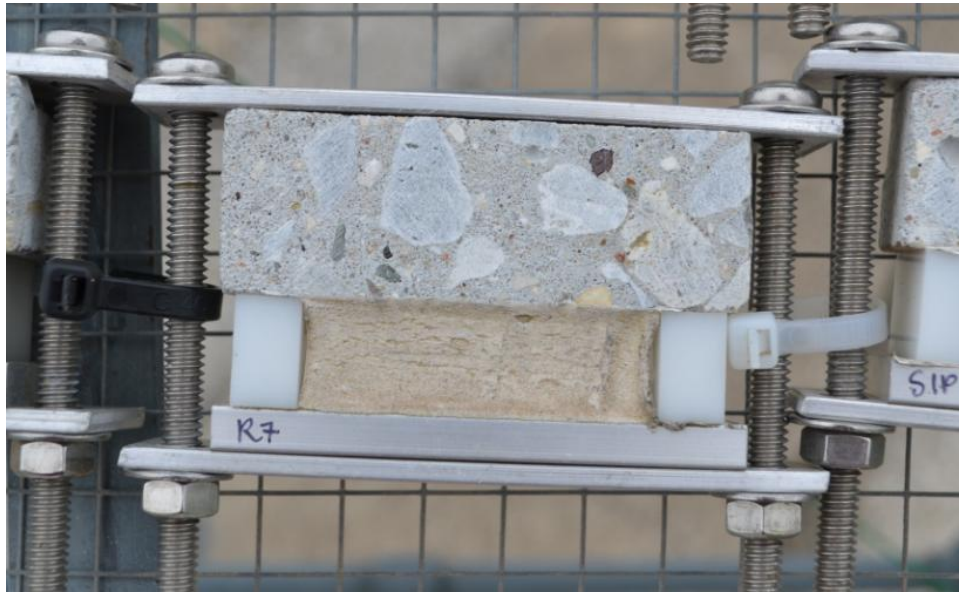
Figure 42. Specimen DRP1014-R7 Chain Scission After 4 Months in Extension
