Durability and Waterproofing Investigations of the Building Envelope

Thesis

The University of Texas at Austin

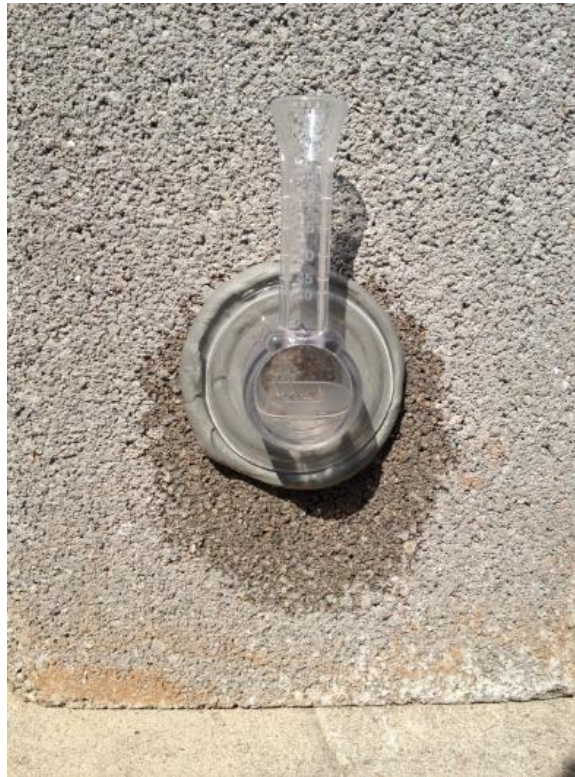
Thus, to further test CMU performance, 24 units (whose results are reported here) were donated from a local stone distributor. Twelve of the units contained IWR and the others did not. Upon delivery, it was unclear as to which CMUs had the IWR and which did not, but by completing the RILEM tube testing, the results showed which units had the IWR. Although all 24 blocks failed the RILEM tube test with the tall, 5-mL tube, there were significant differences in the short tube tests. Those that passed with no water loss after 20 minutes had IWR, and those that failed with lost water almost instantly did not have IWR (Figure 45).

Figure 45: Failed Short RILEM Tube Test on CMU without IWR
