The Preservation of the John A. Kerr Building

Report

Master of Science in Historic Preservation

May 2012

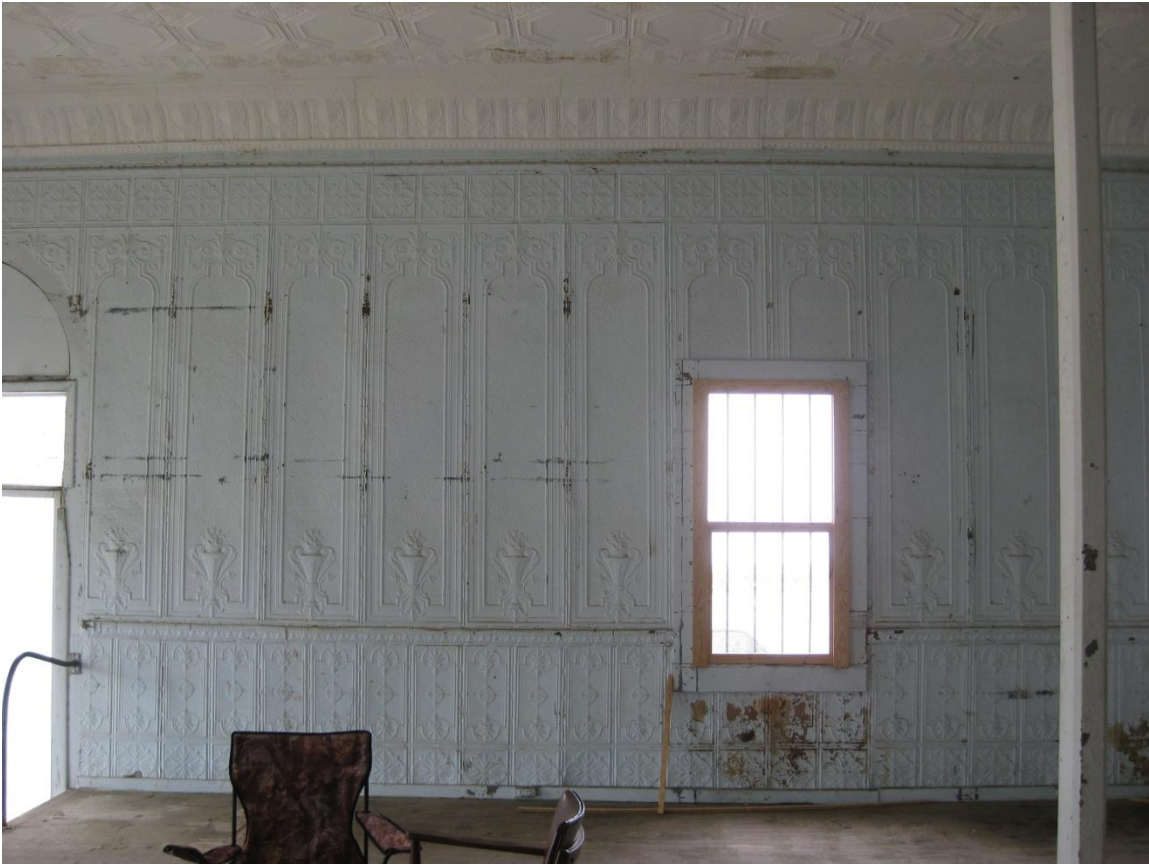
Figure 18: View of southern wall showing pressed metal. Note corrosion under the window.

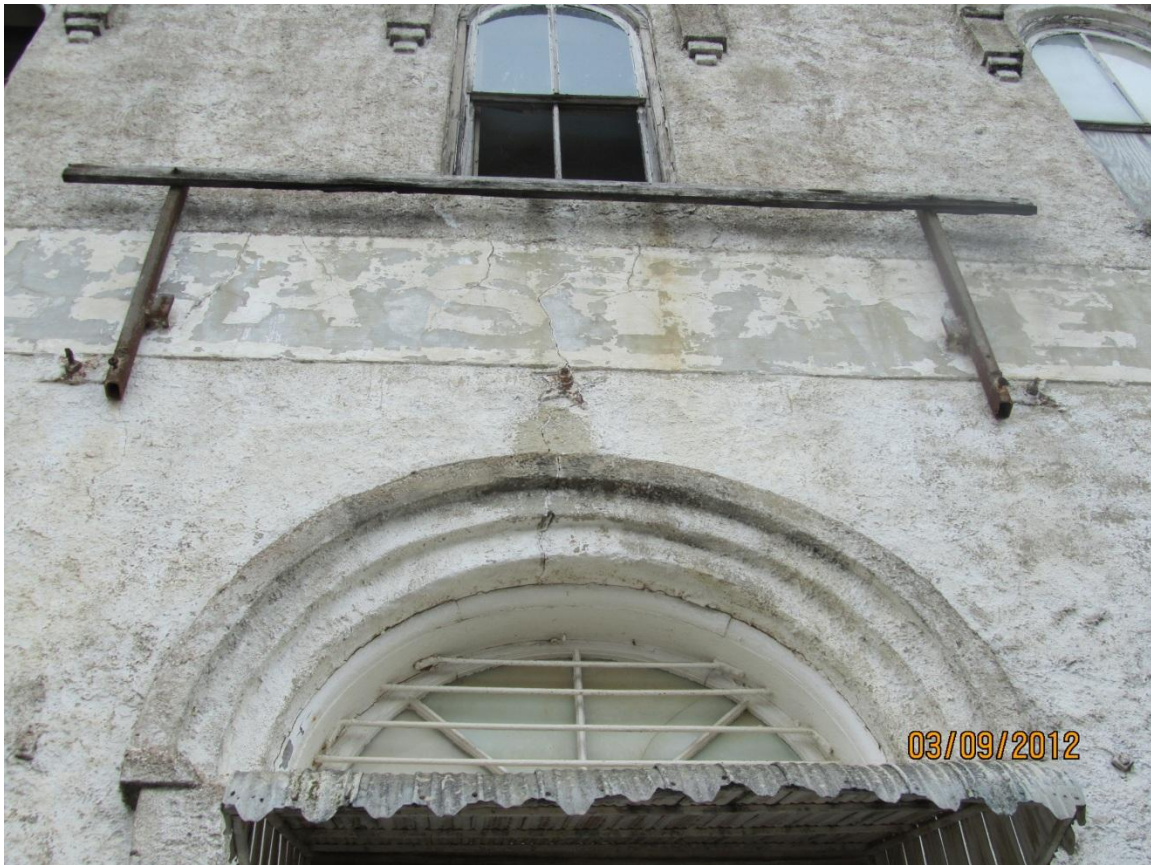
Figure 23: Staining evident on the east elevation.

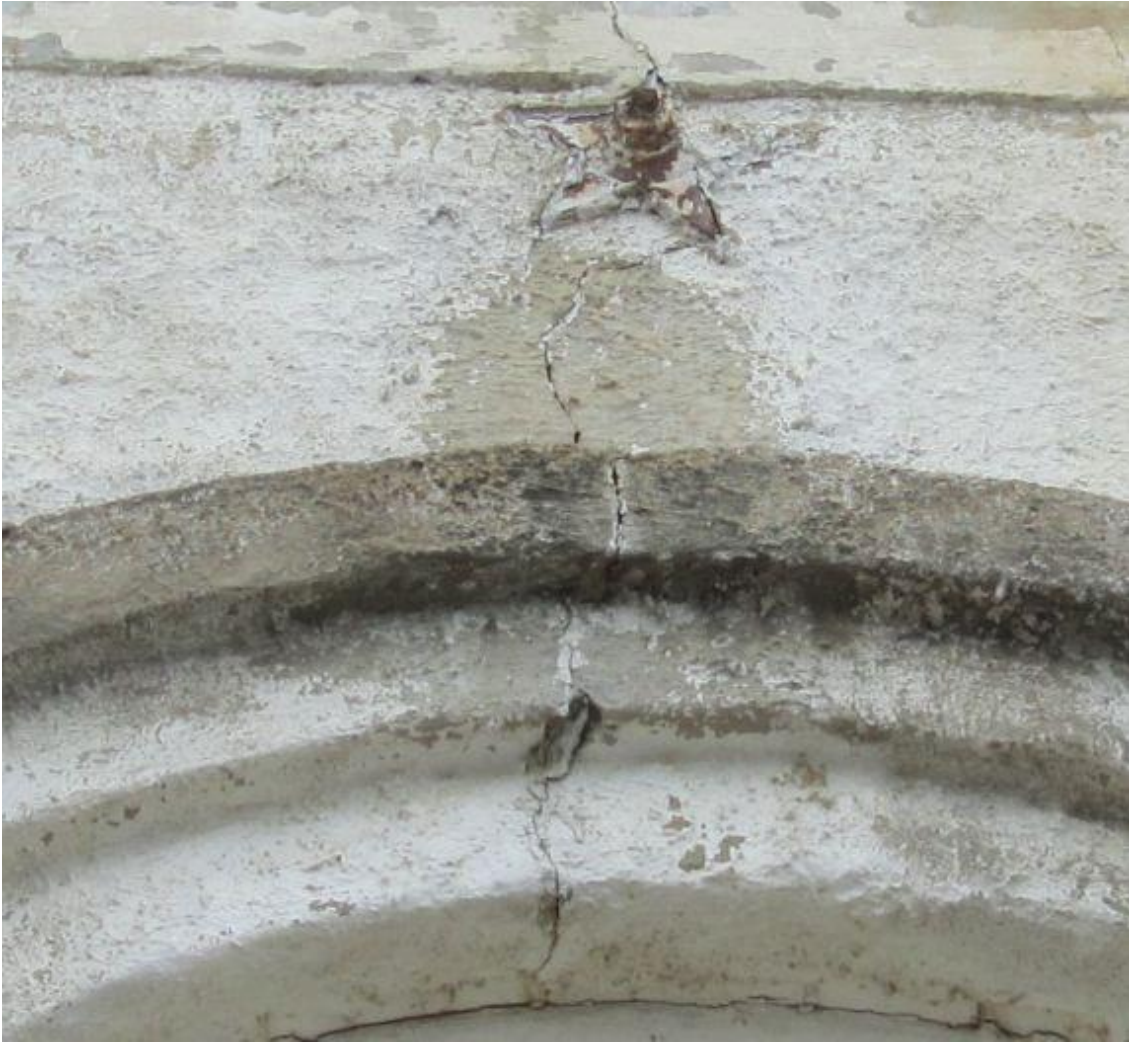
and in some cases they continue diagonally upwards through to the parapet. The cracks do not follow the mortar joints and it is possible that the cracks affect both the brick substrate and cement stucco. Many of these cracks have been inappropriately repaired with a cementitious mortar that does not blend in with the surrounding area due to its darker color. Additionally, of the cracks are still open, indicating that some cracks are still active (Figure 24). Crack repairs can be found above each of the large, first floor arches on the east elevation, and on the first floor arch and below one of the second story windows on the south elevation.

Figure 24: A failed crack patch over the central opening of the east elevation.

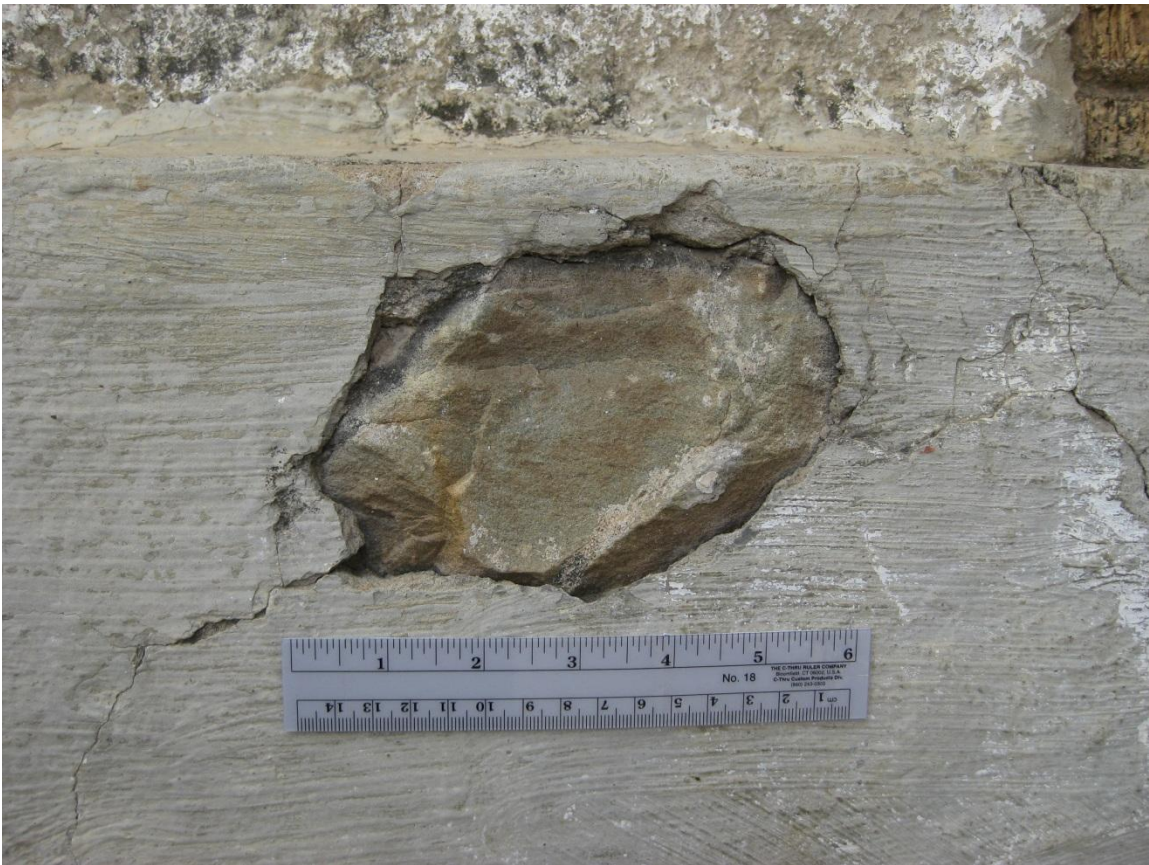
The east elevation, or façade, exhibits severe paint coating failure under the small porch the projects from under the main entrance. To the north of the base, there is also a cement stucco spall that reveals the ironstone substrate (Figure 25). Chipping and holes, resulting from missing parts, are also present on the base around the basement clerestory windows. These windows also contain ferrous cross bars that are corroded.

Figure 25: A cement stucco spall from the base of the east elevation.

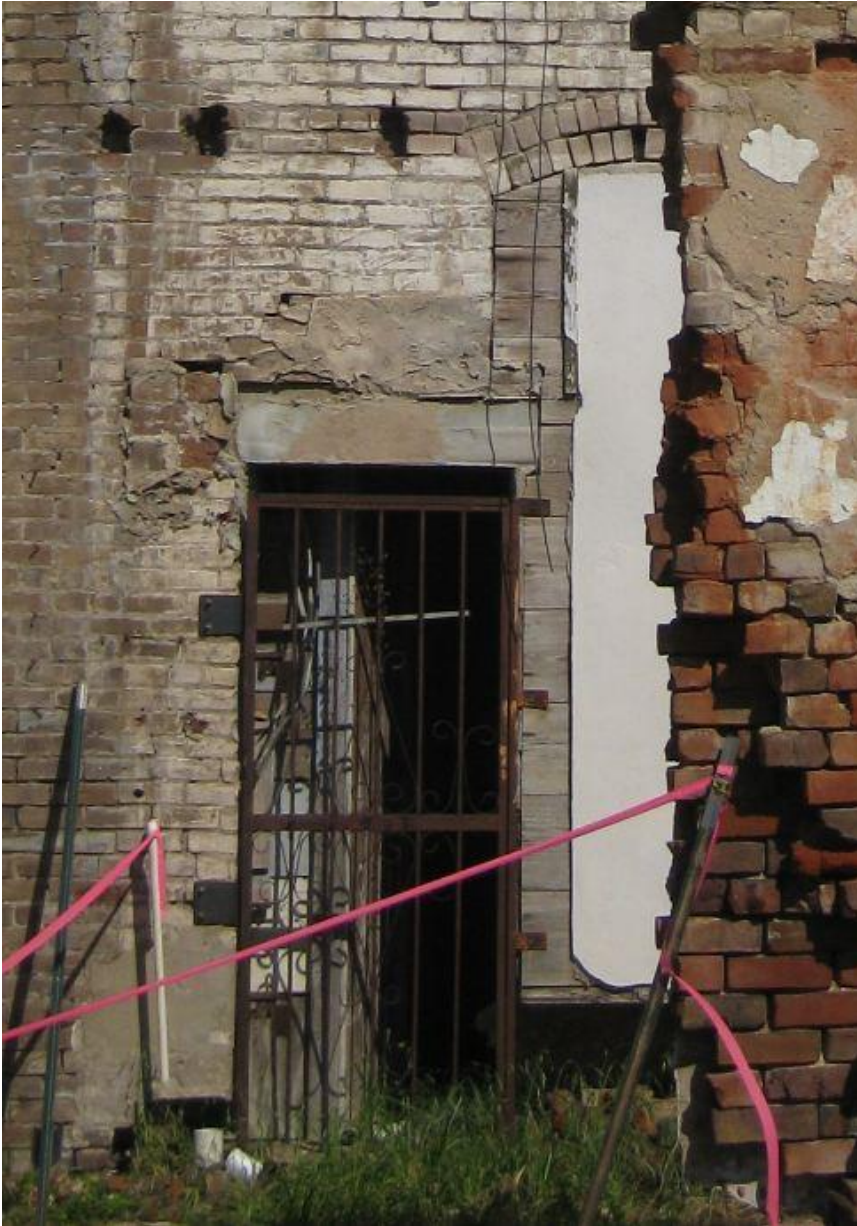
Figure 26: Inappropriate patch, open joints, and holes on the west elevation.

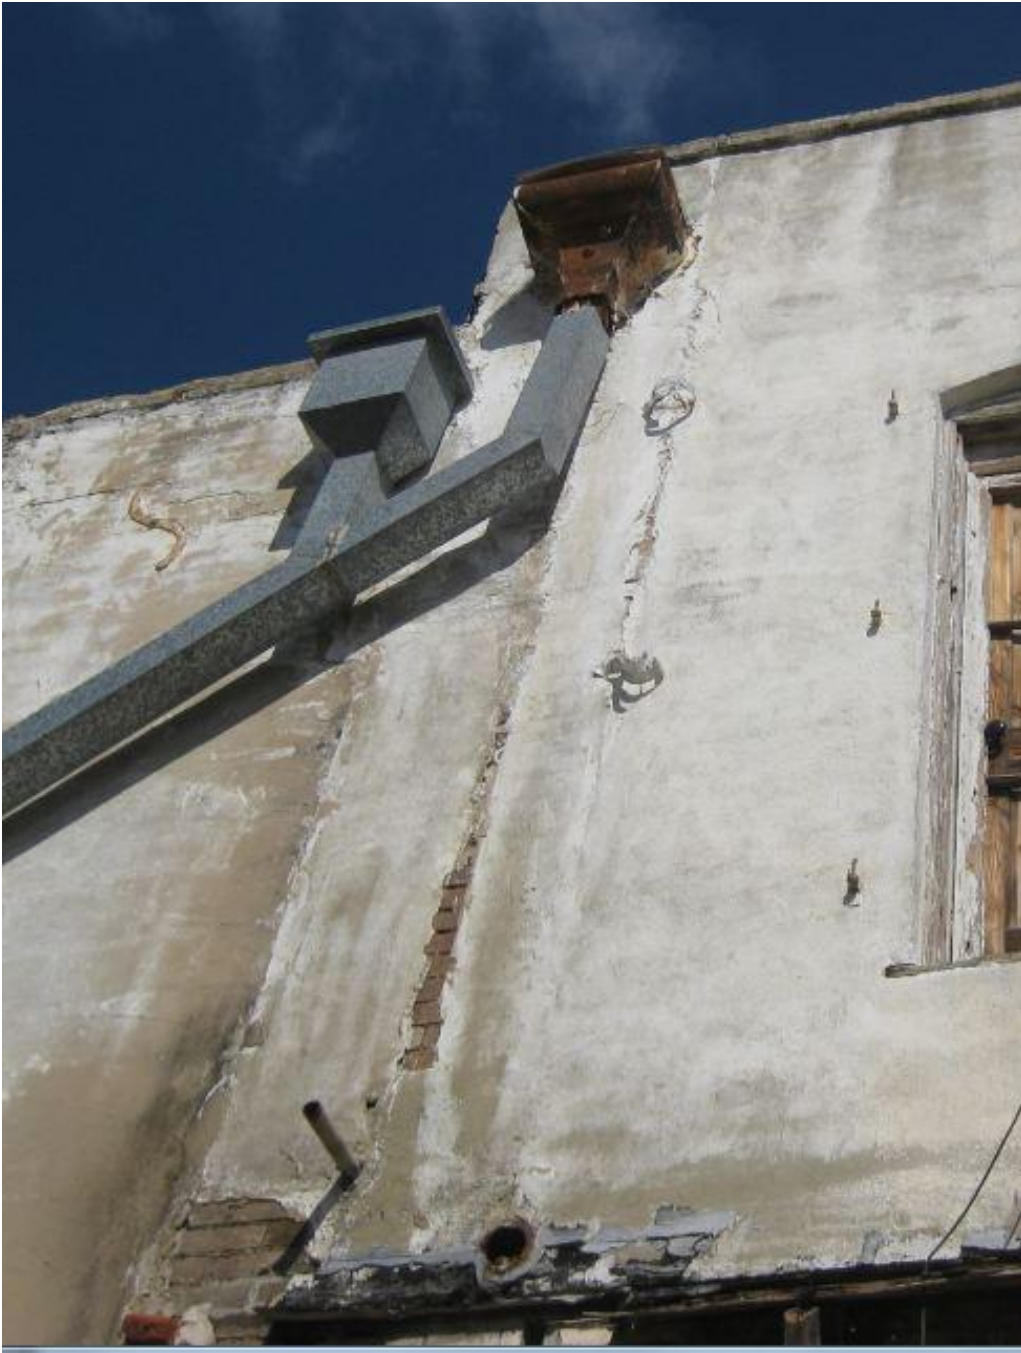
The upper north corner of the west elevation has a large downspout which serves as the only conduit for water drainage. The downspout is heavily corroded, and the stucco around it and below it is either cracking, has failed, or is missing (Figure 27). Like the other stuccoed areas, this area was originally painted white, but the coating is now failing resulting in a mottled appearance. There are also cracks present throughout this area, again ranging from hairline to visible from afar, up to ½ inch wide. The largest crack is visible above the right window opening, and it spans the area between the window opening and the parapet wall. Here, the parapet wall exhibits some biological growth and staining as well, but not on the same scale as the other elevations.

Figure 27: Corroded downspout and stucco loss. West elevation.

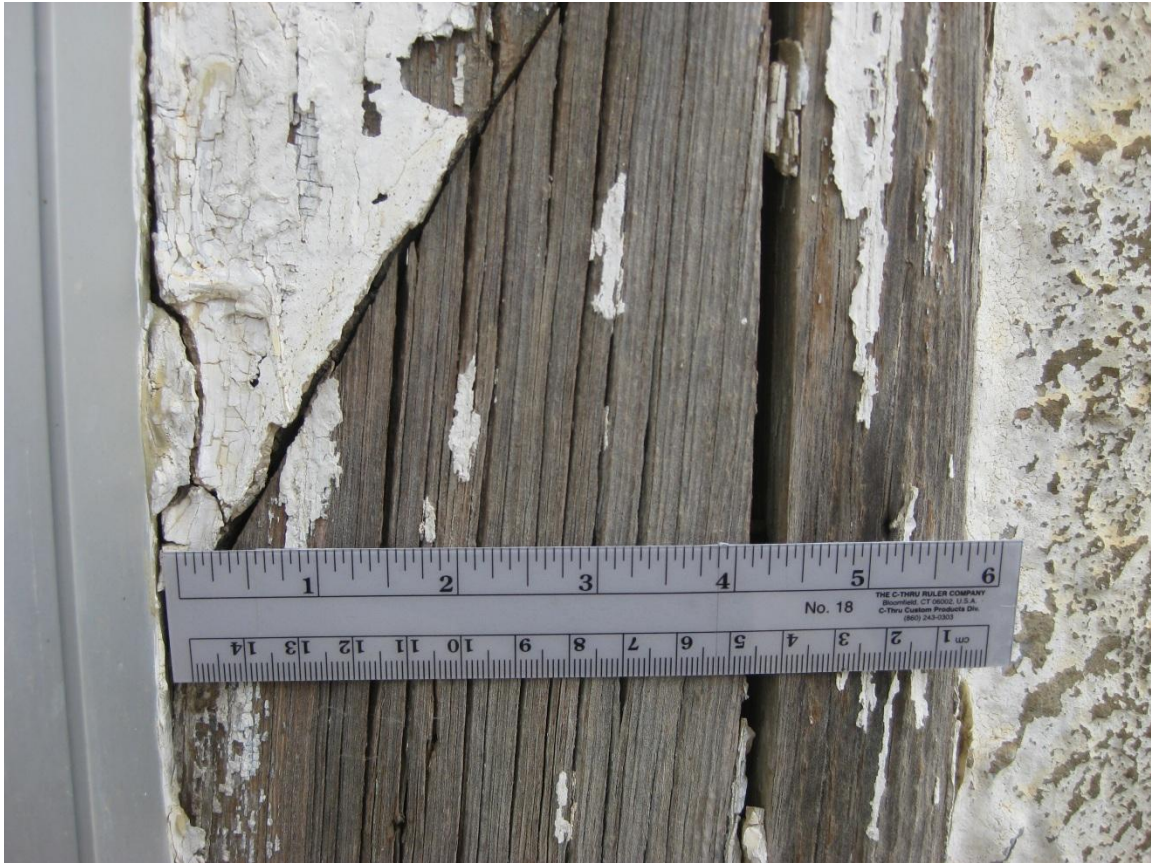
All wood elements of the window and door openings, with few exceptions, have white paint coatings which are in various states of deterioration. The wood elements on the south and west elevations and the second floor of the east elevation, exhibit the greatest loss of paint, while those elements on the first floor of the east elevation exhibit loss of paint to a lesser degree. This could be due to the metal awnings that were present over each window, of which only one survives. However, they too are in poor condition. These wood elements all exhibit cracking and/or splintering and many have a faded, washed out appearance (Figure 28).

Figure 28: Severely deteriorated wood door frame. South elevation.

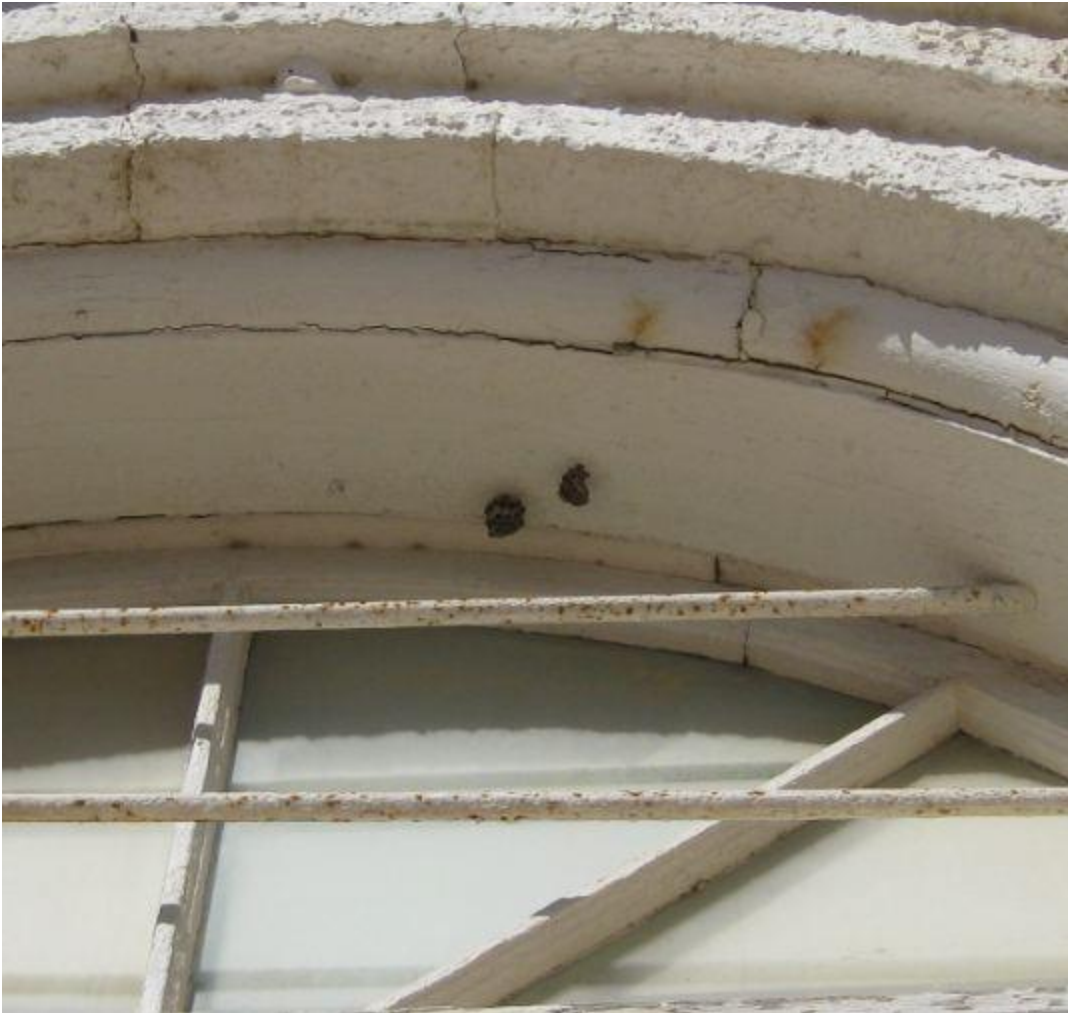
There are also instances of biological colonization found under the wood arches above the larger openings (Figure 29). These are in the form of wasp nests, and although currently small, there is potential for a larger scale infestation if not remedied.

Figure 29: Wasp nests on wood elements. South elevation.

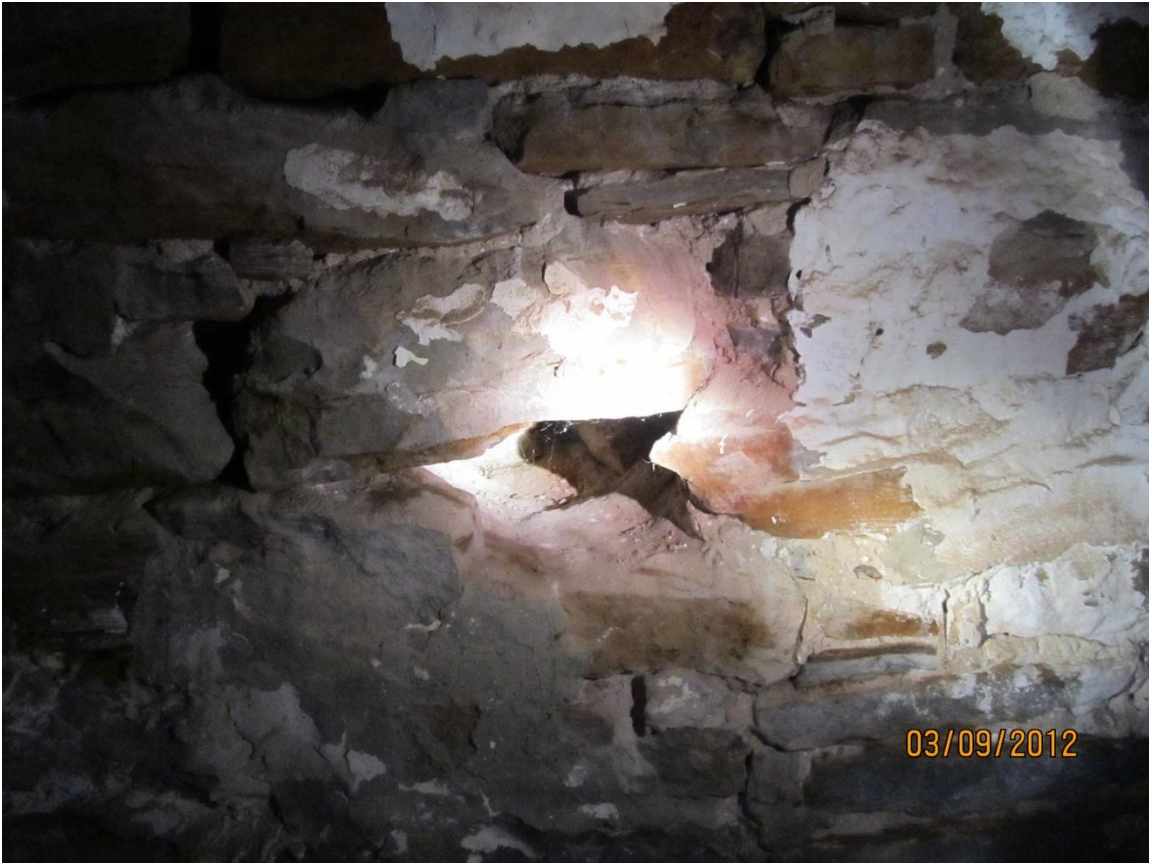
The foundation consists of coursed ironstone rubble in good condition with a presumably lime-based mortar, which is deteriorated and powdery in some areas. Some of the joints are open, and some mechanical damage exists as well, especially along the northern basement wall (Figure 30).

Figure 30: Coursed ironstone rubble on the basement's north wall.

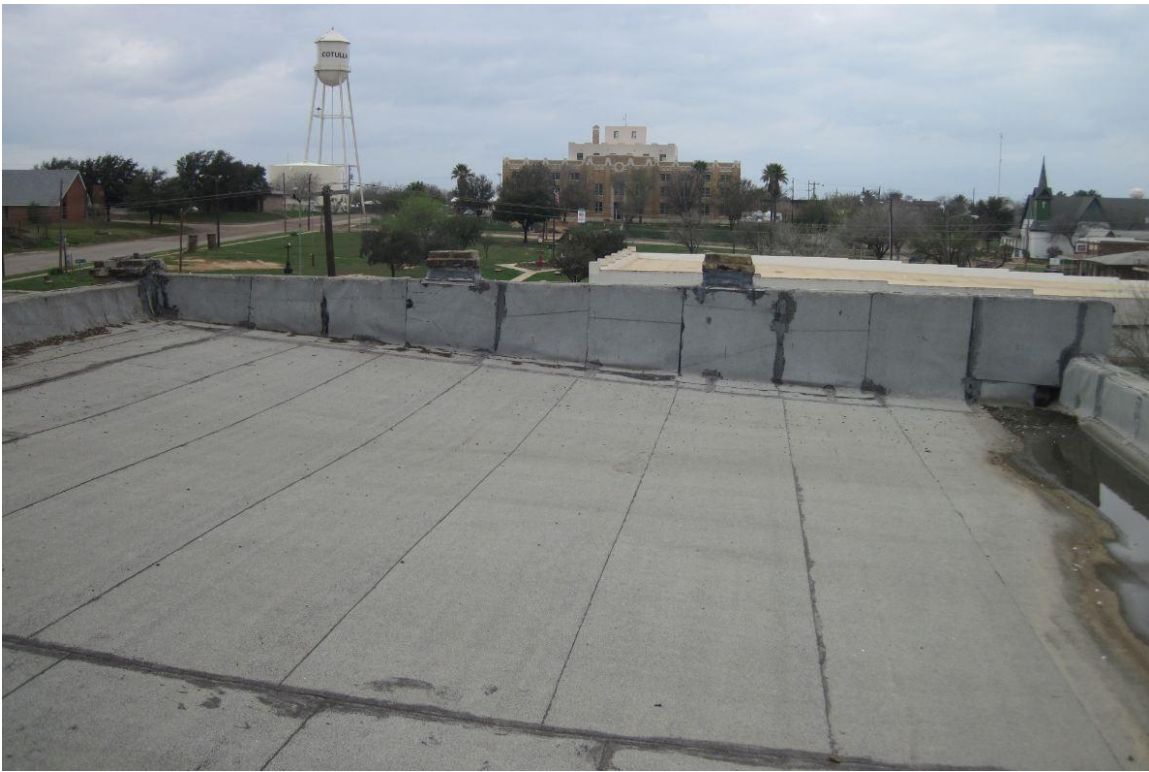
Figure 31: Partial view of the roof with standing water. Camera facing west. (Source: Wade Shoop)

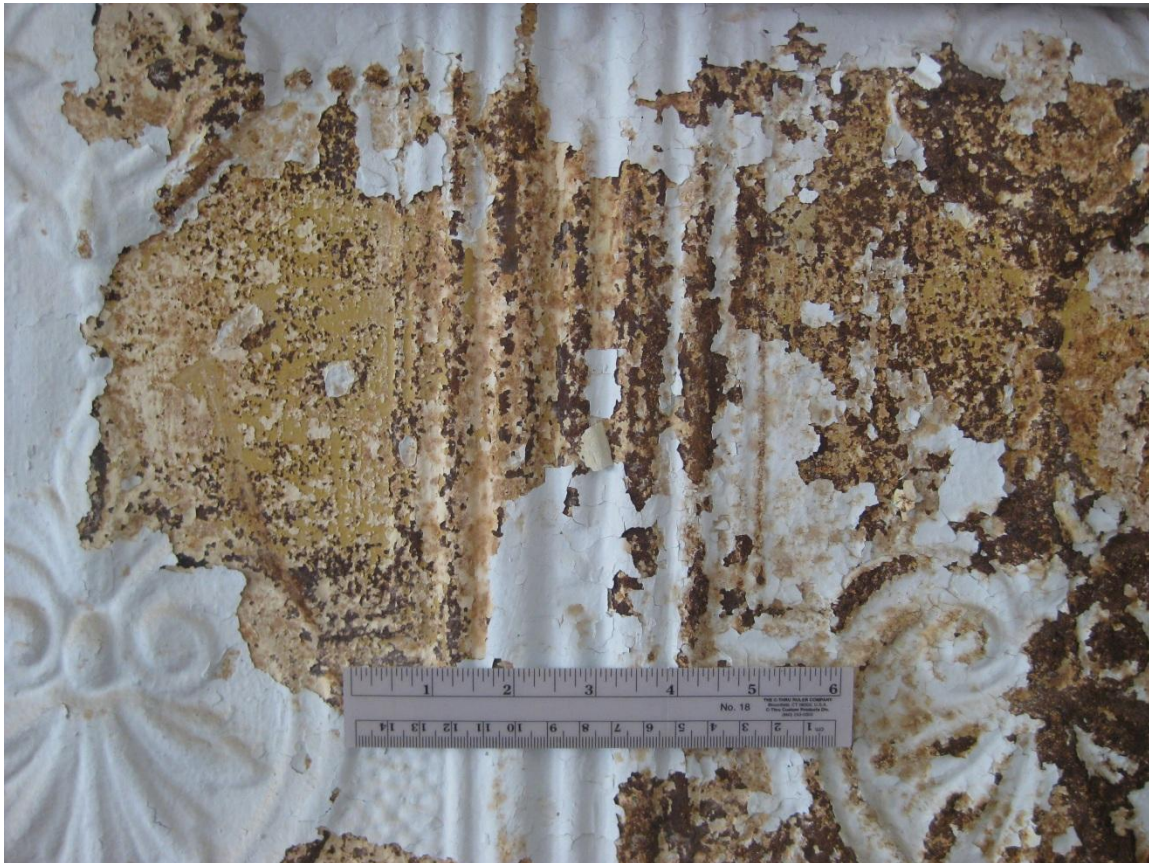
window openings, causing corrosion. This area still retains some of the paint coating, which indicates that the corrosion is continuing under the paint causing it to lose adhesion.

Figure 32: Pressed metal corrosion on the south wall. This area is underneath one the window openings.

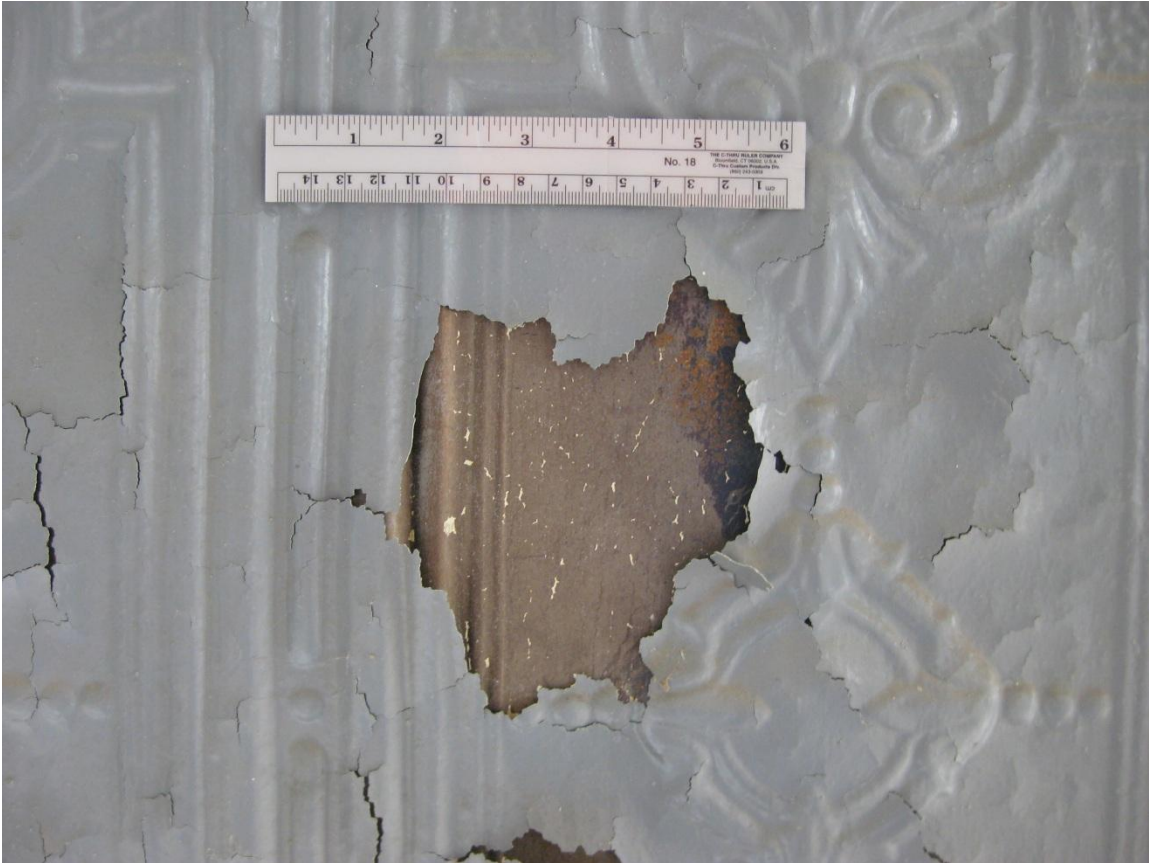
moisture or water vapor beneath paint layers.¹³⁰ These areas are primarily located along the lower portion of the pressed metal, and leave the pressed metal exposed to further corrosion.

Figure 33: Peeling and flaking paint on the east wall.

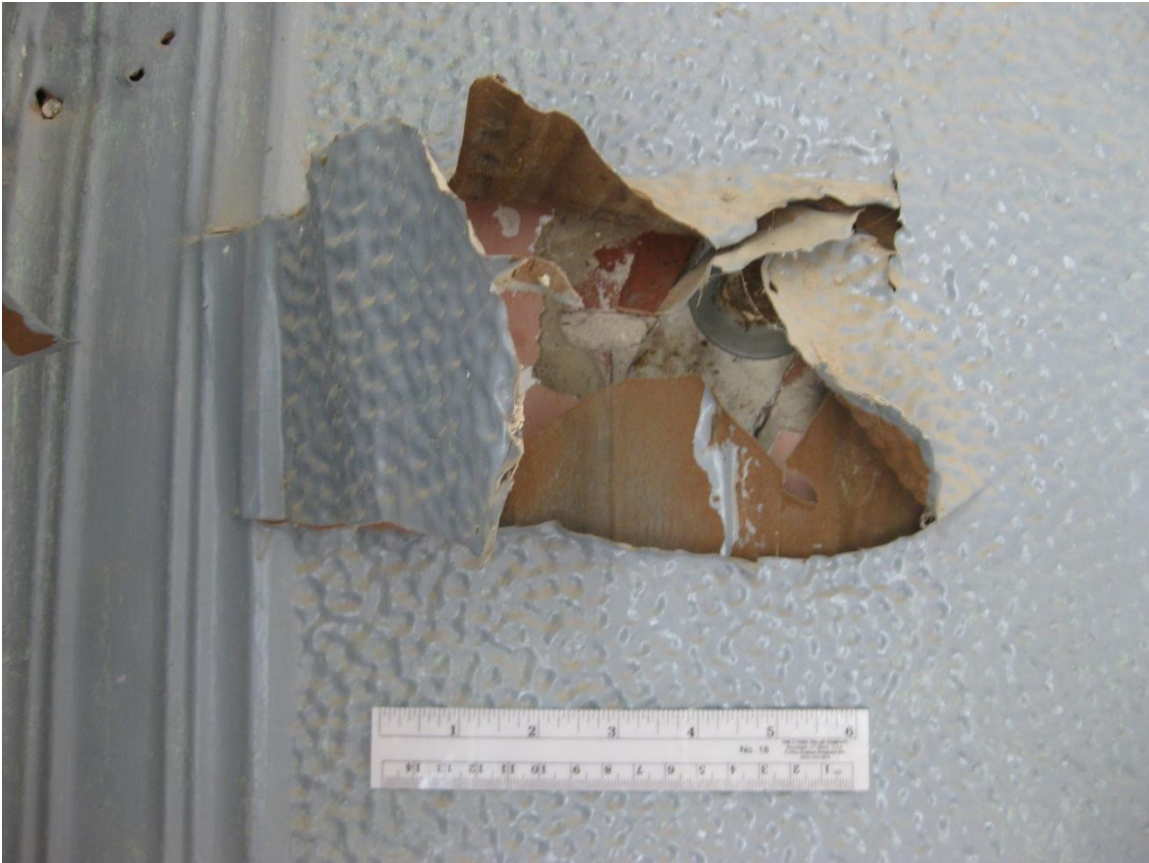
Figure 34: Mechanical damage of the pressed metal wall. South wall.
