Design Considerations for Embankment Protection During Road Overtopping Events

Jeffrey D. G. Marr, Principal Investigator

St. Anthony Falls Laboratory

Final Report 2017-21

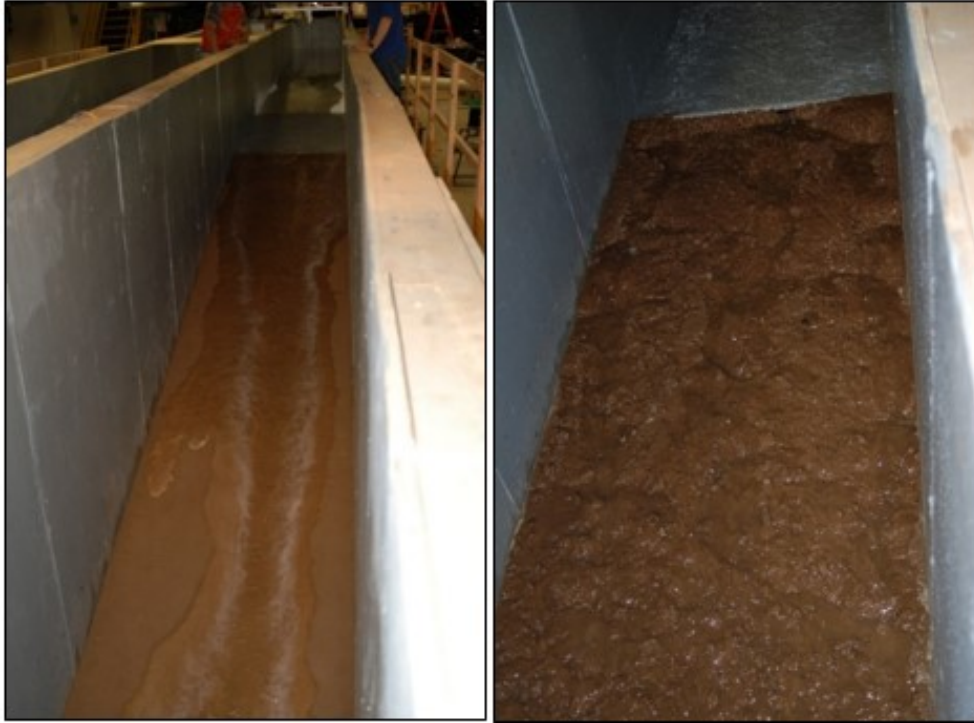
Figure 4.8. (Left) Initiation of flow on 6H:1V slope looking upstream. (Right) Erosion began immediately with incisional channels forming on slope.

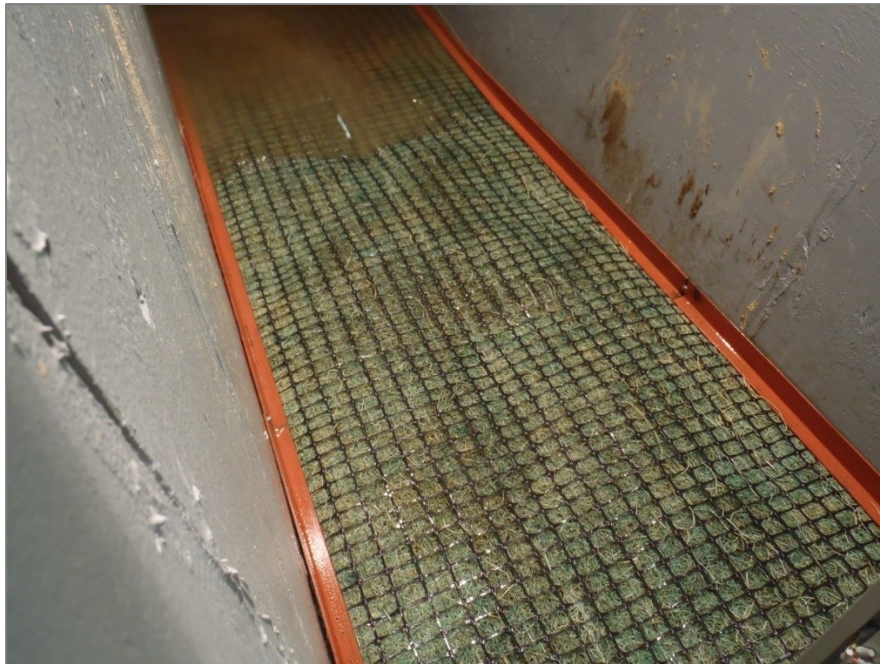
Figure 4.30. Image of early sign of erosion as a depression 75% of the way down slope caused water to separate from bed. Image is looking downstream near toe of slope with tail-water still draining.

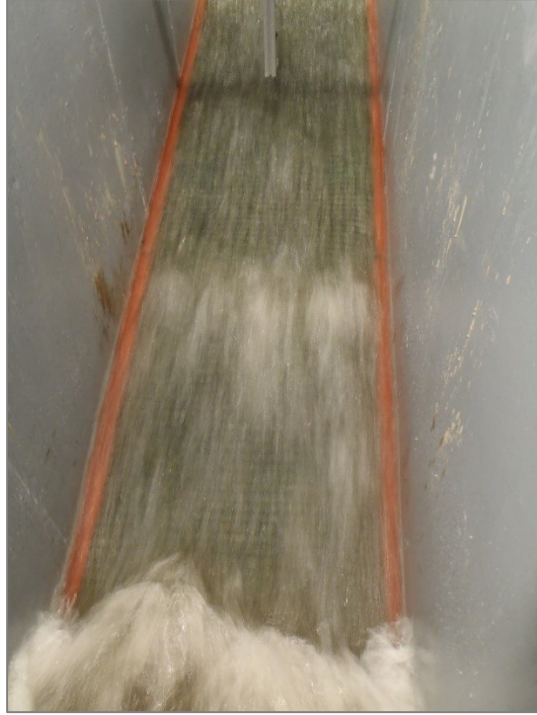
Figure 4.31. Flow on slope becoming aerated because of the increasing depth of erosion and separation of the geogrid from the soil. The image shows the formation of a hydraulic jump at bottom of the slope.

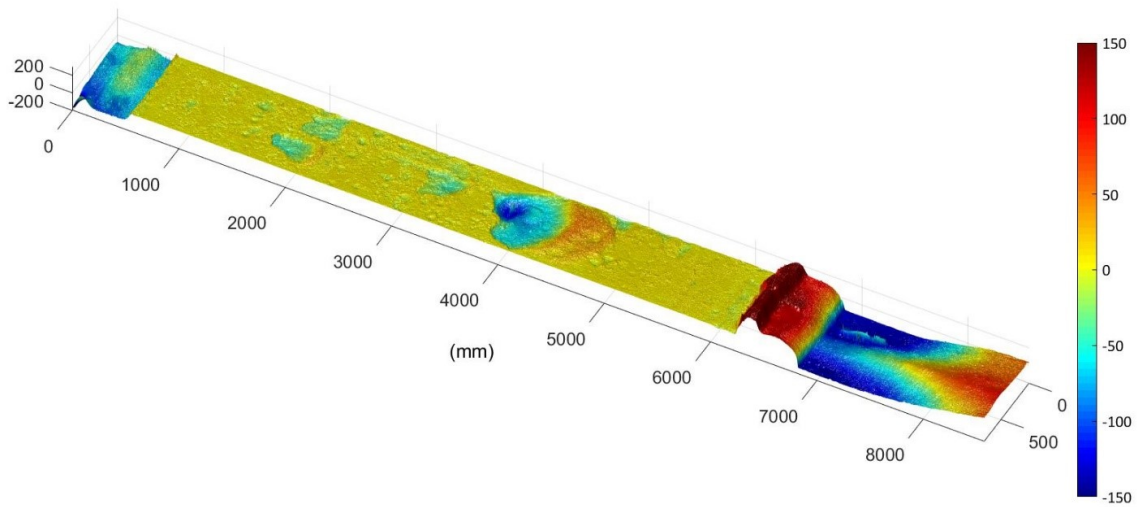
Figure 4.35. Topographic difference plot of final bare soil condition vs. initial bare soil condition. Erosional areas are easily identified here because the ECB covering was removed for the scan.

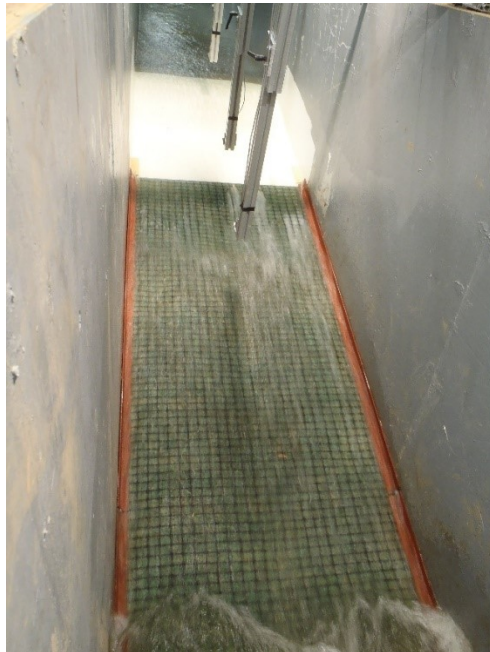
Figure 4.45. Looking upstream after 1.5 hours of run time. Erosion is observed 1.5ft downstream from the shoulder in the river-left half of flume.

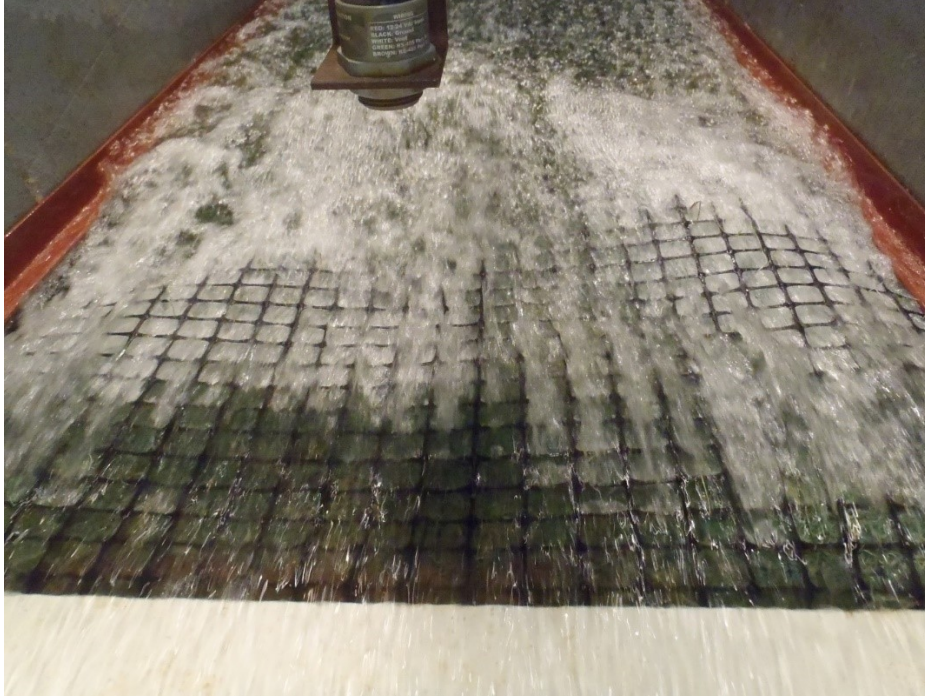
Figure 4.46. Looking downstream from the shoulder during 2-4 hour testing period. Note the large area of erosion occurring near the shoulder specifically near the left wall.

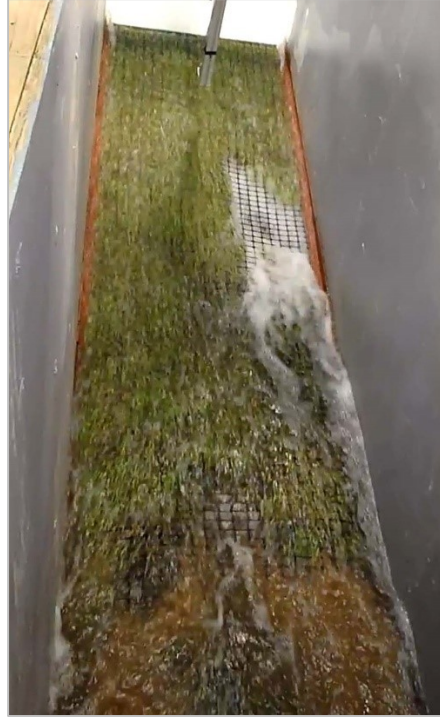
Figure 4.65. During final 4-5.5 hour run, catastrophic erosion took place. Most of the lower slope began eroding under the sod, which had come loose but was held from being washed away by the geogrid and staples.

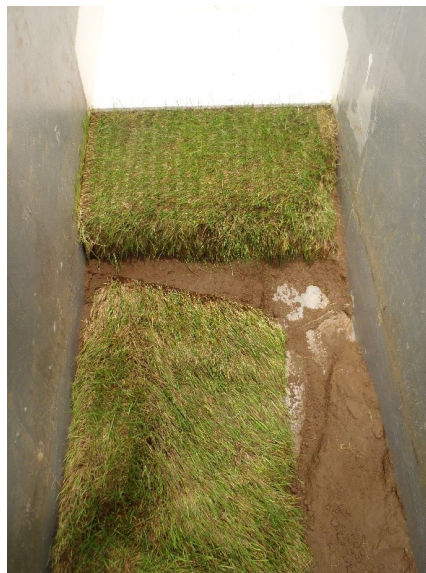
Figure 4.66. Looking upstream at shoulder to slope transition after the geogrid has been removed. Most of the transition is still intact while the areas where there was a seam between the rolled out pieces of sod allowed water to penetrate and erode the slope surface under the sod which was being partly held in place by the geogrid and landscaping staples.

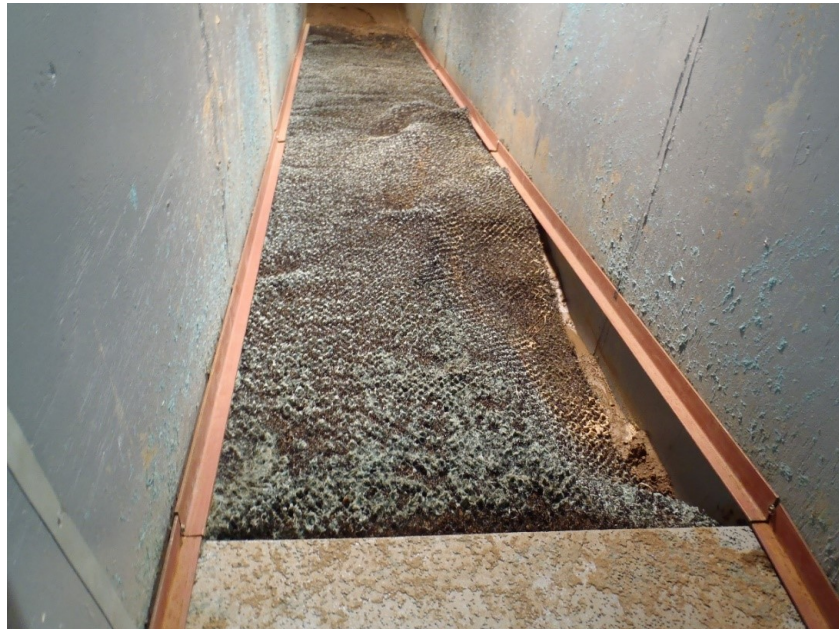
Figure 4.85. View looking downstream after 8.25 hours of run time. The large amount of erosion along right wall represents failure.

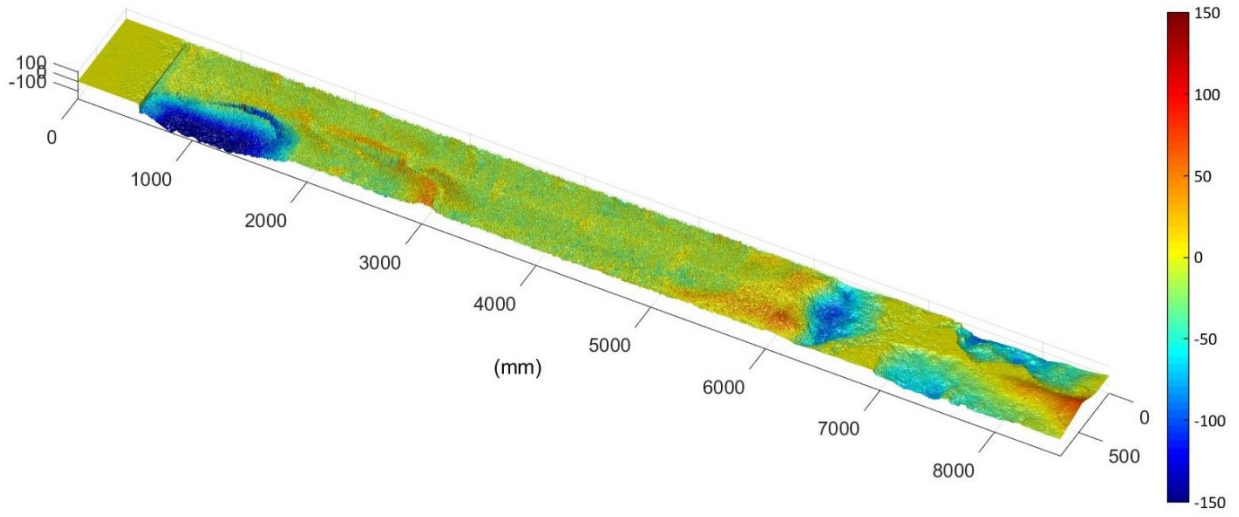
Figure 4.89. Topographic difference plot from zero to 8.25 hours. Erosion quickly expanded near the top of the slope leading to failure.

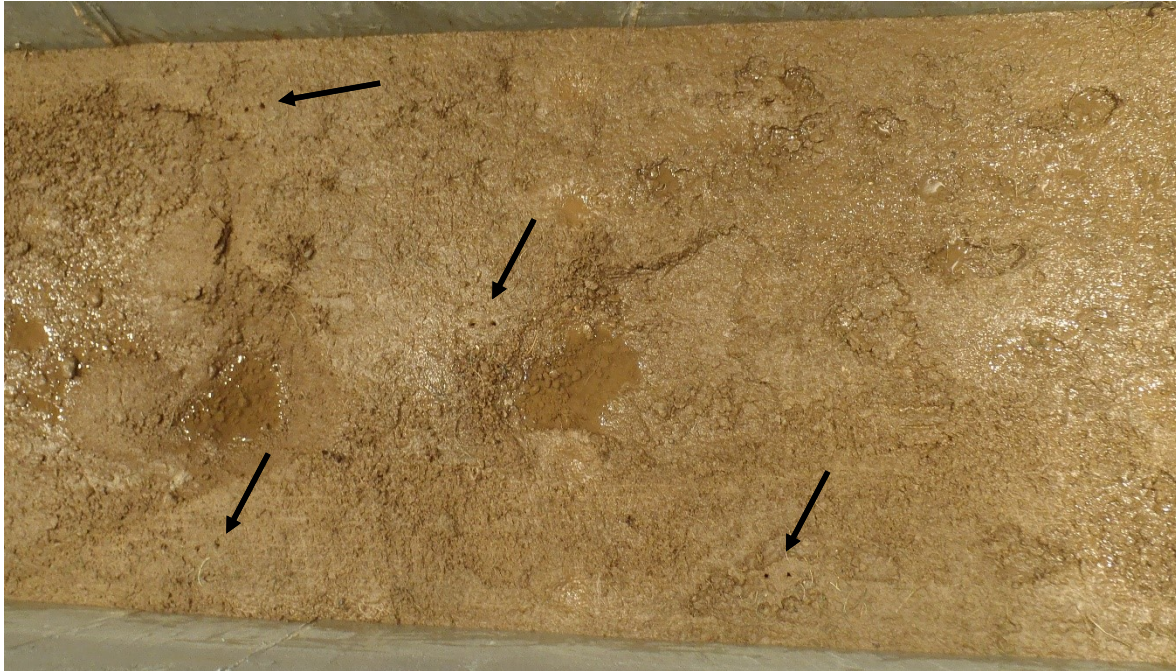
Figure 6.1. View from above of the bare soil after the ECB was removed post-testing, 6H:1V slope. Note the indicated holes where the staples were holding down the stabilization material. Flow was from right to left.

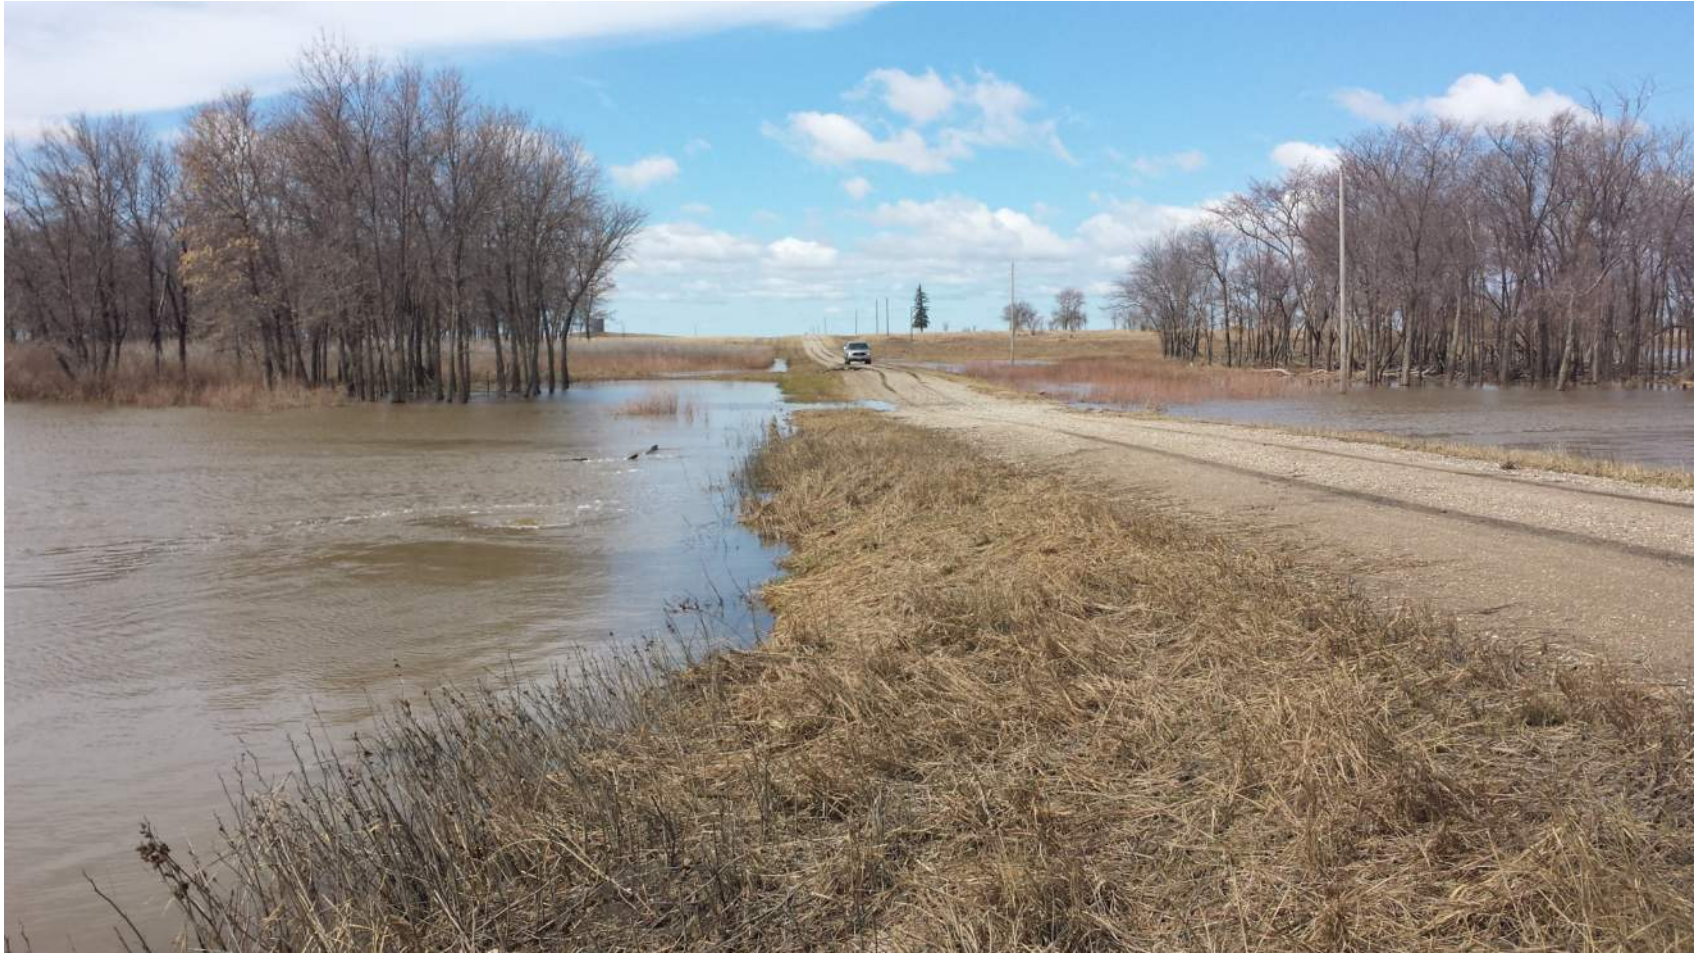
Location 4 Looking west at the upstream shoulder, post-flooding condition

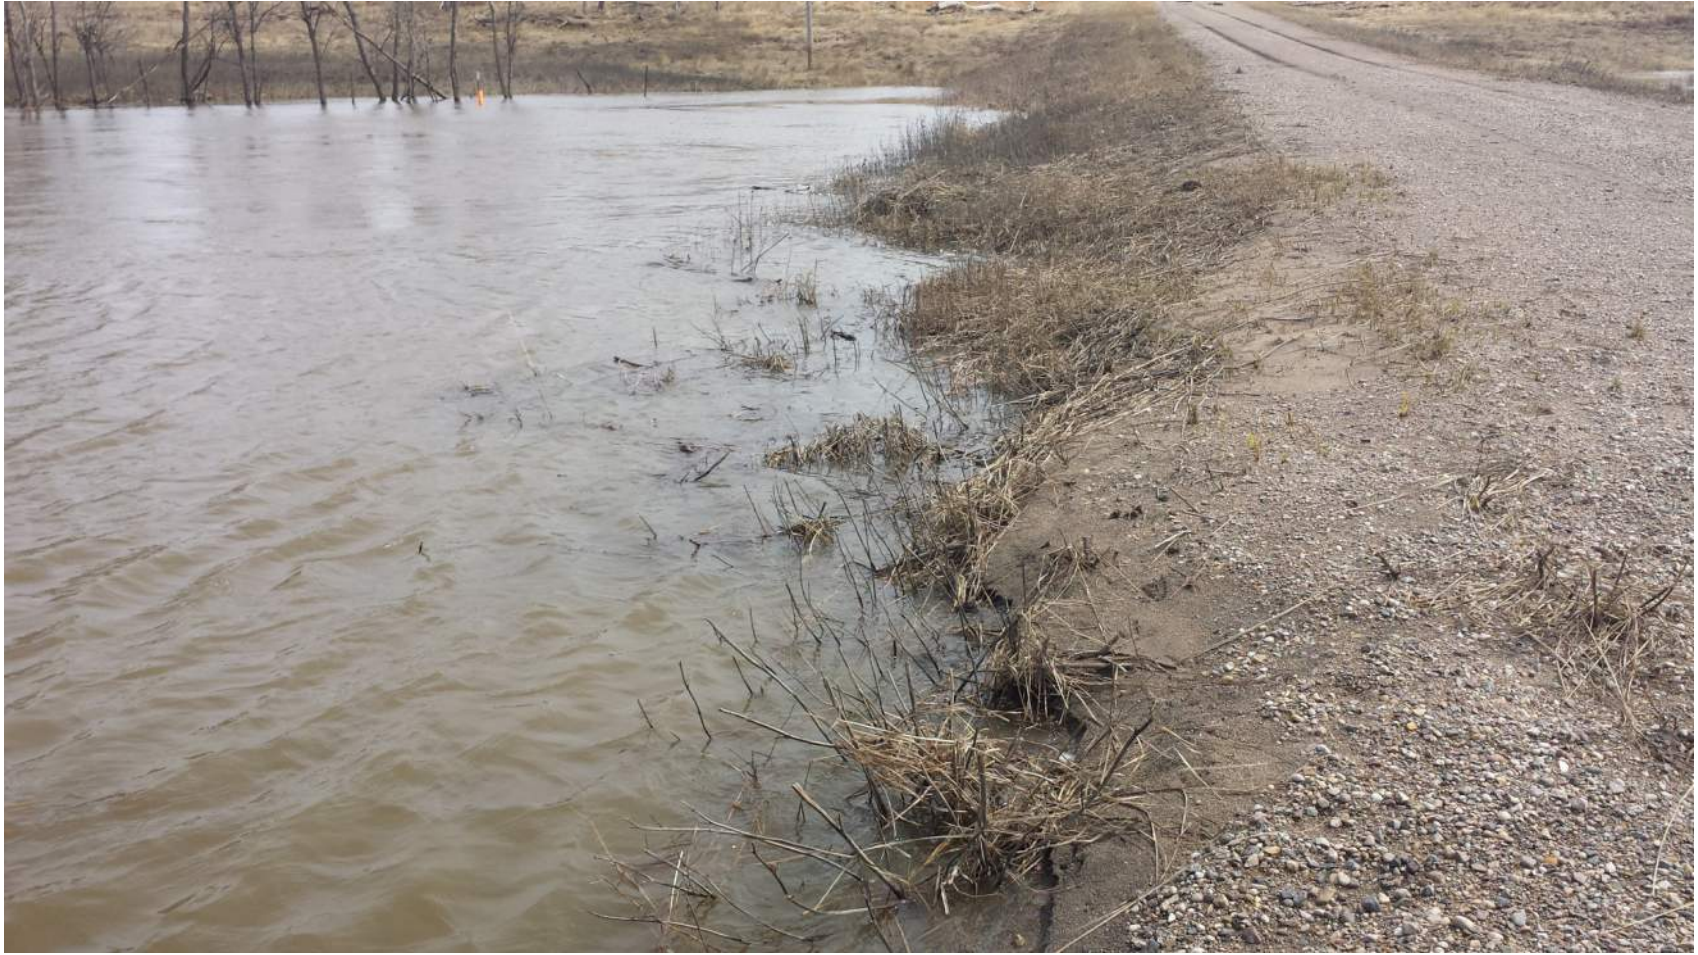
Location 4 looking east at minor erosion and deposition on the downstream shoulder, post-flooding condition

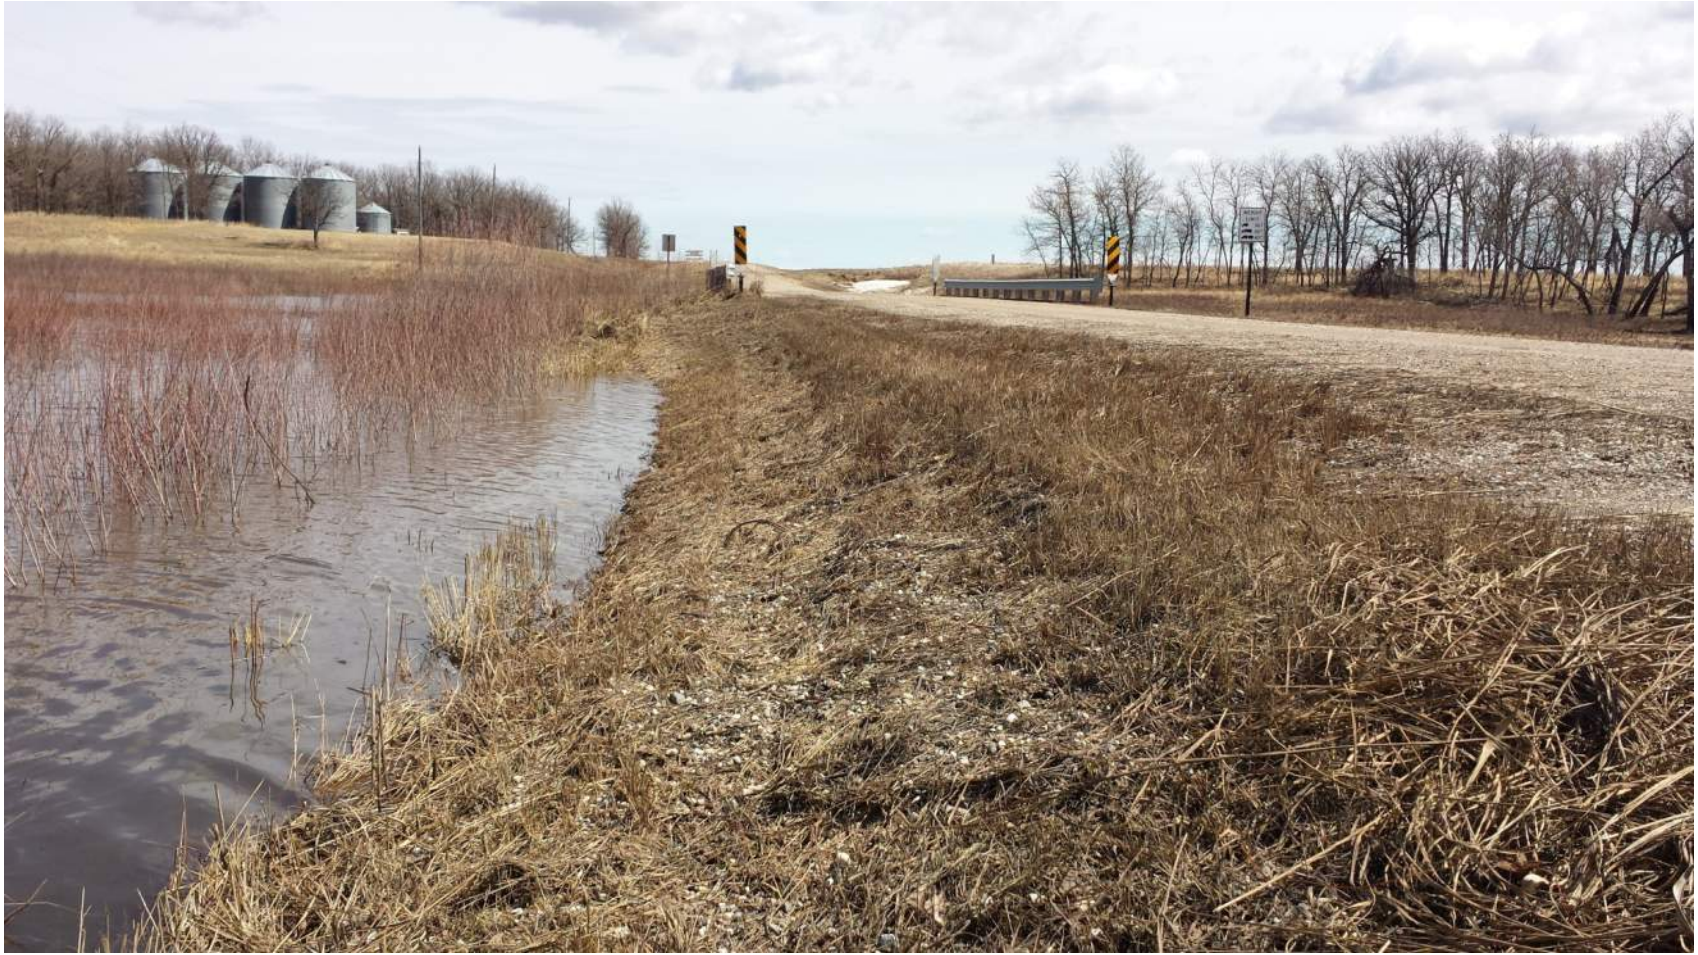
Location 5 Looking east at the upstream shoulder, post-flooding condition

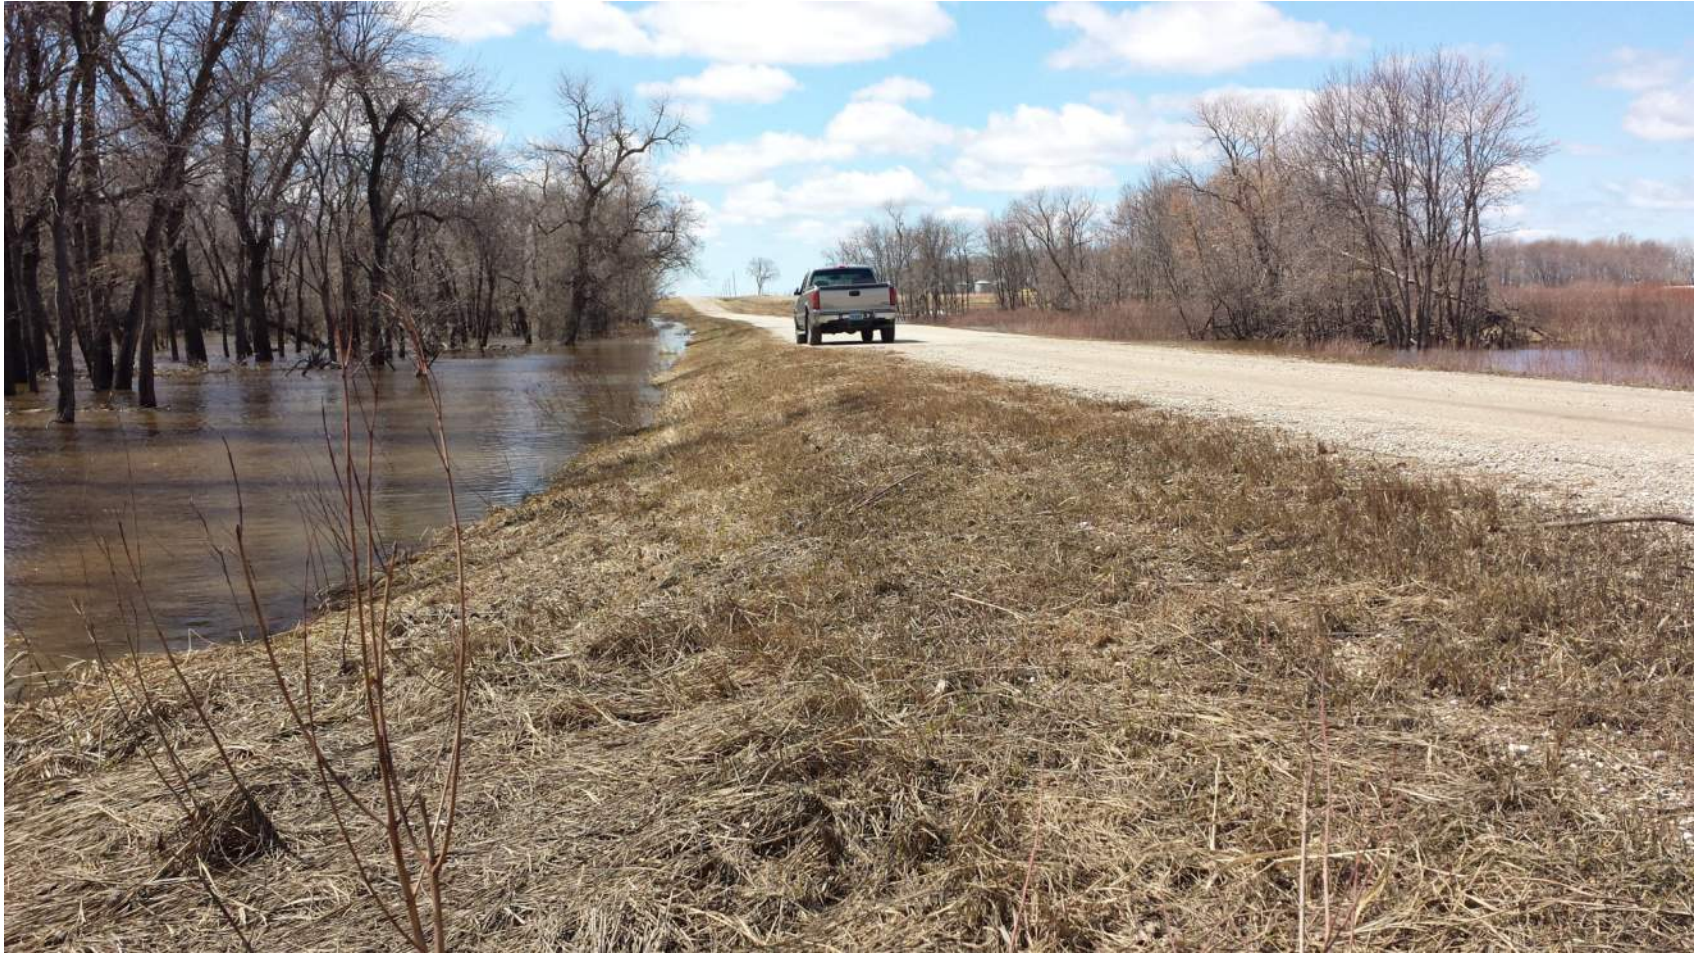
Location 5 looking west at the downstream shoulder, post-flooding condition
