Comprehensive Field Evaluation of Asphalt Patching Methods and Development of Simple Decision Trees and a Best Practices Manual

Department of Civil Engineering
University of Minnesota Duluth

June 2017

Research Project
Final Report 2017-25

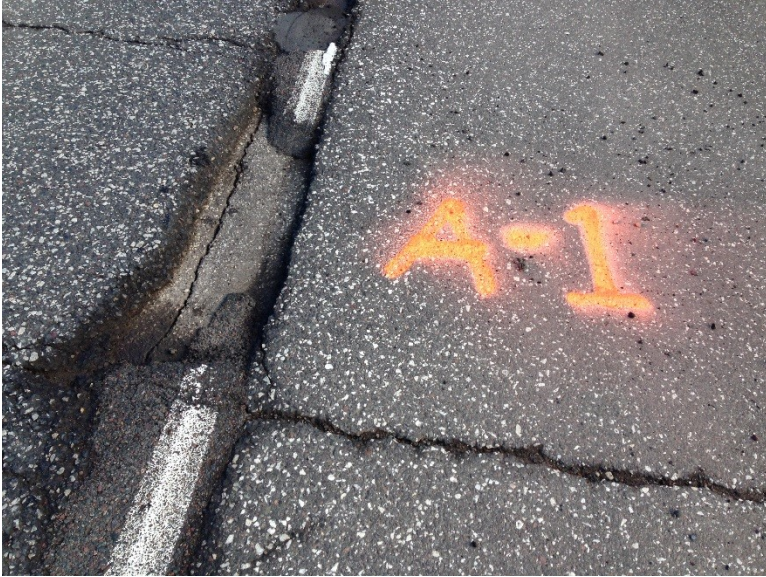
Pothole A-1: This pothole was located along the shoulder joint of the roadway. The pothole lies in between two reflective transverse cracks and has a longitudinal crack running along the bottom of the pothole as shown in Figure 3.1. The pothole was prepped by sweeping the area. The size of the pothole was 40 inches x 14 inches x 2 inches.

Figure 3.1 Pothole A-1 prior to Patching (After Cleaning).

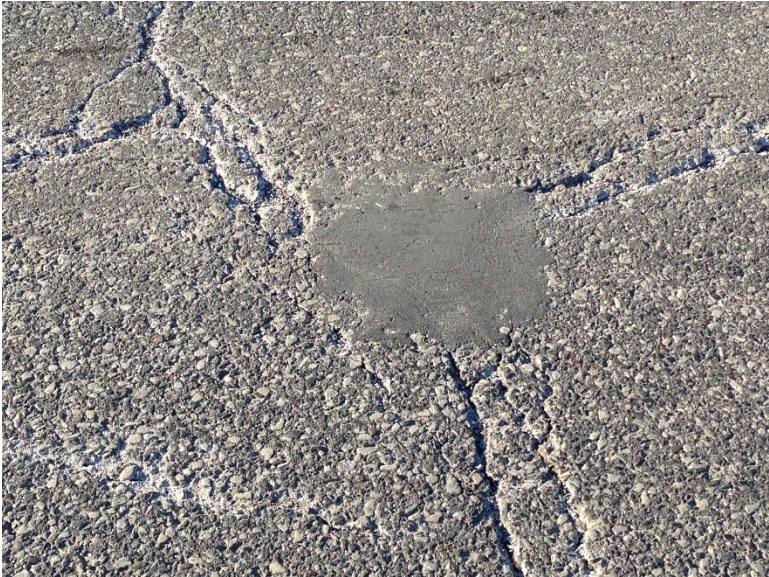
Although the cold mix patches had a hard compacted layer on the top of the patch, underneath that layer was pliable material that still had an oily shine consistent with the day the pothole was patched. Based on the last visit conducted on December 4, 2014, the conditions of the patches were found to be somewhat similar to the previous visits. The only noticeable difference was some abrasion on the patch material from snow plow blades. This abrasion was most noticeable in patch A-4 (Figure 3.19). Also on

Figure 3.19 Pothole A-4 (240 days after installation) with Snow Plow Abrasion.

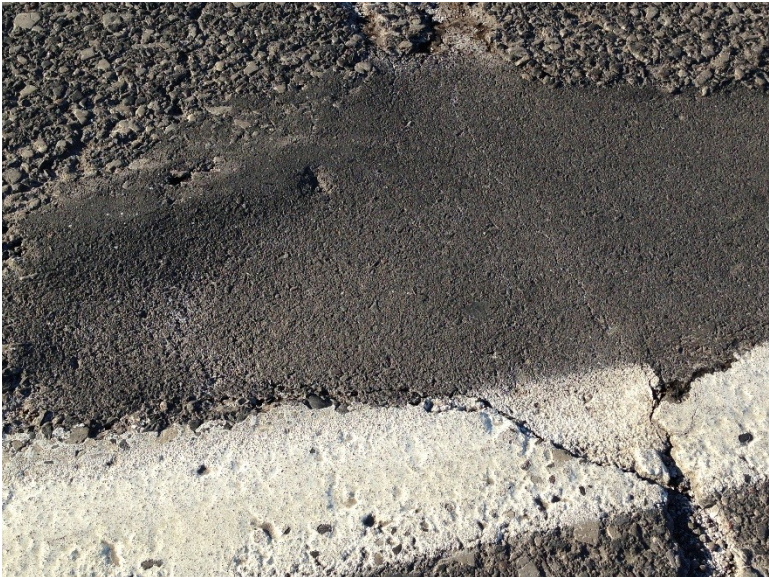
December 4, 2014, it was observed that the pothole A-5 experienced a significant depression in the material since the last visit, as well as some material loss near the bottom of the patch (Figure 3.20).

Figure 3.20 Pothole A-5 (240 Days after Installation).

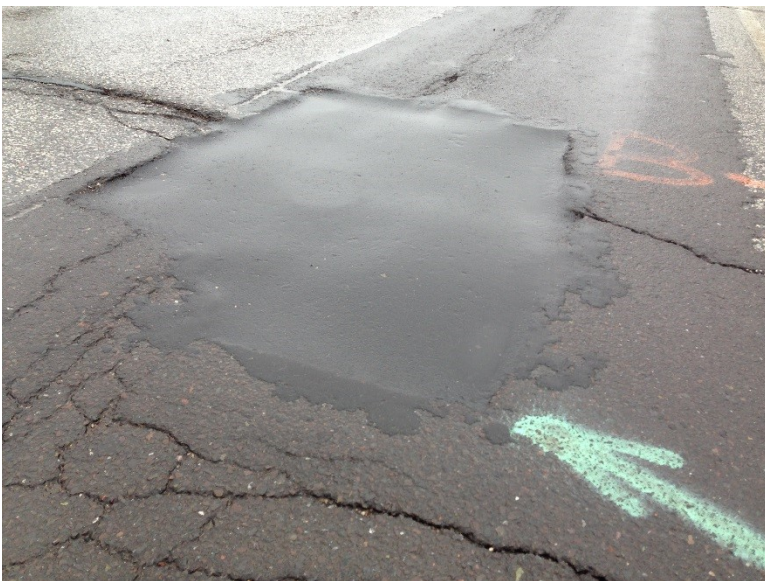
One of the main concerns regarding dishing distresses is the accumulation of water. Pooled water on a roadway provides areas that facilitate hydroplaning during wet conditions as well as icy surfaces in cold conditions (Figure 3.41). Dished areas along patch edges may provide areas for water to infiltrate increasing the deterioration rate of both the roadway and patch material. Dished areas also provide a lower ride quality and potential hazard areas for snow plows.

Figure 3.41 Water Accumulation in Dished Areas of Patch B-3 (18 Days after Patching).

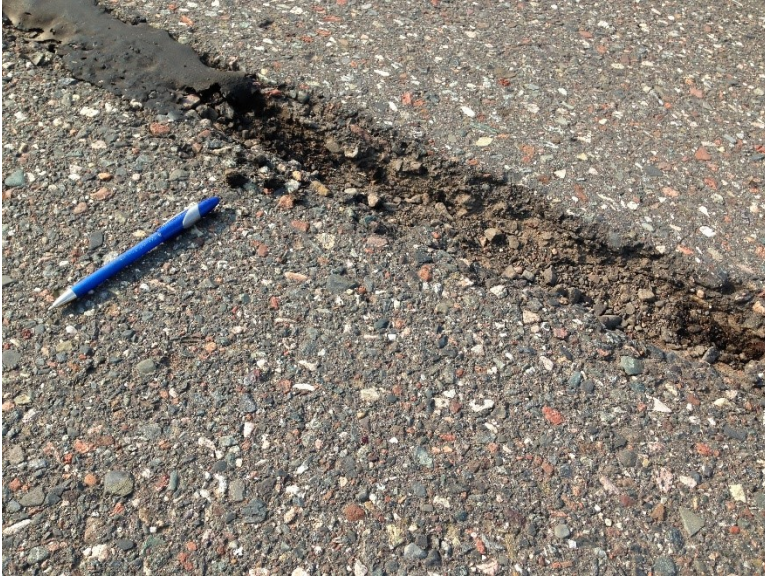
Figure 3.56 Section of Longitudinal Crack with Sealer Missing.

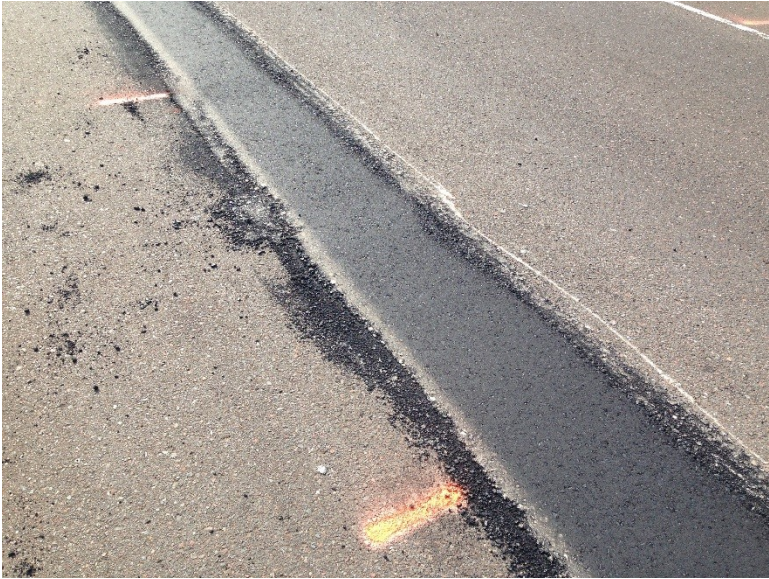
difference between excess material placement (Figure 3.59) and proper placement (Figure 3.60) is illustrated below. Placing the proper amount of material leaves a much cleaner looking product as well as reduces the amount of waste material. Figure 3.61 Shows finished patching work at Pothole D-3.

Figure 3.59 Pothole D-1 after Compaction (Excess Fill Material on Roadway).

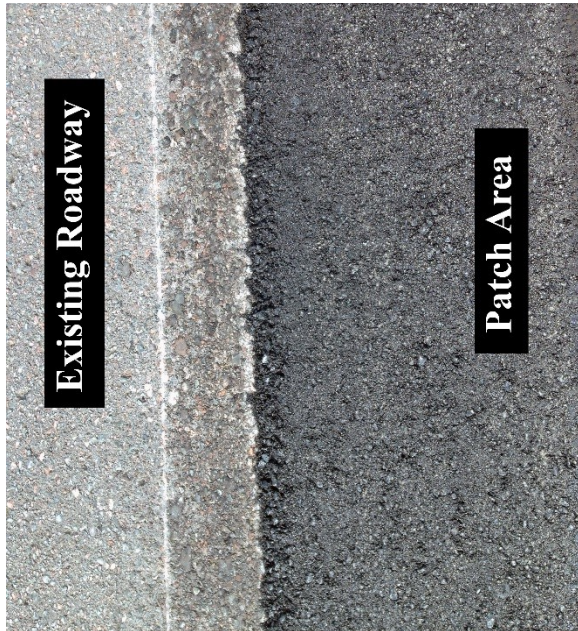
One issue with a mill and fill operation is the compaction along the edge of a patch. A closer look along the edge (Figure 3.62) shows that steel drum rollers, used to compact the fill material, are unable to completely compact the fill material. Since rollers are wider than the patch, the steel drum sits on the existing roadway preventing the compaction of material near the edge. This area of lesser compacted material may lead to a higher rate of water infiltration or patch material raveling.

Figure 3.62 Interface between Patch Area and the Existing Roadway.

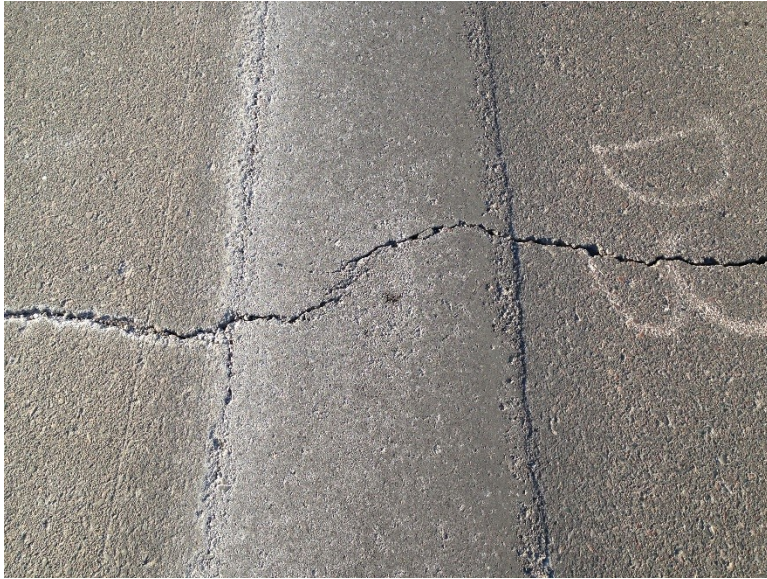
Figure 3.68 Pothole D-3 (126 Days after Installation) with Crack Running Through Patch.

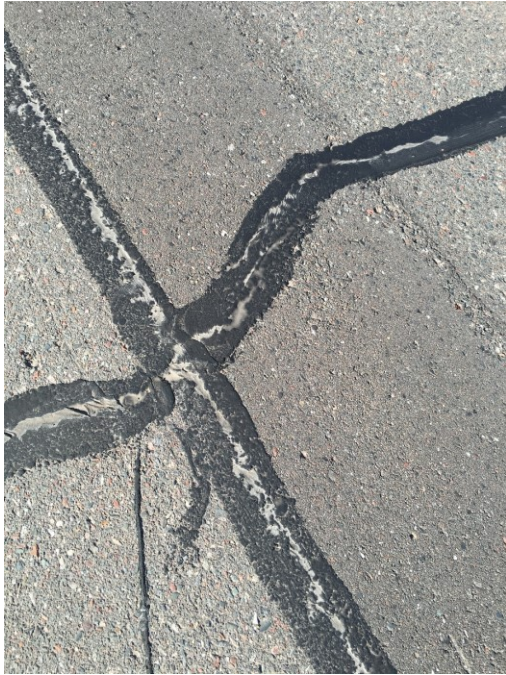
Site visits conducted on July 29, 2015 and October 20, 2015 revealed that severity of the raveling did not increase in second year of service. See Figure 3.69 and Figure 3.70. It was also discovered that the cracks that had propagated through and along the edges of the patches had been sealed sometime during the summer of 2015 (Figure 3.70 and Figure 3.71). This probably helped in arresting the raveling in the year two.

Figure 3.71 Pothole D-3 (446 Days after Installation) with Crack Running Through Patch.

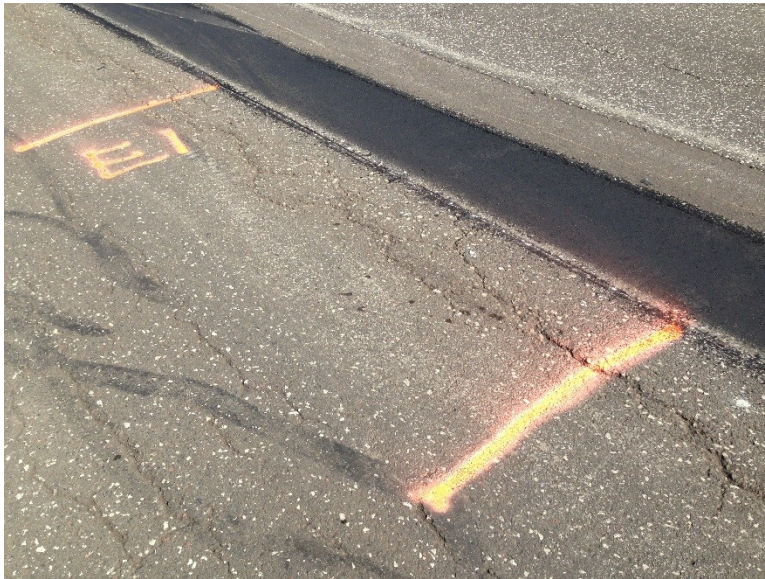
Figure 3.72 Pothole E-1 with Parallel Longitudinal Cracking.

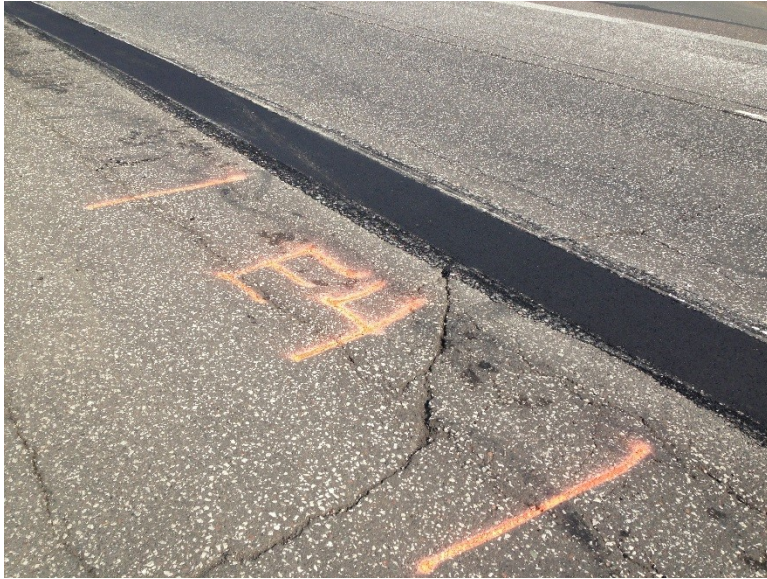
Figure 3.75 Pothole E-4 with Transverse Crack.

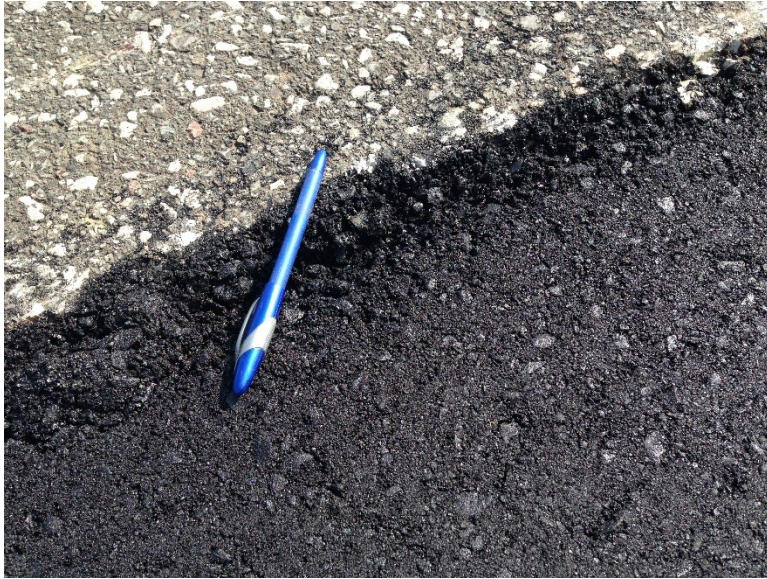
The lack of compaction issue near the interface of the pothole and roadway discussed above in Site D section also existed at this site. The issue however was more prevalent and also included some raveled material right after compaction (Figure 3.77).

Figure 3.77 Lack of Compaction and Material near Interface of Patch Material and Roadway.

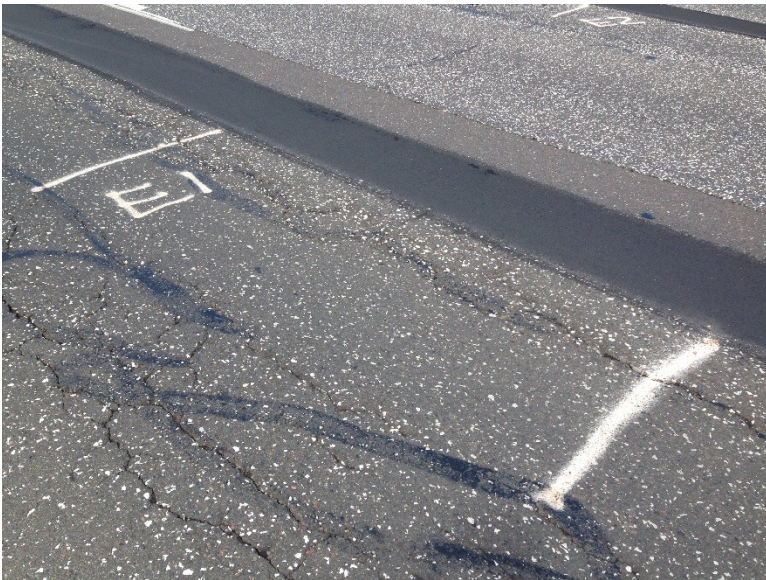
Figure 3.81 Patch E-1 Parallel to Existing Distresses (28 Days after Patching).

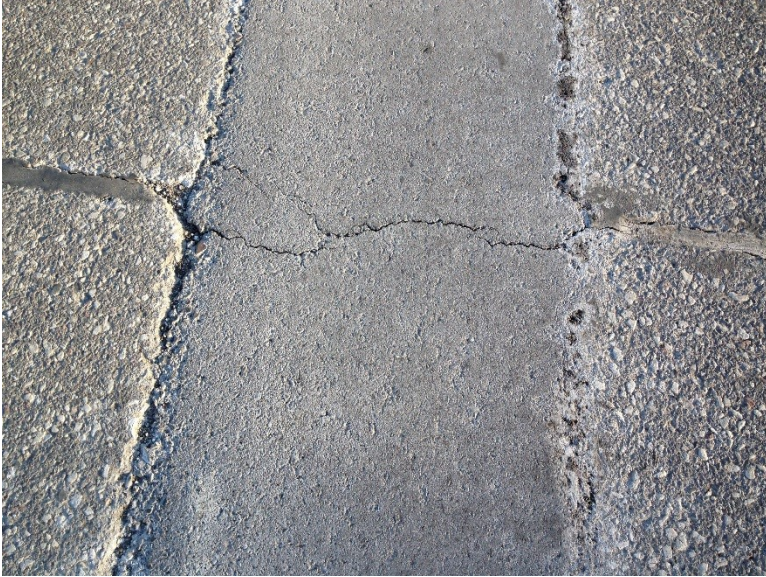
the year was made on December 4, 2014. Figure 3.82 to Figure 3.85 show that a significant amount of damage had occurred to the patch material including cracks and raveling along the patch interface.

Figure 3.82 Cracking of Pothole E-3 (119 Days after Installation).

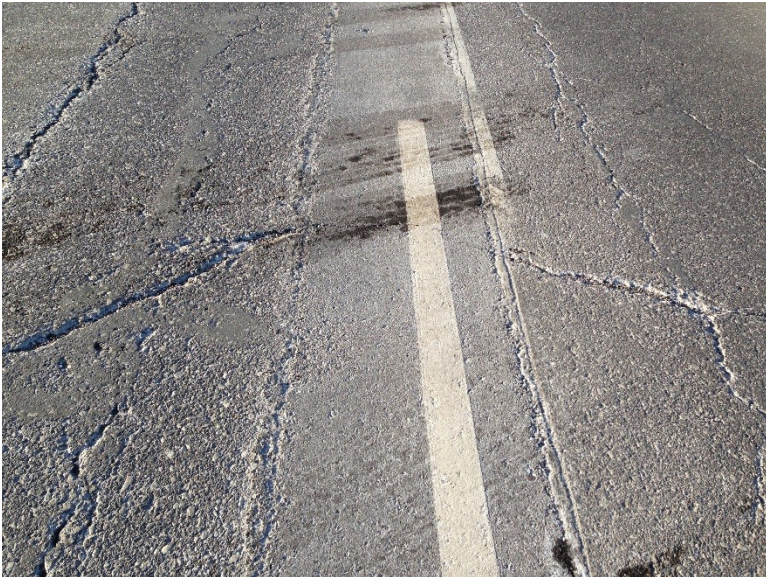
Figure 3.83 Pothole E-4 (119 Days after Installation).

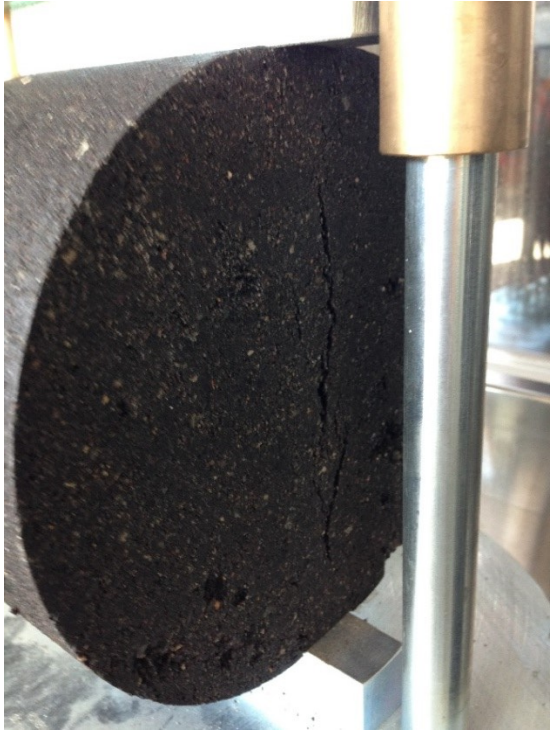
Figure A5: Cracking of Sample due to Testing of Indirect Tensile Strength.
