HISTORY AND DEVELOPMENT OF NON-INTRUSIVE ELECTRICAL TESTING AND ASSESSMENT OF DC TRACTION MOTOR ARMATURE CONDITION AND RELIABILITY DURING OVERHAUL

A Helwig

Queensland Rail - Australia.

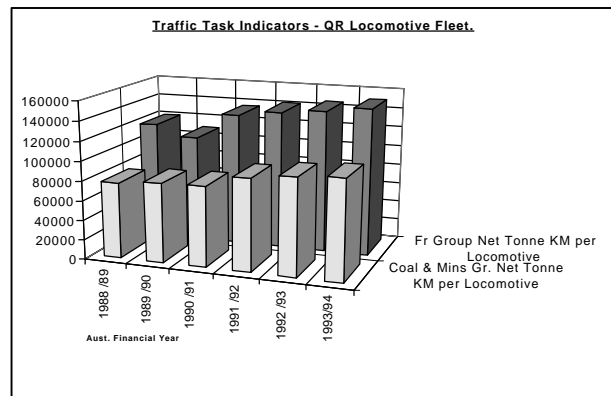
4.0 REVIEW OF TRACTION MOTOR FAILURES: Figure 1

of the machines. The changing QR freight task can be appreciated by the overall increase in net tonnes from 73 million to 92 million over the period from 1985 to 1993. During this period, the locomotive population required to shift this freight task has decreased from 559 to 492 units (i.e. fewer higher kilowatt machines for the increased traffic task). This is reflected in the net tonne per kilometre gains, as shown in Figure 1 for the period of 1988 to 1993 (Nb: statistics are taken from QR's annual reports for this period).

With this trend in mind, it was noted during a survey in the year 1992/93, that only 45% of electric vehicle traction motors and 51% of diesel electric vehicle traction motors remained in service until removed for age related problems or

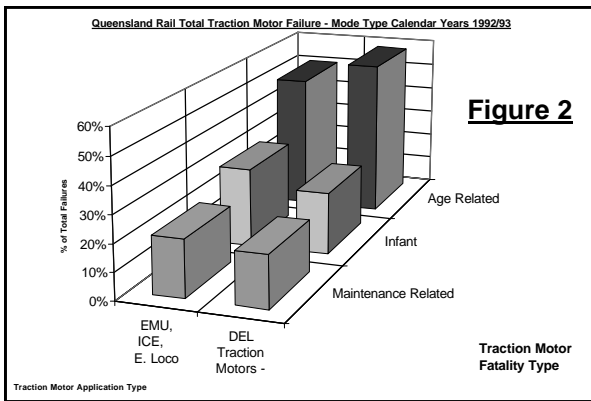
All of the traction machine failures, for the period of 1992/93 financial year, were reviewed as to the cause related possibilities i.e. infantile related failure, maintenance related failure and age removal. The results are shown in Figure 2 for this financial year of 1992/93. Infantile failures are failures that are considered to be related to the repair of the machine, and fit into this category if the failure is within two (2) years of repair or overhaul and reflect the nature of the repair; maintenance failures are those related to short brushes and contamination by external sources or via the cooling air on electrical creepage areas within the machines. This type of categorisation allowed strategic planning to gain impetus. Infantile failures and maintenance failures are

within the scope of both the workshop and depot procedures, and provided the necessary information to implement a procedures review and a training response. This is now underway and implementation (including training material and new recommended practices) should be completed during the 1995/96 financial year.

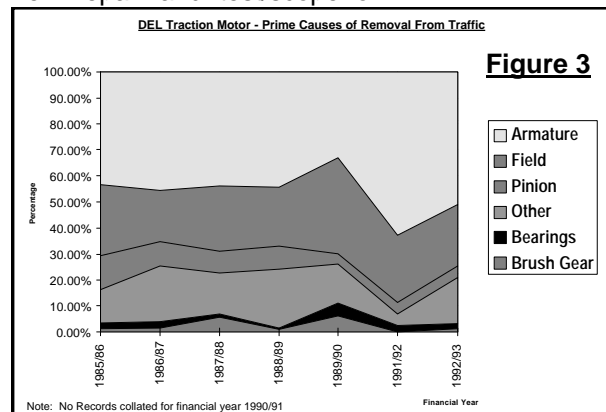
Prior to this failure related cause review, in the years after 1986, QR began to identify the major component causes of failure. The statistics for these revealed that armature related problems were the largest single cause of operational failures. See Figure 3 for the history of prime cause of failure or removal from traffic for Diesel Electric Rollingstock (Nb: Electric Vehicles have a similar graph). In QR's case the armature showed the most potential for improvement. This is further justified by considering the consequential damage a failed motor can cause to the rest of the motor (particularly if the windings fail. Testing and proving the armature insulation, became the prime area of focus for the traction motor repair and overhaul. Figure 4 shows the history of armature type failures for Diesel Electric Rollingstock (Nb: Electric Vehicles have a similar outcome), and mirrors QR's efforts in identifying the two usual causes of DC armature failure:
