UNIVERSITY OF SOUTHERN QUEENSLAND
FACULTY ENGINEERING AND SCIENCE

**ANALYSIS OF BRIDGE FAILURE DUE TO CYCLONE
MARCIA IN CENTRAL QUEENSLAND USING FAULT
TREE METHOD**

Bachelor of Engineering (Civil)

October 2015

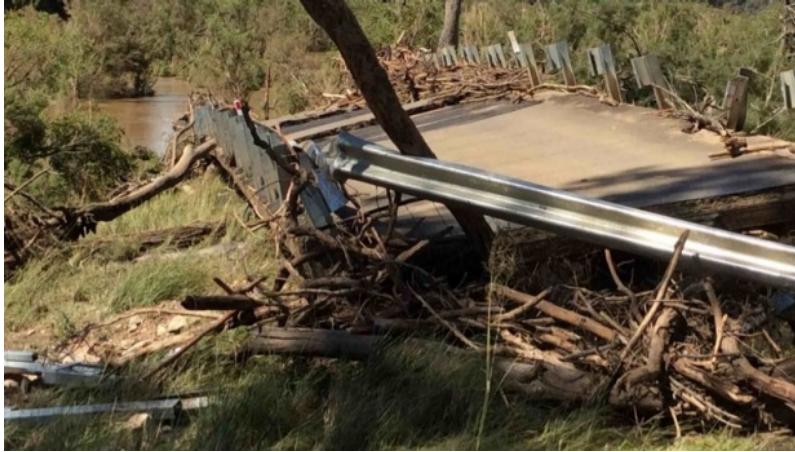
2: Cyclone Marcia Damaged Bridge in Monto

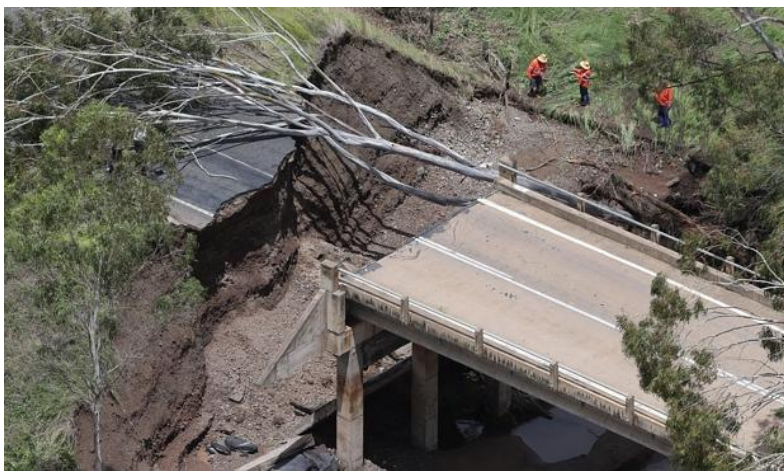
Figure 2-3: Cyclone Marcia Damaged Bridge in Gladstone Biloela Rd

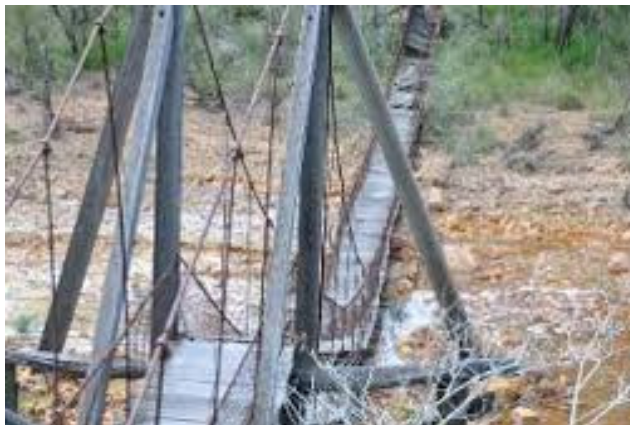
Figure 2-4: Cyclone Marcia Damaged Bridge in Mount Morgan

Suspension bridges are mostly vulnerable for wind damage. Long cable-stayed and suspension bridges must withstand the drag forces induced by strong winds. In addition, such bridges are prone to aeroelastic effects, which include torsion divergence (or lateral buckling), vortex-induced oscillation, flutter, galloping, and buffeting in the presence of self-excited forces (Simiu and Scanlan 1986). Due to the aeroelastic and aerodynamic effects from high winds on long-span bridges, strong dynamic vibrations will be expected. Excessive vibrations will cause the service and safety problems of bridges (Conti et al. 1996; Gu et al. 2001). In Australia there are very few suspension bridges. During Cyclone Marcia 2015, a timber bridge at Mt Morgan was found to be damaged by strong winds (Fig 2.5).

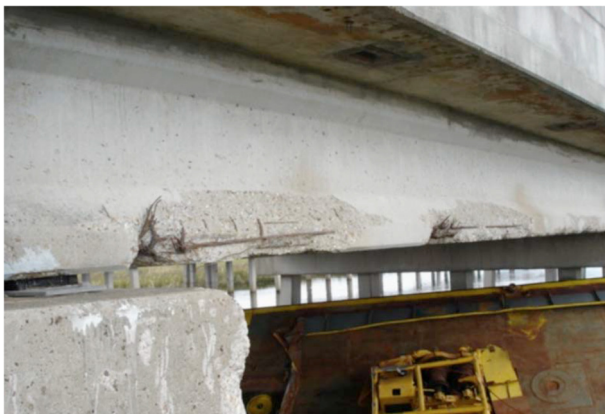
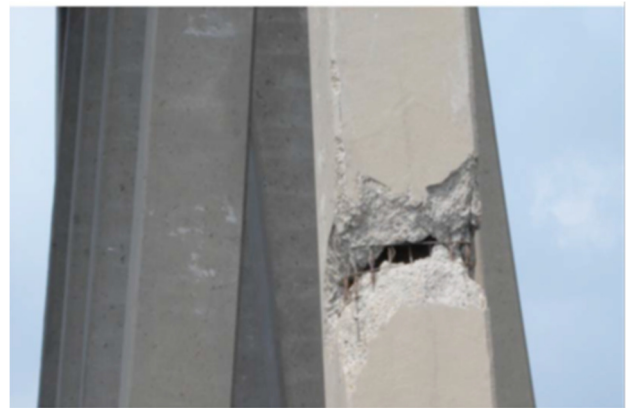
Impact damage is quite common bridges associated with large water ways. Impact damage is generally caused by floating objects i.e. debris, boats any items that gets transported due to flooding resulted from the intensive rainfall caused by cyclones. Post disaster inspections found that in most occasions, impact damage demonstrated itself in the form of span misalignment and fascia girder, fender, and pile damage (Padgett et al. 2008).

Figure 2-6, 2-6: Damage due to impact (Padgett et al. 2008).

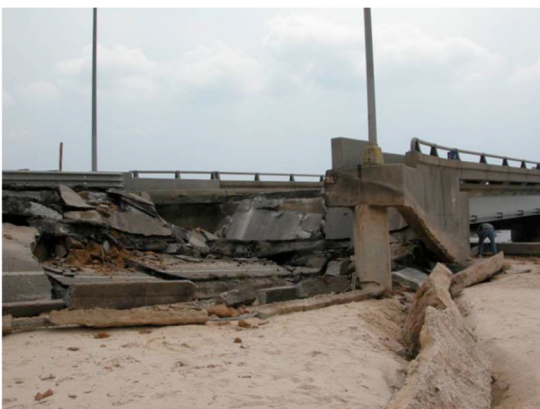
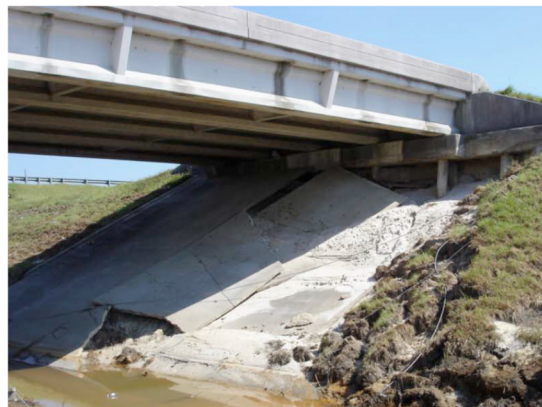
Figure2-7: Damage caused by scouring (Padgett et al. 2008)

The scour damage that was readily visible to inspectors included scour and erosion of the abutment, slope failure, and undermining of the approach (Figure 2.7)
