GEOTECHNICAL ASPECTS OF THE 2016 KAIKŌURA EARTHQUAKE ON THE SOUTH ISLAND OF NEW ZEALAND

ABSTRACT

The magnitude Mw7.8 'Kaikōura' earthquake occurred shortly after midnight on 14 November 2016. This paper presents an overview of the geotechnical impacts on the South Island of New Zealand recorded during the post-event reconnaissance.

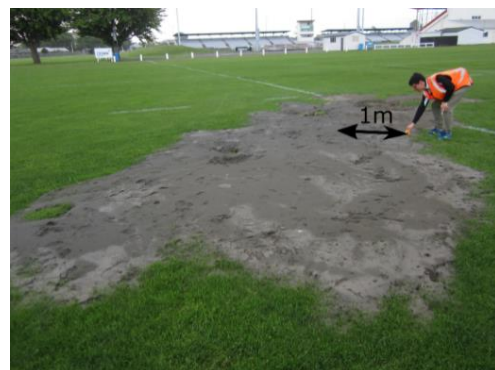
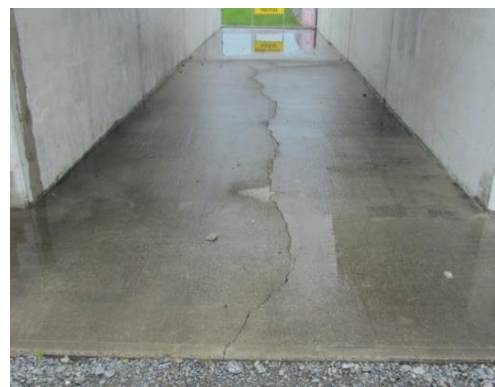
A detailed survey of ejecta was conducted in the southern half of Lansdowne Park; the location of ejecta features are shown in red in Figure 4. Sand boils were typically 1-2 m in diameter and in many cases formed lineaments of aligned sand boils (Figure 5). The ejecta material was largely bluish-grey in colour, but there were some features which were light brown in colour. No liquefaction ejecta was observed adjacent to the main stadium buildings; a single crack in the concrete foundation slab was the only observable damage (Figure 5b).

Figure 5: Ground damage observations at Lansdowne Park: (a) Example of liquefaction ejecta features observed at Lansdowne Park (-41.4996° , 173.959° , taken facing W); (b) cracking of stadium foundation slab (-41.4993° , 173.9569° , taken facing E).

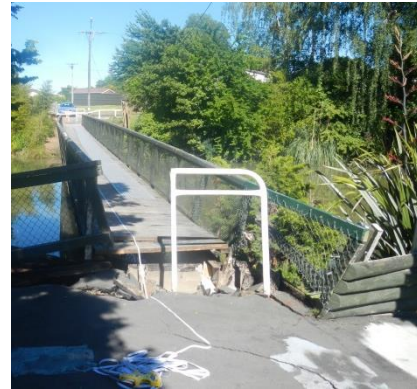
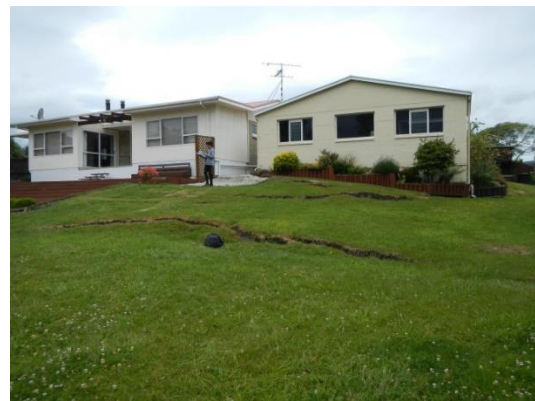
Lateral spreading was observed adjacent to an inner-bank of a meander loop of the Opaao River at the western end of Elizabeth Street, downstream from Lansdowne Park (location shown in Figure 3). The lateral spreading extended approximately 30m from the river channel on the inner meander bend, with cumulative displacements (based on crack widths) of 0.5 – 0.7m. Lateral spreading induced cracks were orientated approximately parallel to the riverbanks on both sides of the apex of meander bend. On the inner meander bend, the ground is steeply sloped within 5m of the river channel, and a series of cracks perpendicular to the river bank were present in this zone. Individual cracks had widths up to 500mm wide, with vertical displacements across the cracks of up to 100 mm and depths of up to 1m. Cracks near the river’s edge were infilled with blueish grey fine-medium sand ejecta and extended through the eastern end of the adjacent footbridge (Figure 7a).

The lateral spreading affected the house on the inside of the meander bend (Figure 7b). The house was subsequently deemed unsafe for permanent occupancy due to the differential movement and settlement; this was the only house in Blenheim deemed unsafe to occupy due to liquefaction related damage. The lateral spreading displacements affected the footbridge at this location, causing the wooden deck to warp as the abutment displaced towards the river by approximately 0.5m.

Figure 7: Damage at Elizabeth Street as a result of lateral spreading: (a) Damage to the footbridge (-41.5087°, 173.9636°, taken facing WSW); (b) damage to residential property (-41.5089°, 173.9636°, taken facing E).

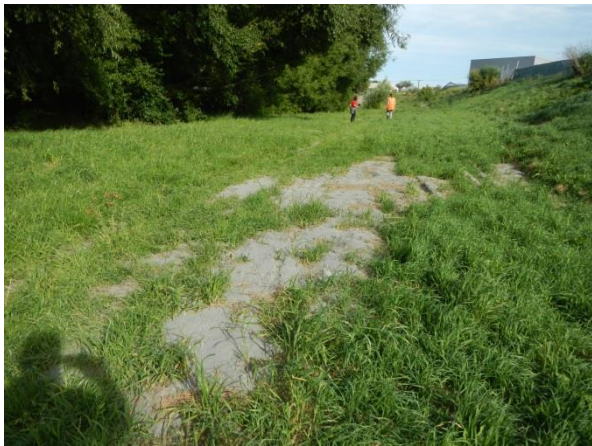
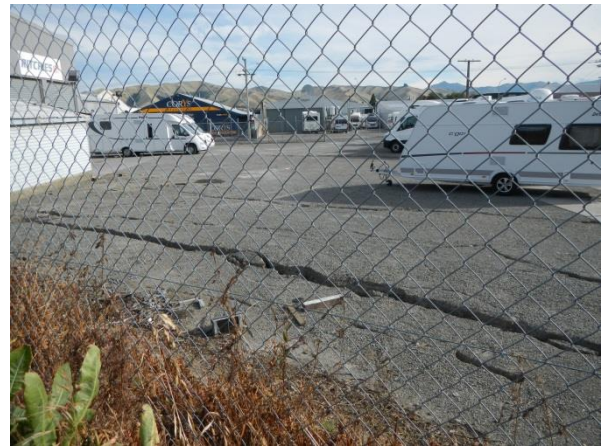
Figure 9: a) Example of liquefaction ejecta proximal to the river bank at the base of the stop bank (-41.5121° , 173.9651° , taken facing SE); b) Example of damage to properties on Park Terrace as a result of lateral spreading (-41.5122° , 173.9649° , taken facing S).

Cracking continued into the properties on Park Terrace that border the stopbank (Figure 9b). Permanent ground deformation, differential settlement of structures, separation between foundation slabs and the surrounding ground, and damage to the stopbanks were observed at these properties and a summary of the location of the cracks are shown in Figure 10. The total crack widths were 1-1.5 m: 0.3 m in floodplain and 0.7 – 1.2 m in the fill. Historic photographs indicate that the position of the stopbank in 1959 lay approximately 20m north of Park Terrace. The affected properties shown in Figure 10 were constructed on an area of fill that raised the elevation of the zone between the historic stopbanks and present-day stopbanks, with the southerly extent of cracking just north of the position of the historic stop bank.

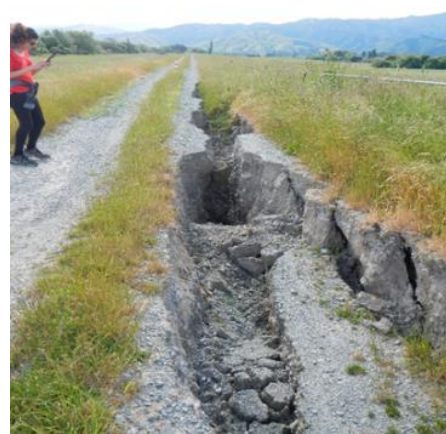
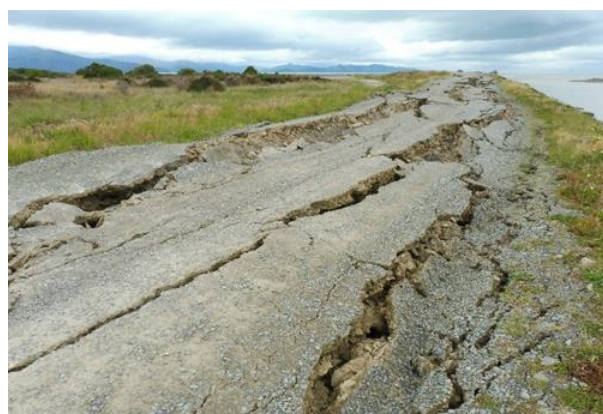
At Blind Creek (indicated in Figure 2), the primary stopbank is set back from the river outside of a cut-off meander bend of the river associated with river avulsion and the construction of the Wairau Diversion in the 1960's (Figure 11). A secondary set of stopbanks runs parallel to the current channel of the Wairau River. A 200-m long section of the secondary stopbank was heavily damaged during the earthquake (Figure 12a), which corresponds with the location of the historical bed of the Wairau River. Cracks exhibited a maximum width and depth of 1 m and indicates that movement occurred to the north and south, away from the major axis of the stopbanks (Figure 11). Sand boils were observed on the foundation soils surrounding the stopbank closer to the river's edge as well as on the northern side of the stopbank within the paleo-channel marked on the figure. Slumping of the stopbank was also observed where Blind Creek flows underneath the stopbank through a culvert.

Lateral spreading and slumping were observed along a 100 m long section of the northern stopbank at the mouth of the Lower Wairau River (Wairau Bar; indicated in Figure 2). The damaged section corresponds to the position of the former river channel that existed prior to diversion and stopbank construction (Figure 2 and Figure 13). Cracks varied in width from 30 to 50 cm and exhibited vertical settlements of 20 to 120 cm (Figure 12b). No liquefaction ejecta was observed along the stopbank or in the mudflats exposed within the river channel. A series of lateral spreading cracks were observed along the inland edge of the stopbank within the paleo-channel and these were surrounded by fine grey sand ejecta.

Figure 12: Examples of stopbank damage: (a) Blind Creek (-41.4407° , 173.9791° , taken facing WNW); (b) Wairau Bar (-41.5012° , 174.0600° , taken facing NE).

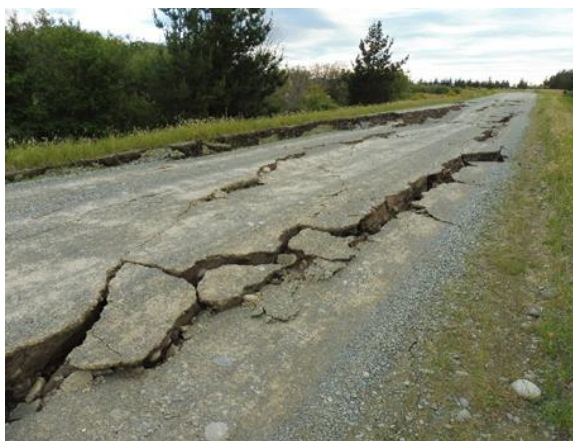
in vegetation (Figure 14). Lateral spreading on the northern stopbank was characterised by cracking ranging in width from approximately 30 to 50 cm and exhibiting 10 to 50 cm of vertical settlement (Figure 15). Localised cracking was observed at the base of stopbank proximal to the river. Lateral spreading along the southern stopbank resulted in cracking ranging in width from ~2 to 10 cm with 1-2 cm of vertical settlement. Lateral spreading was also observed along the river bank. No liquefaction ejecta was observed on either stopbank.

Figure 15: Lateral spreading induced cracking along top of northern stopbank (-41.4387° , 174.0214° , taken facing E).

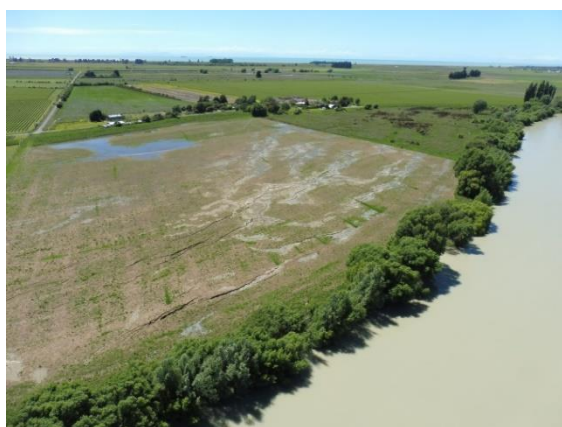
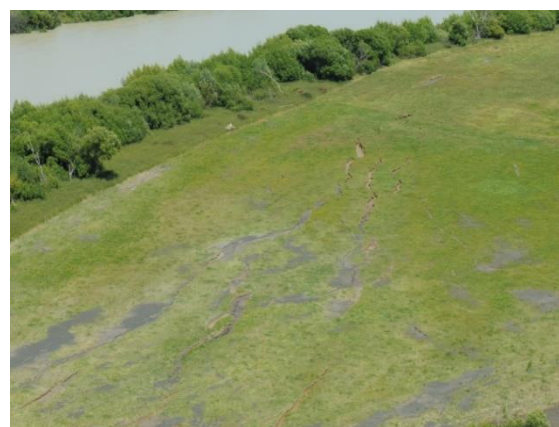
Figure 16: Lateral spreading and liquefaction ejecta on the eastern banks of the Lower Wairau River. (a) -41.4687° , 173.9807° , taken facing SE; (b) -41.4854° , 174.0160° , taken facing W. Photos: Marlborough District Council.

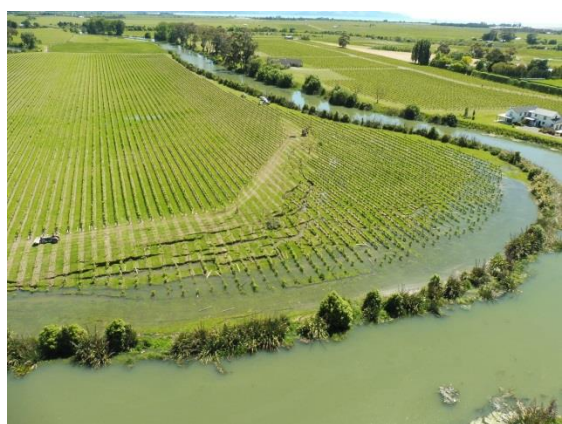
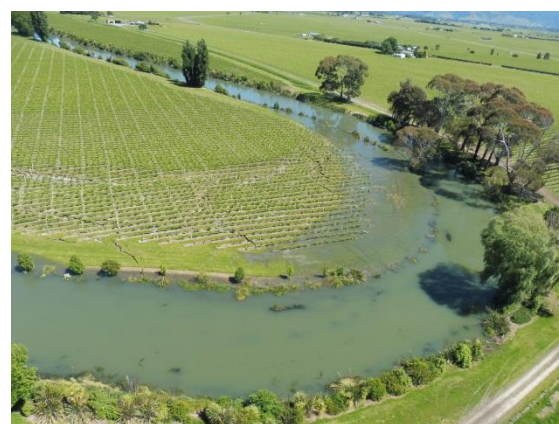
Figure 17: Examples of lateral spreading and sand ejecta damage to vineyards along the Lower Opaoa River. Photo taken 4 days after the earthquake showing completed vine repair and remnants of damaged vines. (a) -41.5270° , 174.0179° , taken facing NE; (b) -41.5217° , 174.0160° , taken facing NW. Photos: Marlborough District Council.

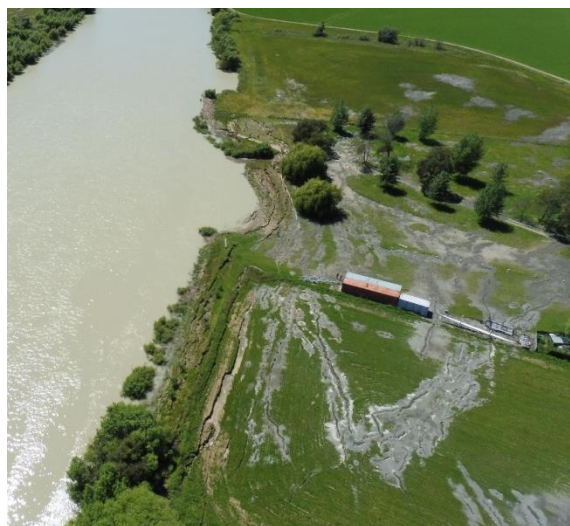
Severe lateral spreading was observed at the Blenheim Rowing Club on the southern bank of the Wairau River, with lateral spreading displacements (estimated from cumulative crack widths) between 2-5 m. Lateral spreading cracks ranging from 0.5 – 1.5 m in width were observed within 75 m of the river at the site (Figure 21 and Figure 22). Many of these cracks also had a number of associated ejecta features that were 1-2 m in diameter. Only minor evidence of liquefaction was observed around the perimeter of the Blenheim Rowing Club building. Two hand augers in the region of severe lateral spreading indicated that the soil profile consisted of silty sand, transitioning to clean fine sand between 1.5-2.5 m below the ground surface. The clean sand changed colour from brown to bluish-grey between 2.5-4 m depth.

Figure 22: Aerial view of liquefaction manifestation at the Blenheim Rowing Club (Approx. coord: -41.4882° , 174.0100° , taken facing E). Photo: Marlborough District Council.

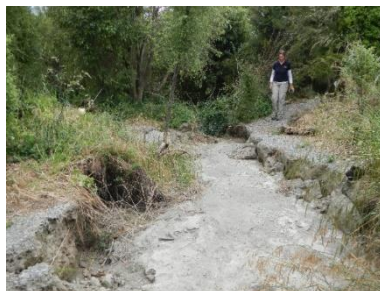
Cracks ranged in width from 1-2 m (also representative of the cumulative lateral displacements at this site), and were associated with up to 50 cm of vertical settlement (Figure 24). A significant volume of ejecta vented into the drainage channels, but this was removed soon after the earthquake to restore the channel. A line of sand boils orientated parallel to the river was additionally observed ~ 70 m inland from the river in the grassy area between the drainage channels. The sand boils transitioned into an ~ 10 cm wide lateral spreading crack within the surrounding vegetation. Numerous minor to moderate sand boils were also observed around the rowing club building on the west side of the stopbank. Lateral spreading cracks also formed along the southern drainage channel (i.e. within the paleo channel) proximal to the rowing club house (Figure 23). Particle size distribution characteristics of ejecta samples (collected from both sides of the stopbank) are summarised in Figure 20, and were comprised of finer sand than samples from both the Blenheim Rowing Club and the Equestrian Club sites.

Figure 24: Lateral spreading cracks adjacent to the Wairau River at the Wairau Rowing club (a) -41.4765° , 173.9862° , taken facing S; (b) -41.4761° , 173.9860° , taken facing S.

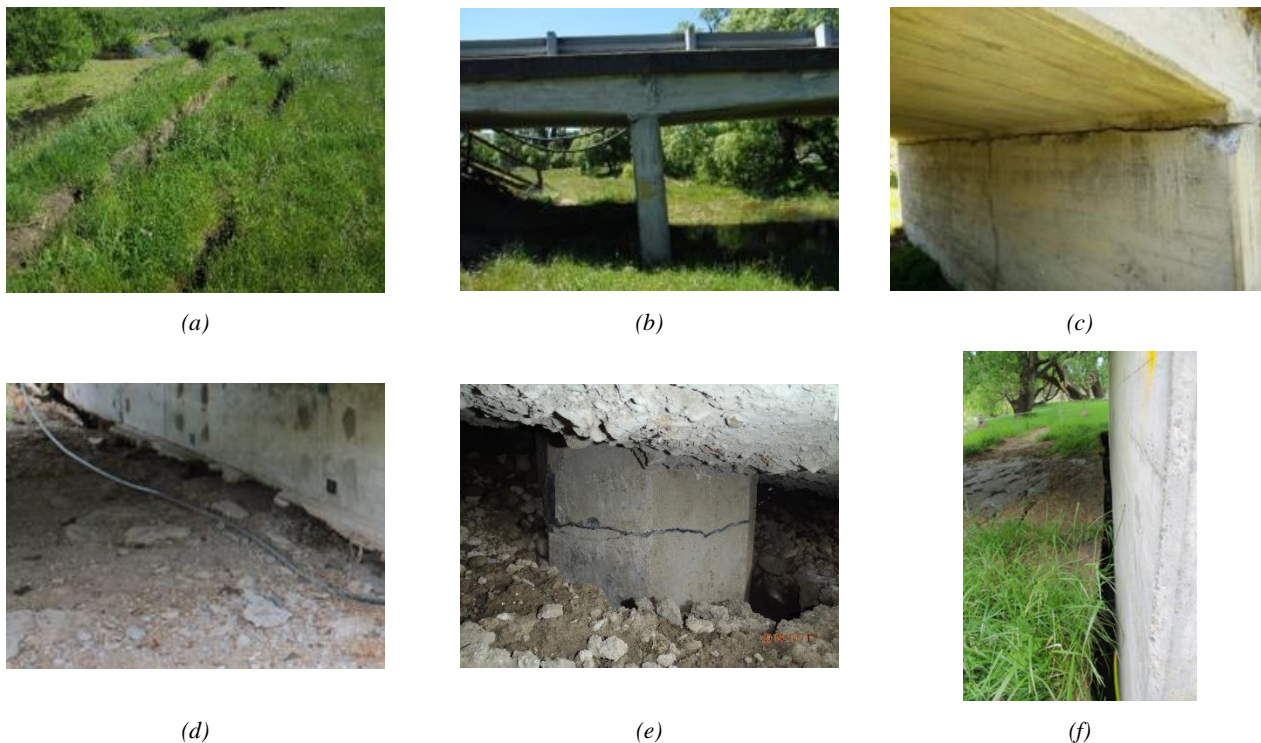
The lateral spreading resulted in some structural damage to several of the bridge piers and in the tops of some visible abutment piles. As shown in Figure 26 b-c, the inward movement of the soil has caused some rotation of the piers. The movement caused single cracks to develop at the top and

Figure 26: Damage at Needles Creek Bridge (-41.8217°, 174.137°): (a) Tilting of first pier from north abutment looking east; (b) Cracking across the top of first pier from north abutment caused by tilting, taken facing SE; (c) Subsidence of fill exposing base of north abutment, taken facing NW; (d) Free-field lateral spreading cracks, taken facing W.

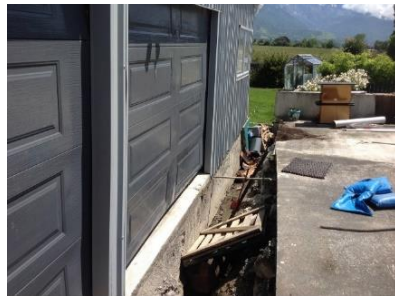
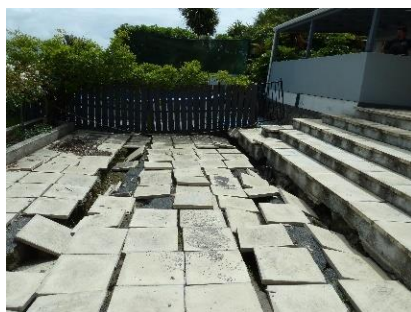
At the property shown in Figure 29, the garage (centreline located ~10 m from the creek) displaced ~1 m directly west towards the creek. The movement was accompanied by a vertical drop relative to the concrete slab originally leading to the garage. At the north end of the garage structure, some ejected soil was reported. The ground cracks at this location extended up to 30 m from the river. A similar example is shown in Figure 30, where the lateral movement towards the creek and the vertical offset are both of the order of 1 m. It should be noted that at this location, the apparent ground movement between the photographer and the garage is much larger than the displacement of the garage building. The house shown in Figure 31 was built on short timber posts which were fixed into small concrete footings. Large lateral ground movements occurred at this site towards the creek. As shown, this resulted in the foundations at the west end of the house being pulled laterally by the horizontal movement, but also being left exposed by the vertical movements.

Figure 29: Large displacement at a property adjacent to Lyell Creek (approx. coordinates: -42.382° , 173.680°): (a) Separation of concrete slabs and garage (70 cm wide) due to lateral movements. (taken facing N); Note the garage has moved laterally in the picture (i.e. Lyell Creek is behind the garage, to the left of the picture). (b) vertical gap in wall due to lateral movement and ejecta. (taken facing S). (c) Cracking in the ground at 30m from the river.

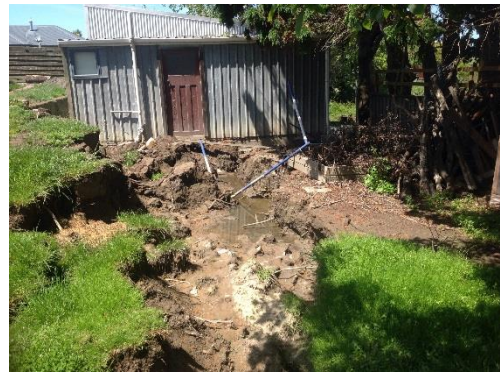
Figure 30: A garage/shed at a house on Beach Road displaced ~1 m towards Lyell Creek, and moved downwards ~ 1 m (-42.3860° , 173.6783° , taken facing S).

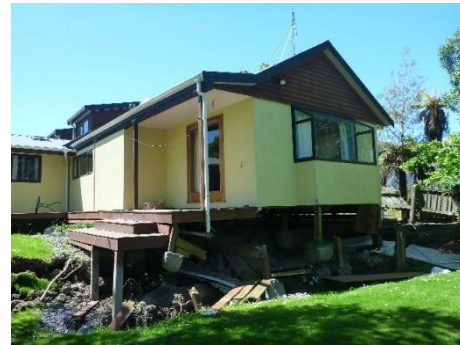
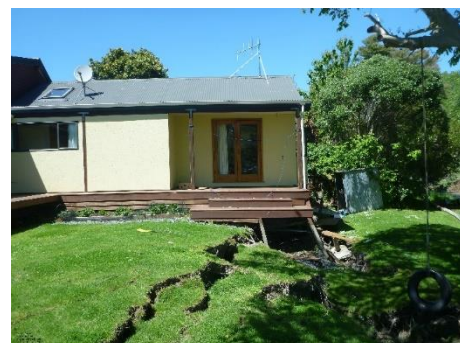
Figure 31: Complete loss of support to foundations at W end of house on Beach Road (-42.3851° , 173.6783°). (a) taken facing NE, (b) taken facing SE, (c) taken facing S.

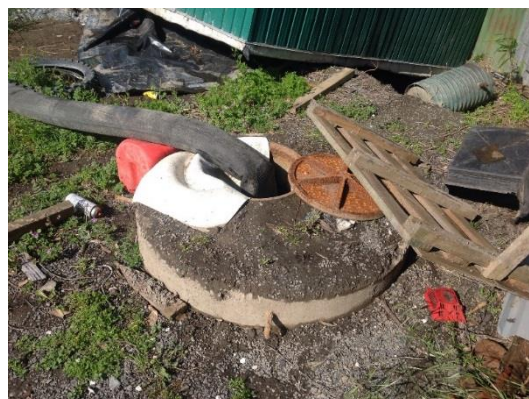
Figure 33: Floatation of manhole on Beach Road near to Lyell Creek (-42.3848° , 173.6783° taken facing SW).

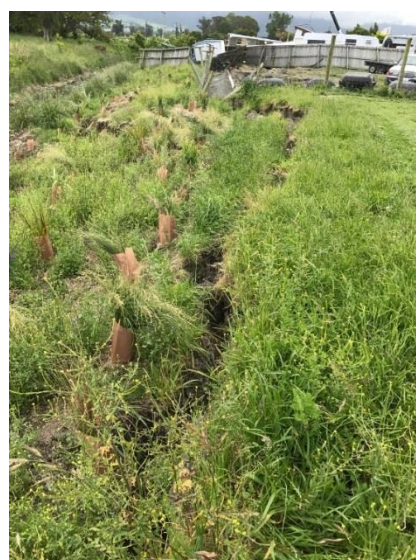
Figure 34: Lateral ground movements associated with vertical settlements in grassy area between Beach road and Lyell Creek. Note: Cracks are associated with vertical offsets and blocks have rotated away from the creek (-42.3902° , 173.6777° , taken facing N).

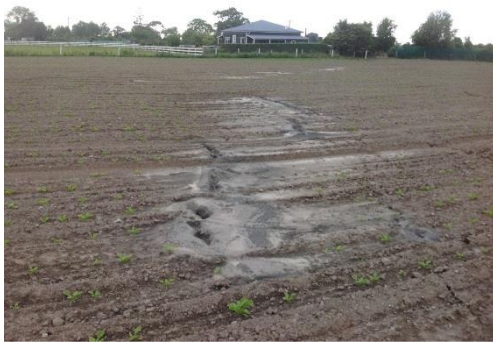
Figure 40: Liquefaction ejecta in the field south of Mill Road. The ejecta are concentrated in lines which continue in the background over a total length of ~100 m (-42.3772°, 173.6753°, taken facing SE).

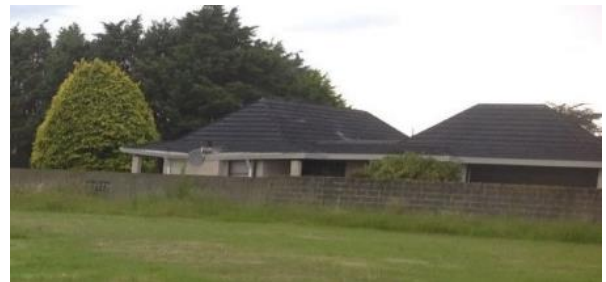
Figure 42: Damage caused to house on Mill Road by lateral ground movements (-42.3784°, 173.6675°, taken facing NE).

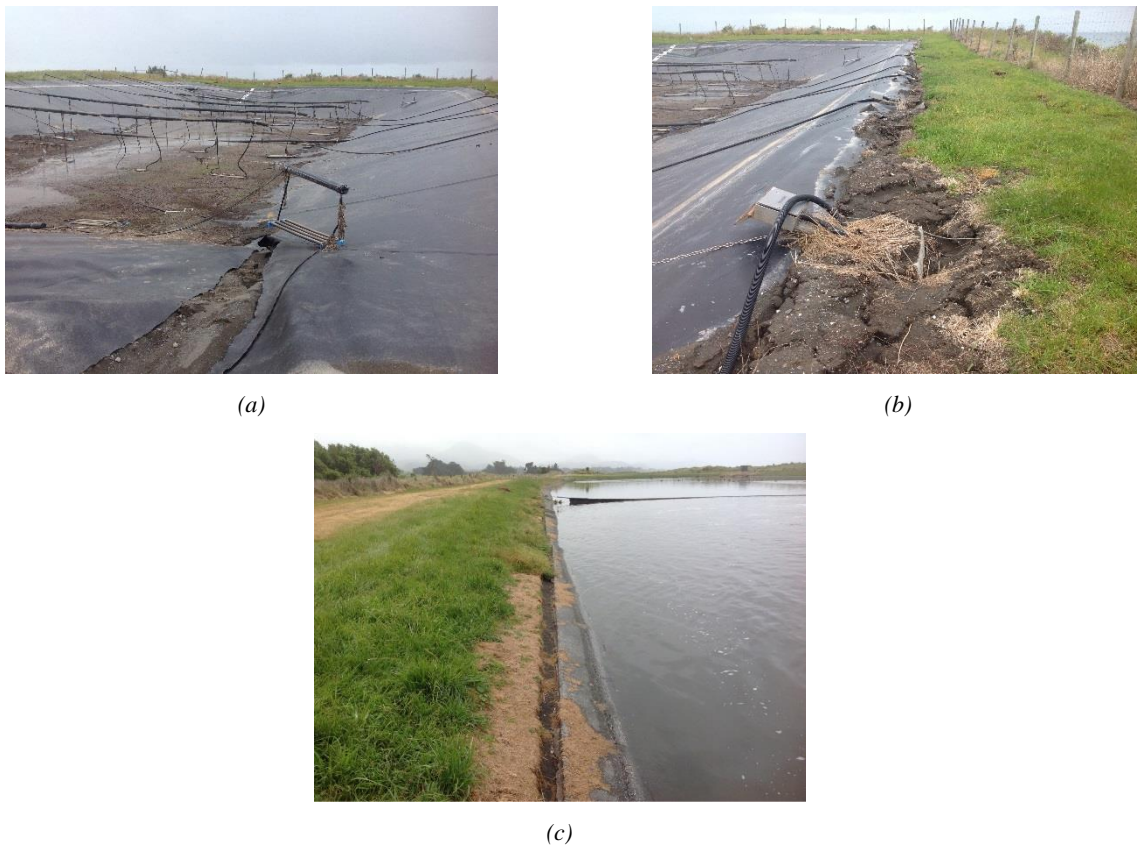
Figure 44: (a) KK-OPS looking from the SW corner. Note: Geoliner in the foreground has ripped (-42.3668° , 173.6865° , taken facing E). (b) Rotation of the aeration-line control posts on the south side of KK-OPS (-42.3669° , 173.6867° , taken facing E). (c) West edge of KK-OPN. Note concrete panel has displaced into pond (-42.3660° , 173.6868° , taken facing N).

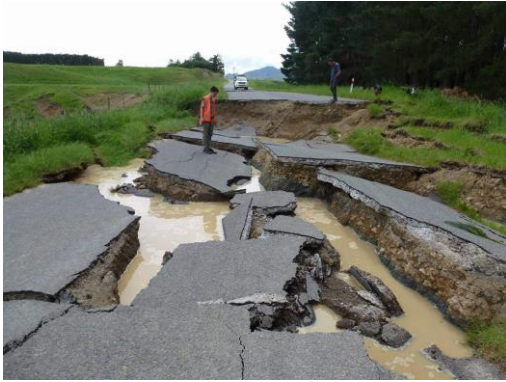
Figure 47: Damage to Leslie Hills road caused by fault rupture (Approx. coord: -42.631°, 172.990°, taken facing W).

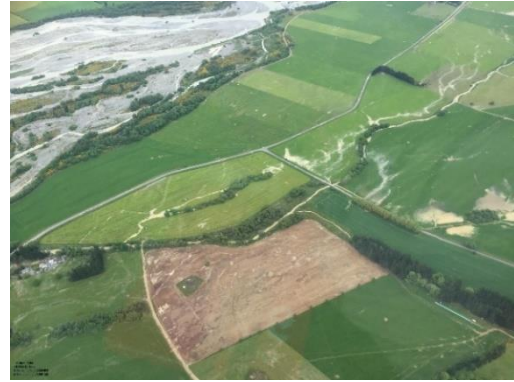
Figure 48: Standing water and ejecta west of Waiau town (-42.638°, 172.993°).

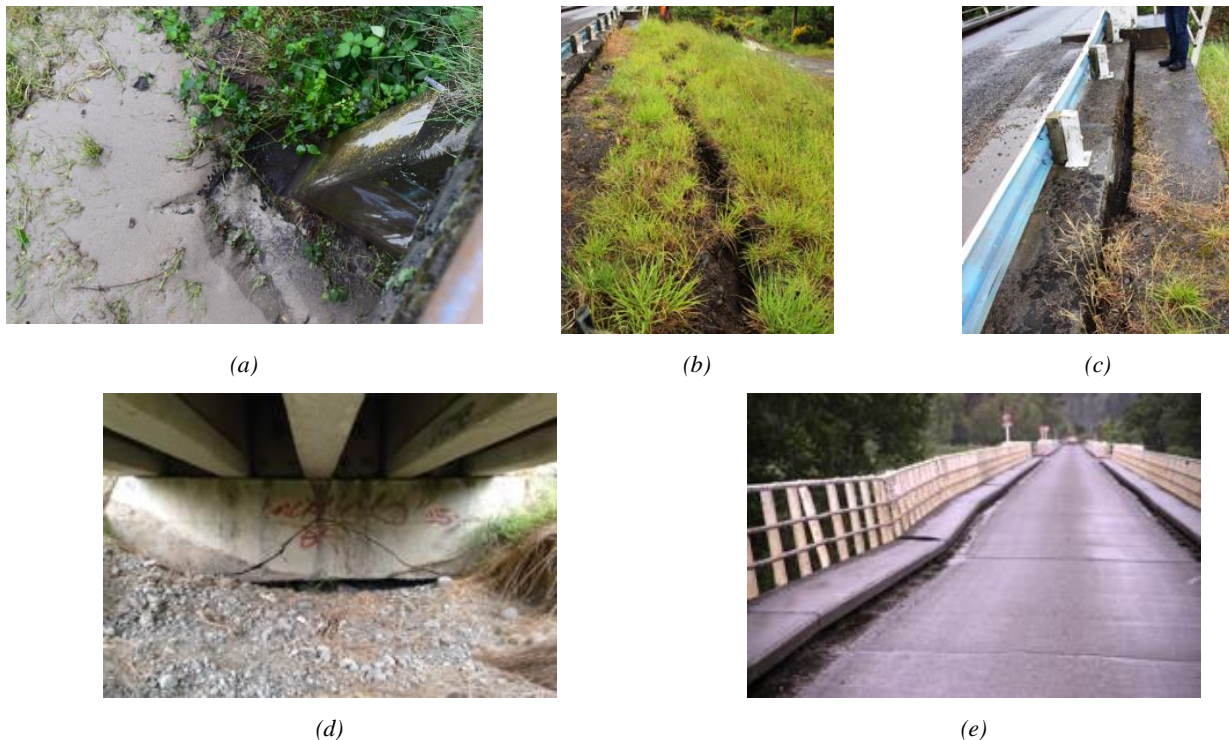
Figure 51: Liquefaction-induced damage at Waiau River Bridge (-42.66°, 173.03°): (a) Moderate liquefaction and gap (from inertial loading) around bridge pier; (b) Lateral cracking in southern side of western approach embankment looking E; (c) Settlement at outward movement at western abutment looking E; (d) Cracking and subsidence of fill at river side of western abutment looking W; (e) Differential settlement at second pier from western abutment looking E.

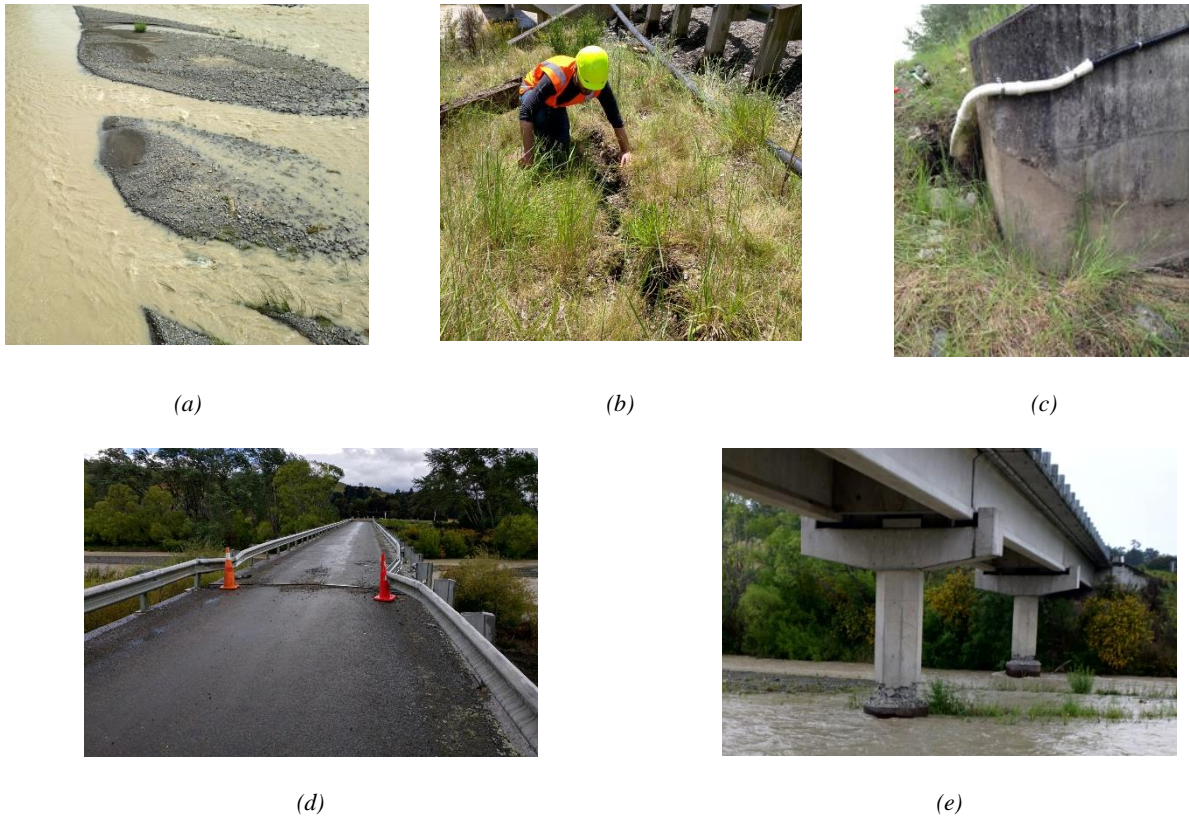
Figure 52: Liquefaction, deformation and damage at the Lower Mason Road Bridge (Approx. Coordinates: -42.63° , 173.07°): (a) Ejecta within the braided river channel (taken facing W); (b) Large outward spreading (~ 40 cm) at the west side of the south approach (taken facing N); (c) Settlement of fill materials at west side of north abutment (taken facing N); (d) Lateral displacement of bridge deck relative to the abutment and buckling of crash barrier (taken facing S); (e) Structural damage at the base of the bridge piers.

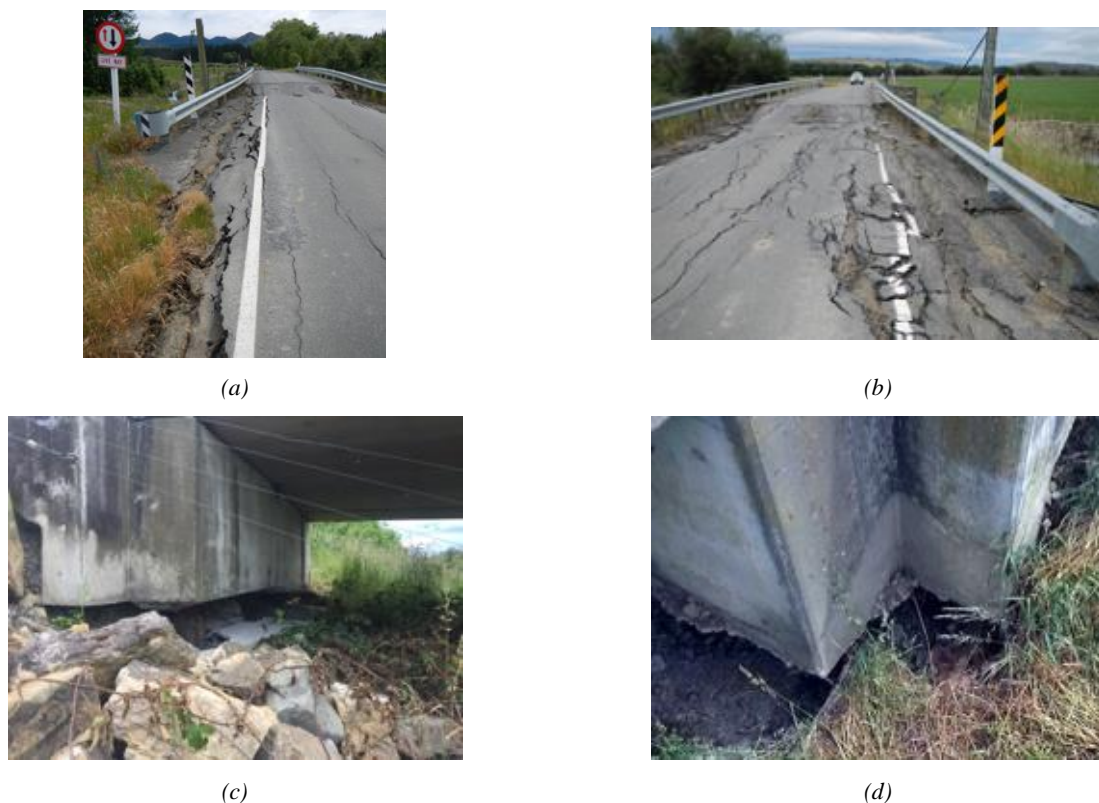
Figure 53: Settlement and cracking in approaches to Mt Paul Bridge (-42.64° , 172.99°): (a) SW corner looking N (d) NW corner looking S. (c) Settlement and spreading of fill on north (stream) side of southern abutment (looking W) exposing severely damaged piles; (d) Settlement and soil gapping on eastern side of north abutment facing N.

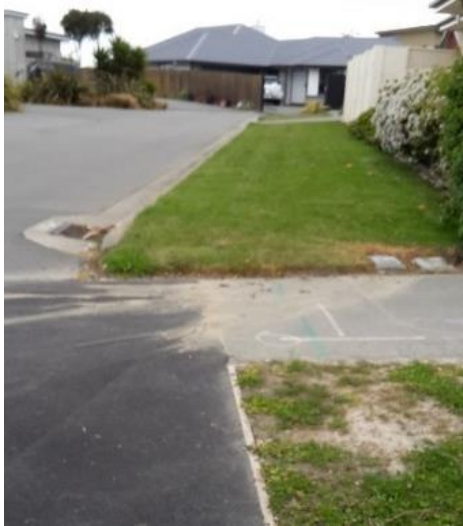
Figure 54: Isolated ejecta in the Parklands area of Christchurch (Approx. coord: -43.47°, 172.71°; Photo courtesy of S. Cox).
