This article demonstrates how the inclusion of partial discharge as a measurement parameter ensures a more reliable diagnosis of insulation condition in transformer bushings. Comparative diagnostic tests showed that the partial discharge measurements best enabled the detection of bushing defects, which the other methods were not able to detect alone.

# Effective bushing diagnosis using partial discharge testing

# Partial discharge measurements effectively detect failure-causing defects

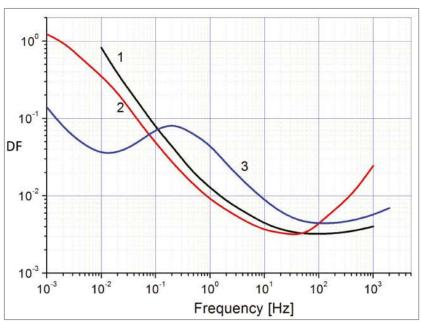
Figure 2. DF measurements on: healthy bushing (1), ungrounded tap for 3h (2), tap grounded 50 h AC test (3)

Off-line C and DF measurements can be performed in a wide frequency range to identify the presence of defects, such as shorted grading layers; contact problems and high impedance faults between layers or at the test tap; insulation ageing; as well as contamination and moisture ingress. As an example, the results of such measurements performed on an OIP bushing with a damaged test tap are shown in Fig. 2.

The bushing was in operation for three hours with an ungrounded measuring tap. This led to a voltage potential of about 15 kV between the tap and flange (calculated after opening the bushing based on the insulation thickness and the recommended electrical field distribution inside the bushing). These triggered electrical discharges resulting in the bushing tap damage. The results of the DF measurements performed on the defected bushing (curve 2) were compared to the ones obtained on the healthy bushing from another phase of the same transformer (curve 1). Curve 3 was obtained after the same defected bushing was subjected to the operating voltage (grounded tap) in the lab for 50 hours.

Two types of polarization processes (interface and orientation) were noted in the defective bushing, Fig. 2, curve 2. At frequencies above 100 Hz, the migration of the by-products resulting from oil and paper decomposition (e.g. acids, water, hydrocarbons and even solid particles) increased the DF value. The relaxation at frequencies below 0.01 Hz could be the result of the presence of a small amount of gas. When the bushing with the damaged but grounded measuring tap was tested at the operation voltage for 50 hours, Fig. 2, curve 3, the electrical field triggered the interface polarization and the separation of the by-products at the insulation oilpaper interfaces. This lead to an increase of electrical conductivity between the insulation layers and to a higher DF value.

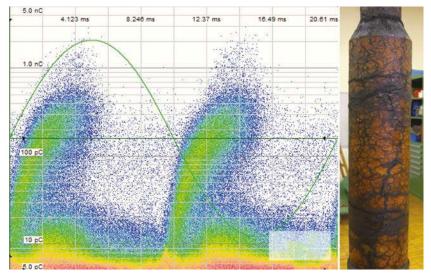
Figure 3. Example of PRPD pattern of defective RBP bushing (discharges of the surface of the bushing insulation)

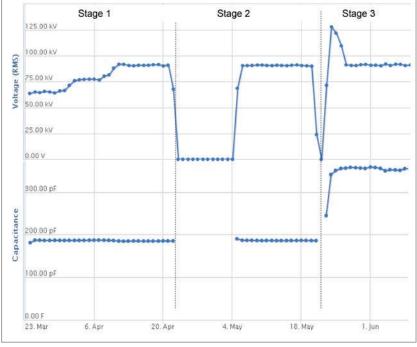
Figure 5. Test voltage and capacitance during the testing period

At Stage 1, the test voltage was gradually increased from  $0.75 \cdot U_{\rm m}/\sqrt{3}$  to  $1.05 \cdot U_{\rm m}/\sqrt{3}$ , Fig. 5, upper trend. The C value was constant, about 190 pF, Fig. 5, lower trend.

In Stage 3, an oil leakage was simulated by partly removing the oil from the bushing enclosure. The test voltage remained constant (88 kV). In this case, an increase in the bushing capacitance from 190 pF to 350 pF was recorded. The capacitance increase can be explained based on the parallel capacitances introduced after oil removal. The amount of paper left above the oil gets contaminated with the moisture from the surrounding air. Thus a capacitor of higher capacitance was created having the (wet) paper as a dielectric. The dielectric constant of the (wet) paper  $\epsilon_r$  is one of the factors that lead to the capacitance increase.

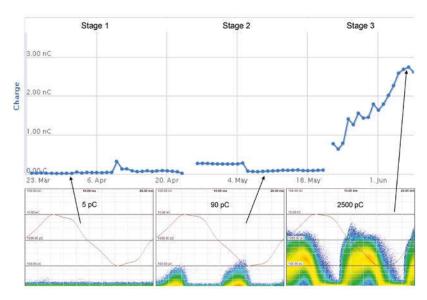
Figure 6. PD trend and PRPD patterns during OIP bushing testing

Regardless of the test voltage level, no PD signal was detected, Fig. 6. The voltage at Stage 2 was constant and equal to  $1.05 \cdot U_m / \sqrt{3}$  (88 kV) and the bushing capacitance remained stable throughout the test. During the PD measurements, defect-specific PRPD patterns were detected. These were probably the result of discharges in the air bubbles, Fig. 5, middle PRPD, that were artificially introduced. Therefore, it can be concluded that the insulation contamination in the OIP bushings could be detected based on PD.

A significant increase in PD levels after reducing the bushing oil level was noticed as well, Fig. 6, Stage 3. This can be seen by analysing both the PD trend and the corresponding PRPD patterns. However, by comparing the PRPDs from Stages 2 and 3, the presence of two different types of defects can be seen. In conclusion, any oil leakage that may occur during the operation of OIP bushings can be detected based on both C and PD measurements.

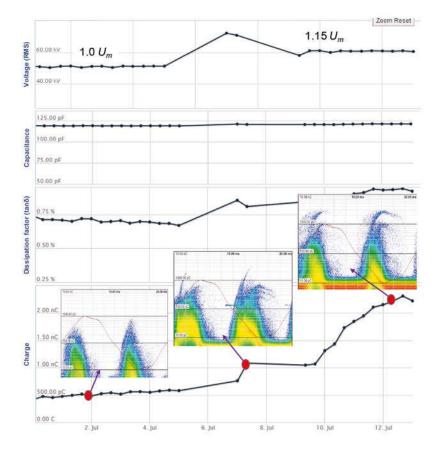
Figure 7. C, DF and PD variation for RBP bushing

A 52 kV RBP bushing with design flaws was investigated (the bushing failed at the factory acceptance test). According to reference [8], the PD test is passed if the PD level does not exceed the value of 300 pC while testing the bushing at voltages between the 1.05 and 1.5· $U_{\rm m}$ . The bushing being presented here showed a PD level of 500 pC at  $U_{\rm m}$  (caused by the design flaws).

During the C, DF and PD tests in the laboratory, the test voltage took values between  $1.0 \cdot U_{\rm m}$  (52 kV) and  $1.15 \cdot U_{\rm m}$  (60 kV) throughout the investigation. At  $1.0 \cdot U_{\rm m}$ , both C and DF show stable values, Fig. 7, upper trends, while the PD level increases with a low slope, Fig. 7, lower trend. After increasing the test voltage to the value of  $1.15 \cdot U_{\rm m}$ , a steeper increase of the DF and PD values can be observed. The bushing C remains constant as no short circuit of the grading layers occurred. The evolution of the PRPD patterns characteristic to discharges in gas cavities of the insulation is presented in Fig. 7 as well. It can be noticed that the amplitude and the repetition rate of the PD pulses continuously increase.

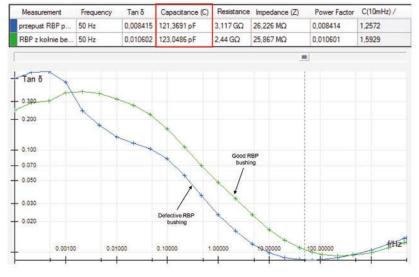
Off-line measurements of C and DF were performed in a wide frequency range on this RBP bushing as well, Fig. 8. The results obtained here are very close to those obtained from online testing at  $1.0 \cdot U_{\rm m}$ . The voltage level applied for the off-line tests was 100 V and therefore too low in order to trigger the PD activity in the existing gas cavities. At the next step, the bushing was opened for a detailed investigation and several traces of PD activity were found, Fig. 9. Most of the carbonized areas were located in the region of the flange. Only few insulation punctures were found near the ends of this RBP bushing.

Figure 8. Off-line measurements of C and DF

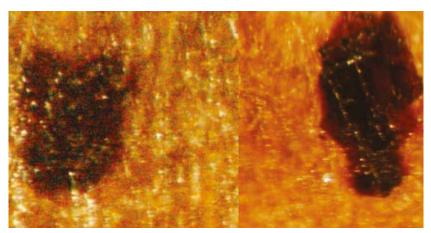
Figure 9. Evidences of PD activity in RBP bushing

It is commonly accepted that the capacitance is one of the most important dielectric indicators of bushing insulation condition. In this case however, the presence of the gas cavities could not be identified as the capacitance value remained constant throughout the test, as no short circuit of a grading layer occurred. Thus by measuring the PD level and analysing the PRPD patterns, incipient condition defects can be identified before developing into serious failures.
