# RESEARCH INTO POSSIBILITIES OF REDUCING THE X155CrVMo12-1 TOOL STEEL FRAGILITY

Preliminary Note – Prethodno priopćenje

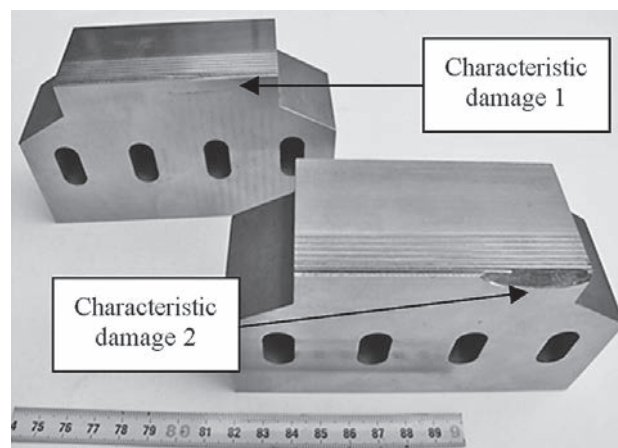
As a typical example, the research was performed on the damage caused on the tool for manufacture of nails. The tool was made out of two pieces, composed of two jaws. The Figure 1 presents the tool damaged after shorter service time.

Figure 1 Nails making tool, jaws damaged while service

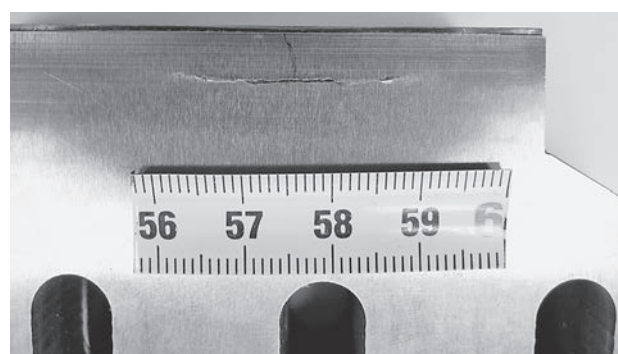
The Figure 2 presents characteristic crack on the tool work surface.

Figure 2 Characteristic cracks at work surface of the jaw 1

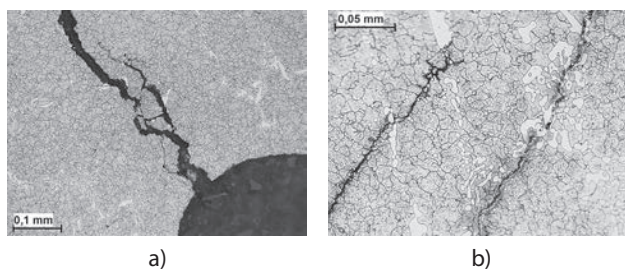
After visual control, there were characteristic parts of the tool selected and the test samples were cut out. Detailed metallographic inspection showed expressed advancement of cracks from the surface at the point of the rounded slot for holding the nail head, the Figure 3a.

The cracks were present also toward the tool middle, the Figure 3b. It is noticed that the progression was intercrystalline, mostly along the carbides that were arranged by coalescence causing their “concretion”.

**Figure 3** Characteristic cracks on the tool part a) crack start; b) crack progression toward the middle of the tool

of 15 mm from the surface. This indicates good hardenability of the tool. It was concluded that the presence of cracks at the transversal cross-section of the tool was most likely a consequence of dynamic stresses that progressed relatively intensively because of the fragility of carbides distributed by coalescence. Due to joining of such cracks, local parts of the work surface were torn off.

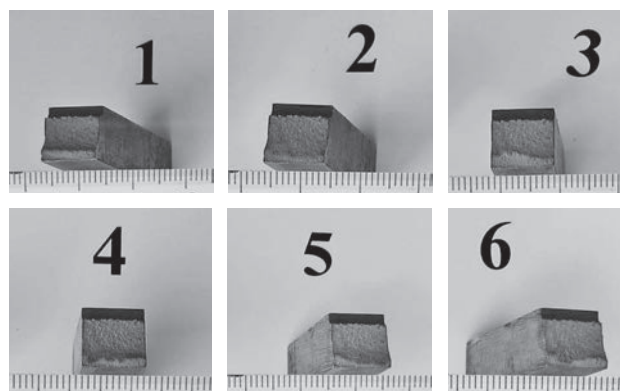
**Figure 4** Characteristic appearance of broken sample surfaces for toughness

Due to the steel specificity, i.e. its good hardenability, the testing was performed at the impact energy of 150 J. Toughness J/cm<sup>2</sup> was determined by reading the impact. The Figure 4 presents characteristic appearance of the broken surfaces of test samples. On cross-sections, values of hardness HV0,5 were measured from the surface to the core.
