# An Evaluation of Nantucket's Town Facilities

An Interactive Qualifying Project  
submitted to the Faculty of  
WORCESTER POLYTECHNIC INSTITUTE  
in partial fulfillment of the requirements for the  
degree of Bachelor of Science

Gregg Tivnan  
Nantucket Town Manager's Office

Larry Kester  
Nantucket Department of Public Works

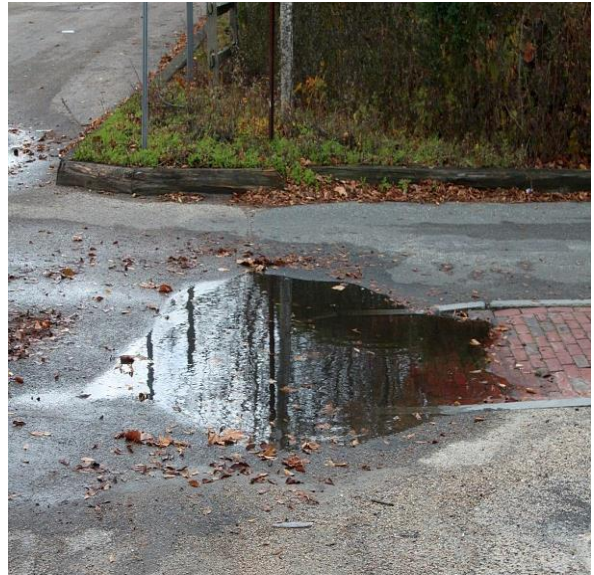
responders park in these spaces, the fire engines would again be blocked. There are also frequent issues with drainage in parking lots, including those at the Natural Resources Department, the Main Fire Station, the Community School, and the Finance Building (see Figure 18).

Figure 18: Poor drainage at the Finance Building

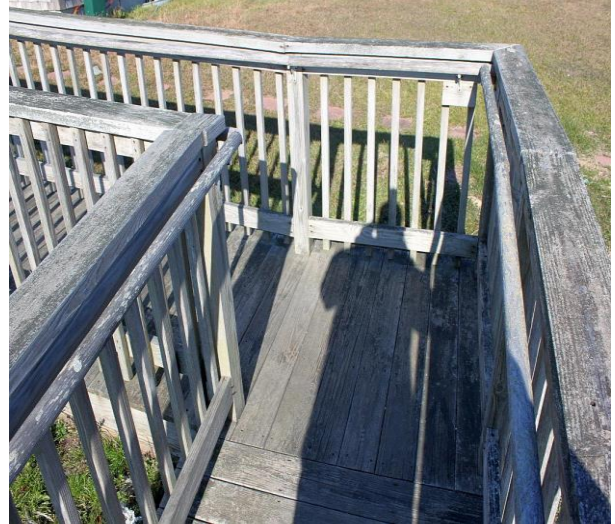
Figure 20: Tight ramp at DPW Administrative Building

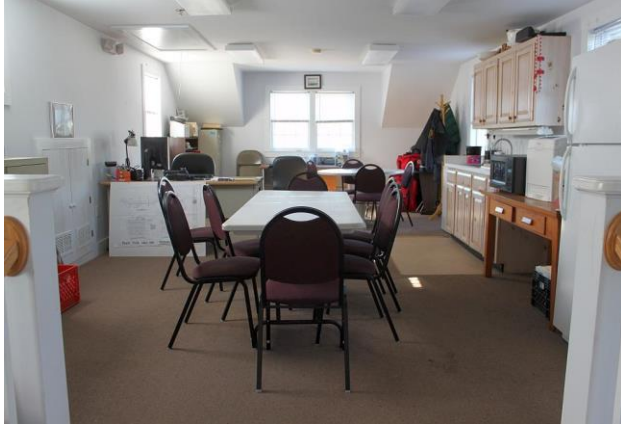
Aside from parking and accessibility issues, many of the town facilities also lack adequate communal and meeting spaces. This is a major inconvenience for town employees and their associates, and often hinders them from conducting comfortable, productive meetings. One such facility with this issue is the Harbormaster Building. According to the Harbormaster, summer staff meetings include up to 50 people, but the facility's conference room can seat only 15 (see Figure 21). Across the road at the Finance Department, the only communal area is a small table in the corner of an employee's office; at best, only four people can be seated at this table (see Figure 22). Similar issues exist at the Town Building, Visitor Services, and the DPW Administrative Building.

Figure 21: Meeting space at Harbormaster Building

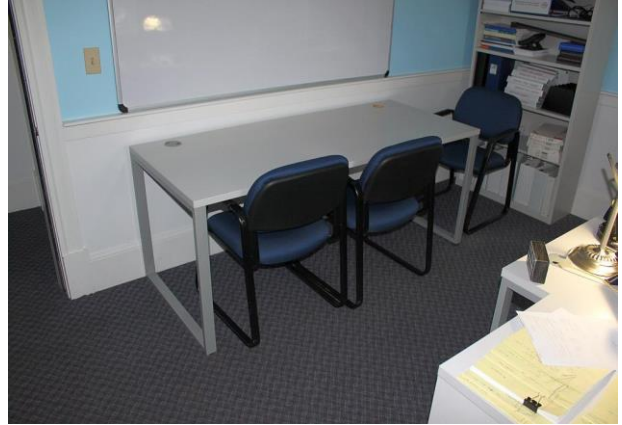
Figure 22: Meeting space at Finance Building

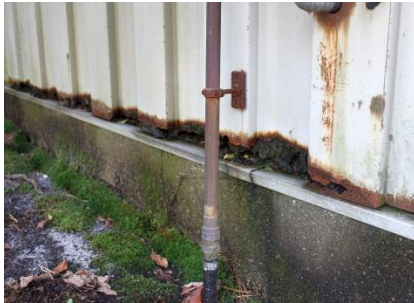
Figure 27: Rusting building shell

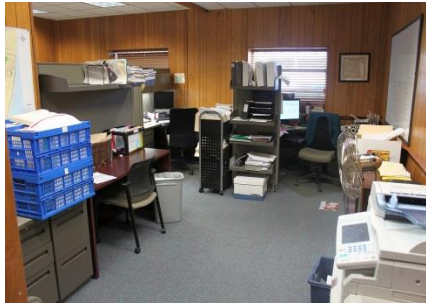
Figure 28: Cramped office space

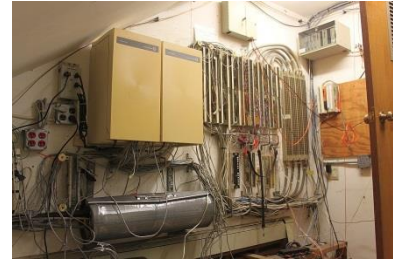
Figure 34: Messy IT room

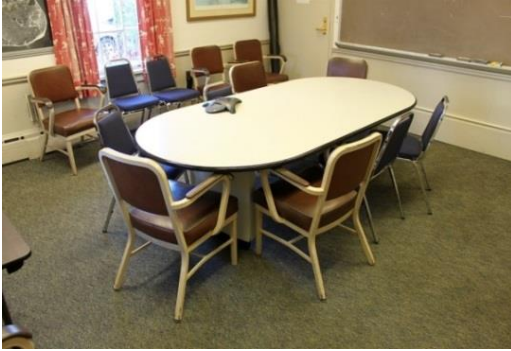
- Leaking water circulators;
- Boiler room floor does not drain properly;
- Asbestos is present in the building's slate tiles, stucco ceiling, and radiator backing boards (*Report for Hazardous Materials Identification Survey at the Town Hall Nantucket, Massachusetts, 2014*);
- The building's only security system is located in the upstairs courtroom area;
- Significant lack of waiting space throughout building - waiting people often spill out on stairs, within the court security area, and outside of the building;
- Lack of meeting space – only two conference rooms (one is private and the other comfortably fits about eight) (see Figure 36);
- Some windows cause noticeable heat loss to office spaces; and,
- Lack of parking, notably in summer months (see Figure 37).

Figure 36: Limited meeting space

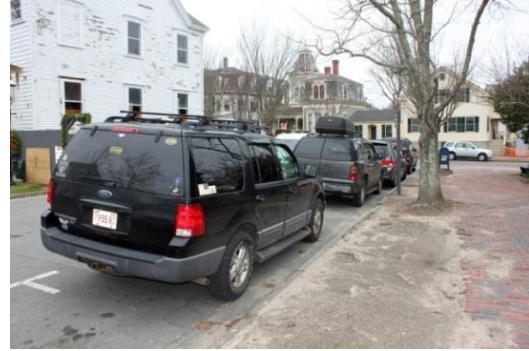
Figure 37: Limited parking

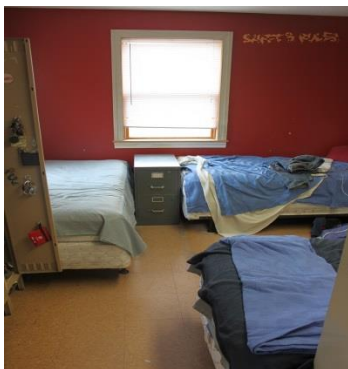
Figure 40: Cramped sleeping quarters

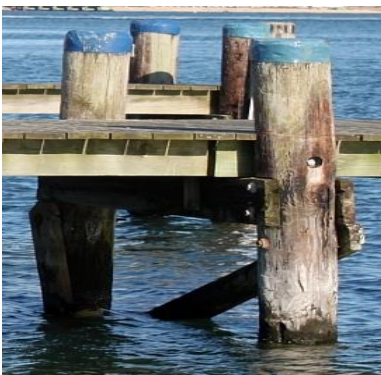
Figure 44: Broken bracing/rotting pylon

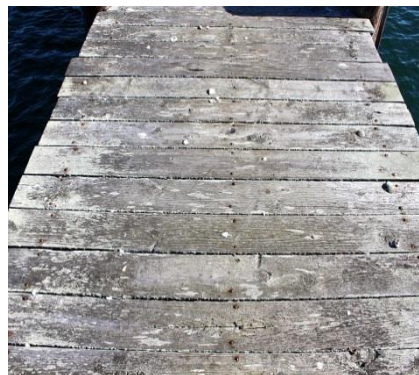
Figure 45: Rotting decking

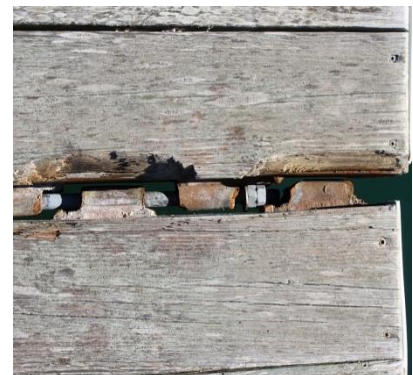
Figure 46: Rusting connections

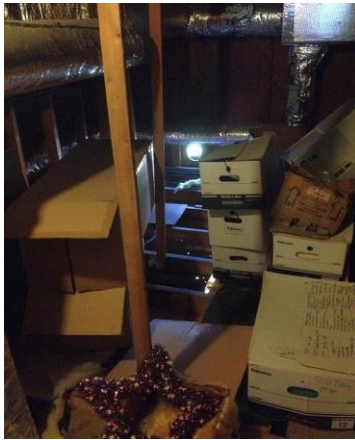
**Figure 47: Inadequate storage space at Visitor Services**

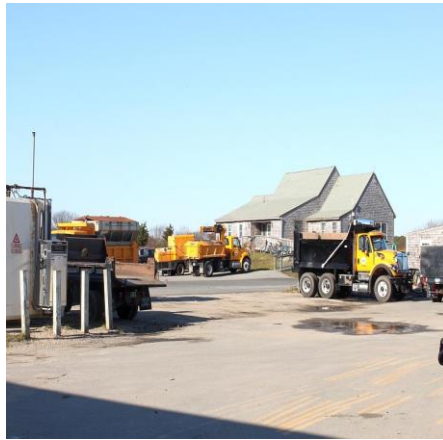
**Figure 48: Inadequate covered storage space at DPW**

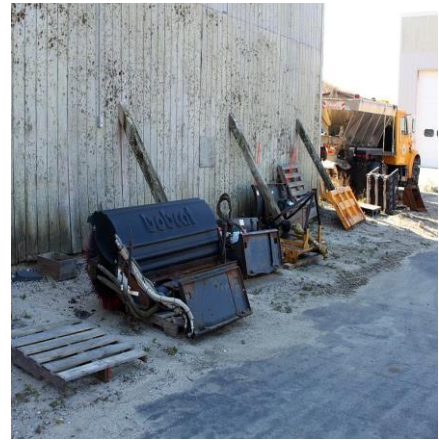
**Figure 49: Expensive equipment stored outside at DPW**

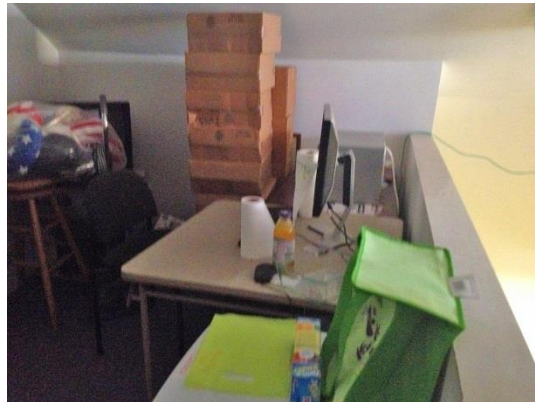
- Great location - close to ferry docks, and in center of downtown; home to public bathrooms in the downtown area;
- Poor heating - during winter, employees must wear layers of clothing and coats to stay warm, and during especially harsh winters, pipes freeze;
- No communal staff space;
- Inadequate office or storage space;
- No interior doors - not possible to have private offices or quiet; and,
- Exterior doors have large gaps, broken knobs, and do not open or close properly.

Figure 51: Cramped break room

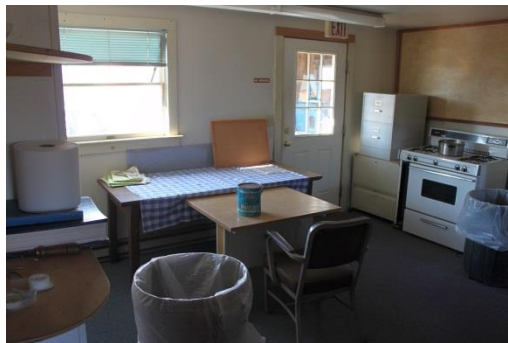
- Two of these sheds are outdated portable classrooms;
- Used for storage, communal space, offices, and break rooms;
- Insufficient space to serve all necessary functions; and,
- Several sheds are unheated and in significant disrepair - the door for one of the sheds is constructed from a piece of plywood and section of rope.

Figure 54: Break room/communal space

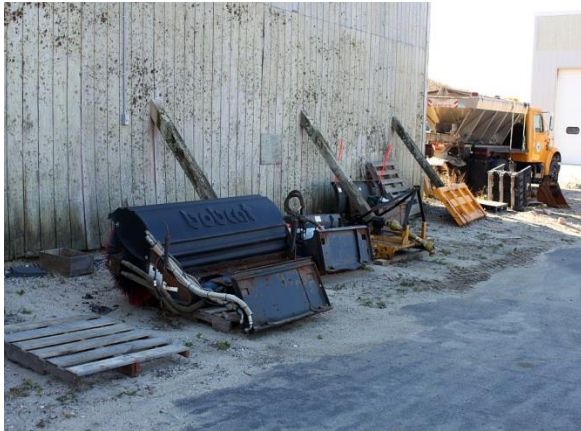
- In generally good condition from a structural standpoint;
- Garages do not provide adequate space to house all of the town's equipment - multiple trucks and pieces of equipment are left outside and exposed to weather (see Figure 56 and 57);
- Inadequate storage space for spare parts for equipment; and,
- Inadequate space to house equipment needed to repair vehicles - it is time-inefficient to not have all equipment on hand, seeing as it already takes, on average, 4-6 weeks for repair requests to get through the procurement process.

Figure 56: Expensive equipment stored outside

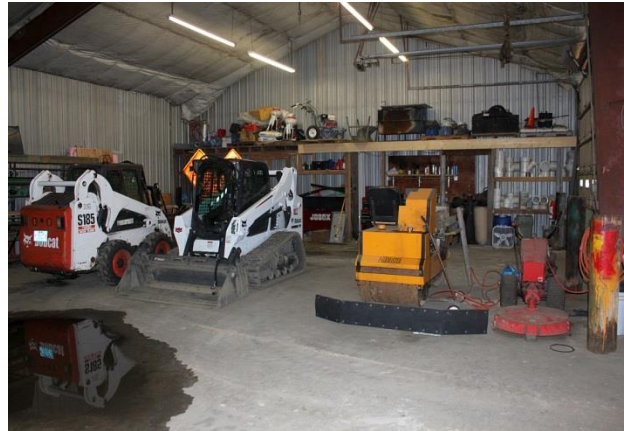
Figure 57: Garage nearly at capacity

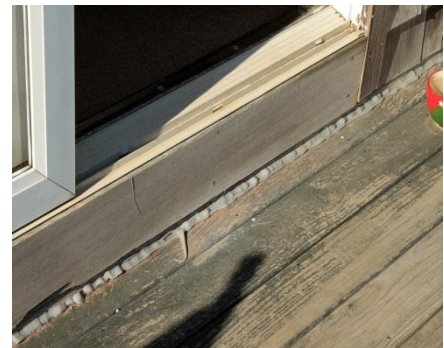
Figure 61: Silicone seal

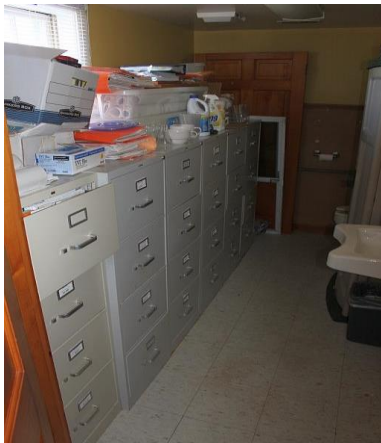
**Figure 62: Filing cabinets in the bathroom**

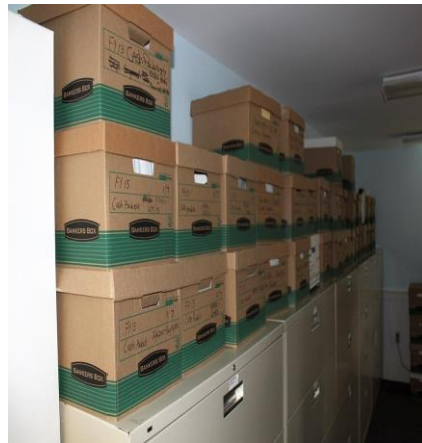
**Figure 63: Excess files at the Finance Department**

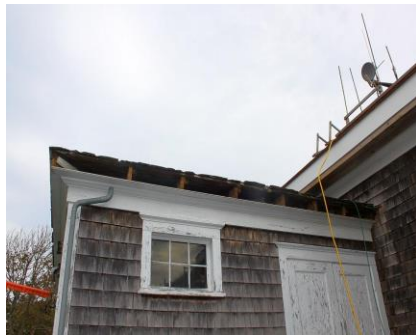
Figure 72: Roof construction at Siasconset Fire Station

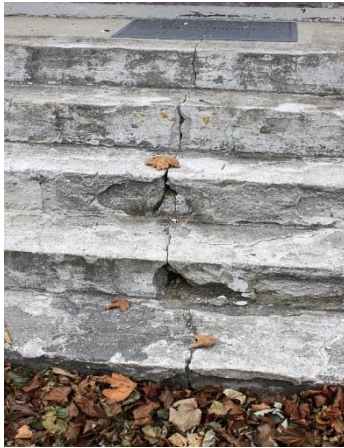
- Front door and windows in need replacement and/or paint - they are all in disrepair and are not weatherproofed;
- Concrete front steps in need of replacement (see Figure 82);
- No parking (see Figure 83);
- Front steps, front door, garage bay doors, and windows all need replacement - they are all in disrepair and are not weatherproof; however,
- Plans are in place to request funding for many additional alterations within the next year and,
- Building is currently undergoing repairs - roof and gutters are being replaced.

Figure 82: Deteriorating concrete staircase

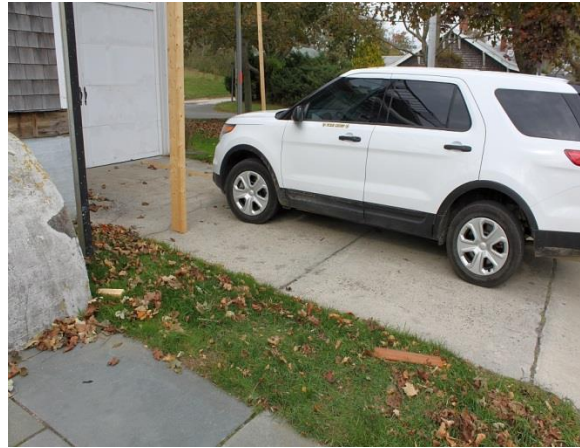
Figure 83: Parked vehicles block engine bays
