# Maintaining the Integrity of Structural and Fire Protection Systems and Building Documentation in Historic Buildings: Washburn Shops Case Study

# Washburn Shops Case Study

in partial fulfillment of the requirements for the  
Degree of Bachelor of Science  
in Civil Engineering by

Date:  
March 1<sup>st</sup> 2012

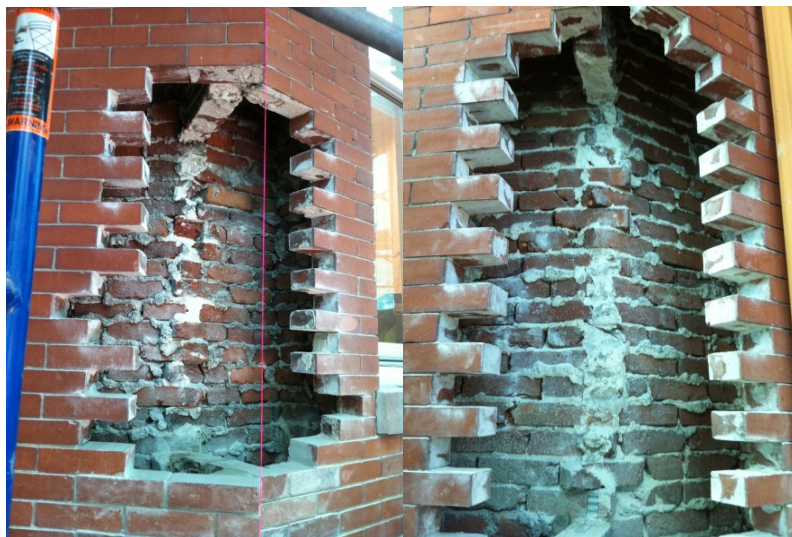
Figure 19: Washburn Tower Masonry Wall Cross-Sections

interior brick walls (Salter, 2011). The most concerning questions that arose from this situation are thermal and seismic stability. The tower walls were the only ones to be reinforced with bracing, and these did not contain any added insulation. Currently, the masonry walls of the original building only have a supporting column between each window and the addition's masonry walls are completely hollow between the windows (Guertin, 2011). A cross-section of the tower's masonry walls is shown in Figure 19.

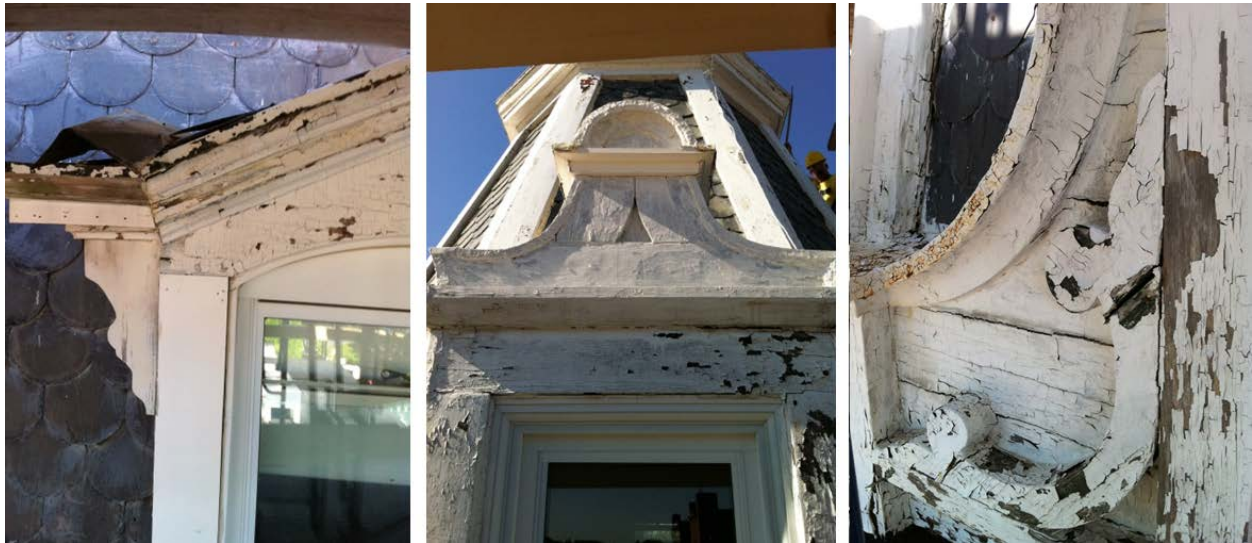
Figure 20: Pre-Renovation Window Conditions

The majority of the renovation work made changes to the upper portions of Washburn. The roof was entirely re-slatted, the top row of windows were replaced but kept the “divided light” style, and 31 window eaves were rebuilt with zinc coated copper. The before and after conditions of the windows are illustrated in Figure 20 and Figure 21.

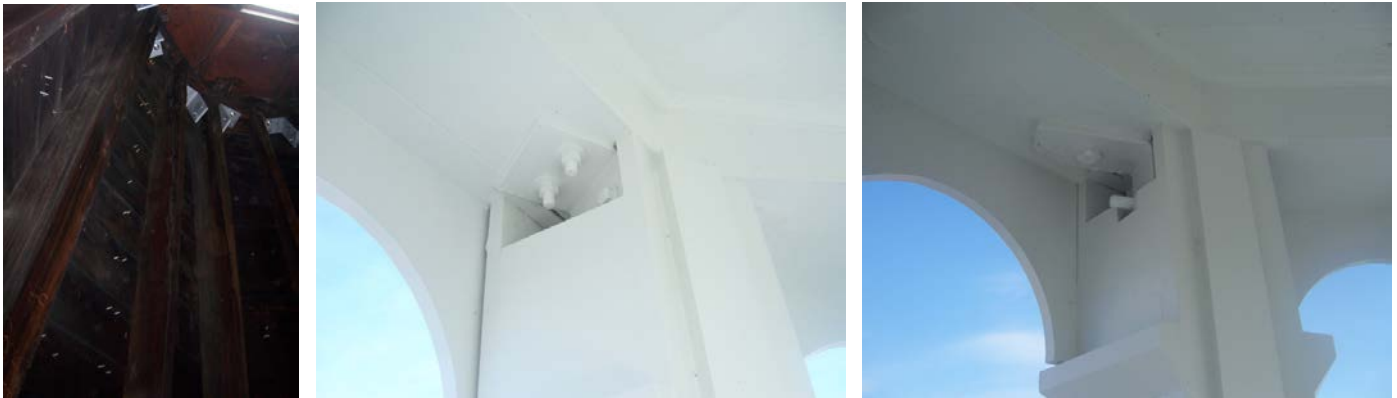
Figure 22: Views of Tower Bracing

tower was replaced due to rotting. The mansard roof also had rotting sections and falling concrete that were refurbished. The tower needed to be reinforced, and bracing was installed along the inside framing. Figure 22 details the new bracing as well as the old (Guertin, 2011).

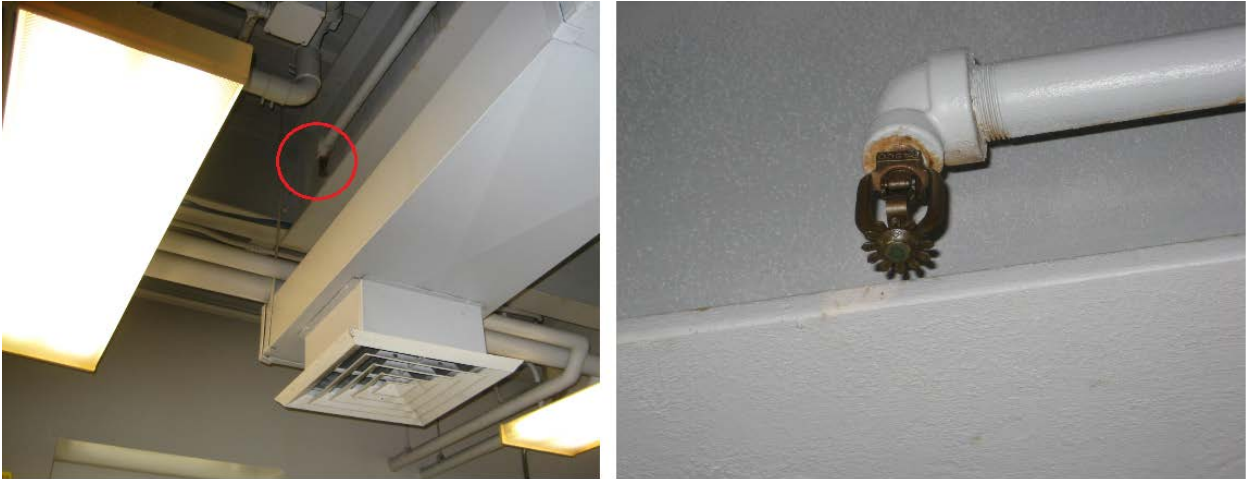
heads are presented in Figure 56-Figure 58.

Figure 56: Beam Obstruction Room 339

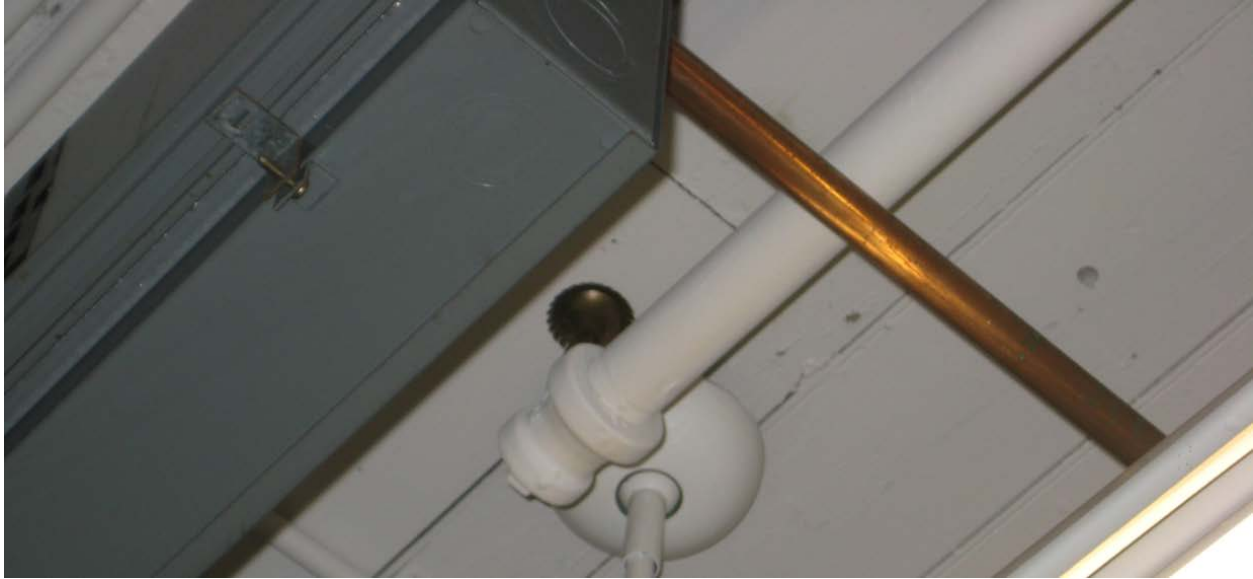
Figure 58: Metal Box Obstruction Room 107

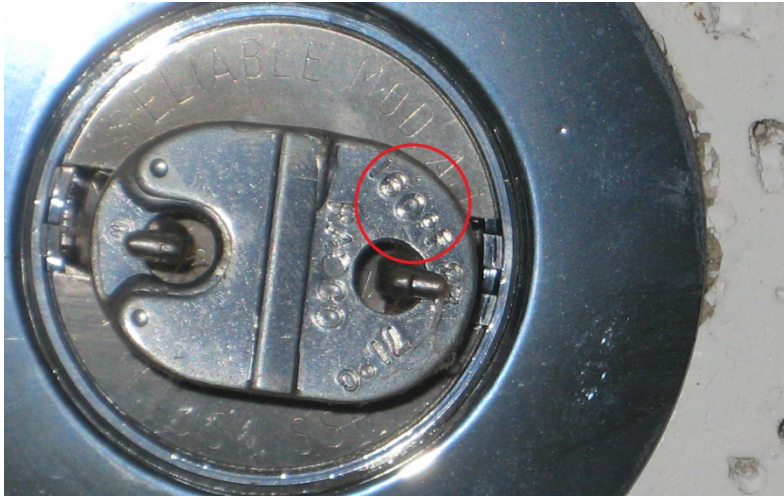
The sprinkler system was also examined on the condition of the individual sprinkler heads. Results showed the sprinkler were appropriately temperature rated (the heads in the suspended ceilings); however, some heads were dirty, painted, or damaged. Figure 59 through Figure 62 display these situations.

Figure 59: Temperature Rating for Sprinklers in Suspended Ceilings

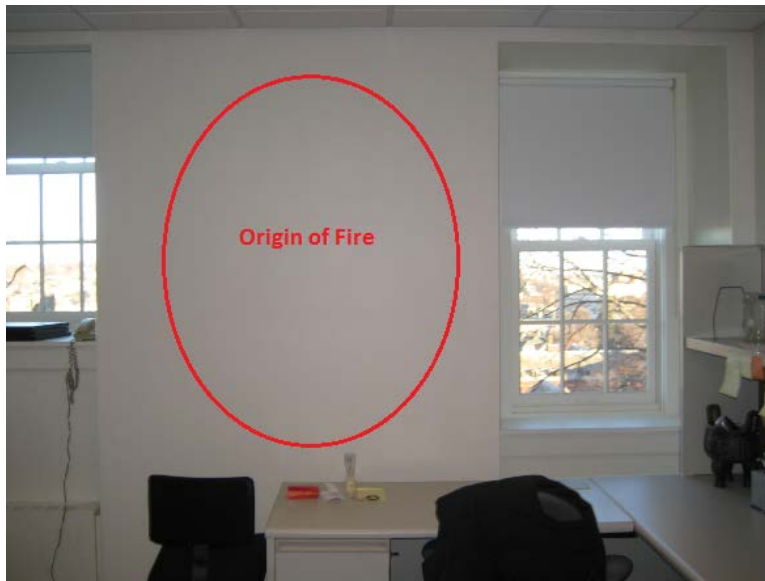
During the roof renovation of Washburn in 2011, a fire started from welding on mansards within an office wall. The office was located on the third floor, room 315. The fire started within the wall area shown in Figure 63 (The wall has since be repaired).

**Figure 63: Origin of 2011 Roof Renovation Fire**

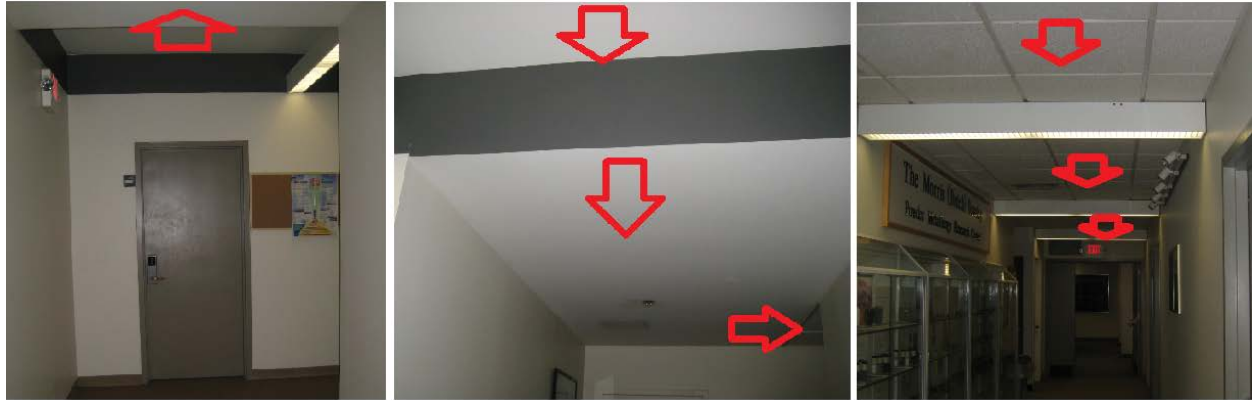
The smoke from the fire traveled from inside the wall to concealed areas above the ceiling. The smoke then traveled in this concealed area outside the room and above the outside hallway as shown in Figure 64.

Figure 64: Smoke Pattern of 2011 Roof Renovation Fire

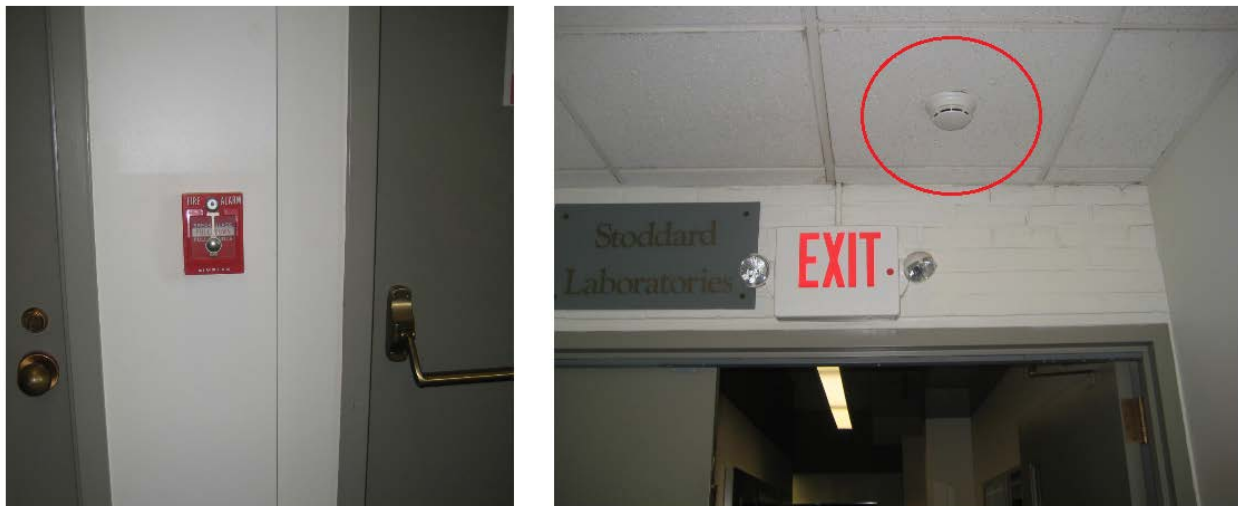
This pull station is seen in Figure 65. The smoke would have eventually reached a smoke alarm at the end of the hallway shown in the far right picture of Figure 64. This detector is also shown in Figure 65.

Figure 65: Manual Pull Station and Smoke Detector used in 2011 Roof Renovation Fire

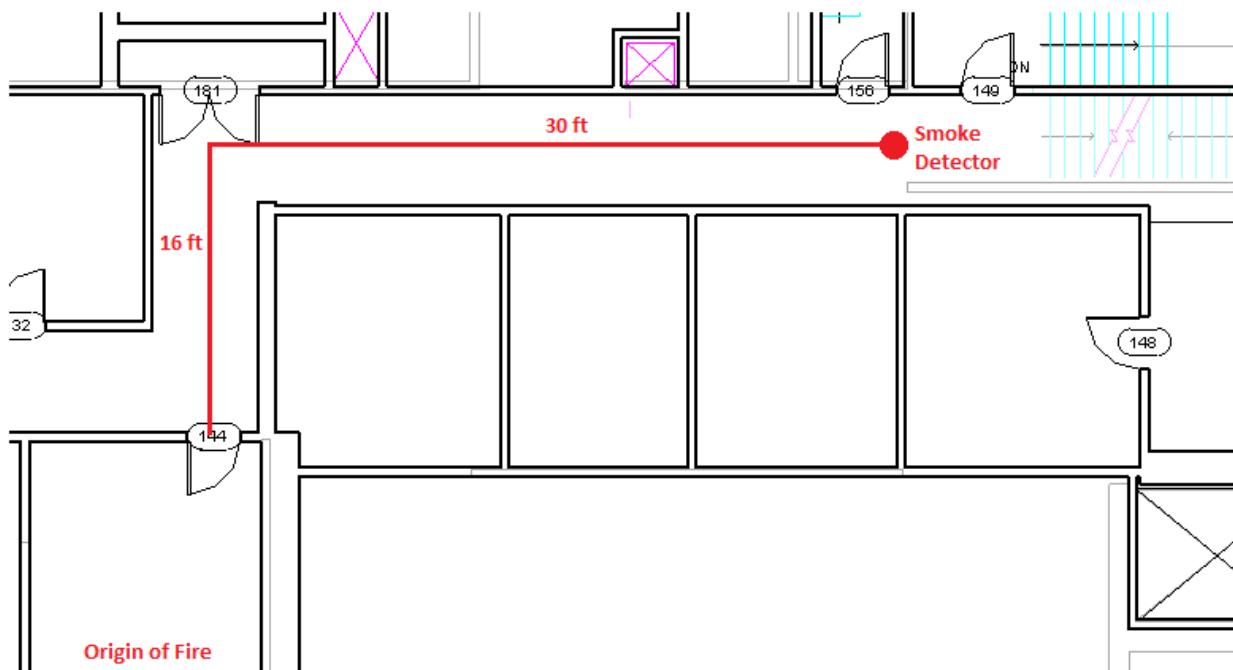
Since there were no detectors within the concealed space above the ceiling, there is a violation of *NFPA 13* 5.5.2.1 and 5.7.1.9 (items 15 and 16 in Appendix 7.2). The distance from the smoke detector located in the hall that did not activate to the door of the room in which the fire originated is depicted in Figure 66. This distance to the door is 46 feet but according to *NFPA 13* 5.7.3.2.3.1 (item 19 in Appendix 7.2) the detectors are allowed to be a maximum of 30 feet apart.

Figure 66: Distance to Nearest Smoke Detector in 2011 Roof Renovation Fire

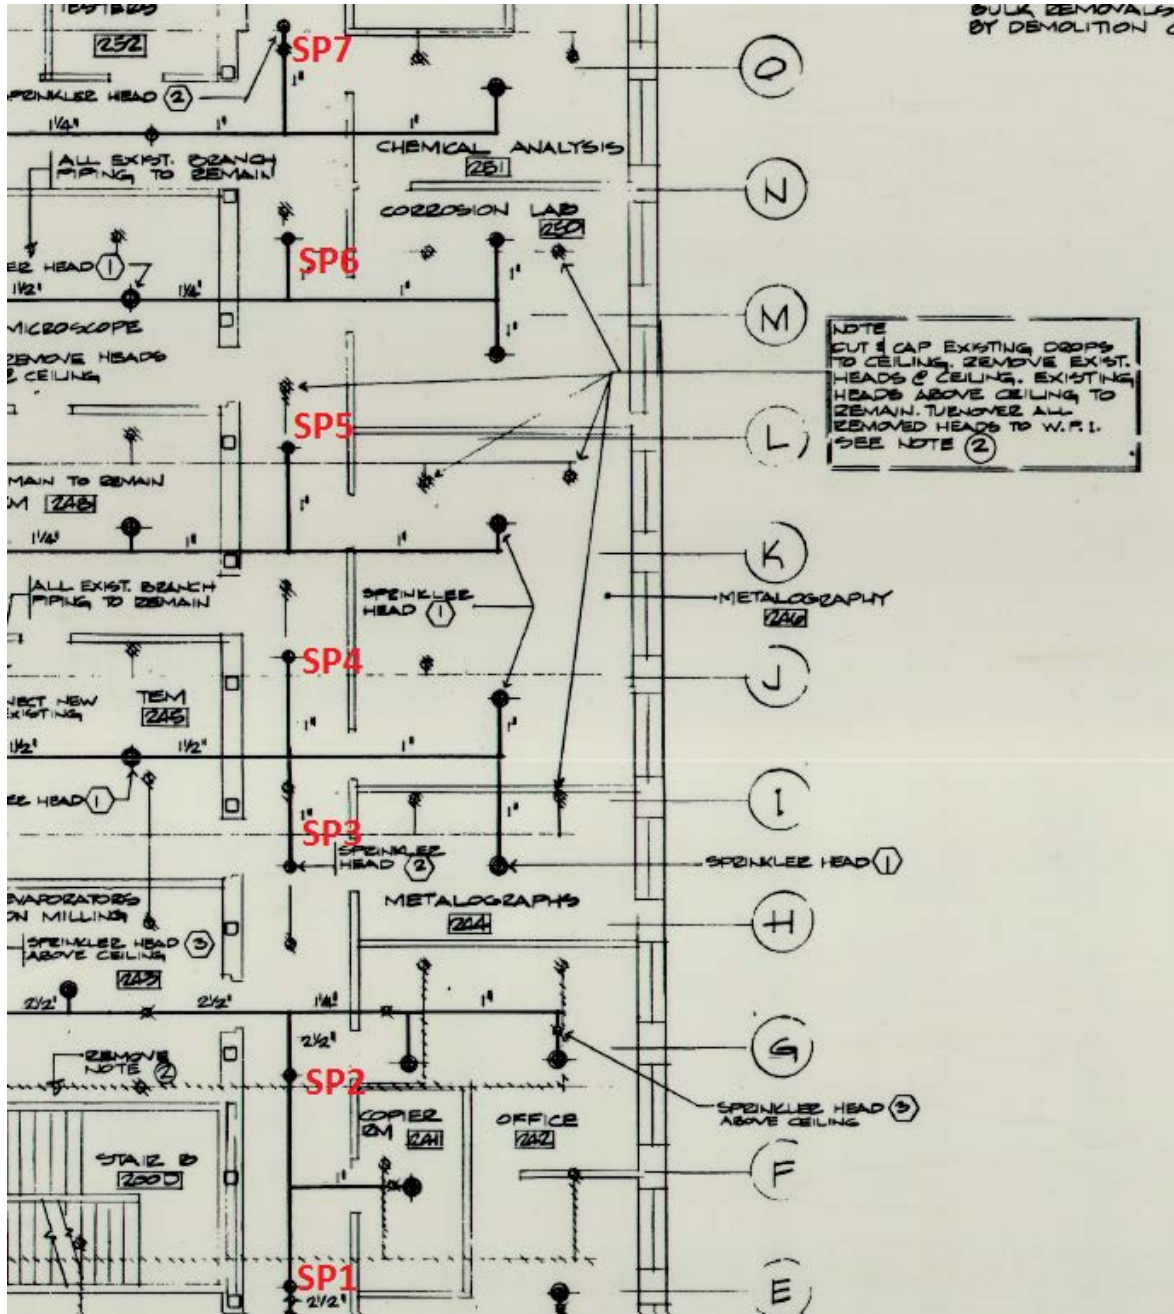
Figure 84: Current Sprinklers in Second Floor Hallway of Washburn

Seven new sprinklers would be added to account for the seven sprinklers that are obstructed by the current construction conditions. Figure 84 shows where the current sprinklers are located within this hallway. The full floor plan with the fire protection system is included as Appendix 7.6.

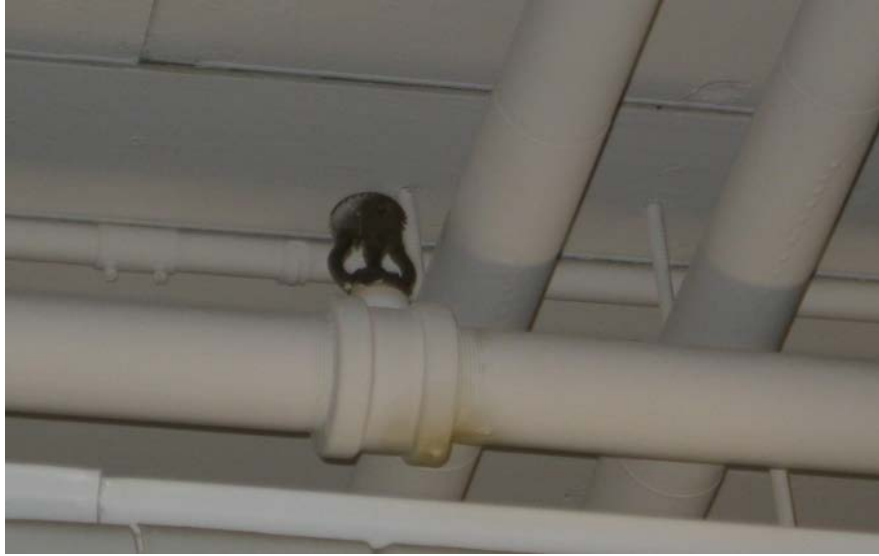
Figure 88: Frame arms parallel to branch line (item 4) Deflector parallel to ceiling (item 7)

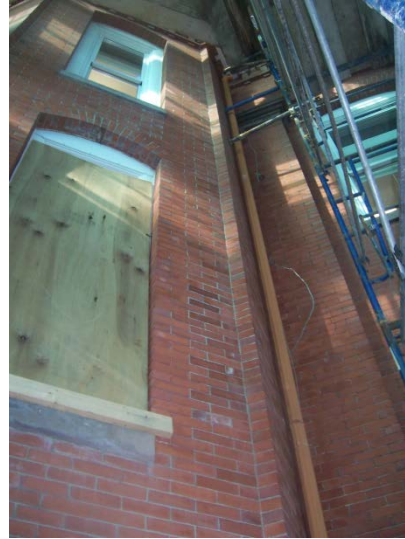
Replaced Bricks on Front Tower

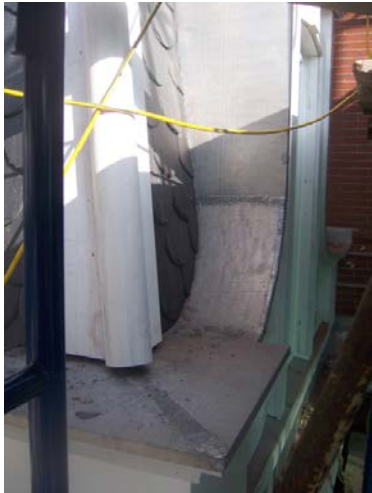
Soldering on Window
