The Collapse of the Alto Río Building during the 27 February 2010 Maule, Chile, Earthquake

Cheng Song,^{a)} Santiago Pujol,^{a)} M.EERI, and Andrés Lepage,^{b)} M.EERI

The Alto Río Building, a 15-story building located in Concepción, Chile, collapsed during the 2010 Maule earthquake. Construction of the building was completed in 2009 following the Chilean building code of 1996. The building was provided with reinforced concrete structural walls (occupying nearly 7% of the floor area) to resist lateral and vertical loads. The walls failed in the first story, causing the overturning of the entire building. This paper provides detailed field observations and discusses plausible causes of the collapse. [DOI: 10.1193/1.4000036]

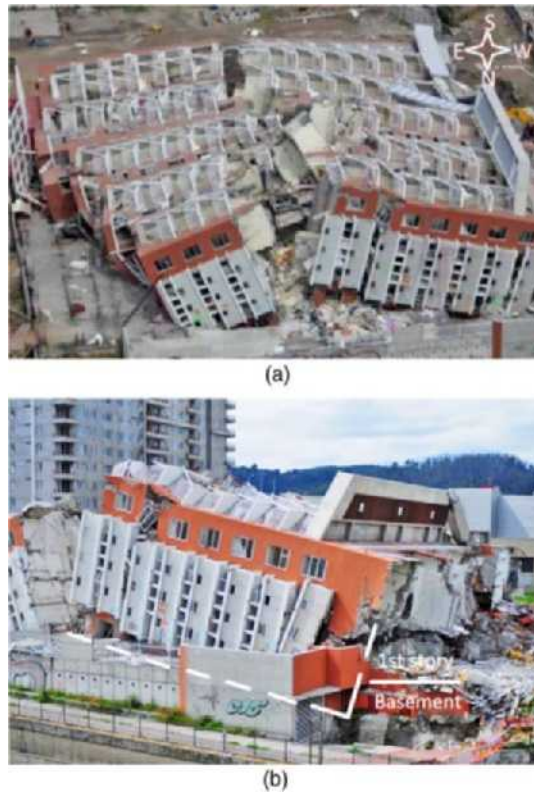
The Alto Río Building (Figure 4a) was the only building with more than three stories that suffered total collapse during the 2010 Maule Earthquake. The building overturned toward the east, rotating about the longitudinal axis of the building in the first story (Figure 4b). During the collapse, the building penetrated the slabs of underground parking spaces, which had a larger floor plan (extending further to the east) than the aboveground stories. Where it met an underground wall oriented in the NS direction, the building split in two (Figure 4).

Figure 4. General photos for the Alto Río Building: (a) the Alto Río building after collapse (from <http://skyscraperpage.com/cities/?buildingID=85186>); (b) the damage view from north.

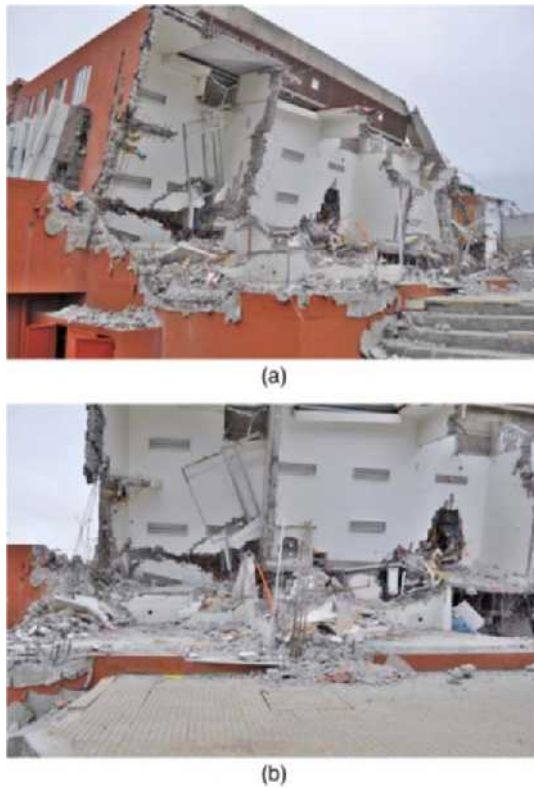
The east ends of first-story walls penetrated into the basement during collapse. The ceiling of the first story rotated approximately 90 degrees (clockwise if observed from the south) and fell approximately 4 m (13 ft) to the west of axis I.

Figure 5. Damage photos for the first story: (a) damage in the first story (view from northwest); (b) observed shift of walls toward the south (view from west). Photo credit: E. Fierro and A. Iruretagoyena.

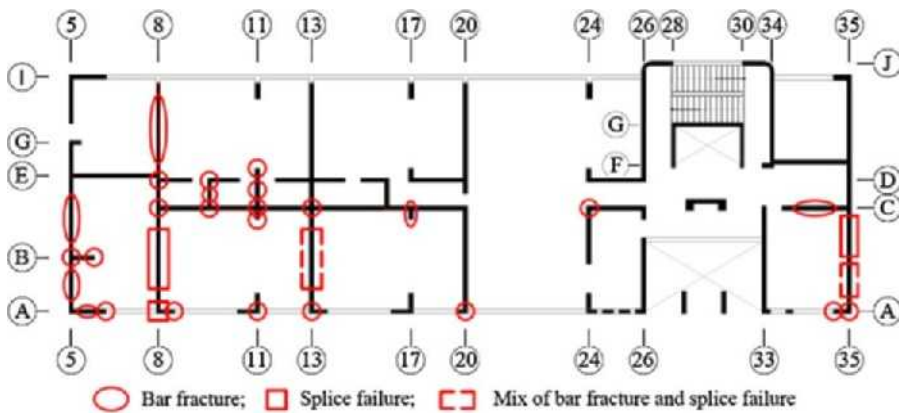
Walls in the first story failed along cracks that joined the ends of lap splices located in the first story. As the building collapsed, parts of the first-story walls that remained attached to the upper stories rotated approximately 90 degrees, with the ceiling of the first story becoming nearly vertical (Figure 5). The structure shifted as much as 0.8 m (2.6 ft) toward the south, and the east walls penetrated the basement (Figure 5). Both splice failures and bar fractures were observed on the west side of the first story. Bond failures were observed in bar splices of $\Phi 8$ mm, $\Phi 10$ mm, and $\Phi 25$ mm bars. Locations where splice failures and bar fractures were observed in the first story are shown in Figure 6.

Figure 6. Observed locations of splice failures and bar fractures in the first story (walls without marks could not be inspected).

The index was less than 0.10 for approximately 50% of the wall sections in both the first and second stories of Alto Río. This suggests that fracture of the reinforcement could have led to the collapse. Figure 6 shows that bar fractures occurred. But they occurred at the base of the first story rather than at the base of the second story. This fact and the conventional analyses presented suggest that the solid walls in the first story were weakened either by shear failures under openings (as suggested by the model by Moehle et al. 2011), or by bond failures along lap splices (Figure 6), or both.

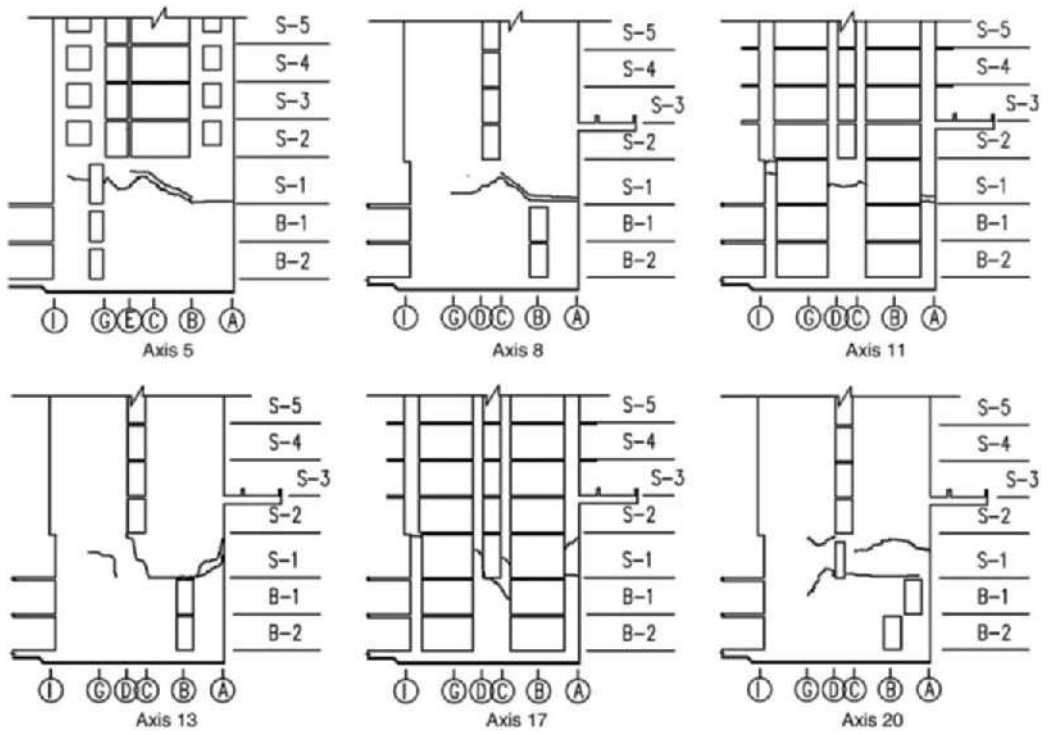
Failure surfaces observed along axes 5 to 20 (on 29 November 2010) are shown in Figure 7. Detailed descriptions of the damage observed along each axis are presented in the following sections.

Figure 7. Failure surfaces visible on November 2010 (view from north).

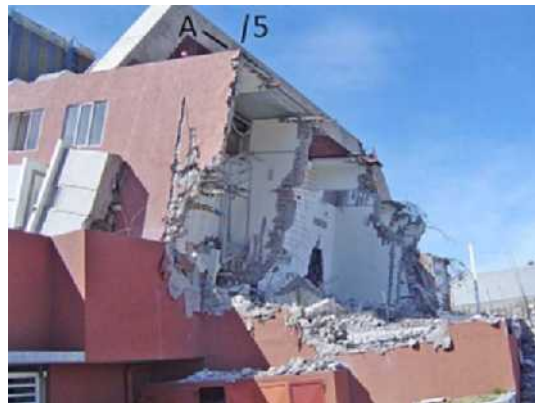
On the northwest side of the building, the wall along axis 5 failed at the base of the first story. The failure surface was horizontal from axis A to axis B, and ascended gradually from axis B to the top of 1.5 m (60 in.) lap splices near axis C (Figure 8).

Figure 8. Wall along axis 5, 29 March 2010. Photo credit: G. Alarcón.

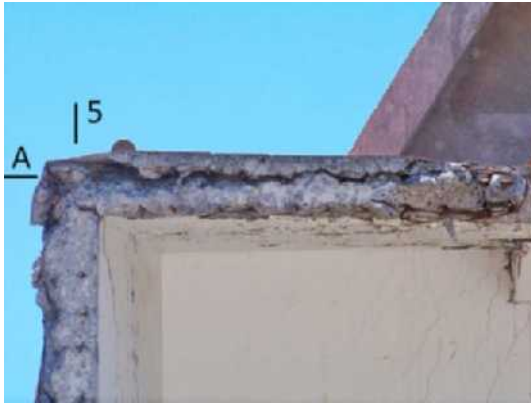
Bar fractures were observed in $\Phi 10$ mm reinforcing bars in the wall web between axes A and C. In the wall flanges along axes A and B, bar fracture was observed in $\Phi 18$ mm bars. The west end of the wall did not show signs of damage related to compression or shear, but splitting cracks were observed along vertical reinforcement layers (Figure 9).

Figure 9. Splitting cracks in wall segments.

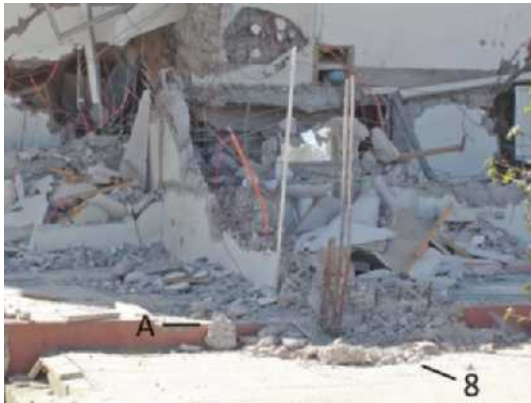
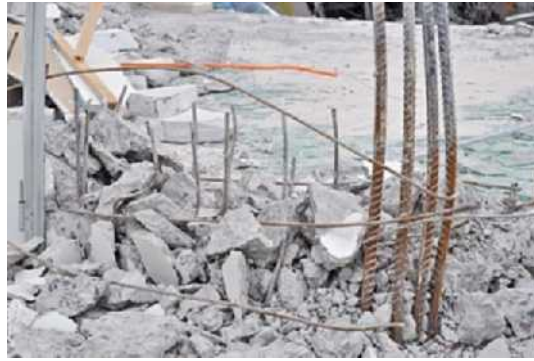
Figure 10. Wall along axis 8 (two of the vertical bars in the foreground had been cut for testing), 29 March 2010.

On the west side of the building, the wall along axis 8 failed along a nearly horizontal surface between axes A and B. The failure surface ascended from axis B to axis C, to reach a height of 1.7 m (68 in.) at the top end of lap splices of $\Phi 25$ mm bars at C (Figure 10). From axis C to axis D, the failure surface descended to reach the top end of lap splices of $\Phi 22$ mm bars at D, approximately 1.3 m (50 in.) above ground. Both bar fractures and splice failures were observed in the wall web between axes A and C. In the flange

Figure 11. Wall at axes A and 8 (base of the first story), 16 March 2010. Photo credit: G. Alarcón.

along axis A, bar fracture was observed in $\Phi 16$ mm bars and bond failure was observed in bar splices of $\Phi 25$ mm bars (Figures 10 and 11).

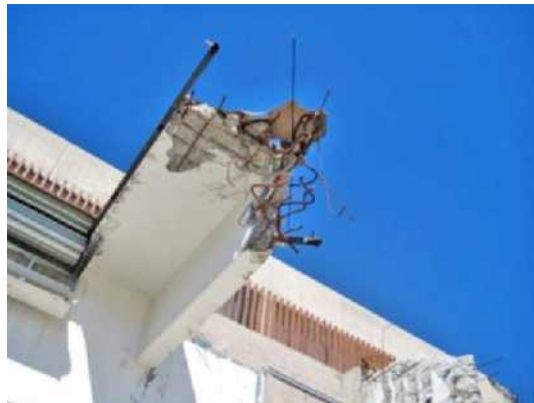
Figure 12. Pilaster at axes A and 11 (top of the first story), 29 November 2010.

In the first story, axis 11 had two pilasters (at A and I') and a short wall in the center of the building (between C' and F). The west pilaster failed near its base at the bottom of lap splices of four $\Phi 16$ mm bars at node A-11 (Figure 12). The bottom 0.3 m to 0.4 m (1 ft to 1.3 ft) of the pilaster appeared to have disintegrated. The pilaster at axis I' failed at its connection with a similar (but offset) pilaster in the second story.

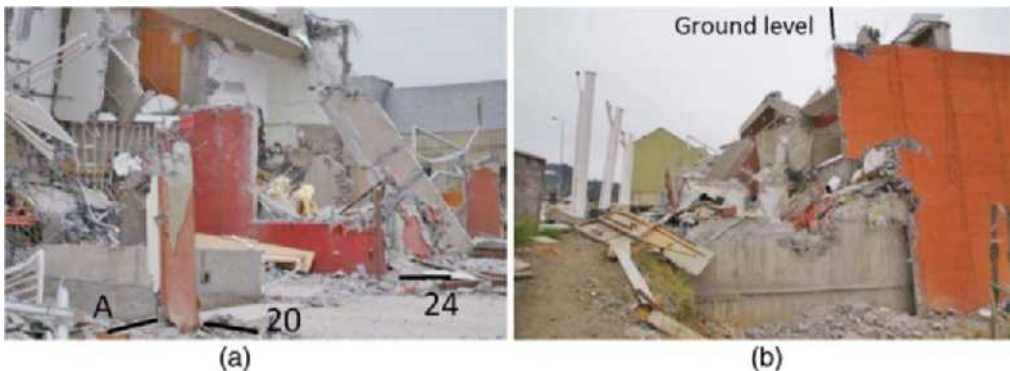
On the west side of the building, the wall along axis 20 failed near two thirds of the height of the first story. The wall flange below the observed failure surface, parallel to axis A, remained nearly intact, showing no clear signs of failure in compression at the base of the first story (Figure 13). The flange ruptured near the end of lap splices.

Photos taken before intervention (IDIEM 2010) are shown in Figure 13. Notice that large segments of walls along axes 24 and 35 show no large inclined cracks, nor signs of out-of-plane buckling. The lower half of the west boundary of the solid wall along axis 35 disintegrated at the base of the first story.

Figure 13. Damage photos before intervention: (a) Axis 24 (view from northwest); (b) axis 35 (view from south). Photo credit: IDIEM.

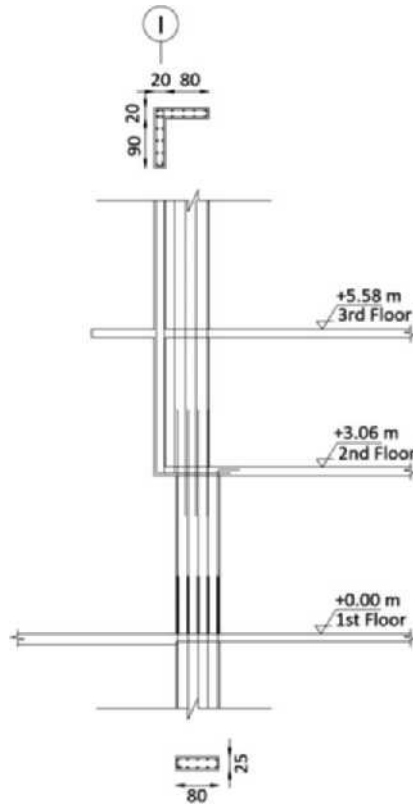
- 1) Pilasters at nodes I-11, I-17, and I-24 had an offset and a change in cross section (Figure 21).
- 2) Wall and pilaster flanges, and in a number of cases entire pilasters, present in the second and upper stories, did not extend into the first and underground stories (Figures 2 and 3).

Figure 21. Pilaster offset at I-11, I-17, and I-24 (view from north); cross-sectional dimensions in cm.

It has been suggested (IDIEM 2010) that the discontinuities along axis I and the re-entrant corners and flange cutoffs in walls along axes 8, 13, and 20 caused failure in compression of wall sections near the top of the first story on the east side of the building (Figure 22). This plausible failure is more likely to have led to collapse mechanism II than collapse mechanism I because mechanism II is weaker. But field evidence indicates that mechanism II did not occur. Mechanism I could have governed if the wall segments under hallways were damaged by shear and/or the bases of the first-story walls on the west side of the building were weakened in tension by splice failures at the bottom of the first story.

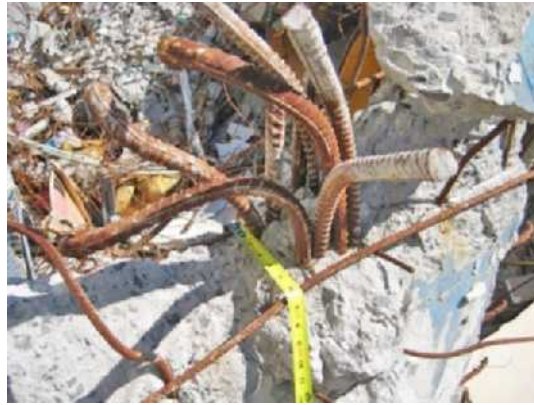
Walls in the first story had lap splices in all main boundary reinforcement and vertical web reinforcement. Walls in the second story had similar splices in one third of the main boundary reinforcement. Lengths of lap splices specified in structural drawings are listed in Table 6. These lap lengths are within current U.S. practice. But (1) current U.S. standards are based mostly on tests of lap splices shorter than 40 bar diameters, (2) mean unit bond strength decreases with splice length (within the lengths that have been tested so far), and (3) the clear spacing between the bars was observed to be less than 1 bar diameter in surviving lap splices (Figure 23).

Figure 23. Surviving lap splices.
