**CRACK SURVEYS OF LOW-CRACKING
HIGH-PERFORMANCE CONCRETE
BRIDGE DECKS IN KANSAS
2011-2013**

**A Report on Research Sponsored by
CONSTRUCTION OF CRACK-FREE BRIDGE DECKS
TRANSPORTATION POOLED-FUND PROGRAM
PROJECT NO. TPF-5(174)**

**Structural Engineering and Engineering Materials
SL Report 13-6**

**THE UNIVERSITY OF KANSAS CENTER FOR RESEARCH, INC.
LAWRENCE, KANSAS
December 2013**

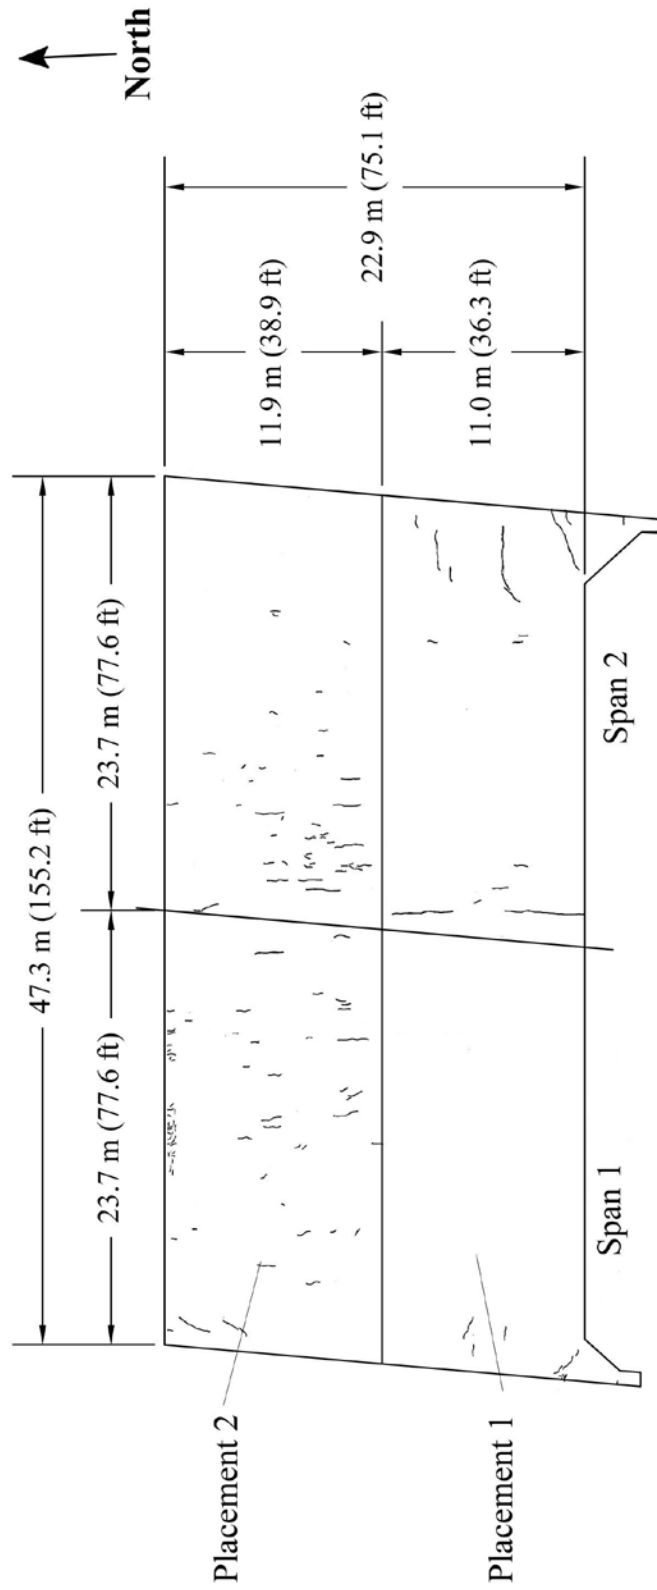
Figure 3: LC-HPC-1 (Survey 6)

LC-HPC-1 was cast in two separate placements, which were placed 19 days apart. The results of Survey 6 at 70.6 and 69.9 months, Survey 7 at 79.0 and 78.4 months, and Survey 8 at 91.3 and 90.6 months are included in this report. At 70.6 months, LC-HPC-1 had a crack density of 0.061 m/m² for Placement 1 and 0.103 m/m² for Placement 2. These values are both significantly larger than the densities from the previous survey (0.032 m/m² for Placement 1 and 0.023 m/m² for Placement 2) reported by Pendergrass et al. (2011). The crack densities at 79.0 and 78.4 months increased to 0.096 m/m² for Placement 1 and decreased to 0.081 m/m² for Placement 2. In Survey 8 at 91.3 and 90.6 months, the crack densities decreased markedly to 0.059 m/m² for Placement 1, and Placement 2 fell to 0.023 m/m². During Survey 8, it was noted

Bridge Number: 105-304 (LC-HPC-1)	Bridge Length: 47.3 m (155.2 ft)	Bridge Age:
Bridge Location: EB Parallel Pkwy over I-635	Bridge Width: 22.9 m (75.1 ft)	Placement 1: 70.6 months
Construction Date:	Skew: -5°	Placement 2: 69.9 months
Placement 1 (South): 10/14/2005	Number of Spans: 2	Crack Density: 0.082 m/m ²
Placement 2 (North): 11/2/2005	Span 1 (West): 23.7 m (77.6 ft)	Placement 1: 0.061 m/m ²
Crack Survey Date: 9/1/2011	Span 2 (East): 23.7 m (77.6 ft)	Placement 2: 0.103 m/m ²
	Number of Placements: 2	Span 1: 0.073 m/m ²
		Span 2: 0.089 m/m ²

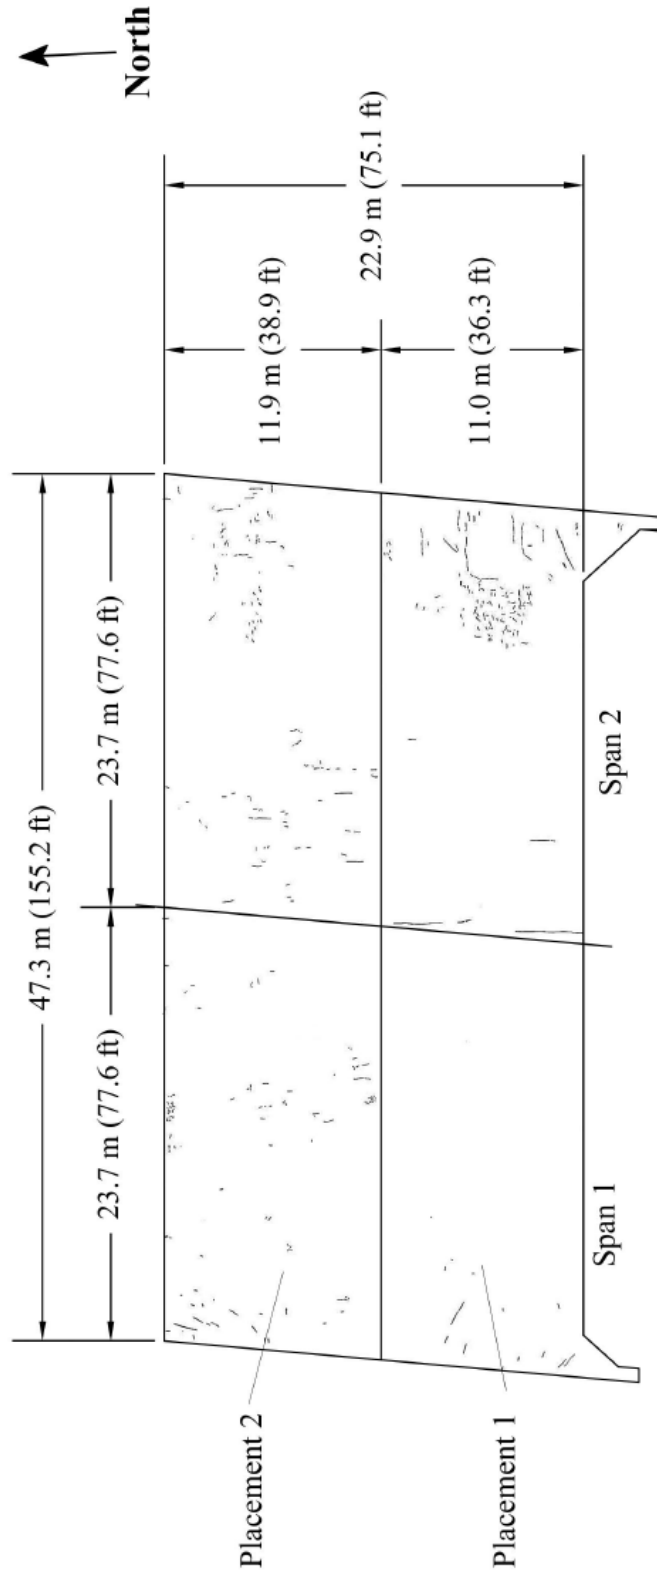
Figure 4: LC-HPC-1 (Survey 7)

Bridge Number: 105-304 (LC-HPC-1)
Bridge Location: EB Parallel Pkwy
 over I-635
Construction Date:
Placement 1 (South): 10/14/2005
Placement 2 (North): 11/2/2005
Crack Survey Date: 5/16/2012

Bridge Age:
Placement 1: 79.0 months
Placement 2: 78.4 months
Crack Density: 0.085 m/m²
Placement 1: 0.096 m/m²
Placement 2: 0.081 m/m²
Span 1: 0.046 m/m²
Span 2: 0.124 m/m²

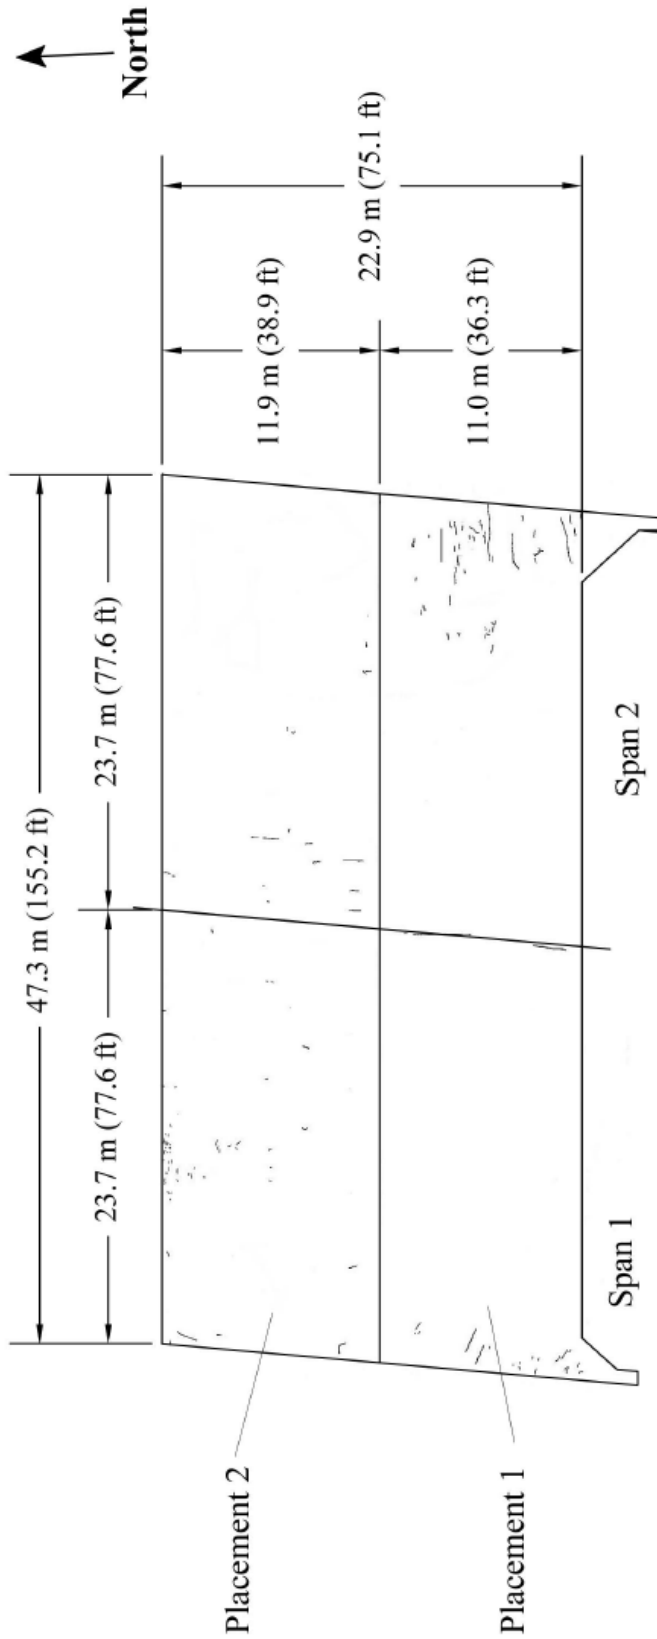
Figure 5: LC-HPC-1 (Survey 8)

that many surfaces on the bridge had experienced scaling, which exposed the aggregate at the surface of the deck. It is believed that the outlines of these aggregates were mistaken as cracks in previous surveys. Figures 3, 4, and 5 show the crack maps for Surveys 6, 7, and 8. It is evident that many of the small cracks, which are likely misidentified as such, shown in Surveys 6 and 7, are not present in Survey 8. Cracking on LC-HPC-1 consists mainly of small cracks parallel to and directly above the top layer of deck reinforcement, except near the abutments, where cracks propagate longitudinally. Survey 6 has more distinct cracking near the midspan than is present in either of the two later surveys.

Bridge Number: 105-304 (LC-HPC-1)	Bridge Length: 47.3 m (155.2 ft)	Bridge Age:
Bridge Location: EB Parallel Pkwy over I-635	Bridge Width: 22.9 m (75.1 ft)	Placement 1: 91.3 months
Construction Date:	Skew: -5°	Placement 2: 90.6 months
Placement 1 (South): 10/14/2005	Number of Spans: 2	Crack Density: 0.040 m/m ²
Placement 2 (North): 11/2/2005	Span 1 (West): 23.7 m (77.6 ft)	Placement 1: 0.059 m/m ²
Crack Survey Date: 5/23/2013	Span 2 (East): 23.7 m (77.6 ft)	Placement 2: 0.023 m/m ²
	Number of Placements: 2	Span 1: 0.030 m/m ²
		Span 2: 0.051 m/m ²

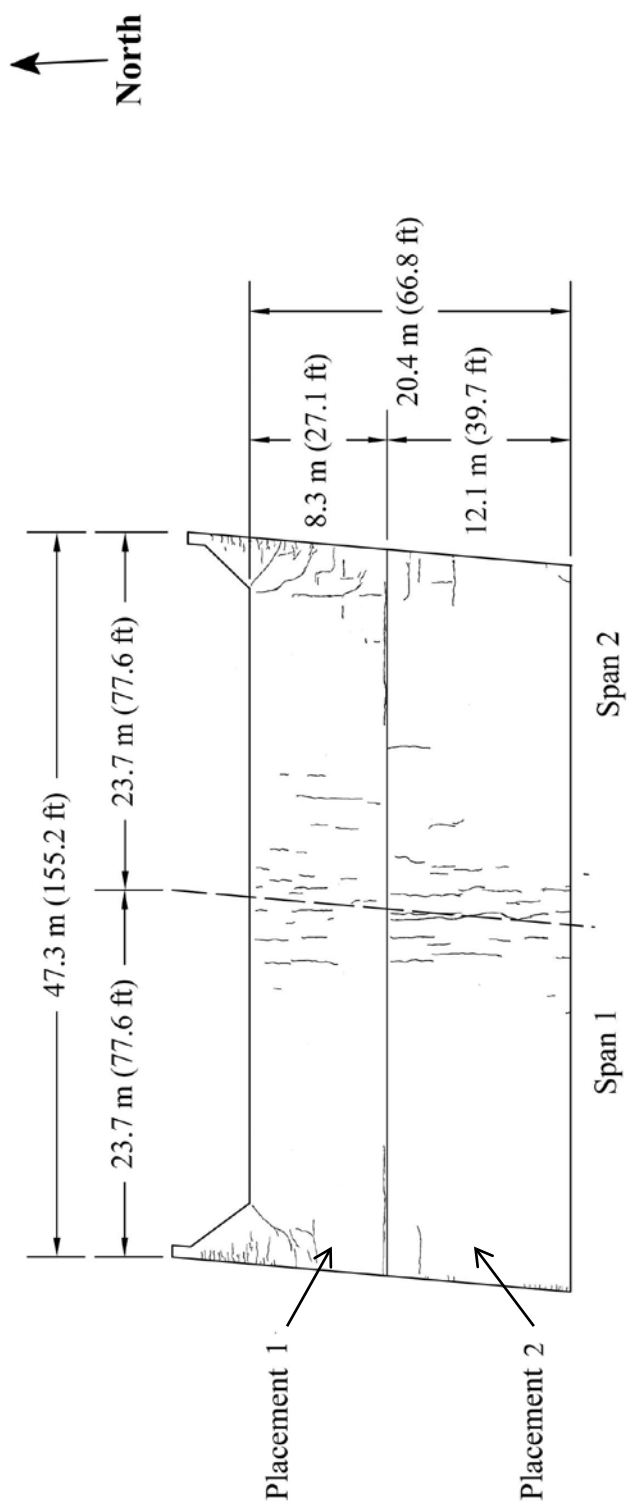
Control-1/2 is adjacent to LC-HPC-1 and serves as the control deck for both LC-HPC-1 and LC-HPC-2. Like LC-HPC-1, Control-1/2 was cast in two separate placements. The results of Survey 6 at 70.7 and 70.1 months, Survey 7 at 79.2 and 78.6 months, and Survey 8 at 91.4 and 90.8 months are included in this report. The crack densities for Placement 1 and 2 measured in Survey 6, shown in Figure 6, were 0.139 and 0.176 m/m², which are both higher than measured in Survey 5 (Pendergrass et al. 2011). In Survey 7, the crack density of Placement 1 increased to 0.240 m/m² at 79.2 months, while the crack density of Placement 2 decreased to 0.161 m/m² at 78.6 months (see Figure 7). Crack densities for both placements decreased in Survey 8, to 0.141 m/m² and 0.149 m/m², respectively. The crack map for Survey 8 is shown in Figure 8. Cracking on Control-1/2 is very prominent around the pier at midspan. Cracks in this area run directly parallel to and above the reinforcing bars. There is also significant cracking at the ends of the bridge. Particularly, there are two large cracks running longitudinally down the middle of the bridge originating at either abutment. There is also map cracking in the northeast and northwest

Bridge Number: 105-311 (Control-1/2) **Bridge Length:** 47.3 m (155.2 ft) **Bridge Age:**
Bridge Location: WB Parallel Pkwy over I-635 **Bridge Width:** 20.7 m (67.8 ft) **Placement 1 (N):** 70.7 months
Construction Dates: **Number of Spans:** 2 **Crack Density:** 0.190 m/m²
North Subdeck: 9/30/2005 **Span 1 (West):** 23.7 m (77.6 ft) **Placement 2 (S):** 70.1 months
North Overlay: 10/10/2005 **Span 2 (East):** 23.7 m (77.6 ft) **Placement 1:** 0.259 m/m²
South Subdeck: 10/18/2005 **Number of Placements:** 2 **Placement 2:** 0.137 m/m²
South Overlay: 10/28/2005 **Span 1:** 0.148 m/m²
Crack Survey Date: 9/1/2011 **Span 2:** 0.227 m/m²

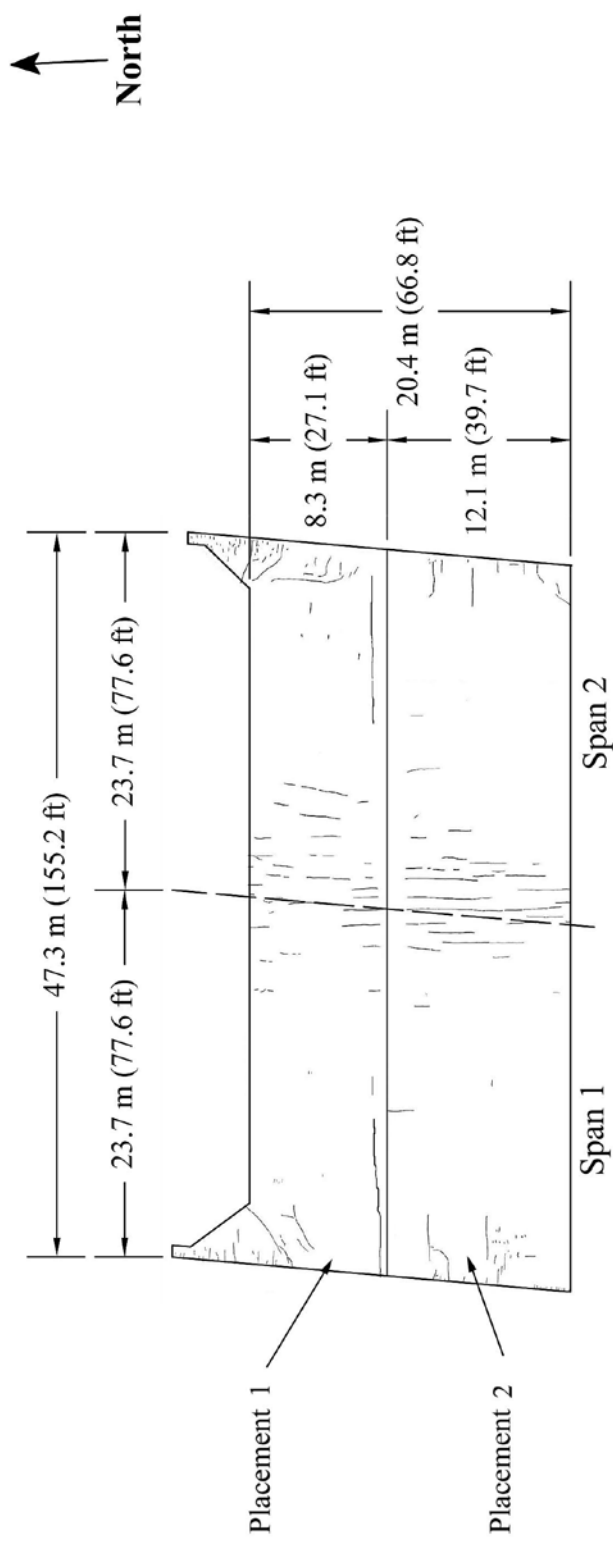
Bridge Number: 105-311 (Control-1/2) **Bridge Length:** 47.3 m (155.2 ft)
Bridge Location: WB Parallel Pkwy over I-635 **Bridge Width:** 20.7 m (67.8 ft)
Construction Dates: **Number of Spans:** 2
 North Subdeck: 9/30/2005 **Span 1 (West):** 23.7 m (77.6 ft)
 North Overlay: 10/10/2005 **Span 2 (East):** 23.7 m (77.6 ft)
 South Subdeck: 10/18/2005 **Number of Placements:** 2
 South Overlay: 10/28/2005
Crack Survey Date: 5/16/2012

Bridge Age:
Placement 1 (N): 79.2 months
Placement 2 (S): 78.6 months
Crack Density: 0.196 m/m²
Placement 1: 0.240 m/m²
Placement 2: 0.161 m/m²
Span 1: 0.166 m/m²
Span 2: 0.226 m/m²

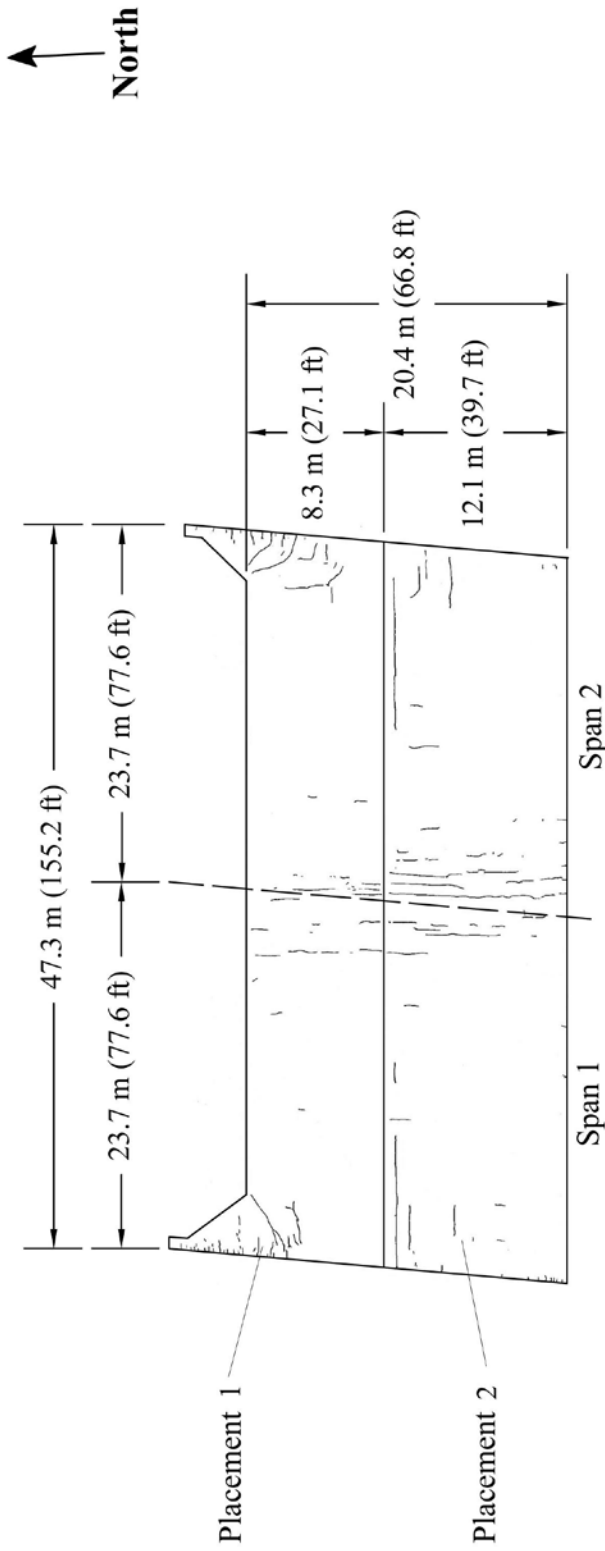
Bridge Number: 105-311 (Control-1/2) **Bridge Length:** 47.3 m (155.2 ft)
Bridge Width: 20.7 m (67.8 ft) **Skew:** -5°
Bridge Location: WB Parallel Pkwy over I-635
Number of Spans: 2
Span 1 (West): 23.7 m (77.6 ft)
Span 2 (East): 23.7 m (77.6 ft)
Number of Placements: 2
Bridge Age:
Placement 1 (N): 91.4 months
Placement 2 (S): 90.8 months
Crack Density: 0.144 m/m²
Placement 1: 0.141 m/m²
Placement 2: 0.149 m/m²
Span 1: 0.128 m/m²
Span 2: 0.160 m/m²
Construction Dates:
North Subdeck: 9/30/2005
North Overlay: 10/10/2005
South Subdeck: 10/18/2005
South Overlay: 10/28/2005
Crack Survey Date: 5/23/2013

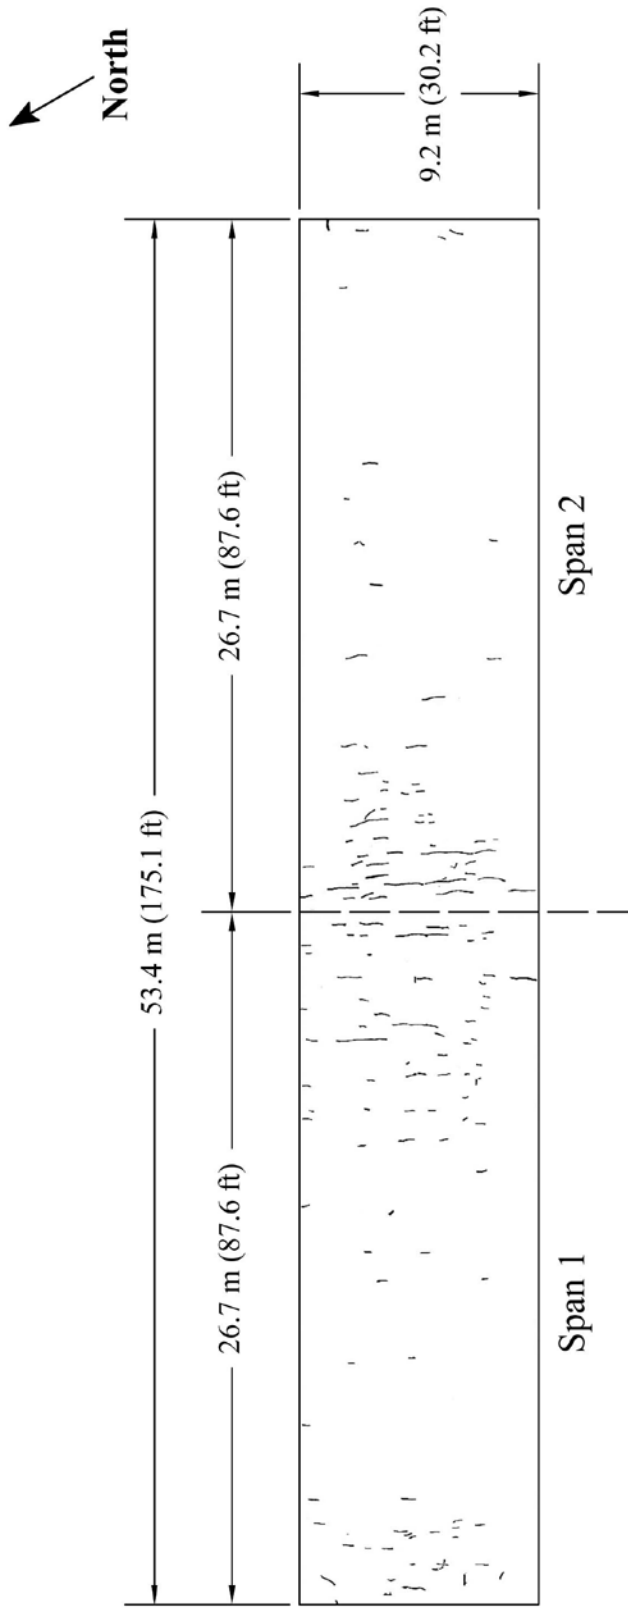
The results of Survey 5 at 59.3 months, Survey 6 at 68.1 months, and Survey 7 at 80.3 months are included in this report. Crack densities of 0.143 m/m² and 0.197 m/m² were measured at 59.3 months and 68.1 months, respectively. These densities are, respectively, more than two and three times the previous density of 0.059 m/m² at 44.5 months reported by Pendergrass et al. (2011). Crack maps for Surveys 5 and 6 are shown in Figures 10 and 11. At 80.3 months, LC-HPC-2 had a crack density of 0.141 m/m², more than 25% lower than the density at 68.1 months. Figure 12 shows the crack map for Survey 7. Cracking in all three of these surveys is

Bridge Number: 105-310 (LC-HPC-2) **Bridge Length:** 53.4 m (175.1 ft) **Bridge Age:** 59.3 months
Bridge Location: 34th St over I-635 **Bridge Width:** 9.2 m (30.2 ft) **Crack density:** 0.144 m/m²
Construction Date: 9/13/2006 **Skew:** 0° **Span 1 (West):** 0.152 m/m²
Crack survey Date: 8/22/2011 **Number of Spans:** 2 **Span 2 (East):** 0.135 m/m²
Span 1 (West): 26.7 m (87.6 ft)
Span 2 (East): 26.7 m (87.6 ft)
Number of Placements: 1

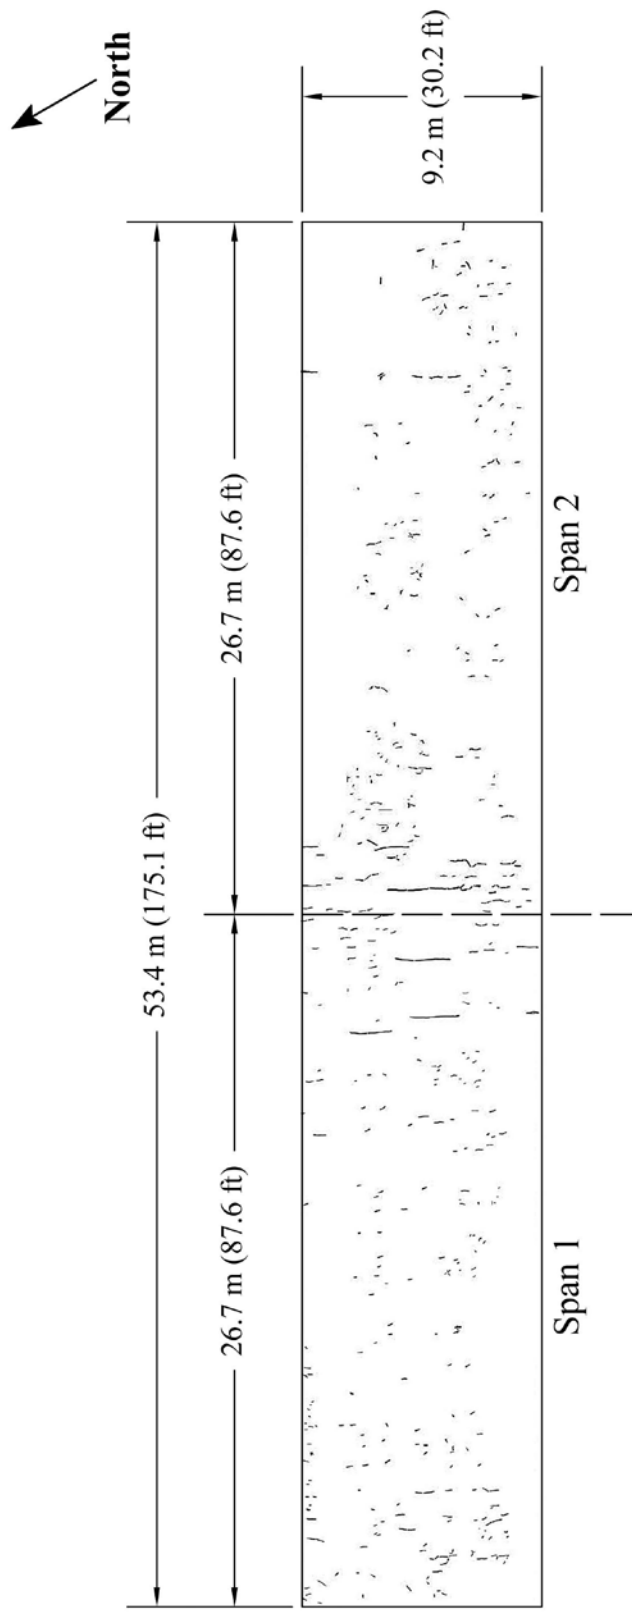
Bridge Number: 105-310 (LC-HPC-2)	Bridge Length: 53.4 m (175.1 ft)	Bridge Age: 68.1 months
Bridge Location: 34th St over I-635	Bridge Width: 9.2 m (30.2 ft)	Crack density: 0.197 m/m ²
Construction Date: 9/13/2006	Skew: 0°	Span 1 (West): 0.204 m/m ²
Crack survey Date: 5/18/2012	Number of Spans: 2	Span 2 (East): 0.191 m/m ²
	Span 1 (West): 26.7 m (87.6 ft)	
	Span 2 (East): 26.7 m (87.6 ft)	
	Number of Placements: 1

prominent in the negative moment region above the pier, with small cracks extending from the northern edge of the deck and distributed throughout the entire deck. The crack map for Survey 6 shows many small cracks throughout the deck that were not captured in any previous surveys, likely the result of mistaking aggregate boundaries for cracks. Figure 13 compares cracking on LC-HPC-2 to Control-1/2 over time. It is evident that cracking on LC-HPC-2 has increased over time, experiencing a sharp rise after 42 months, and has moved closer in value to the crack densities for Control-1/2 in recent years.

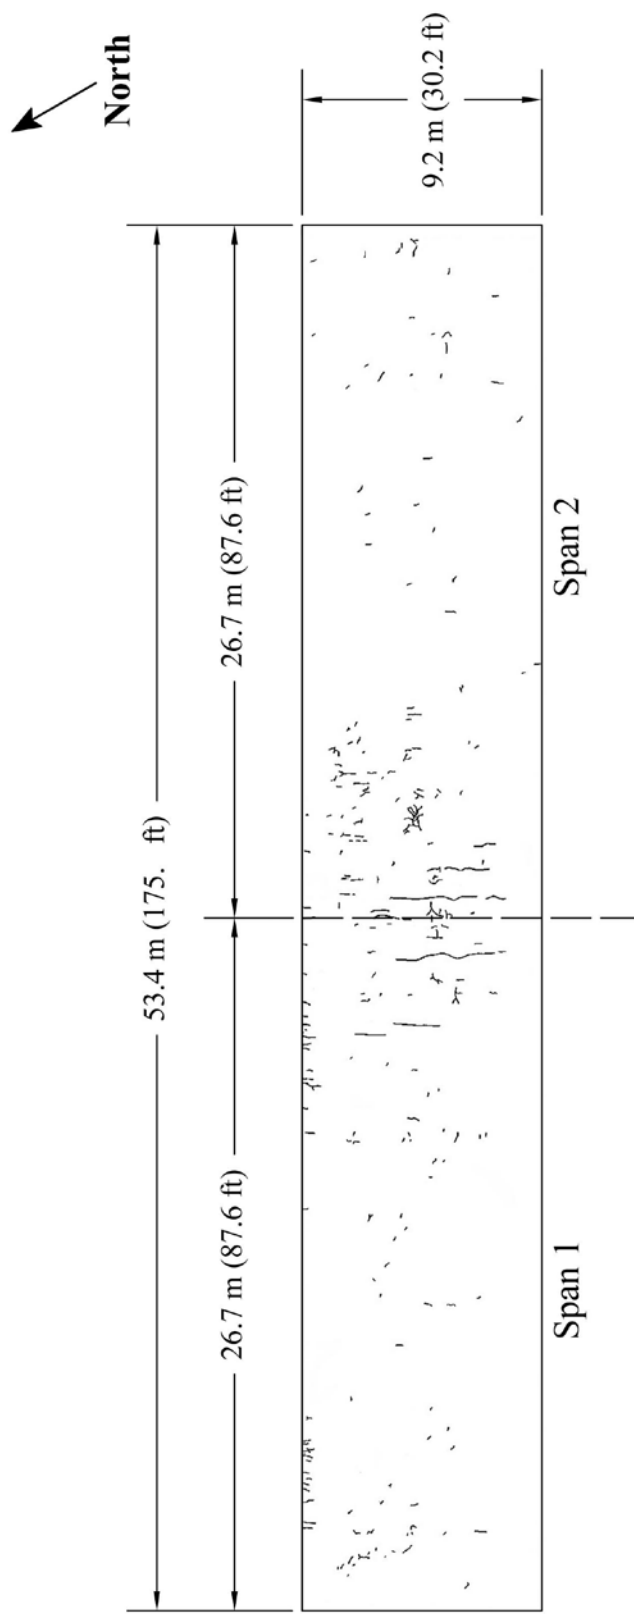
Bridge Number: 105-310 (LC-HPC-2) **Bridge Length:** 53.4 m (175.2 ft) **Bridge Age:** 80.3 months
Bridge Location: 34th St over I-635 **Bridge Width:** 9.2 m (30.2 ft) **Crack density:** 0.141 m/m²
Construction Date: 9/13/2006 **Skew:** 0° **Span 1 (West):** 0.129 m/m²
Crack survey Date: 5/24/2013 **Number of Spans:** 2 **Span 2 (East):** 0.151 m/m²
Span 1 (West): 26.7 m (87.6 ft)
Span 2 (East): 26.7 m (87.6 ft)
Number of Placements: 1

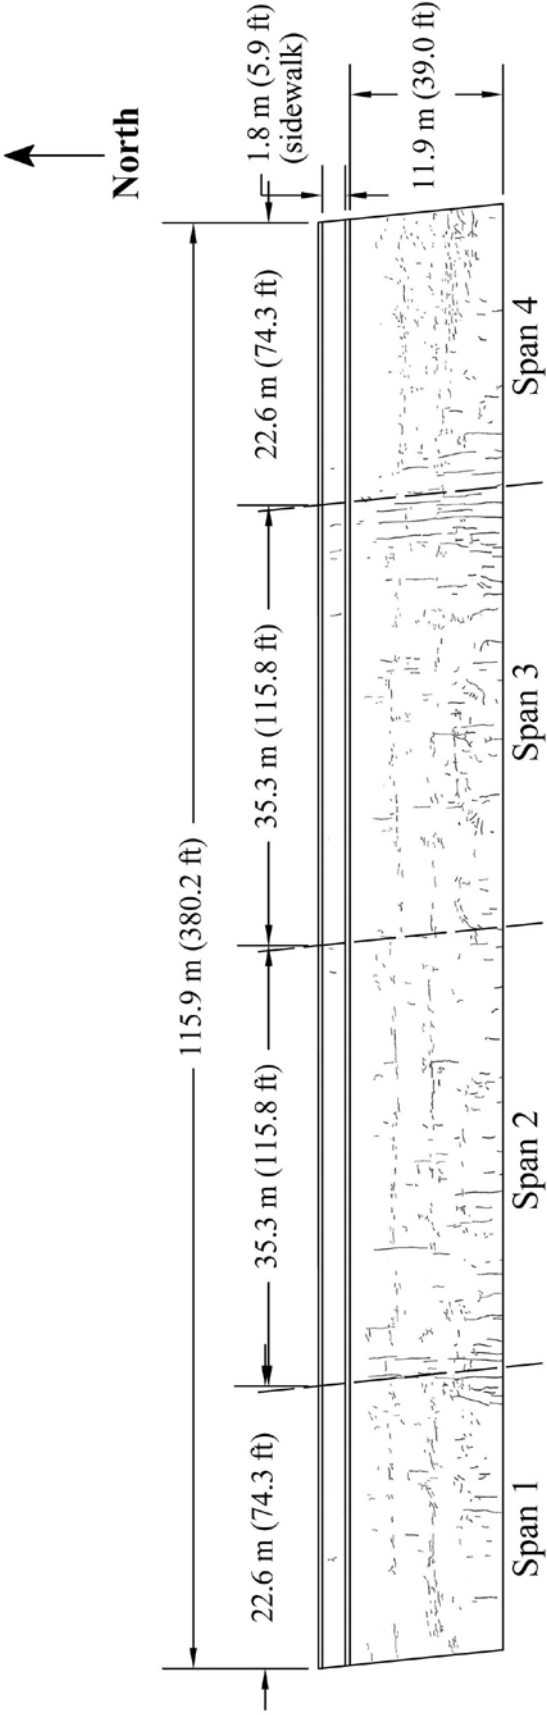
The results of Survey 4 at 42.6 months, Survey 5 at 54.0 months, and Survey 6 at 66.2 months for LC-HPC-3 are included in this report. Crack densities measured in Surveys 4, 5, and 6 were 0.315 m/m², 0.173 m/m², and 0.174 m/m², respectively. These densities represent an increase from Survey 3, which measured a crack density of 0.108 m/m², as presented by

Pendergrass et al. (2011). In relation to the crack densities calculated for LC-HPC-3 in previous years, the large increase in crack density corresponding to Survey 4 (0.315 m/m^2) appears to be an outlier. Crack maps for Surveys 4, 5, and 6 are shown in Figures 14, 15, and 16, respectively. Cracking is significant above the outside piers, but not at center span. Smaller cracks are within the spans and at the east end of the bridge. The larger cracks located above the piers appear to lie directly above and parallel to the reinforcement.

Bridge Number: 46-338 (LC-HPC-3) **Bridge Length:** 115.9 m (380.2 ft) **Bridge Age:** 42.6 months

Bridge Location: WB 103rd St over US 69 **Bridge Width:** 11.9 m (39.0 ft) **Crack density:** 0.315 m/m²

Crack survey Date: 6/1/2011 **Span 1:** 22.6 m (74.3 ft) **Span 2:** 0.287 m/m²

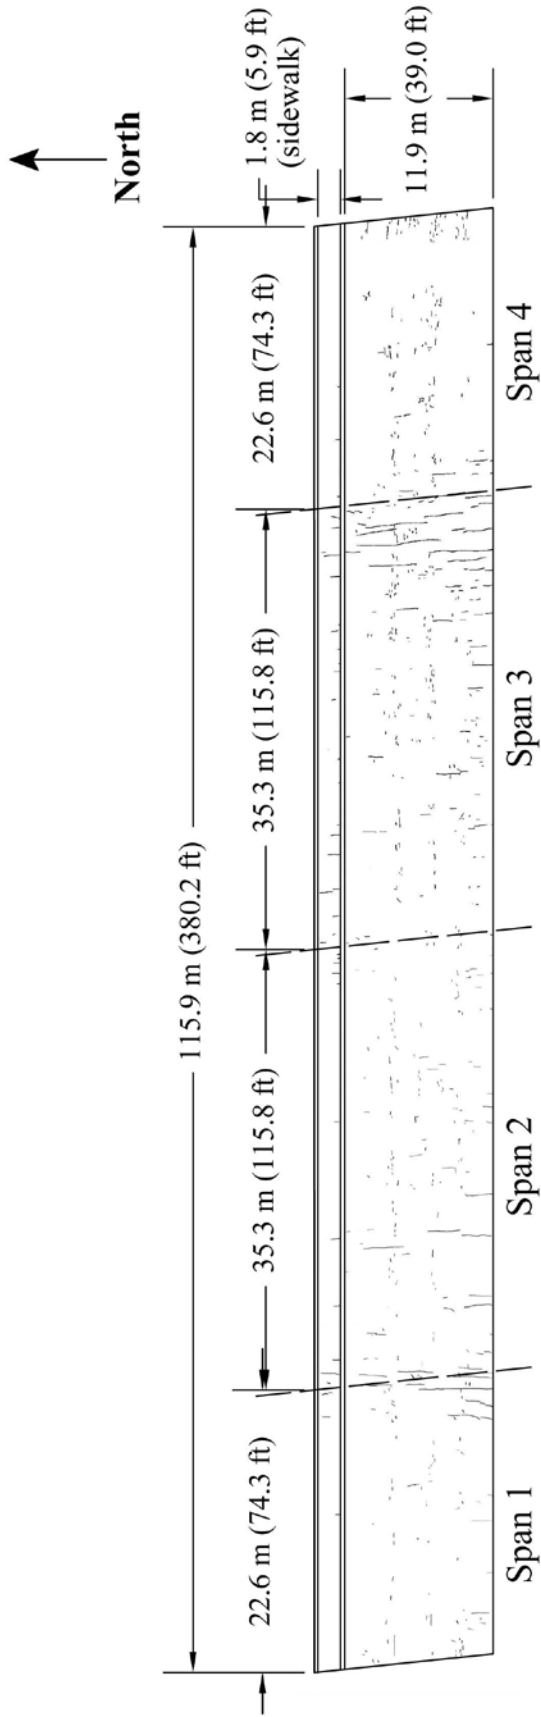
Bridge Number: 46-338 (LC-HPC-3) **Bridge Length:** 115.9 m (380.2 ft) **Bridge Age:** 54.0 months

Bridge Location: WB 103rd St over US 69 **Bridge Width:** 11.9 m (39.0 ft) **Crack density:** 0.173 m/m²

Crack survey Date: 5/14/2012 **Span 1 :** 22.6 m (74.3 ft) **Span 2 :** 0.138 m/m²

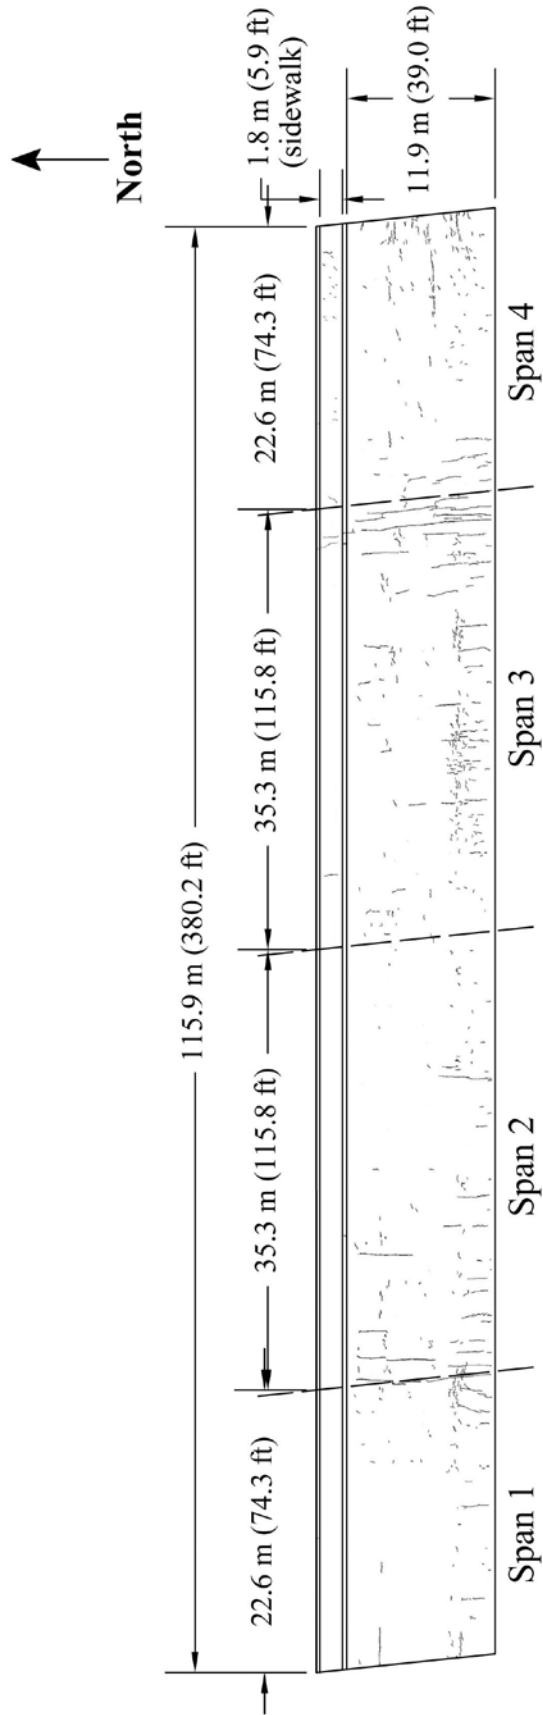
Bridge Number: 46-338 (LC-HPC-3)	Bridge Length: 115.9 m (380.2 ft)	Bridge Age: 66.2 months
Bridge Location: WB 103rd St over US 69	Bridge Width: 11.9 m (39.0 ft)	Crack density: 0.174 m/m ²
Construction Date: 11/13/2007	Skew: 6°	Span 1 : 0.109 m/m ²
Crack survey Date: 5/21/2013	Number of Spans: 4	Span 2 : 0.124 m/m ²
	Span 1 : 22.6 m (74.3 ft)	Span 3 : 0.249 m/m ²
	Span 2 : 35.3 m (115.8 ft)	Span 4 : 0.180 m/m ²
	Span 3 : 35.3 m (115.8 ft)	
	Span 4 : 22.6 m (74.3 ft)	
	Number of Placements: 1

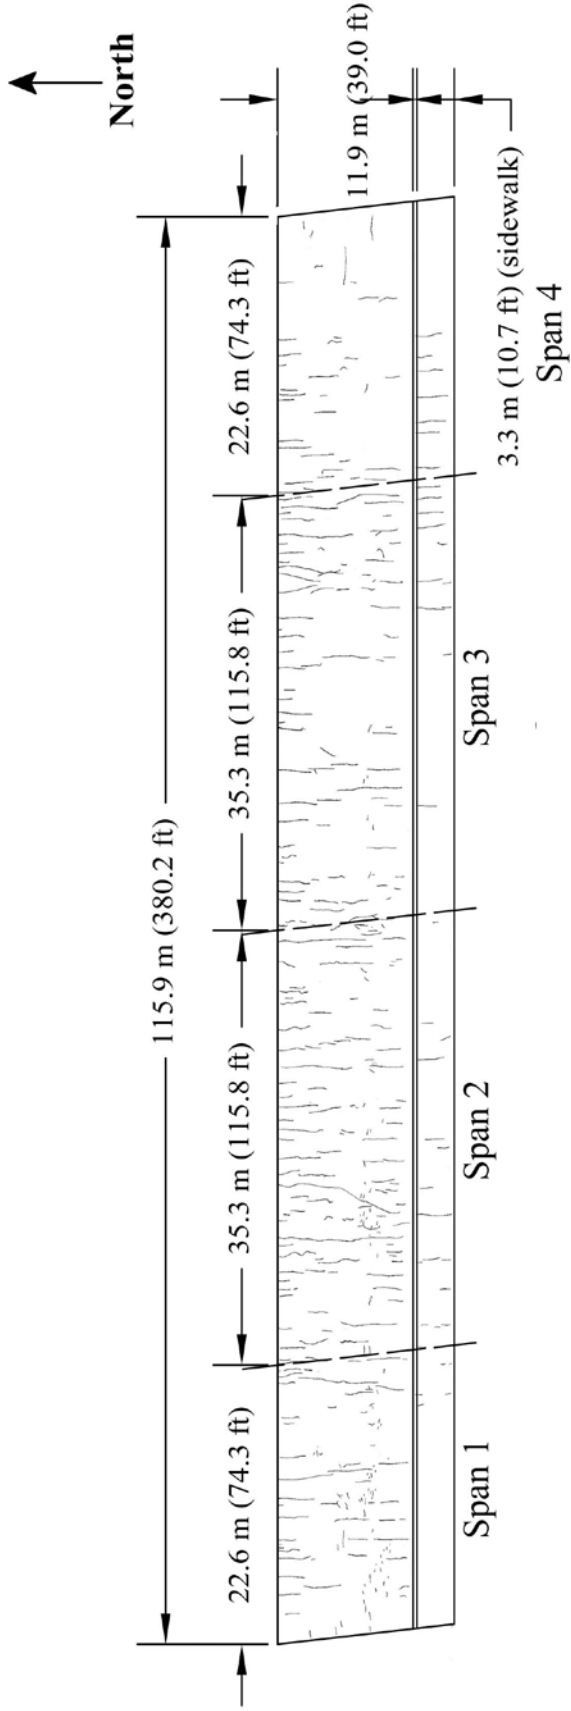
The results of Survey 4 at 46.6 months, Survey 5 at 57.9 months, and Survey 6 at 70.1 months are included in this report. Crack densities of 0.323 m/m^2 and 0.314 m/m^2 were observed in Surveys 4 and 5, respectively. These values represent a significant increase from crack densities of 0.216 m/m^2 and 0.232 m/m^2 corresponding, respectively, to Surveys 2 and 3 (Pendergrass et al. 2011). The crack density of Control-3 at 57.9 months, 0.314 m/m^2 , is nearly double the crack density of LC-HPC 3 at 54 months, 0.173 m/m^2 . At 70.1 months, a crack density of 0.288 m/m^2 was recorded in Survey 6, which is slightly lower than the densities measured in Surveys 4 and 5, but is still larger than the crack density of LC-HPC-3 at 66.2 months, 0.174 m/m^2 . Figures 17, 18, and 19 show the crack maps for Surveys 4, 5, and 6, respectively. Cracking on Control-3 is largely located parallel to the reinforcement and is relatively evenly distributed throughout the deck. Figure 20 compares cracking on Control-3 to LC-HPC-3 over time. Cracking on LC-HPC-3 has, for the most part, remained lower than cracking on Control-3 over the life of the decks, with the exception of the density of LC-HPC-3 at 42.6 months, which, as discussed earlier in this section, appears to be an outlier.

Bridge Number: 46-337 (Control-3)
Bridge Location: EB 103rd St. over US-69
Construction Date: 7/17/2007
Crack survey Date: 6/7/2011

Bridge Age: 46.6 months
Crack density: 0.323 m/m²
Span 1: 0.300m/m²
Span 2: 0.396 m/m²
Span 3: 0.323 m/m²
Span 4: 0.207 m/m²

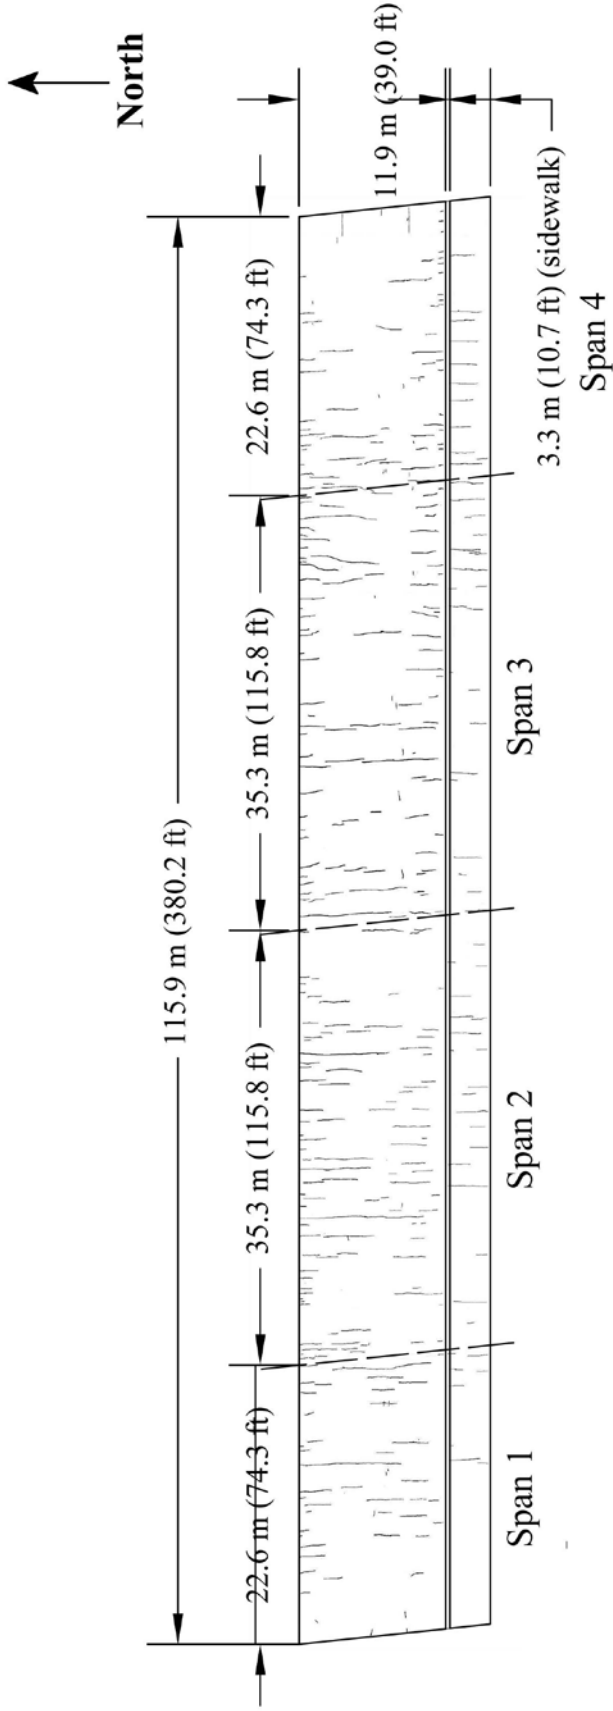
Bridge Number: 46-337 (Control-3)

Crack survey Date: 5/14/2012

Crack density: 0.314 m/m²

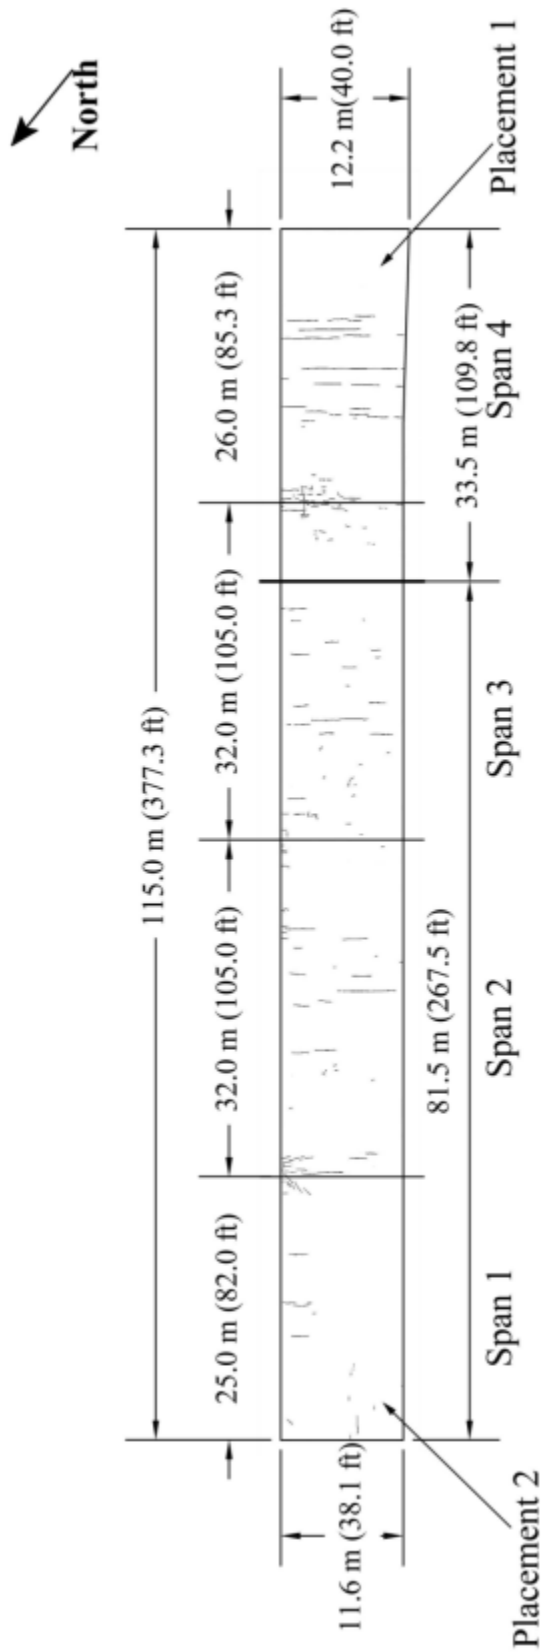
Bridge Number: 46-339 Unit 1 (LC-HPC-4)	Bridge Length: 115.0 m (377.3 ft)	Bridge Age:
Bridge Location: Flyover Ramp US-69S to I-435W	Bridge Width: 11.6 m (38.1 ft)	Placement 1: 56.0 months
Construction Date:	Skew: 0°	Placement 2: 55.9 months
Placement 1 (South): 9/29/2007	Number of Spans: 4	Crack Density: 0.120 m/m ²
Placement 2 (North): 10/2/2007	Span 1: 25.0 m (82.0 ft)	Placement 1: 0.184 m/m ²
Crack Survey Date: 5/30/2012	Span 2: 32.0 m (105.0 ft)	Placement 2: 0.092 m/m ²
	Span 3: 32.0 m (105.0 ft)	Span 1: 0.054 m/m ²
	Span 4: 26.0 m (85.3 ft)	Span 2: 0.110 m/m ²
	Number of Placements: 2	Span 3: 0.124 m/m ²
		Span 4: 0.188 m/m ²

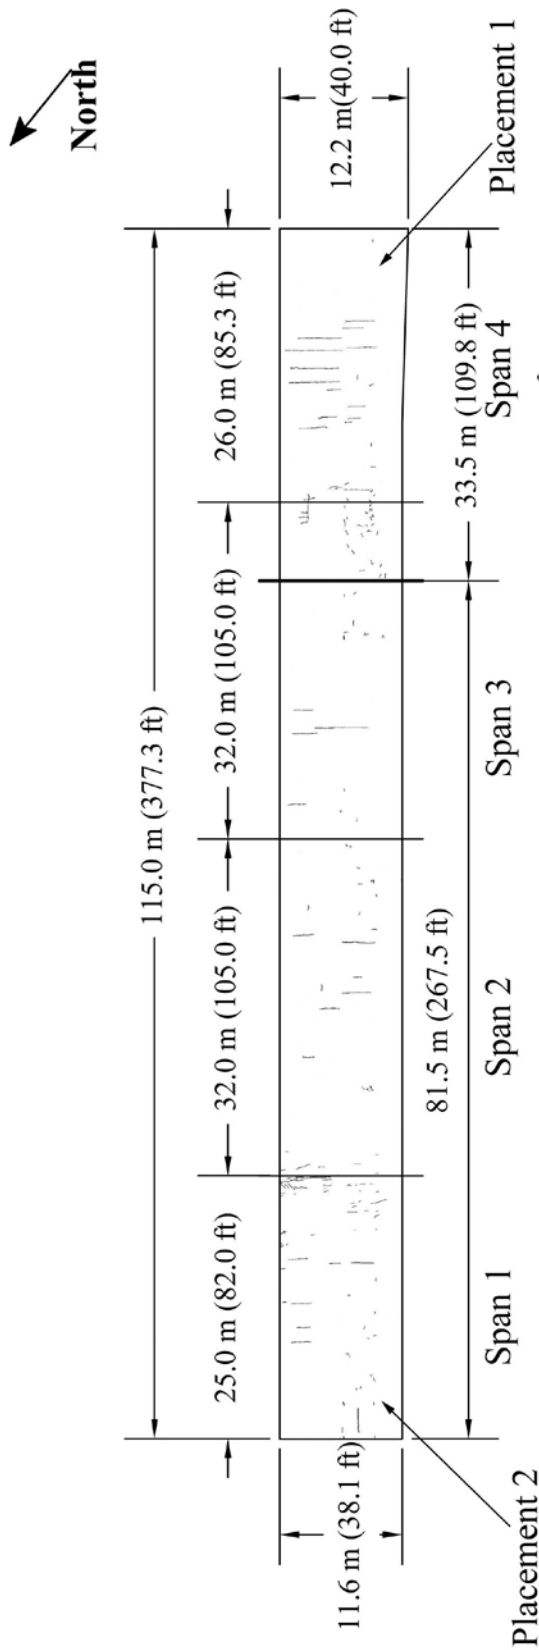
Bridge Number: 46-339 Unit 1 (LC-HPC-4)	Bridge Length: 115.0 m (377.3 ft)	Bridge Age:
Bridge Location: Flyover Ramp US-69S to I-435W	Bridge Width: 11.6 m (38.1 ft)	Placement 1: 68.5 months
Construction Date:	Skew: 0°	Placement 2: 68.4 months
Placement 1 (South): 9/29/2007	Number of Spans: 4	Crack Density: 0.105 m/m ²
Placement 2 (North): 10/2/2007	Span 1: 25.0 m (82.0 ft)	Placement 1: 0.147 m/m ²
Crack Survey Date: 6/13/2013	Span 2: 32.0 m (105.0 ft)	Placement 2: 0.077 m/m ²
	Span 3: 32.0 m (105.0 ft)	Span 1: 0.125 m/m ²
	Span 4: 26.0 m (85.3 ft)	Span 2: 0.056 m/m ²
	Number of Placements: 2	Span 3: 0.070 m/m ²
		Span 4: 0.153 m/m ²

Placement 2 measured during Survey 5 (0.184 m/m^2 versus 0.092 m/m^2). For Survey 6 at 68.5 months, the overall crack density was 0.097 m/m^2 , a decrease from Survey 5. The crack density of Placement 1 decreased slightly to 0.179 m/m^2 and the crack density of Placement 2 at 68.4 months decreased about 35 percent to 0.060 m/m^2 . Cracking of LC-HPC-4 Placement 1 occurs around the easternmost pier, along with transverse cracks located in the midspan. Cracking of Placement 2 is most prominent around the westernmost pier. Placement 2 also contains transverse cracks in the midspans.

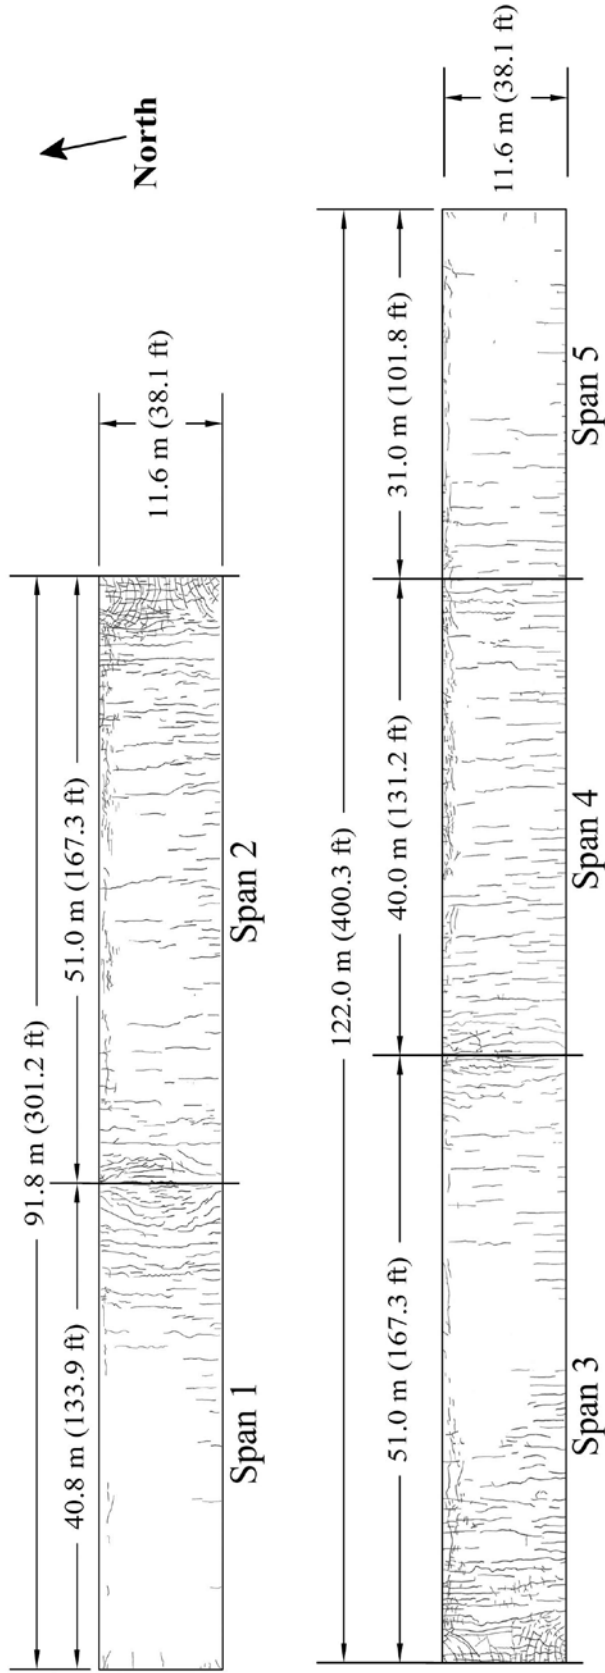
The results of Surveys 4, 5, and 6, at 42.7, 54.9, and 67.1 months, are included in this report. The crack densities of Control-4 measured in Surveys 4 and 5, shown in Figures 24 and 25, were 0.618 m/m^2 and 0.669 m/m^2 , respectively. These densities represent a significant increase from the value measured in Survey 3 at 31.6 months of 0.473 m/m^2 (Pendergrass et al. 2011). These densities are also much larger than the crack densities of LC-HPC-4 at 45.0 and 56.0 months. The crack density at 67.1 months was 0.561 m/m^2 (see Figure 26), a decrease from the crack densities measured in Surveys 4 and 5. However, this density is still much greater than the overall crack density of LC-HPC-4 at 68.5 months of 0.105 m/m^2 . Control-4 has significant transverse cracking near the piers of the bridge. Above the second pier from the west, there is longitudinal and transverse cracking. There is also significant longitudinal cracking along the northern edge of the deck, which is likely due to a small portion of the bridge deck that is cantilevered out over the exterior girder. Figure 27 compares crack densities on Control-4 to crack densities on LC-HPC-4 over time. Clearly, cracking on Control-4 has been significantly greater than on either placement of LC-HPC-4 over time. While LC-HPC-4 seems to have had relatively stable cracking over its life, Control-4 has had a general trend of increased cracking.

Bridge Number: 46-347 (Control-4)

Crack survey Date: 6/7/2011

Crack density: 0.618 m/m²

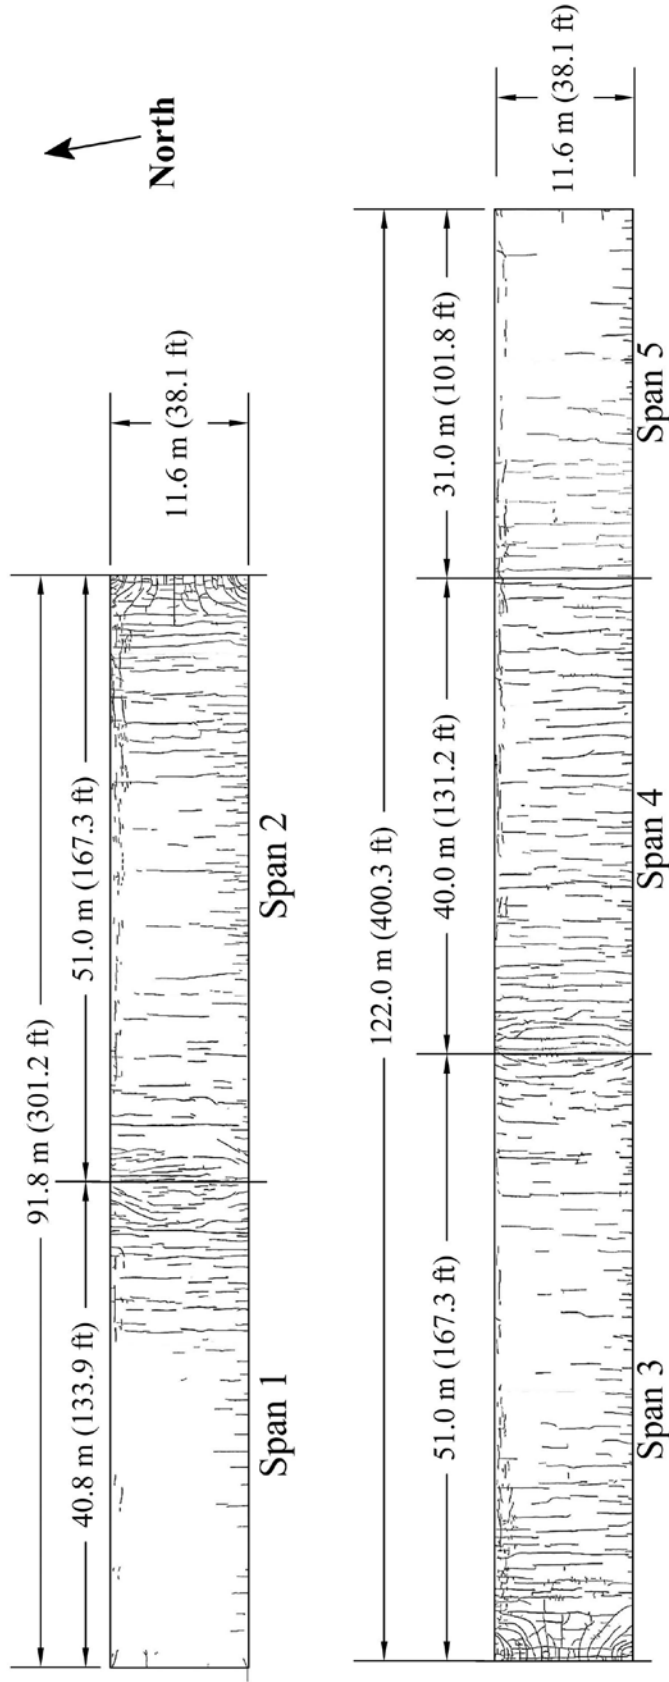
Bridge Number: 46-347 (Control-4)
Bridge Location: NB US-69 Rd
Construction Date: 11/16/2007
Crack survey Date: 6/12/2012

Bridge Age: 54.9 months
Crack density: 0.669 m/m²
Span 1: 0.523 m/m²
Span 2: 0.649 m/m²
Span 3: 0.931 m/m²
Span 4: 0.885 m/m²
Span 5: 0.134 m/m²
