**CRACK SURVEYS OF LOW-CRACKING
HIGH-PERFORMANCE CONCRETE
BRIDGE DECKS IN KANSAS
2011-2013**

**A Report on Research Sponsored by
CONSTRUCTION OF CRACK-FREE BRIDGE DECKS
TRANSPORTATION POOLED-FUND PROGRAM
PROJECT NO. TPF-5(174)**

**Structural Engineering and Engineering Materials
SL Report 13-6**

**THE UNIVERSITY OF KANSAS CENTER FOR RESEARCH, INC.
LAWRENCE, KANSAS
December 2013**

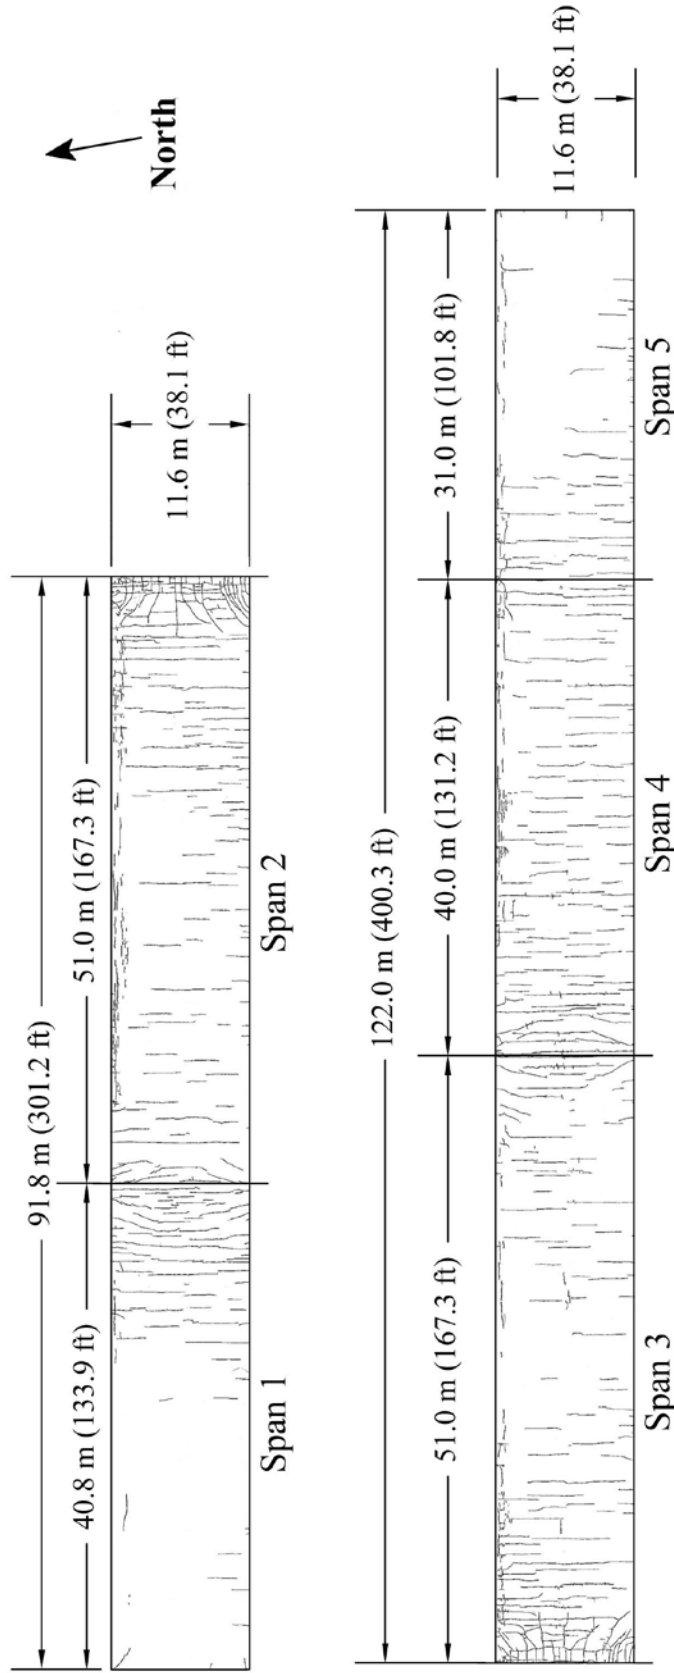
Bridge Number: 46-347 (Control-4) **Bridge Length:** 213.8 m (701.5 ft) **Bridge Age:** 67.1 months
Bridge Location: NB US-69 Rd **Bridge Width:** 11.6 m (38.1 ft) **Crack density:** 0.561 m/m²
Construction Date: 11/16/2007 **Skew:** 0° **Number of Spans:** 5
Crack survey Date: 6/20/2013 **Span 1:** 40.8 m (133.9 ft) **Span 1:** 0.348 m/m²
Span 2: 51.0 m (167.3 ft) **Span 2:** 0.667 m/m²
Span 3: 51.0 m (167.3 ft) **Span 3:** 0.609 m/m²
Span 4: 40.0 m (131.2 ft) **Span 4:** 0.720 m/m²
Span 5: 31.0 m (101.8 ft) **Span 5:** 0.312 m/m²
Number of Placements: 1

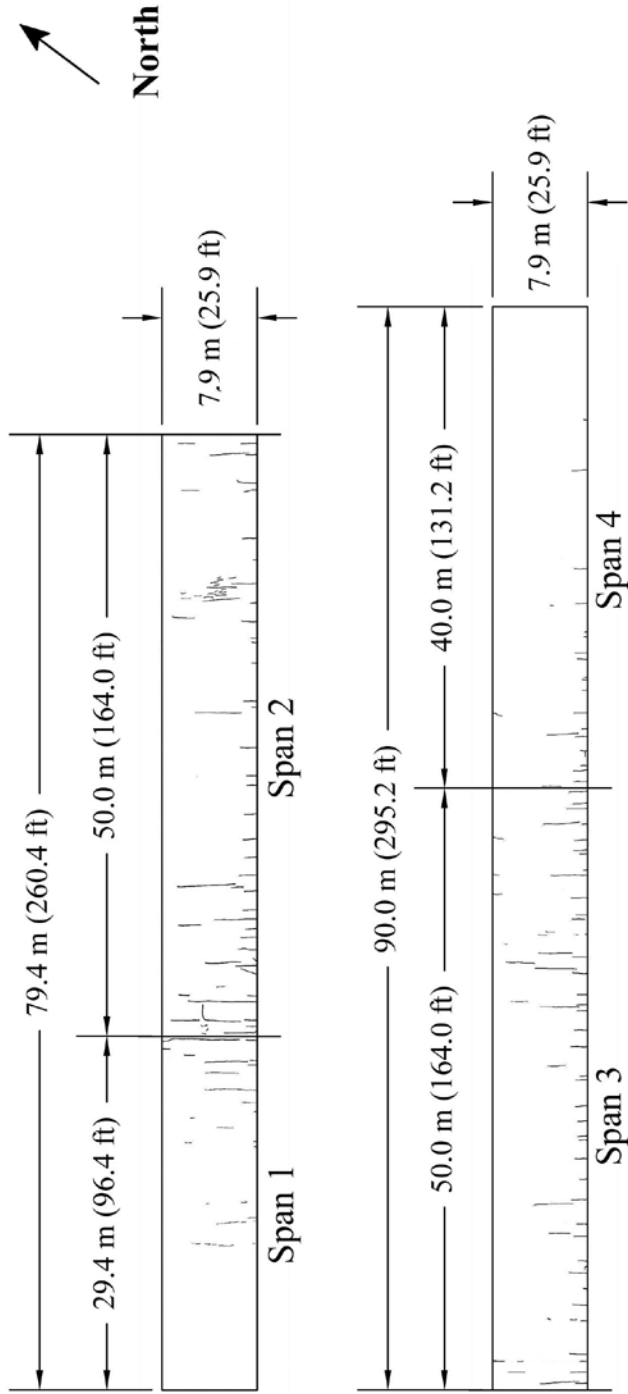
Bridge Number: 46-340 Unit 1 (LC-HPC-5)

Crack survey Date: 5/23/2012

Crack density: 0.158 m/m²

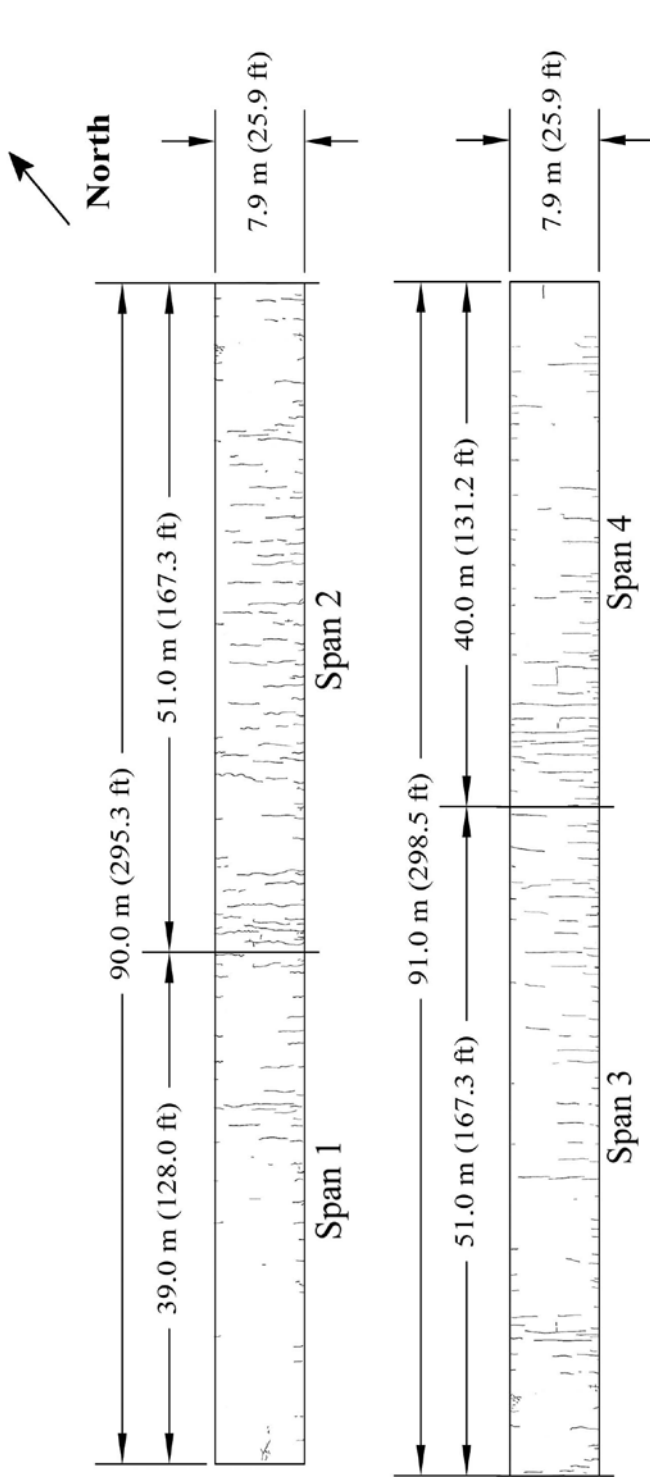
Bridge Number: 46-340 Unit 2
 (LC-HPC-6)
Bridge Location: SB US-69 to WB
 I-435
Construction Date: 11/3/2007
Crack survey Date: 6/14/2011

Bridge Age: 43.3 months
Crack density: 0.336 m/m²
Span 1: 0.194 m/m²
Span 2: 0.451 m/m²
Span 3: 0.334 m/m²
Span 4: 0.328 m/m²

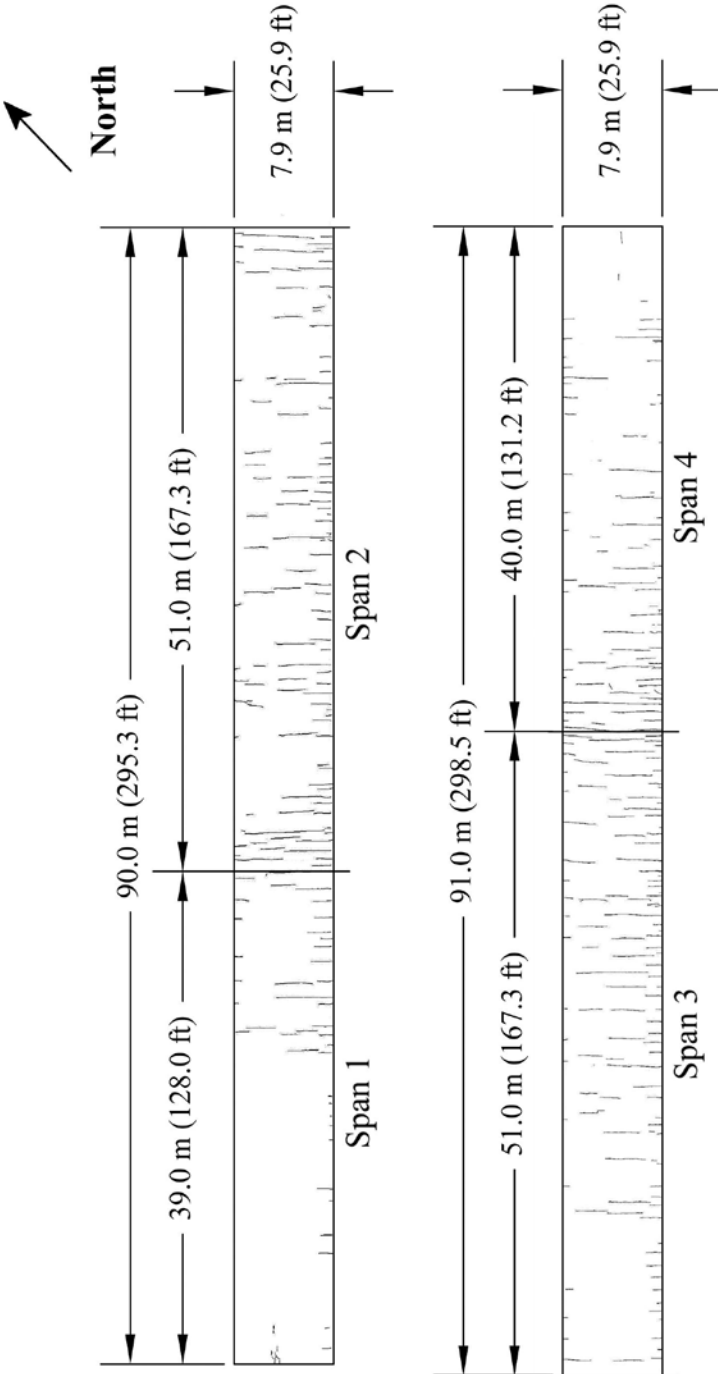
Bridge Number: 46-340 Unit 2 (LC-HPC-6)	Bridge Length: 181.0 m (593.8 ft)	Bridge Age: 54.6 months
Bridge Location: SB US-69 to WB I-435	Bridge Width: 7.9 m (25.9 ft)	Crack density: 0.362 m/m ²
Construction Date: 11/3/2007	Skew: 0°	Span 1: 0.168 m/m ²
Crack survey Date: 5/23/2012	Number of Spans: 4	Span 2: 0.451 m/m ²
	Span 1: 39.0 m (128.0 ft)	Span 3: 0.418 m/m ²
	Span 2: 51.0 m (167.3 ft)	Span 4: 0.365 m/m ²
	Span 3: 51.0 m (167.3 ft)	
	Span 4: 40.0 m (131.2 ft)	
	Number of Placements: 1

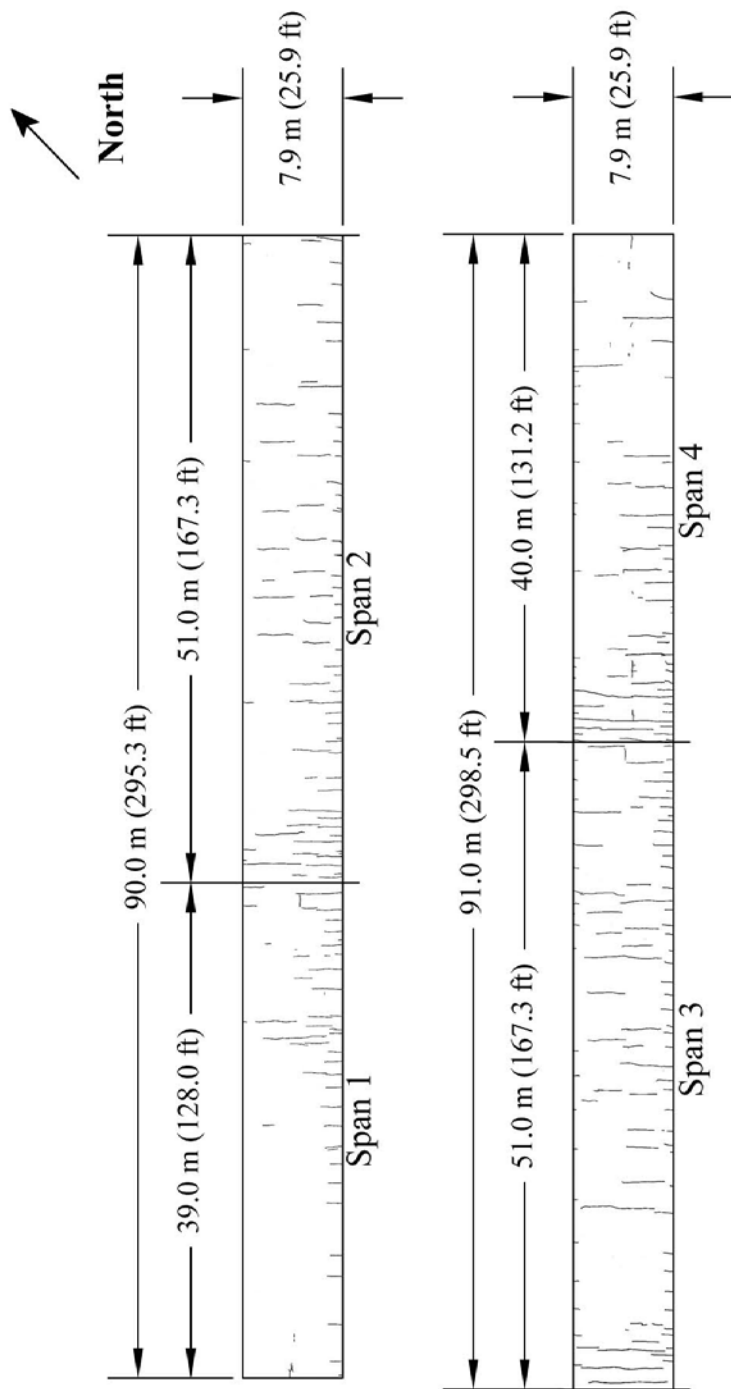
Bridge Number: 46-340 Unit 2
(LC-HPC-6)

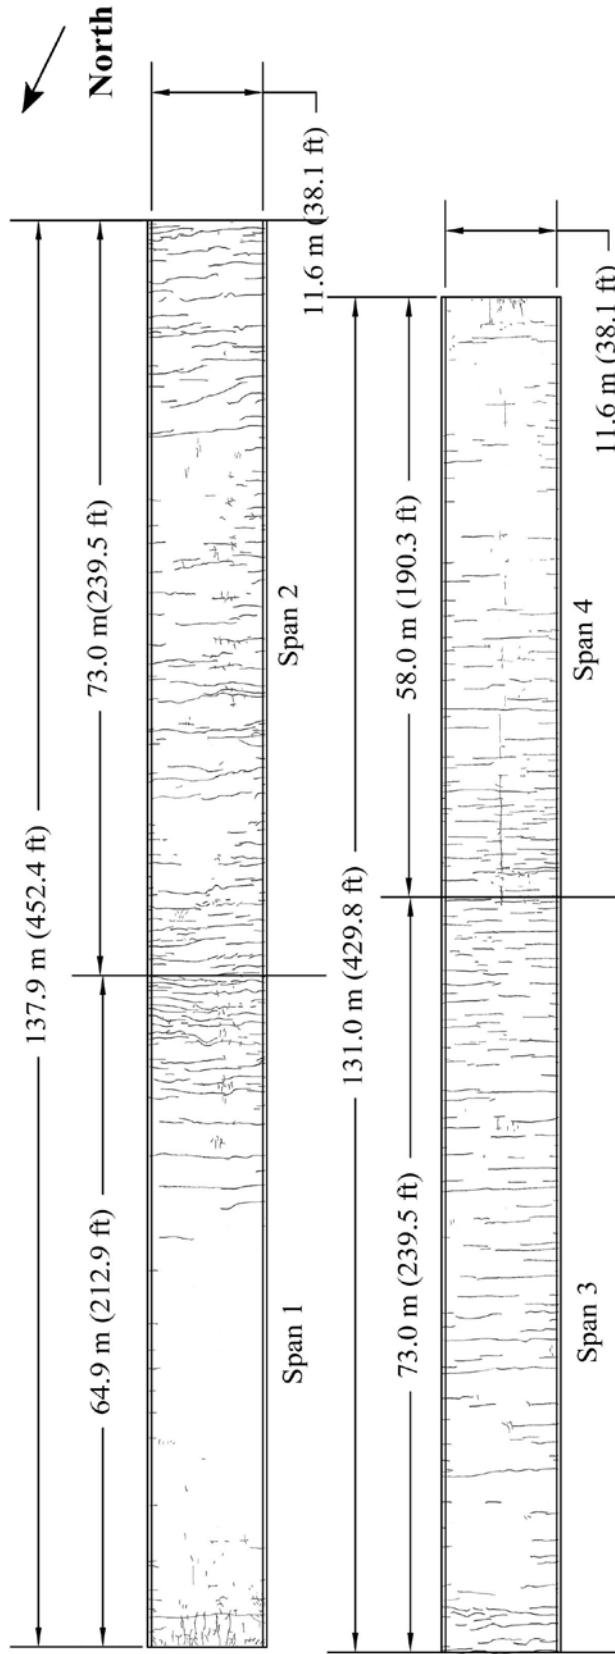
Bridge Number: 46-341 Unit 4
(Control-6)
Bridge Location: Flyover Ramp
 S-69 to I-435 E, Kansas City, KS
Construction Date: 10/20/2008
Crack survey Date: 6/14/2011

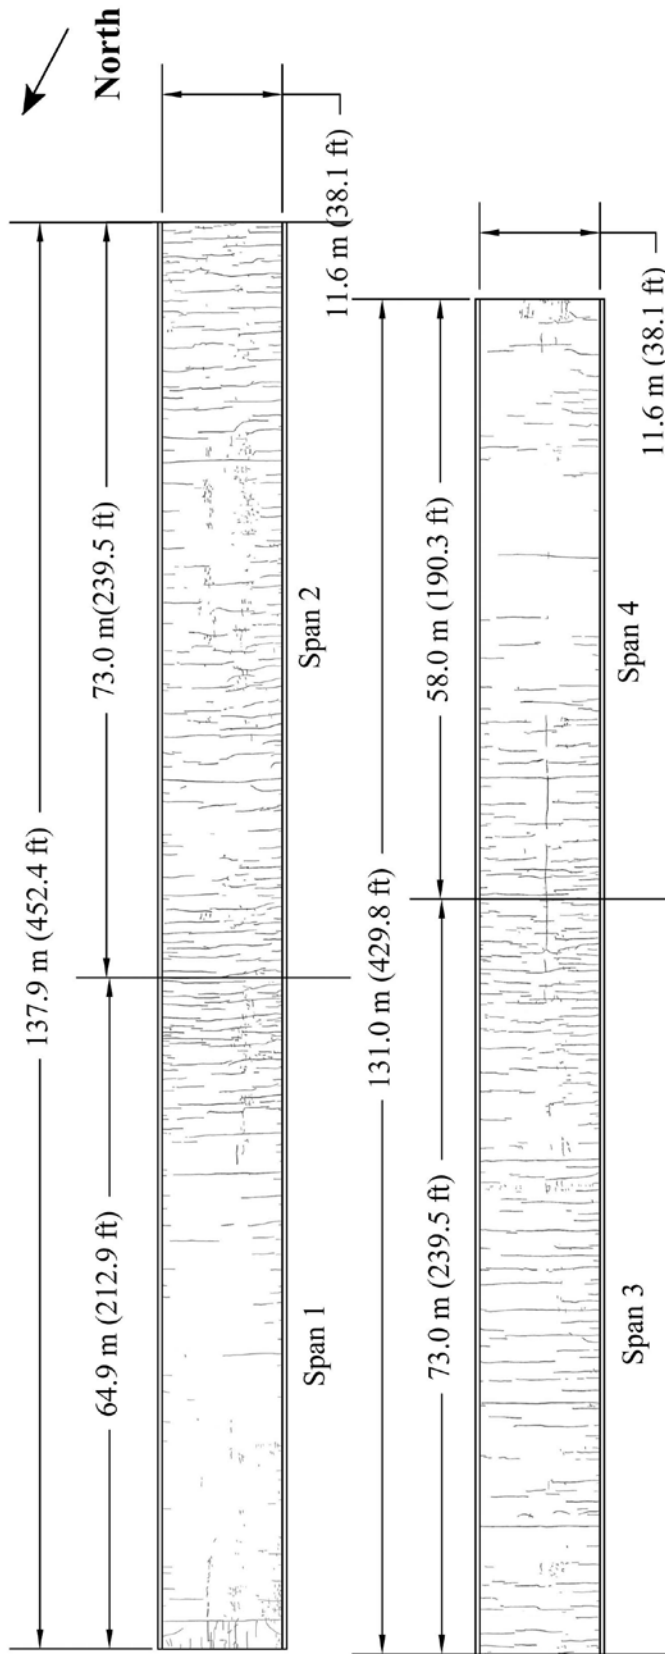
Bridge Number: 46-341 Unit 4
 (Control-6)
Bridge Location: Flyover Ramp
 S-69 to I-435 E, Overland Park, KS
Construction Date: 10/20/2008
Crack survey Date: 5/30/2012

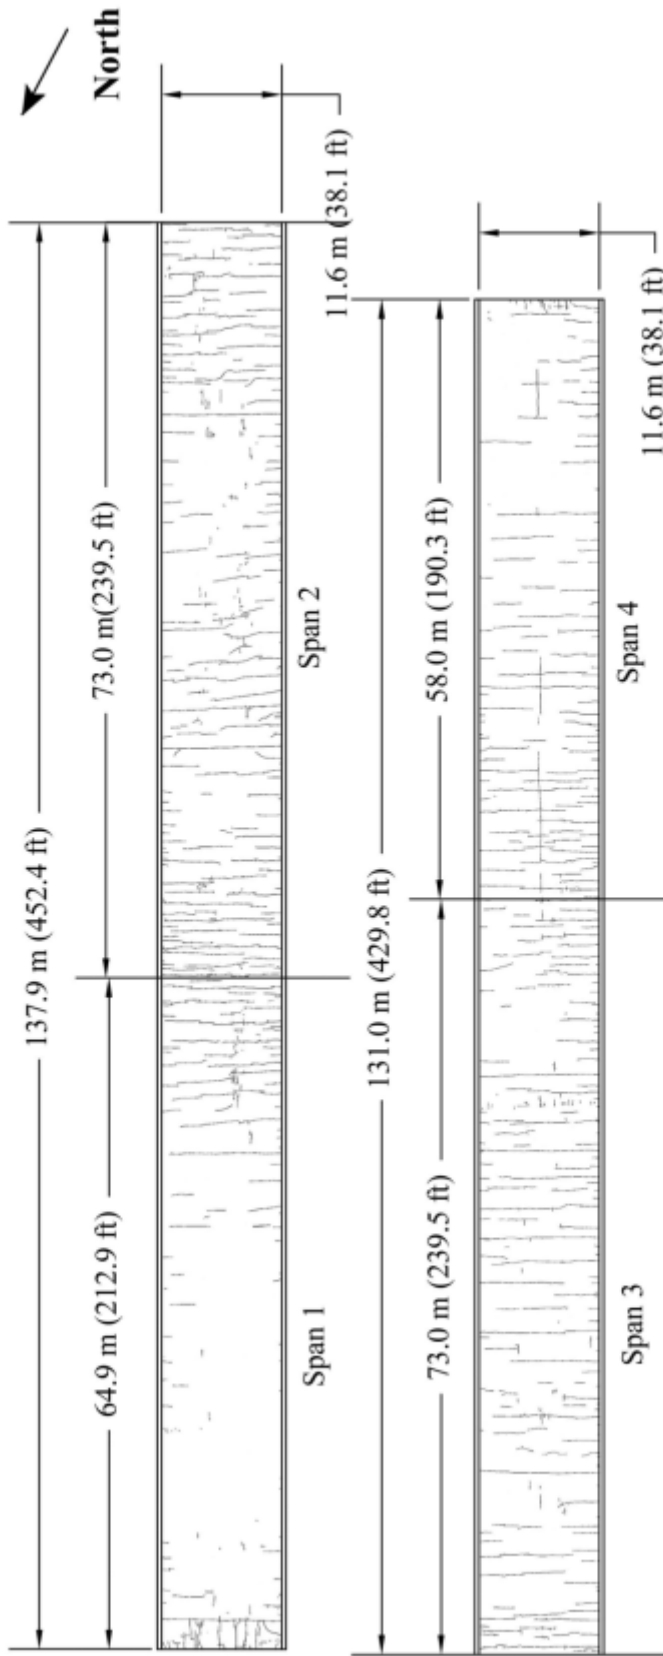
Bridge Number: 46-341 Unit 4
(Control-6)
Bridge Location: Flyover Ramp
 S-69 to I-435 E, Overland Park, KS
Construction Date: 10/20/2008
Crack survey Date: 6/19/2013

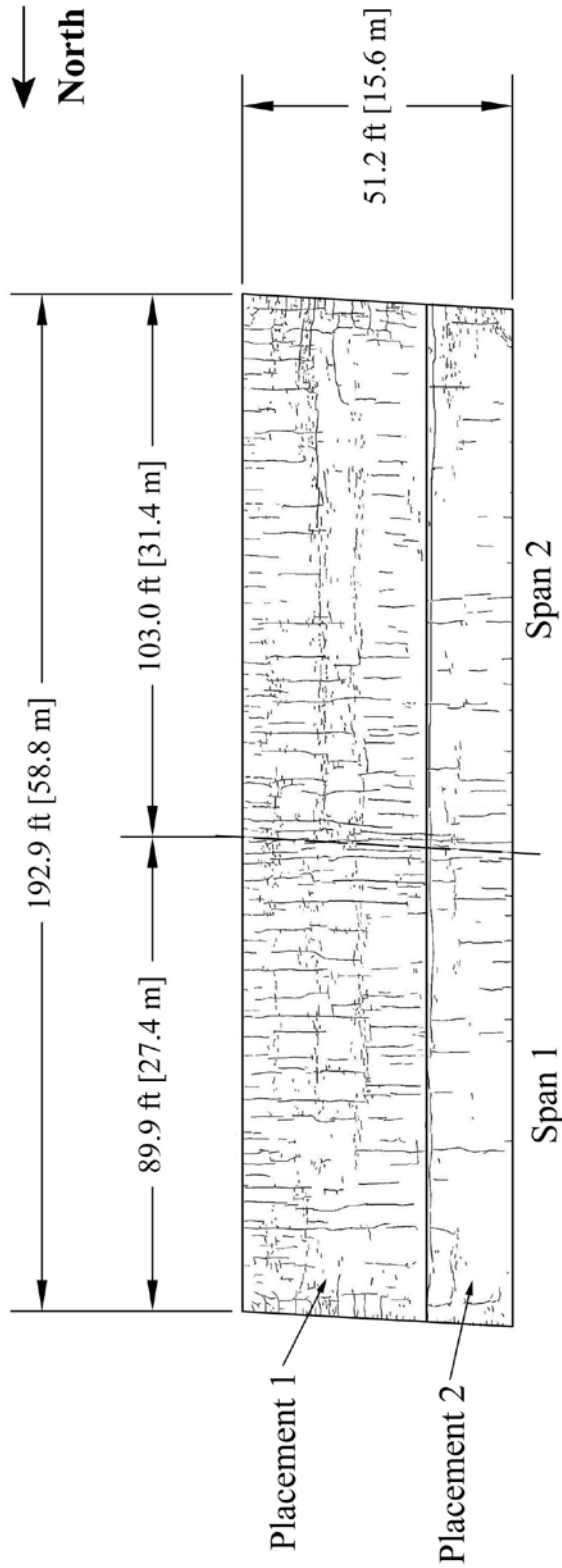
Bridge Number: 46-334 (Control-7)	Bridge Length: 58.8 m (192.9 ft)	Bridge Age:
Bridge Location: NB Antioch over I-435	Bridge Width: 15.6 m (51.2 ft)	Placement 1: 74.5 months
Construction Date:	Skew: -3.3°	Placement 2: 68.9 months
Placement 1 (East): 3/29/2006	Number of Spans: 2	Crack density: 0.899 m/m ²
Placement 2 (West): 9/15/2006	Span 1 (North): 27.4 m (89.9 ft)	Span 1: 0.904 m/m ²
Crack survey Date: 6/12/2012	Span 2 (South): 31.4 m (103.0 ft)	Span 2: 0.895 m/m ²
	Number of Placements: 2	Placement 1: 1.022 m/m ²
		Placement 2: 0.638 m/m ²

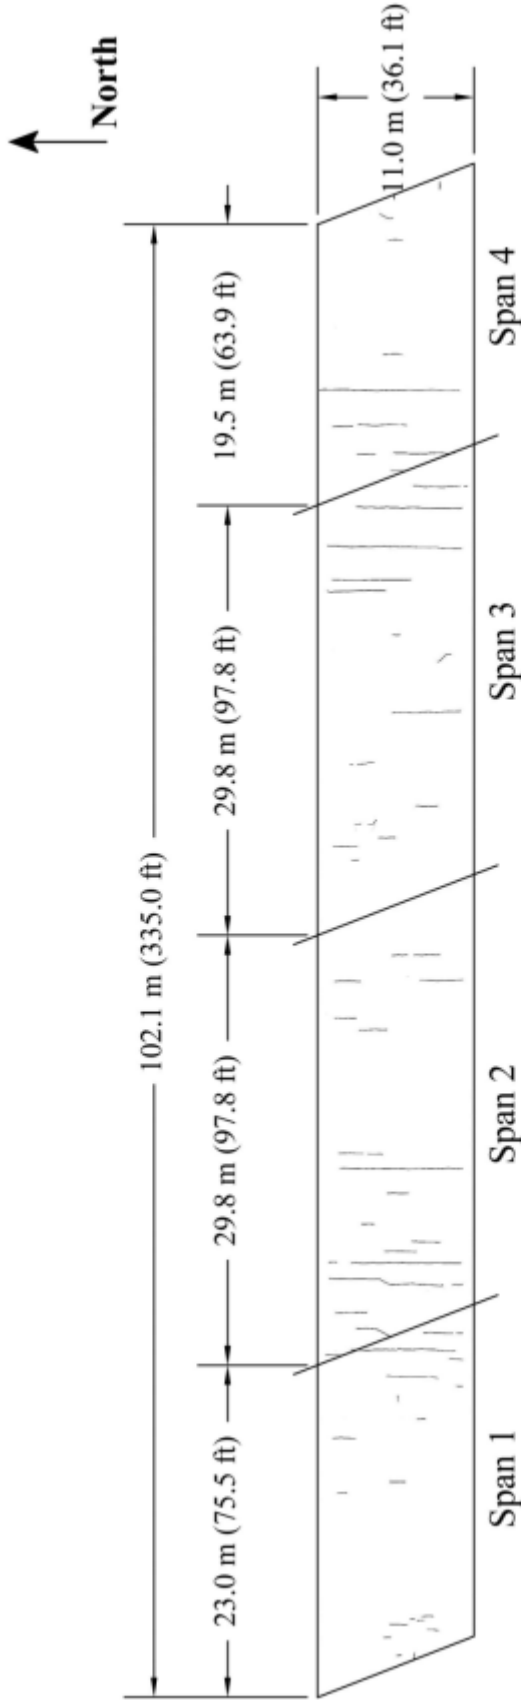
Bridge Number: 54-60 (LC-HPC-10) **Bridge Length:** 102.1 m (335.0 ft) **Bridge Age:** 60.0 months
Bridge Location: E1800Rd over US-69 **Bridge Width:** 11.0 m (36.1 ft) **Crack density:** 0.125 m/m²
Construction Date: 5/17/2007 **Skew:** 21.3° **Span 1 (West):** 0.091 m/m²
Crack survey Date: 5/15/2012 **Number of Spans:** 4 **Span 2 (West):** 0.156 m/m²
Span 1 (West): 23.0 m (75.5 ft) **Span 3 (East):** 0.128 m/m²
Span 2 (West): 29.8 m (97.8 ft) **Span 4 (East):** 0.114 m/m²
Span 3 (East): 29.8 m (97.8 ft) **Number of Placements:** 1
Span 4 (East): 19.5 m (63.9 ft)

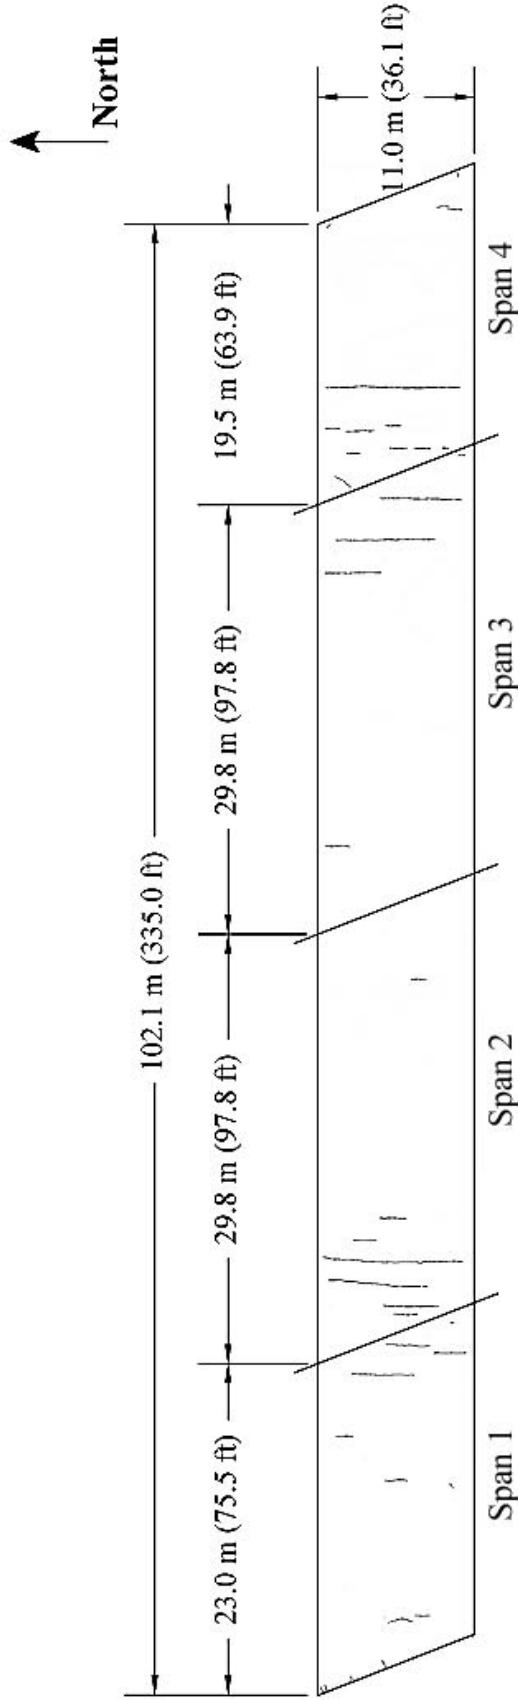
Bridge Number: 54-60 (LC-HPC-10)
Bridge Location: E1800Rd over
 US-69
Construction Date: 5/17/2007
Crack survey Date: 5/22/2013

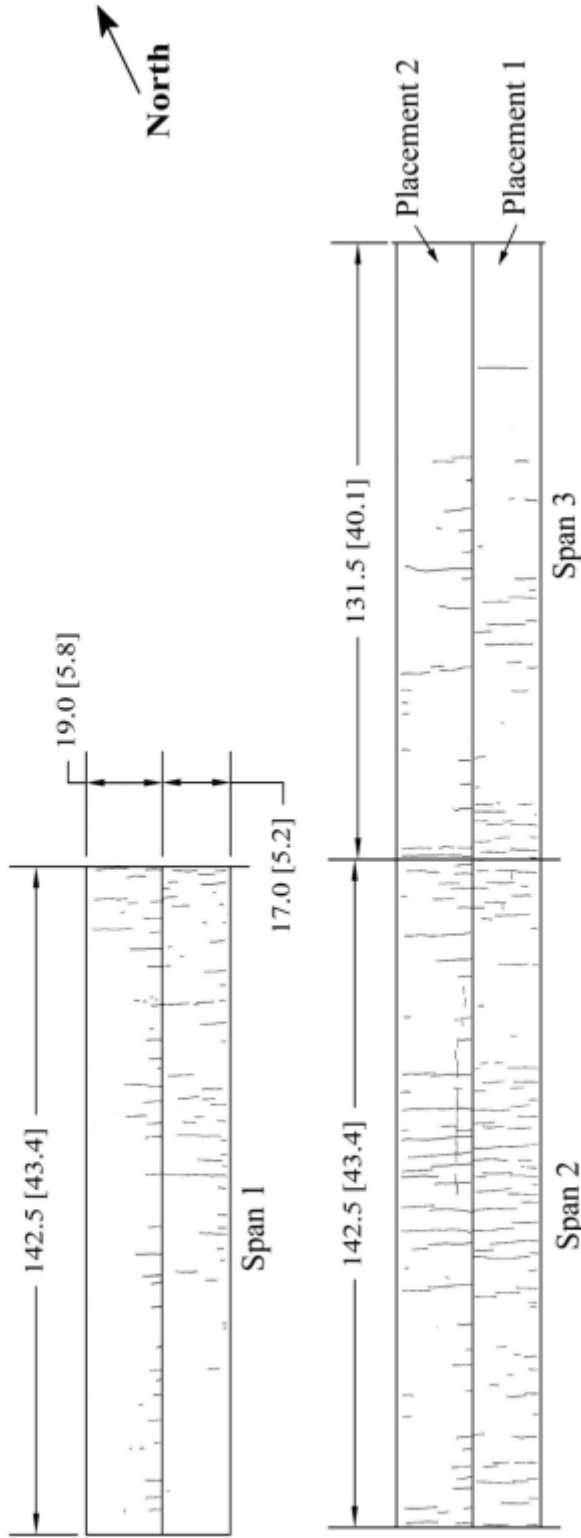
Bridge Number: 56-057 (LC-HPC-12)	Bridge Length: 416.5' (126.95m)	Bridge Age:
Bridge Location: K-130 over Neosho Rv Unit 2	Bridge Width: 36' (10.97m)	Placement 1: 38.8 months
Construction Date:	Skew: 0°	Placement 2: 27.4 months
Placement 1 (east): 4/4/2008	Number of Spans: 3	Crack Density: 0.289 m/m ²
Placement 2 (west): 3/18/2009	Span 1 (West): 142.5' (43.43m)	Placement 1: 0.315 m/m ²
	Span 2 (Mid): 142.5' (43.43m)	Placement 2: 0.268 m/m ²
Crack Survey Date: 6/28/2011	Span 3 (East): 131.5' (40.08m)	Span 1: 0.216 m/m ²
	Number of Placements: 2	Span 2: 0.474 m/m ²
		Span 3: 0.168 m/m ²

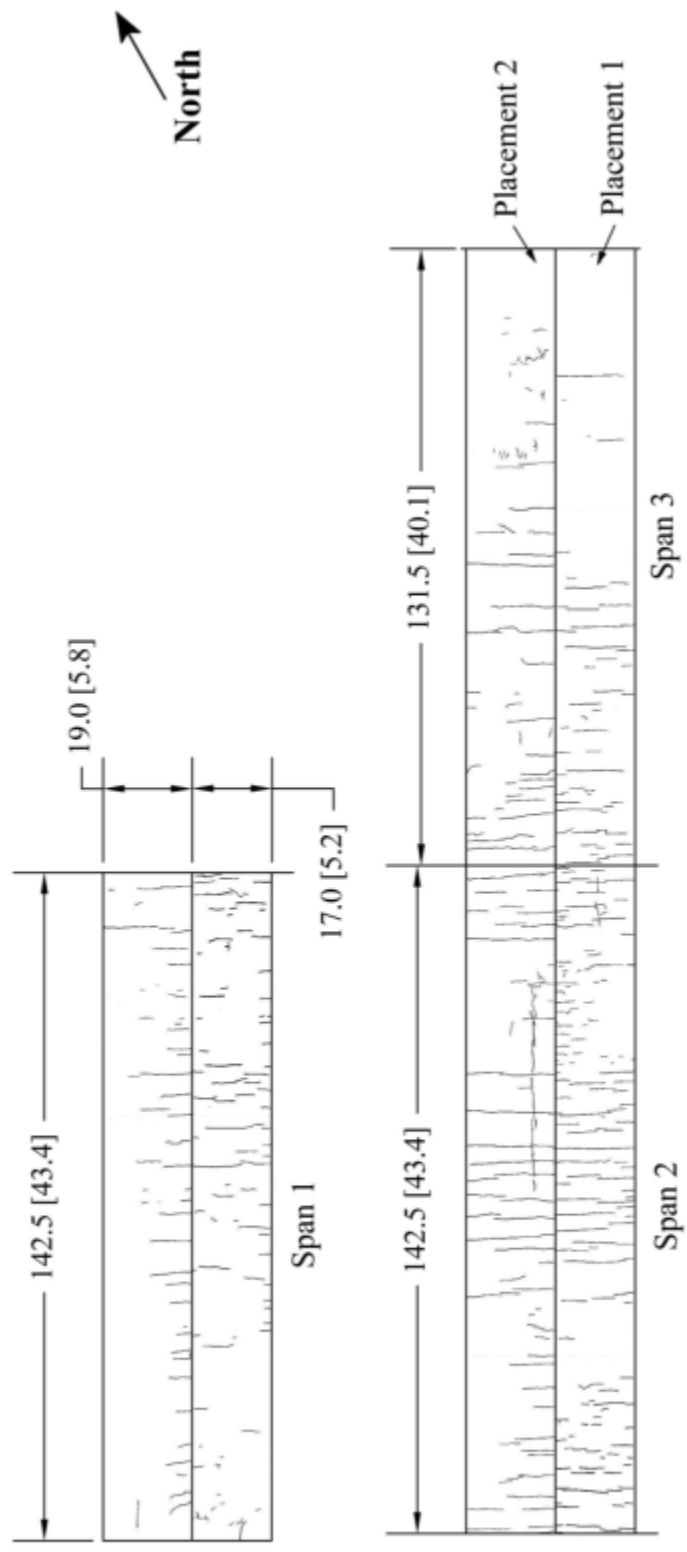
Bridge Number: 56-057 (LC-HPC-12) **Bridge Length:** 416.5' (126.95m)
Bridge Location: K-130 over Neosho **Bridge Width:** 36' (10.97m)
Construction Date: Rv Unit 2 **Skew:** 0°
Construction Date: Placement 1(east): 4/4/2008 **Number of Spans:** 3
Placement 2(west): 3/18/2009 **Span 1 (West):** 142.5' (43.43m)
Crack Survey Date: 5/21/2012 **Span 2 (Mid):** 142.5' (43.43m)
Span 3 (East): 131.5' (40.08m)
Number of Placements: 2

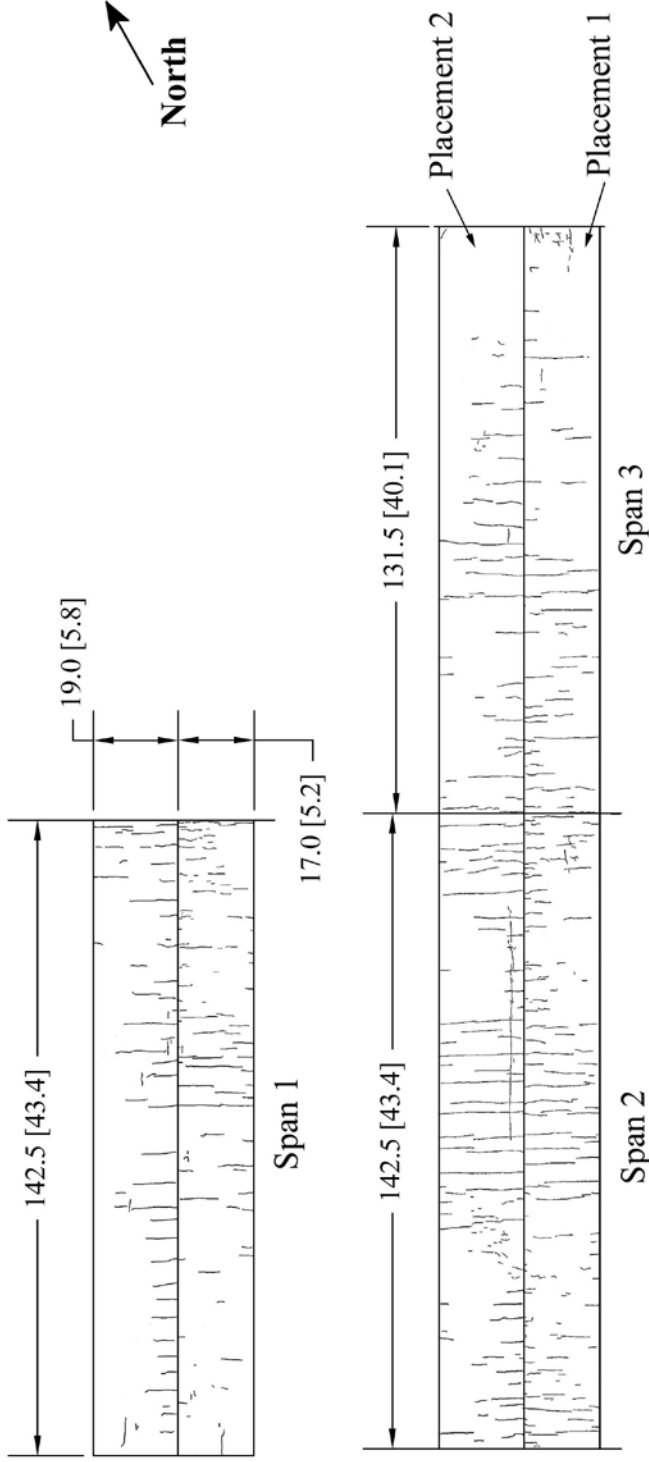
Bridge Number: 56-057 (LC-HPC-12)	Bridge Length: 416.5' (126.95m)	Bridge Age:
Bridge Location: K-130 over Neosho Rv Unit 2	Bridge Width: 36' (10.97m)	Placement 1: 64.5 months
Construction Date:	Skew: 0°	Placement 2: 53.1 months
Placement 1 (east): 4/4/2008	Number of Spans: 3	Crack Density: 0.431 m/m ²
Placement 2 (west): 3/18/2009	Span 1 (West): 142.5' (43.43m)	Placement 1: 0.478 m/m ²
Crack Survey Date: 8/19/2013	Span 2 (Mid): 142.5' (43.43m)	Placement 2: 0.381 m/m ²
	Span 3 (East): 131.5' (40.08m)	Span 1: 0.349 m/m ²
	Number of Placements: 2	Span 2: 0.610 m/m ²
		Span 3: 0.327 m/m

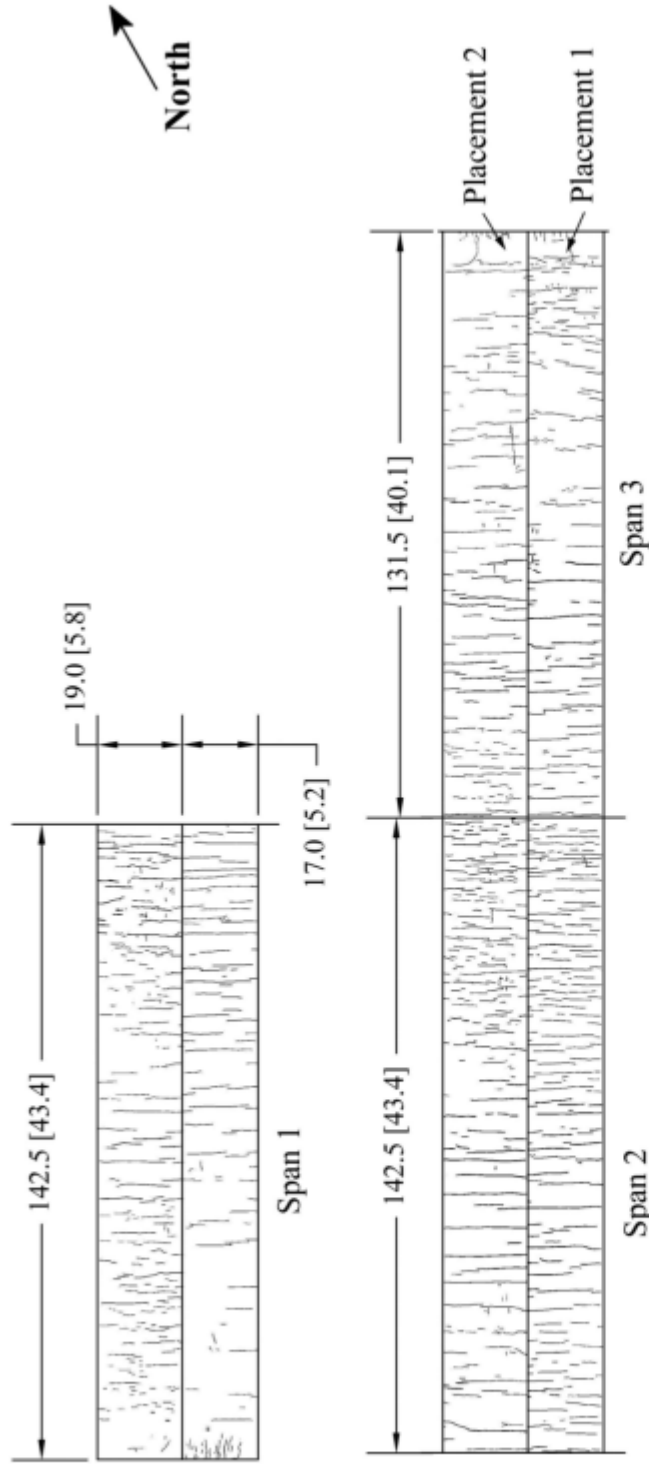
Bridge Number: 56-057 (Control-12)	Bridge Length: 416.5' (126.95m)	Bridge Age:
Bridge Location: K-130 over Neosho	Bridge Width: 36' (10.97m)	Placement 1: 49.6 months
Construction Date: Rv Unit 1	Skew: 0°	Placement 2: 37.2 months
Construction Date: Placement 1(east): 4/1/2008	Number of Spans: 3	Crack Density: 0.843 m/m ²
Placement 2(west): 4/14/2009	Span 1 (West): 142.5' (43.43m)	Placement 1: 0.857 m/m ²
Crack Survey Date: 5/21/2012	Span 2 (Mid): 142.5' (43.43m)	Placement 2: 0.831 m/m ²
	Span 3 (East): 131.5' (40.08m)	Span 1: 0.723 m/m ²
	Number of Placements: 2	Span 2: 1.015 m/m ²
		Span 3: 0.786 m/m ²

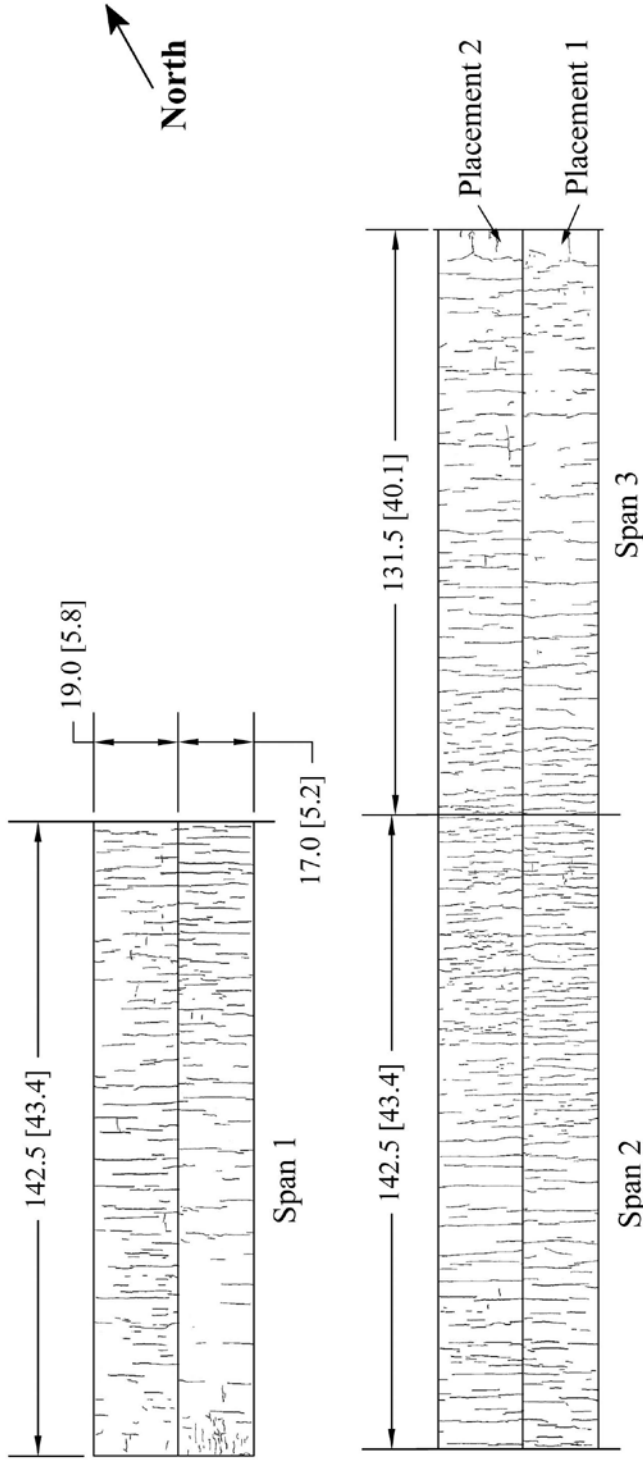
Bridge Number: 56-057 (Control-12)	Bridge Length: 416.5' (126.95m)	Bridge Age:
Bridge Location: K-130 over Neosho Rv Unit 1	Bridge Width: 36' (10.97m)	Placement 1: 64.6 months
Construction Date:	Skew: 0°	Placement 2: 52.2 months
Placement 1 (East): 4/1/2008	Number of Spans: 3	Crack Density: 0.858 m/m ²
Placement 2 (West): 4/14/2009	Span 1 (West): 142.5' (43.43m)	Placement 1: 0.838 m/m ²
Crack Survey Date: 8/19/2013	Span 2 (Mid): 142.5' (43.43m)	Placement 2: 0.880 m/m ²
	Span 3 (East): 131.5' (40.08m)	Span 1: 0.750 m/m ²
	Number of Placements: 2	Span 2: 1.085 m/m ²
		Span 3: 0.728 m/m ²

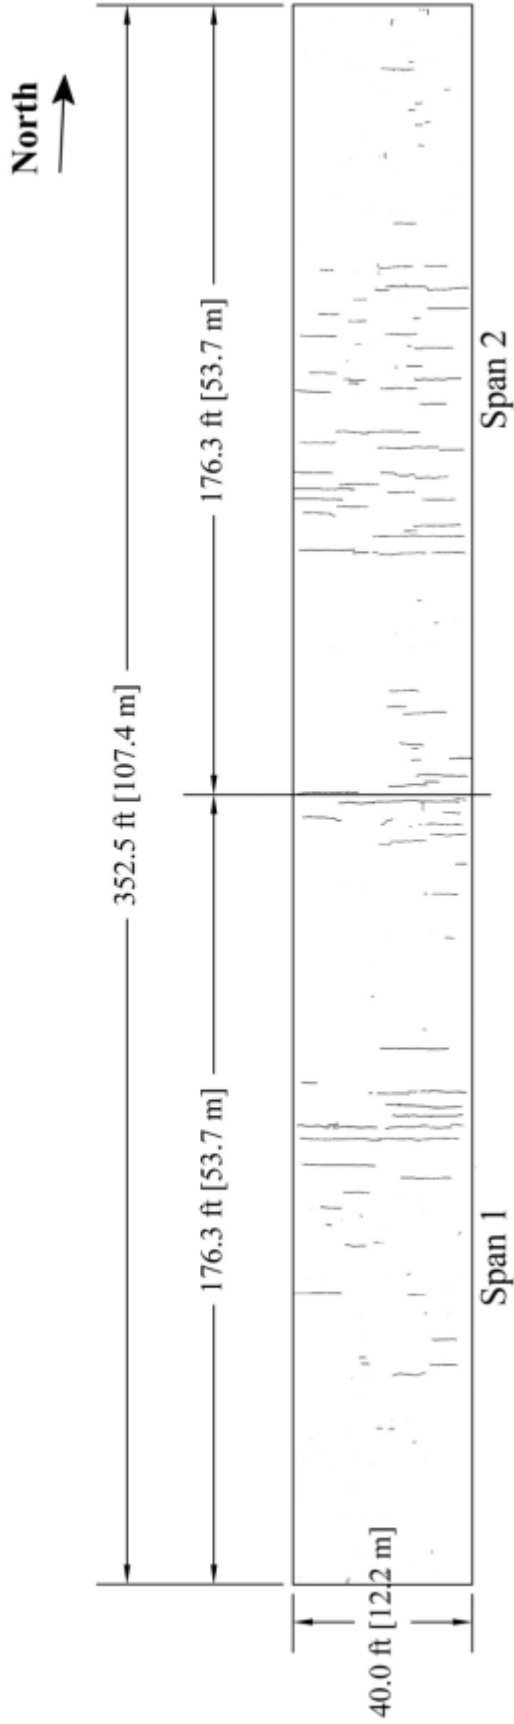
Bridge Number: 46-351 (LC-HPC-15) **Bridge Length:** 352.5 ft (118.2 m) **Bridge Age:** 30.8 months
Bridge Location: NB K-7 over Johnson Dr./55th St. **Bridge Width:** 40.0 ft(12.2 m) **Crack Density:** 0.161 m/m²
Construction Date: 11-10-10 **Skew:** 0° **Number of Spans:** 3 **Span 1:** 176.25 ft (36.7 m) **Span 1:** 0.134 m/m²
Crack Survey Date: 6-3-2013 **Number of Placements:** 1 **Span 2:** 176.25 ft (44.8 m) **Span 2:** 0.182 m/m²

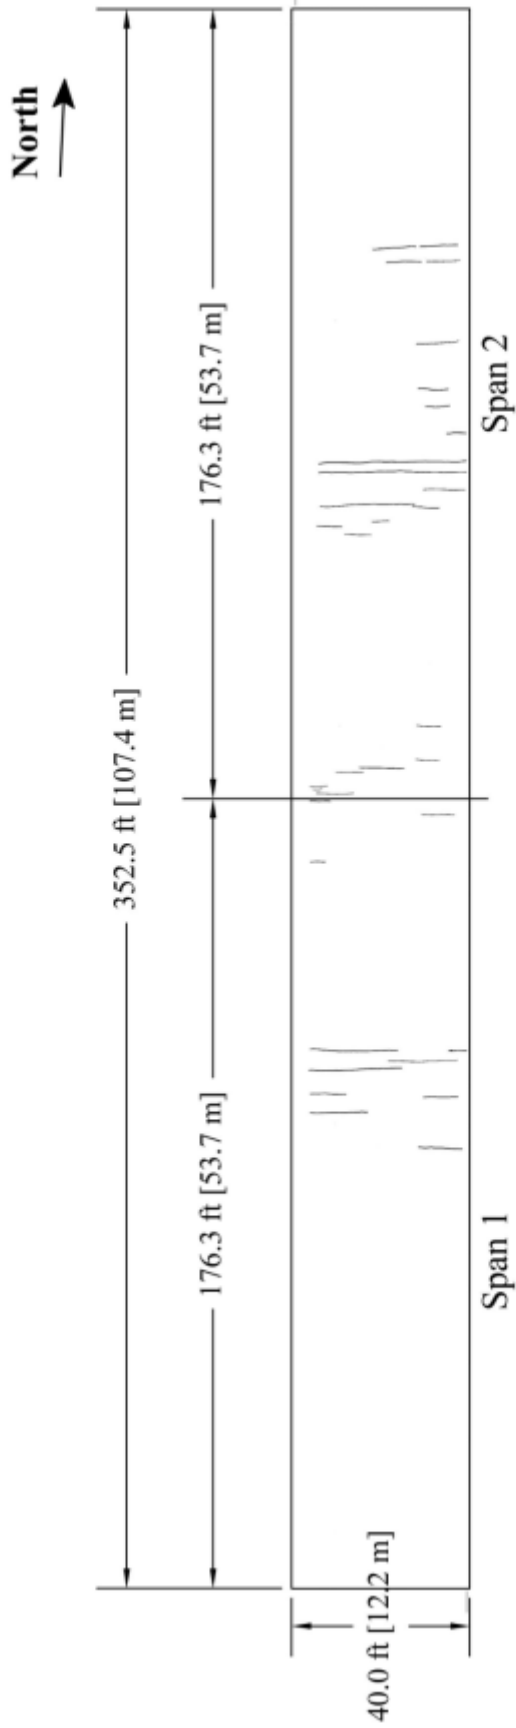
Bridge Number: 46-352 (LC-HPC-16) **Bridge Length:** 352.5 ft (118.2 m) **Bridge Age:** 7.7 months
Bridge Location: SB K-7 over Johnson Dr./55th St. **Bridge Width:** 40.0 ft(12.2 m) **Crack Density:** 0.092 m/m
Construction Date: 10-28-2010 **Skew:** 0° **Number of Spans:** 3 **Span 1:** 0.058 m/m²
Crack Survey Date: 6-20-2011 **Span 1:** 176.25 ft (36.7 m) **Span 2:** 0.119 m/m²
Number of Placements: 1 **Span 2:** 176.25 ft (44.8 m)

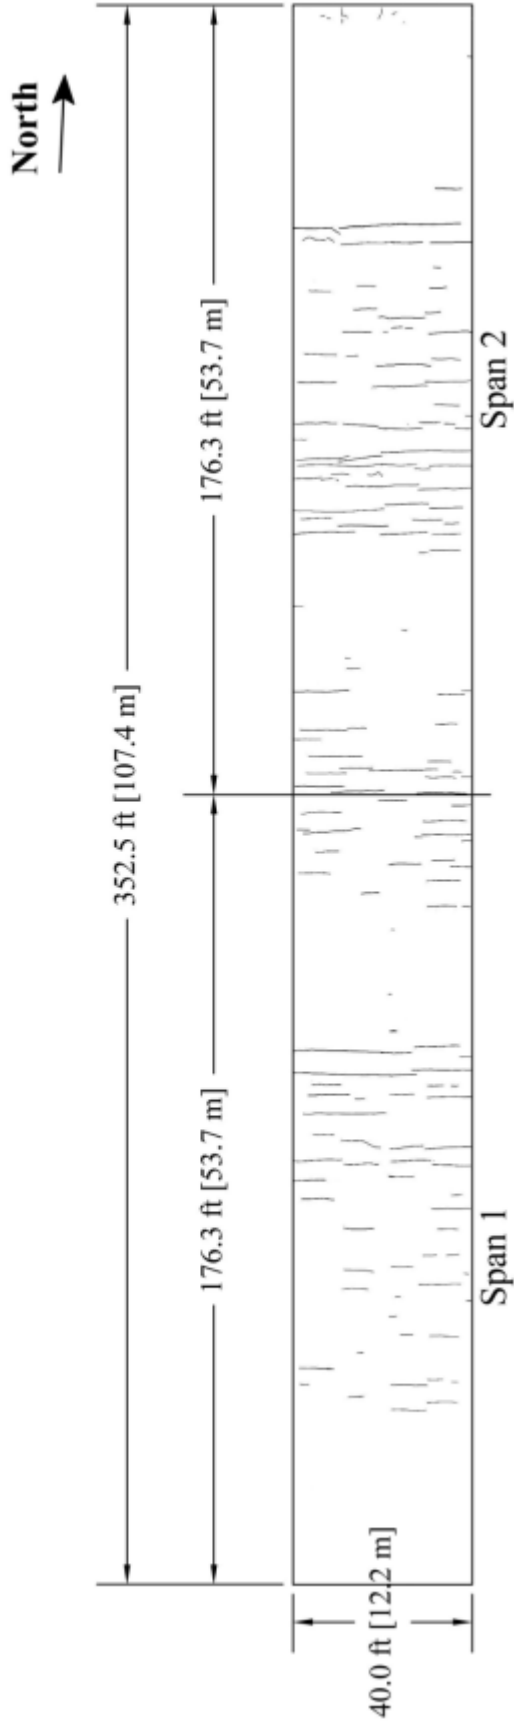
Bridge Number: 46-352 (LC-HPC-16) **Bridge Length:** 352.5 ft (107.4 m) **Bridge Age:** 19.4 months
Bridge Location: SB K-7 over Johnson Dr./55th St. **Bridge Width:** 40.0 ft(12.2 m) **Crack Density:** 0.249 m/m²
Construction Date: 10-28-2010 **Skew:** 0° **Number of Spans:** 2 **Span 1:** 176.25 ft (53.7 m) **Span 1:** 0.204 m/m²
Crack Survey Date: 6-8-2012 **Number of Placements:** 1 **Span 2:** 176.25 ft (53.7 m) **Span 2:** 0.287 m/m²

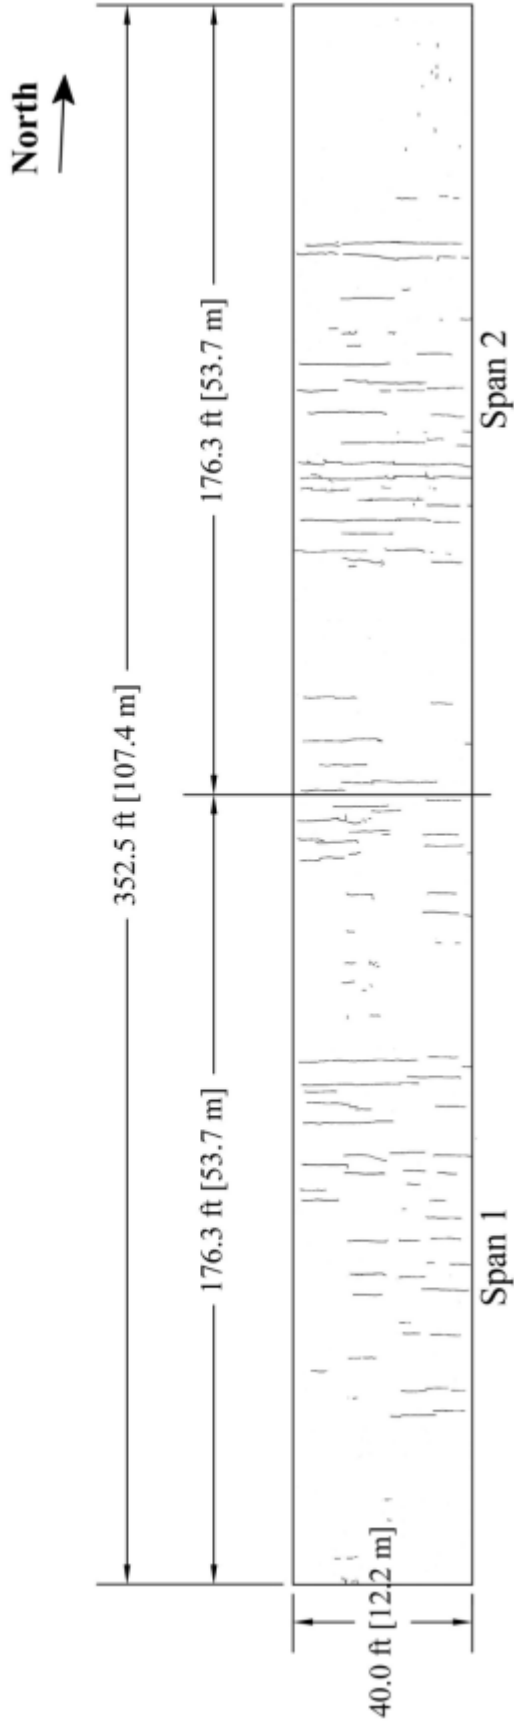
Bridge Number: 46-352 (LC-HPC-16)	Bridge Length: 352.5 ft (107.4 m)	Bridge Age: 31.2 months
Bridge Location: SB K-7 over Johnson Dr./55th St.	Bridge Width: 40.0 ft(12.2 m)	Crack Density: 0.211 m/m ²
Construction Date: 10-28-2010	Skew: 0°	Span 1: 0.196 m/m ²
Crack Survey Date: 6-3-2013	Number of Spans: 2	Span 2: 0.225 m/m ²
	Span 1: 176.25 ft (53.7 m)	
	Span 2: 176.25 ft (53.7 m)	
	Number of Placements: 1

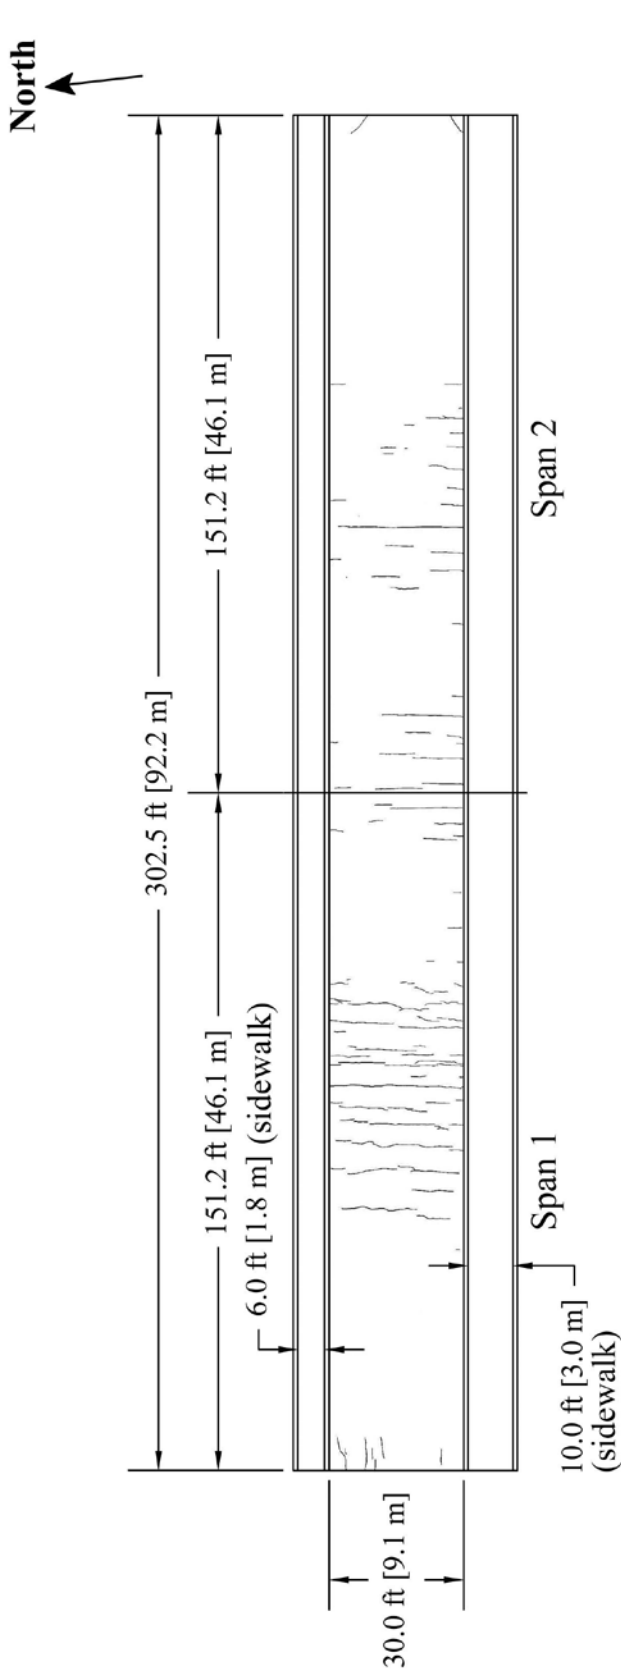
Bridge Number: 46-373 (LC-HPC-17) **Bridge Length:** 302.5 ft (92.2 m) **Bridge Age:** 8.94 months
Bridge Location: Clear Creek **Bridge Width:** 48.0 ft (14.6 m) **Crack Density:** 0.226 m/m²
Parkway over K-7 **Skew:** 0° **Span 1:** 0.302 m/m²
Construction Date: 09-28-11 **Number of Spans:** 2 **Span 2:** 0.145 m/m²
Crack Survey Date: 6-26-2012 **Span 1:** 151.25 ft (46.1 m) **Span 2:** 151.25 ft (46.1 m)
Number of Placements: 1
