**CRACK SURVEYS OF LOW-CRACKING
HIGH-PERFORMANCE CONCRETE
BRIDGE DECKS IN KANSAS
2011-2013**

**A Report on Research Sponsored by
CONSTRUCTION OF CRACK-FREE BRIDGE DECKS
TRANSPORTATION POOLED-FUND PROGRAM
PROJECT NO. TPF-5(174)**

**Structural Engineering and Engineering Materials
SL Report 13-6**

**THE UNIVERSITY OF KANSAS CENTER FOR RESEARCH, INC.
LAWRENCE, KANSAS
December 2013**

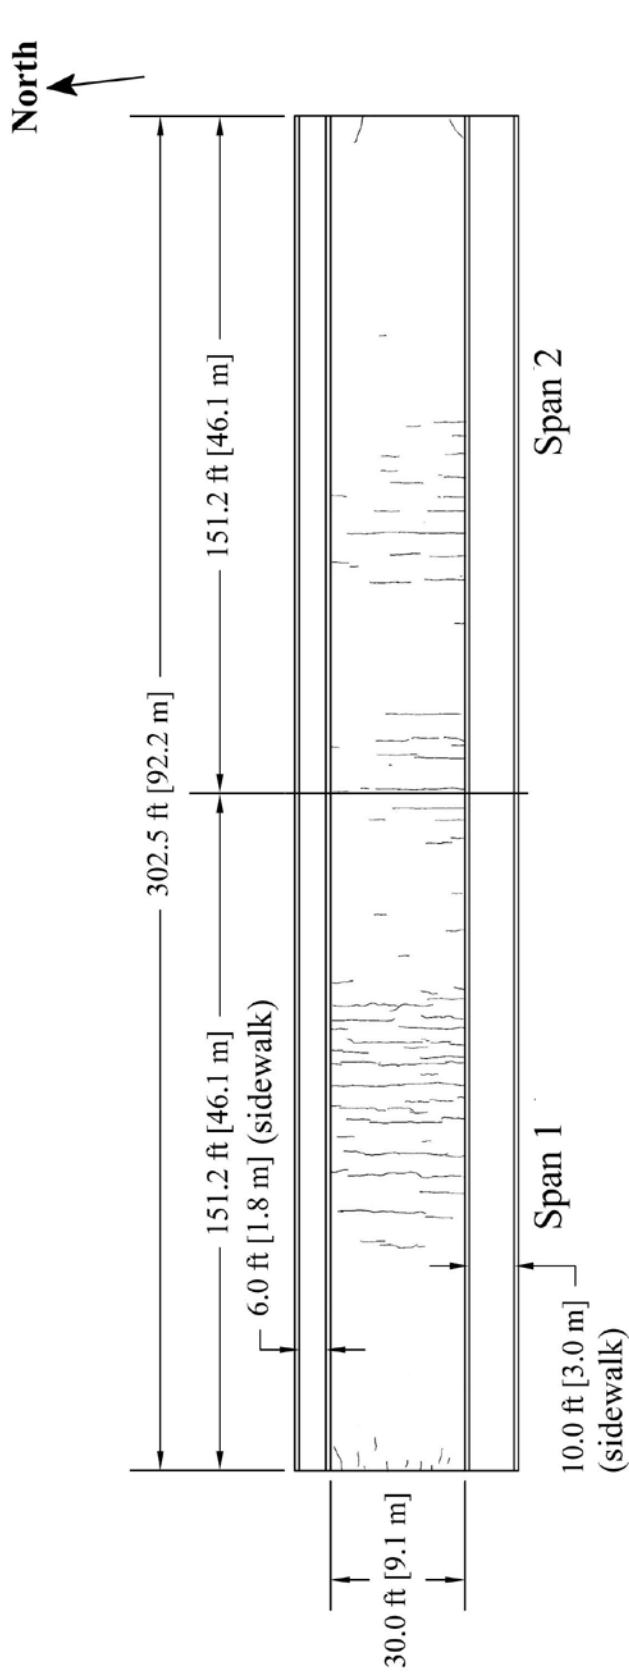
Bridge Number: 46-373 (LC-HPC-17) **Bridge Length:** 302.5 ft (92.2 m) **Bridge Age:** 20.5 months
Bridge Location: Clear Creek Parkway over K-7 **Bridge Width:** 48.0 ft (14.6 m) **Crack Density:** 0.240 m/m²
Construction Date: 09-28-11 **Skew:** 0° **Number of Spans:** 2 **Span 1:** 0.314 m/m²
Crack Survey Date: 6-14-2013 **Span 2:** 0.157 m/m²
Number of Placements: 1

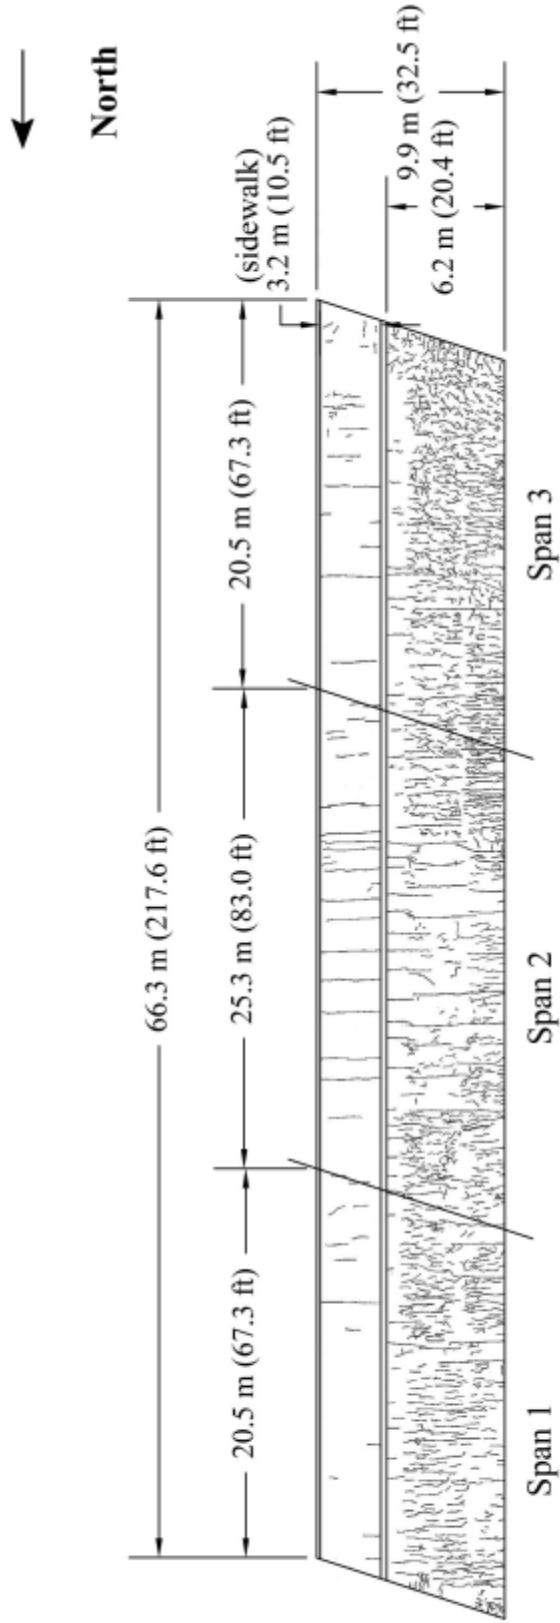
Bridge Number: 46-363 (OP Bridge - Placement 3)	Bridge Length: 66.3 m (217.6 ft)	Bridge Age: 61.6 months
Bridge Location: Metcalf Ave over Indian Creek, OP, Kansas	Bridge Width: 9.9 m (32.5 ft)	Crack Density: 1.387 m/m ²
Construction Date: 5/21/2008	Skew: -18°	Span 1: 1.248 m/m ²
Crack Survey Date: 7/8/2013	Number of Spans: 3	Span 2: 1.369m/m ²
	Span 1: 20.5 m (67.3 ft)	Span 3: 1.555 m/m ²
	Span 2: 25.3 m (83.0 ft)	
	Span 3: 20.5 m (67.3 ft)	
	Number of Placements: 1
