**POST RETROFIT ANALYSIS OF THE  
TUTTLE CREEK BRIDGE  
Br. No. 16-81-2.24**

**THE KANSAS DEPARTMENT OF TRANSPORTATION  
KDOT PROJECT NUMBER: KTRAN, KU-04-5**

**Structural Engineering and Engineering Materials  
SM Report No. 88  
January 2007**

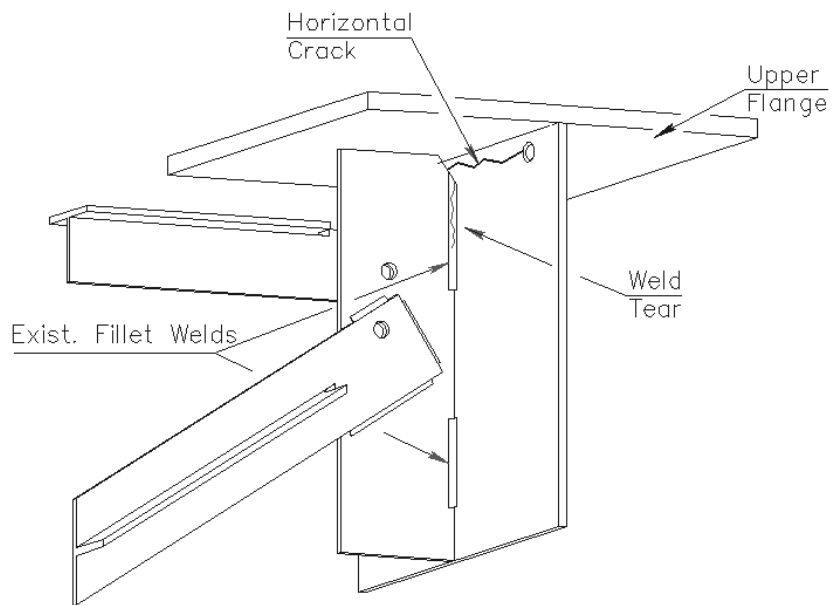
Of the two types of cracking, weld tears were found to be the most common. The weld tears propagated down the 4 in. fillet weld between the upper portion of the stiffener and the web. Many of the 4 in. top intermittent welds on the stiffener were broken completely by weld tears. In addition, some weld tears propagated from the fillet weld into the web of the girder.

The other cracking pattern found in the web gap region was horizontal cracking. The horizontal cracks occurred at the base of the fillet weld that connects the upper flange to the web. Horizontal cracks were located mainly on the interior side of the girders, but were also found on the exterior side.

The primary source of fatigue cracking in the Tuttle Creek Bridge was the lack of attachment between the top of the stiffener and the tension flange. The web-gap cracking was the result of differential deflection of the girders. Braces in the diaphragms created a tension force on the stiffener due to the difference in deflections between the two girders. This caused the web-gap to undergo double-curvature bending. Figure 2-5 shows the tension force created by the diaphragms. This type of detail is classified as a category C fatigue detail according to the 2004 AASHTO LFRD specifications.

**Figure 2-3: Web-Gap Cracking Patterns**

A previous repair of the web-gap region was implemented in 1986. To repair the weld tears, the joint was “softened” by cutting the stiffeners 1 in. below the termination of the existing cracks. A 0.5-in. radius was placed at the end of the cut. Even though this was supposed to have repaired the problem, weld tears continued to

grow in this region. To stop the horizontal cracks, 0.75 in. diameter stop holes were drilled at the tips of existing cracks. However, the horizontal cracks reinitiated after the retrofit.

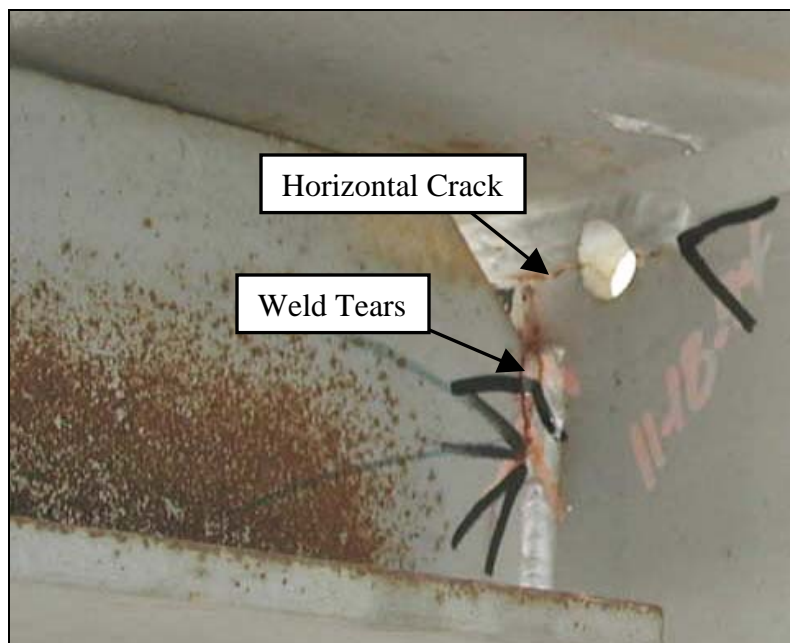
**Figure 2-4: Web-Gap Cracking Patterns (Picture)**

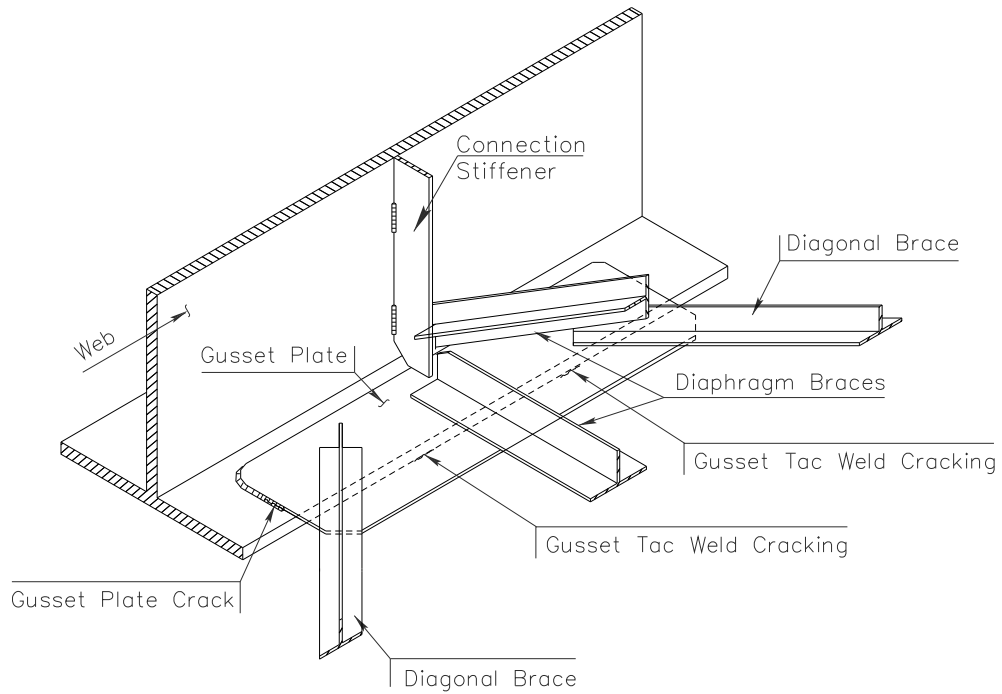
Cracks developed in welds that were both perpendicular and parallel to the gusset plate. Figure 2-6 shows a drawing of the cracking patterns, while Figure 2-7 displays an actual fillet weld crack.

The more common of the two was the cracking of the fillet weld perpendicular to the gusset plate. The fillet welds extended symmetrically across the back six inches along the sides of the gusset plate. This type of detail is classified as a Category E

detail according to the 2004 AASHTO Bridge Specifications. The cracks are found at the end of the weld along the sides of the plate. The cracks were assumed to be only in the weld material, but could potentially propagate into the lower tension flange.

**Figure 2-6: Gusset Plate Cracking Patterns**

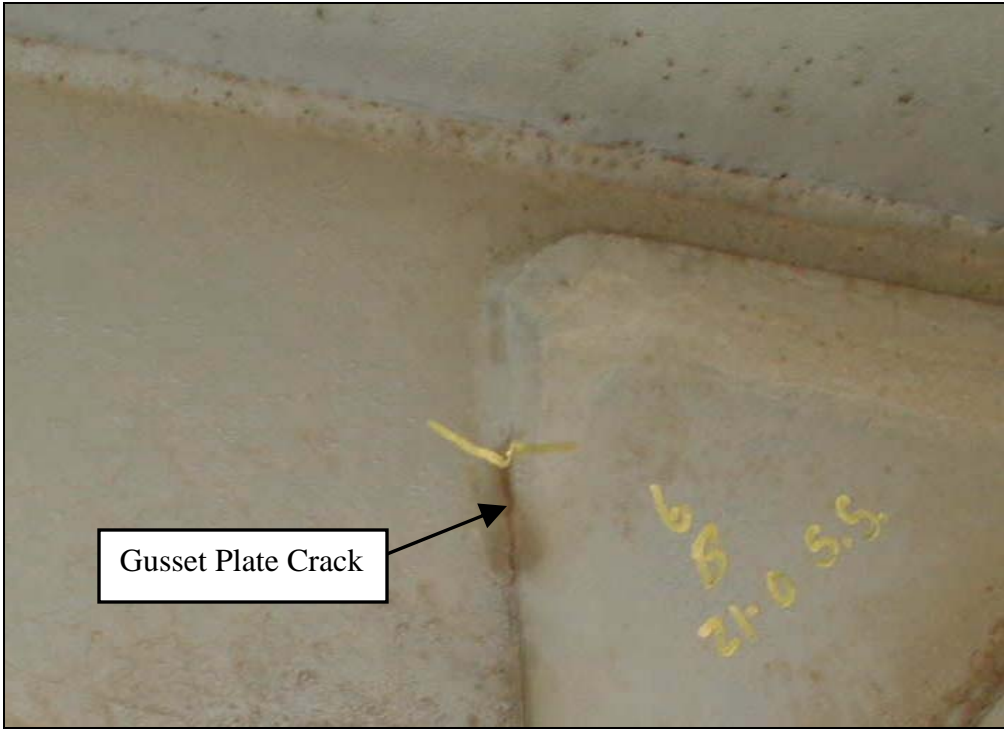
Fatigue cracking also occurred in the fillet weld between the gusset plate and the lower flange of the girder. Gusset plates connect the girders to the lateral bracing of the girders. As shown in Figure 2-7, three structural tees enter the connection. Loads imposed by the lateral bracing caused cracking of the gusset plate connection.

**Figure 2-7: Gusset Plate Cracking Patterns (Picture)**

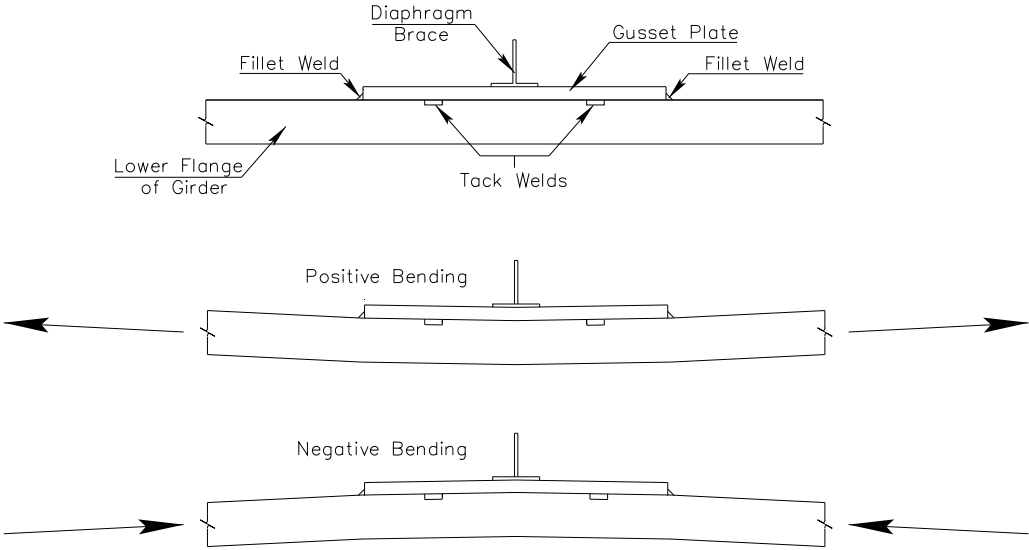
The source of the gusset plate cracks was not clearly defined. One theory was that cracks developed from the bending stress of the girder (Figure 2-8). Another possibility considered was that distortion of the girder caused high compressive stresses in the diagonal bracing. The lateral bracing could potentially buckle upward along its weak axis introducing a prying action on the gusset plate (Figure 2-9). Another theory considered racking of the gusset plate due to loads from the diagonal bracing. Twisting of the gusset plate would cause cracking to develop at the ends of the fillet weld (Figure 2-10). To help clarify this issue, strain gages were placed on the top and the bottom of the plate as shown in Figure 2-11.

**Figure 2-8: Gusset Plate Cracking Source (Bending Stresses)**

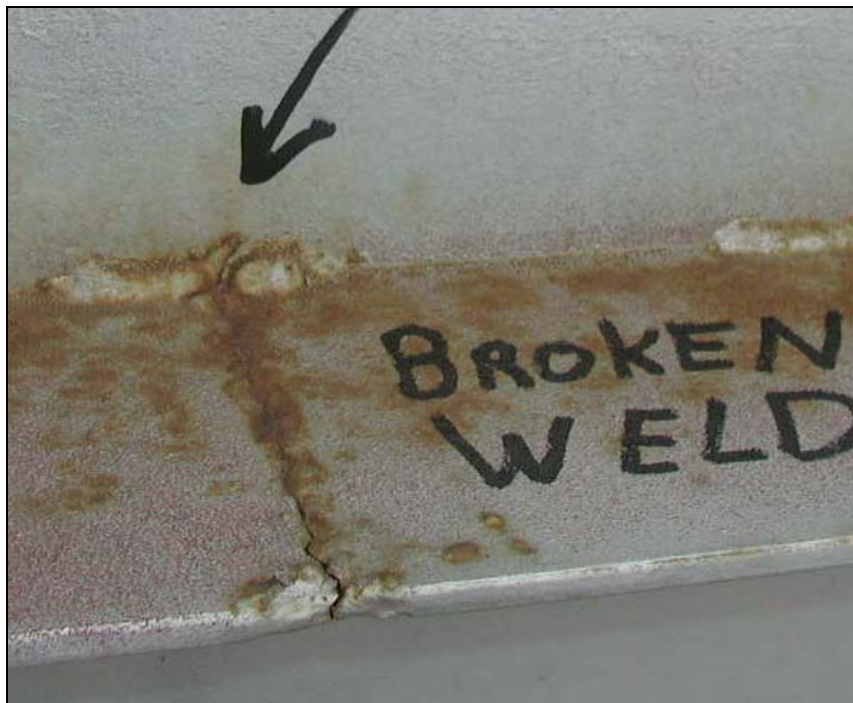
Cracks had developed in the butt welds of the stiffener splices. The cracks are found only in the weld material. Figure 2-12 shows a crack in the longitudinal stiffener.

The crack was probably generated from a defect in the weld. Due to the bending of the girder, stress cycles occurred within the stiffener. These cycles propagated the crack in the stiffener.

**Figure 2-12: Longitudinal Stiffener Crack**

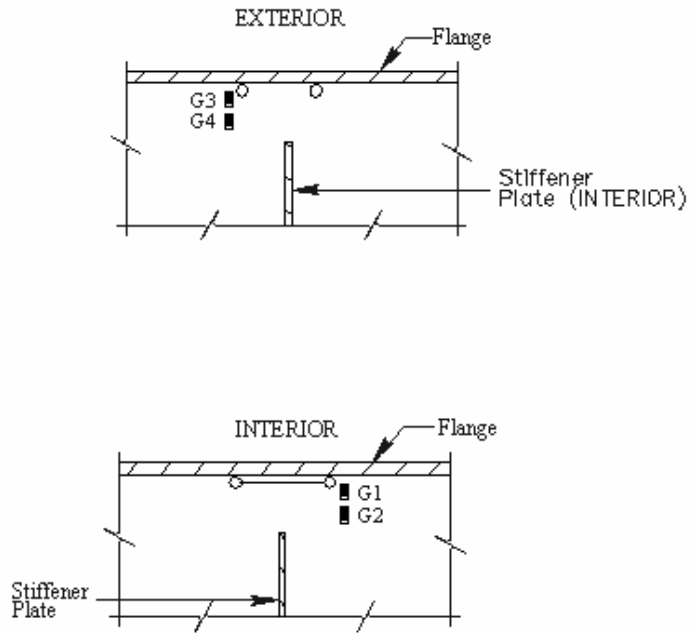
According to the results, the retrofit procedure succeeded in reducing the stresses in the web-gap regions. Using absolute stress values, reductions of up to 90 percent were observed for some gage locations. These reductions are consistent with the finite element model created by Dr. Zhao (Zhao and Roddis, 2003). Smaller pre-retrofit absolute stress values generally showed a smaller percent reduction in stress values.

For the upper web-gap extrapolated values with the truck moving westbound, the average maximum stress was reduced from 35.4 ksi to 9.3 ksi. For the truck moving eastbound, the maximum average stress value changed from 12.6 ksi to 6.7 ksi. These values show a significant decrease in stress at the critical point where a crack might form in the upper web gap region. In the lower web gap region, the absolute value of the stress was reduced, but the margin was not as pronounced as in the upper web-gap region.

**Figure 5-1: Upper Web Gap Gages**

The web-gap region had been previously repaired in 1986, as described in Chapter 2. Because that repair was ineffective, a different retrofit scheme was implemented to fix the connection. Part of the strategy was to create a positive connection between the upper flange and the connection stiffener. To achieve this connection, two brackets were added and were connected to the upper flange by two welded studs. The brackets were then bolted to the connection stiffener. In addition, stop holes were drilled in the web to arrest the horizontal cracking. To repair the lower web-gap region, the stiffener was fillet welded to the gusset plate.

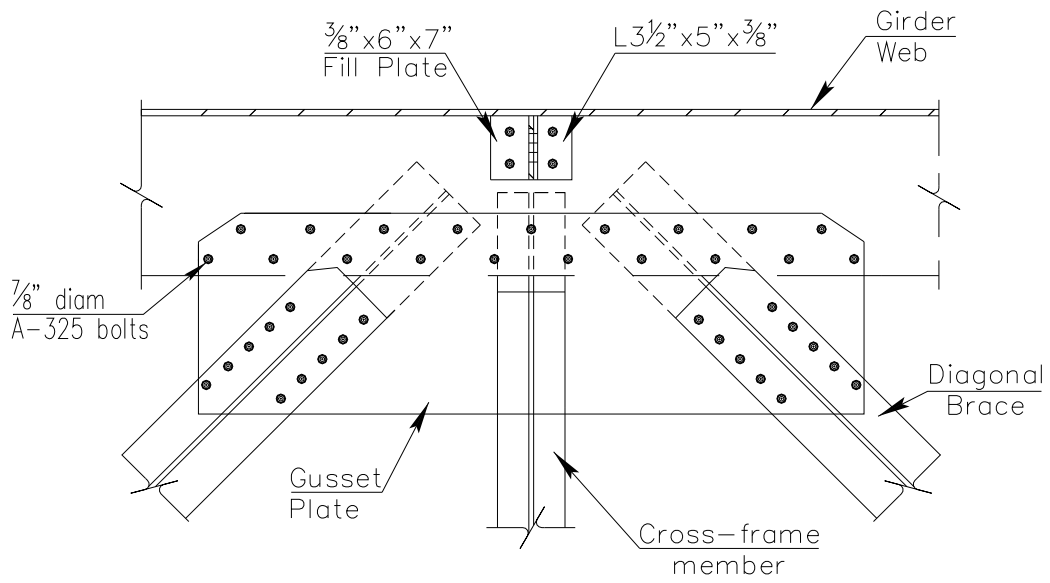
**Figure 6-1: 1986 Repair of Gusset Plate (Only Gusset Plates Closest to Piers)**

Some gusset plates were repaired in 1986 due to the presence of fatigue cracks. The only plates that were repaired were located nearest to the piers. The repair consisted of bolting a larger gusset plate to the flange and removing all welds in the connection (Figure 6-1). This repair strategy was effective but was not done for every gusset plate.

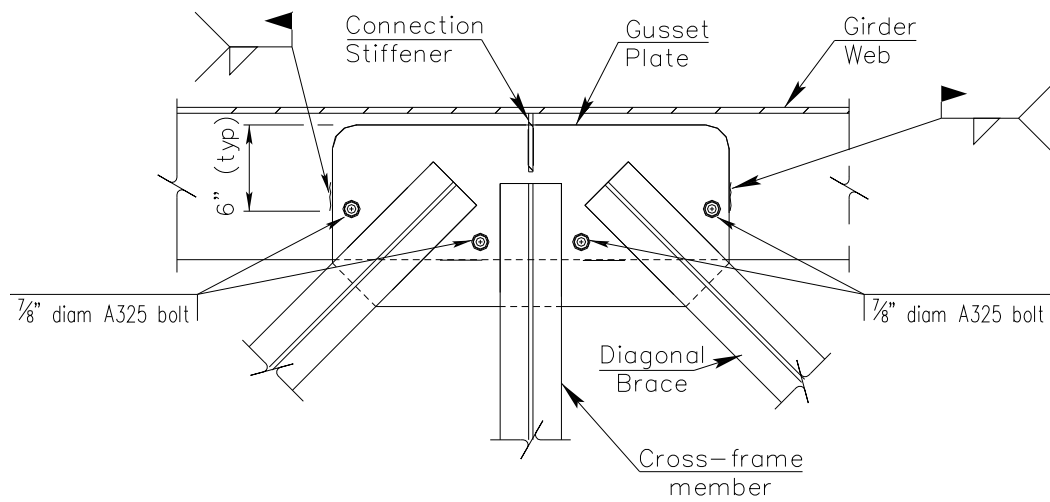
**Figure 6-2: Repaired Gusset Plate (Remaining Gusset Plates)**

After 1986, cracks developed at diaphragms next to repaired plates. To repair these gusset plates, KDOT used a slightly different strategy. Figure 6-2 shows the new retrofit scheme that was used. All cracked welds were repaired and the gusset plates were bolted to the lower flange. In addition, some gusset plates were replaced due to damage.

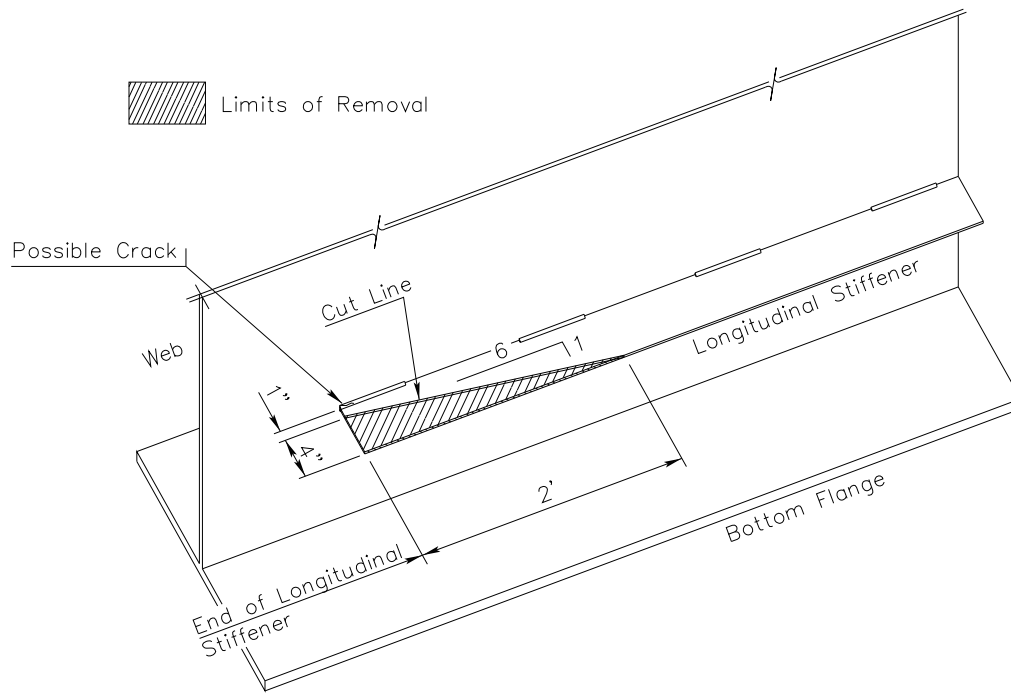
**Figure 7-1: Completed Longitudinal Stiffener Repair**
