# **Evaluation and Repair of Blast Damaged Reinforced Concrete Beams**

**Structural Engineering and Engineering Materials  
SL Report 05-1**

**UNIVERSITY OF KANSAS CENTER FOR RESEARCH, INC.  
LAWRENCE, KANSAS  
January 2005**

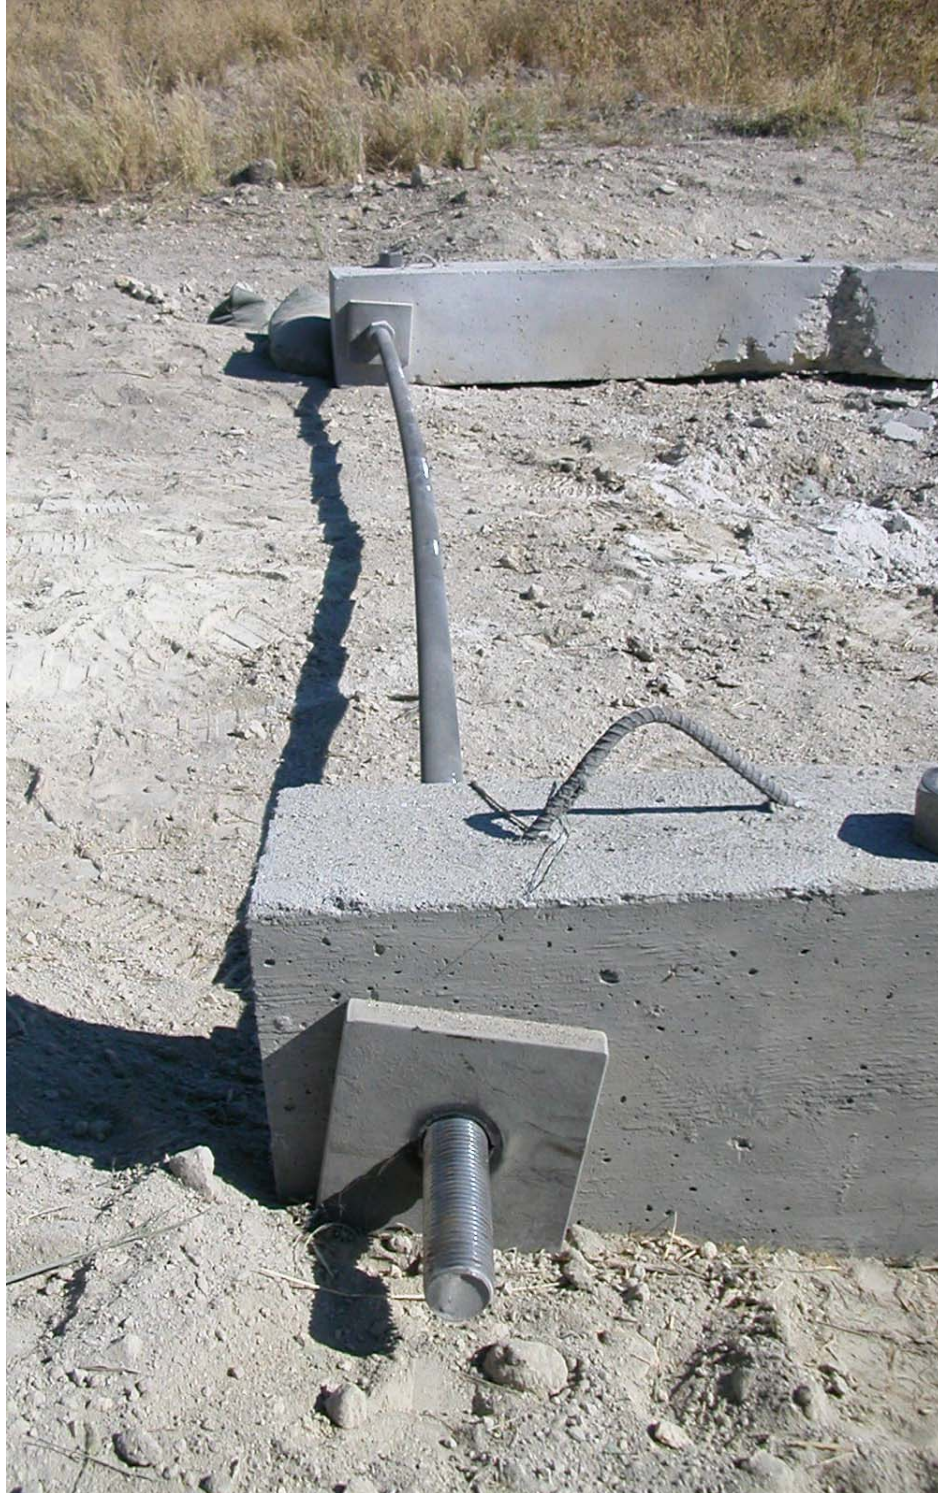
Figure A.15 –Set 3 following detonation of 15 lbs (6.80 kg) of C-4. Note the inward bow in the steel rod, following the blast, due to yielding of the concrete beams. A similar bow in the steel rod was observed on Sets 1 and 2 following their blasts.

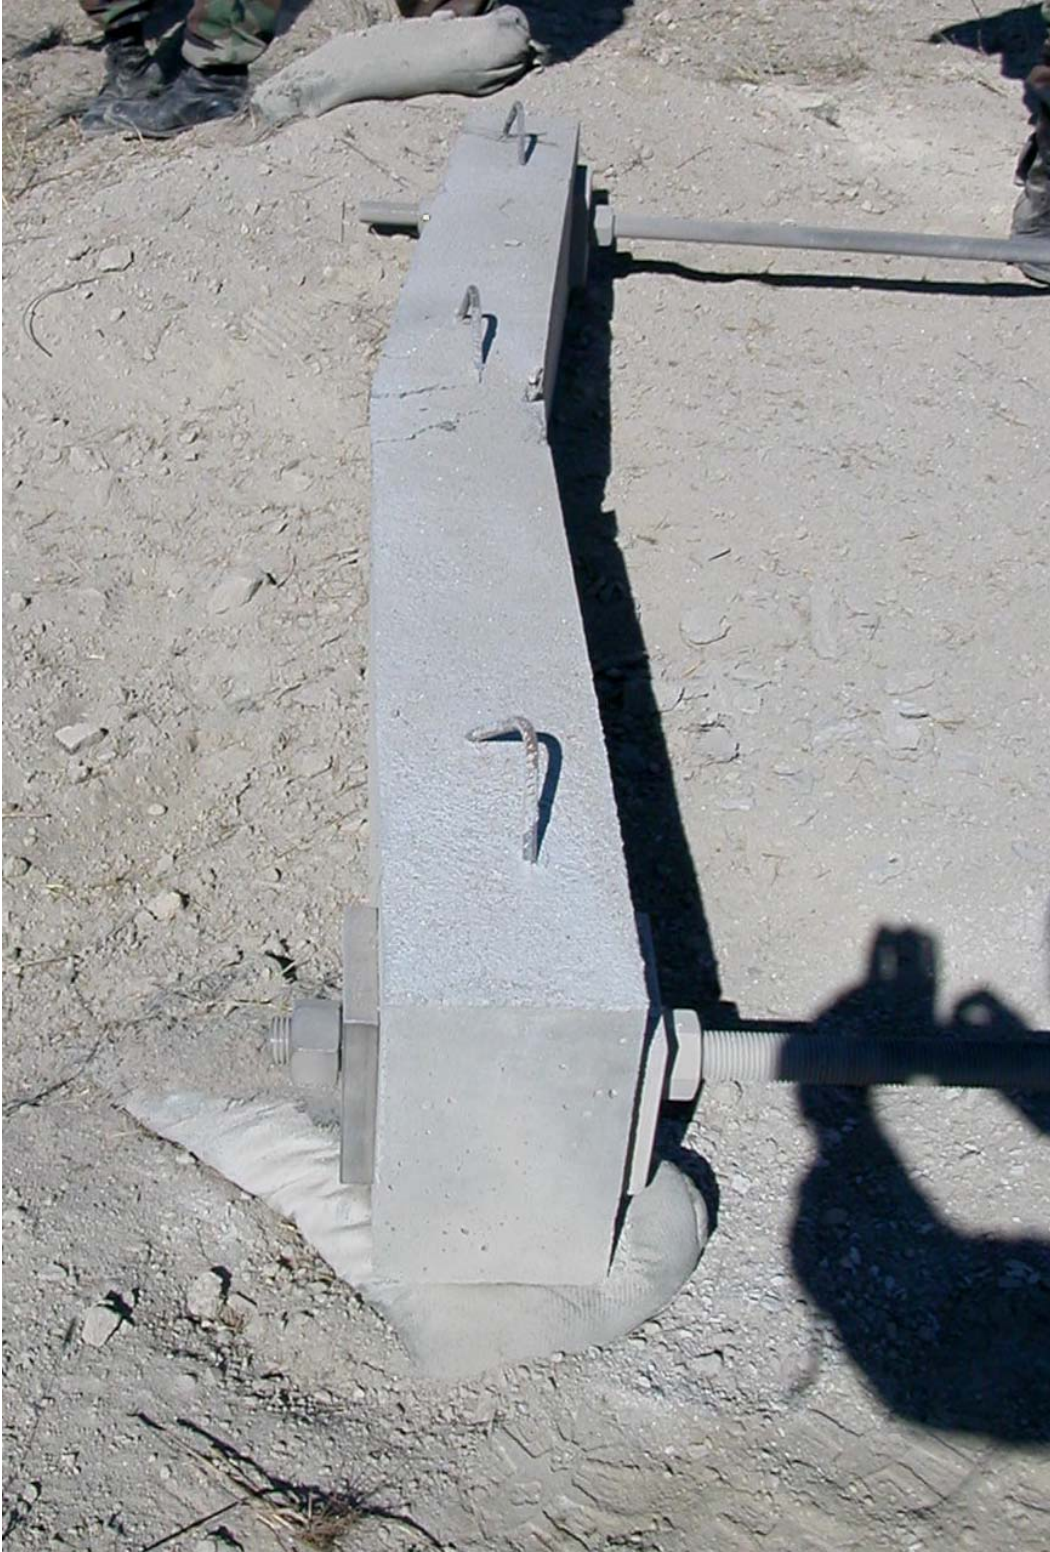
Figure A.16 – Beam 3B following detonation of 15 lbs (6.80 kg) of C-4. Note the outward bend due to the yielding of the concrete beams.

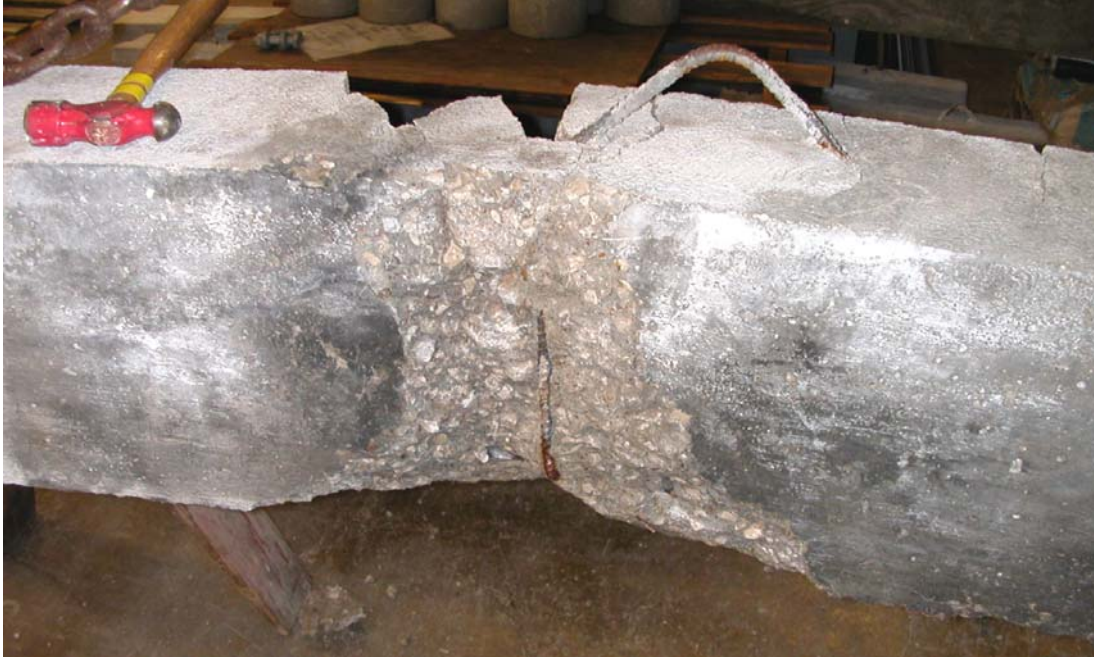
Figure A.23 – The beams were all brought back to the lab where the crushed concrete was removed using a hammer and chisel. This is the inside face of beam 3B after all crushed concrete has been removed.

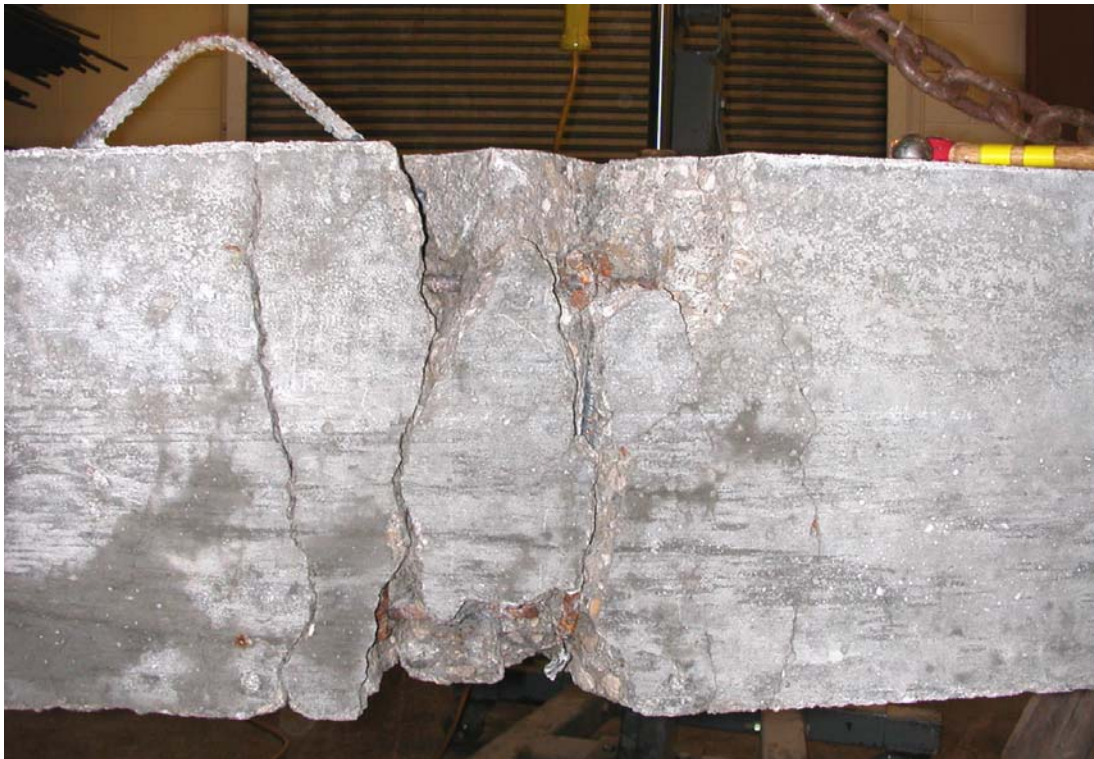
Figure A.24 –This is the outside face of beam 3B after all loose concrete has been removed.

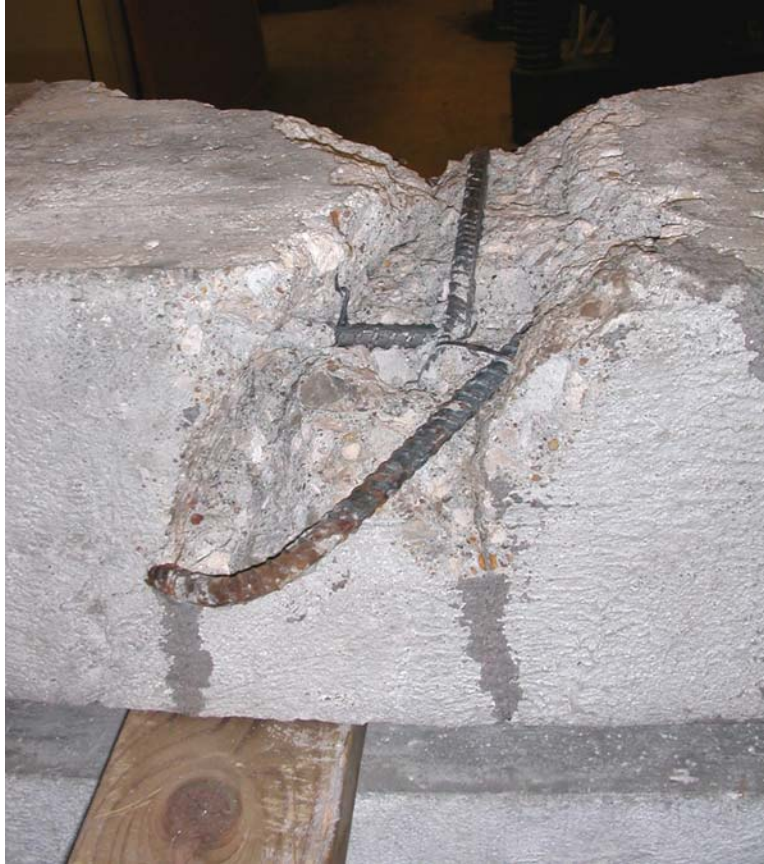
Figure A.27– Top view of Beam 2A after it has been straightened. The dark gray lines are from the epoxy that had been injected into the large cracks prior to straightening.

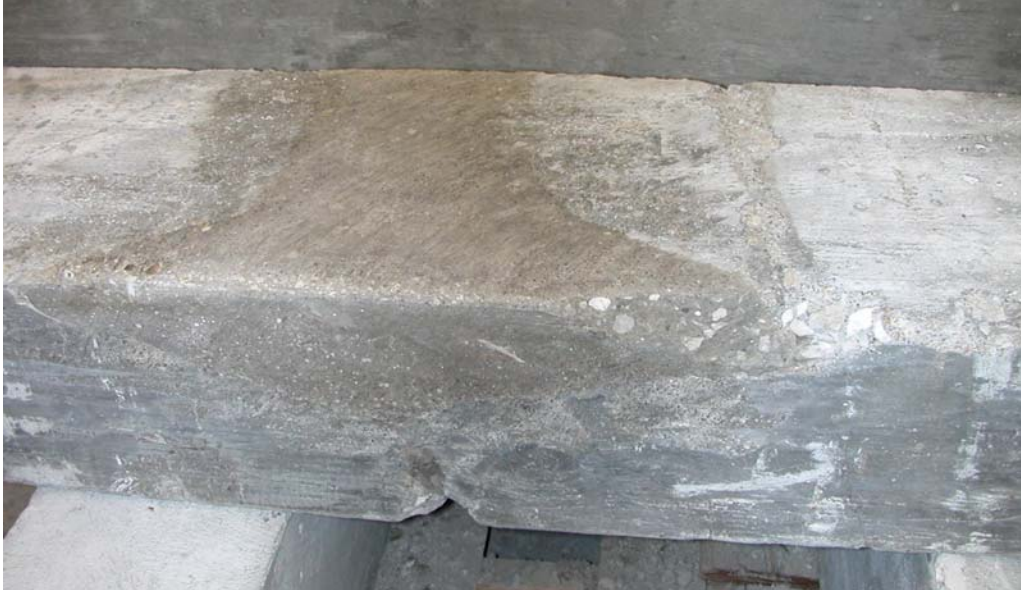
Figure A.30 – Beam 2A after the repair mortar has cured. Because the damaged area was greater than 1 in. (25 mm) in depth, ½ in. (13 mm) max size limestone aggregate was added to the mortar. Note the beam still has remaining damage at the center of the bottom edge and on the right side of the top front edge.

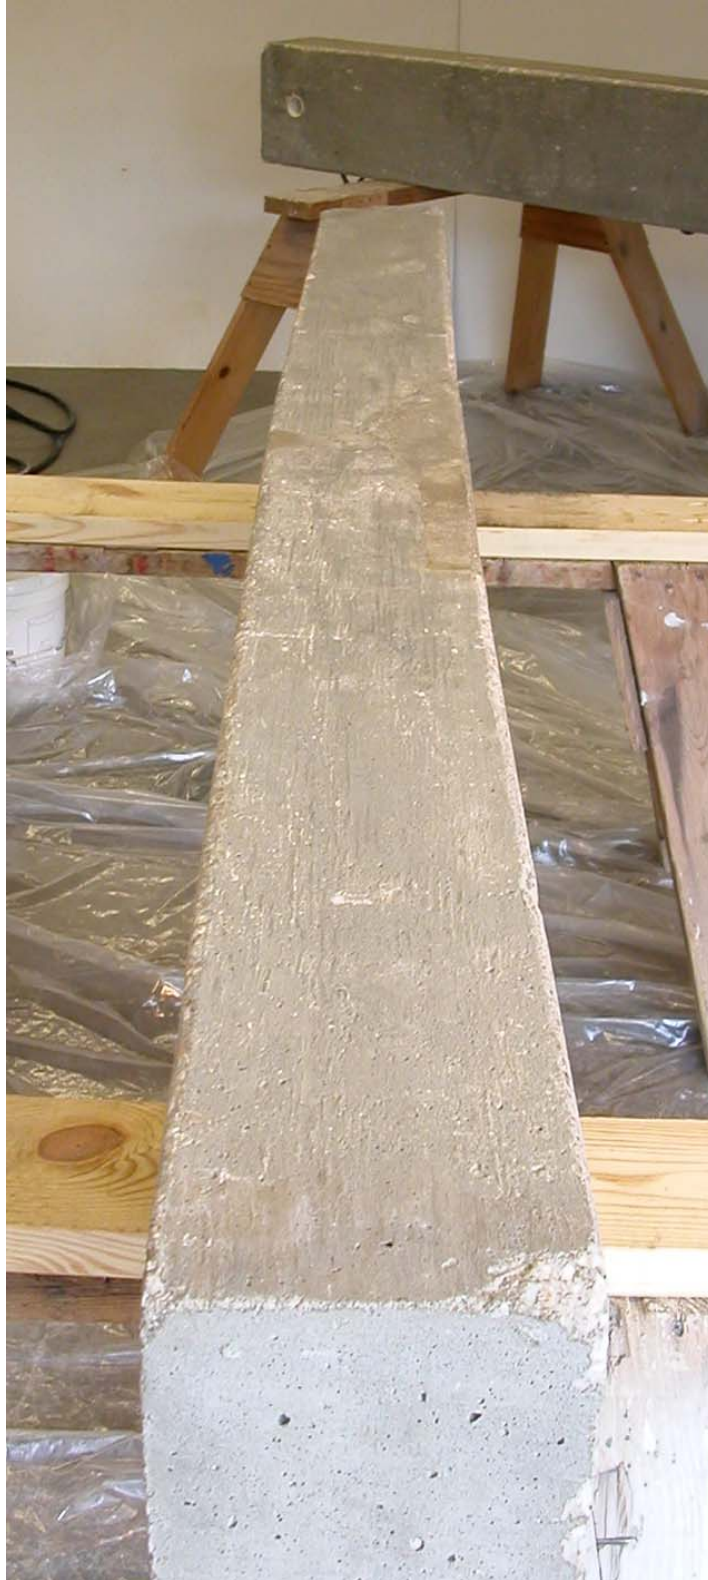
Figure A.36 – Beam 2B still had a slight bow in it after the straightening process had been completed. Beam 4A can be seen in the back ground.

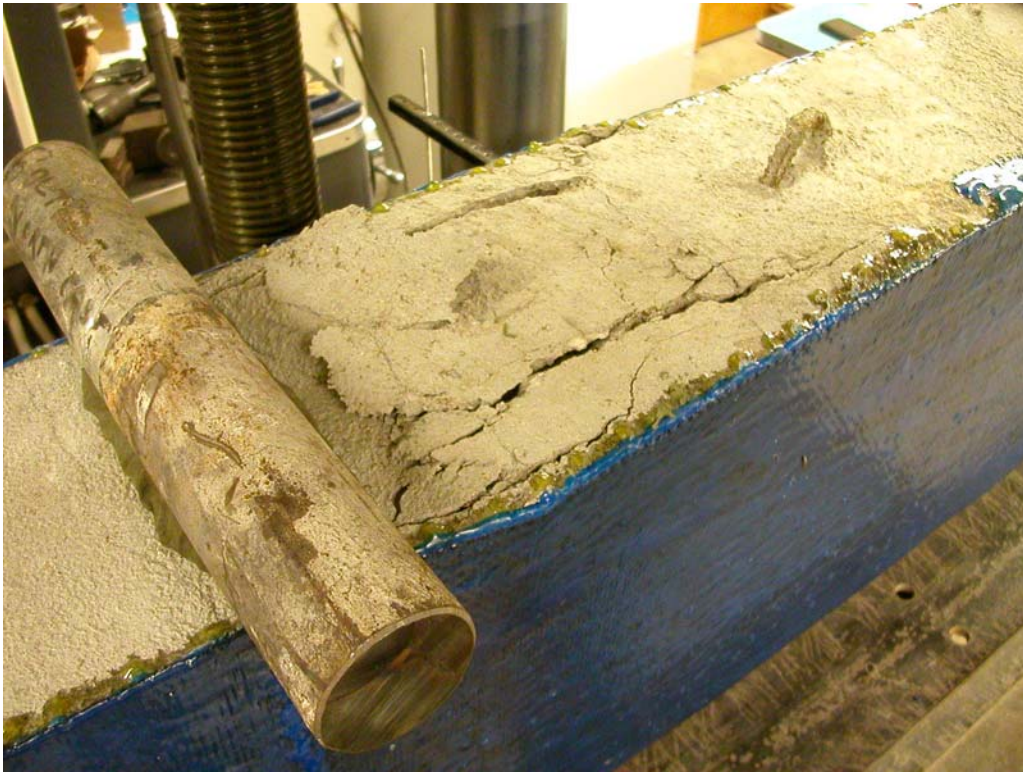
Figure A.55 – Compression failure in the concrete of beam 4A after reaching a load of 56,700 lb (252.2 kN) in third-point loading.
