EVALUATION OF CRACKING PERFORMANCE OF BRIDGE DECKS IN MINNESOTA

**CONSTRUCTION OF CRACK-FREE BRIDGE DECKS
TRANSPORTATION POOLED-FUND STUDY
PROJECT NO. TPF-5(174)**

**Structural Engineering and Engineering Materials
SL Report 13-4**

**THE UNIVERSITY OF KANSAS CENTER FOR RESEARCH, INC.
LAWRENCE, KS
OCTOBER 2013**

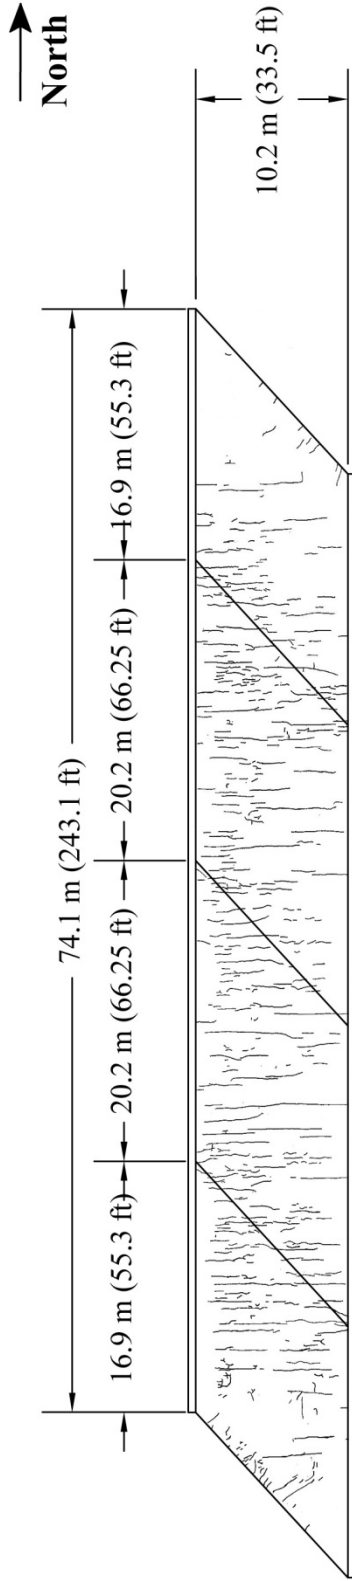
Figure 1 Crack survey of Bridge 9725 (MN LC #1) at 48.2 months of age

The crack map for MN LC #1 is shown in Figure 1. At an age of 48.2 months, the deck had a crack density of 0.702 m/m². A majority of the cracks have propagated in the transverse direction, parallel to the deck reinforcement and not parallel to the skew of the bridge and piers. Many of the transverse cracks are long, at times extending across much of the deck width. Smaller cracks have developed throughout the deck between the longer cracks. Cracks have developed relatively evenly throughout the deck, with slight reductions in cracking near the abutments. Small, longitudinal cracks have propagated from the south abutment. These longitudinal cracks at the abutment were likely caused by restraint provided by the abutment.

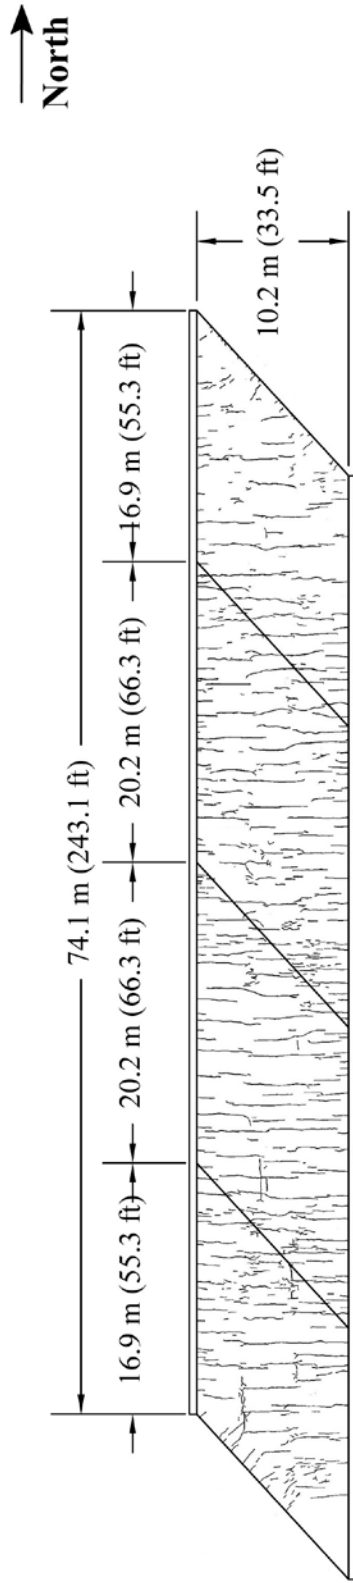
Figure 2 Crack survey of Bridge 9726 (MN Control #1) at 62.0 months of age

The crack map for MN Control #1, the companion deck for MN LC #1, is shown in Figure 2. At an age of 62.0 months, the deck has a crack density of 0.939 m/m², approximately 30 percent greater than the crack density of MN LC #1 at 48.2 months. This deck has the highest crack density of the six decks surveyed. Significant transverse cracking was found throughout the deck. The transverse cracks extend across the entire deck width along the full length of the bridge. As with MN LC #1, the transverse cracking has developed parallel to the deck reinforcement, not parallel to the skew of the bridge and piers. Small, longitudinal cracks have developed from each abutment, likely due to the restraint provided by the abutments. The

distribution of cracking on MN Control #1 is similar, but more pronounced than the cracking distribution on MN LC #1.

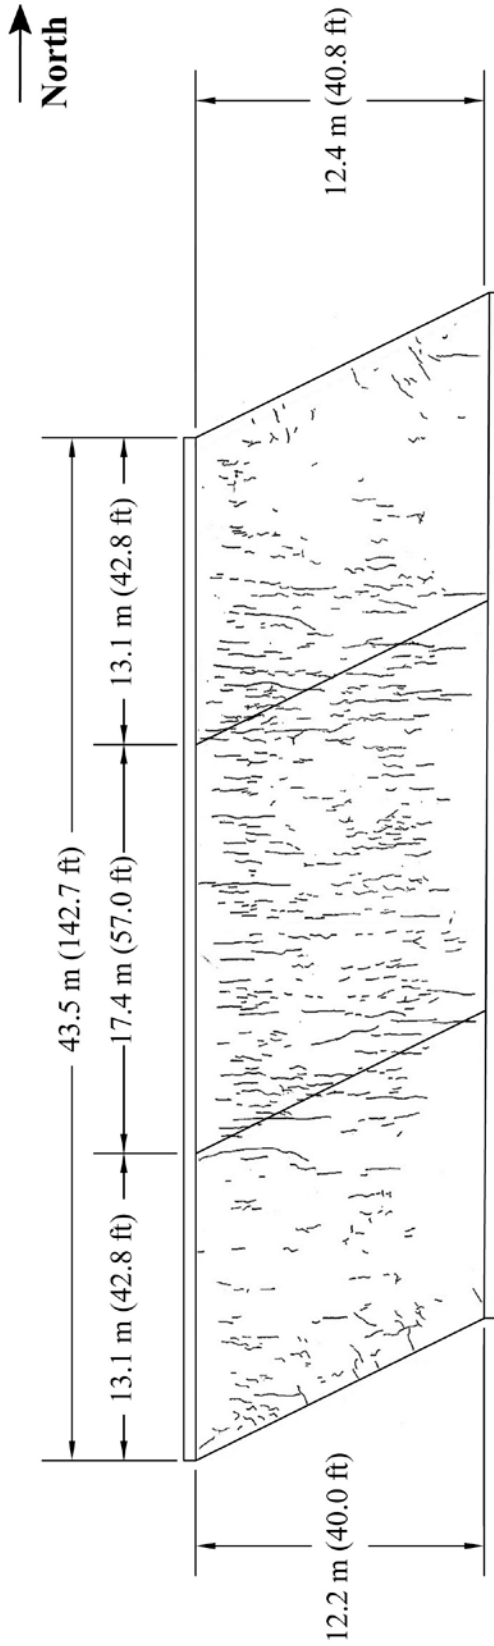
Figure 3 Crack survey of Bridge 82806 (MN LC #2) at 37.6 months of age

The crack map for MN LC #2 is shown in Figure 3. At an age of 37.6 months, the deck had a crack density of 0.648 m/m^2 , the lowest of the six decks surveyed. Many small cracks have propagated in the transverse direction throughout the deck. A greater amount of cracking is found in the middle span than in the outer spans. The cracks have generally developed parallel to the deck reinforcement, not parallel to the skew of the bridge or piers. A few small cracks have propagated from each abutment. Smaller cracks, like those found in this deck, are commonly caused by plastic shrinkage. Plastic shrinkage cracking results from the evaporation of water from the surface while the concrete is in the plastic condition. Plastic shrinkage cracking may be increased as the result of slow initiation of wet-curing, over finishing of the surface, or over vibrating during consolidation – the latter two contribute to excess surface paste. The average temperatures of the concrete [61° F (16° C)] and ambient air [62° F (17° C)] recorded during the construction of this deck, however, are not characteristic of a high evaporation rate or plastic shrinkage cracking. In addition, burlap placement was completed quickly during construction, minimizing the potential for plastic shrinkage cracking. These observations suggest that the cracks were likely caused by extra paste worked to the surface as a result of over finishing or by improper vibration techniques, which can lead to increased plastic or settlement cracking, or both.

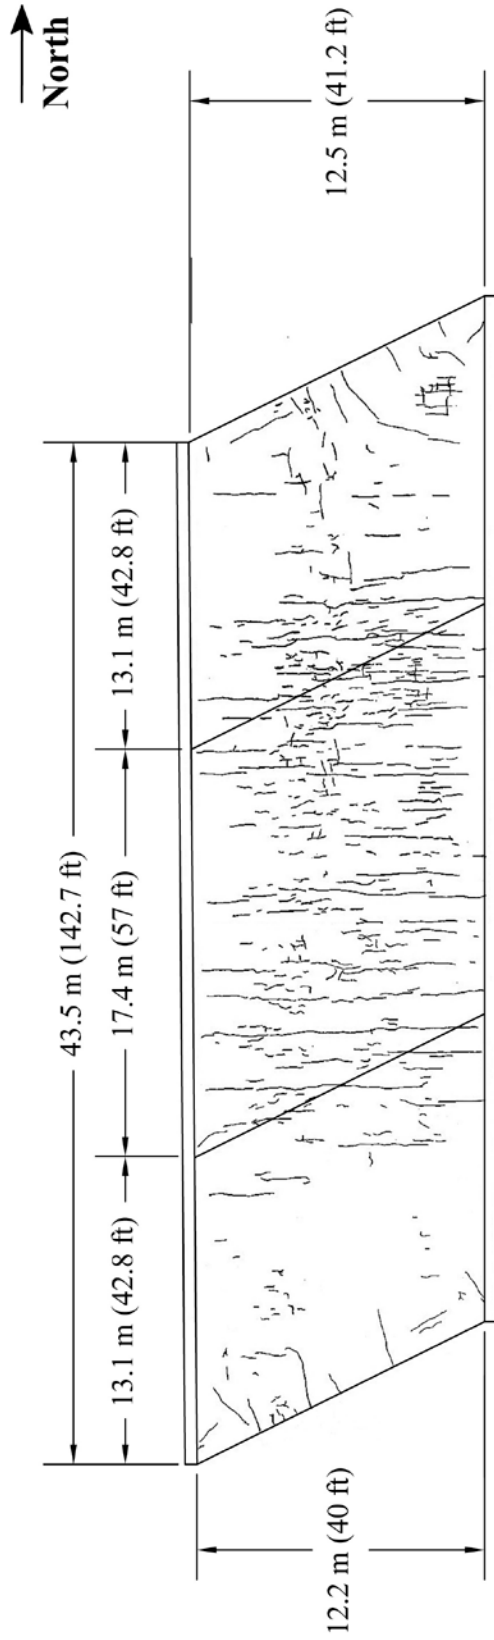
Figure 4 Crack survey of Bridge 82805 (MN Control #2) at 35.2 months of age

The crack map for MN Control #2, the companion deck for MN LC #2, is shown in Figure 4. At an age of 35.2 months, the deck had a crack density of 0.744 m/m^2 , approximately 15 percent greater than the crack density of MN LC #2. As with the other decks, a majority of the cracks have developed in the transverse direction, parallel to the deck reinforcement. A number of long transverse cracks are found in the middle span, occasionally extending across the entire deck width. Transverse cracking is somewhat higher above the north pier (again, not parallel to the pier). Less cracking is found near the south abutment. Similar to other decks, short longitudinal cracks extend from each abutment.

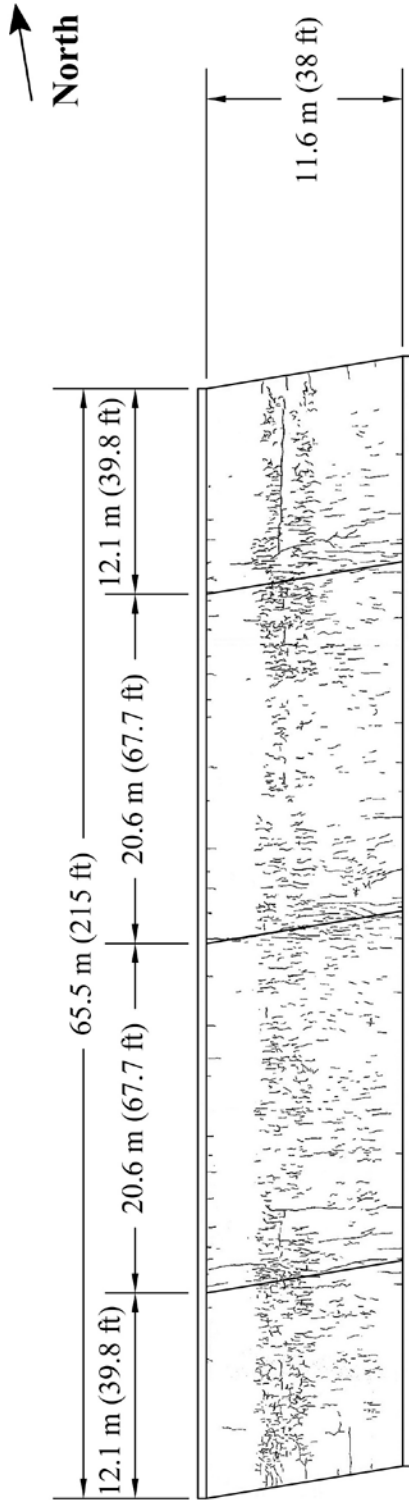
Figure 5 Crack survey of Bridge 82807 (MN Control #3) at 35.3 months of age

The crack map for MN Control #3 is shown in Figure 5. At an age of 35.3 months, the deck had a crack density of 0.841 m/m^2 . The cracks on this deck are significantly smaller than on the other decks. The small cracks are observed throughout the deck, increasing in density near the piers. The greatest cracking occurs along the outer edge of the driving lane. Little cracking is found outside of the lane line, in the shoulder area (west side of deck). The small cracks are typical to those caused by plastic shrinkage cracking. The construction data indicates that the average concrete temperature was 78° F (26° C), above the limit of 70° F (21° C) allowed in the LC-HPC specifications. The construction records also show that burlap placement was slow (average of 30 minutes between strike off and burlap placement). Increasing concrete temperatures and decreasing rates of burlap placement both can increase evaporation and the potential for plastic shrinkage cracking. As with MN LC #2, over vibration may have also contributed to plastic shrinkage cracking. A few long, transverse cracks have formed above and parallel to the south pier, in the negative moment region of the deck, a region in which the upper surface of the deck is in tension, increasing the potential for cracking. Although flexural stresses are significantly lower than shrinkage and thermal stresses induced in bridge decks, the combination of the different mechanisms increases the potential for cracking. A single, longitudinal crack, extending approximately 30 ft (9.1 m), has formed along the outer lane line in the north span. A few longitudinal cracks propagate from the abutments.

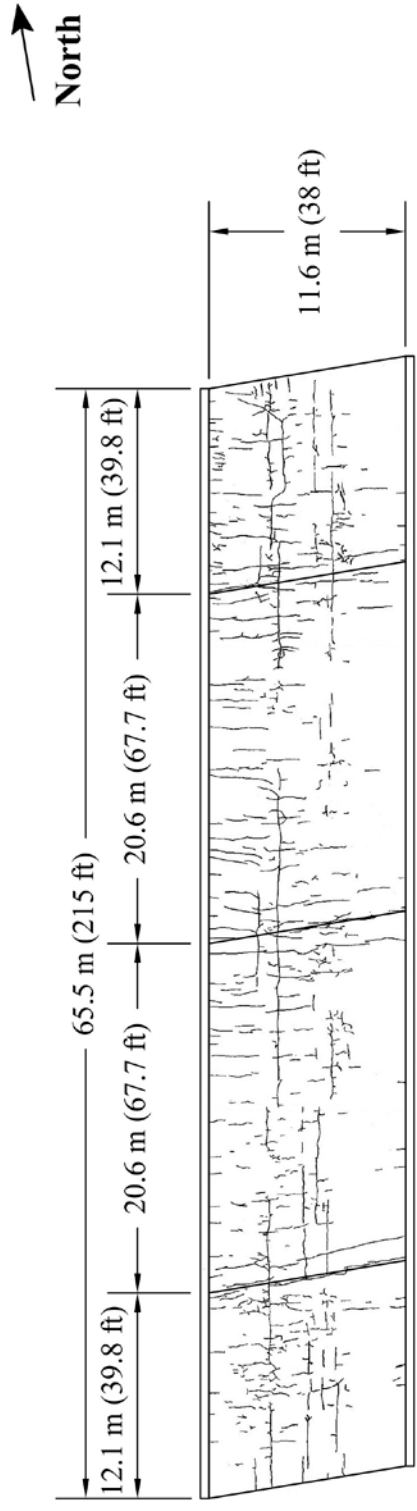
Figure 6 Crack survey of Bridge 82808 (MN Control #4) at 37.8 months of age

The crack map for MN Control #4 is shown in Figure 6. At an age of 37.8 months, the deck had a crack density of 0.735 m/m^2 . A greater number of longitudinal cracks have formed on this deck than on the other decks. A number of longitudinal cracks, located approximately 15 ft (4.6 m) from the west edge of the deck, extend along most of the bridge length. Another group of longitudinal cracks have formed approximately 15 ft (4.6 m) from the east edge of the deck, extending along portions of the bridge length. Many transverse cracks have propagated from the west edge of the deck. As with MN Control #3, minimal cracking is noted in the shoulder area of the deck. A number of long, transverse cracks extend across most of the deck width, directly above and parallel to the piers in the negative moment region.

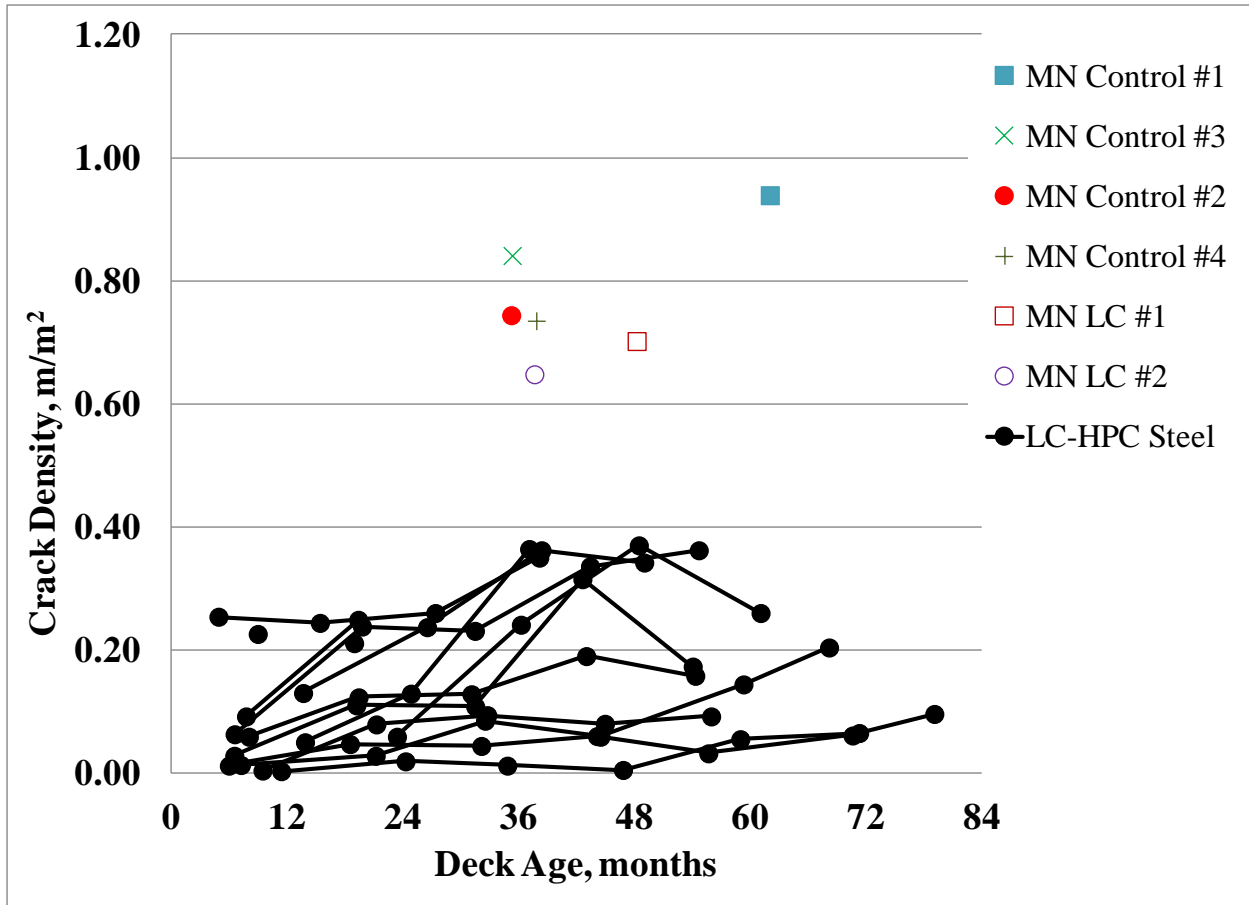
Figure 7 Crack density versus deck age for the standard Minnesota decks (MN Control), low-cracking Minnesota decks (MN LC), and low-cracking high-performance concrete decks constructed in Kansas on steel girders (LC-HPC Steel)

The figures show that the two Minnesota low-cracking (MN LC) decks have lower crack densities than all four of the Minnesota Control (MN Control) decks. As described earlier, the crack density of MN Control #1 is approximately 30 percent greater than the crack density of MN LC #1 (0.939 vs. 0.702 m/m²). Similarly, the crack density of MN Control #2 is approximately 15 percent greater than the crack density of MN LC #2 (0.744 vs. 0.648 m/m²). The other two MN Control decks also had higher crack densities than the two MN LC decks.

The comparison of the Minnesota decks with the Kansas LC-HPC decks in Figure 7 shows that all six Minnesota decks have significantly more cracking than the Kansas LC-HPC decks at similar ages. No Kansas LC-HPC deck has a crack density greater than 0.400 m/m², while all six Minnesota decks have crack densities above 0.600 m/m².

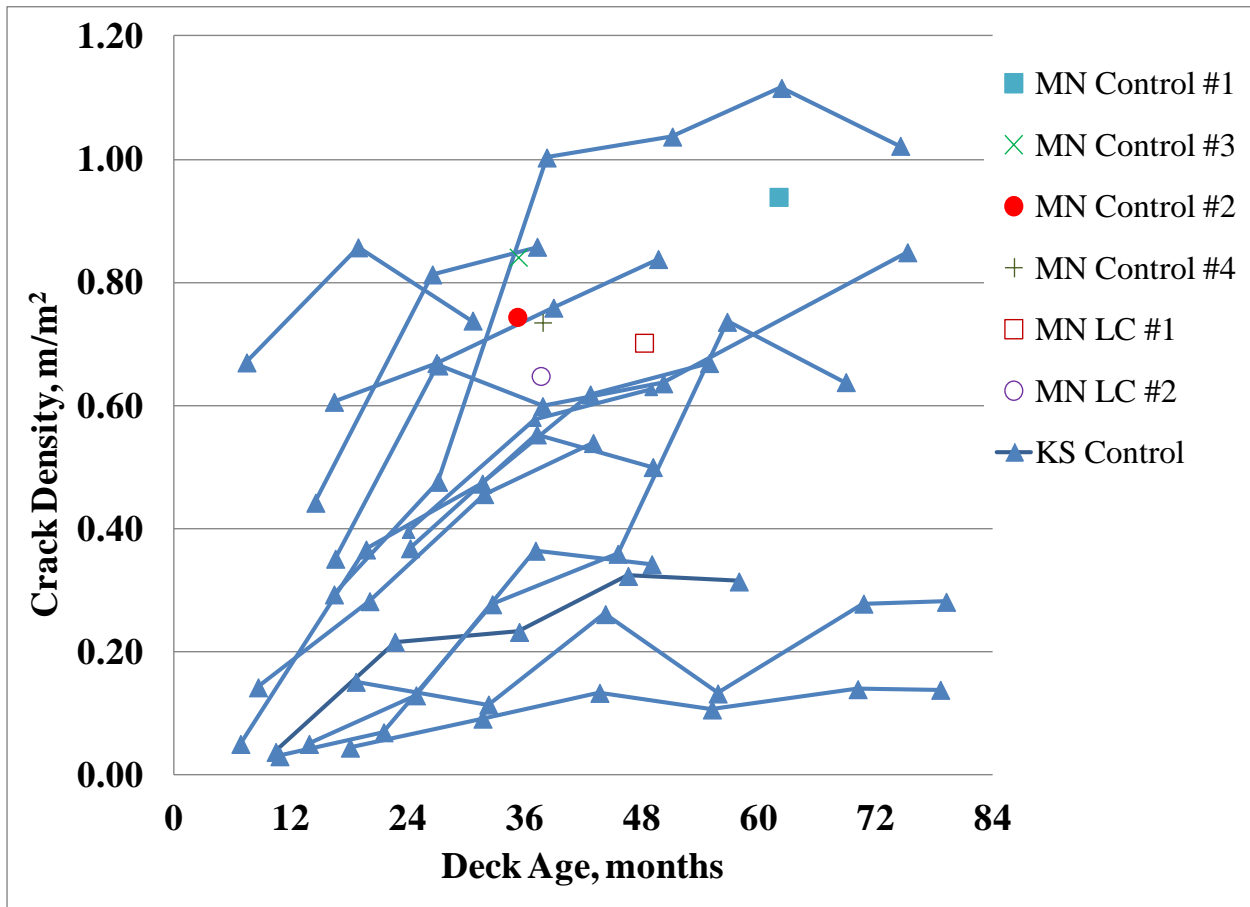
Figure 8 Crack density versus deck age for the standard Minnesota decks (MN Control), low-cracking Minnesota decks (MN LC), and decks constructed in Kansas on steel girders in accordance with the standard Kansas Department of Transportation (KDOT) specifications (KS Control)

Figure 8 compares the cracking performance of the Minnesota decks with the decks constructed in Kansas in accordance with the standard KDOT specifications (KS Control). The figure shows that the Minnesota decks yielded higher crack densities than a majority of the KS Control decks. Four of the fourteen KS Control decks have equal or greater cracking than the Minnesota decks at similar ages. Previous studies at the University of Kansas observed greater cracking in decks with silica fume overlays, such as the KS Control decks and three of the Minnesota standard decks (MN Control #1, #3, and #4) (Lindquist et al. 2005). Additional surveys of the Minnesota decks would provide a better understanding of the progression of cracking performance over time.
