A LONGITUDINAL STUDY OF PLAYGROUND SURFACES TO EVALUATE ACCESSIBILITY

Final Report

October 2013

Project Team
Jennifer K. Skulski, CPSI, Principal Investigator
Dr. Sherril York, Executive Director

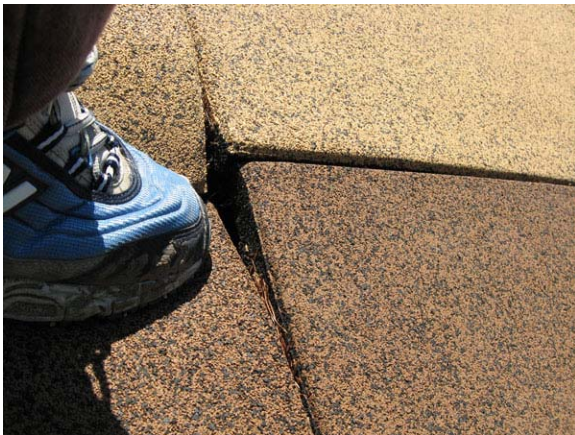
A greater number of TIL sites were recorded in need of maintenance than originally hypothesized. TIL deficiencies included punctures holes ranging from .50 inches to more than 2 inches in diameter; and instances where the seams had started to shift or buckle creating openings and changes in level along the accessible route. The playground owners reported mixed opinions on continued use of the TIL systems. The playground owner that had invested the most, both in material and staff training, had the highest number of surface deficiencies requiring maintenance. After five years of use, the playground owner decided to go with a different unitary surface system. Yet, a neighboring playground owner who had the surface installed by a contractor, only had to replace one tile during the study. The playground crew reported the replacement of the tile took two people less than an hour and it was relatively easy. The contrasting experiences of the two agencies could be as simple as products supplied by two different manufacturers.

Photo 7: TIL where seams have started to shift.

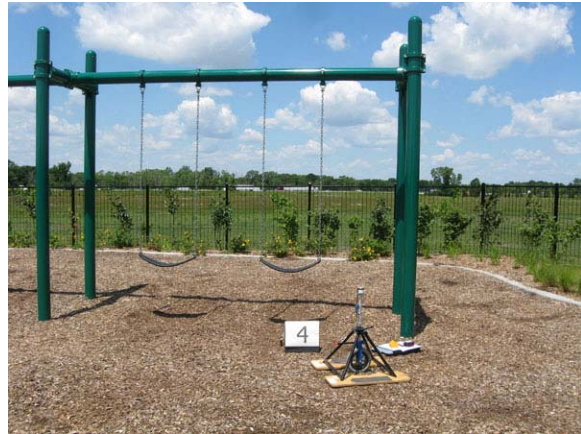
Large areas where the loose material had been displaced under heavy use areas with motion such as at swings, slides, sliding poles, climbers, spinners, and teeter totters were observed at all of the sample sites with EWF. A kick-out area at a swing could be as large as 3 ft. x 8 ft. with a depth of more than 5 inches. The accessibility standards require the minimum 30 x 48 inch clear floor space for transfer to/from the accessible play components have a level surface with less than a 2.08 percent cross slope in all directions. The displaced surface material at locations such as the bottom of slides, a swing, or ground level play component rendered the accessible route to the play component non-compliant with the accessibility standards. Maintenance issues at sites began to emerge where the product was filled at the kick-out area rather than the raked level, compacted and then filled and compacted. Where the kick-out areas had been filled, again it would eventually be displaced. This time it created higher undulating mounds at the front and back of the kick-out area and greater cross slopes within the required clear floor space.

Photo 10: EWF with displaced area under swings.
