PLAYGROUND SURFACES:
AN EVALUATION OF SURFACES FOLLOWING INSTALLATION
TO DETERMINE ACCESSIBILITY
FOR CHILDREN WITH DISABILITIES

Jennifer K. Skulski

Submitted to the faculty of the University Graduate School
in partial fulfillment of the requirements
for the degree
Master of Sciences
in the School of Health, Physical Education, and Recreation
Department Recreation, Parks, and Tourism Studies
Indiana University
December 2010

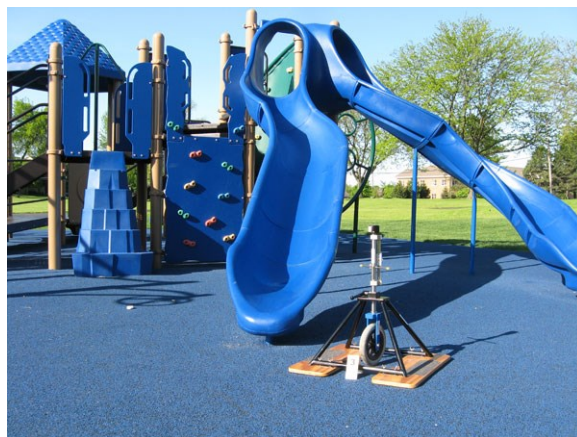
Photo 2: PIP with no recorded locations where the surface samples exceeded the accessibility standards.

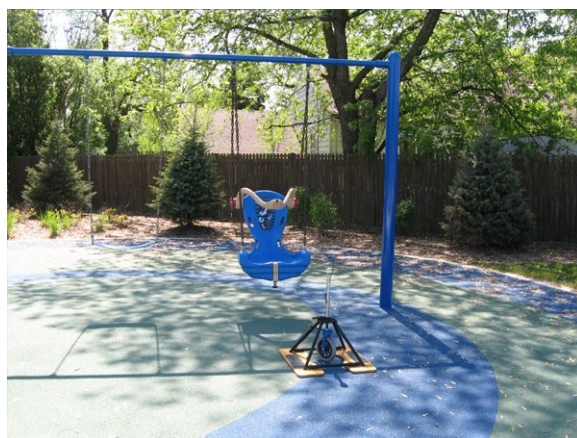
values allowable by the standard are 200 for GMAX and 1,000 for HIC. Drop heights from composite equipment up to 8 ft. high passed the field test. But it was the PIP surface at two swing bays that was found in non-compliance with HIC scores well over the 1,000 HIC allowable under the standard. A report of field test results for GMAX and HIC at the various test locations was submitted to the playground owner and, in turn, forwarded to the surface manufacturer. The playground owner used the terms of the warranty and purchase order as a binding agreement requiring the manufacturer, at its own expense, to return to the site and repair the surface installation. Approximately 2,000 sq. ft. at the swing bays was resurfaced to add more depth to the PIP. When the surface area was retested with the TRIAX, the HIC ranged from 650-750 at the swings, well under the 1,000 maximum allowable by the standard.

Photo 4: PIP location at swings found in non-compliance with HIC scores over 1,000.

The discovery of surface failures for impact attenuation came at the onset of field data collection and illustrated two significant lessons. First, visual inspection alone cannot determine if a playground surface is both accessible and impact attenuating in compliance with the ASTM standards F1292 and F1951. Second, the field test procedure for impact attenuation is critical for the playground owner to assure the surface has been installed correctly and the terms of the warranty are met in order to gain full use of the product life cycle. Had the playground owner not discovered the non-compliant surface area until after the warranty had expired, it would have cost the agency in excess of \$35,000 to correct the surface area serving four swings.

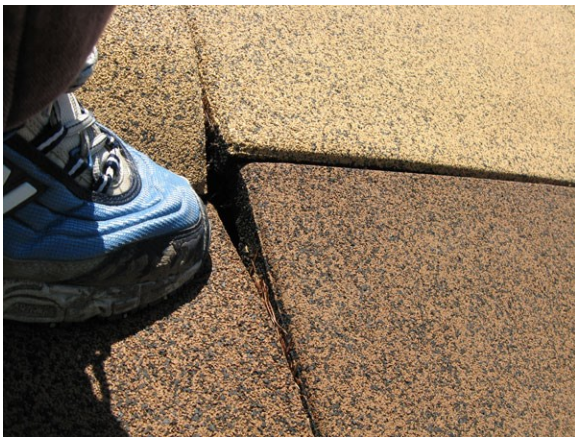
started to add up quickly was where the TIL had punctures holes ranging from .50 inches to more than 2 inches in diameter and where the seams had started to shift or buckle creating openings and changes in level along the accessible route. It was unclear to the assessment team whether the puncture holes were products of intentional vandalism or unintentional damage from users stepping on rocks and other foreign objects with enough force to penetrate the surface. The TIL had started to shift on at least two playgrounds where the parks maintenance staff had installed the surface system as opposed to installation by a contractor certified by the manufacturer. The agency had selected the TIL based on perceptions that installation by its own personnel would help to drive down the overall cost of the playground project, stretching more dollars when budgets are tight. The playground owner attributed the construction error to the learning curve involved with installation of the new surface and reported each new site was looking more improved based on the experience maintenance staff was gaining. The agency's third playground with TIL was bordered by a landscaped paver retaining wall. Improper drainage from the landscape in the retaining wall was causing a build-up of silt on and under the tiles. Within the first month of installation, at least a dozen tiles at the border were pulled up to remove the silt build-up, the section was thoroughly cleaned, dried and the TIL were re-adhered to the concrete sub-base. Maintenance staff was on site making the repairs when the accessibility assessment was conducted. The assessment team brought another area to their attention where the four tiles bordering the concrete walk at the entry to the playground were raised more than a quarter of an inch and adversely affecting the accessible route into the play area. Maintenance staff was able to remove the four tiles, shave the underside and re-install so that they were flush level with the

Photo 7: TIL where seams have started to shift.

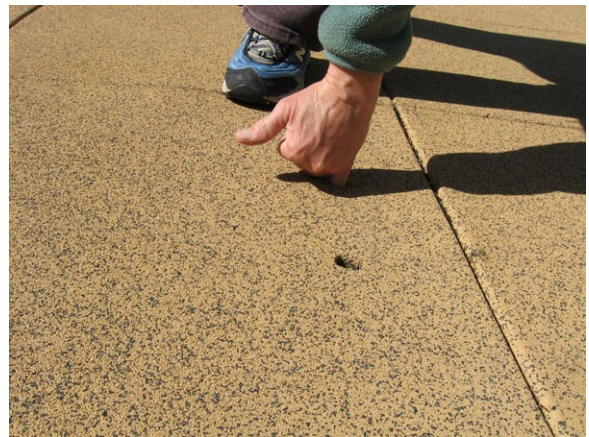
Photo 8: TIL with puncture holes.

Maintenance staff was also able to replace the TIL with puncture holes following the site assessments.

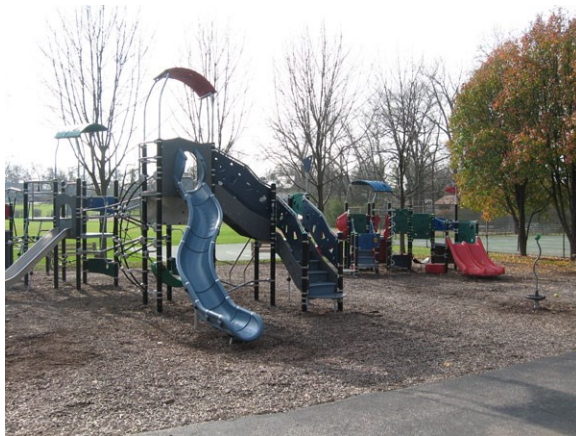
The playground sites in the sample with EWF experienced the greatest frequency of high SDS and mean for firmness and stability. Every playground installed with EWF was observed with undulation across the horizon of the surface area. The undulating surface material created changes in level, running and cross slopes exceeding the maximum allowable standards resulting in non-compliant accessible routes to play components. There was no observational difference in the issue of undulating surface between sites installed by maintenance personnel compared to sites installed by contractors. Review of installation data and discussions with staff indicated the loose fill surface installations did not follow the same procedures noted in the installation instruction by the surface manufacturer or in ASTM F1951 lab reports. EWF surface installations were mostly infilled, raked and leveled. A minimum amount of surface

Photo 9: EWF noted with observed undulating surface.

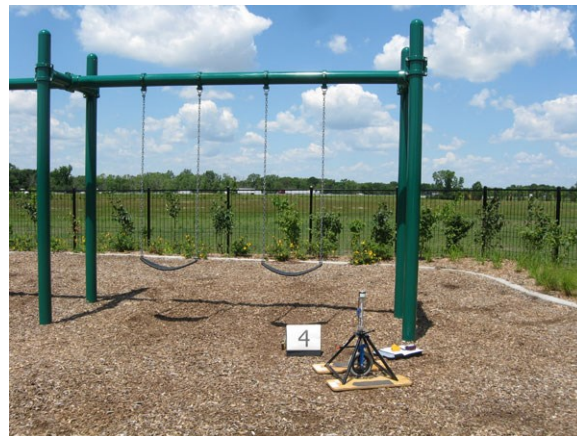
Large areas where the loose material had been displaced under heavy use areas with motion such as at swings, slides, sliding poles, climbers, spinners, and teeter totters were observed at all of the sample sites with EWF. A kick-out area at a swing could be as large as 3 ft. x 8 ft. with a depth of more than 5 inches. The accessibility standards require the 30 x 48 inch clear floor space for transfer to/from the accessible play components have a level surface with less than a 2.08 percent cross slope in all directions. The displaced surface material at locations such as the bottom of slides, a swing, or ground level play component rendered the accessible route to the play component non-compliant with the accessibility standards.

Photo 10: EWF with displaced area under swings.

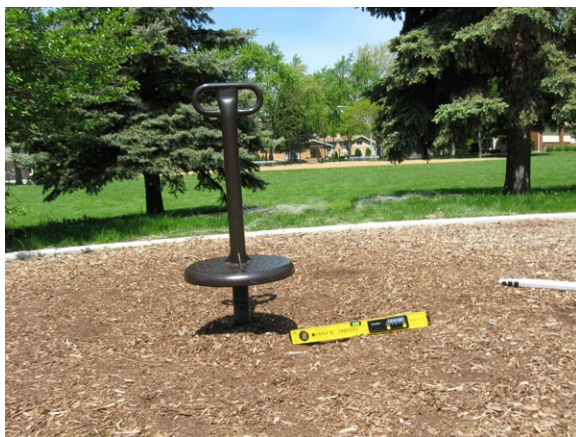
Photo 11: EWF with noted cross slope at ground level play component.

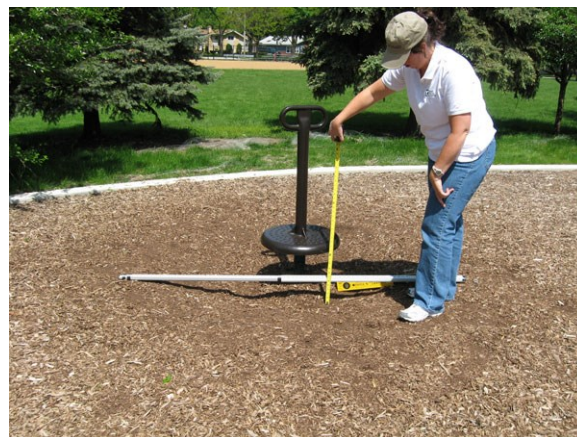
Photo 12: EWF with measurable displaced surface material at ground level play component.
