# Demining Programme Office in the Falkland Islands - Technical Support 2013

## Demining Programme Office in the Falkland Islands – Technical Support 2013

**Submitted by:** Fenix Insight Ltd

EXPLOITATION OF ITEMS RECOVERED DURING DEMINING OPERATIONS: 2012/13

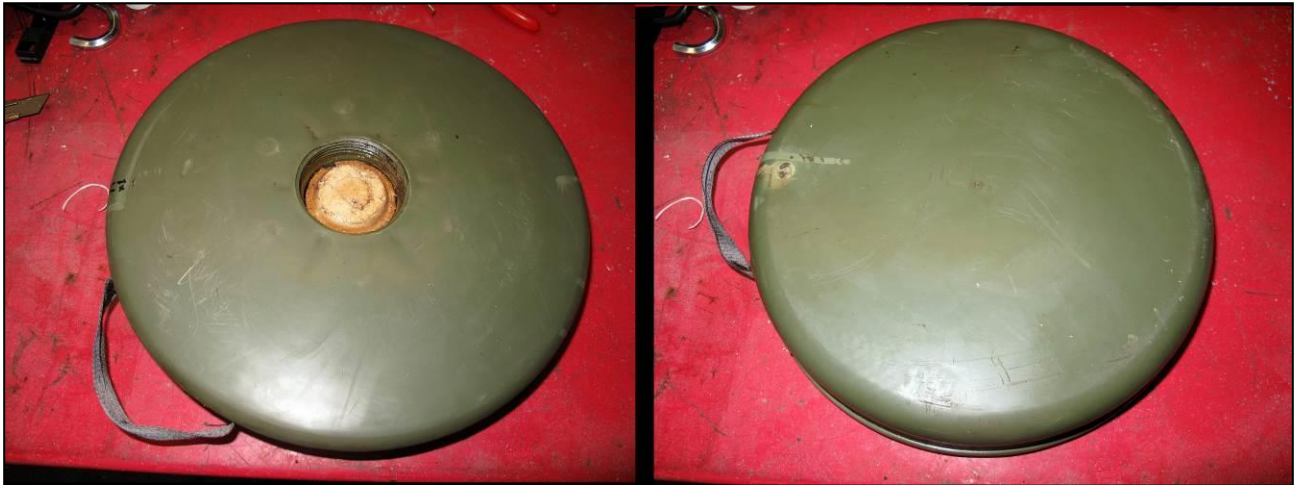
**Figure A5**

*The top surface (left) and underside (right) of the mine body with fuze removed. All of the mines recovered appeared to be in good condition superficially; however, every mine had cracks in the casing*

14. All of the C3B mines recovered from SA064 appeared to be in good condition superficially, but all of the casings were cracked. The ingress and subsequent freezing of water is gradually causing the deterioration of the casings, but the effect is slow due to the small volumes of water and the flexibility of the plastic. The process is likely to accelerate as existing cracks enlarge and the plastic becomes more brittle.

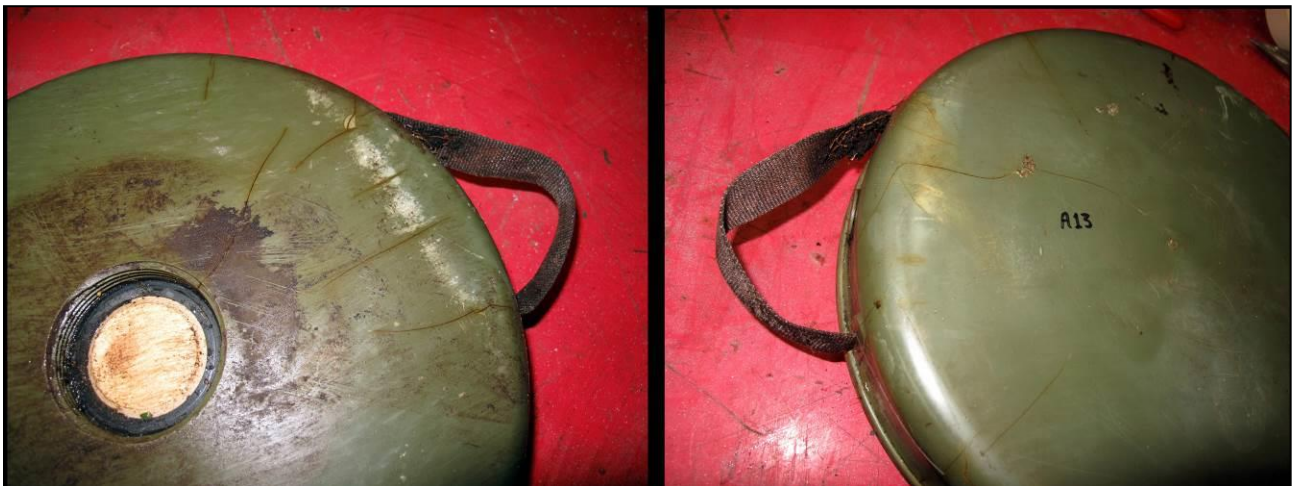
**Figure A6**

*Fine cracks in the casing allow the ingress of water; freezing then gradually extends the breaks*

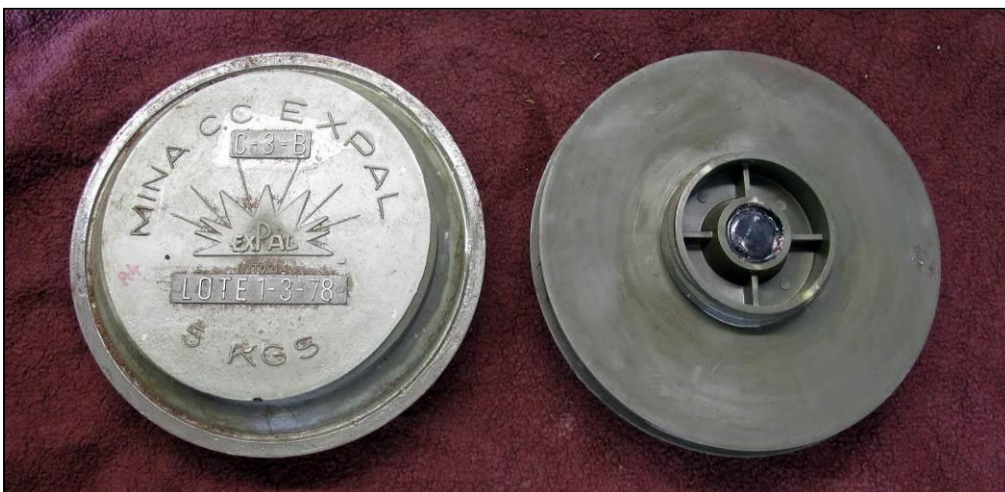
**Figure A7**

*The top surface (left) and underside (right) of the fuze assembly. Most of the fuze bodies appeared to be undamaged and well sealed, yet almost all were wet inside*

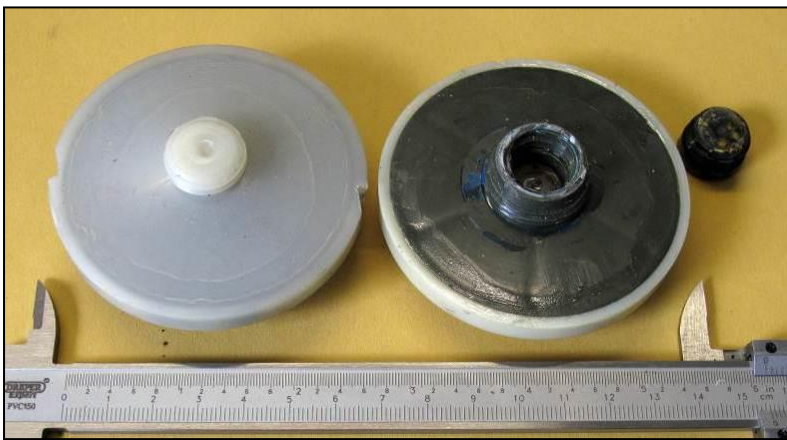
**Figure A9**  
The sealed fuze assembly is very similar to that used in the P4B anti-personnel mine. Water was found inside almost all of these units

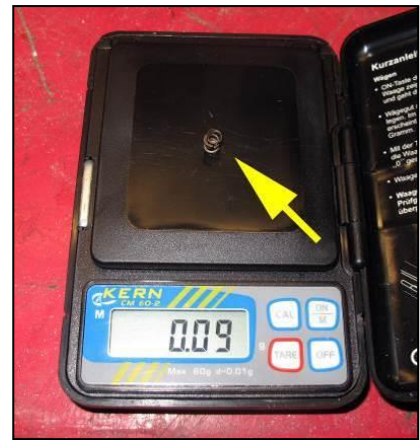
**Figure A10**  
Due to corrosion, this striker Spring weighed only 0.09 g

17. All fuze mechanisms appeared to be operational, despite the corrosion of some striker springs. Fuzes are likely to remain functional despite the deterioration of the striker spring.

18. The striker spring is the only metal component within the mine. The spring weighs less than 0.15 g when new and is positioned around 20 mm below the surface of the pressure plate; this makes its detectability marginal at best. If the striker spring is corroded, the metal content of the mine may be reduced or eliminated altogether, making it impossible to locate with a metal detector.

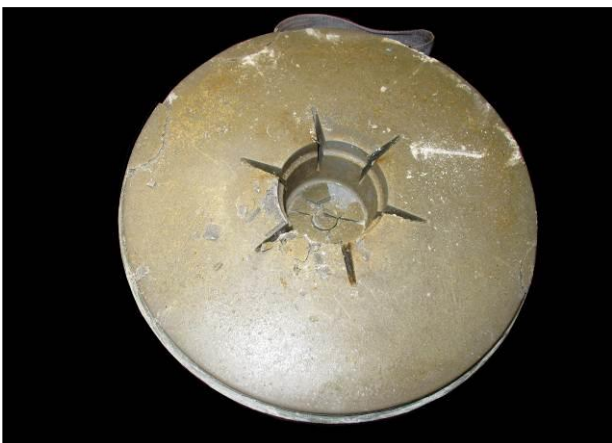
**Figure A11**  
Upper section of the casing removed to reveal the main charge; most were in good condition with little or no cracking or deterioration evident in the explosive. Although the inside of the plastic casing was wet, the cast filling contains very few voids

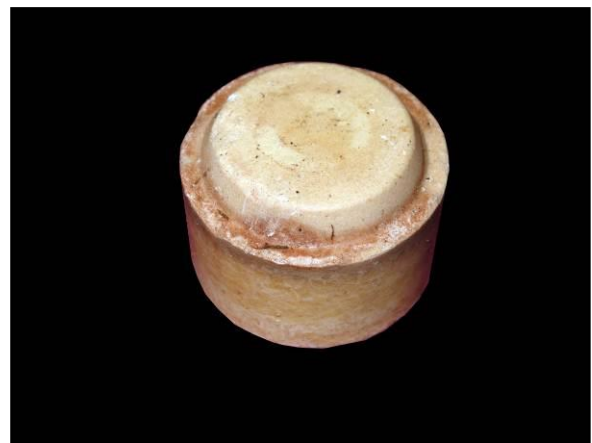
**Figure A12**  
Booster pellets are composed of a pressed TNT/RDX (60/40) mixture and virtually all were in good condition. Despite the neoprene seal between the base of the fuze and the booster, all of the booster pockets contained water

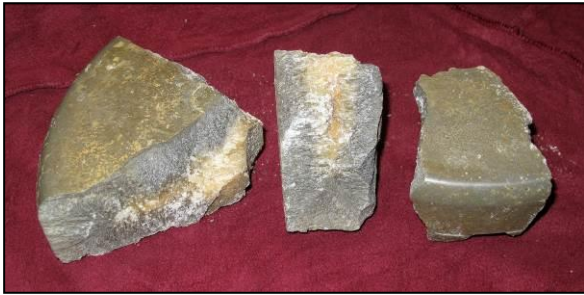
**Figure A13**

*The composition of the main charge is quoted as being TNT/RDX/aluminium (50/30/20) but, as shown here, the mixture is rarely homogenous. The aluminium content does not affect the detectability of the mine*

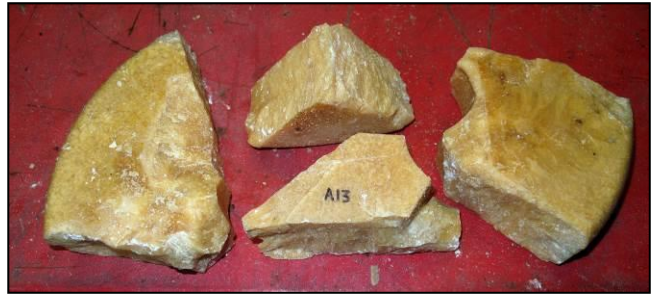
**Figure A14**

*The proportions of the constituents in the high explosive varied significantly; this sample contained no aluminium whatsoever. This is evidence that different material characteristics and specifications may be found within the same lot number*

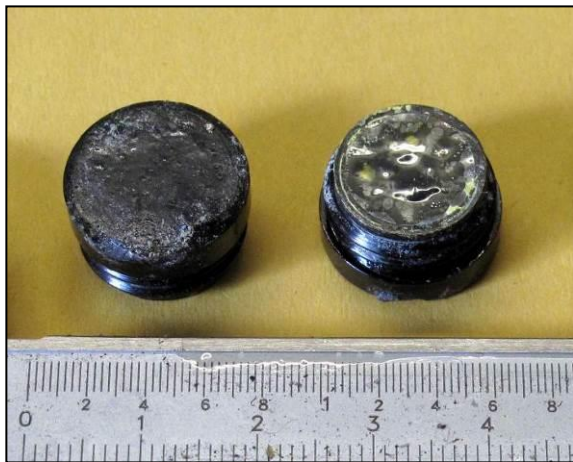
**Figure A15**

*All of the C3B detonator assemblies examined were wet. The protective layer of clear plastic film over the stab receptor (right) did not provide an effective water-tight seal*

21. Findings from the Ageing Study suggest that the primary explosive in the detonator is likely to remain viable for many years, being well protected by its plastic casing. However, the stab-receptive composition used to initiate the primary explosive is vulnerable to water and prolonged immersion appears to have rendered many of the detonator assemblies incapable of functioning as designed.

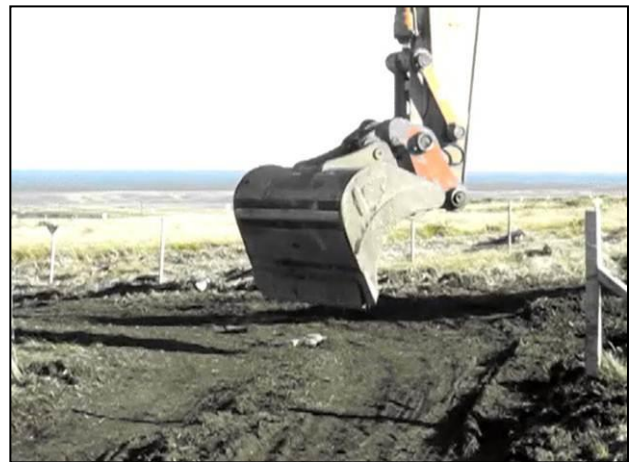
**Figure A16**

*Subjecting live fuzes to an operating load (>300 kg) using an excavator bucket did not produce any detonations. The most likely explanation is that the stab-receptive composition is no longer functional*

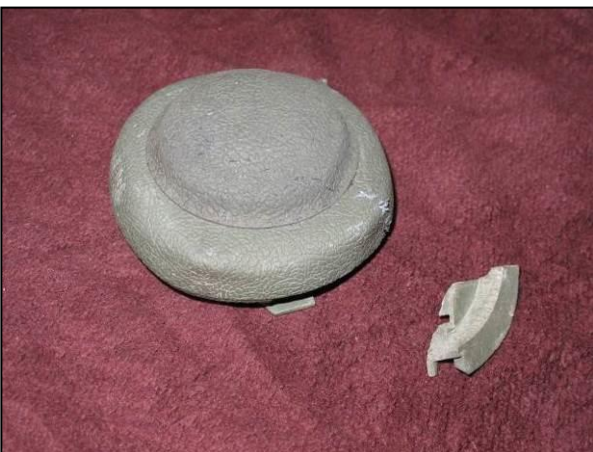
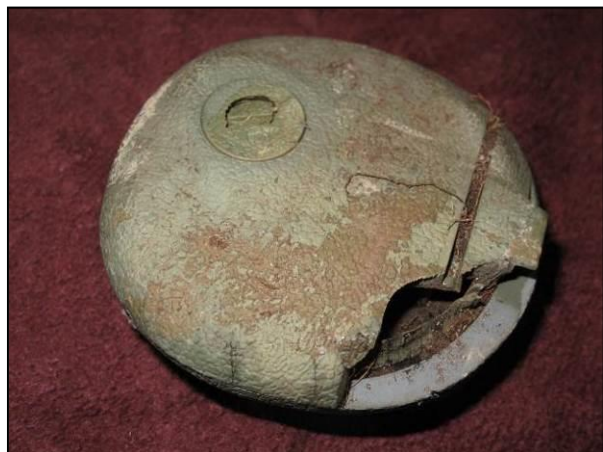
3. The isolated mine found in SA064 (**Figure B2**) showed obvious damage, particularly to the base (**Figure B3**) where the detonator plug was cracked and a section of the mine casing had been broken away. The broken section of the base was found close to the mine body.

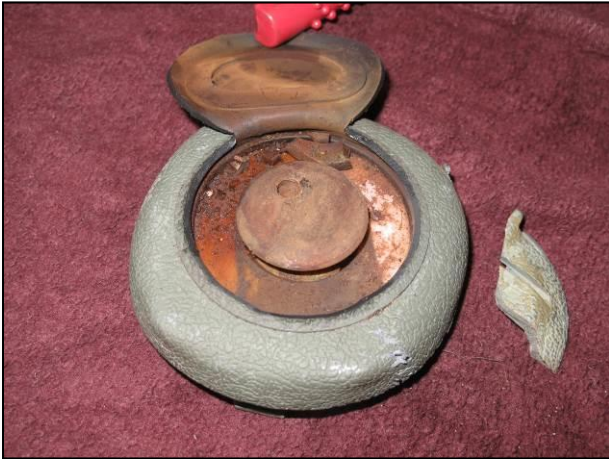
**Figure B4**

*On initial inspection, the fuze and main charge appeared to be relatively intact. The ingress of water would not prevent the mine from functioning*

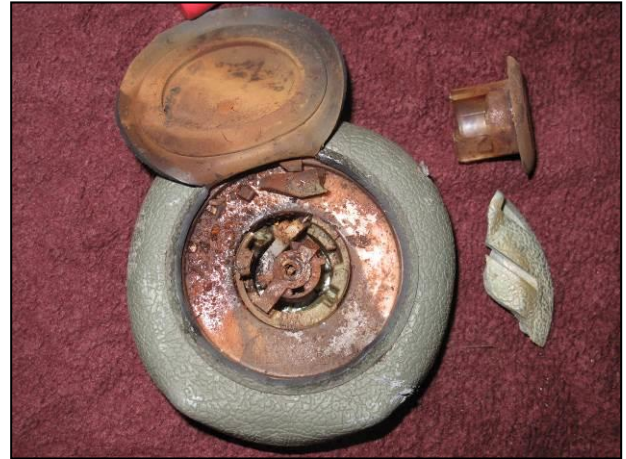
**Figure B5**

*Removal of the fuze plunger revealed that the several of the fuze components had been shattered and the striker displaced*

5. The isolated SB-33 mine discovered in SA064 had clearly been subjected to a substantial amount of shock. This was evident in the shattering of fuze components made from polycarbonate (the plastic used in protective visors) and the pulverisation of the main charge.

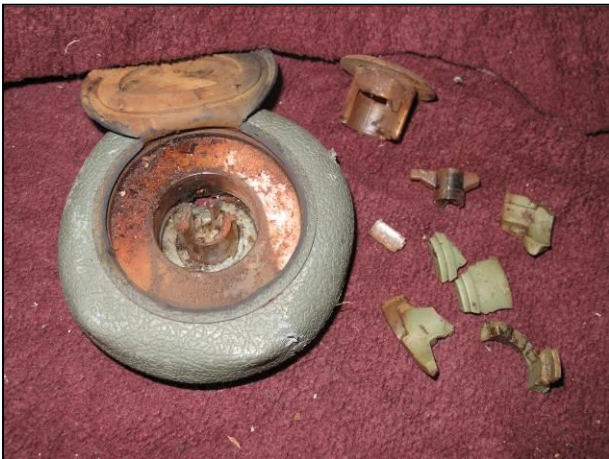
**Figure B6**

*Removal of the fuze components exposed the full extent of the damage*

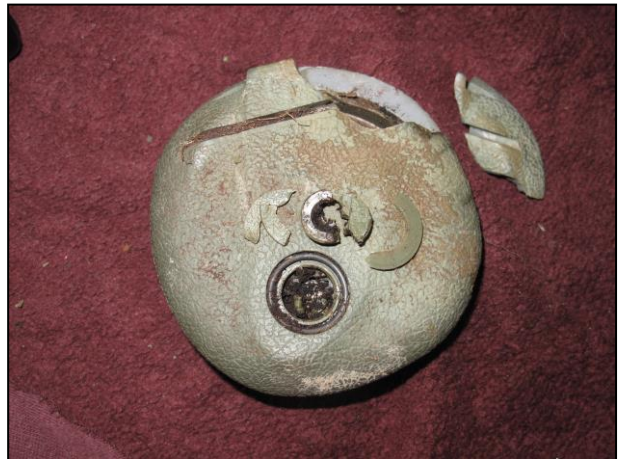
**Figure B7**

*The detonator plug had also been shattered and could not be used to remove the detonator*

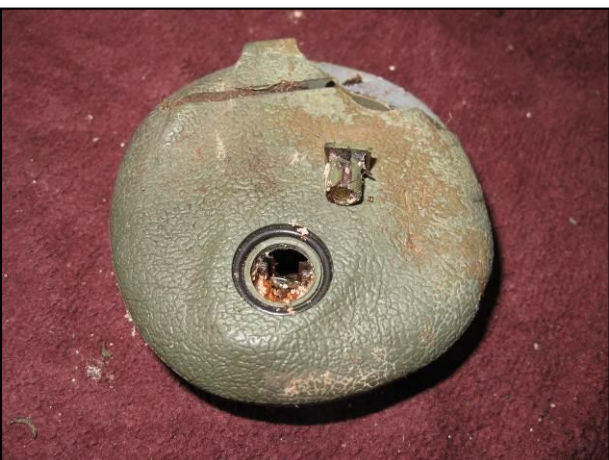
**Figure B8**

*The detonator was seized into place and surrounded by impacted explosive from the main charge*

8. The mine was incapable of functioning as designed; however, the condition of the detonator means that it might have been in an unstable state.
9. The demining team and DPO were absolutely correct not to attempt to defuze or disassemble this mine.

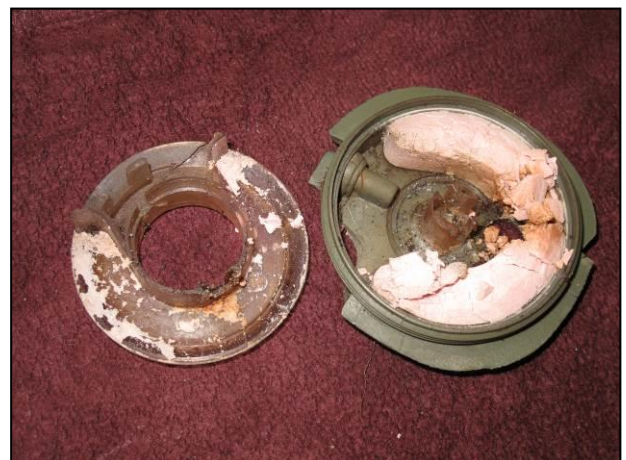
**Figure B9**

*The main charge, normally a rigid horseshoe of pressed explosive, had been pulverised*

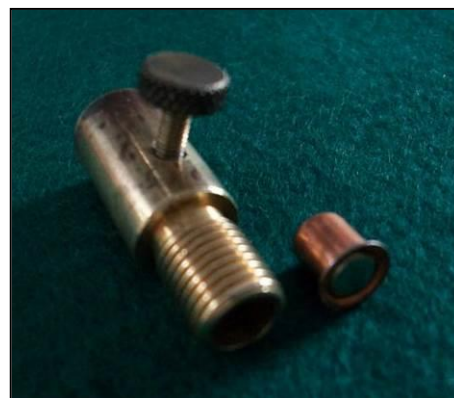
**Figure C2**

*The fuze holder with percussion cap removed. The cap unit is a standard 12 bore shotgun primer. Although robust, these are unlikely to remain functional after 30 years exposure to wet conditions*

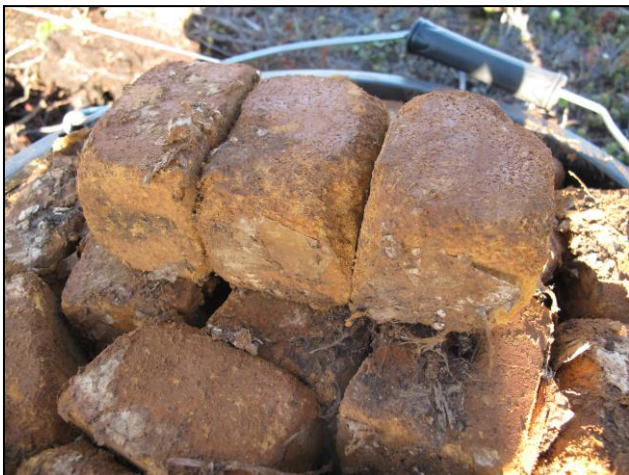
**Figure C4**  
*TNT charges from a booby trap in SA064. These appear to have been 400 g blocks of pressed TNT, wrapped in waxed paper. Pressed TNT is deemed 'cap sensitive', meaning that it can be initiated directly by a No 8 strength detonator. The edges of the blocks have been eroded but the bulk of the explosive remains intact. Historical data on TNT suggests that it can remain capable of detonation for several decades*

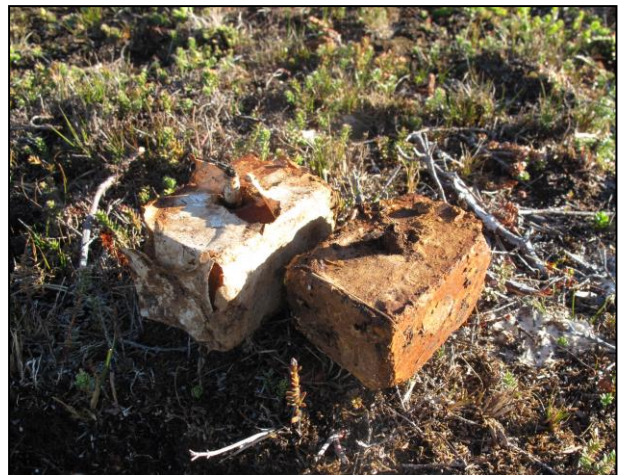
**Figure C5**  
*TNT blocks containing detonators and the remnants of safety fuzes. It is clear that any pyrotechnic composition in the fuse or detonator will be non-functional. However, findings from the Ageing Study (involving explosives of a similar type and age) suggested that the primary explosive in the detonator may be viable; this means that the explosive could be initiated by either fire or substantial impact*
