# Demining Programme Office in the Falkland Islands - Exploitation 2017

CPG/1107/2016

## Demining Programme Office in the Falkland Islands – Exploitation 2017

## FALKLANDS ORDNANCE EXPLOITATION – JANUARY 2017

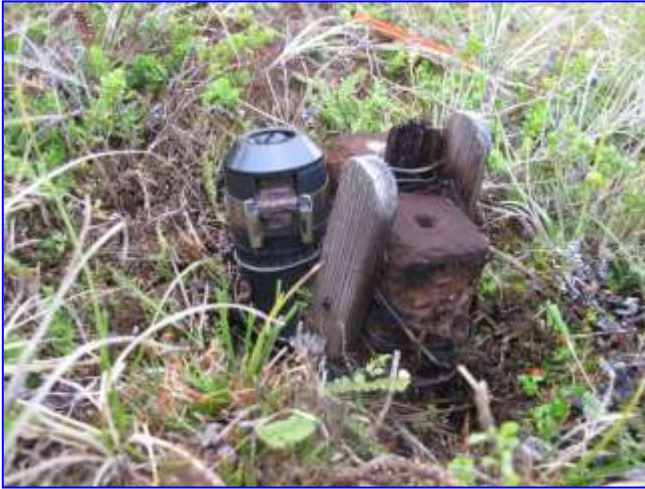
The booby trap consisted of a Spanish M5 grenade, which was wired to two wooden stakes at ground level. Adjacent to the grenade were two 1-pound blocks of TNT. Unlike other booby traps found to date, the anchorage of the device used purpose-made stakes made from treated wood and copper wire, both of which remained in good condition.

*The M5 booby trap, prior to recovery*

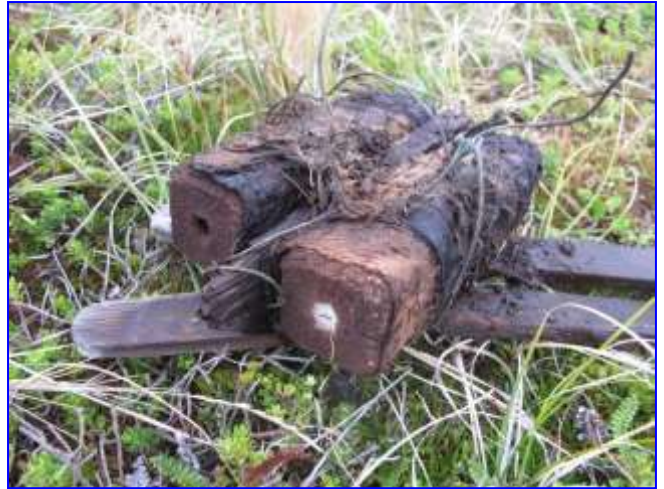
*The stakes and wire were still in good condition*

The use of treated wood and copper wire means that the grenade is held firmly, which is key to successful operation should the tripwire be pulled. Without this, the grenade might be pulled out of the ground without functioning. In this case, the tripwire was absent, having been made from steel and rusted away.

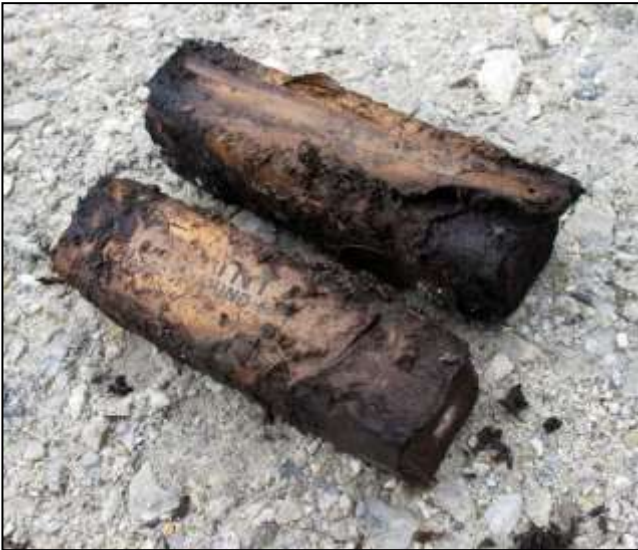
The blocks appeared to be in very poor condition, but this was largely due to the degradation of the cardboard sleeves and the heavily rusted end caps. Internally, the TNT was in good condition, and fully capable of detonation. The same conclusion was reached during the examination of similar TNT blocks during a previous phase of exploitation.

*The TNT blocks appeared to be heavily degraded*

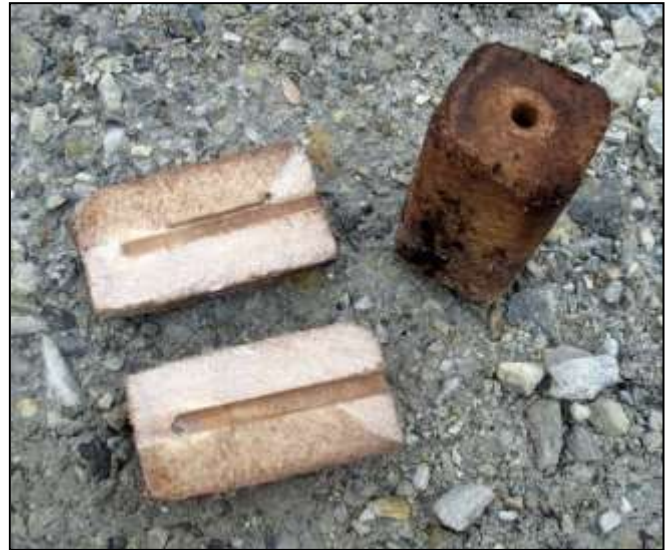
Findings from First World War battlefields confirm that high grade TNT can remain intact for more than 100 years. However, TNT requires substantial shock, or other energy input, in order achieve detonation – especially when it is not encased. The danger posed by these blocks is therefore wholly dependent on the viability of the primary munition in a booby trap.

*Internally, the explosive was still in good condition*

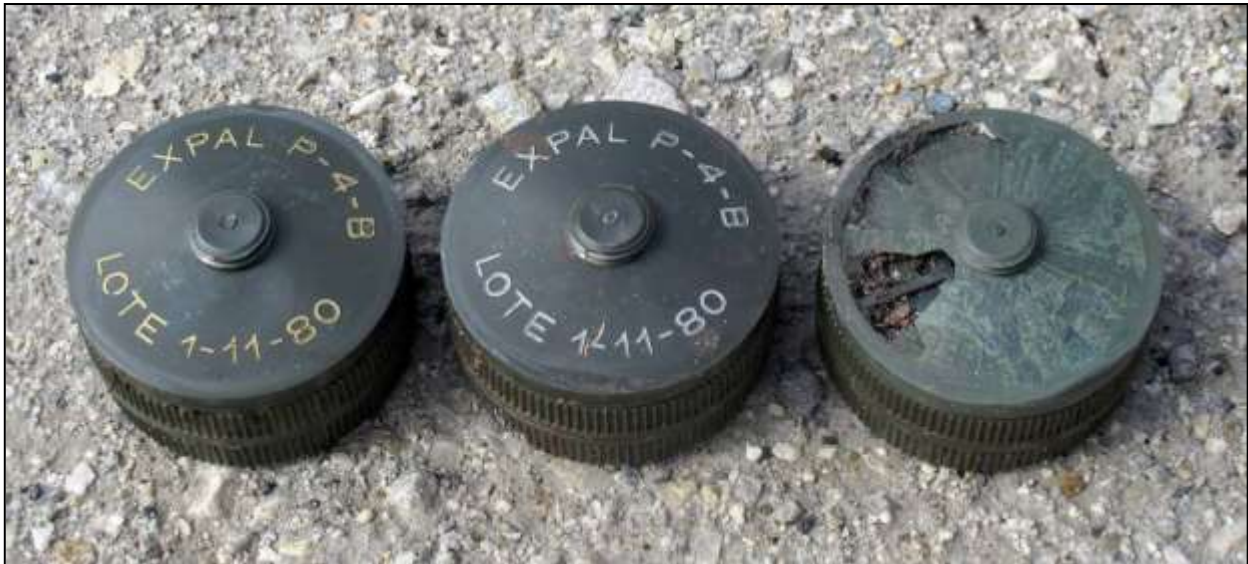
In contrast, a high proportion of the P4B mines cleared during Phase 5a were found to be detectable at far greater depths (around 20 cm). All of these mines appeared to come from a different lot, namely 1-11-80. A large number of these mines were recovered and retained for examination during exploitation.

*P4B mines from Lot 1-11-80 were found to be far more detectable than the types previously encountered. The variation in markings was also unusual for mines originating from the same batch.*

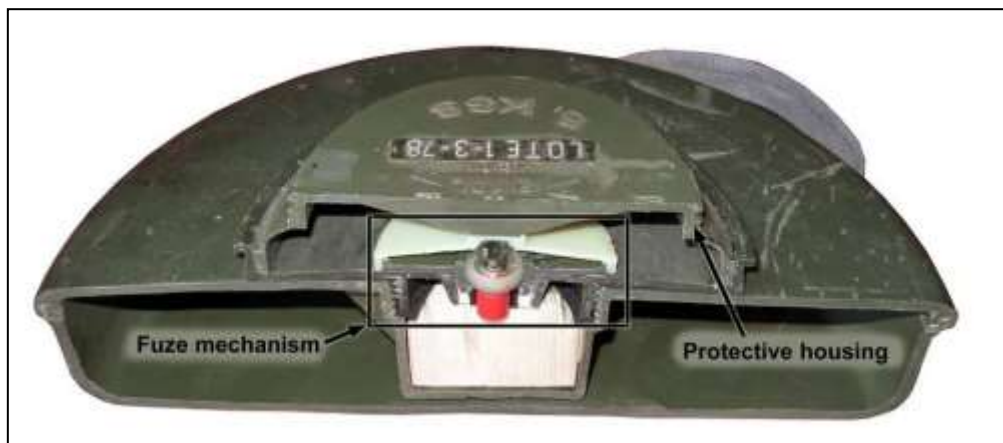
The outer fuze housing provides an additional barrier against the ingress of water, which is normally the primary cause of degradation within the fuze. This means that, all other factors being equal, C3B fuzes are likely to remain functional for longer than P4B fuzes.

*The protective housing of the C3B raises the operating pressure, but also helps to keep water out*

If the fuze housing cracks, then the operating pressure could be substantially lowered, perhaps to a level where the mine could be actuated by a person. However, the ingress of water is also likely to accelerate the degradation of the fuze to the point where it is no longer functional.

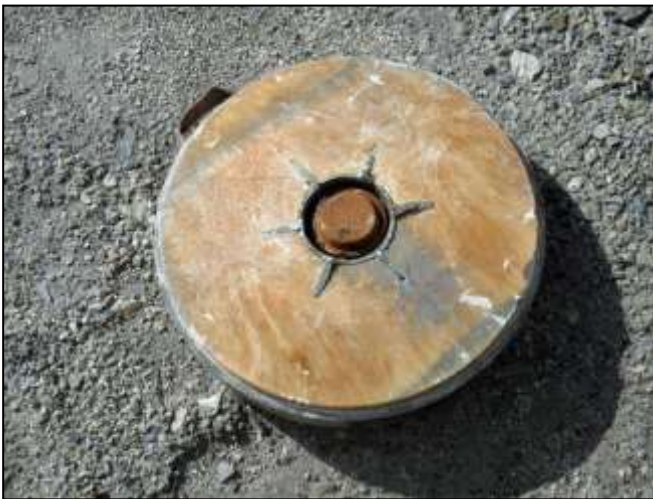
The main charge of the C3B tends to remain in very good condition, regardless of cracks in the casing or the ingress of water. Once again, great variation in explosive composition was encountered, with some parts of the filling heavily aluminised and others where virtually no aluminium was evident. At present, the metal dust plays no part in the mine's detectability and only affects its explosive power. If, at some point, the metal were involved in a new detection technique, then the variation in content might be significant.

*The central booster and main charge in C3B mines tend to remain in good condition*

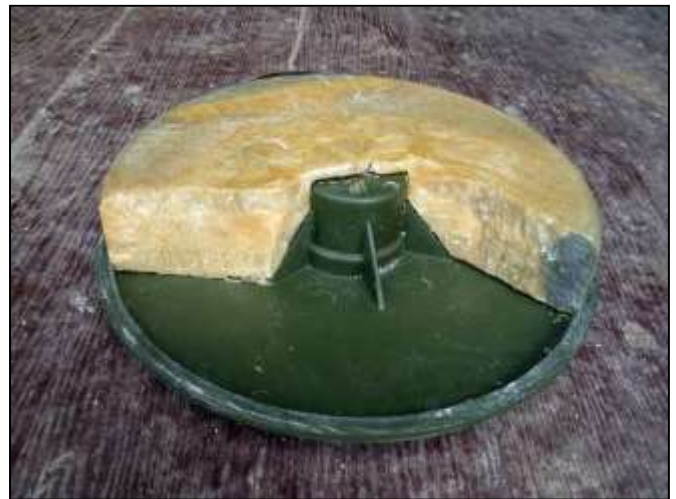
*The distribution of aluminium within the explosive is very uneven; in some case, virtually absent*

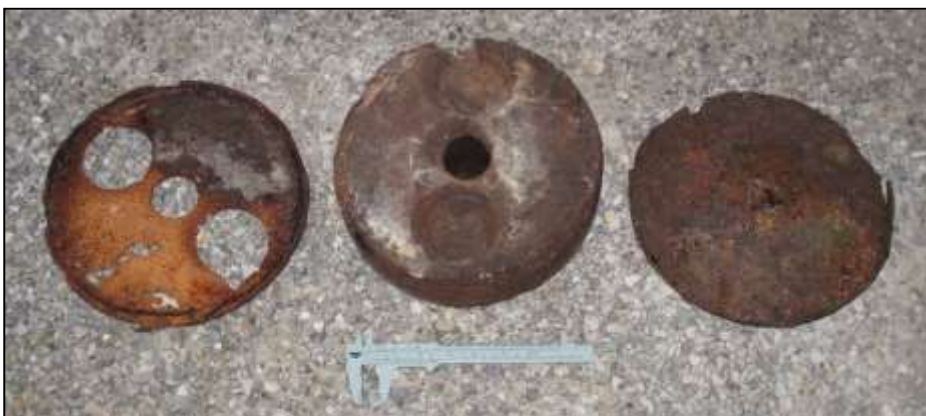
*This mine was recovered during Phase 4. A brief examination concluded that it was an 'M1' and that, what at first appeared to be an inert filling, was in fact TNT. No fuze was present*

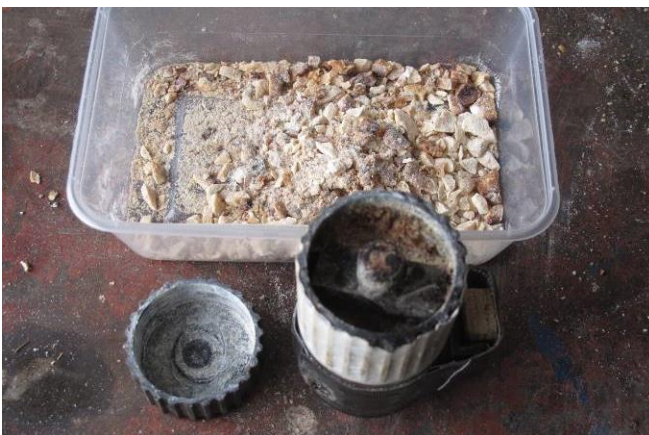
Exploitation revealed that the main charge was in good condition and appeared to consist of Composition B (RDX/TNT mixture) rather than the pure TNT mentioned in technical references. Composition B is substantially more powerful than TNT, causing greater blast and, therefore, being far more likely to initiate the adjacent TNT charges.

*The main charge was moulded around every component, making disassembly difficult*

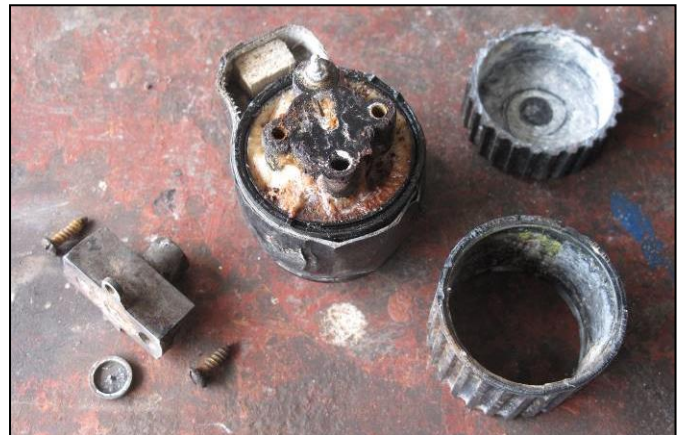
*Examination quickly revealed the level of deterioration within the fuze mechanisms*

The fuzeing mechanisms, however, were heavily corroded and it soon became apparent that neither of the actuating sequences could function. The primary and secondary arming plungers were seized into place, with their actuating springs rusted away and no longer capable of applying any force; this means that the mechanism was incapable of arming as designed.

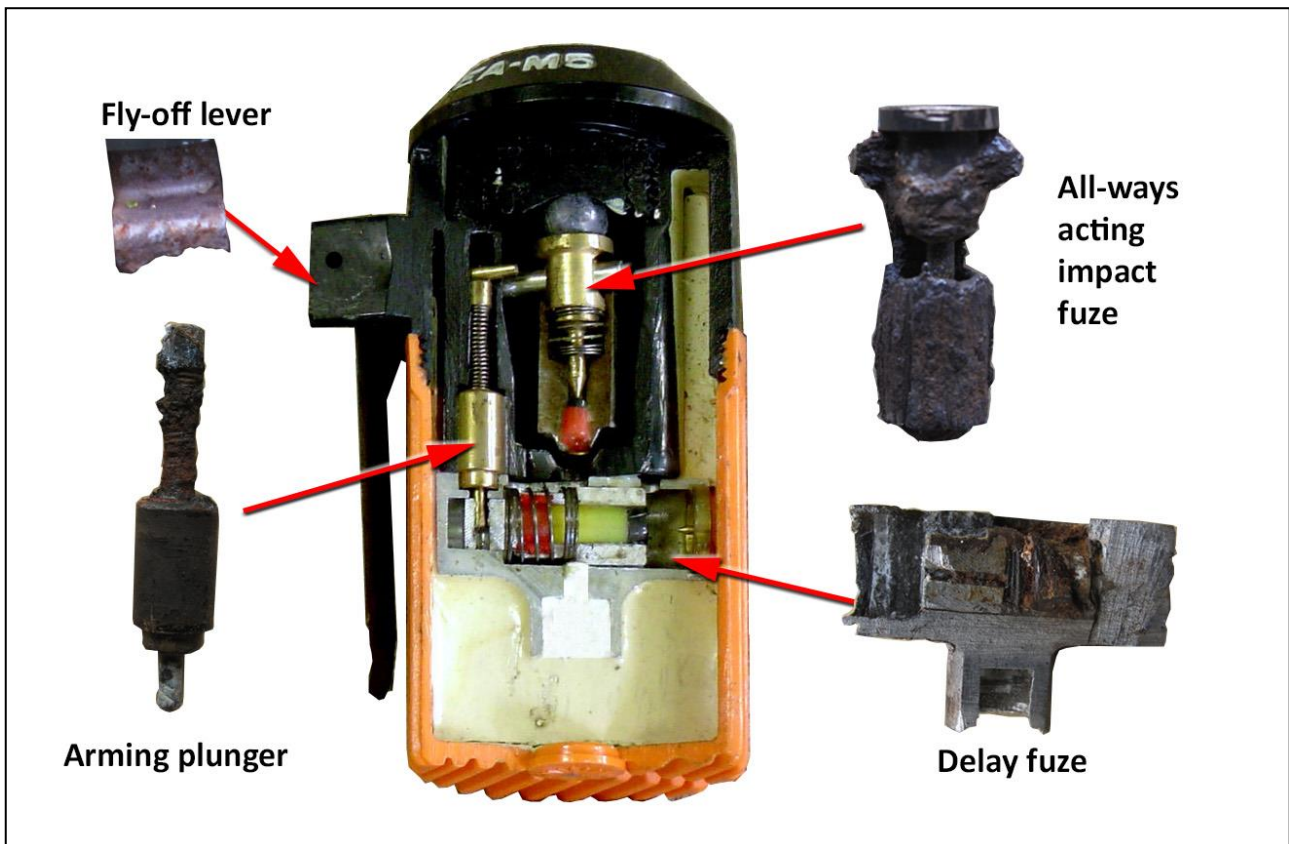
The delay fuze relies on an arming plunger releasing a spring-loaded slide onto a firing pin; this initiates a pyrotechnic delay while also bringing a secondary detonator into line. The space into which the slide moves was filled with aluminium oxide, the slide itself was seized into place and the spring had rusted away. The delay composition was no longer viable and it is likely that the detonator was also non-functional. The same was found with the impact fuze, with all mechanical components corroded and seized, and energetic elements apparently deteriorated.

*All of the major fuzeing components were badly corroded and non-functional*

The conclusion of these findings was that the M5 grenade was completely incapable of functioning as designed. Ageing of the complex fuzeing mechanism has resulted in multiple points of failure, effectively rendering the grenade safe. The high explosive charge remained viable; however, there was no internal means by which it could be initiated.

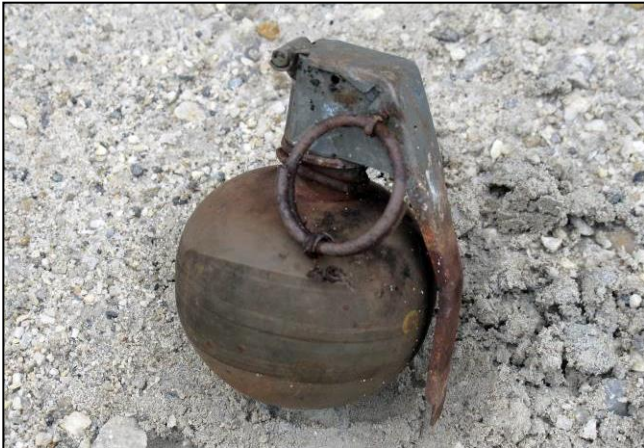
*The grenade was in remarkably good condition, considering its age*

Once cleaned, it was clear that the grenade was in surprisingly good condition, with only minimal and superficial rust in places. Markings were just about discernible and confirmed the identification as an M67. The fuze was confirmed as an M213 pyrotechnic delay of the type normally associated with the M67.

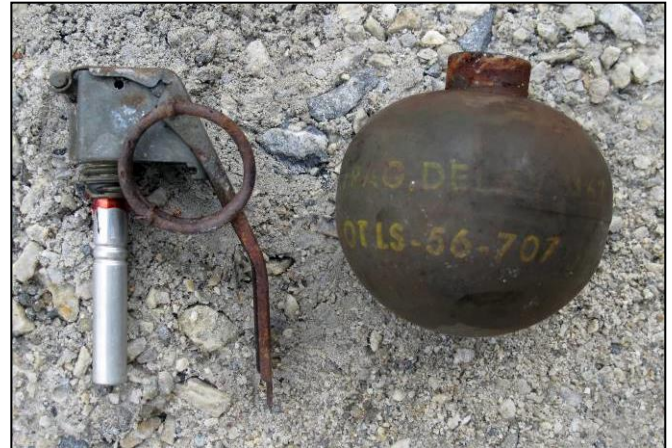
*The fuze type and markings confirm that the grenade is indeed a US M67*

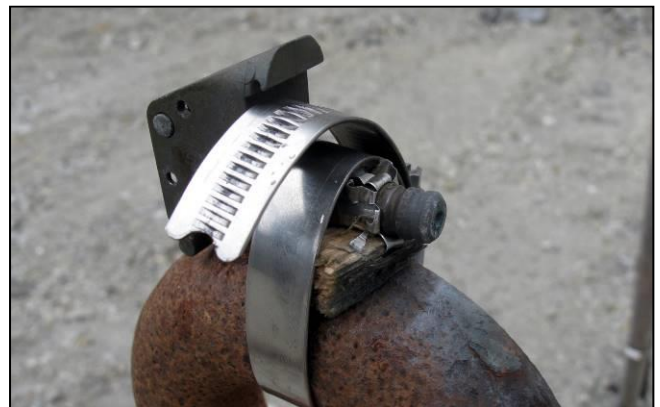
*The result of the detonation*

Once the pin had been pulled, there was a delay of approximately 4 seconds before the detonator exploded. This confirmed that the both the fuzing mechanism and the energetic components of the detonator assembly had been fully functional.

Had the body been fitted, there is no doubt that the grenade would have functioned as intended. Unlike the anti-personnel mines encountered during clearance work in the Falklands, this grenade has a 'coined' (pre-fragmented) steel casing with the potential to cause multiple fatalities.

The M67 should be considered, and treated as, a high threat item. Its continued functionality and potential to cause multiple fatalities should be clearly understood.

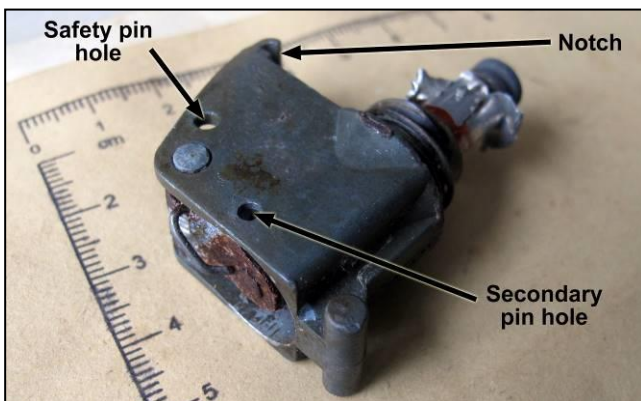
The secondary pin hole allows a steel pin or wire to be inserted through the fuze body, directly blocking the path of the striker. The notch on the fuze body also allows the fly-off lever to be wired into place. The images below show the locations of these safety features, and how they can be used.

*Safety features of the M213 fuze body*

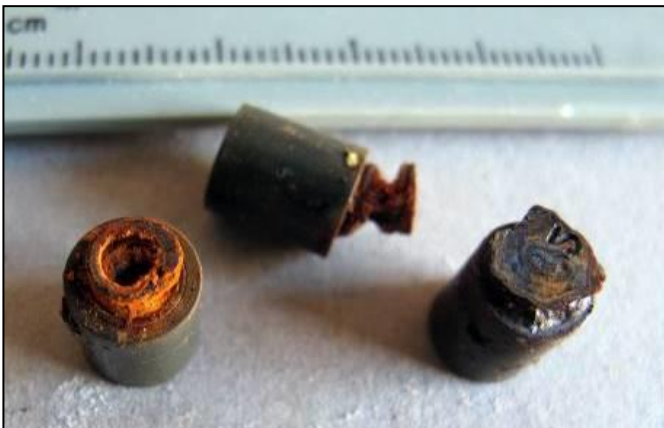
When new, the striker spring of the P4B weighs just 0.14 g is detectable to a maximum of 5 cm. Sometimes the spring cannot be detected at all, and previous exploitation work revealed that many springs have rusted away altogether. The metallic foil covering the main charge also makes little contribution to the detection signature. Until now, this minimal detection signature has meant using manual excavation to locate mines.

*The spring in the P4B fuze is only detectable to a maximum of 5 cm, and many have rusted away*

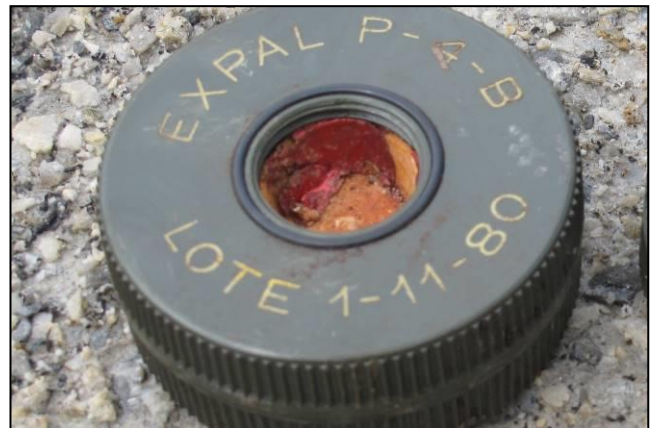
*The red metallic foil is a lead/tin/antimony alloy and is virtually undetectable*

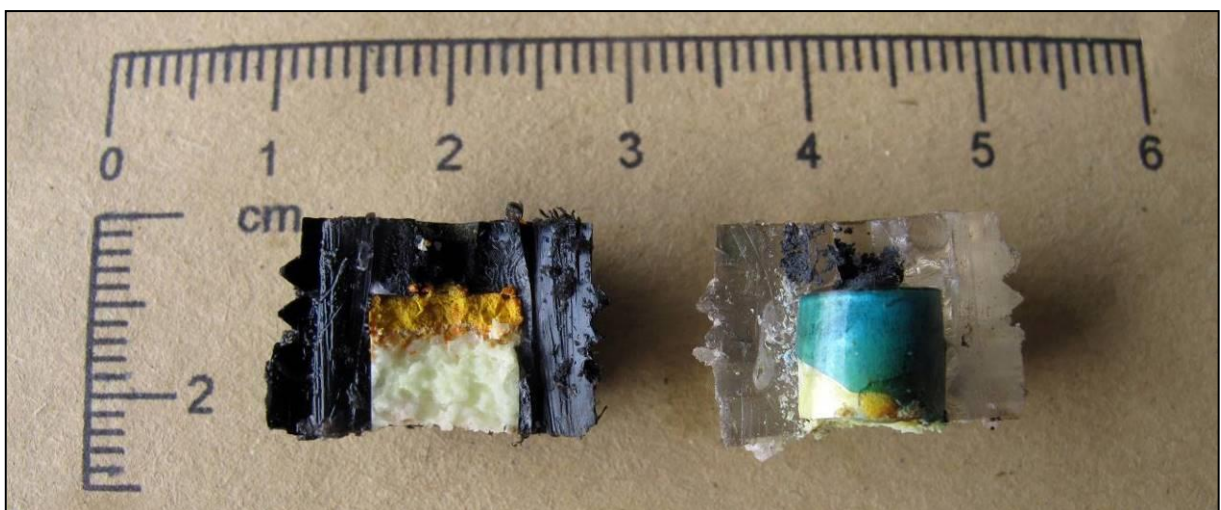
In the P4B mines recovered and examined in previous phases, the detonators were pressed directly into the plastic well of the detonator plug. Examination of the fuzes from mines of lot 1-11-80 indicated that the detonators were contained in small aluminium capsules.

*The detonator compositions of mines from 1978 (left) are pressed directly into the plastic of the detonator plug, while those of the 1980 mines (right) are contained in an aluminium capsule*

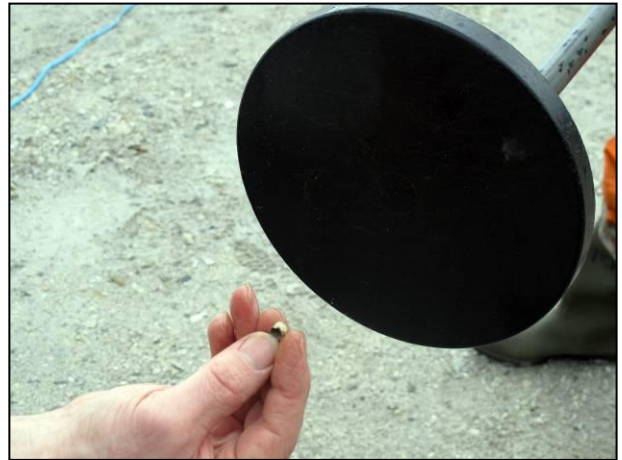
*Testing the detectability of the capsule*

Despite the relatively crude test, it was possible to establish that each of these detonator capsules could be detected to around 20 cm (in air, with no other detectable material nearby).

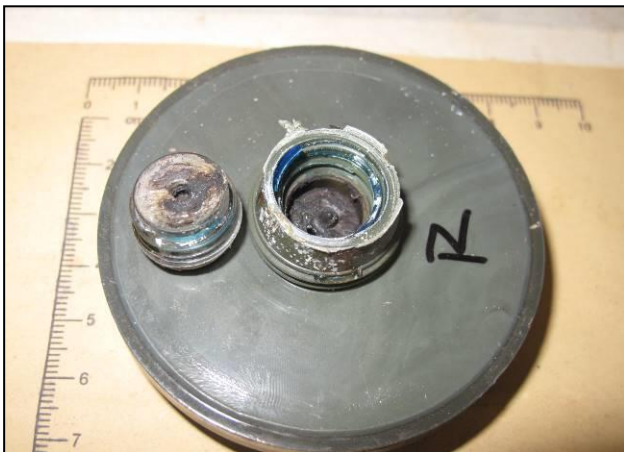
- Of the 100 fuzes tested, only 3 produced any reaction at all.
- Of these, two produced a weak effect, indicating that only the composition in the stab receptor had been consumed; this had failed to initiate the primary and secondary explosive in the detonator.
- Only one fuze functioned fully, and would have detonated the main charge in the mine body.

*In two fuzes, only the stab receptor functioned, with the detonator failing to explode*

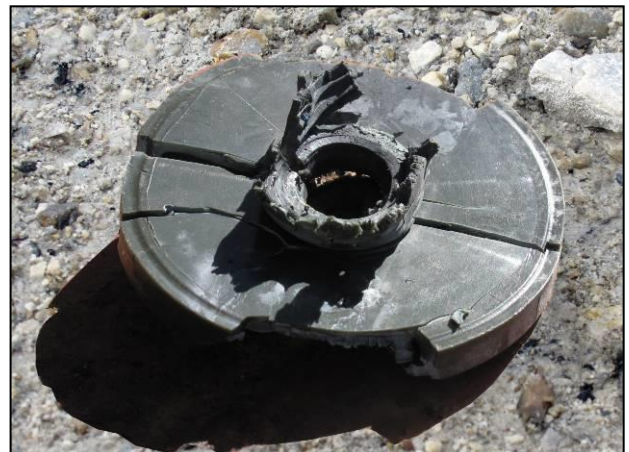
*Of the 100 fuzes tested, only one detonated, and would have initiated the main charge*

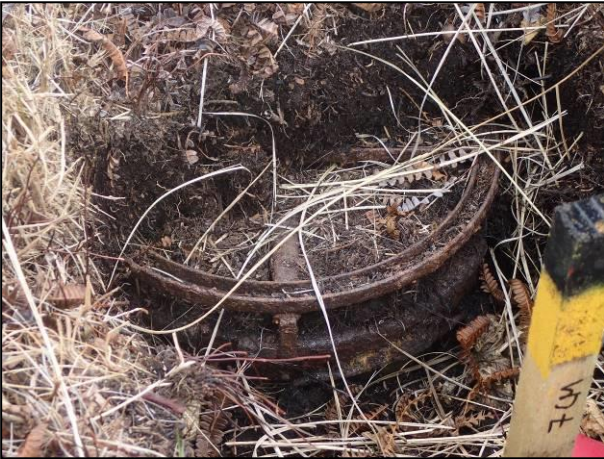
Most images show mines in flat, stable locations, within the bounds of expected burial depths, and with the main assemblies present.

This suggests that they have remained largely undisturbed, and that the only significant influences will have been environmental.

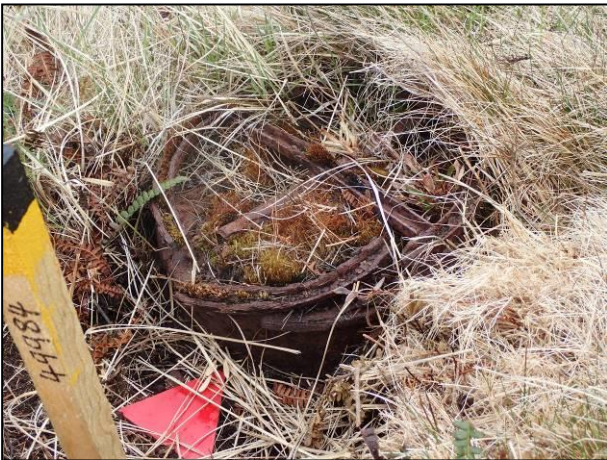
Some mines are heavily degraded, to the point where even thick steel sections have rusted through.

This generally appears to be the case with mines on, or near, the surface. In the unlikely eventuality that the fuze were functional, these heavily degraded mines may have lost the structural integrity needed in order to function.

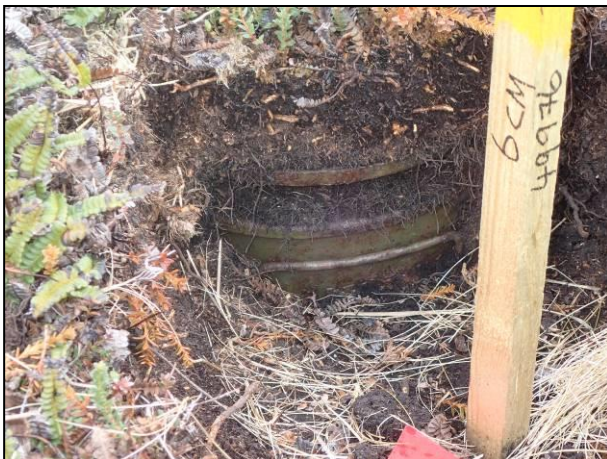
Although many mines are heavily rusted, a number appear to be in good condition, with external painted surfaces showing only superficial corrosion.

The extreme differences in condition are surprising, since the mines are likely to have very similar characteristics, and all mines have been subjected to similar conditions for the same duration. It appears that burial can slow the degradation process.

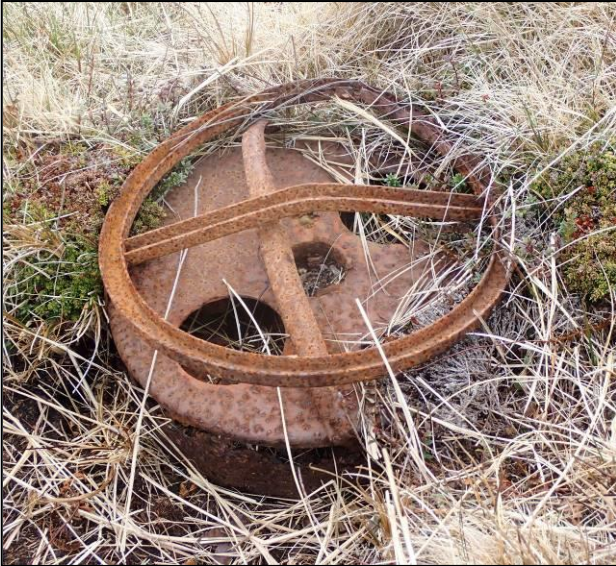
The casing of this mine is empty; there is a pronounced upward bend in one of the bars of the 'spider', while the other bar has been displaced.

The main explosive charge has almost certainly burned away, blowing out the large round filling plugs in the top surface. Any remaining paint would have been burned off during the fire, rendering the casing more vulnerable to corrosion. Since this mine is on the surface, yet only lightly rusted, it appears that the fire was fairly recent. The damage to the spider bars was probably caused by explosion of the detonator. This indicates that the primary explosive was still viable at the time of the fire.

Examples of 'M1' mines in good condition should be recovered for exploitation, the purposes of which should be to:

- Characterise the mine (external appearance, dimensions, weight, markings etc)
- Photograph external appearance and internal components
- Confirm the composition and viability of the main charge and booster
- Determine the type of operating mechanism used in the fuze
- Examine fuze components to assess functionality
- Test the functionality of detonators
- Establish whether there is a link between condition (or rate of degradation) and burial depth
- Assess likelihood of any 'M1' mines remaining functional
- Consider implications for clearance methods.
