Demining Programme Office in the Falkland Islands - Technical Support 2010

Demining Programme Office in the Falkland Islands – Technical Support 2010

Submitted by: C King Associates Ltd

April 2010

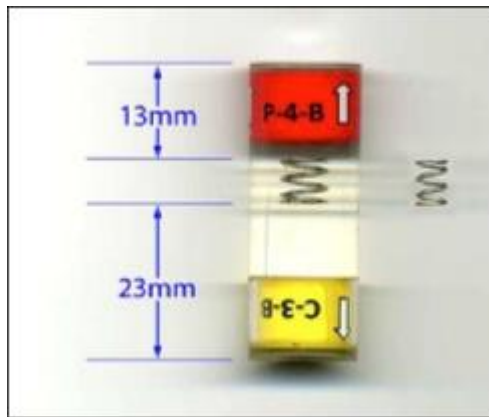
Figure 3

A detection test piece developed by CKA.

Note that in the image the spring inside the detection piece is magnified by the curve of the polymer surface making it appear larger than the free air example on the right. The two springs are actually identical

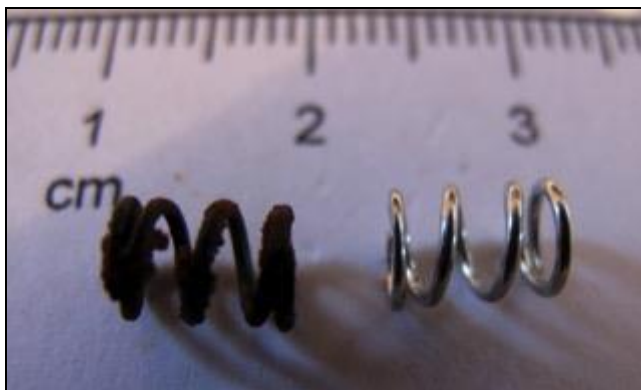
Figure 4

Corrosion testing.

Two springs of the type used in the Spanish P4B and C3B mines. The spring on the left has been immersed in weak saline solution for two weeks. The effect indicates that the spring is vulnerable to rusting, which might reduce its detectability

14. The conclusion of the corrosion test was that springs were likely to be heavily rusted if water had penetrated the fuze assembly. If so, the detection signature might be even lower, making the mine virtually undetectable⁴.

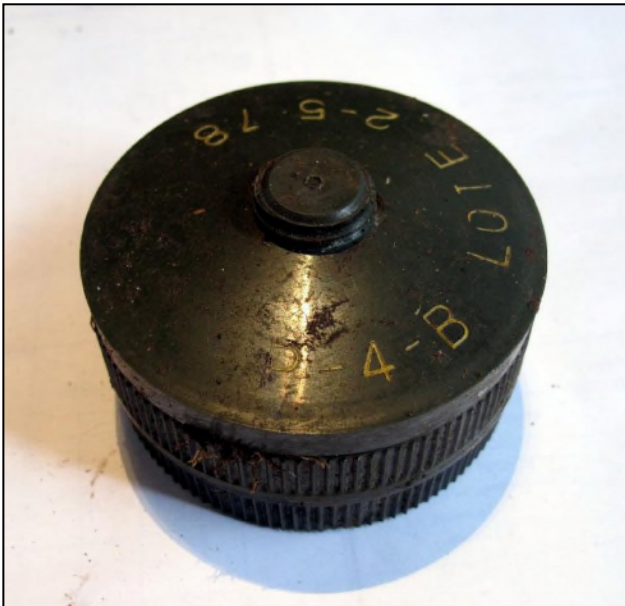
Figure 1

Most of the P4B mines examined showed little obvious sign of external degradation, with both the colour and the texture of the plastic casing appearing virtually 'as new' (Figure 1). However, the condition of some mines suggests that this initial visual impression may be misleading, and that all of the plastic casings are now beginning to deteriorate.

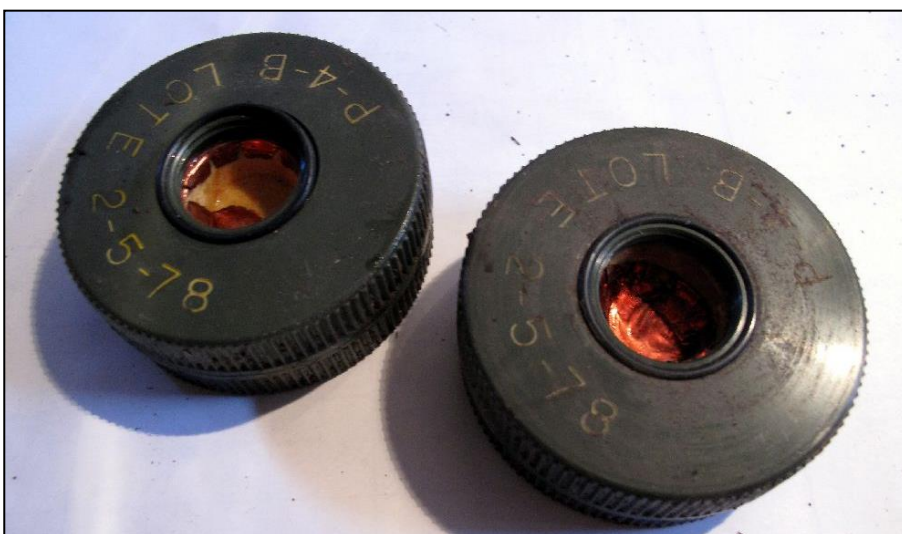
Figure 3

Throughout the course of the clearance operation, all but one of the P4B mines examined had the red lacquered lead foil present in fuze well. As the fuze assembly is fitted, this foil ruptures in unpredictable patterns (Figure 3). The shape of the ruptured foil is known to affect the return on short-wave radar and may also affect the signature with some metal detectors.

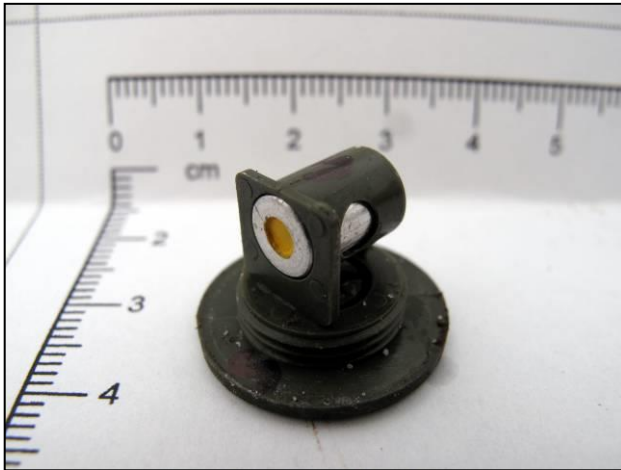
Figure 8: Most detonator assemblies were in very good condition

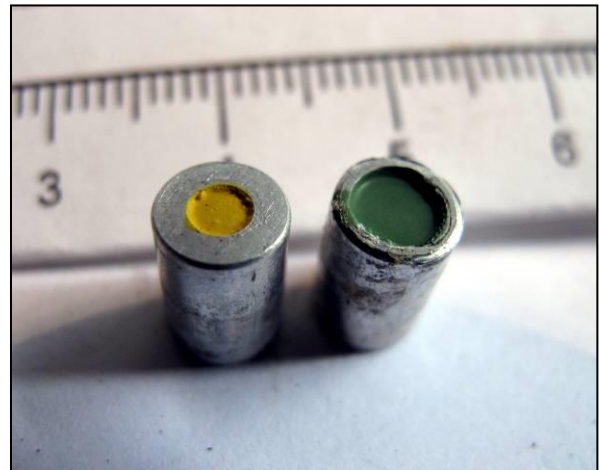
Figure 9: The end seals of these detonator capsules show no signs of deterioration

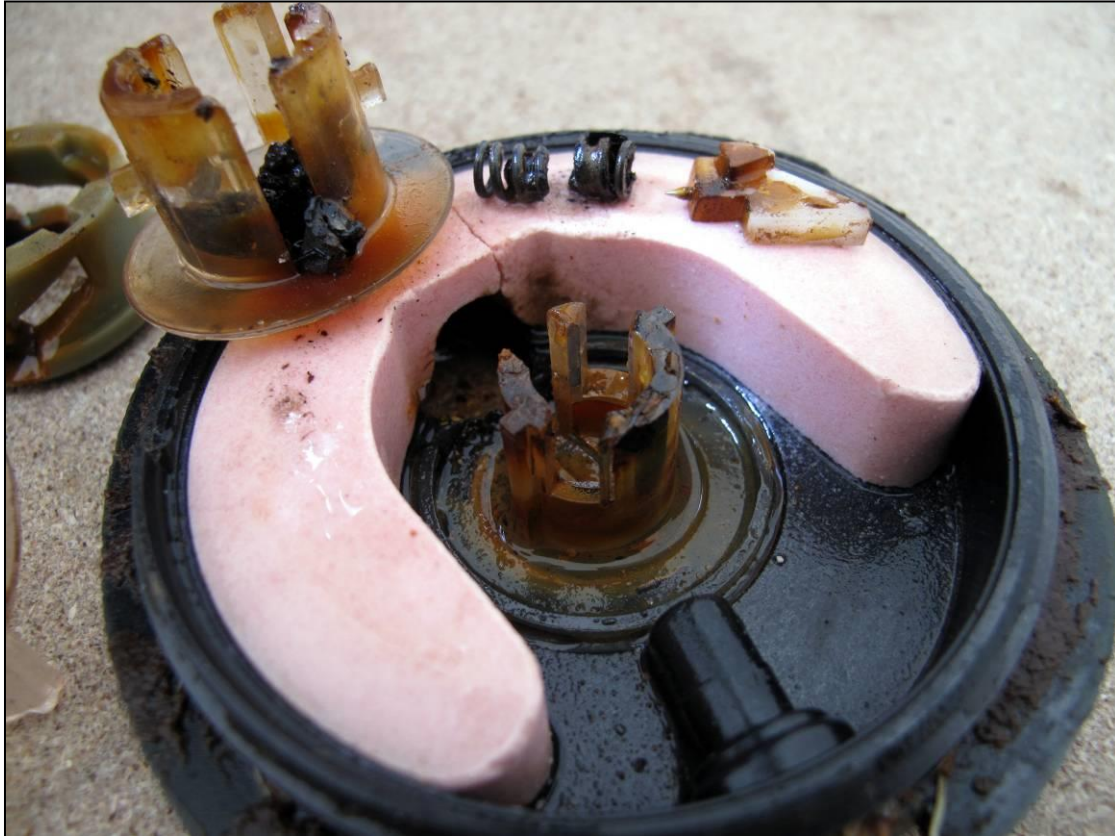
Only one of the recovered SB-33 mines contained a significant quantity of water; this was caused by the detonator plug not being screwed into place sufficiently tightly. The most obvious result of the water ingress was the disintegration of the striker spring, which would probably prevent the mine's fuze mechanism from actuating and might also make the mine more difficult to detect. The detonator capsule was also substantially corroded and possibly non-functional.

The badly corroded mine (shown in Figure 12) demonstrates the longer-term fate of all SB-33 mines, as rubber seals gradually deteriorate and permit water to enter the mine.

Figure 12: Inside an SB-33 which had been penetrated by water. The most likely cause of failure would be the disintegration of the striker spring, although degradation of the detonator capsule might also prevent the mine from operating. Note that the stainless steel firing pin is virtually unaffected

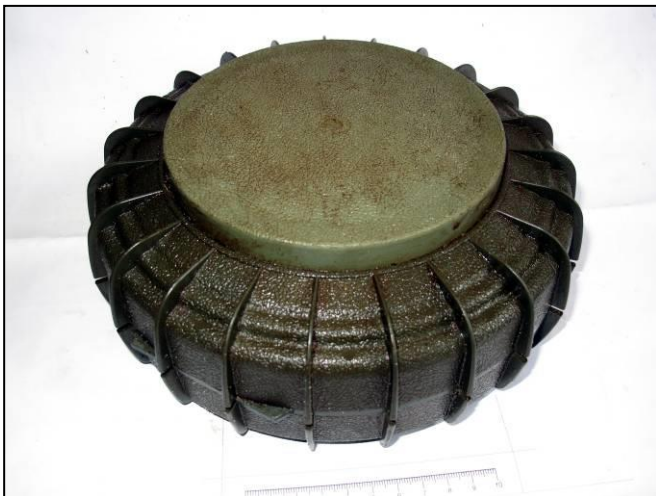
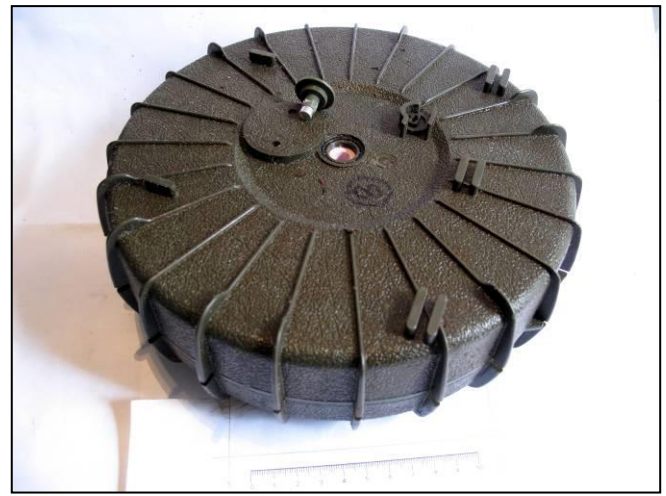
Fifteen SB-81 Anti-Tank (AT) mines were recovered from a mixture of dry and wet sites (Figures 1 and 2). None of these mines showed signs of significant external degradation; in fact, their appearance was virtually 'as new', as shown in Figures 3 and 4.

Examination of the casing and pressure plate showed that all of the mines had remained watertight. Where there was evidence of moisture on the inside, as with the SB-33, this appeared to be because the detonator plug (shown in Figure 4) had not been tightened sufficiently.

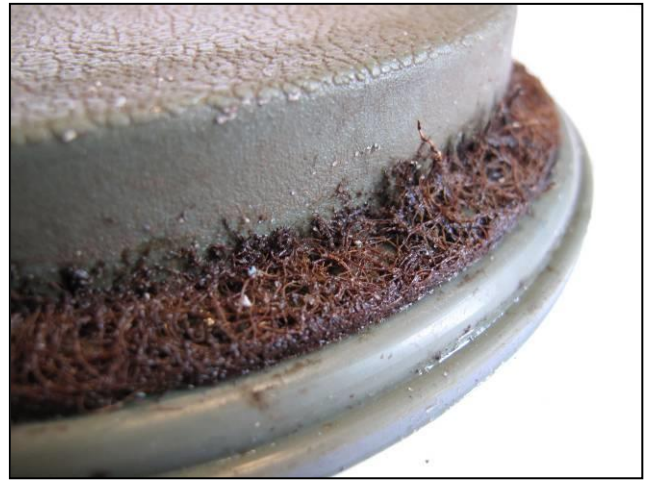
Figure 6

With the halves of the casing separated, the internal components could be examined. Figure 5 shows upper section of the mine with the pressure plate removed to reveal the top of the fuze assembly. The seal around the edge of the pressure plate is critical to the pneumatic function of the fuze; this is a common point of failure among Italian AT mines. Although small roots were present on the outside (Figure 6) all seals were intact.

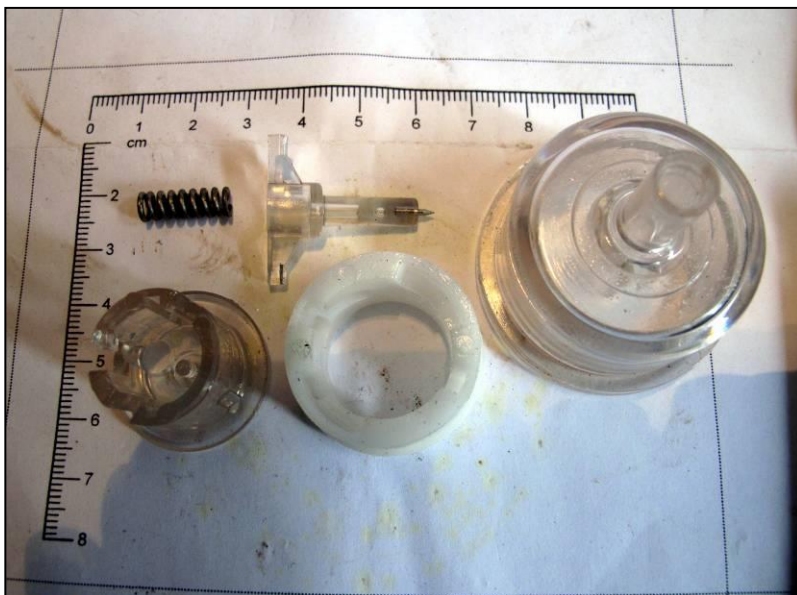
Figure 7 shows the major components of the fuze mechanism. The fuze is similar to that used in the SB-33, with most of the clear plastic internal fuze components made from polycarbonate.

Not only were the components in perfect condition, but the thin layer of grease applied during manufacture was also present.

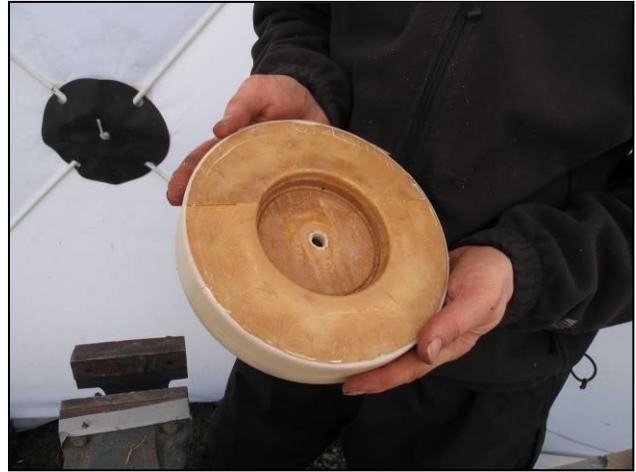
The main charge (approximately 2 kg of TNT/RDX/HMX) is encapsulated in plastic, while the booster (approximately 140 g of RDX/HMX/wax) is in the form of a pressed disc. These are shown in Figure 8. Removal of the plastic showed the main charge to be in perfect condition (Figure 9).

Figure 9: The main charge casting
