Demining Programme Office in the Falkland Islands - Technical Support 2013

Demining Programme Office in the Falkland Islands – Technical Support 2013

Submitted by: Fenix Insight Ltd

EXPLOITATION OF ITEMS RECOVERED DURING DEMINING OPERATIONS: 2012/13

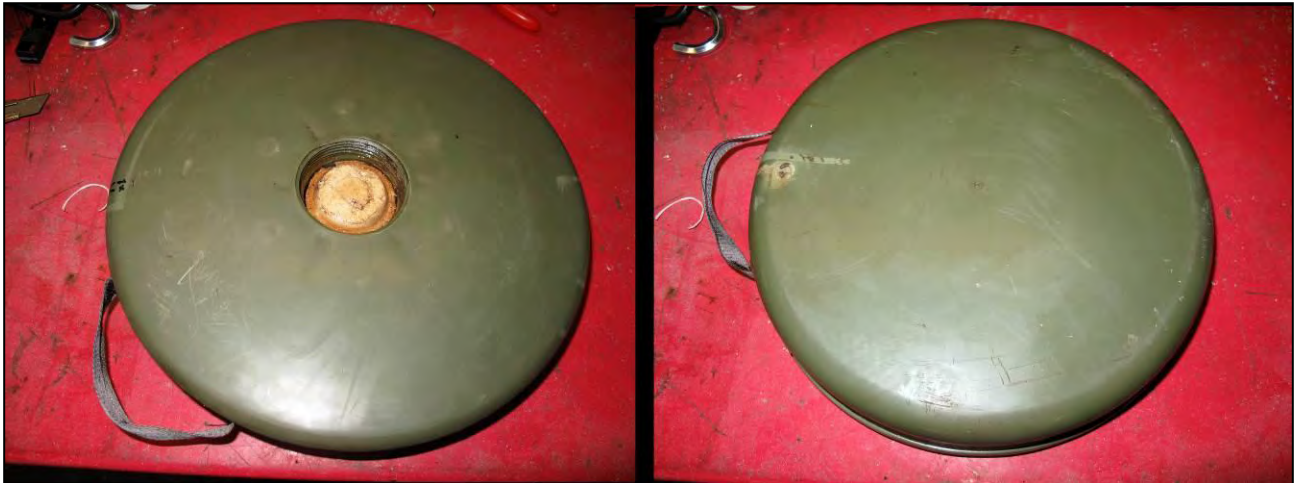
Figure A5

The top surface (left) and underside (right) of the mine body with fuze removed. All of the mines recovered appeared to be in good condition superficially; however, every mine had cracks in the casing

14. All of the C3B mines recovered from SA064 appeared to be in good condition superficially, but all of the casings were cracked. The ingress and subsequent freezing of water is gradually causing the deterioration of the casings, but the effect is slow due to the small volumes of water and the flexibility of the plastic. The process is likely to accelerate as existing cracks enlarge and the plastic becomes more brittle.

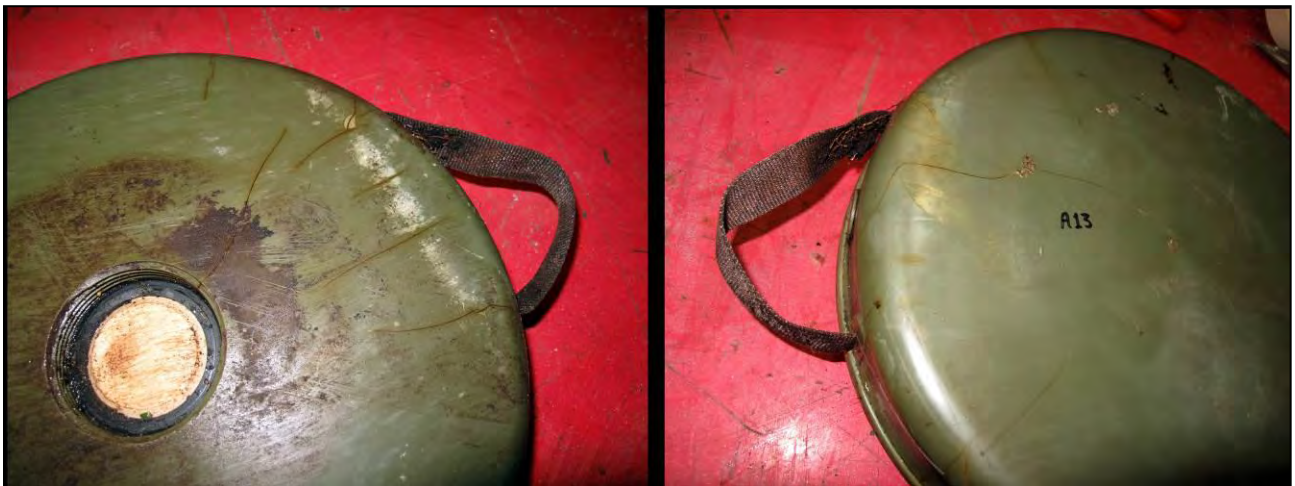
Figure A6

Fine cracks in the casing allow the ingress of water; freezing then gradually extends the breaks

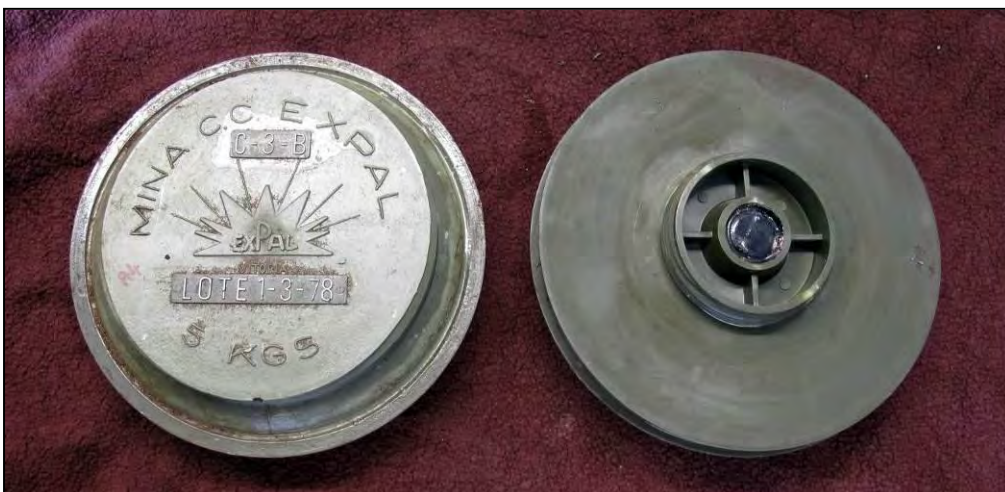
Figure A7

The top surface (left) and underside (right) of the fuze assembly. Most of the fuze bodies appeared to be undamaged and well sealed, yet almost all were wet inside

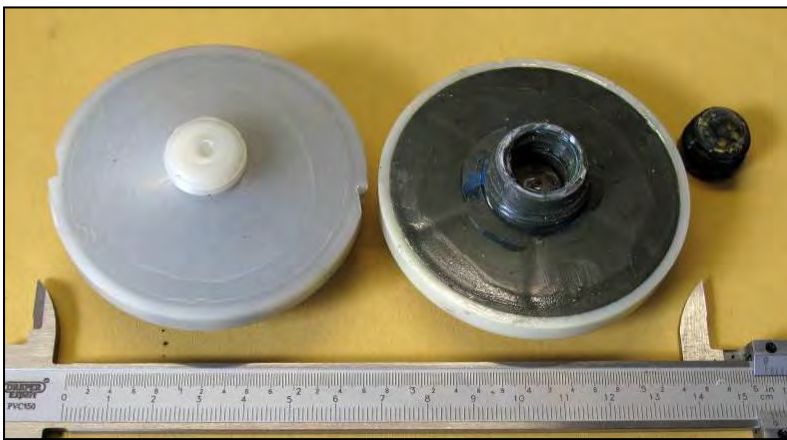
Figure A9
The sealed fuze assembly is very similar to that used in the P4B anti-personnel mine. Water was found inside almost all of these units

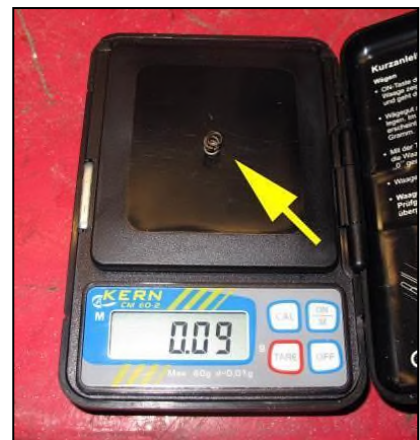
Figure A10
Due to corrosion, this striker Spring weighed only 0.09 g

17. All fuze mechanisms appeared to be operational, despite the corrosion of some striker springs. Fuzes are likely to remain functional despite the deterioration of the striker spring.

18. The striker spring is the only metal component within the mine. The spring weighs less than 0.15 g when new and is positioned around 20 mm below the surface of the pressure plate; this makes its detectability marginal at best. If the striker spring is corroded, the metal content of the mine may be reduced or eliminated altogether, making it impossible to locate with a metal detector.

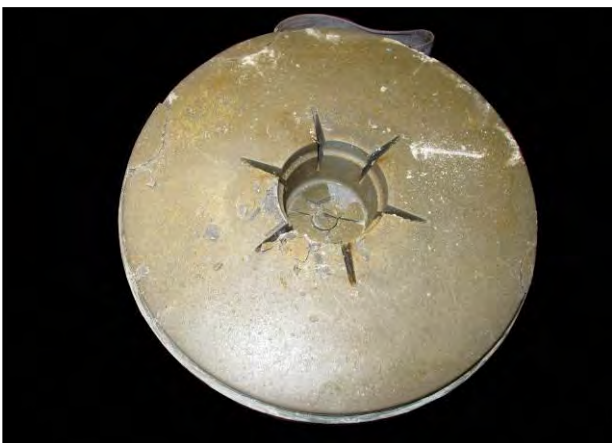
Figure A11
Upper section of the casing removed to reveal the main charge; most were in good condition with little or no cracking or deterioration evident in the explosive. Although the inside of the plastic casing was wet, the cast filling contains very few voids

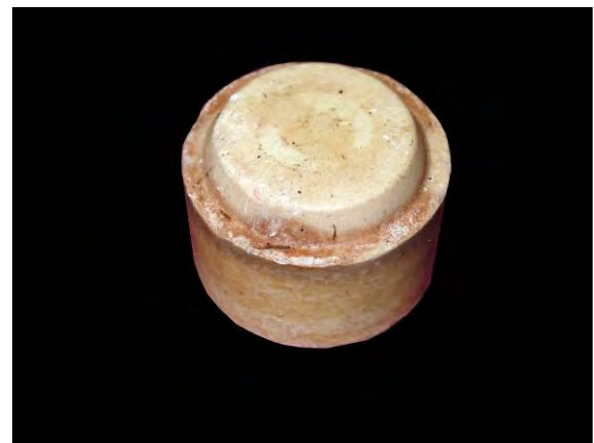
Figure A12
Booster pellets are composed of a pressed TNT/RDX (60/40) mixture and virtually all were in good condition. Despite the neoprene seal between the base of the fuze and the booster, all of the booster pockets contained water

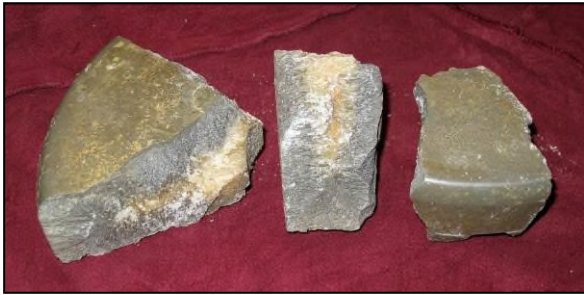
Figure A13

The composition of the main charge is quoted as being TNT/RDX/aluminium (50/30/20) but, as shown here, the mixture is rarely homogenous. The aluminium content does not affect the detectability of the mine

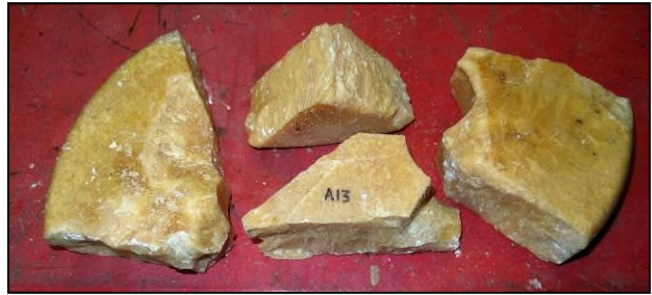
Figure A14

The proportions of the constituents in the high explosive varied significantly; this sample contained no aluminium whatsoever. This is evidence that different material characteristics and specifications may be found within the same lot number

19. The explosive constituents of the main charge may vary, but this has little significance to the functionality of the mine. The booster and main charge remain intact while enclosed by the mine casing and solubility in ground water is low; the charges are therefore likely to remain viable for many years in buried mines.

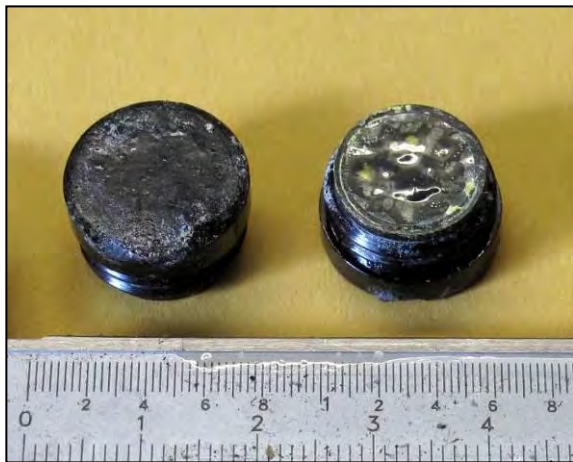
Figure A15

All of the C3B detonator assemblies examined were wet. The protective layer of clear plastic film over the stab receptor (right) did not provide an effective water-tight seal

21. Findings from the Ageing Study suggest that the primary explosive in the detonator is likely to remain viable for many years, being well protected by its plastic casing. However, the stab-receptive composition used to initiate the primary explosive is vulnerable to water and prolonged immersion appears to have rendered many of the detonator assemblies incapable of functioning as designed.

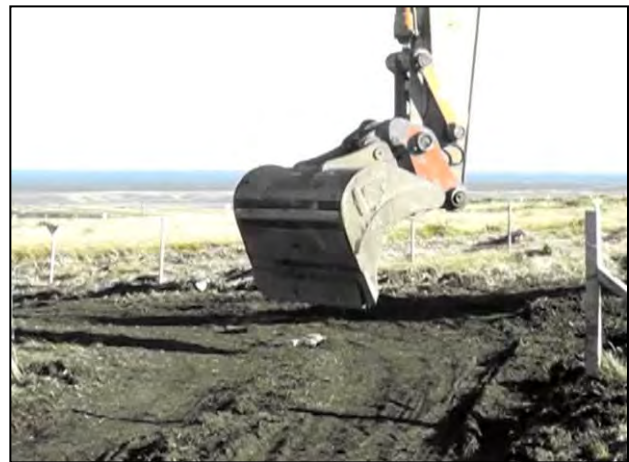
Figure A16

Subjecting live fuzes to an operating load (>300 kg) using an excavator bucket did not produce any detonations. The most likely explanation is that the stab-receptive composition is no longer functional

22. The ingress of water into the detonator is dependent on a number of factors and it is entirely possible that some remain capable of operating as designed. Those that cannot, but which still contain viable primary explosive, may be detonated by other influences, such as fire or impact.

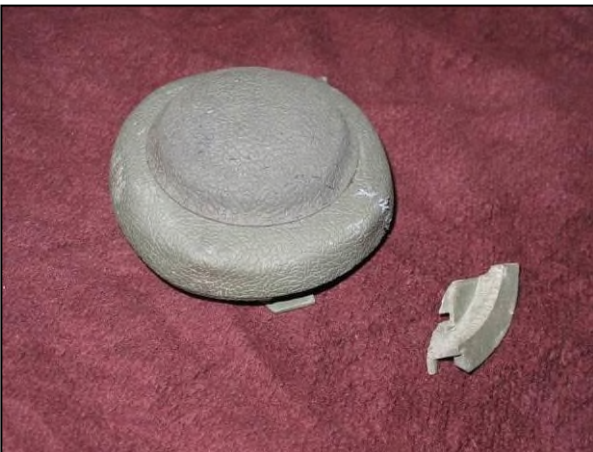
Figure B2
The SB-33 mine found in SA064

3. The isolated mine found in SA064 (**Figure B2**) showed obvious damage, particularly to the base (**Figure B3**) where the detonator plug was cracked and a section of the mine casing had been broken away. The broken section of the base was found close to the mine body.

7. The damage to the mine, together with its displacement and the presence of a crater in the mine row, strongly suggest that this mine was thrown out by the detonation of an artillery shell during the conflict.

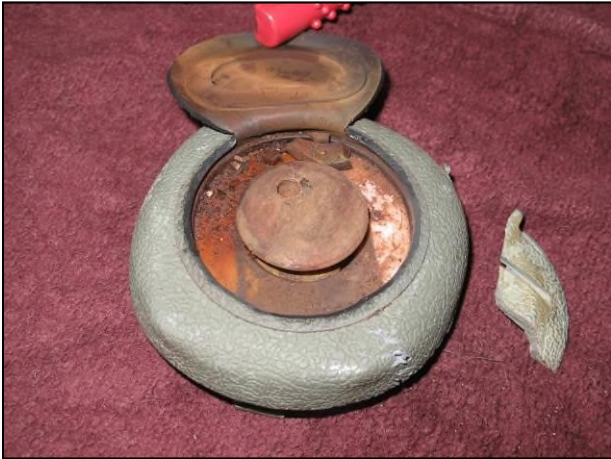
Figure B4

On initial inspection, the fuze and main charge appeared to be relatively intact. The ingress of water would not prevent the mine from functioning

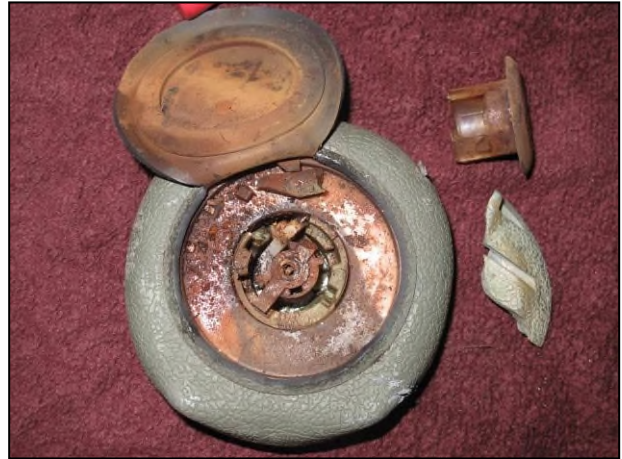
Figure B5

Removal of the fuze plunger revealed that the several of the fuze components had been shattered and the striker displaced

5. The isolated SB-33 mine discovered in SA064 had clearly been subjected to a substantial amount of shock. This was evident in the shattering of fuze components made from polycarbonate (the plastic used in protective visors) and the pulverisation of the main charge.

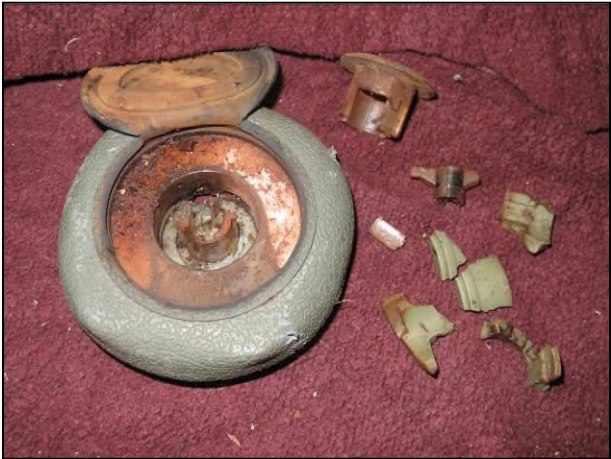
Figure B6

Removal of the fuze components exposed the full extent of the damage

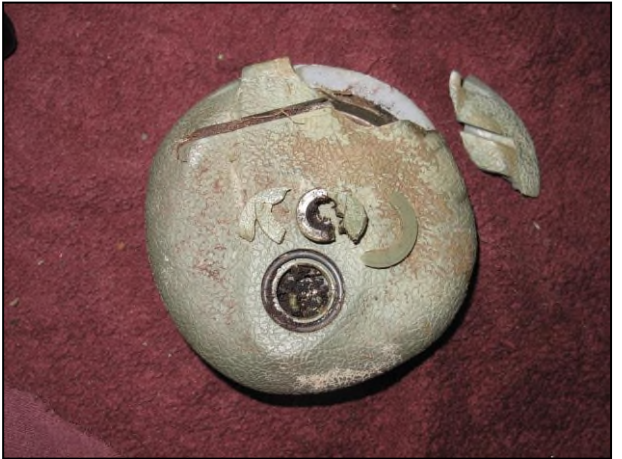
Figure B7

The detonator plug had also been shattered and could not be used to remove the detonator

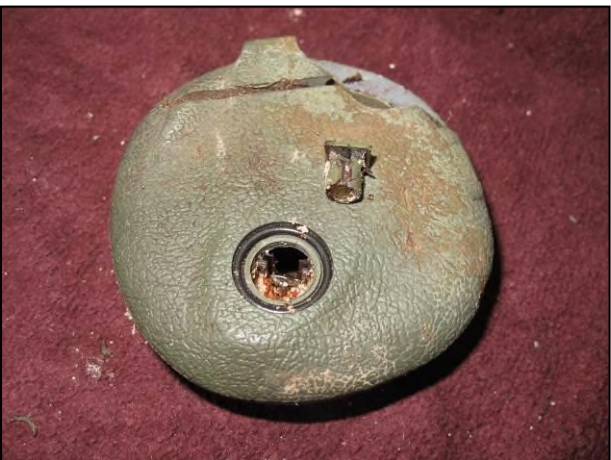
Figure B8

The detonator was seized into place and surrounded by impacted explosive from the main charge

8. The mine was incapable of functioning as designed; however, the condition of the detonator means that it might have been in an unstable state.
9. The demining team and DPO were absolutely correct not to attempt to defuze or disassemble this mine.

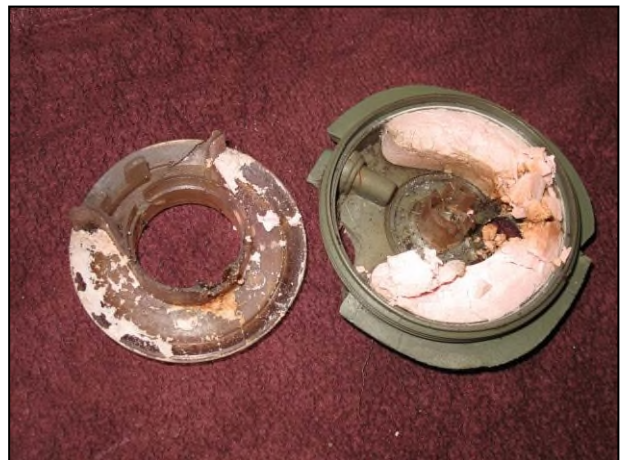
Figure B9

The main charge, normally a rigid horseshoe of pressed explosive, had been pulverised

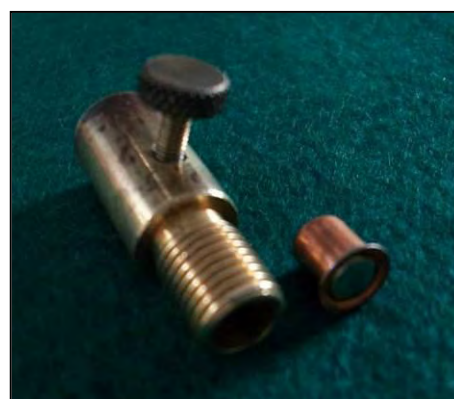
Figure C2

The fuze holder with percussion cap removed. The cap unit is a standard 12 bore shotgun primer. Although robust, these are unlikely to remain functional after 30 years exposure to wet conditions

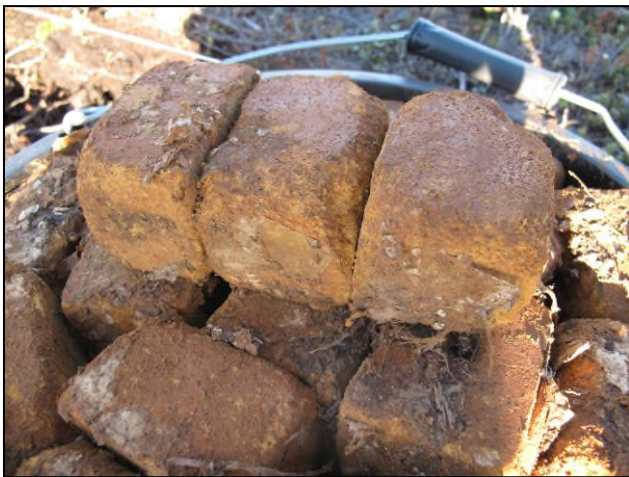
Figure C4
TNT charges from a booby trap in SA064. These appear to have been 400 g blocks of pressed TNT, wrapped in waxed paper. Pressed TNT is deemed 'cap sensitive', meaning that it can be initiated directly by a No 8 strength detonator. The edges of the blocks have been eroded but the bulk of the explosive remains intact. Historical data on TNT suggests that it can remain capable of detonation for several decades

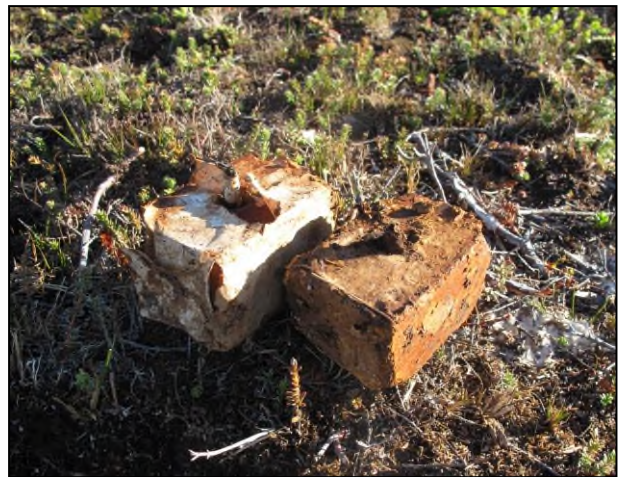
Figure C5
TNT blocks containing detonators and the remnants of safety fuzes. It is clear that any pyrotechnic composition in the fuse or detonator will be non-functional. However, findings from the Ageing Study (involving explosives of a similar type and age) suggested that the primary explosive in the detonator may be viable; this means that the explosive could be initiated by either fire or substantial impact

6. The Ageing Study suggests that the primary explosive within the detonator may still be capable of detonation. Initiation might arise from heat (such as a peat fire) or from shock (such as the impact from a flail hammer).
