DDASaccident492

DDAS Accident Report

Report date: 21/01/2008	Accident number: 492
Accident time: 10:00	Accident Date: 19/05/2006
Where it occurred: Task # 1144, Wazirabad Village, Pule Khumri District, Baqhlán province	Country: Afghanistan
Primary cause: Field control inadequacy (?)	Secondary cause: Inadequate survey (?)
Class: Excavation accident	Date of main report: 14/06/2006
ID original source: OPS/03/01-07	Name of source: UNMACA
Organisation: [Name removed]	
Mine/device: grenade	Ground condition: grass/grazing area
Date record created:	Date last modified: 21/01/2008
No of victims: 1	No of documents: 2

Demining Accident Report

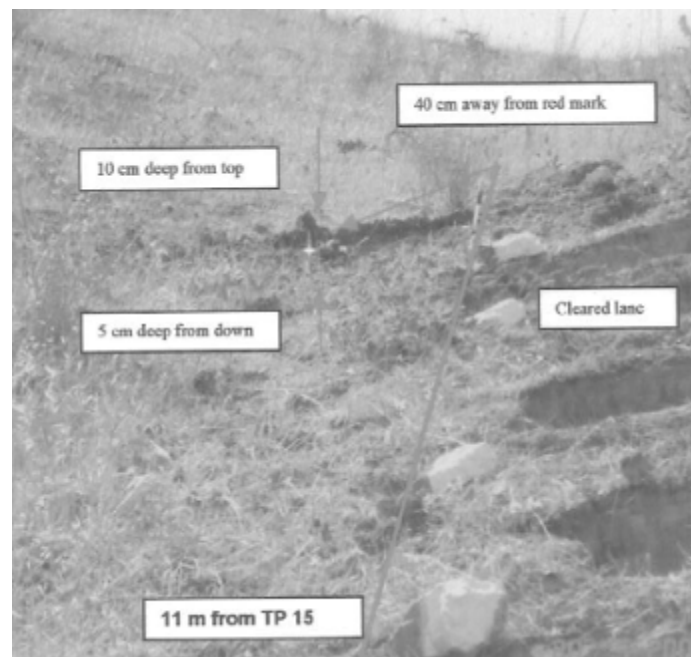
Accident Point measurement

Description of the accident: Based to observation and witness comments of the [International demining NGO] team No 27 the general situation and condition of this task was too sloppy [sloping, steep gradient] which was difficult for normal operation on it. This is why the site supervisor initiated a protection system to save deminers to rolling down from the hill upper side to down. Hence he recommended all deminers to tie themselves by a rope and the same action was exercised with the injured Deminer who was busy in the clearance lane with same condition in task No 1144. His location was 11m ahead from TP-15. This lane was cleared by him during this operation. He recognized a signal through his detector 40 cm out of his clearance lane left side and starting excavation for initiation of this buried item. While the excavation was going on his trowel touched with grenade which was buried in the ground. Because he had not full control on his hand in order he was squatting remote from the signals and additional his site also was not stable. Before that accident happened the injured Deminer heard a sound of fuse activation through his trowel touching with sensitive part of the grenade. By recognition of this the Deminer started to escape from the scene and he was able to get away about 2-3m but because of his fastening by rope he was blocked to going further. So the grenade exploded and he got injuries and fell down on the ground. As the ground was sloppy the existing rope prevent him to rolled down in suspected area. The rope had advantage and disadvantage. The advantage was that it stopped him from being fallen down in the suspected area and the disadvantage was that if he wasn't fastened to the rope he might run a little more and might saved himself to being hit by fragments of the detonated grenade.

4. The Deminer tried to operate on a signal out of his adjacent lane's safety margin in the 40cm distance far — off the lane, this is why he did not have sovereignty / over control on his hand so the trowel was touched to device and accident happened.
