DDASaccident323

Humanitarian Demining Accident and Incident Database
AID

DDAS Accident Report

Report date: 15/03/2004	Accident number: 323
Accident time: 12:50	Accident Date: 30/05/2001
Where it occurred: Rasa Koshare minefield No.358	Country: Kosovo
Primary cause: Field control inadequacy (?)	Secondary cause: Inadequate training (?)
Class: Missed-mine accident (survey)	Date of main report: 11/06/2001
ID original source: TG/CC/JF No 006/2001	Name of source: KMACC
Organisation: Name removed	
Mine/device: PMA-3 AP blast	Ground condition: bushes/scrub electromagnetic woodland
Date record created: 20/02/2004	Date last modified: 21/02/2004
No of victims: 1	No of documents: 2

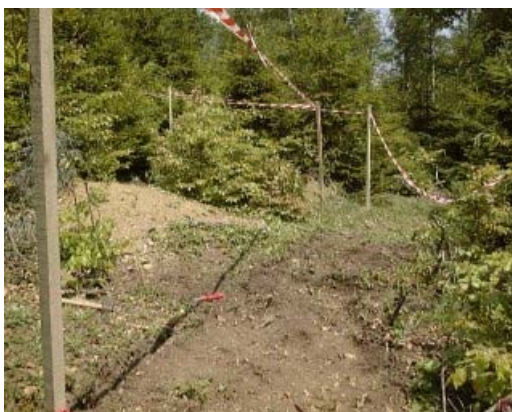
As a consequence of the explosion the hammer was forced into the victim's chest causing bruising, and he then dropped the hammer [the photograph below shows a small hand axe, not a hammer: the red handled knife marks the crater].

The hammer has then fallen outside the marked area. The International Supervisor was standing approximately 2 metres from the victim, and facing in the opposite direction. The International Supervisor did not see the actual explosion or receive any injuries from the blast. Immediately after the explosion he moved to assist the victim and calm him. As the International Supervisor did not realise the victim had received injuries to his foot he attempted to guide him out of the lane and onto the road approximately 35 metres away. The victim was unable to walk and therefore the International Supervisor called to the SL to bring a stretcher to his site. The International Supervisor then called the demining NGO base and reported the accident and requested a helicopter casevac. When the SL arrived both he and the International Supervisor carried the victim out to the road on the stretcher where the medical team was waiting to provide first aid.

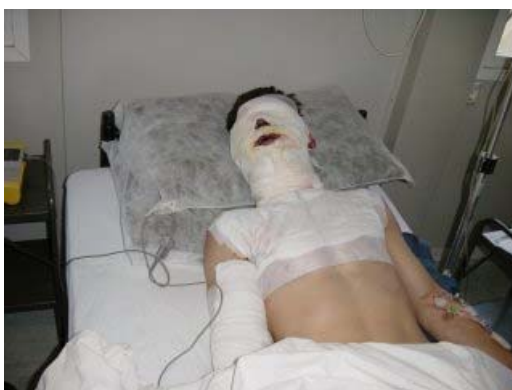
The victim was stabilised and from there he was then taken by ambulance to the HLS located approximately 1.5 km to the south. Further treatment was provided at the HLS whilst awaiting the arrival of the casevac helicopter. The helicopter arrived at 13:47 which was 50 minutes after the request for the helicopter was made and almost 60 minutes after the accident. The photograph below shows the victim in hospital on the day after the accident. The victim was conscious and able to talk whilst awaiting the arrival of the helicopter.
