DDASaccident604

DDAS Accident Report

INCIDENT INVESTIGATION [Demining group] - MINE ACTION TEAM - JORDAN

MINEFIELD NO - 387, MINEFIELD TASK ID - E 387 AL SHAJARAH 1

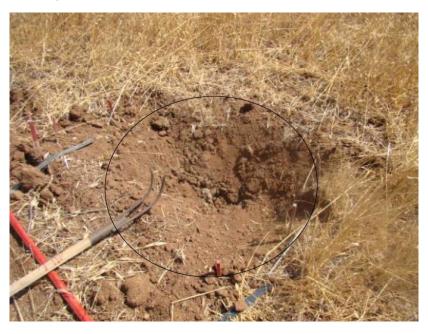
while the deminer try to investigate a signal in lane 15 (12 O'clock mine) he didn't approached the mine in the proper procedure which caused the deminer to hit the mine from the top of the pressure plate and initiate the mine 2.2 m away from the deminer (the distance of the heavy RAKE).

17. Comments (include measurements of any crater resulting from the explosion): Crater Depth: approx. 15 cm / Width: approx. 40 cm.

[The accident site.]

According to the preliminary investigation the incident happened due to individual mistake. The area very loose and the depth of the mine (based on the crater) no more than 18 cm.
