DDASaccident554

DDAS Accident Report

Report date: 06/02/2008	Accident number: 554
Accident time: 11:33	Accident Date: 26/11/2006
Where it occurred: Task # 193, Haji Bashar Village, Dand District, Kandahar Province	Country: Afghanistan
Primary cause: Field control inadequacy (?)	Secondary cause: Inadequate training (?)
Class: Tripwire accident	Date of main report: 03/12/2006
ID original source: OPS/03/01-24	Name of source: UNMACA
Organisation: [Name removed]	
Mine/device: POMZ AP frag	Ground condition: dry/dusty soft
Date record created:	Date last modified: 06/02/2008
No of victims: 1	No of documents: 2

Investigation Report of Mine/UXO Accident/Incident

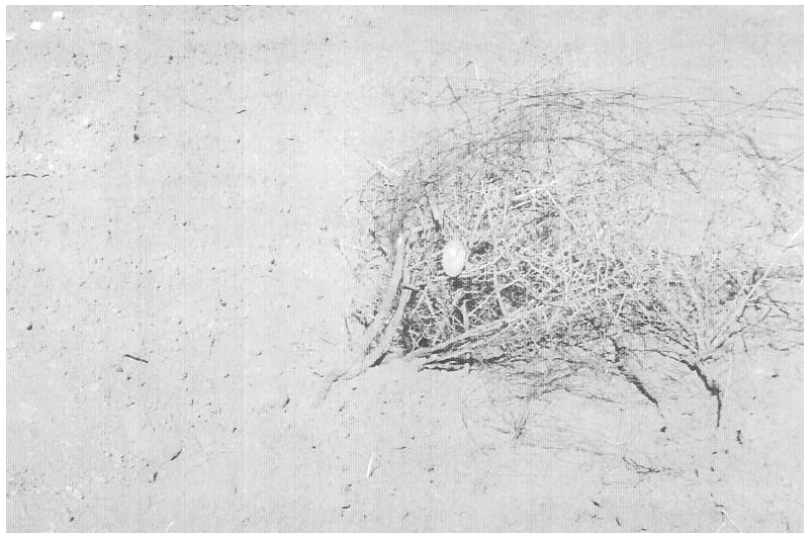
During the excavating of soil, which prepared (removed soil during the preparation by backhoe) by backhoe the mine was setoff. The deminer has pulled the bushes which were removed by Backhoe from the actual place and the visible wires were connected to the bushes it could be trip wires but the deminer has pulled it carelessly the accident has occurred.)

Site conditions: The terrain was uneven and open. The soil was soft and dry. The weather was clear and mild. The vegetation was light bushes.

[Over-exposed and photocopied pictures showed long apron PPE with small blood spots (implying that it was worn), a small thumb, index and forefinger injury on the left hand, a small fragment in the inner thigh, 15cm above the knee, a small injury inside the left forearm and a small fragment on the left shoulder (which would have been exposed if the deminer had been side-on to the detonation. The accident site is shown below.)

1. The command group of the team have obligation to control and guide their subordinates (deminers) during field operations especially while they are doing prodding, excavation and pulling.
2. Deminer should fully brief his successor during each change process about the specifications of each area (clearance Lane) and they should consult each other regularly.
3. Deminers are to wear full PPE while entering to operational area.
4. All deminers are to work on a signal with an approved position.
5. The deminer should never touch and pull bushes and any suspected wires without instruction of command group (immediate supervisor).
6. A refresher training with a focus on prodding, excavation, pulling and use of PPE should be provided to the team members.
