DDASaccident569

DDAS Accident Report

BOARD OF INQUIRY (BOI) INVESTIGATION REPORT

Ref: 06/2007

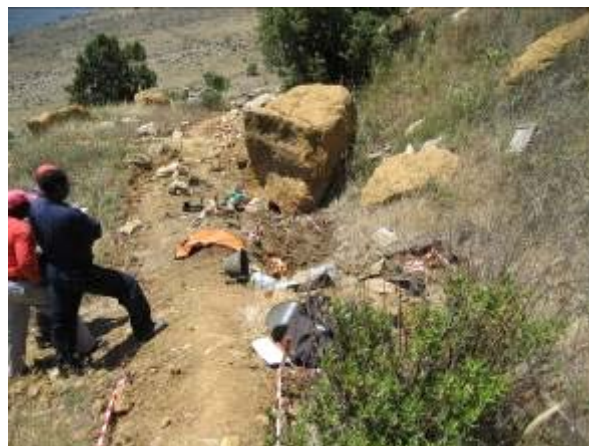
Note: The (Commercial demining group) Demining Accident Report, Paragraph 6, details that the accident site was photographed and left untouched for the LMAC/MACCSL investigation team. In accordance to the NTSG, Chapter 16, Investigations; the accident scene should be secured pending the arrival of the BOI team and photographs of the accident scene taken as soon as possible by the BOI team and Demining Organisation together.

[Photographs taken by the internal demining group investigation showed staff not wearing PPE.]

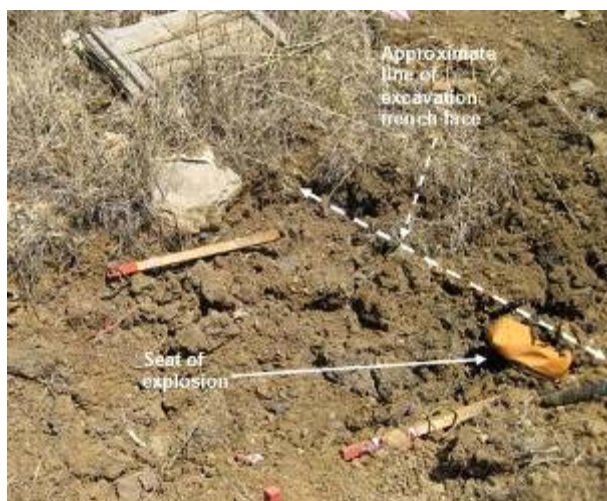
Photographs of the crater and the accident site were taken during the investigation, however it was not possible to physically examine the crater as the immediate area is pending further clearance as part of the on-going investigation. The crater was partially obscured by an orange bag and comprised loose clumps of earth and there was evidence of burn marks on the inside of the crater which is consistent with the effects of an explosion. The crater was shallow which may be attributed to the hardness of the ground and that the explosive device had been close to the surface. The BOI team had been informed by (Commercial demining group) that the closest mine located had been at a depth of 3 cm and that mines were generally found at a depth of 3-10cm.

[It is strange that people stood this close to the seat of initiation but did not think it safe to move the orange bag.]

Although, it was apparent that some excavation had taken place in the area of the crater, the precise location of the excavation trench face was not obvious due to the nature of the ground.

At the earliest opportunity, (Commercial demining group) shall conduct clearance of the crater site and recover the visor harness as additional evidence.

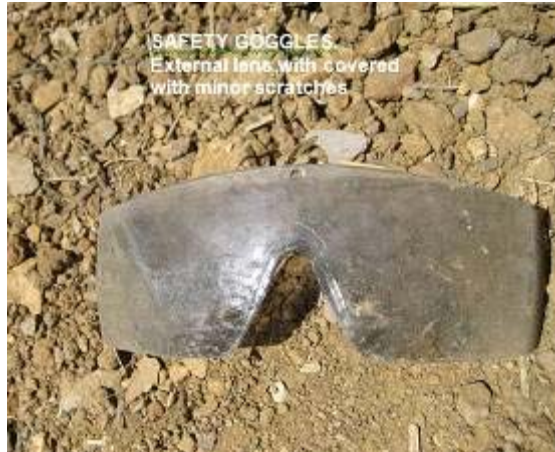
Safety Goggles

According to information received during the interview process, the casualty was wearing safety goggles beneath the visor prior to the accident. The lens was intact, slightly scratched on the outside and dirty across the inside. Both of the arms were missing. The goggles had retained their integrity during the explosion. The dirt on the interior lens, injuries sustained to the right eye and information from the medic that both eyes required cleaning, indicates that although, the goggles may have been worn correctly, they were unable to provide complete protection to the eyes during the explosion. It is possible however, that had they not been worn, the damage to the both eyes may have been more severe.

[The goggles did not “retain their integrity” because their arms broke off. They appear to be 2mm thick.]

Dirt on the inner lens of the goggles;

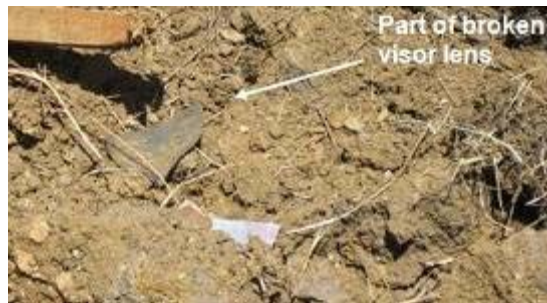
Ballistic Visor

According to information gained during the interview process, the Team Leader had seen [the Victim] wearing his PPE consisting of body armour, visor and inner safety goggles, correctly. The only visor evidence at the accident site was part of the lens which was positioned in the front / left side of the clearance lane and the harness. The broken lens was dirty and in the proximity of clumps of earth which appeared to be burnt. The visor harness was visible a few metres slightly forward and left of the clearance lane on the bank of the hill in an uncleared area. The lens was not attached.

[See Analysis.]

This evidence and the injuries sustained by the casualty indicate that the visor had been worn at the time of the explosion. The colour and shape of the lens fragment indicates that it had been broken off from the edge of the visor during the explosion and the location of the harness signifies that the visor had been pulled from the deminer’s head by the blast from the explosion. There was no other visor evidence in the immediate accident area which suggests that it had either shattered or been thrown into another area.

Visor lens broken and the location of harness;

- k) [The Victim] had been wearing his PPE (visor, body armour and safety goggles) at the time of the explosion. It is not possible to conclude whether the visor lens was completely down or tilted at the time of the explosion, however, based on damage to the visor, the location of the harness and injuries sustained, it can be concluded that the casualty's head was in close proximity and maybe over the seat of detonation.

The secondary cause is listed as a "*Field control inadequacy*" because the Victim suffered severe facial injury, including amputation of a lip, loss of teeth and loss of at least one eye. This indicates that the visor was not being worn correctly. It was raised and the field supervision should have corrected this.

It should be possible to conduct a thorough examination of the lens fragment and visor harness after additional clearance of the lane has been conducted.

- i) Supervisory staff should ensure that PPE is worn correctly at all times when working in the hazardous area. Consideration should be given to the use of helmets in conjunction with the visor when operating in mountainous / rocky conditions. It is however, understood that the balance between comfort and safety is a key factor when selecting appropriate PPE.

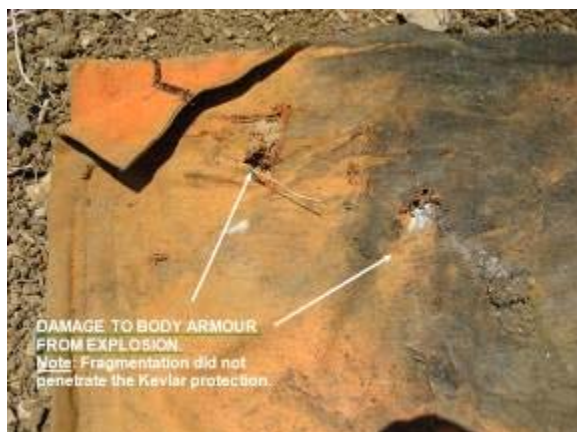
Ballistic Body Armour

The body armour is a one-piece 'apron style' design and comprises Kevlar protective material which covers the neck, chest, abdomen and groin regions of the body. The apron was covered in dirt and blackened through the blast effects of an explosion. There were tears on the outer cover primarily in the centre lower, right lower, right upper, right shoulder and right side of the collar which corresponds to the fragmentation effects of an explosion. There is evidence of blood on the right shoulder and around the rim of the collar. The Kevlar retained its integrity and the only evidence of penetration was a small hole on the seam of the collar.

[The apron is not made from Kevlar but a cheaper ballistic aramid. The position of its collar and the STANAG V50 rating of 380 m/s mean that it does not meet IMAS (as formulated in 2007).]

- l) The condition of the apron indicates that it had been worn correctly and that the right side took the brunt of the explosion.
- m) There is no evidence to suggest that the PPE was worn incorrectly by the casualty at the time of the accident. The type of PPE is in compliance with the NTSG and IMAS.

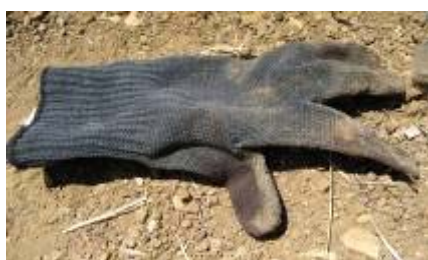
Gloves

According to information gathered during the investigation, Aramid protective gloves had been worn by the casualty prior to the accident. It was only possible to locate the left hand glove at the accident site and its appearance corresponded to information that it was worn by the casualty at the time; dirt on the palm and fingers with evidence of blood stains. The absence of the right hand glove is consistent to the traumatic amputation of the casualty's right arm by the explosion.

[The glove that was not on the Victim's other hand. "Aramid" simply means nylon. There is no evidence that any aramid or Kevlar glove is of any value at close quarters to an AP mine blast.]

The issue of thin "aramid" working gloves is a novelty. Aramid is a nylon, and thin aramid could make severe burns worse by trapping the burning fragments (fragments "weld" themselves inside body armour at times). In order to be flexible, the gloves have to be thin. The protection offered by aramid varies by weave and by the number of layers used (12-16 layers is common), so the fragmentation protection the gloves offered must have been very low.
