DDASaccident628

DDAS Accident Report

INCIDENT INVESTIGATION [Demining group] – MINE ACTION TEAM - JORDAN

TASK NAME AL SHAJARAH 1 (387)

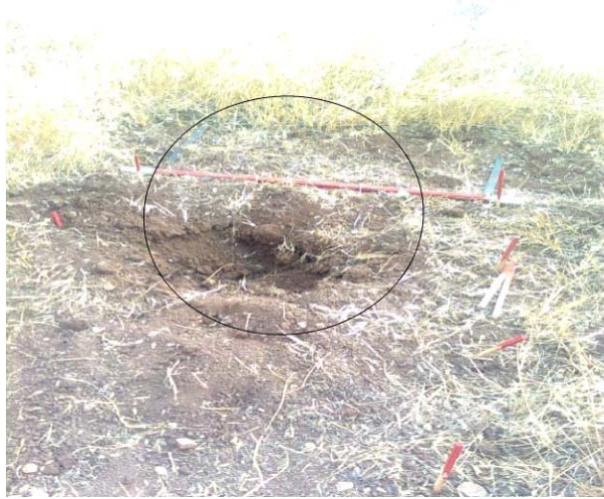
Deminer was clearing the first 60 cm of one cluster heading toward the centre mine after he cleared the 1st 60 cm by one 1m width with no signals he moved his base stick a head to clear the next 60 cm, then he stepped on the area which considered to be cleared by the same deminer, accidentally his foot went down due to the soil collapse under his foot (loose soil), the mine was in a depth of about 30 cm that when the deminer foot dived in the loosen soil he applied a pressure on the mine which activated the mine and caused the accident, note that from the accident result there was no direct contact between the deminer foot and the mine.

[The accident site, behind the base-stick in the area considered "cleared" by the deminer.]

Deminer was applying the drill as per as sop without any mistakes, he stepped on a loose soil area after he cleared it by the metal detector and investigated all the signals, the soil under his foot collapsed and caused the deminer foot to went down inside the loosen soil and activated the mine which was not exactly in its right place..

This accident is classed as a *Missed mine accident* because the photograph showed that the site of the initiation was behind the base-stick and between the side of lane markings – so in an area that the deminer had “cleared”.

The primary cause of this accident is listed as *Victim inattention* because the Victim had not located the mines when using his detector and had not used the demining group's excavation/detector drill appropriately enough to find a mine at this depth. (This drill is designed to locate mines that are too deep for the detector to locate without removing some of the ground. The ground he stepped on had been loosened, but had not been removed and searched with the detector appropriately.) The secondary cause is listed as a *Management Control Inadequacy* because the investigator concluded that no mistakes had been made, when clearly some had. If management does not recognise an error, it will not be corrected. The investigator's failure to check the performance of the metal detector was unusual and appears to have been an oversight.

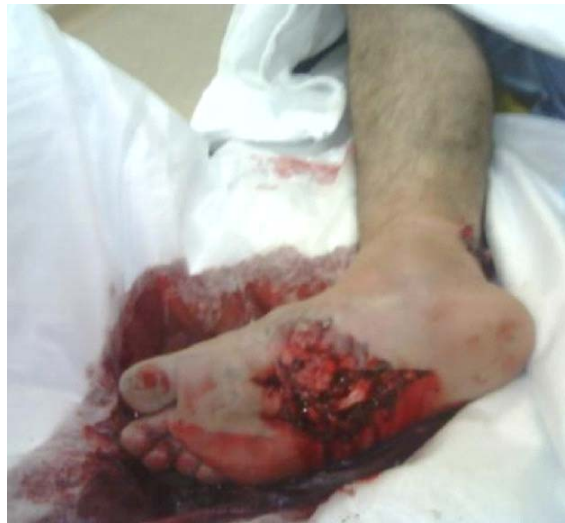
NATURE OF INJURY: Multiple comminutes fracture in his right foot and fracture of lower fibia and tibia.

A photograph showed severe disruption to the instep and apparent injury on the heel.

The Victim's injury includes severe disruption of the sole of the foot, which does imply that there may have been a distance between the mine and the sole of the BFR boot (new research into the impulse and shock wave transfer through various materials supports this). The failure of the blast boot to provide significant protection against a 28g mine may be significant.
