## DDASaccident012

Humanitarian Demining Accident and Incident Database  
*AID*

# DDAS Accident Report

<b>Report date:</b> 22/01/2004	<b>Accident number:</b> 12
<b>Accident time:</b> not recorded	<b>Accident Date:</b> 10/08/1997
<b>Where it occurred:</b> Laghawat Village, Deyak District, Ghazni Province	<b>Country:</b> Afghanistan
<b>Primary cause:</b> Unavoidable (?)	<b>Secondary cause:</b> Inadequate equipment (?)
<b>Class:</b> Excavation accident	<b>Date of main report:</b> [No date recorded]
<b>ID original source:</b> none	<b>Name of source:</b> MAPA/UNOCHA
<b>Organisation:</b> [Name removed]	
<b>Mine/device:</b> PMN AP blast	<b>Ground condition:</b> hard
<b>Date record created:</b> 12/01/2004	<b>Date last modified:</b> 12/01/2004
<b>No of victims:</b> 1	<b>No of documents:</b> 1

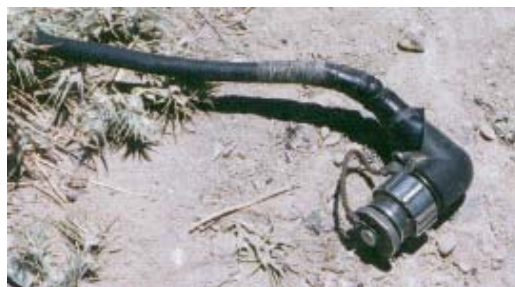
There was no record of the investigators having checked the ability of the detector to operate in the prevailing conditions.

The picture below shows a Schiebel AN/19 detector cable connection crudely repaired in the field. Detectors in similar condition were seen frequently by the researcher in 1998.
