Evaluation of Floorpan Tearing and Cable Splices for Cable Barrier Systems

*Midwest States Pooled Fund Research Program
Fiscal Years 2014-2015 (Years 24 and 25)
Research Project Number TPF-5(193) Supplement #64 and #79
NDOR Sponsoring Agency Code RFPF-14-CABLE-1 and RFPF-15-CABLE-1*

EVALUATION OF FLOORPAN TEARING AND CABLE SPLICES FOR CABLE BARRIER SYSTEMS

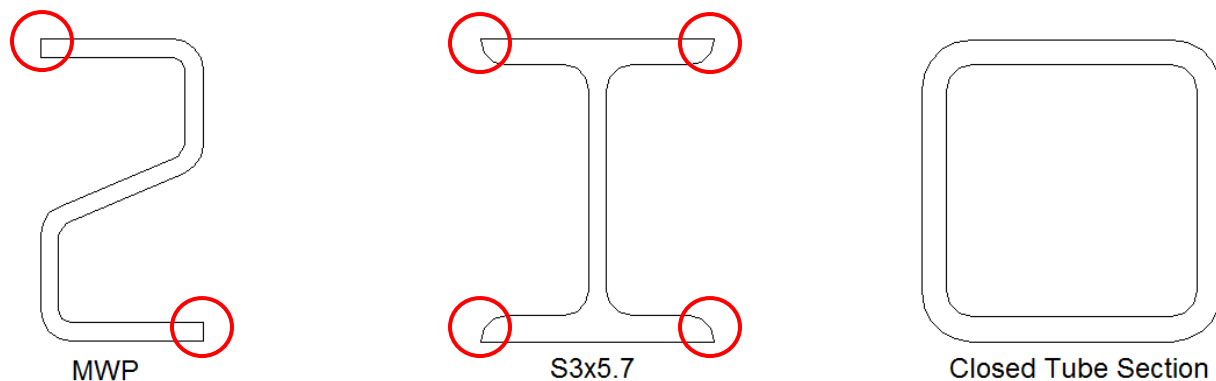
Figure 2. Post Shape Free Edges

The presence of free edges within the post's cross-section amplifies the effect of this restoration force. Free edges are characterized as areas of the post's cross section where an end of a flange, or another thin element, is exposed within the cross section. The location of free edges on common post shapes are shown in Figure 2. The thin elements and small contact areas of these free edges result in higher stress concentrations during impact events. Thus, under equivalent restoration forces, posts with free edges will impart higher stresses to the vehicle's floorpan than posts with continuous faces or closed cross sections.

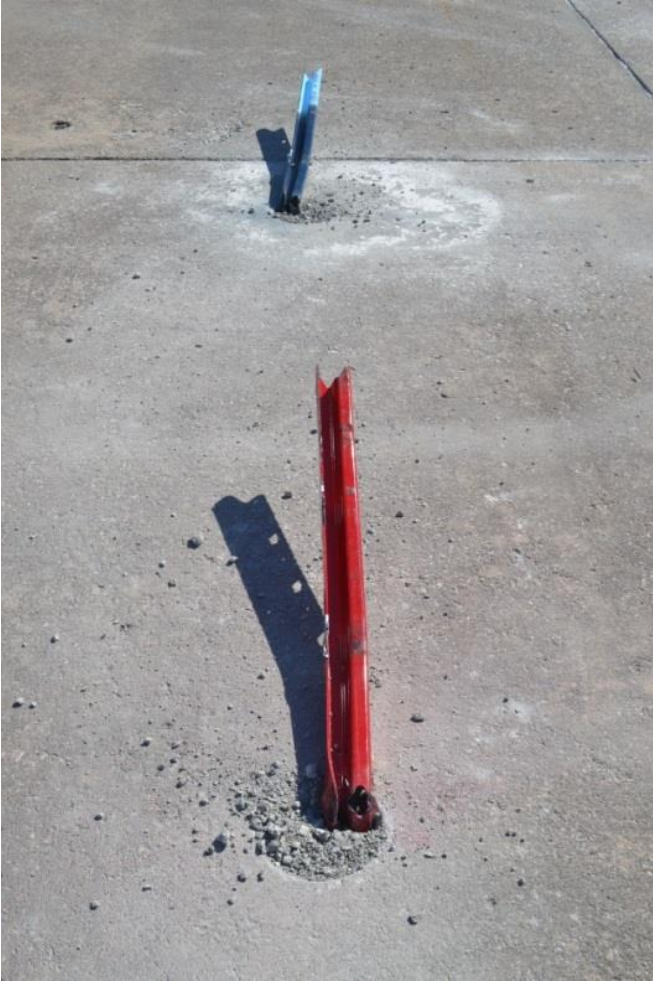
Figure 32. Time-Sequential and Post Damage Photographs, Test No. MWPPF-3

The posts were bent plastically near the groundline, and tearing was found in both posts, as shown in Figure 32. The tears initiated from the weakening holes on the impact side of the posts and extended into the webs and adjacent flanges. Contact marks were found on the top half of the post along the free edge and impact side face of the post. Damage to the simulated floorpan included scrapes and creases but no tearing. Four creases were found in both the front and rear bays of the simulated floorpan, as shown in Figure 33. The creases resulting from contact with the free edges of the posts extended nearly the entire length of the bogie vehicle, while the creases resulting from contact with the continuous edges of the posts were limited in length. All creases observed on the simulated floorpan were measured and are summarized in Table 6.

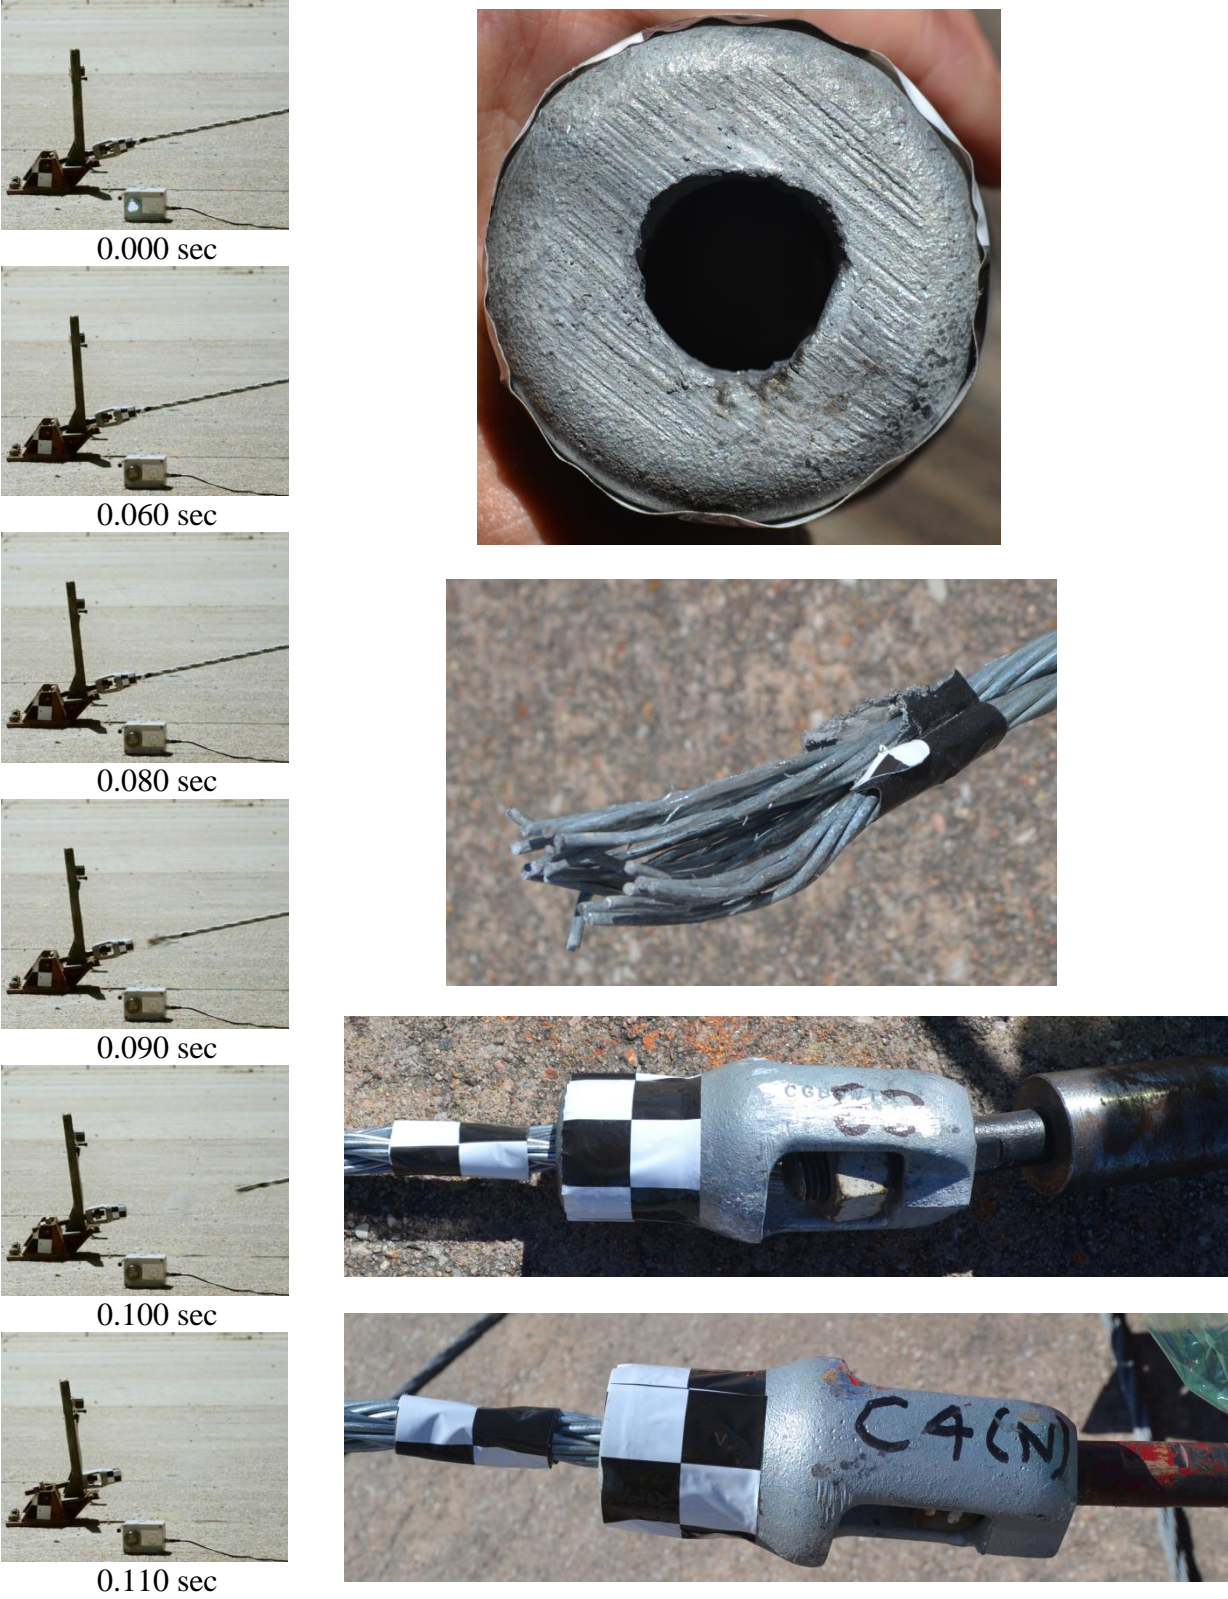
Figure 106. Time-Sequential and Post-Test Photographs, Test No. BBNC-1

The inside of the failed coupler contained striations, formed from the wire rope as it pulled through the opening, but the coupler was otherwise undamaged. The upstream end of the cable that pulled through the coupler was deformed and frayed, and the wedge was no longer entwined within the wire strands. The cable ends pulled $\frac{5}{8}$ in. (16 mm) out of the other three couplers.

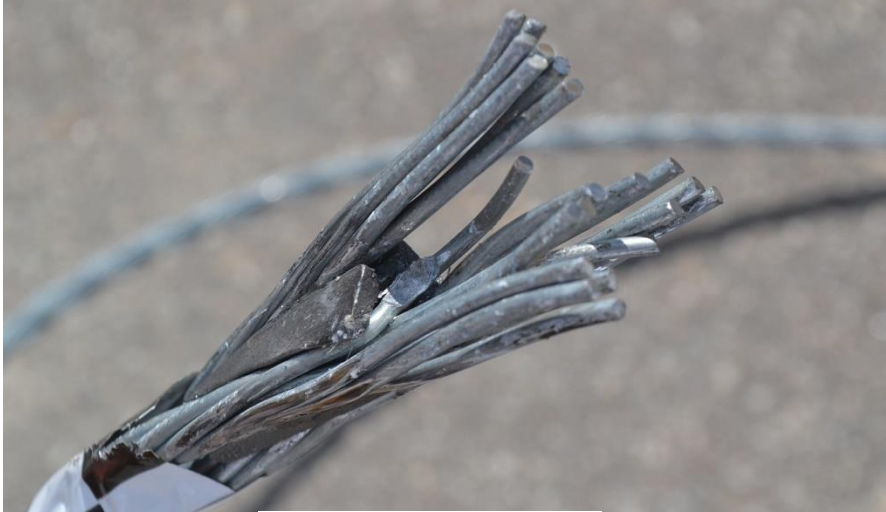
Figure 108. Time-Sequential and Post-Test Photographs, Test No. BBNC-3

The inside of the couplers contained striations formed from the wire rope as it pulled through the opening, but the couplers were otherwise undamaged. The cable ends were deformed and frayed, but unlike the previous tests, the wedges were still entwined within the wire strands at both ends. The wedges were crushed and plastically deformed around the individual wires of the cable.
