# PERFORMANCE OF ULTRA-THIN WHITETOPPING (UTW) IN OKLAHOMA

FINAL REPORT ~ FHWA-OK-10-05  
ODOT SP&R ITEM NUMBER 2222

DECEMBER 2010

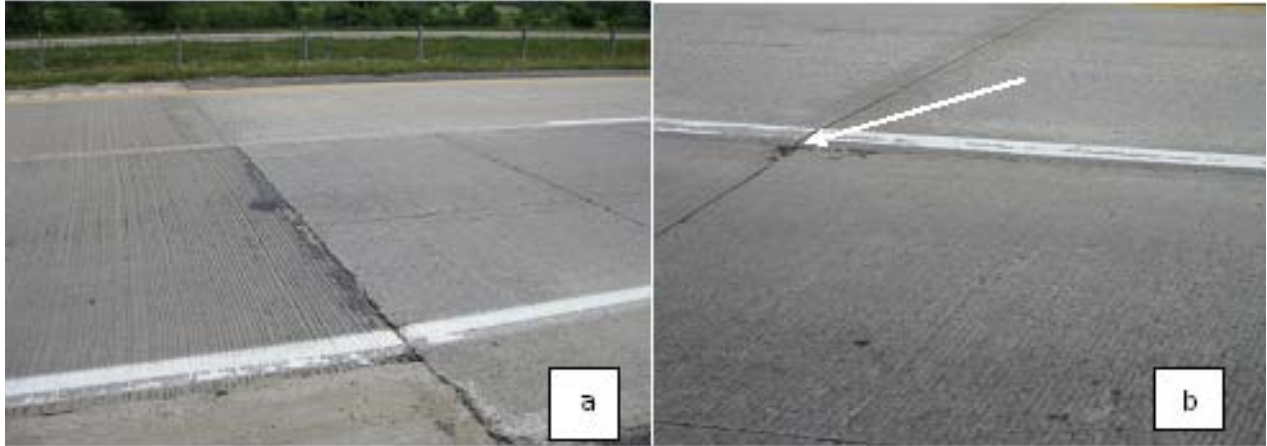
The overall condition of this overlay looks excellent. However, a few problems were observed. Joint raveling was a common problem which was observed as shown in Fig. 2.6 b. Some longitudinal cracks were seen covering multiple panels from 2 panels to 9 panels long. In total, 38 panels had visible cracks, which is about 1% of the total number of panels. Some examples of the longitudinal cracks are shown in Fig. 2.7. The passing lane was in better shape as compared to the driving lane. This is as anticipated as the travel lane would be expected to see significantly more traffic than the passing lane. Also in the driving lane the right wheel path showed more wear when compared to left wheel path. This may be due to the presence of an asphalt shoulder for this overlay. An asphalt shoulder would not provide as much support as the adjacent concrete lane. At about 0.2 miles from the start of the overlay a core was taken for previous testing. However, it was not refilled well; the filler material has been removed over time, as shown in Fig. 2.8. The drainage for this system was excellent.

**Figure 2.6** - Photo a showing the start of the overlay at north end. Photo b shows typical joint raveling seen.

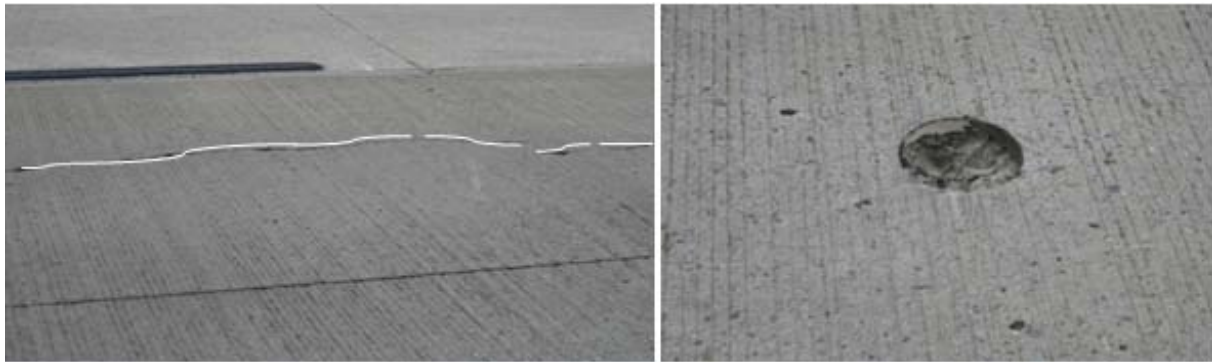
**Figure 2.7** - Longitudinal Cracking spanning over panels

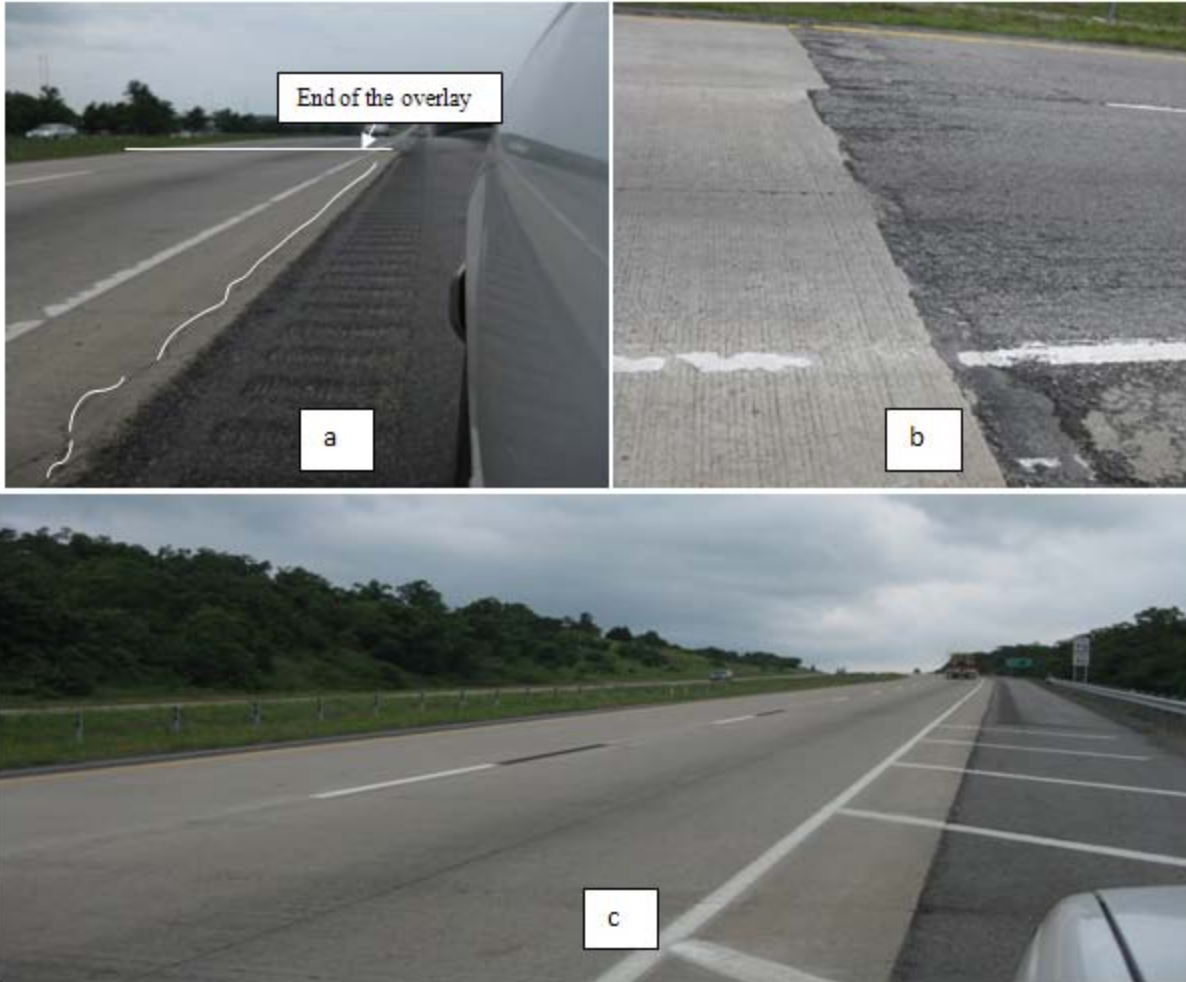
A longitudinal crack that covered 13 panels on the outside of the pavement was seen, as shown in Fig. 2.9 a. Faulting was seen at the end of the overlay. The last seven panels had problems with faulting. Occasional grinding on the surface was seen on these panels. This south bound overlay ended at an asphalt pavement as shown in Fig. 2.9 b. The end was also the top of a hill as shown in Fig. 2.9a.

**Figure 2.9** - Photo a shows the 13 panel long longitudinal crack at the end of the overlay. Photo b shows the transition of concrete into asphalt at the end of the overlay. Photo c shows overall good condition of the overlay.

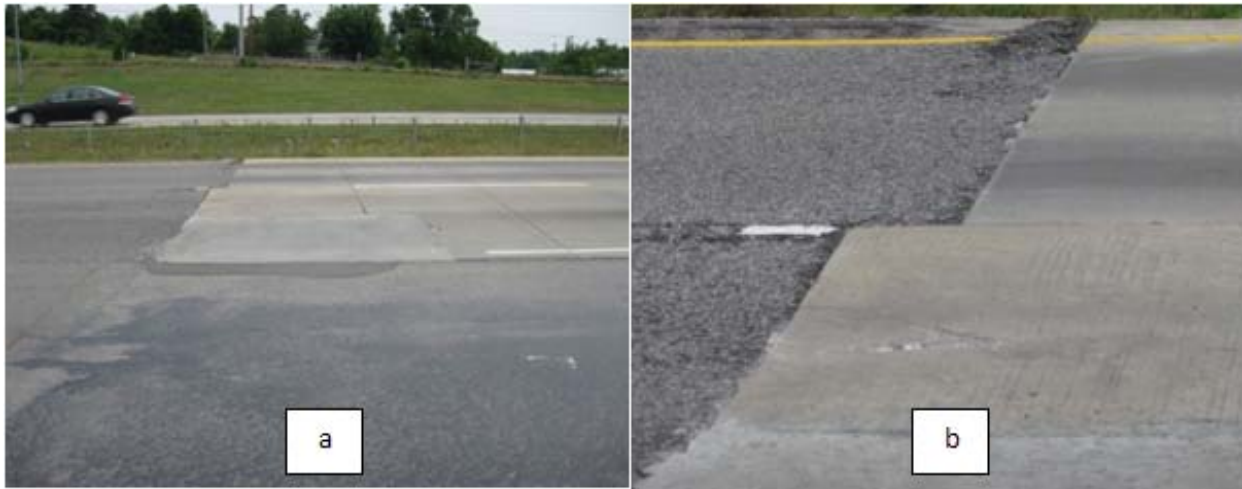
The overall condition of this overlay looked very good. However, there were some problems observed. The initial panels had been replaced with a new concrete panel (Fig. 2.10 a). A definite elevation difference was seen between the asphalt pavement and the approach thin white-topping panel at the beginning of the project. The elevation difference was very significant, with some cracking observed in the approach panels even after the replacement (Fig. 2.10 b). Some heavy polishing was seen in both driving and passing lanes of the overlay, stretching to over 30 panels in length. Longitudinal cracking was also seen, but it was insignificant as it was just at a couple of places over the overlay and also spanned only for two panels. At about 0.7 miles after the start of the overlay (at exit for US 270 west on the highway), two punch outs were seen, as shown in Fig. 2.11. Some corner cracking was also observed where the approach ramp meets the overlay after this exit. None of the problems stated above were extensive, but they should be monitored for future deterioration. The end of the overlay looked good without any sign of distress, as shown in Fig. 2.12, as it ends in a concrete bridge. Also, drainage of this overlay looked quite good and satisfactory.

**Figure 2.10** - Initial panel replacement at the start of overlay as seen in photo a, and in photo b we see how there is an elevation difference between the leaving asphalt panel and approaching concrete panel.

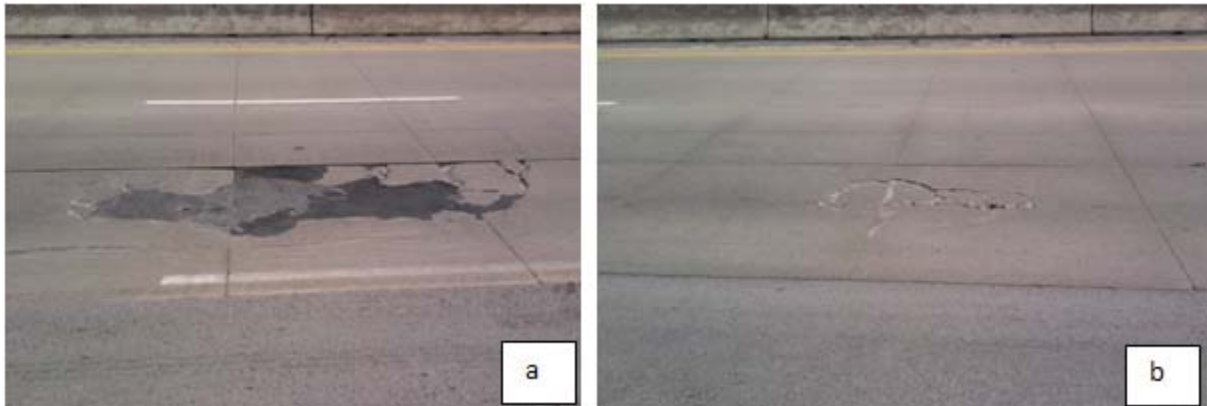
**Figure 2.11** - Punch outs at the exit for US 270 west. These two punch (photos a and b) outs are about ten panels apart from each other.

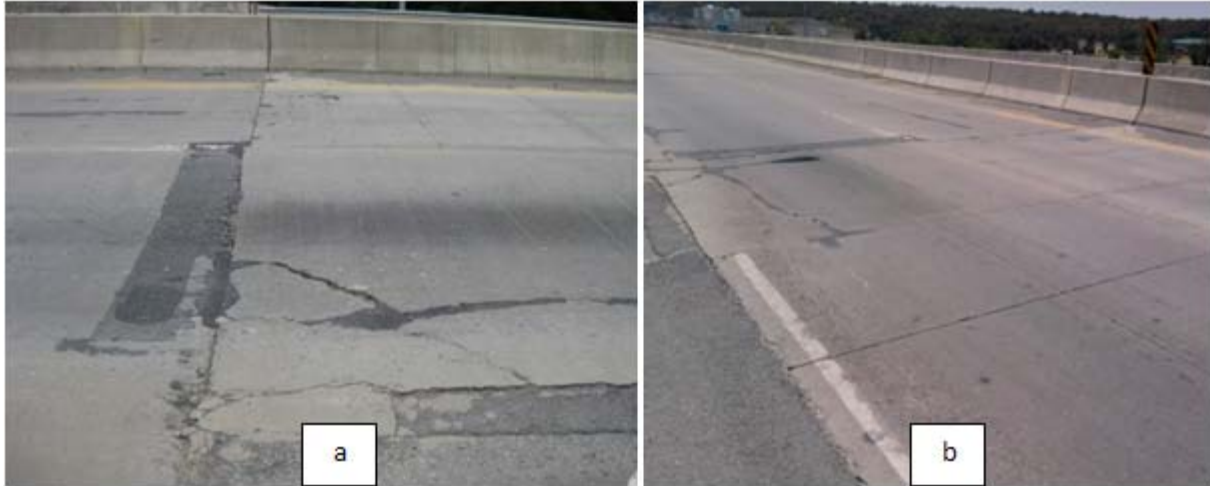
This overlay starts at the end of a concrete bridge in McAlester. The overlay has shown good performance apart from the initial panels. The initial panels have heavy block cracking, as shown in Fig. 2.13 a. The driving lane of the overlay has a continuous replacement panel and not the thin white-topping overlay seen in the passing lane, as shown in Fig. 2.13 b. The reason for these failed initial panels could not be determined. Some minor longitudinal cracking, scaling and polishing were observed in the passing lane. However, they probably are caused by normal wear. At about 0.2 miles from the south end of the overlay, heavy surface scaling and corner cracks were observed in the driving lane. Similar heavy abrasion and scaling was again observed in the passing lane about 0.8 miles from the south end of the overlay.

**Figure 2.13** - Initial panels facing block cracking as shown in photo a. The first panel is replaced after initial failures with a full size panel as shown in photo b.

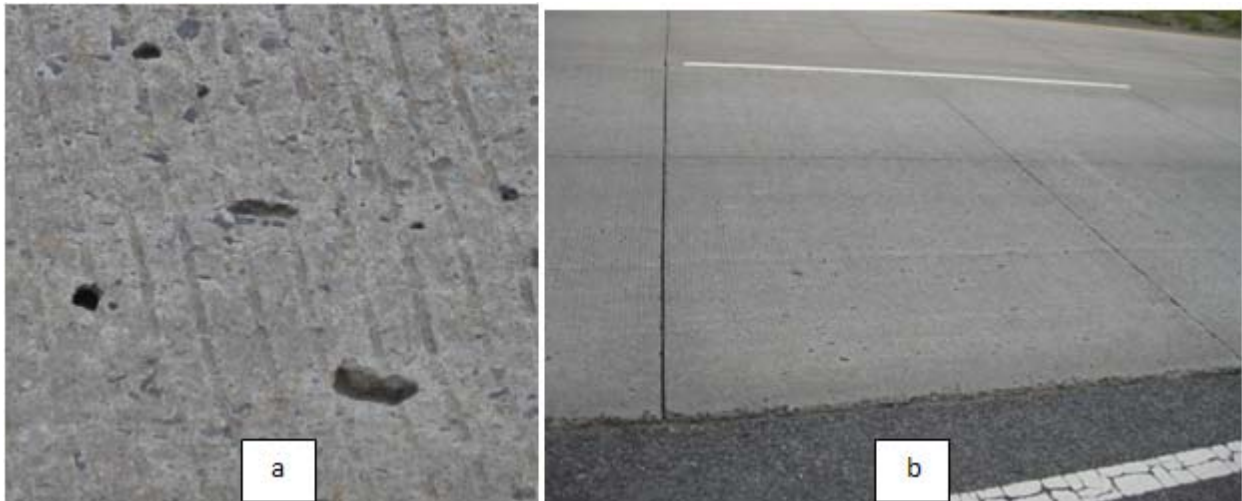
Some pop outs were seen about 0.5 miles from the south end of the overlay. About 24 panels showed pop outs with approximately 20 per panel, as shown in Fig. 2.14. This is likely caused by an unsound aggregate being used in these panels. The overlay ended in a jointed concrete pavement. Significant scaling and faulting were observed where the overlay ends. However, repairs have been done for both panels, as shown in Fig. 2.15.

**Figure 2.14** - Photo a showing pop outs (about 20 pop outs/panel) of larger aggregates (on about 24 panels) at about 0.5 miles from the south end of the overlay. Photo b is just the closer view of photo a.

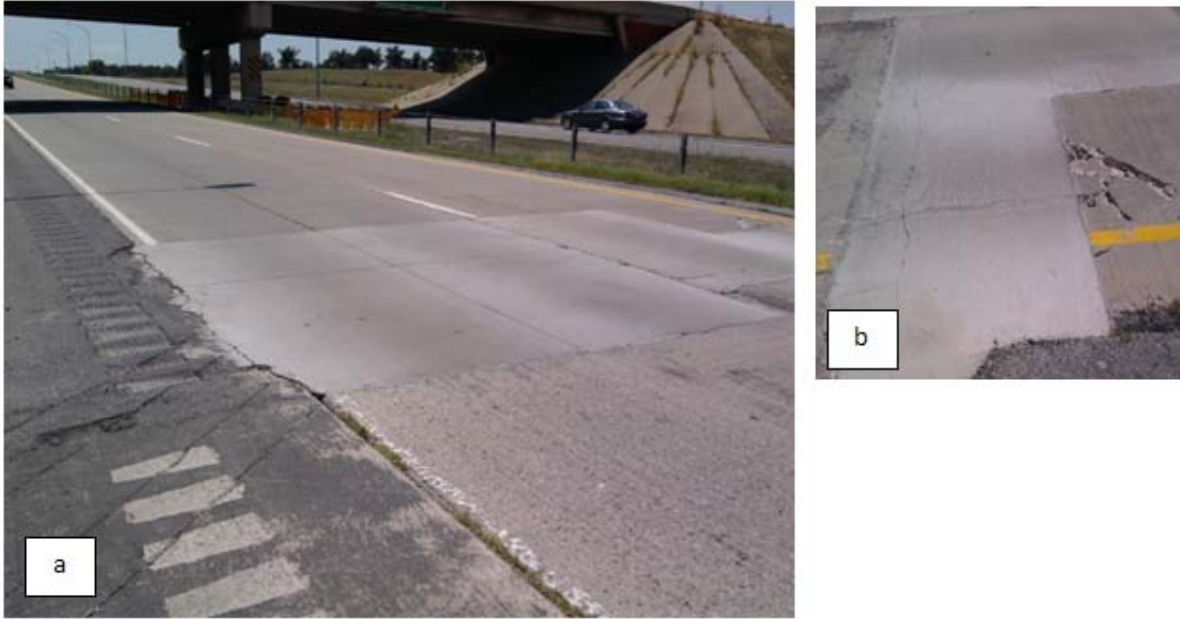
**Figure 2.15** – Photo a shows the repaired panels at the north end of the overlay. Photo b shows a cracked panel at the west end of the overlay.

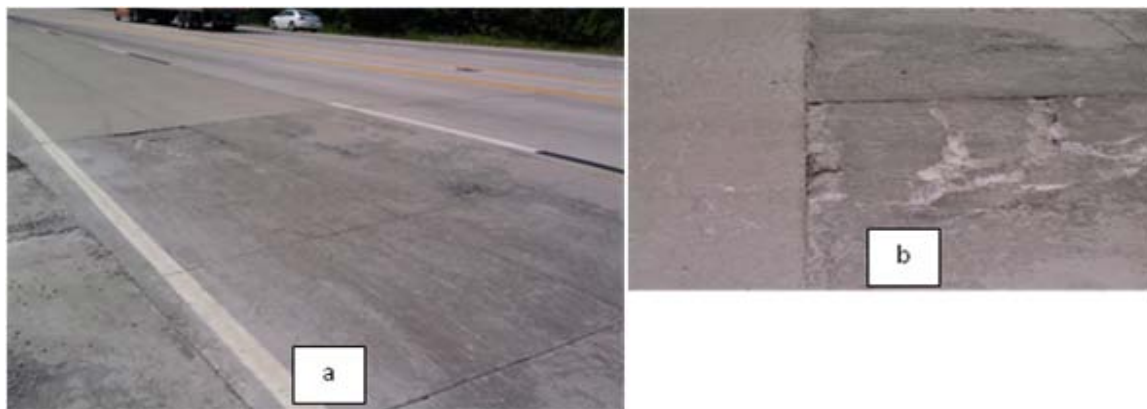
Figure 2.17 shows the start of the north bound overlay. The initial panel has block cracking, as shown in the photo. The reason for this block cracking could not be determined. This is surprising, as the overlay is just one year old.

**Figure 2.17** – Photo a shows a cracked panel at the start of an overlay. Photo b shows a closer view of that panel.

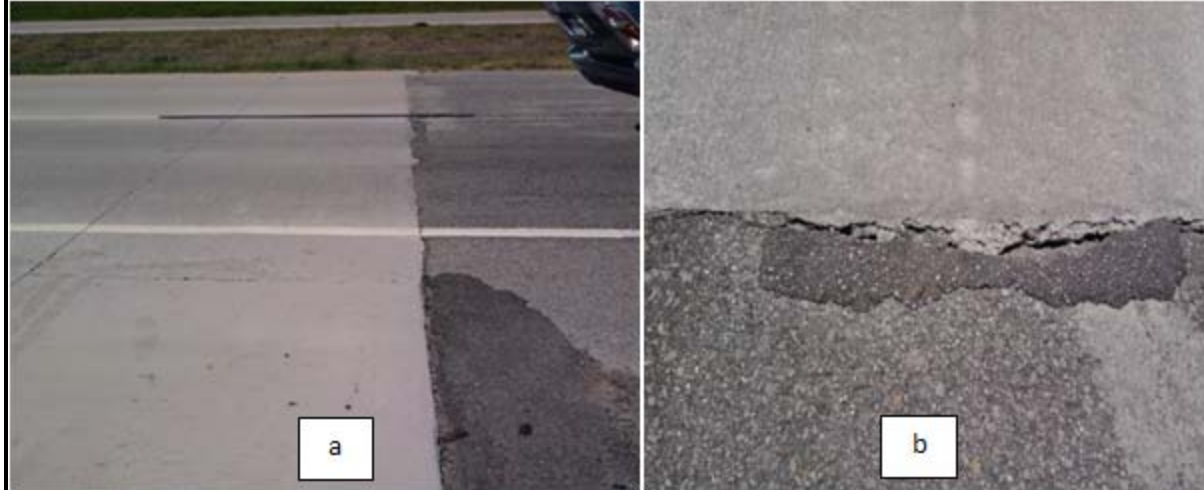
**Figure 2.18** - Photo a shows the end of the overlay. The asphalt pavement looks good where it starts. But there is bit of distress initiation as shown in photo b.

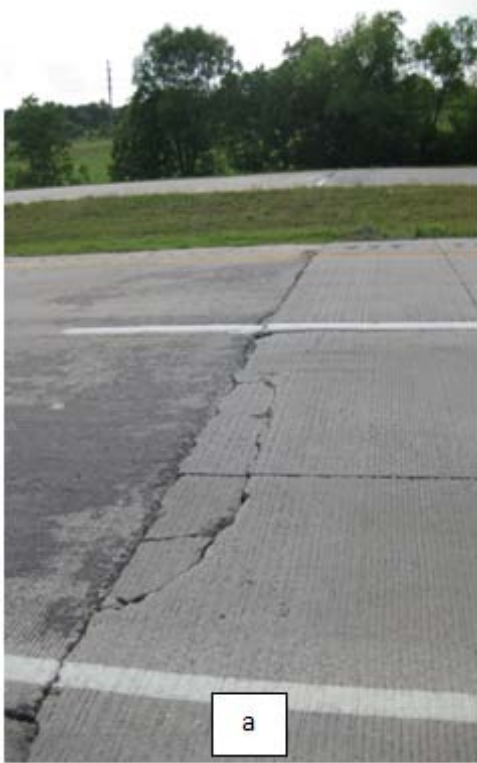
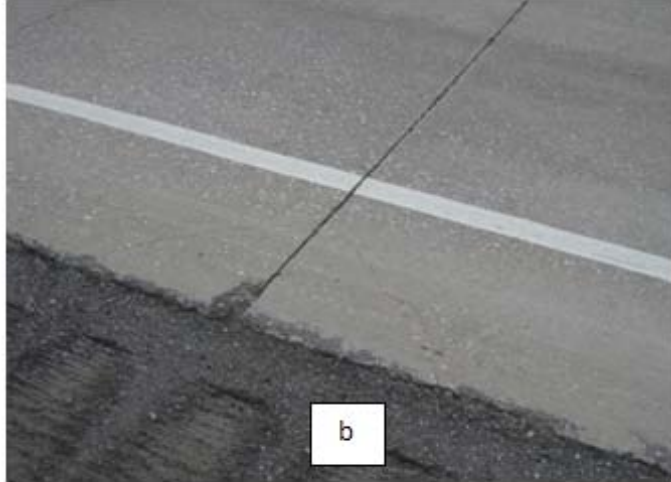
This overlay showed some distress where it was adjacent to a CRCP. This distress included corner cracking and some initial cracking at the interface between the two systems, as shown in Fig. 2.19 a and b. But all of those remain at a very rudimentary level and pose no issue of concern. The overlay otherwise was in good shape. The end of the overlay is shown in Fig. 2.20. Some polishing was seen in the intermediate stage of the overlay, but it looked like mechanical polishing done for smoothing the surface and not the wear of the overlay. Fig. 2.21 shows one of these areas.

**Figure 2.19** – Photo a shows the cracked panels at the junction of the overlay and the existing asphalt pavement. Photo b shows a rare corner crack on the overlay.

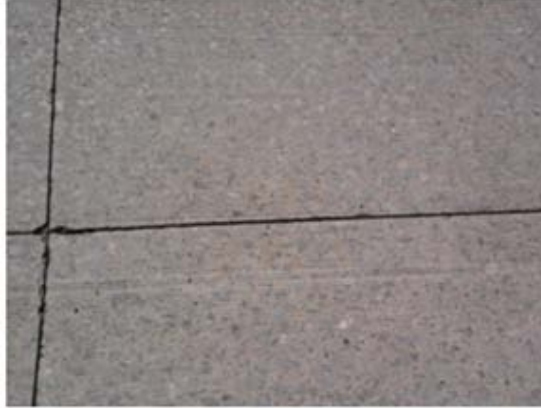
**Figure 2.21** – Polishing of the overlay surface.

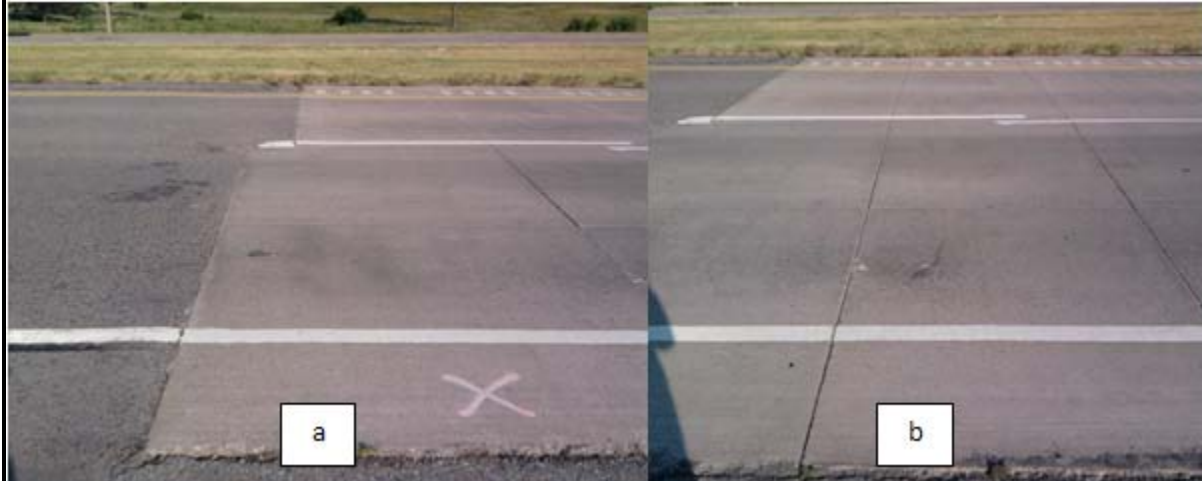
There was very few corner or longitudinal cracks seen on the pavement. Some polishing in the driving lane and some abrasion were seen in a few spots. Grinding was performed at some places to make the surface of the overlay smoother. The initial panel is without any distress, as shown in Fig. 2.22 a. There was some shoulder alligator cracking as shown in Fig. 2.23 a, but it was only seen at two places. The end of the overlay looked excellent, as it ended into a CRCP. The overall health of the overlay is excellent.

**Figure 2.22** - Photo a showing start of the overlay where the asphalt pavement ends. A corner crack was seen on the second panel right after the start of the overlay is shown in photo b.

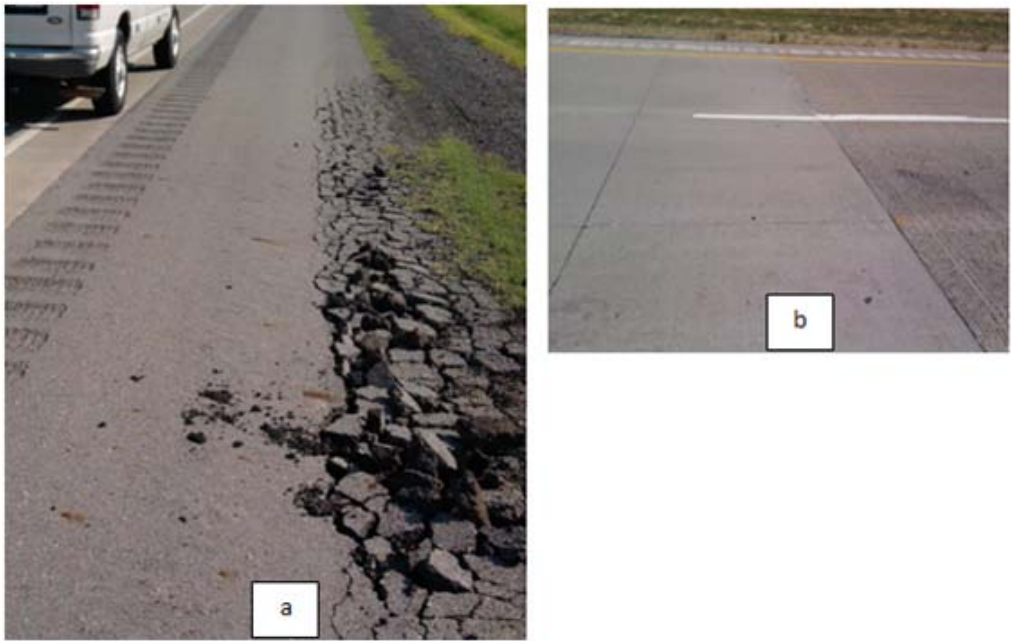
**Figure 2.23** – Photo a shows the deterioration of the asphalt shoulders. Photo b shows the interface of the overlay with a CRCP pavement. The end of the overlay was in excellent condition.

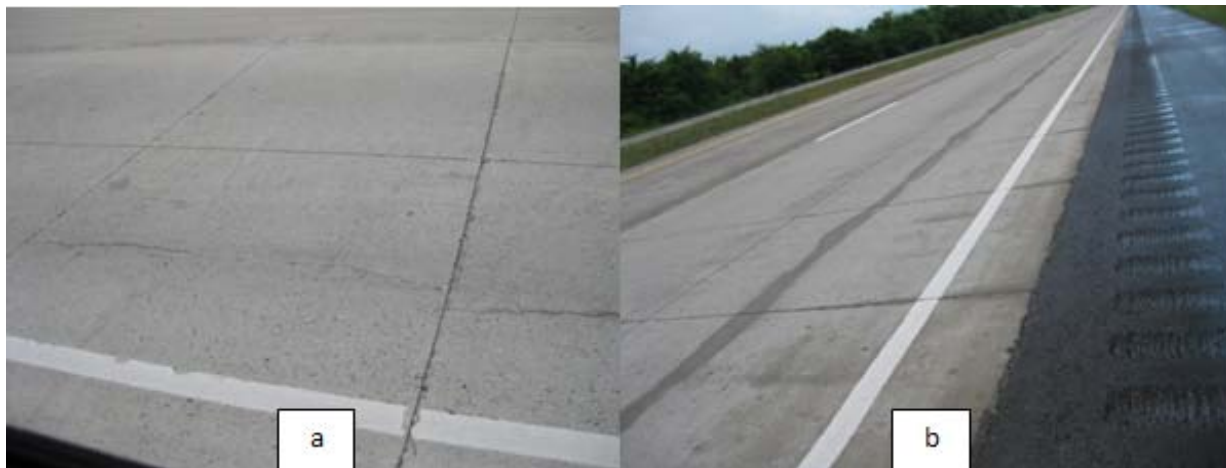
Most of the problems on this overlay were in the right wheel path of the driving lane. The passing lane did not show significant deterioration. Longitudinal cracks extending through two panels on average were seen all along the overlay; some cracks extended through up to 4 panels in a row. The number of cracked panels was significant, as shown in Fig. 2.24. About 200 panels (about 6%) were cracked per mile for the initial two miles. Then this crack pattern stopped abruptly.

**Figure 2.24** - Photo a showing the type of longitudinal cracking pattern. Photo b shows the cracks after heavy rains overnight. The seepage of water through the cracks is clearly visible.

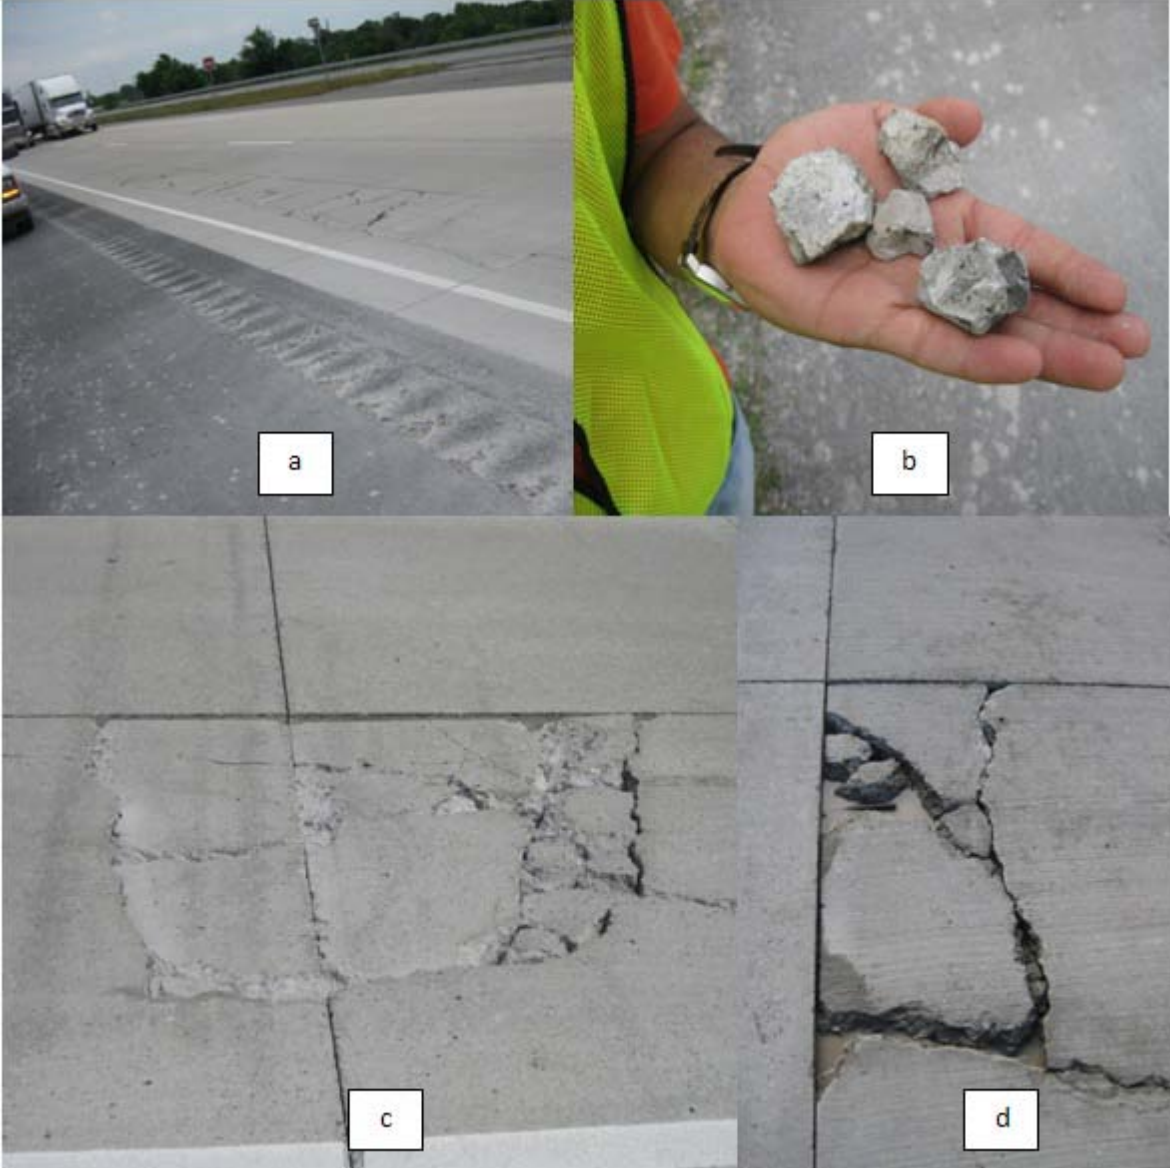
It was noticed that the deterioration of the overlay seemed to correlate with the intersections. Sometimes the failure was seen just as an individual panel failure. Sometimes it was seen as a series of panel failures covering up to seven panel failures in a single stretch. There were also large pieces of

concrete that were from the failed panels. The drainage for this overlay was not good. Several places were seen to retain water instead of letting it flow through the system. However, it is unclear how much of an effect this poor drainage has on the failures. A total of 19 such individual or series panel failures were seen along the 5 mile stretch of the overlay, some of them are shown in Fig. 2.25.

**Figure 2.25** - Photos showing the failures of panels in the right wheel path of driving lane of the overlay. Photo a shows failures observed in continuous panels. Photo b shows the pieces of concrete that came from the failed panels. Photo c shows individual panel failures, typically seen in at the intersections. Photo d shows drainage problems in the pavement.

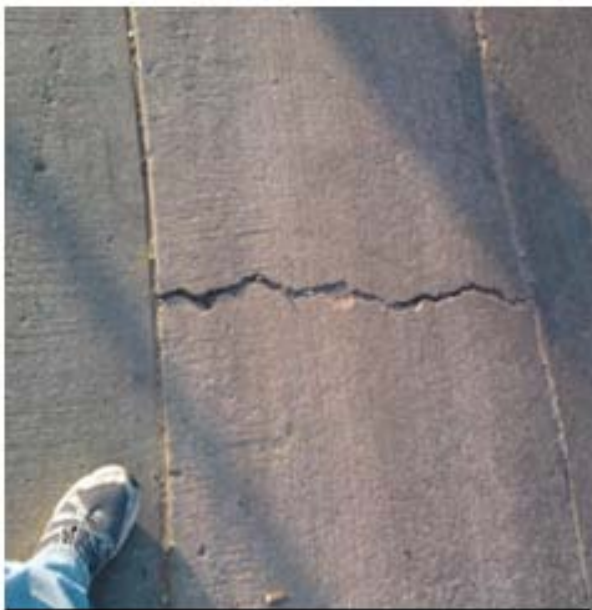
Figures 2.36 through 2.40 show the problems observed primarily at the west approach on SH – 51. The problems observed were cracking in the shoulder, approach panel failures, fines movements, and abutment cracking. Figure 2.36 shows the cracking in the shoulder on the US – 177 south side turn from west SH – 51. Figure 2.37 shows the approach panel failures from west SH – 51. The first panel is longer (6' x 9') than all of the other overlay panel dimensions. The 9' dimension is in the east-west direction, the same direction as the traffic. Also, there is considerable rutting (refer Fig. 2.37 b) on the adjacent concrete leave slab on the east side of the concrete bridge connecting to the intersection (refer Fig. 2.29 for layout of bridge and overlay). This rutting has induced an elevation difference which may have decreased the performance of the approach panel. In addition, since this panel is longer, one would expect the length to increase the bending stresses in the panel from center loadings as well as the curling of the panel. Severe cracking of the panel can be seen in Fig. 2.37.

**Figure 2.36** – Distress cracking in the shoulder.

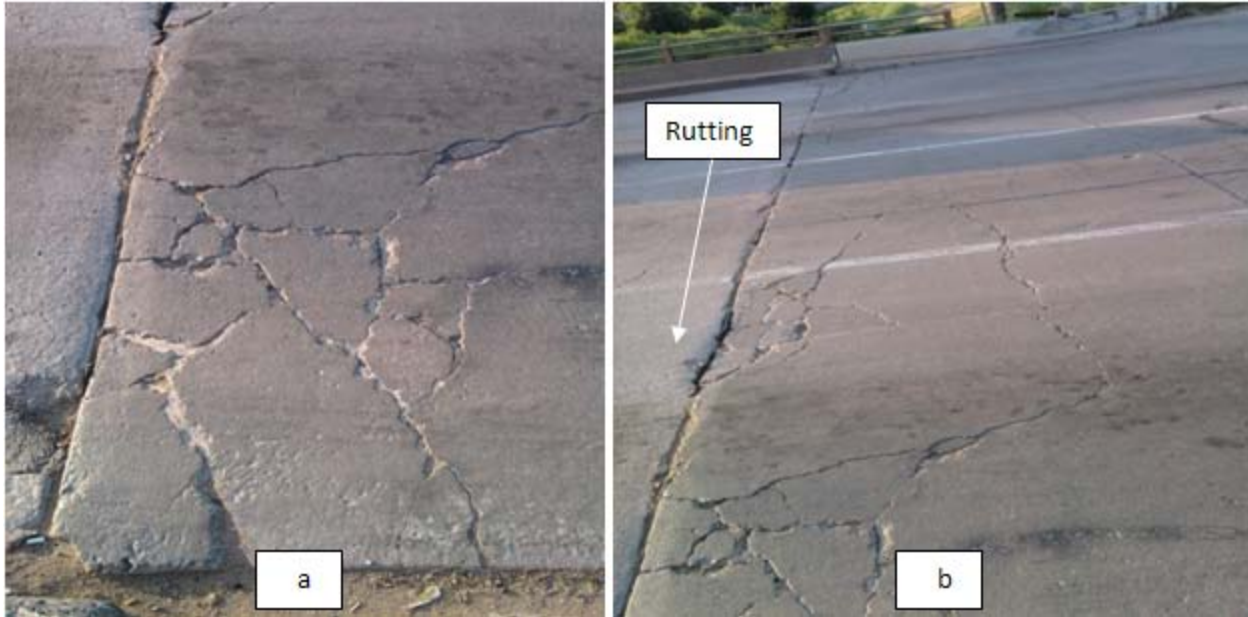
**Figure 2.37** - Photos from west side of intersection on SH – 51. Photo a is at the intersection of the overlay and the concrete bridge. Rutting can be clearly seen in photo b.

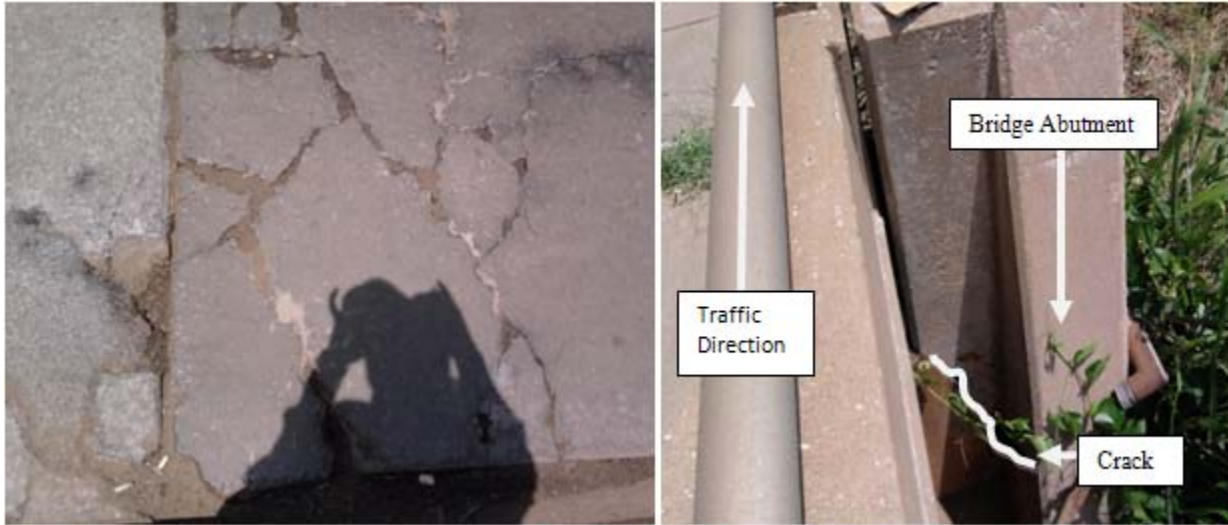
Figures 2.38, 2.39 and 2.40 show the fines movement seen on the pavements, the abutment cracking and the impact loading due to an insufficient turning radius for large trucks. Figure 2.39 shows the abutment cracking which may have been caused by thermal movements of the pavement or perhaps settlement of the compacted soil behind the bridge abutment. However, it is not clear when the cracking occurred. It is also not clear whether there is any type of relation between the fines movement and the bridge abutment. Figure 2.40 is really interesting as it shows how the tire impacts the ground as it leaves the curb and creates stresses on the surface of the pavement.

**Figure 2.38** - Fines movement in first panels of intersection. **Figure 2.39** - Cracking in abutments of the bridge.

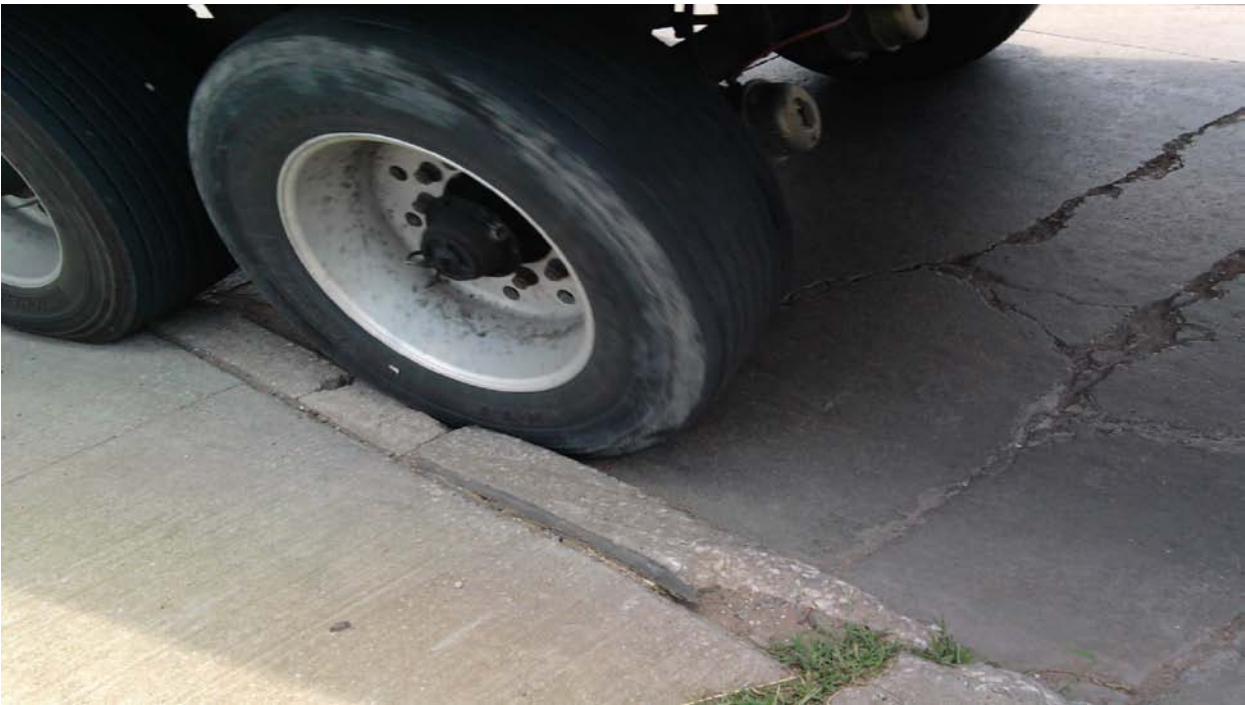
**Figure 2.40** - Photo showing the impact loading due to lack of radius of curvature for large trucks.

2. Maintaining close elevation difference at the approach panels may reduce the possibility of initial panel failures due to impact loading.

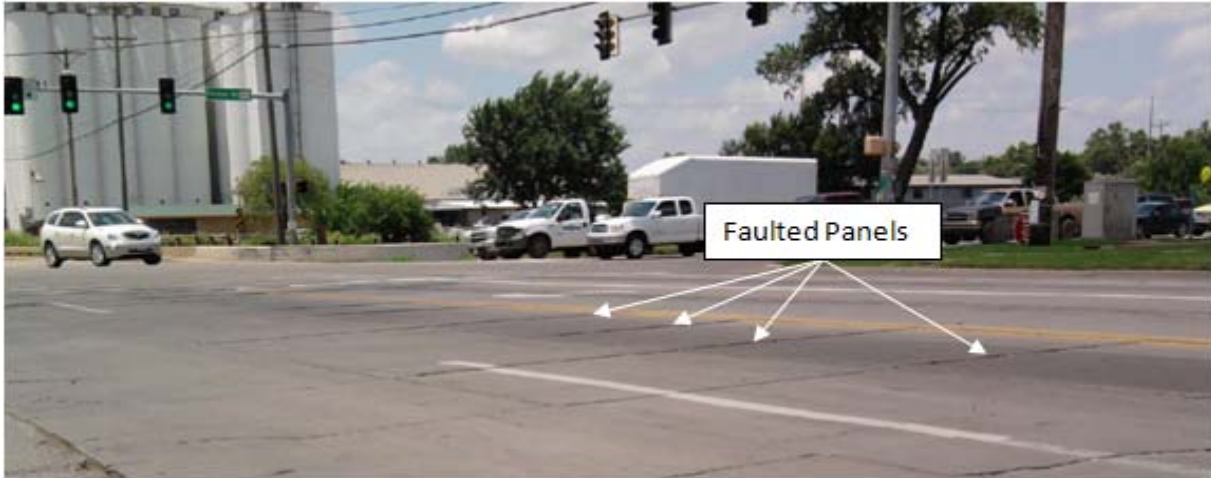
Figures 2.41 through 2.44 show the problems with the east end of the intersection. Again, this is also on SH – 51. Some of the problems observed were faulting and panel cracking where the concrete overlay interfaced the asphalt shoulder. Figures 2.41 through 2.42 show the faulting which is taking place on

the eastern end of the overlay. Predominantly, faulting was seen only in east bound lanes and not in west bound lanes. However, the west bound lanes showed quite a bit of longitudinal cracking.

**Figure 2.41** - Photo showing faulting as seen from east end of the intersection. A repetitive noise was heard from the tires of the vehicles when they passed on the faulted panels.

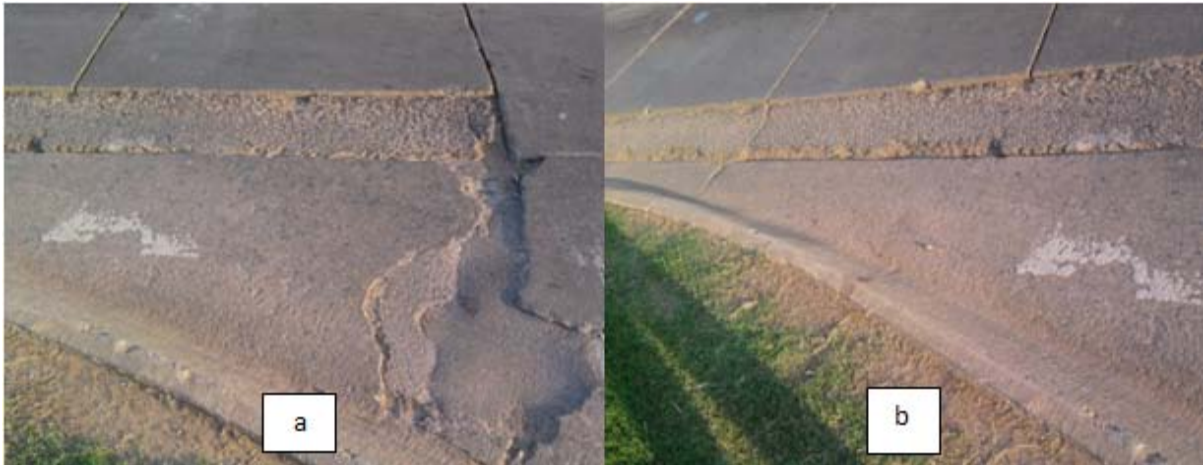
**Figure 2.42** - Photos a and b showing faulting as overlay turns from west SH – 51 to north US – 177.

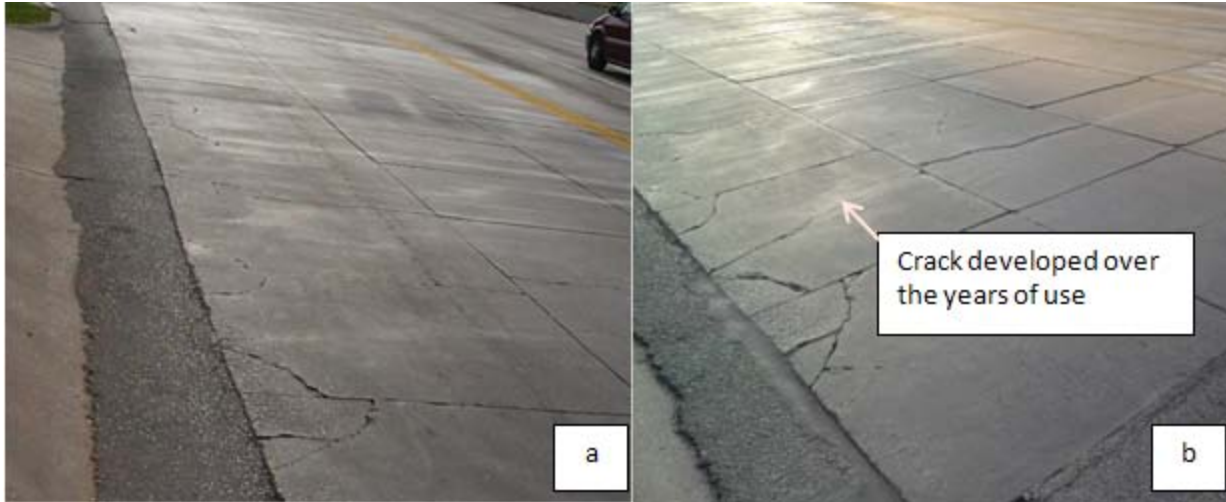
Figures 2.43 through 2.44 show how the cracking has increased. This increase in damage is apparent at the interface of concrete and asphalt. Figure 2.43 shows a crack that has extended from the shoulder since 2004. We know this crack has extended as we have photographs taken by MacArthur and Associates from 2004. Some sections were seen in which some parts of panels have been elevated, as shown in Fig.2.44.

**Figure 2.43** - Photos at the entrance to the gas station showing how the cracking has changed between 2004 and 2010. Photo a was taken in 2004 (David Cline, MacArthur Associated Consultants) and photo b is taken by the research team in 2010.

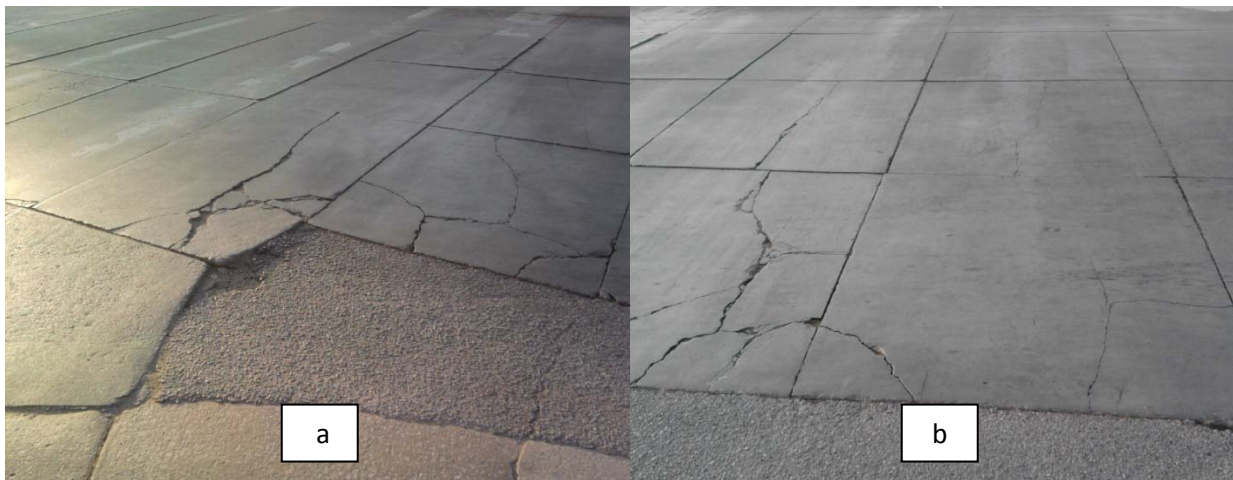
**Figure 2.44** - Large block cracking at the east end of the intersection where the overlay is adjacent to the gas stations. The shadows shown in photo a show the difference in height between to the overlay and the adjacent asphalt. Additional block cracking can be seen in photo b.
