THIN ASPHALT OVERLAYS IN DIVISION VI

CE&F
DW
PJ
MS
Final Report^{Thin}
June 1996^{De}

13. TYPE OF REPORT AND PERIOD COVERED Construction Report	
12. SPONSORING AGENCY NAME AND ADDRESS Oklahoma Department of Transportation		14. SPONSORING AGENCY CODE

15. SUPPLEMENTARY NOTES Division VI is examining the feasibility of substituting thin asphalt overlays for chip seals as a maintenance application on low ADT roadways.

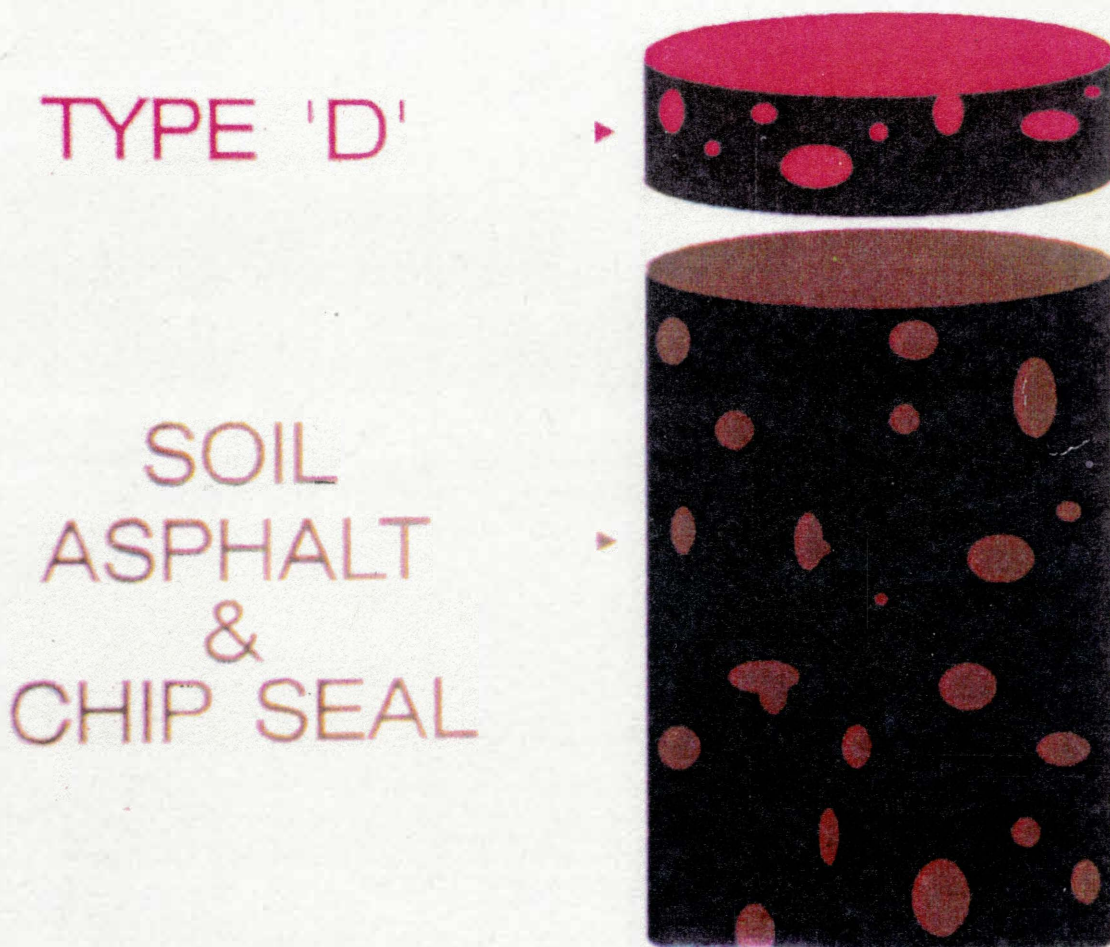
Figure 2. TYPICAL SECTION 1.

Typical Section 1 consisted of a 13 to 19 mm ($\frac{1}{2}$ to $\frac{3}{4}$ in) Type D surface over several successive layers of soil asphalt and chip seal. The thickness ranged from 152 to 254 mm (6 to 10 inches). Typical Section One is representative of the roadway composition at Sites 1, 2, 4 and 6. See Figure 2 for a graphical depiction of Typical Section 1.

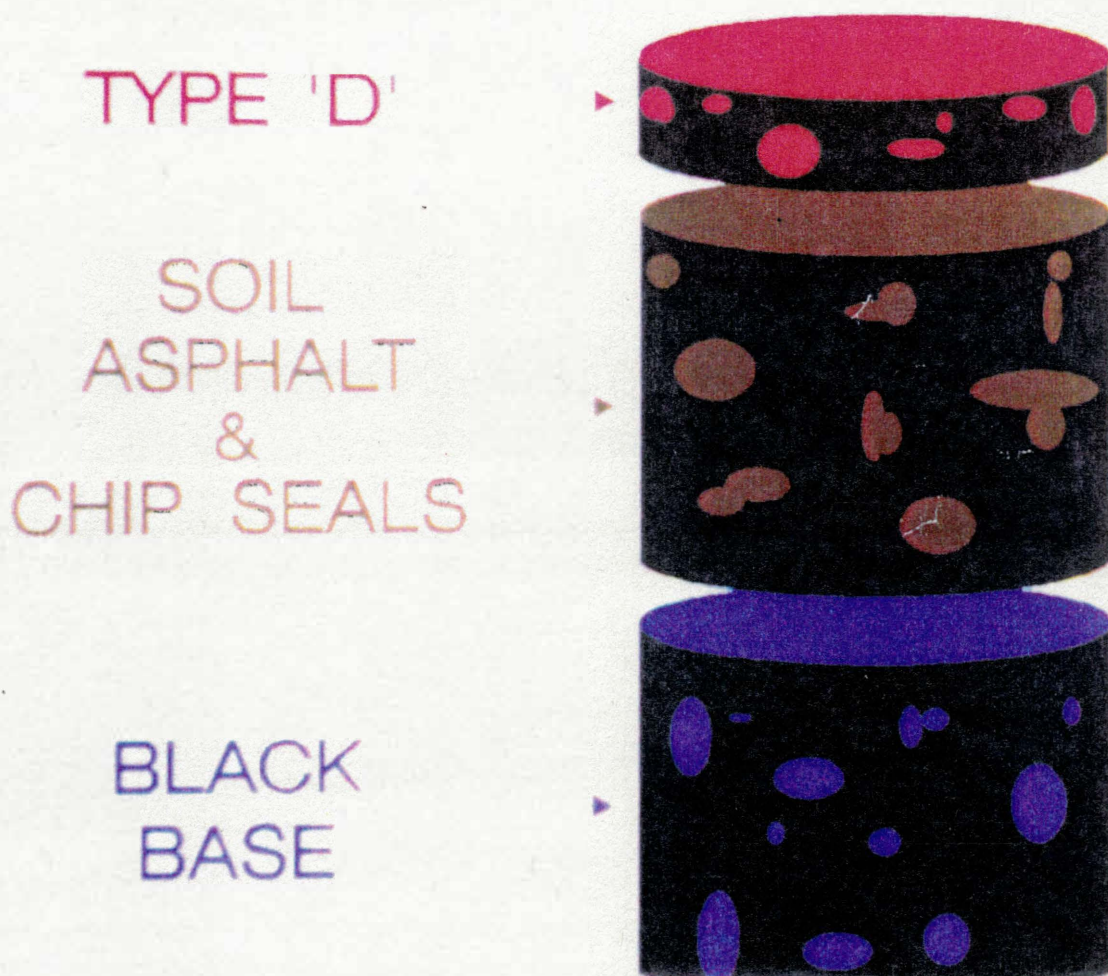
Figure 3. TYPICAL SECTION 2.

Typical Section 2 had a 13 mm (½ inch) Type D surface over three layers of soil asphalt and chip seal measuring 76 mm (3 in). The base course was a dense graded black base mix. Typical Section 2 (Figure 3) is representative of the roadway composition at Site 3.

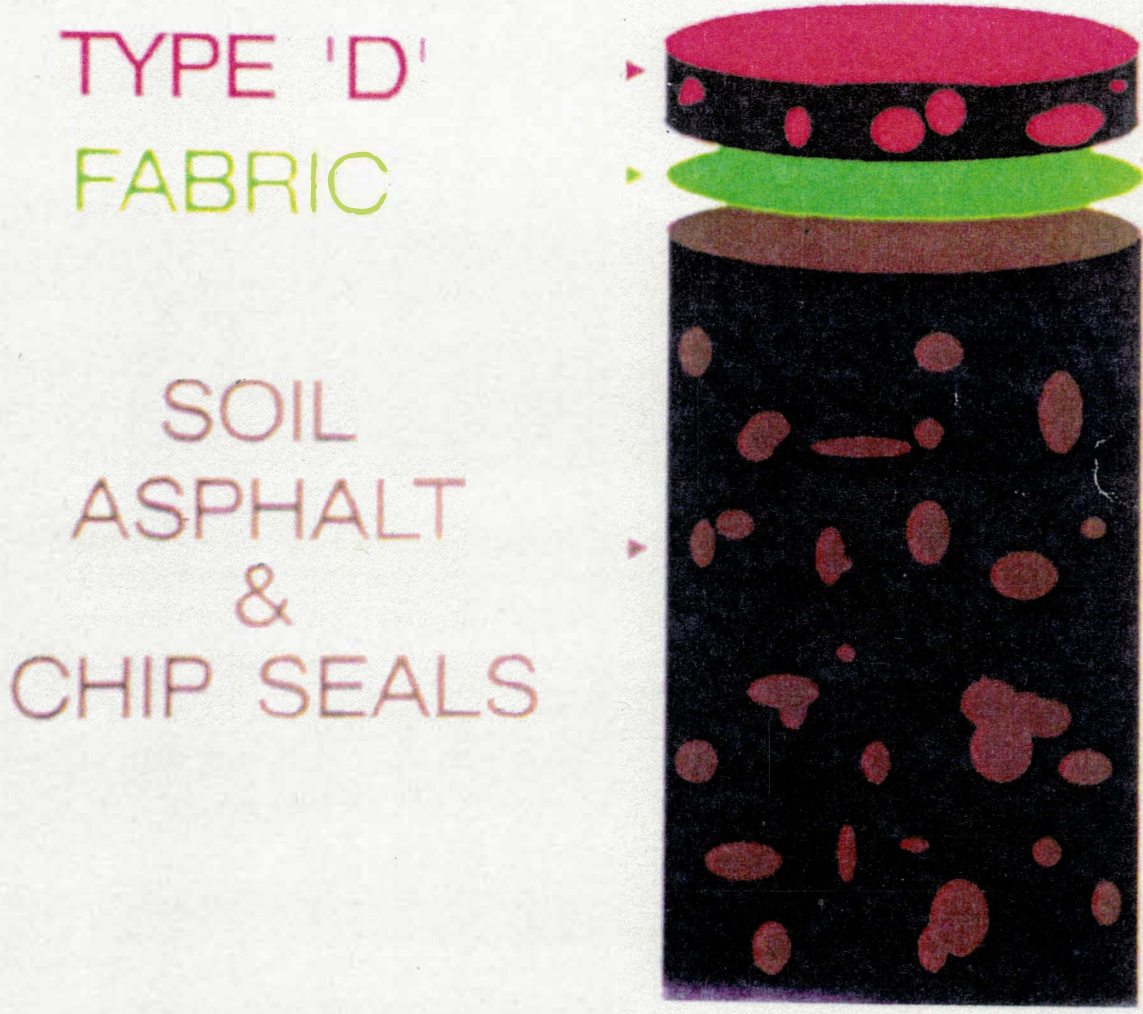
Figure 4. TYPICAL SECTION 3.

The third typical section consisted of a 13 mm (½ in) Type D surface over a fabric membrane and 292 mm (11 ½ in) of successive soil asphalt and chip seal layers. Typical Section 3 (Figure 4) represents the roadway composition at Site 7

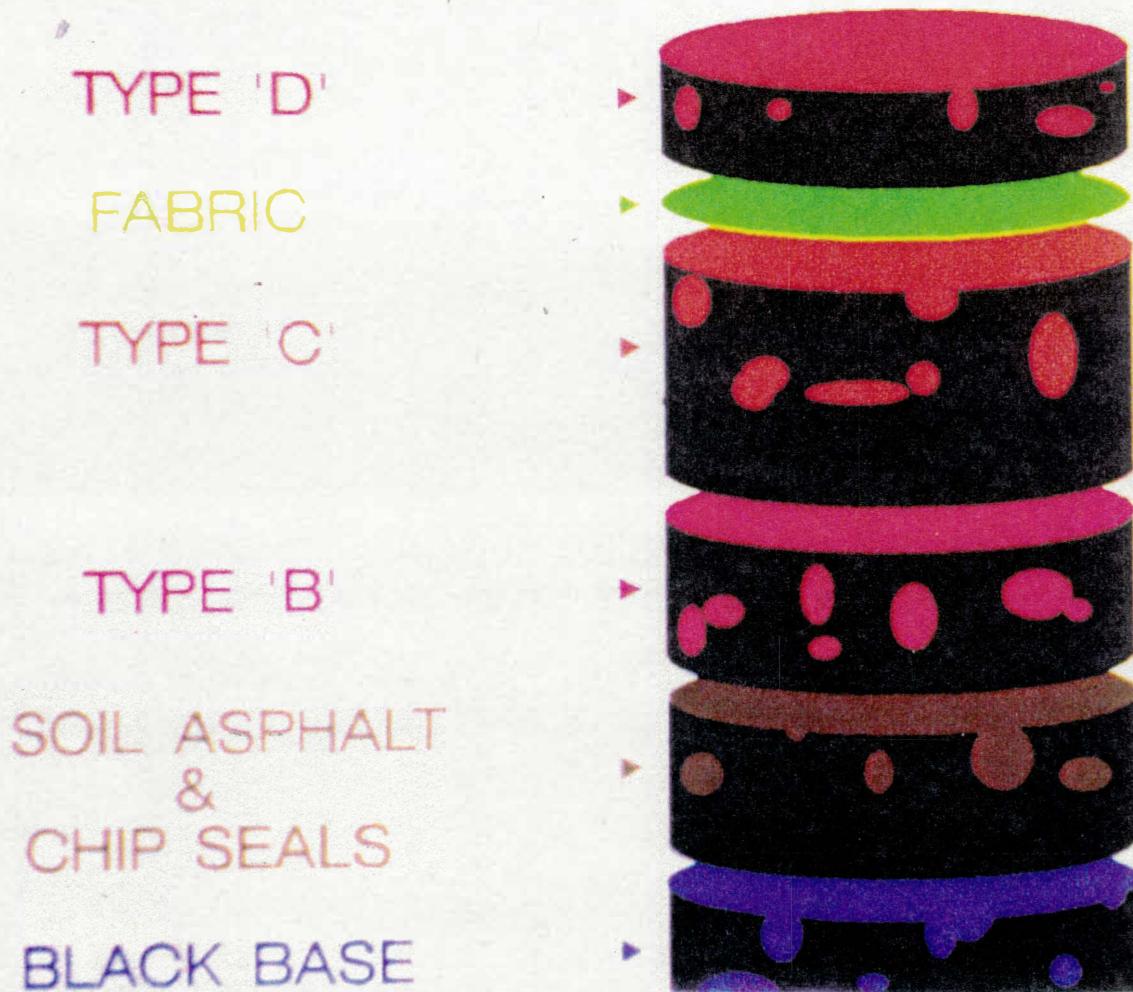
Figure 5. TYPICAL SECTION 4.

Typical Section 4 had a 19 mm (3/4 in) Type D surface over a fabric membrane. Beneath the fabric was 83 mm (3 1/4 in) of a dense graded Type C mix, 51 mm (2 in) of Type B, and 51 mm (2 in) of layered soil asphalt and chip seals. The base course was a dense graded black base mix measuring 38 mm (1 1/2 in). Typical Section 4 (Figure 5) represents the roadway composition at Site 5.

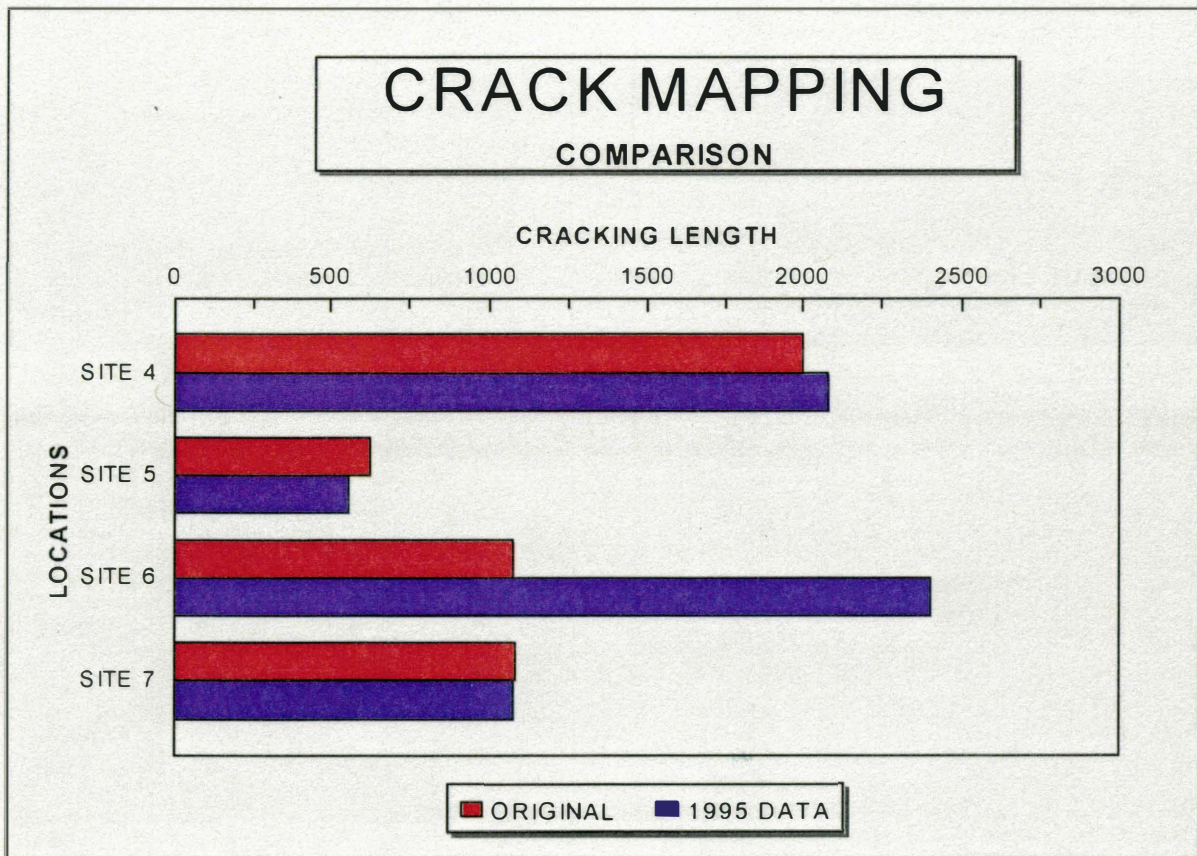
Figure 7. CRACK MAPPING COMPARISON.

In the fall of 1990, original crack maps were diagrammed for Sites 4, 5, 6, and 7 revealing a combined total of 4,781 linear feet of cracking on the four sites. A 1995 survey of the same four sites revealed 6,113 linear feet of cracking, an increase of 1332 feet or 28 percent. At sites 4 and 6, 100 percent of the original cracks had reflected through the overlay. Both sites also displayed new cracks but Site 6 was substantially worse, exhibiting more than twice the number of cracks documented in the original survey. Reflection cracking was also prevalent at Sites 5 and 7 where 89 to 98 percent of the original cracks had reflected to the surface.

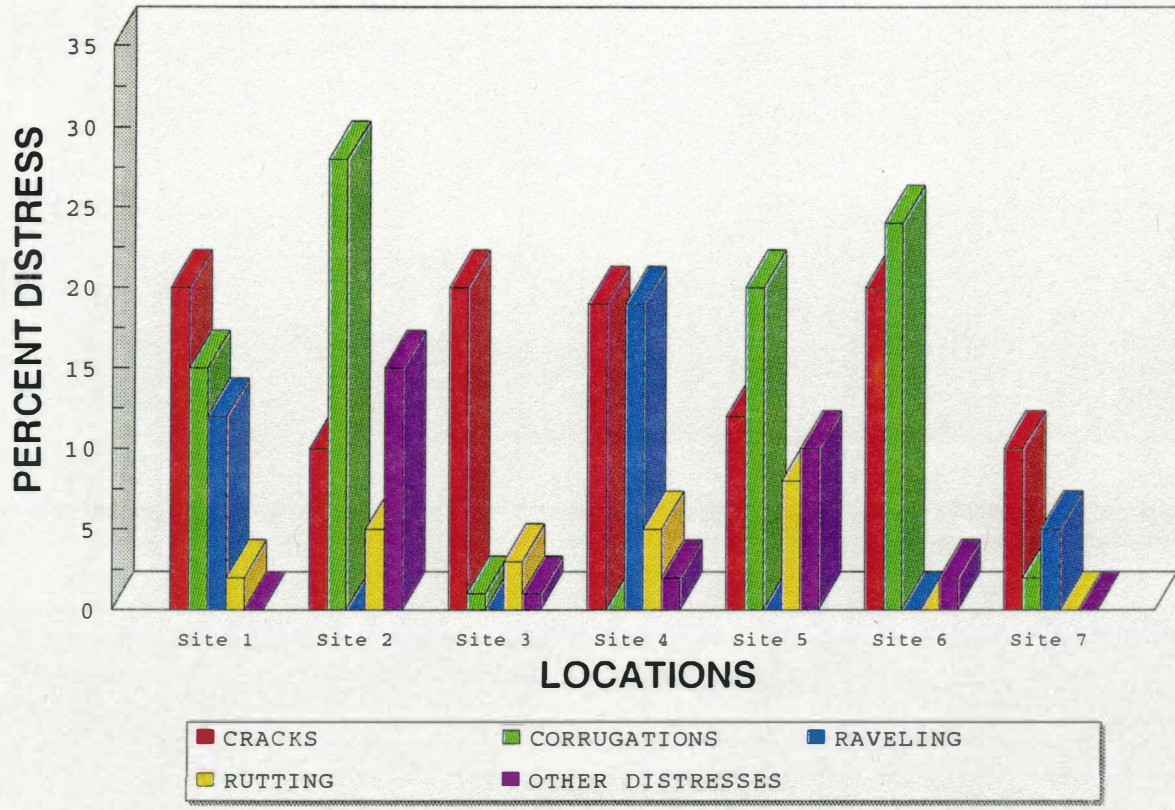
Figure 8. PERCENTAGE OF DISTRESSES FROM EACH SITE.

Cracking was the primary distress encountered, followed by corrugating. Other distresses included base failures, patching, bleeding, shoving, raveling, and rutting, the least of these being rutting. Rut depth averages ranged from 0.00 inches, in the north bound lane at Site 7, to a mere 0.14 inches in the west bound lane at Site 4. Results from the final distress survey appear in Table 3. Percentages are given as part of the total area of the extent rated.

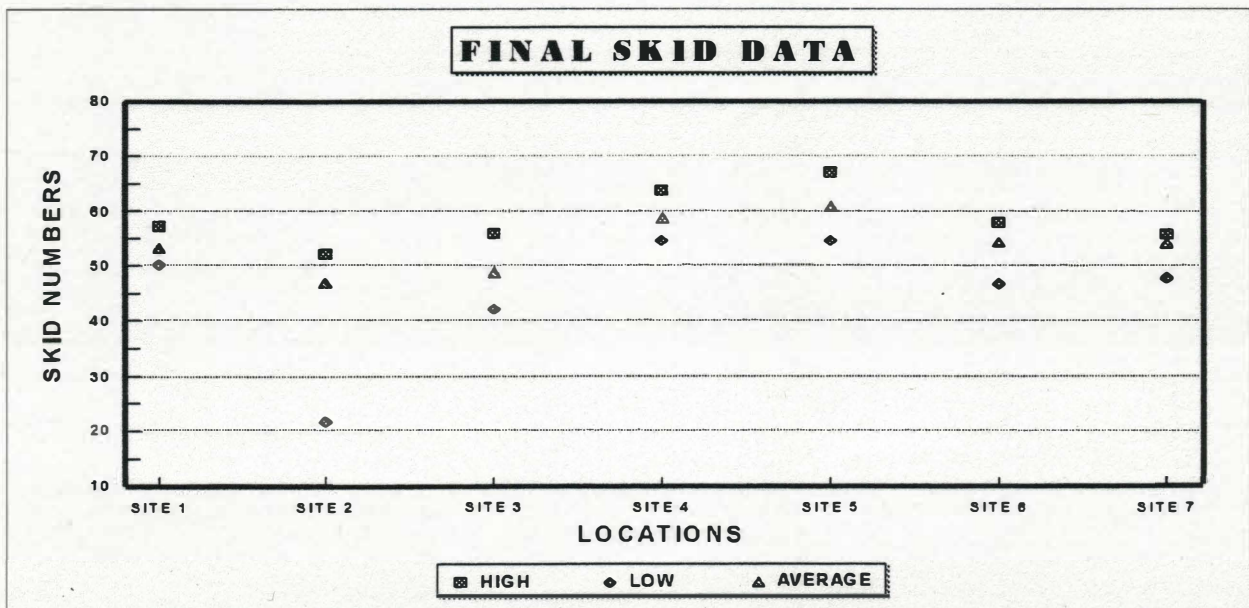
Figure 9. SKID TEST RESULTS.

Skid data was collected on this project in order to evaluate the effect of the small aggregate in the Type D mix on surface resistance. Figure 9 shows the highest, lowest, and average readings from each site.

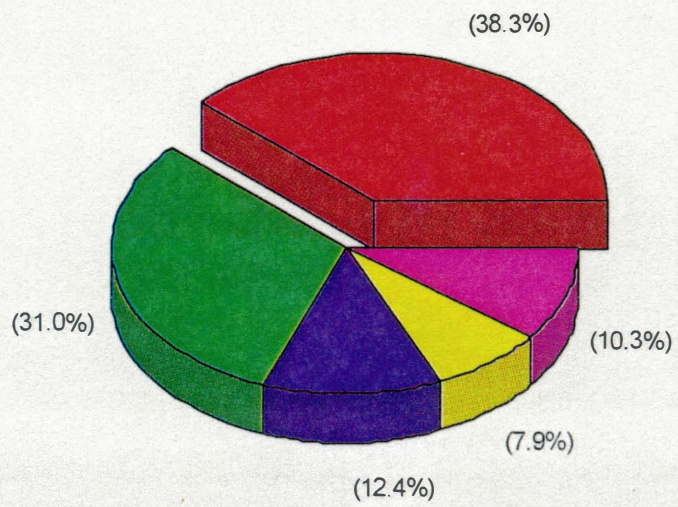
At the end of the four year evaluation period, each site was given a final rating in each category of distress. The results are depicted in Figure 10.

Another option is alternating thin overlays and chip seals. If rutting and corrugating are corrected with a thin overlay and have not recurred by the time another treatment is necessary, a chip seal will sufficiently address other common distresses, i.e., cracking and raveling. The next treatment would be another thin overlay followed by another chip seal and so on until such time as a full replacement is deemed necessary. Of course, periodic crack sealing is still necessary for maximizing the life cycles of both treatments.

Treating with multiple chip seals (chip seal over chip seal) or thin overlays (thin overlay over thin overlay) is not recommended. However, multiple micro-surfacing treatments are an acceptable alternative.
