UNIVERSITY OF OKLAHOMA
GRADUATE COLLEGE

INVESTIGATION OF THE EFFECTS OF END REGION DETERIORATION IN
PRECAST, PRESTRESSED CONCRETE BRIDGE GIRDERS

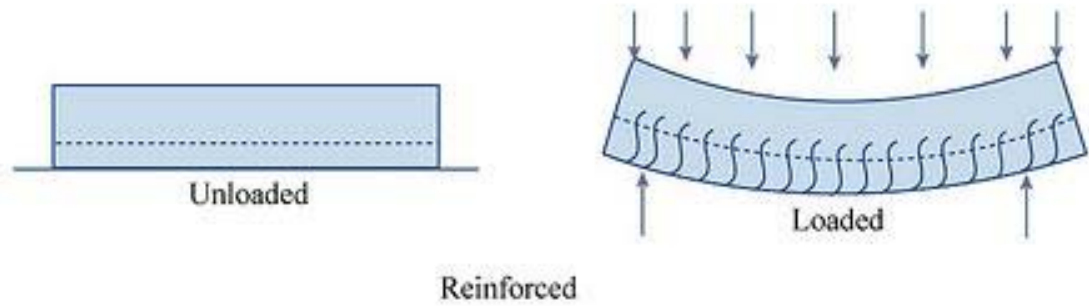
Figure 1. Typical reinforced concrete beam schematic (MIT OpenCourseWare, 2008)

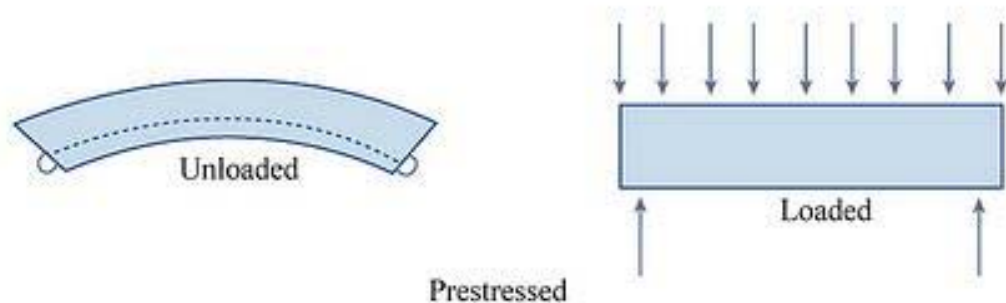
Figure 2. Typical prestressed concrete beam schematic (MIT OpenCourseWare, 2008)

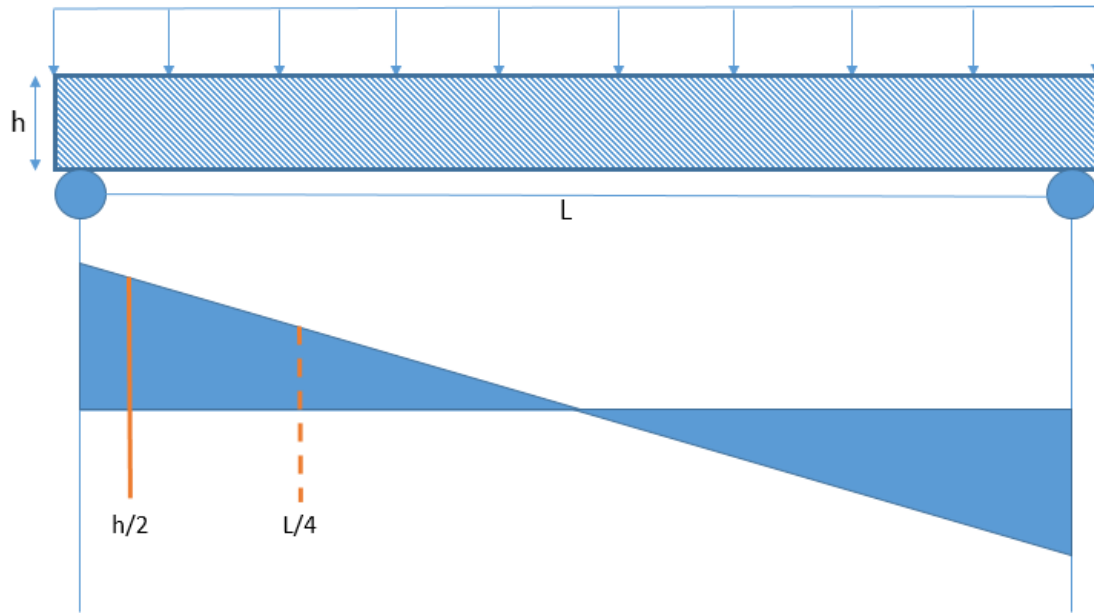
Figure 3. Shear diagram of distributed load on a simply, supported beam

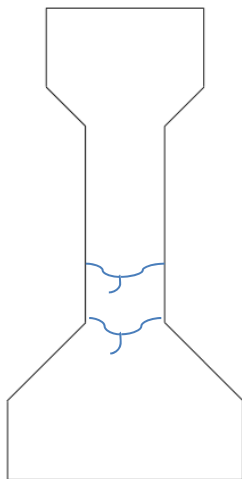
Figure 4. Example of "Y" cracks

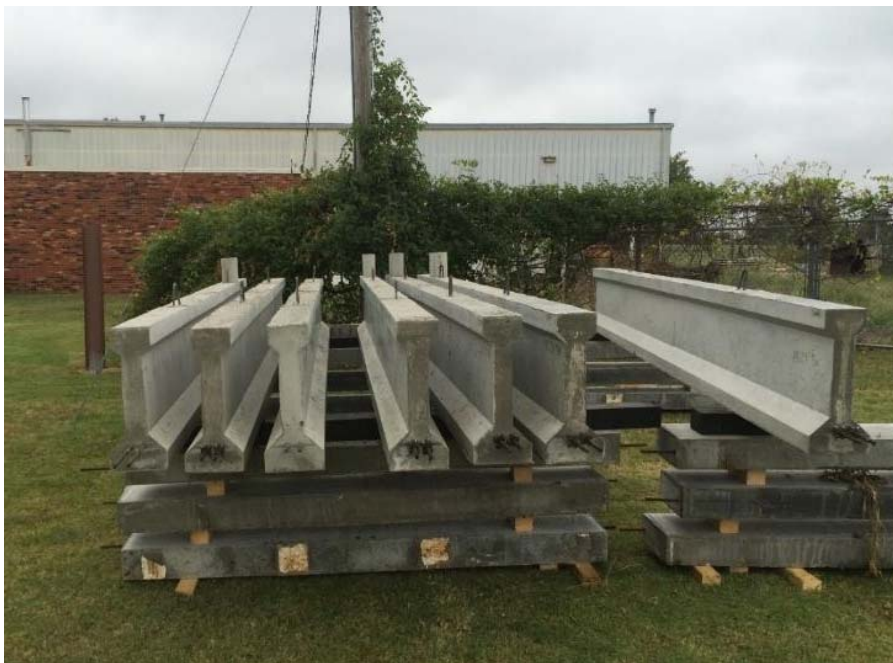
Figure 6. Newly cast half-scale prestressed concrete girders

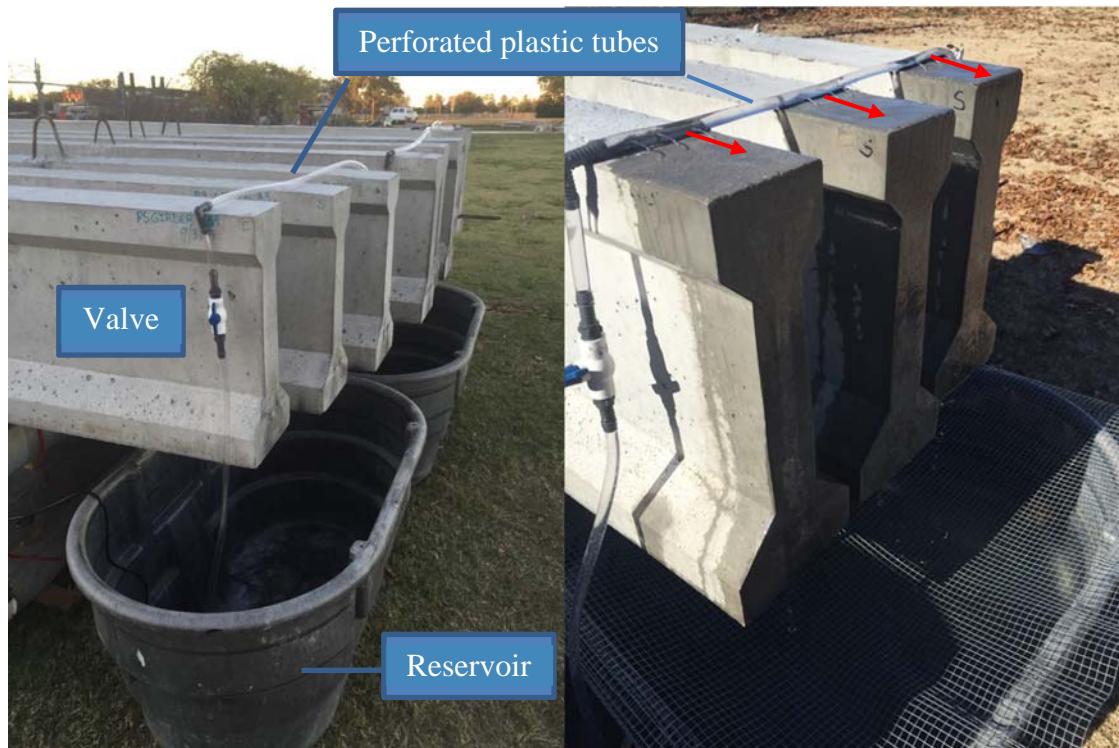
Figure 7. Corrosion Accelerant setup (red arrows indicate the direction of flow from the perforated tubes)

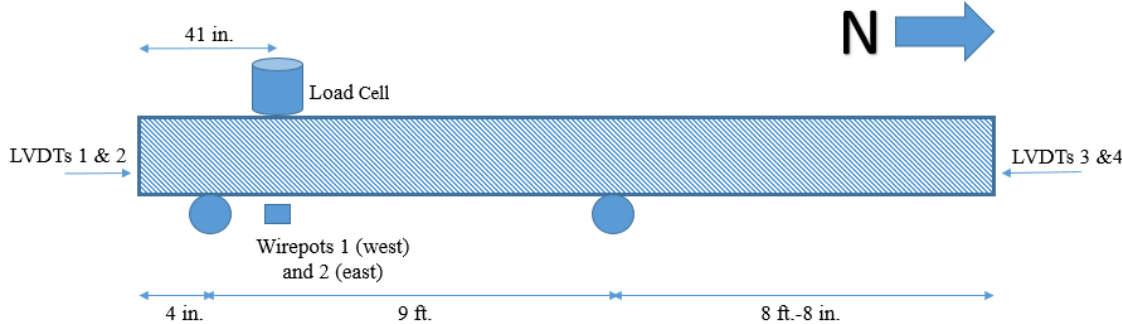
Figure 8. Shear Test Schematic (not to scale)

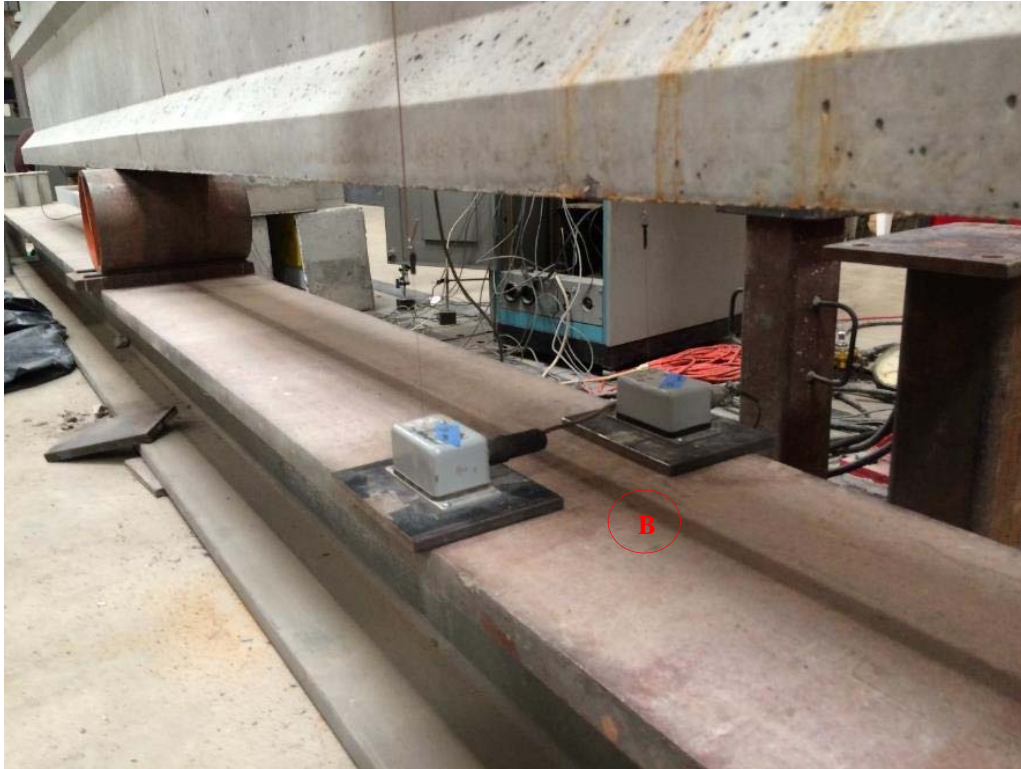
Figure 14. Shear Test Setup - Wirepot 1 (left/west) and Wirepot 2 (right/east) - looking towards the north

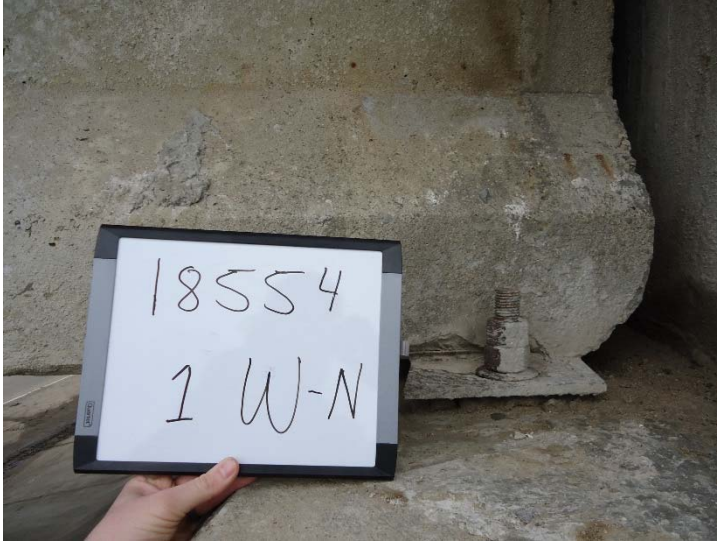
Figure 16. Bridge #18554, photo taken from northern side of the northernmost, west exterior girder

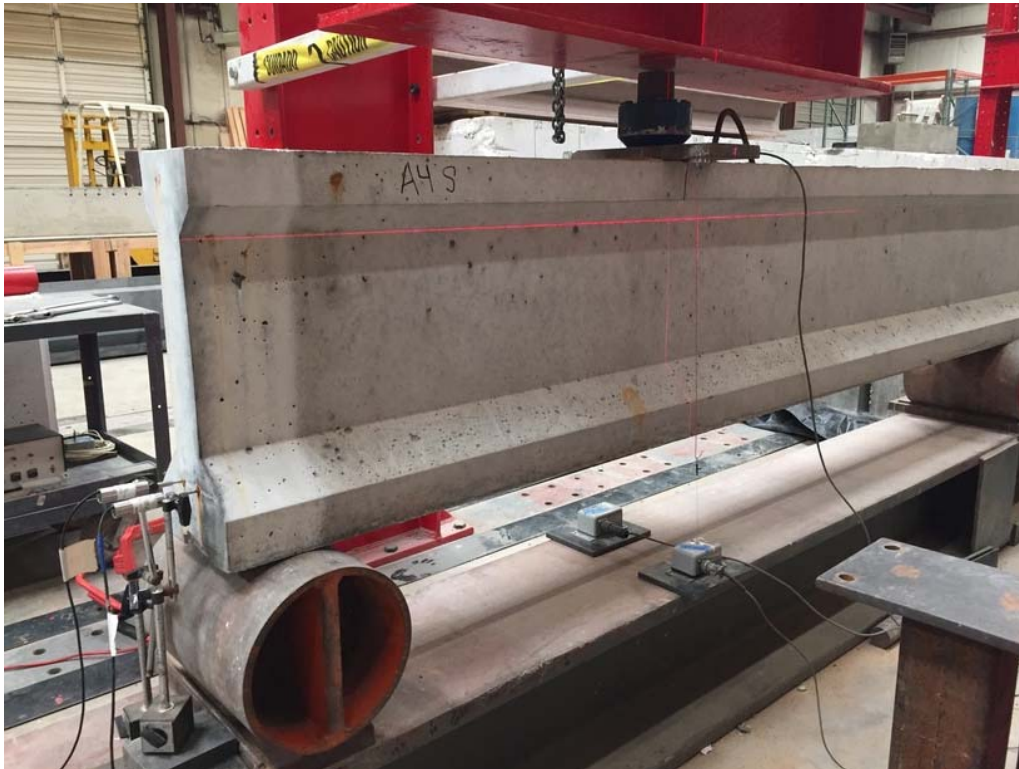
Figure 19. Before shear testing of A4SC

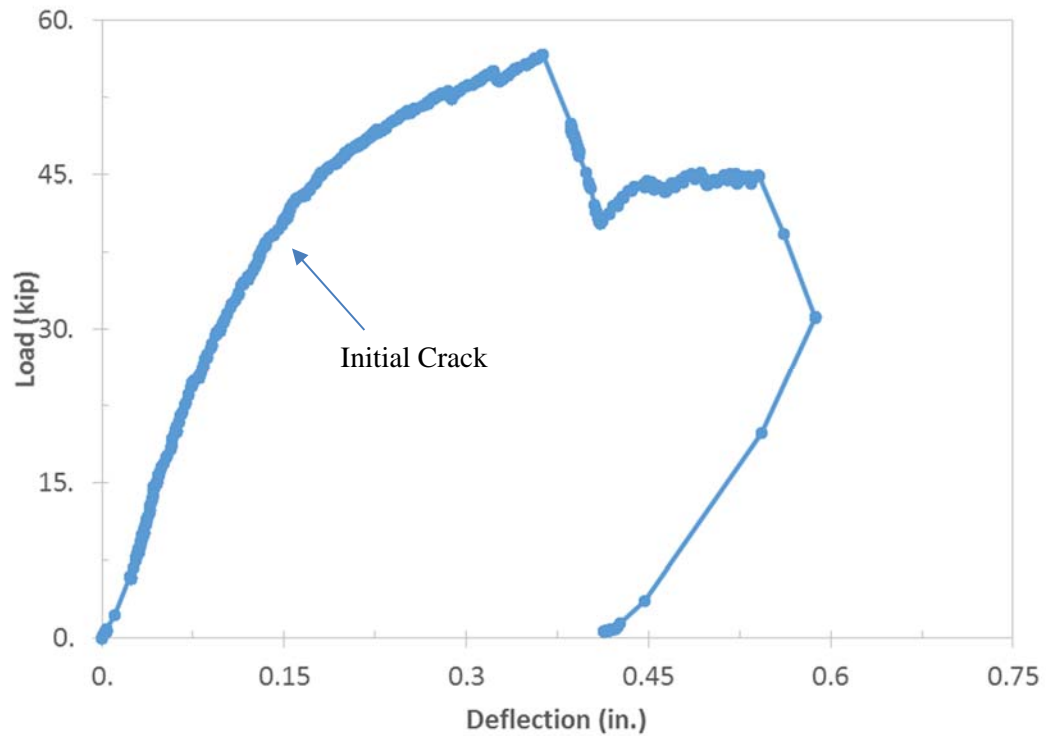
Figure 20. Load vs. Deflection of A4SC

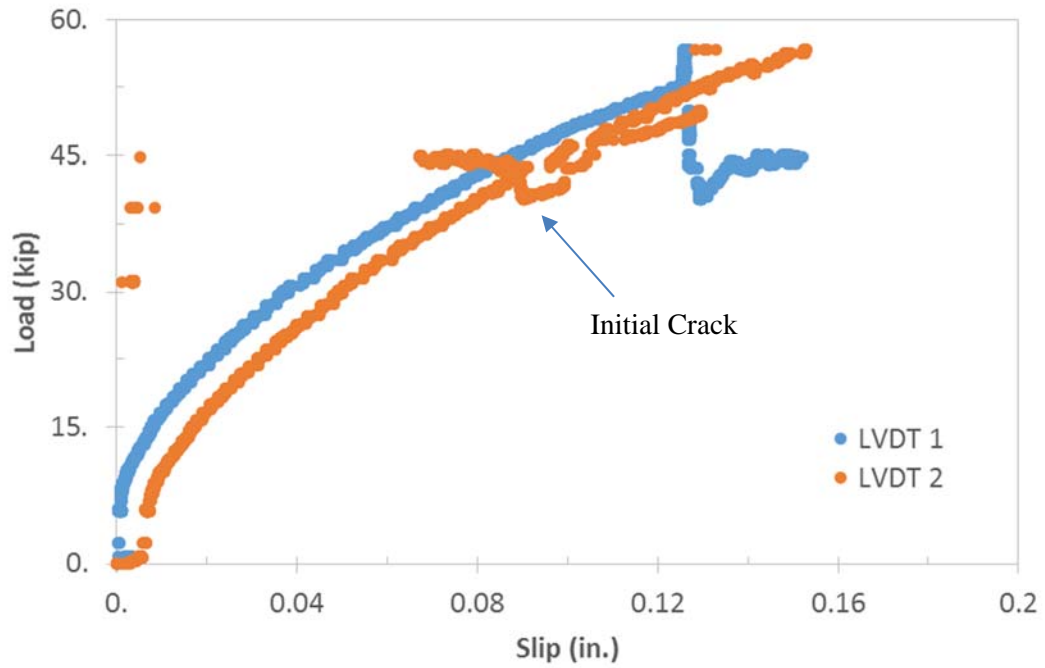
Figure 21. Load vs. Slip of A4SC

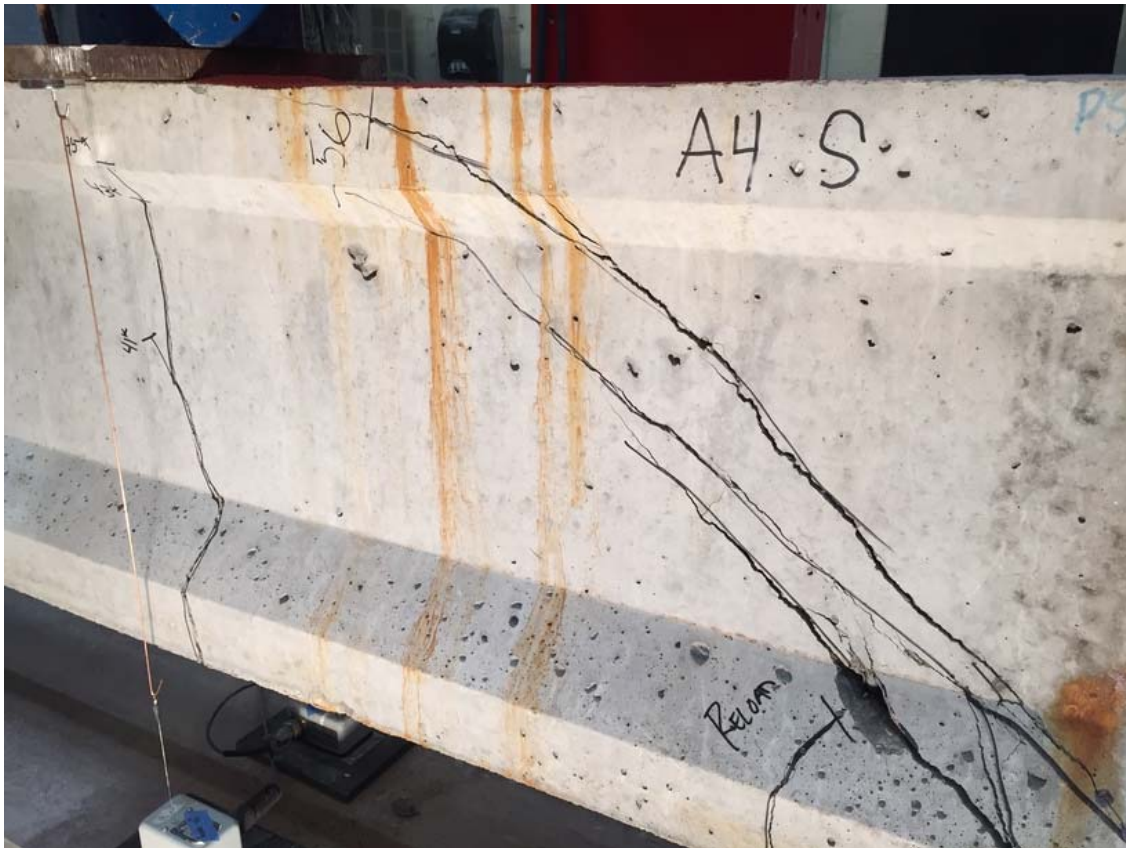
Figure 23. Visual Map of Cracking for Shear Test on A4SC

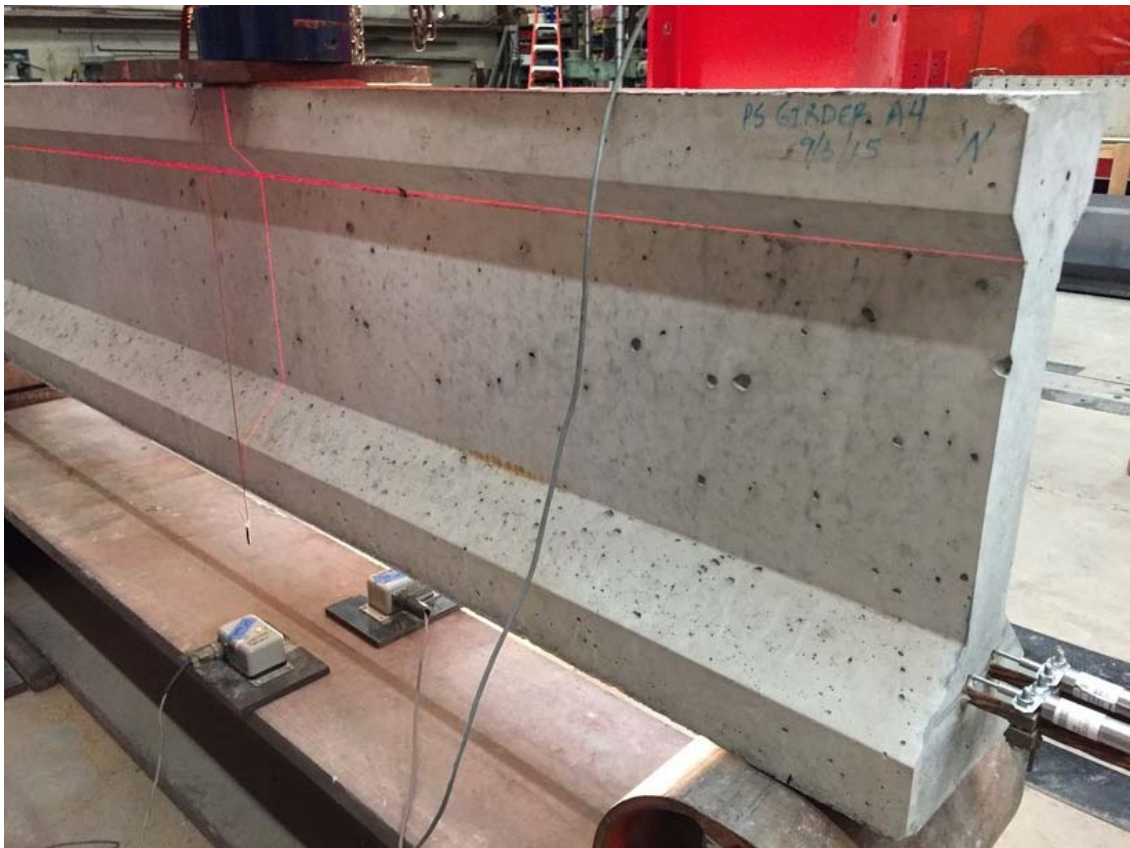
Figure 24. Before shear testing of A4N

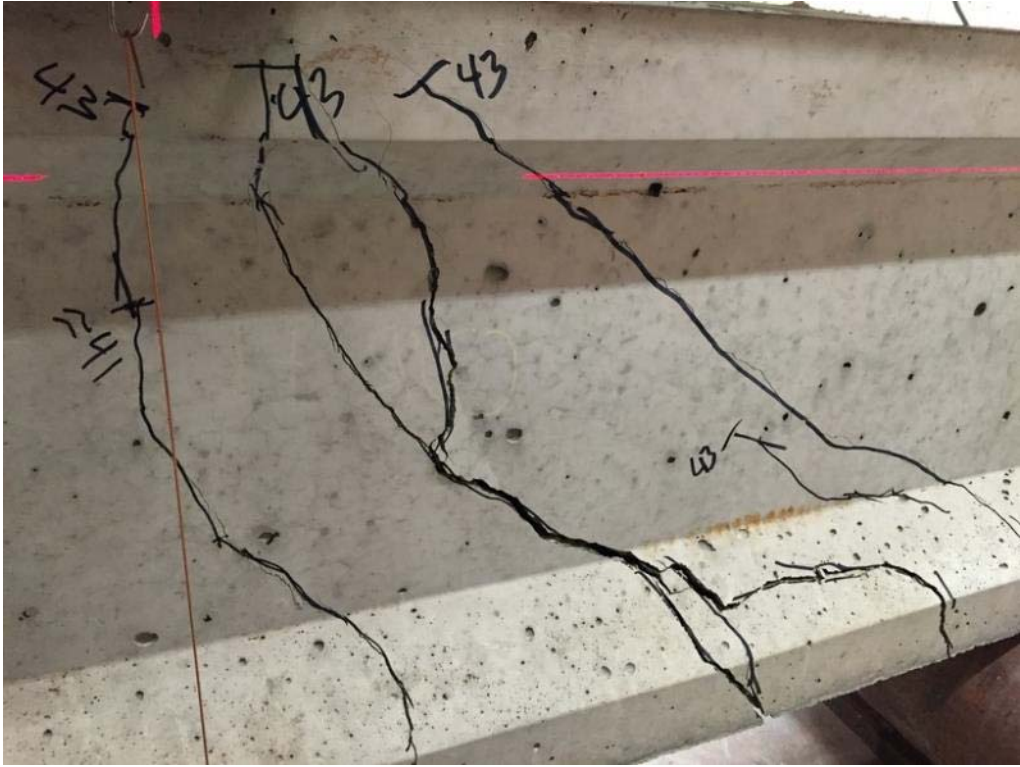
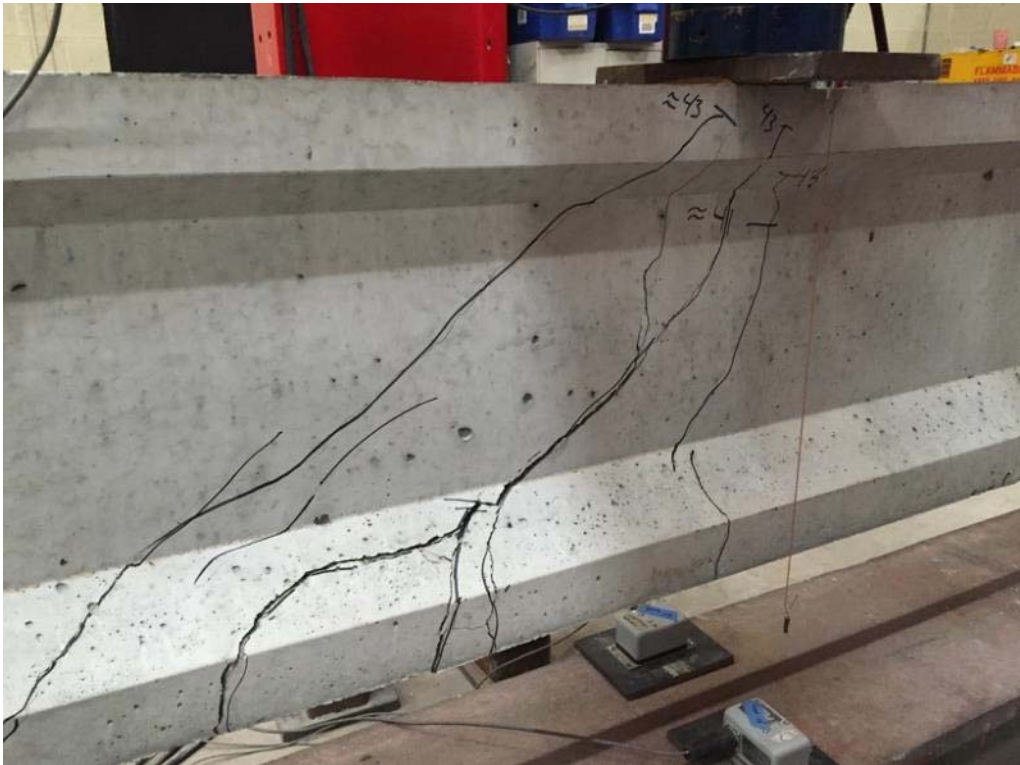
Figure 27. Visual Map of Cracking for Shear Test on A4N

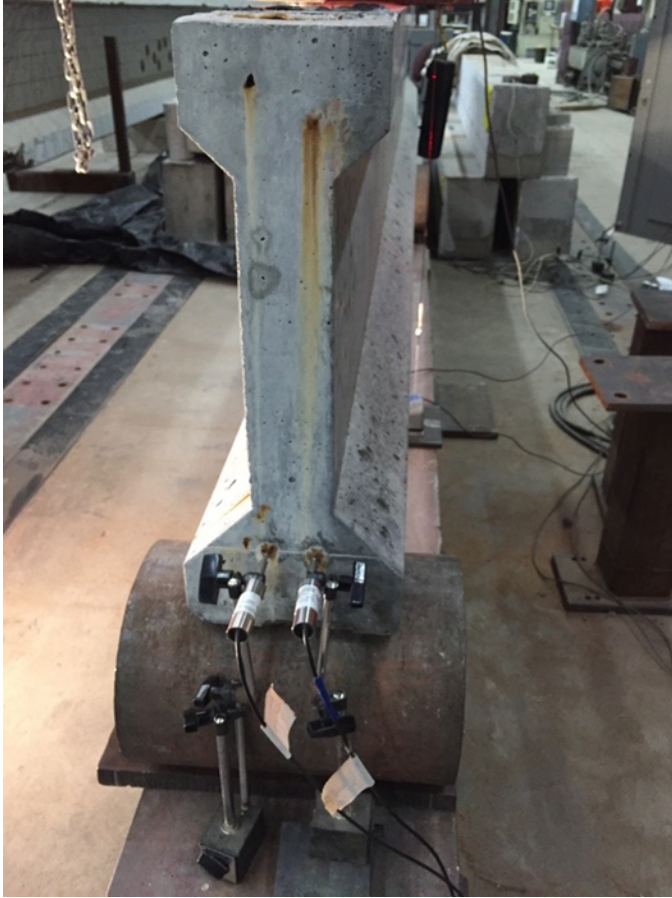
Figure 28. Before shear testing of CINC

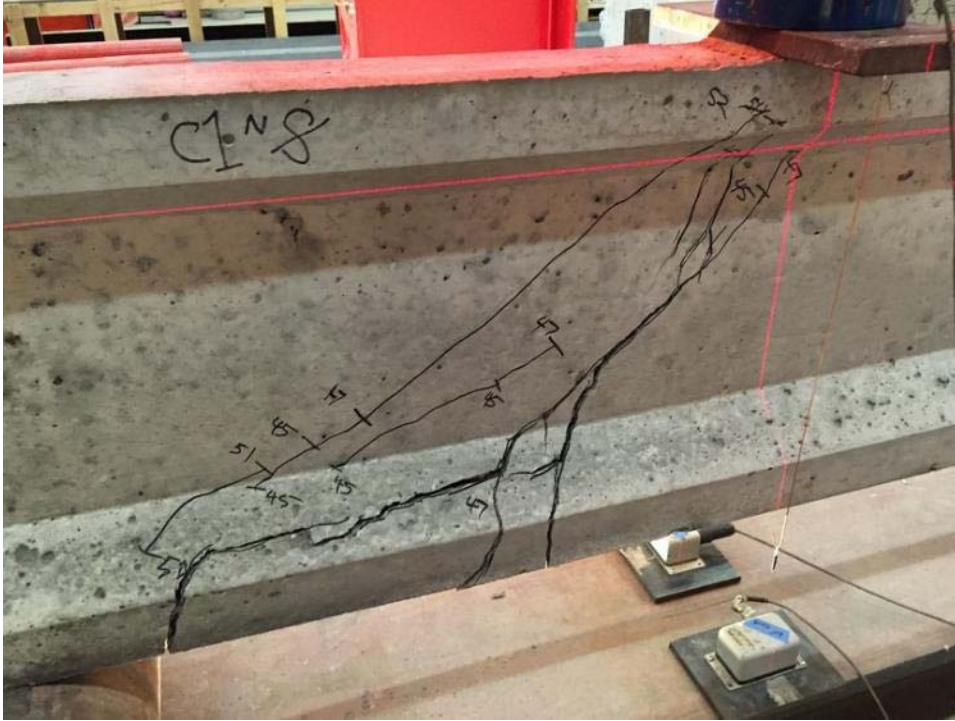
Figure 31. Visual Map of Cracking for Shear Test on C1NC

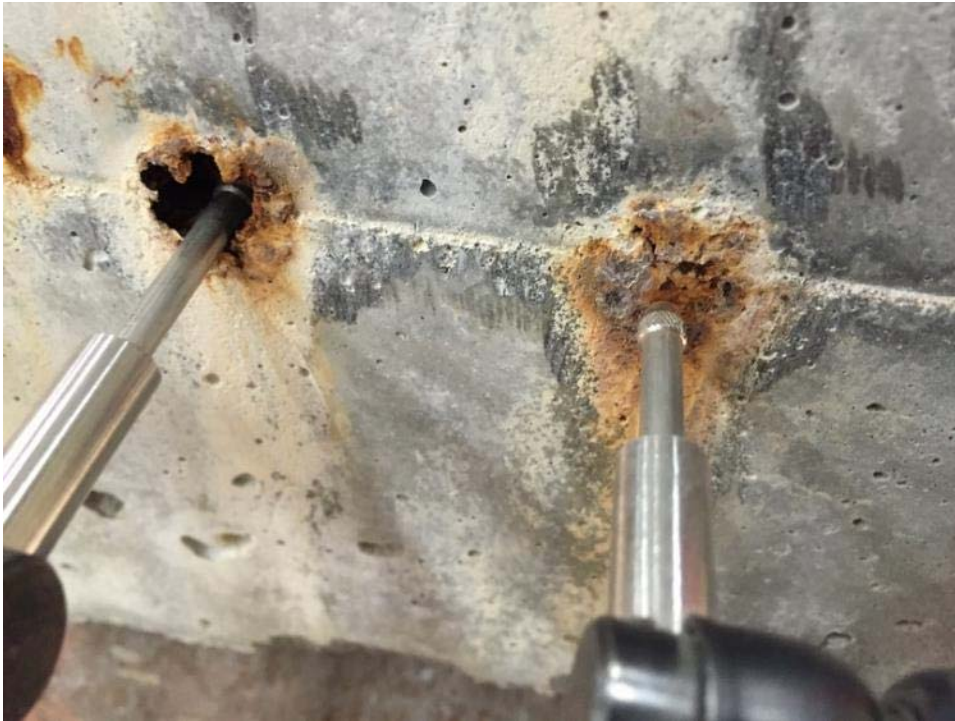
Figure 32. Visible Slip (LVDT 2 - left) after Shear Test on C1NC

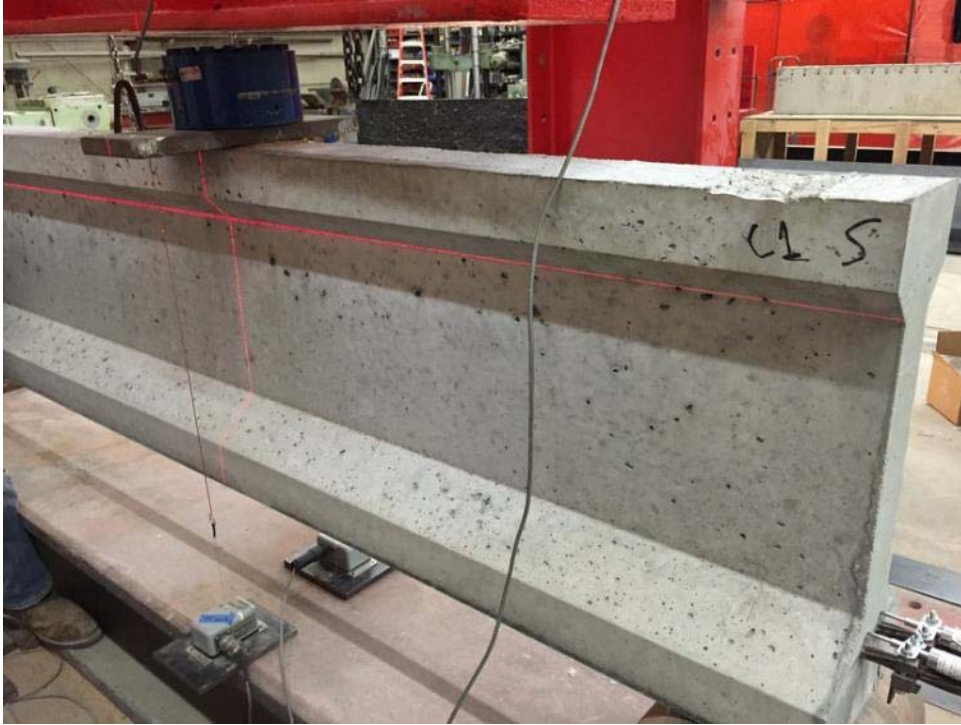
Figure 33. Before shear testing of C1S

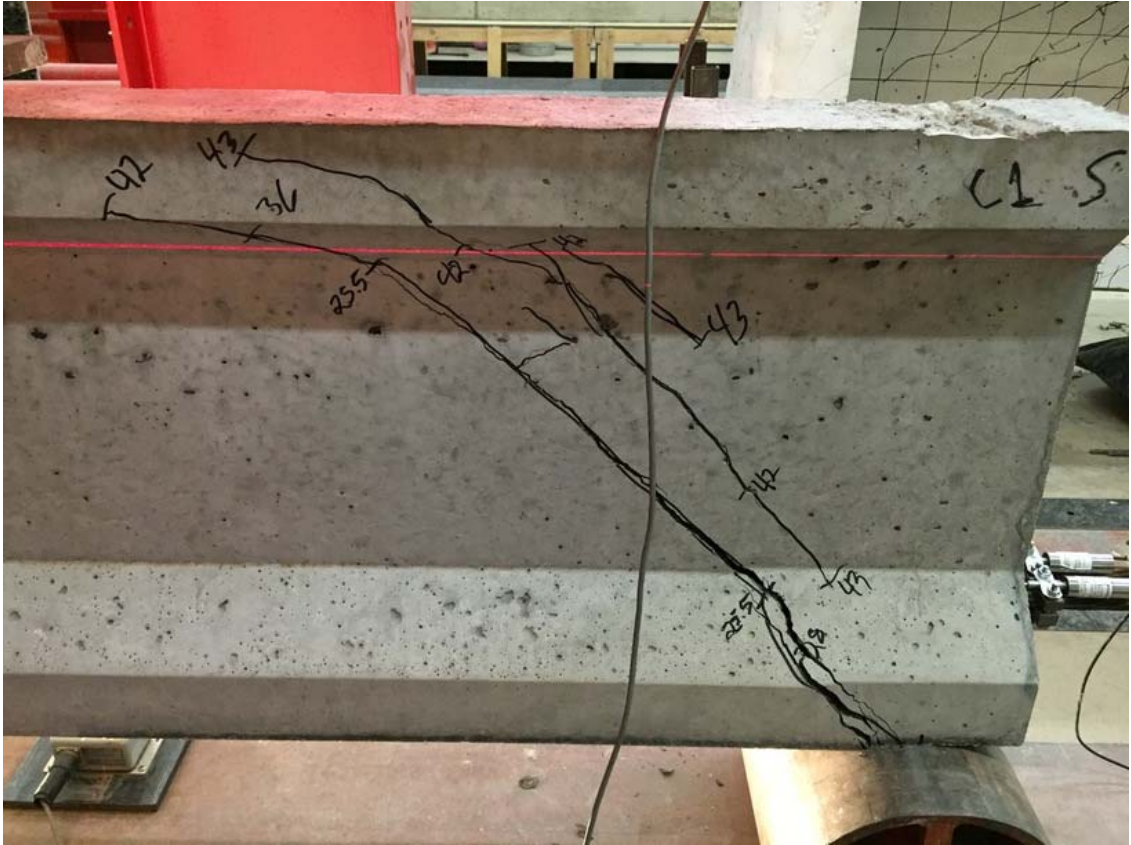
Figure 37. Visual Map of Cracking for shear test on C1S

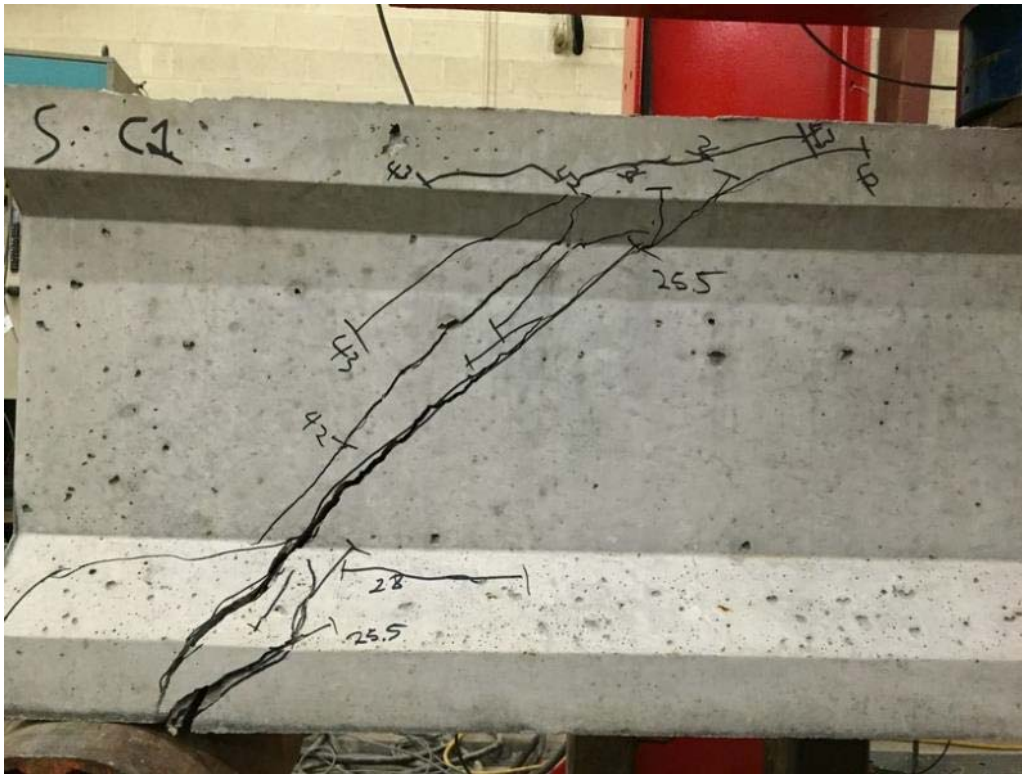
Figure 38. Visual Map of Cracking for shear test on CIS

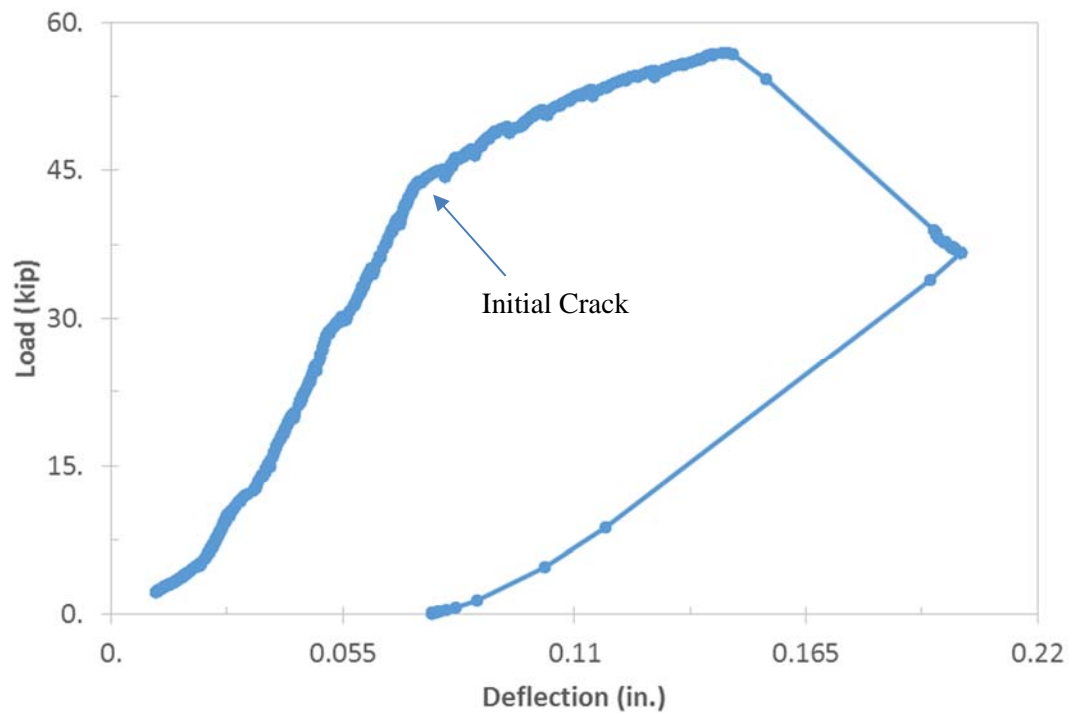
Figure 39. Load vs. Deflection of A3SC

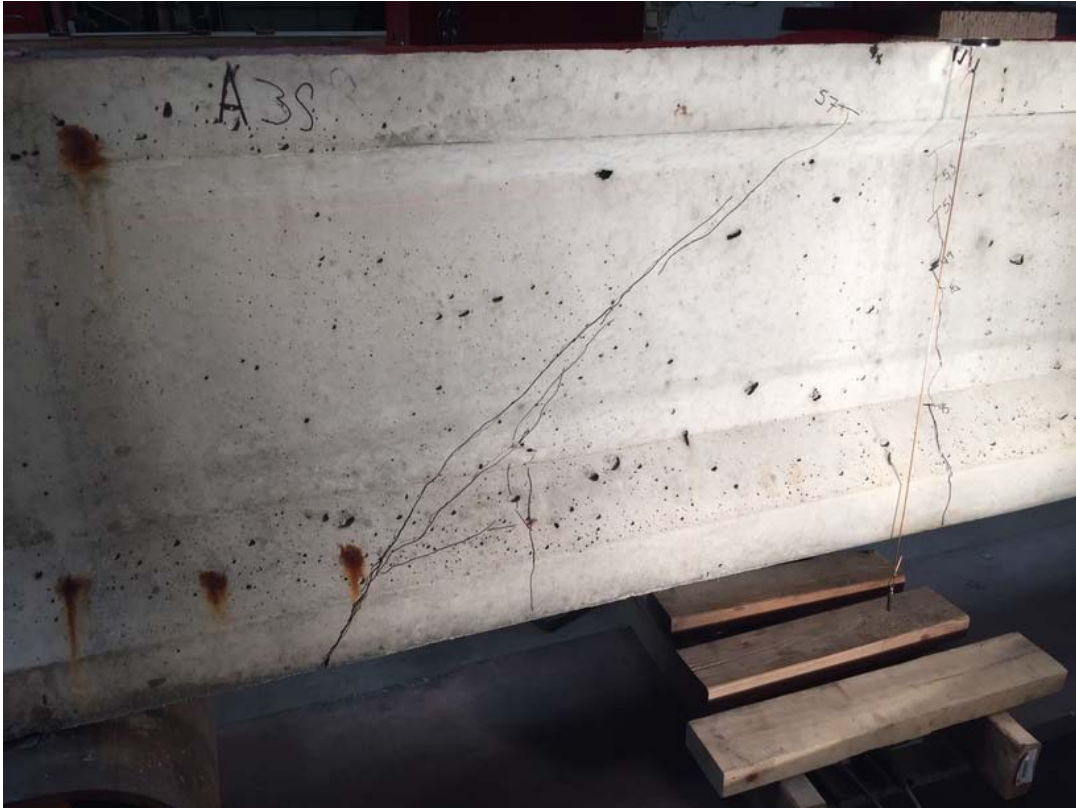
Figure 40. Web-shear crack on A3SC

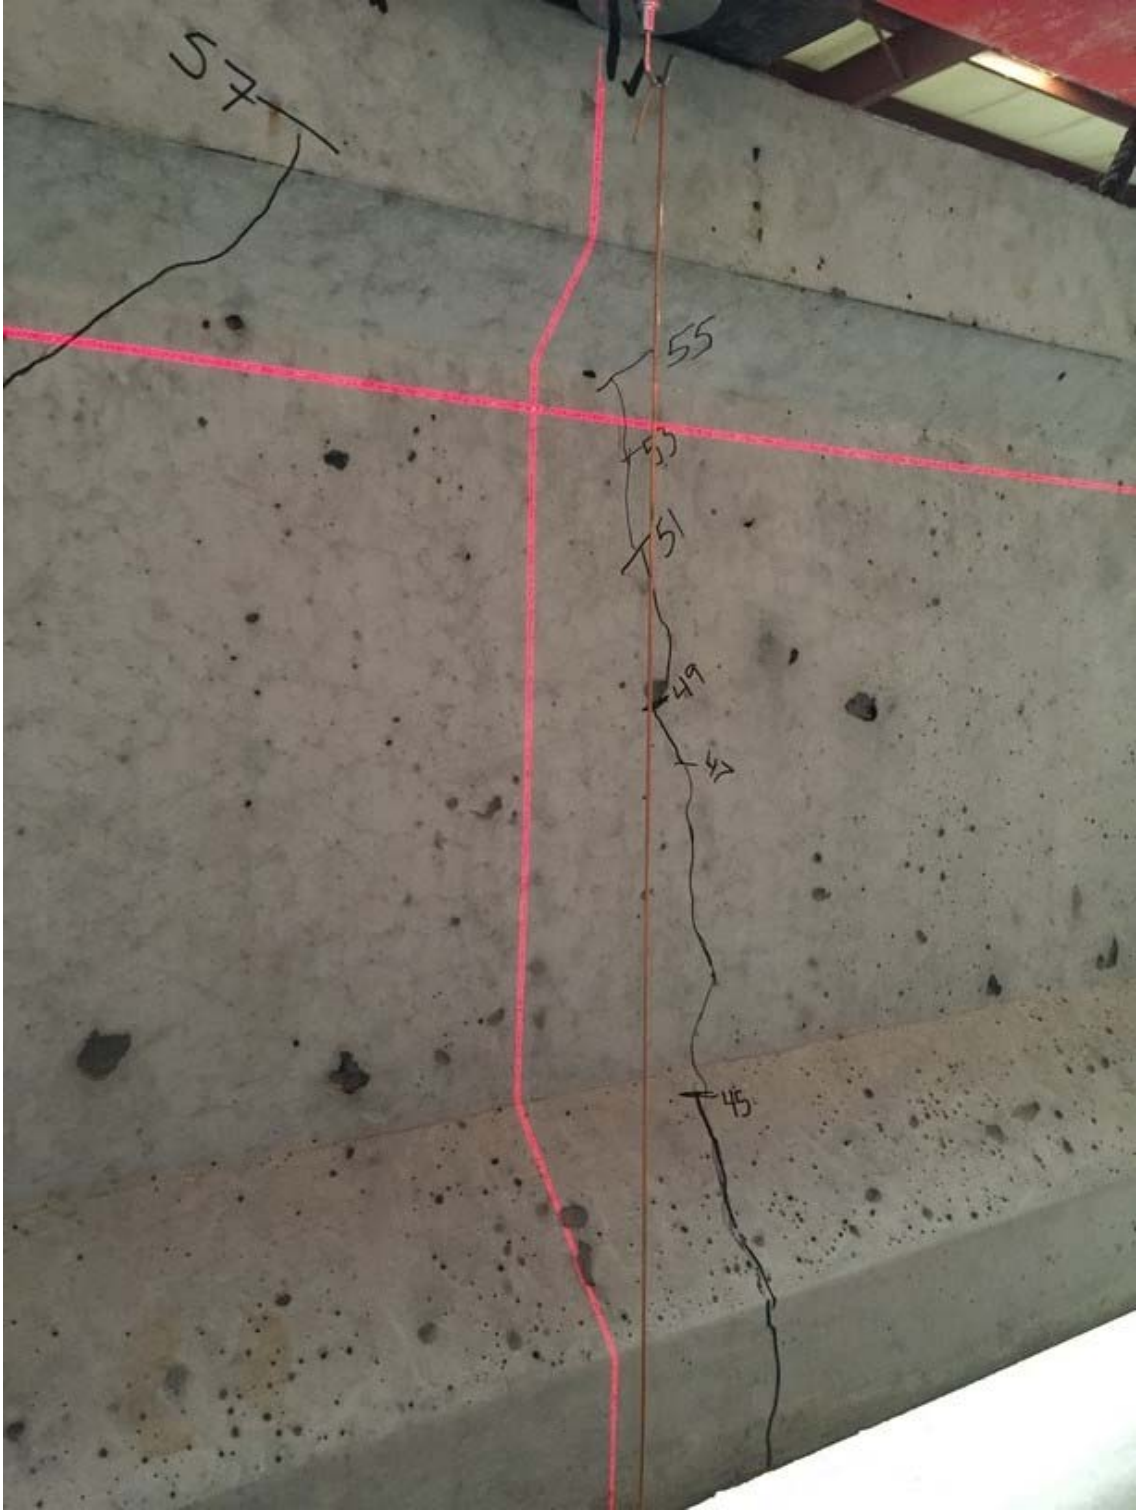
Figure 41. Flexural crack on A3SC

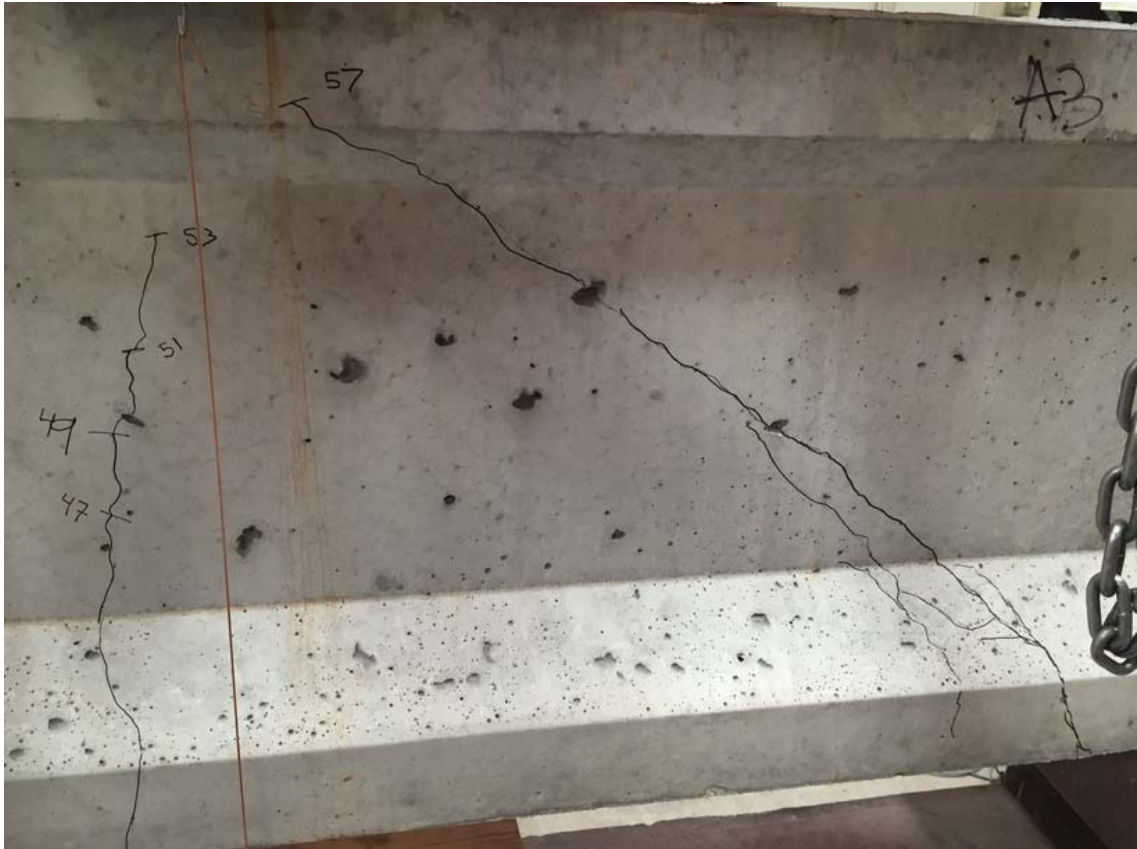
Figure 42. Web shear and flexural cracks of Girder A3SC

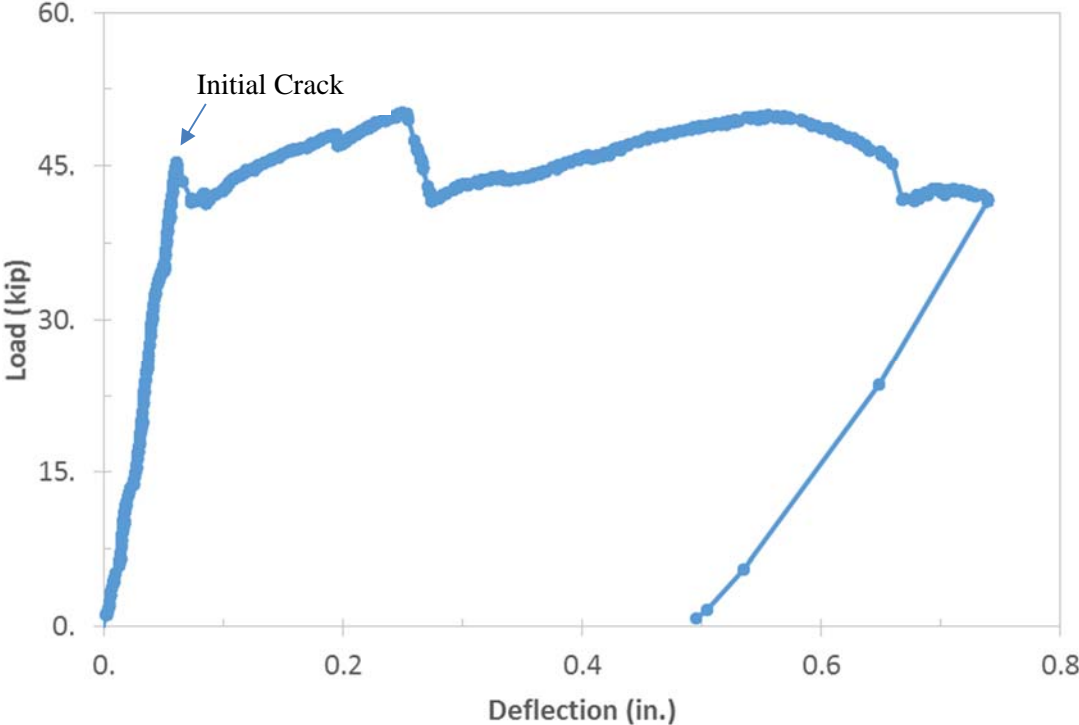
Figure 43. Load vs. Deflection of A3N

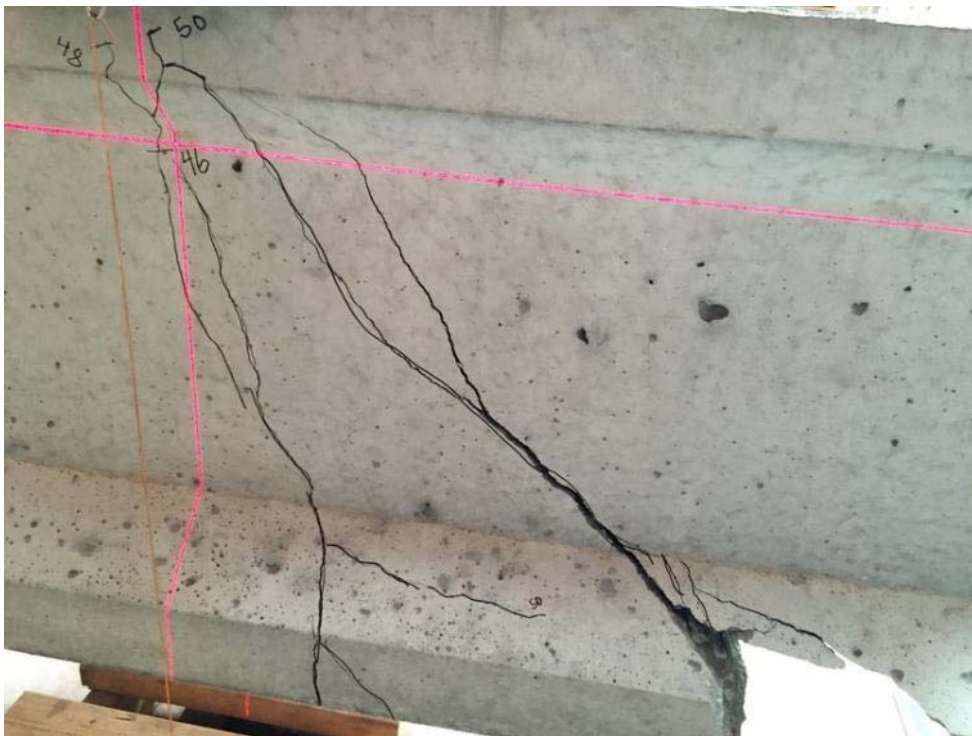
Figure 45. Visual Map of Cracking along A3N

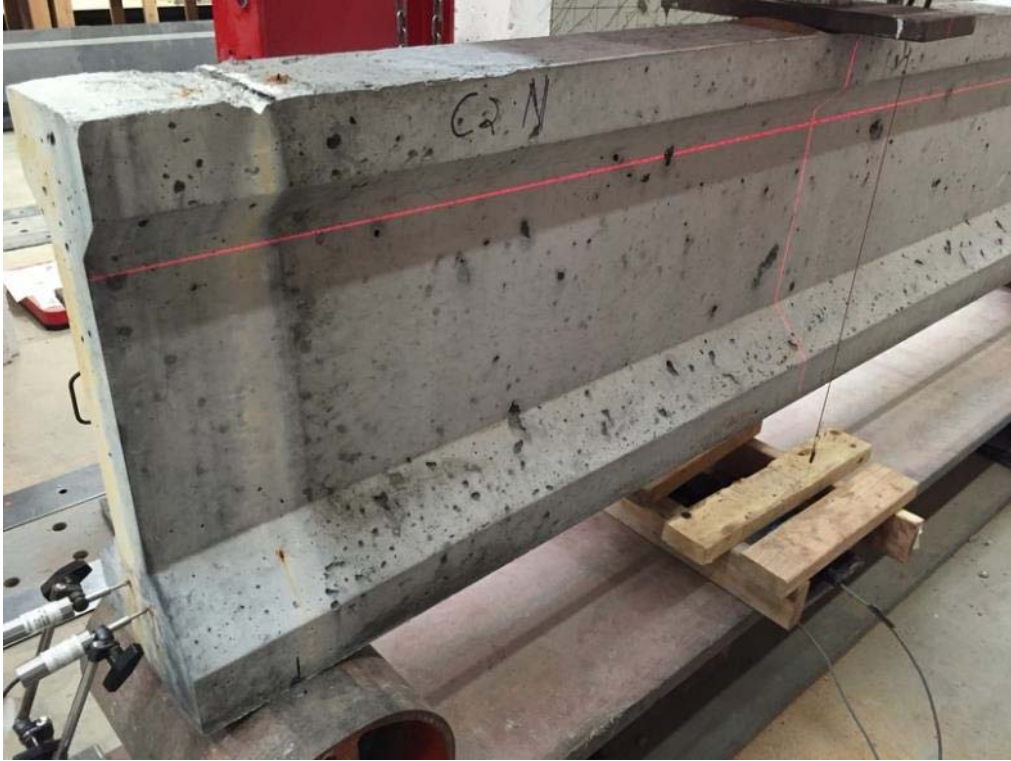
Figure 46. Initial photos of C2NC

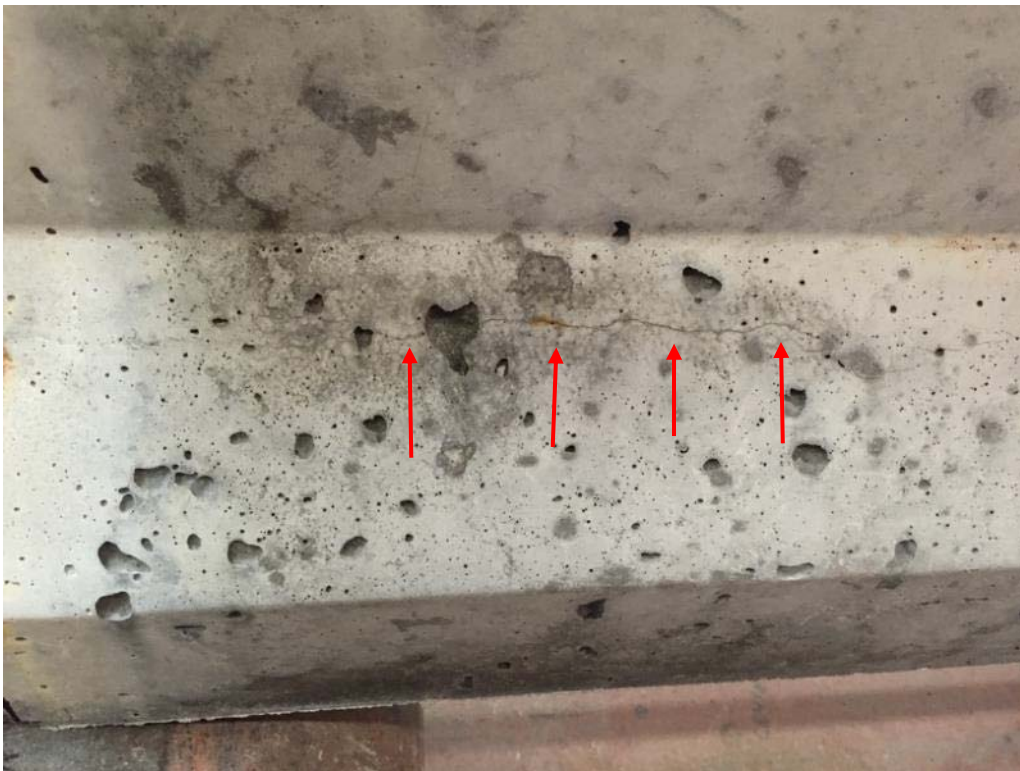
Figure 47. Horizontal crack below the web/flange interface of C2NC

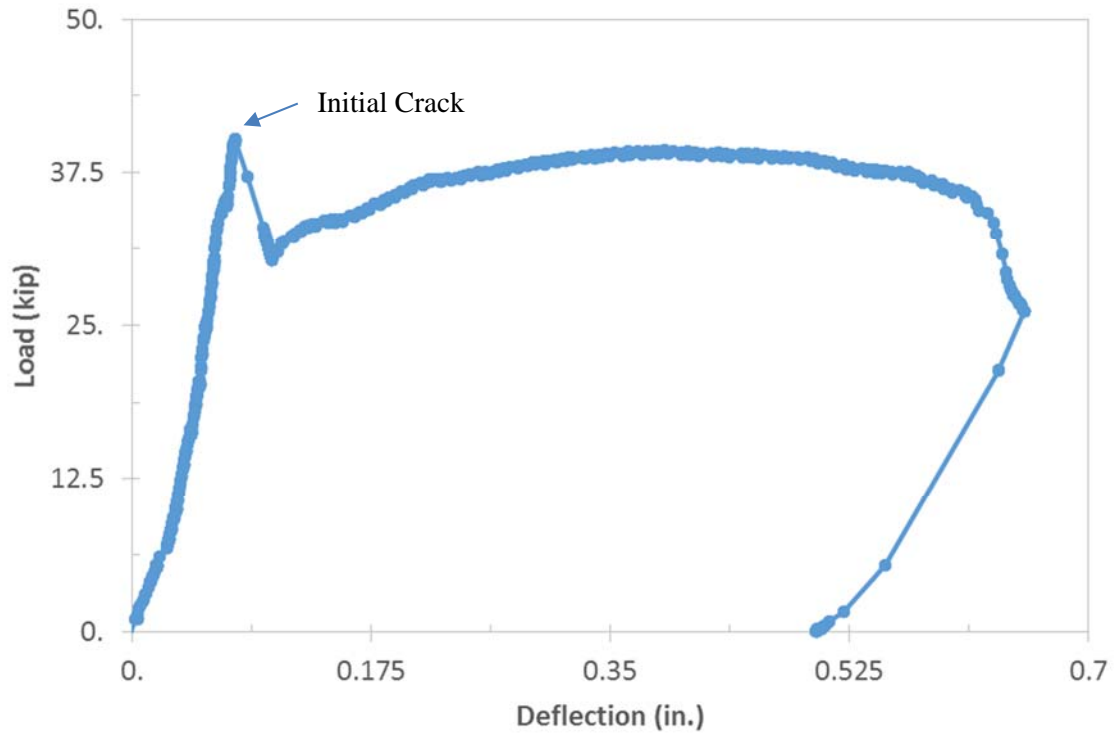
Figure 48. Load vs. Deflection of C2NC
