UNIVERSITY OF OKLAHOMA
GRADUATE COLLEGE

INVESTIGATION OF THE EFFECTS OF END REGION DETERIORATION IN
PRECAST, PRESTRESSED CONCRETE BRIDGE GIRDERS

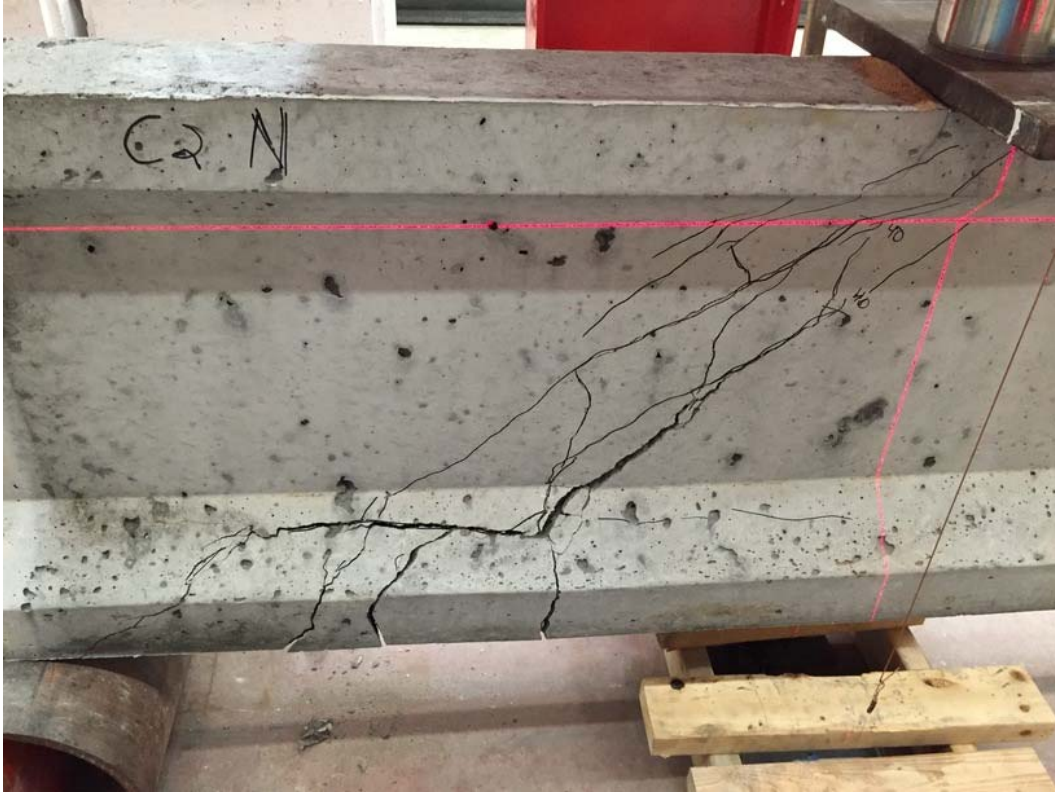
Figure 50. Visual Map of cracking of C2NC

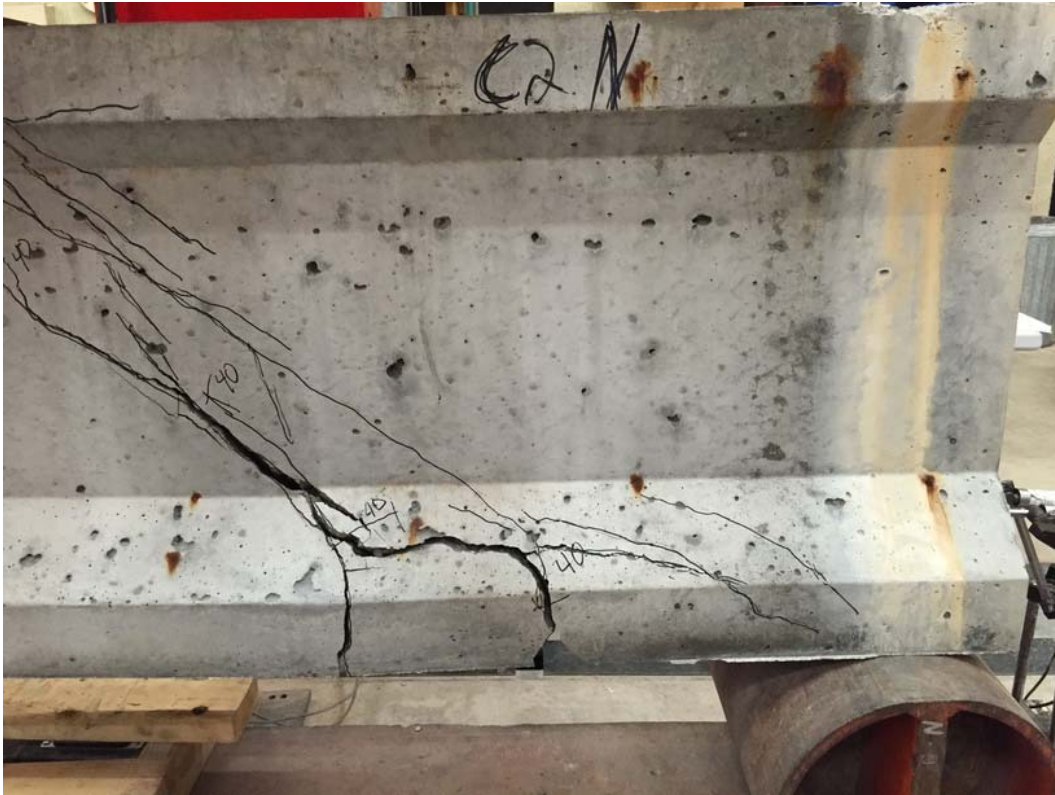
Figure 51. Visual Map of cracking of C2NC

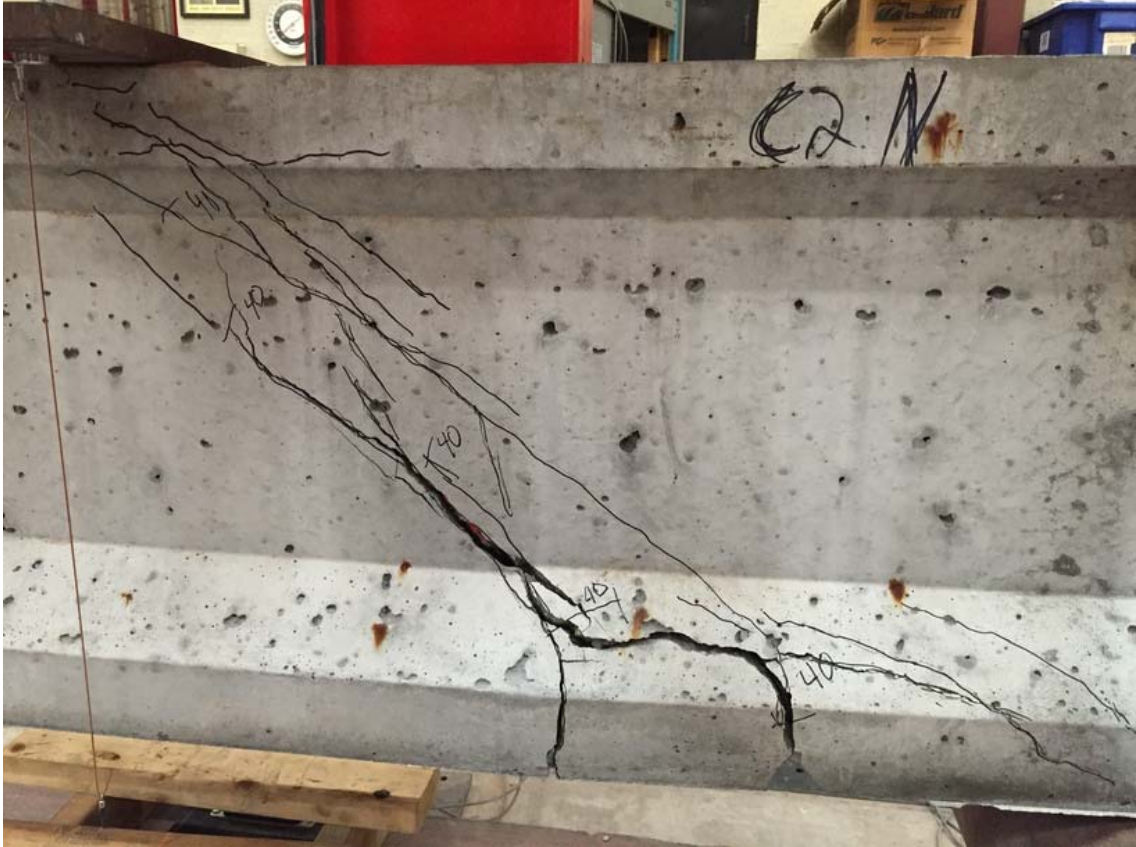
Figure 52. Visual Map of cracking of C2NC

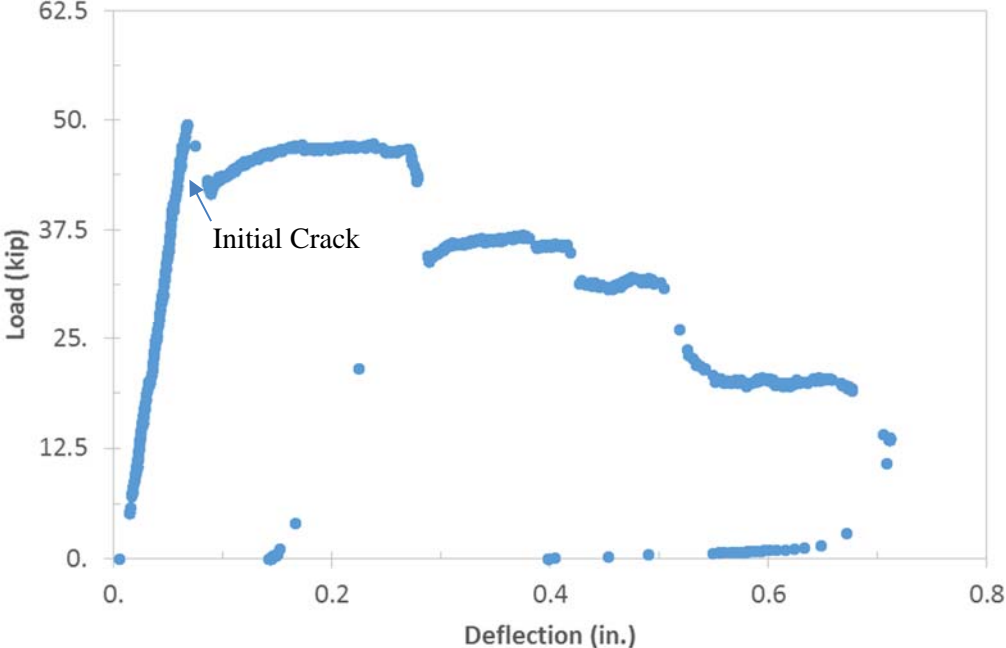
Figure 53. Load vs. Deflection of C2S

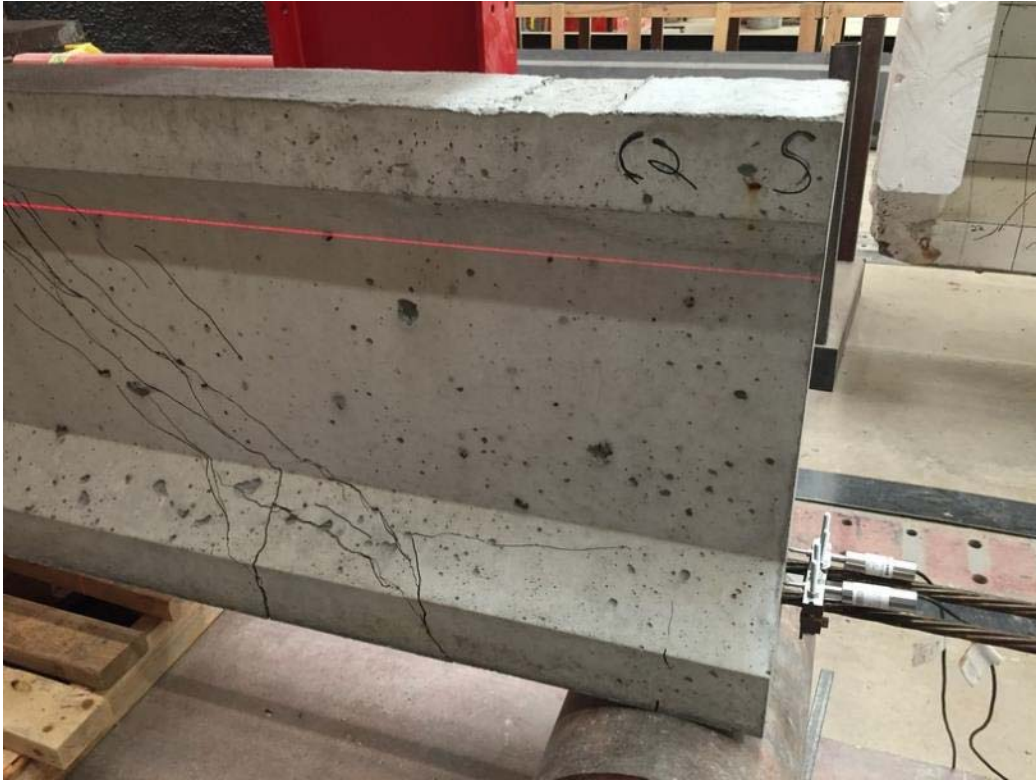
Figure 55. Cracking of C2S

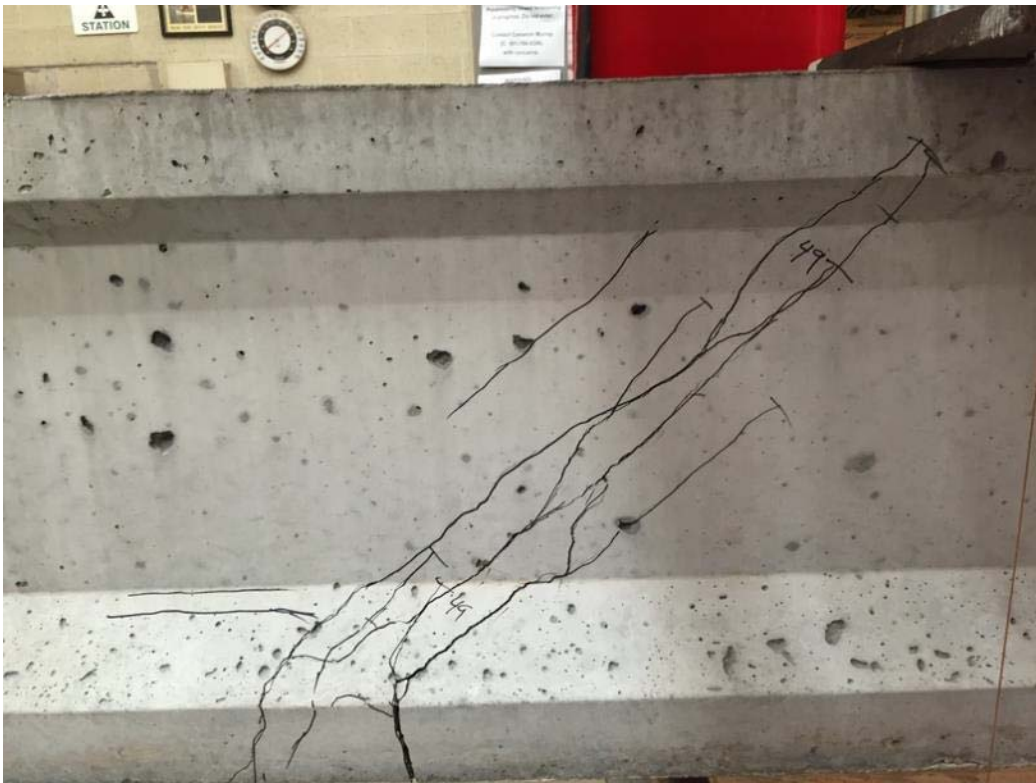
Figure 56. Cracking of C2S

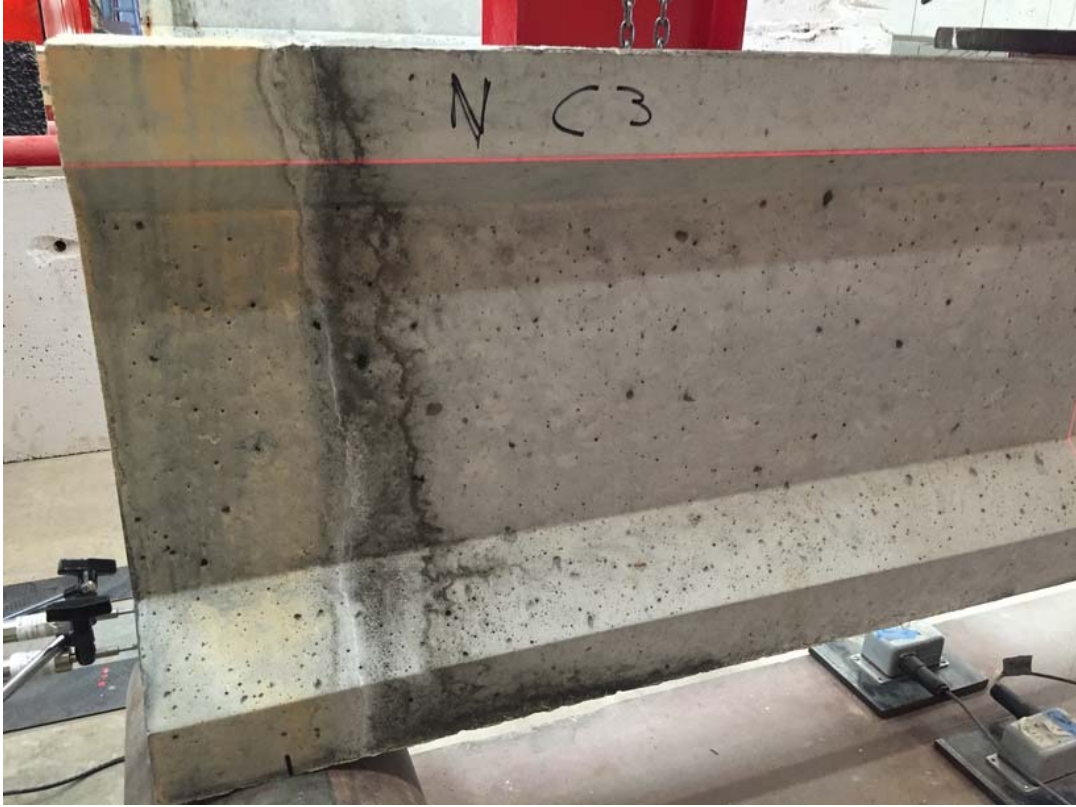
Figure 57. C3NC before testing

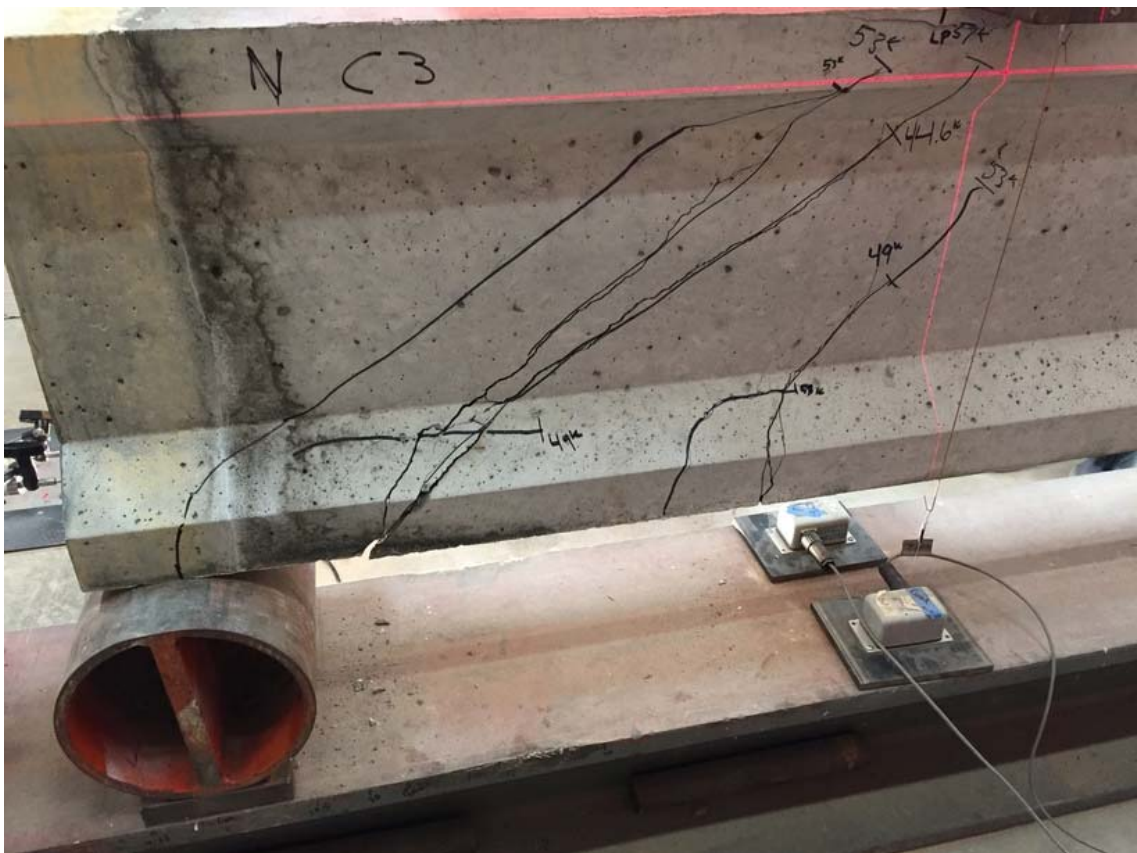
Figure 60. Shear cracking of C3NC after shear test

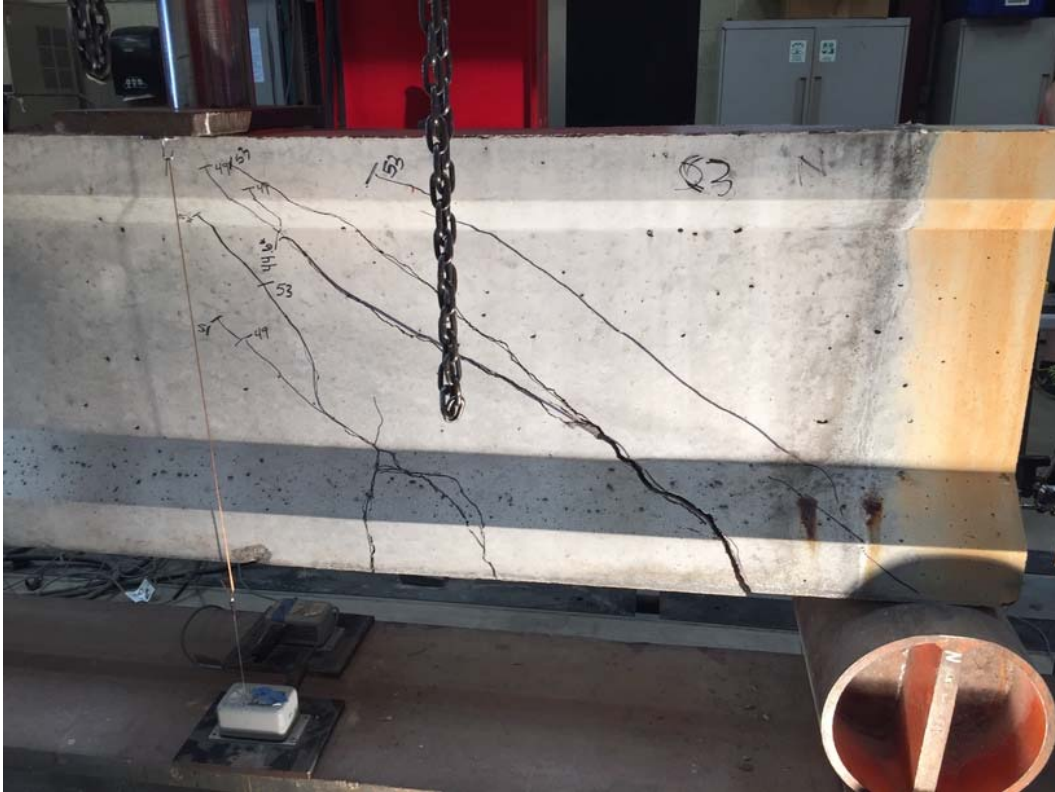
Figure 61. Shear cracking of C3NC after shear test

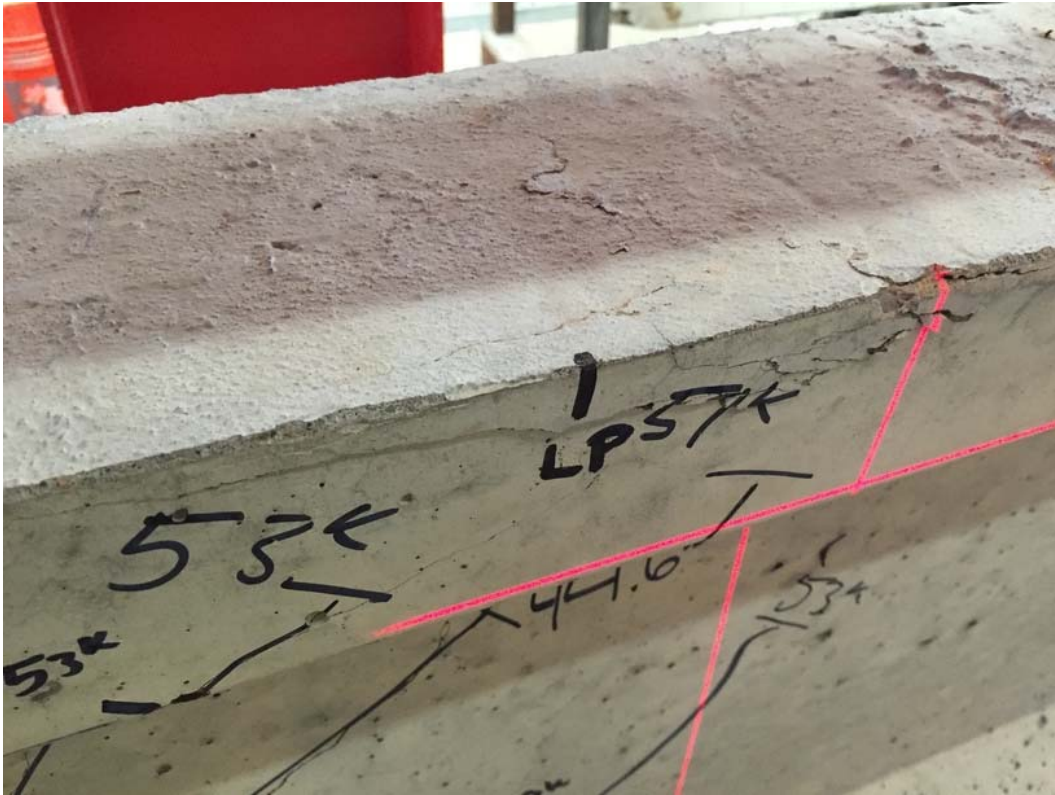
Figure 62. Concrete failure at top of top flange, C3NC

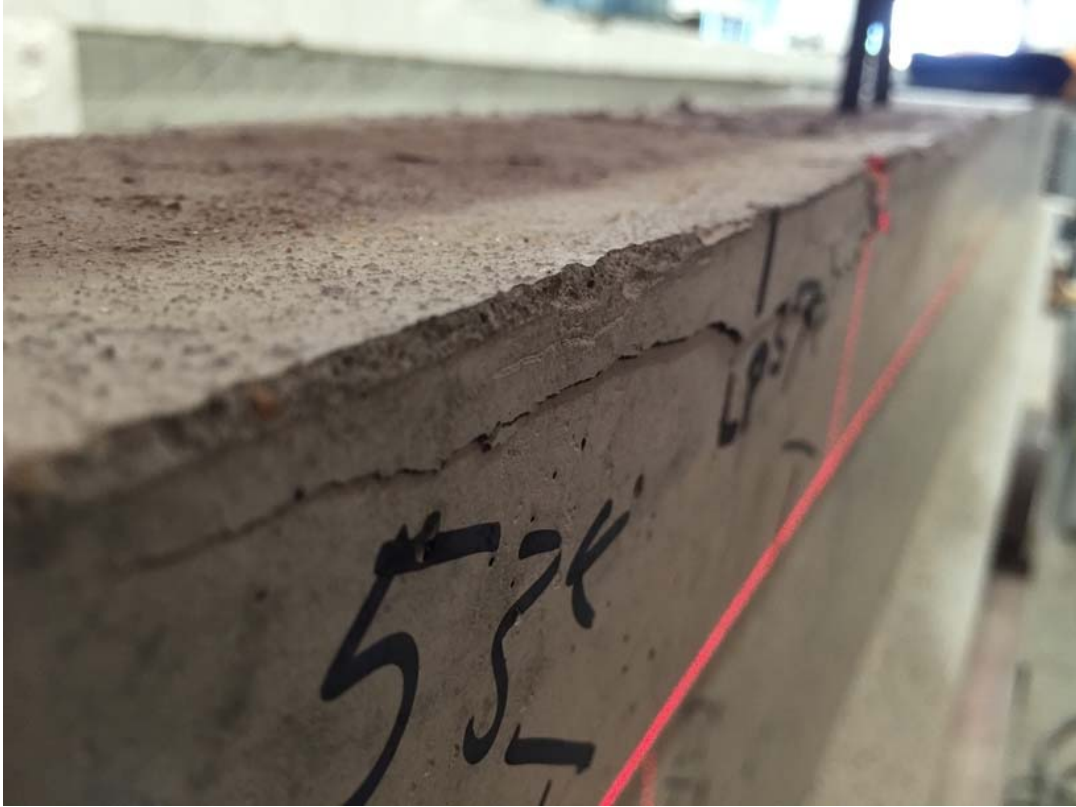
Figure 63. Concrete failure at top of top flange, C3NC

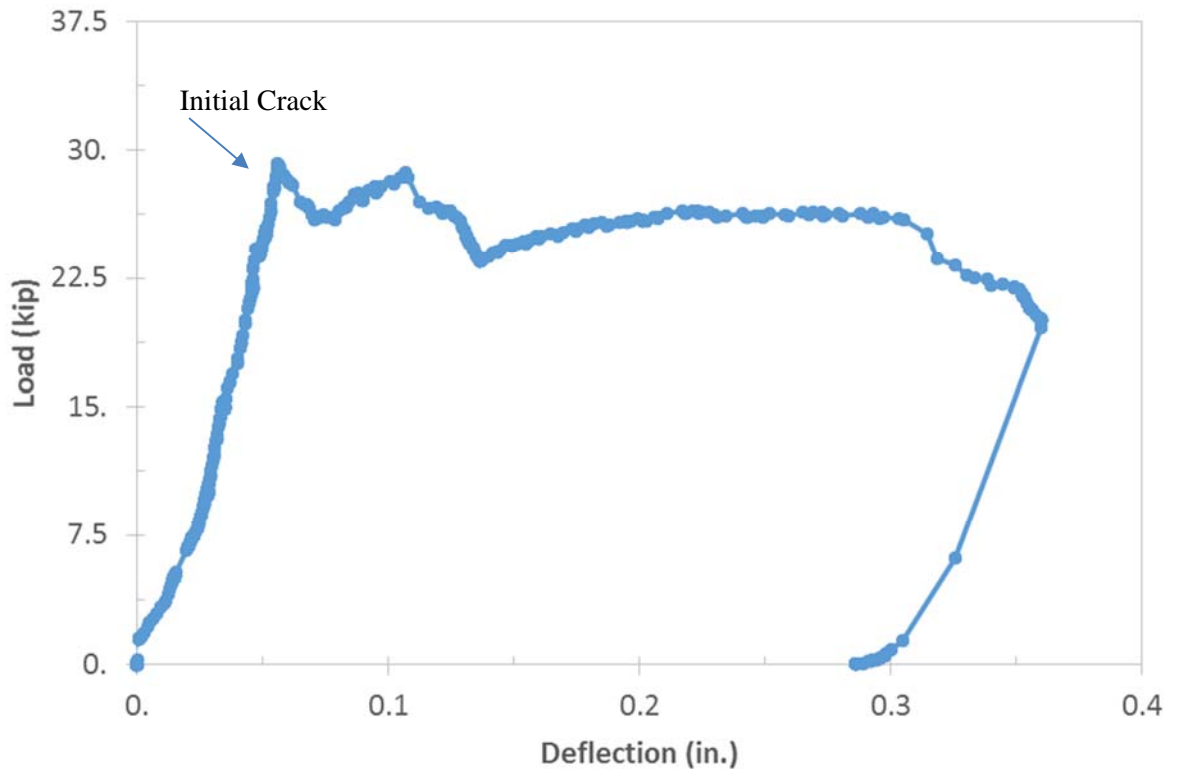
Figure 64. Load vs. Deflection of C3S

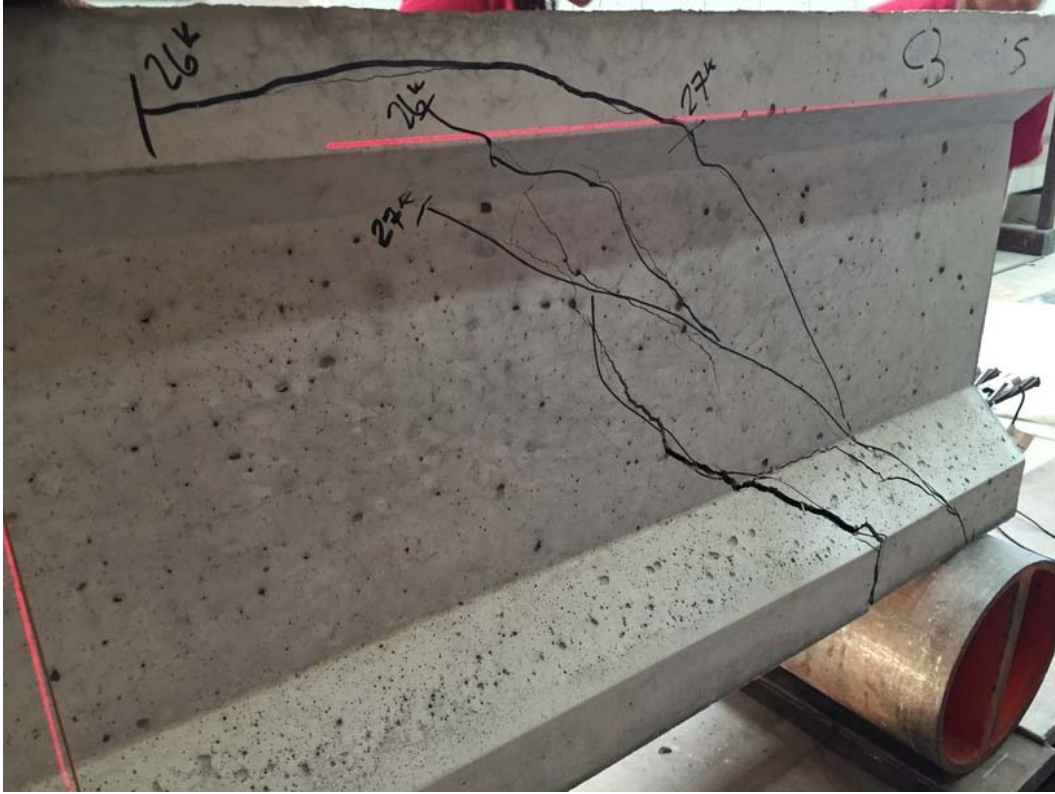
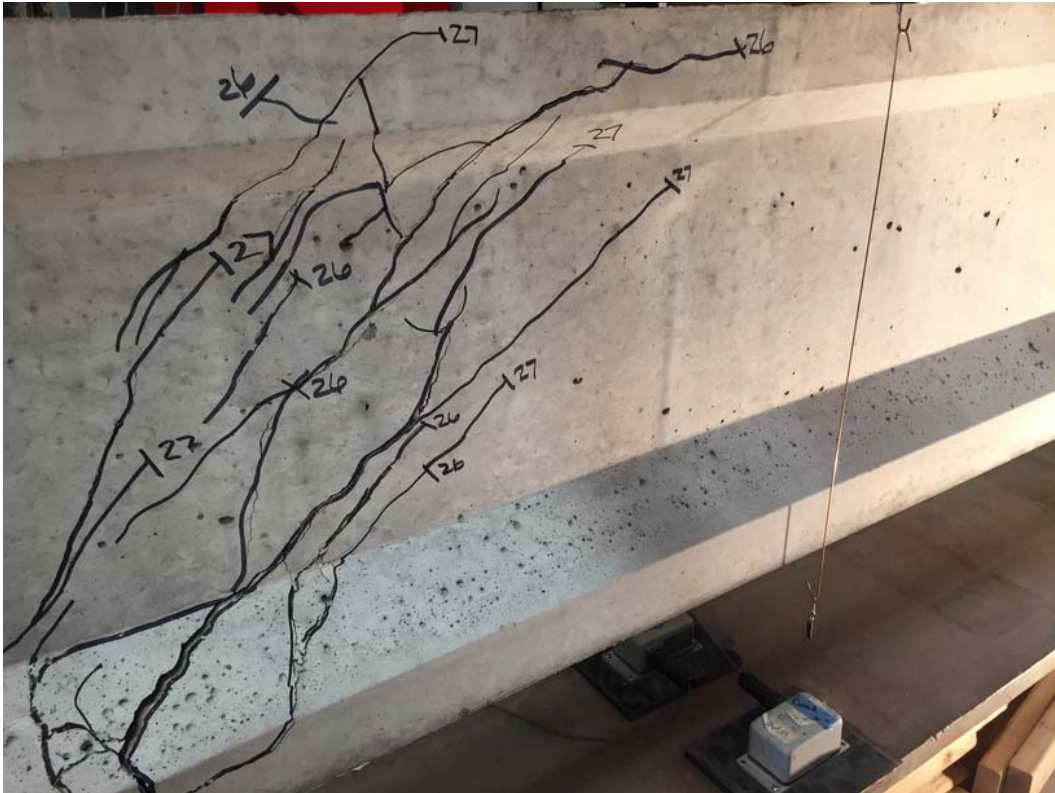
Figure 66. Visual map of cracking of C3S

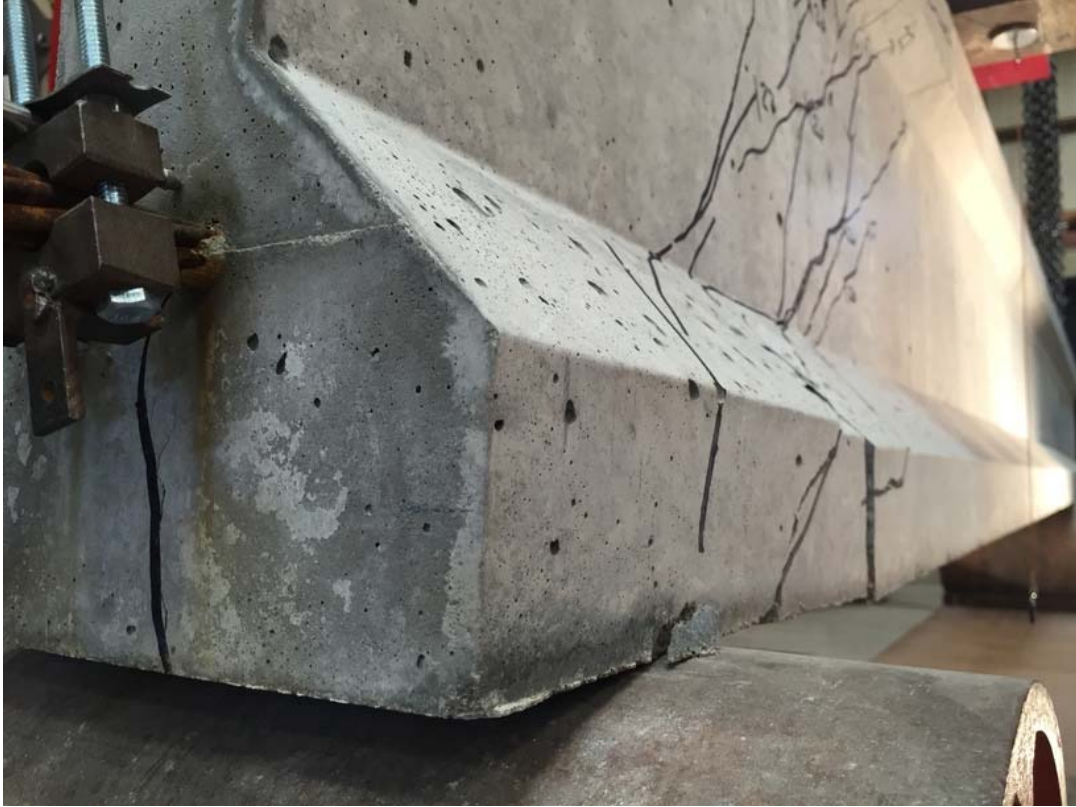
Figure 67. Visual map of cracking of C3S

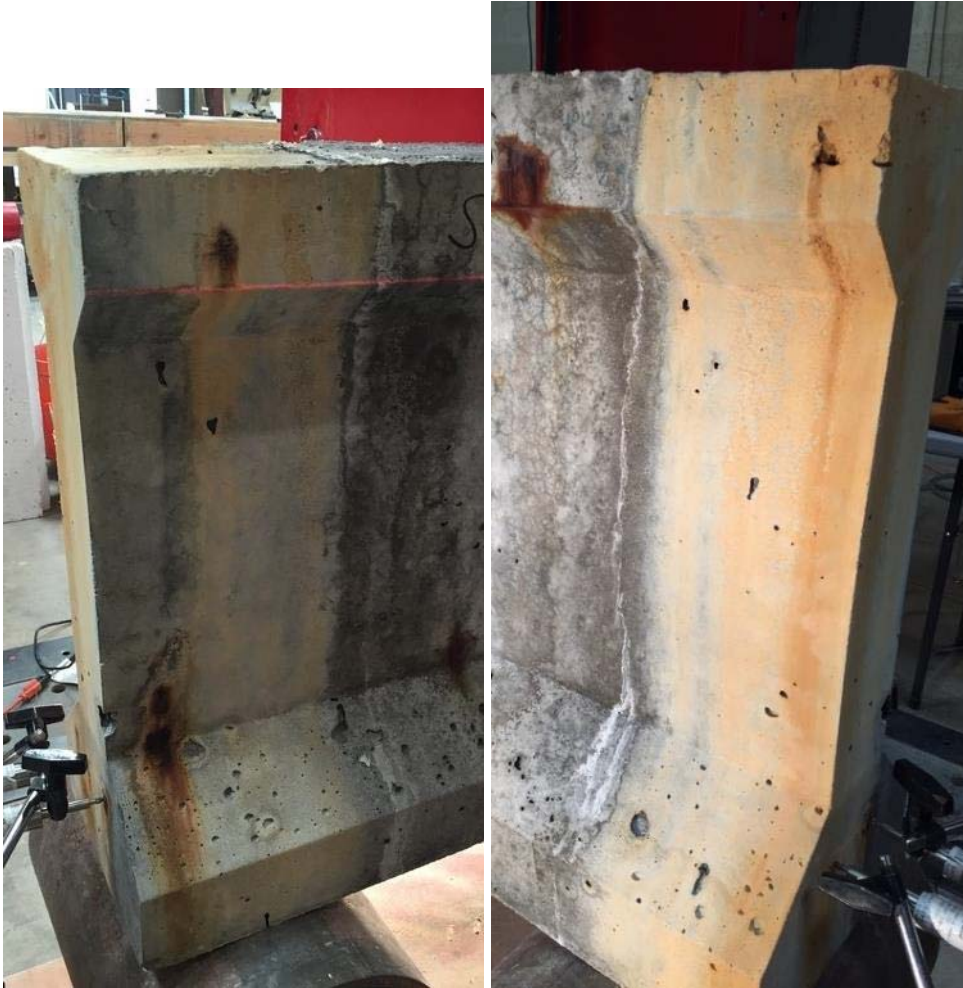
Figure 68. Prior to testing of A2SC

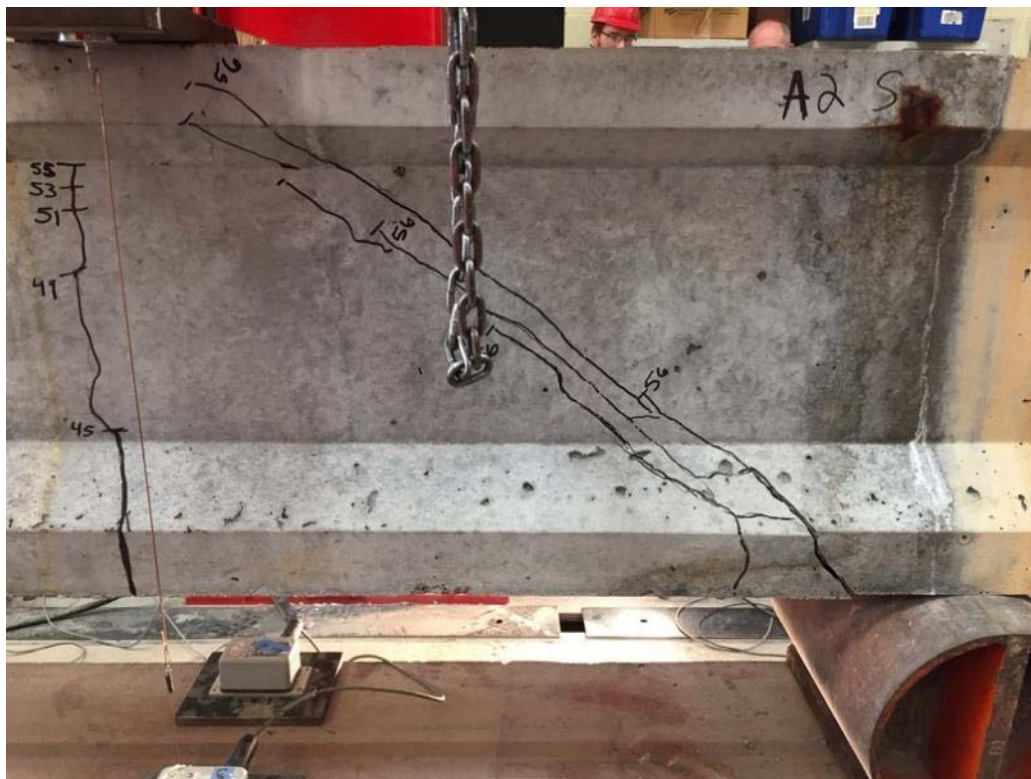
Figure 70. Visual map of cracking of A2SC

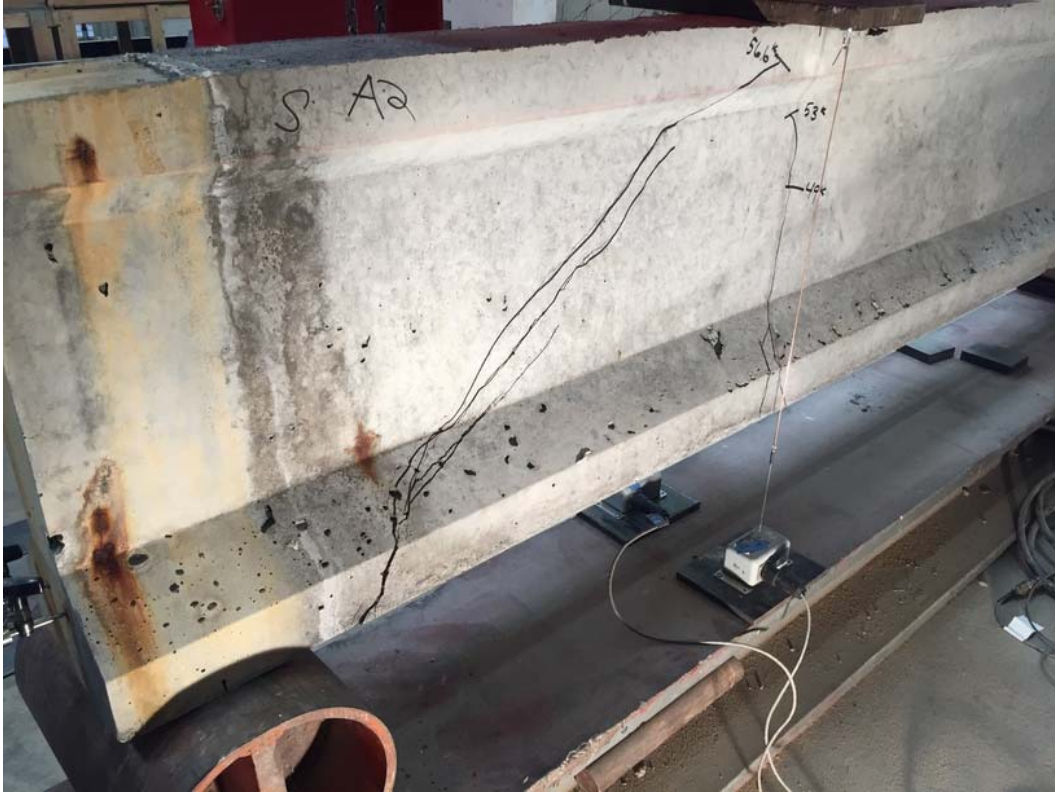
Figure 71. Visual map of cracking of A2SC

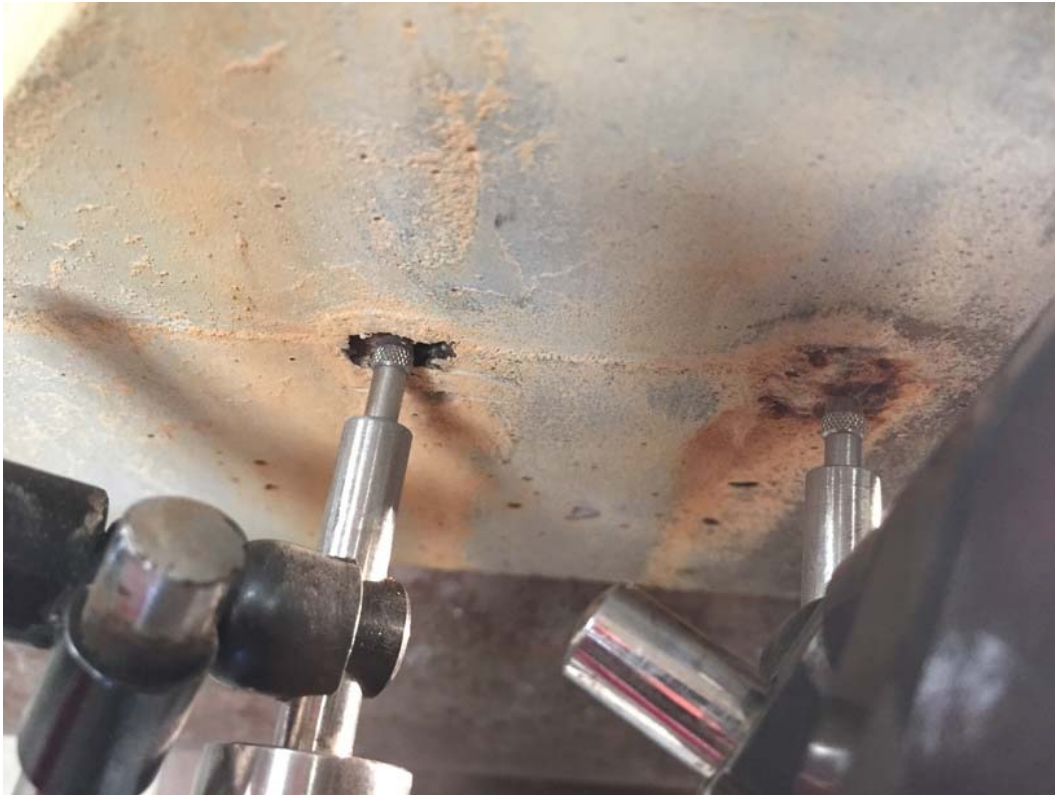
Figure 72. Visible Slip of A2SC

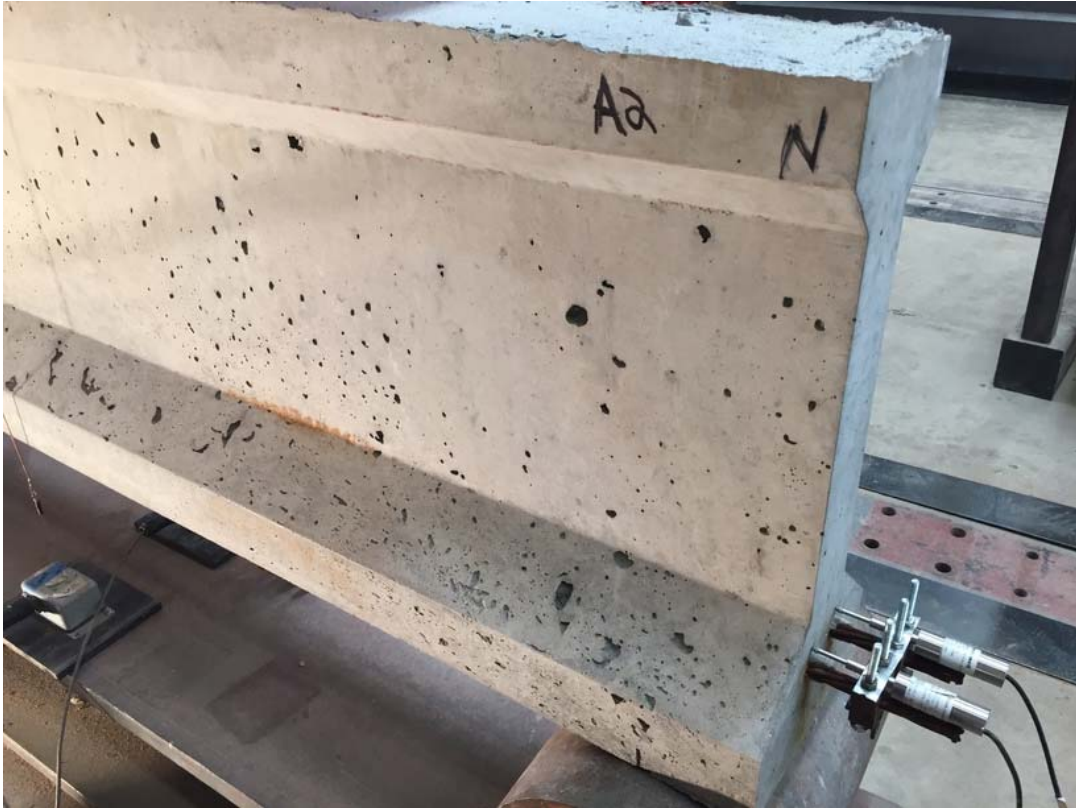
Figure 73. Prior to testing A2N

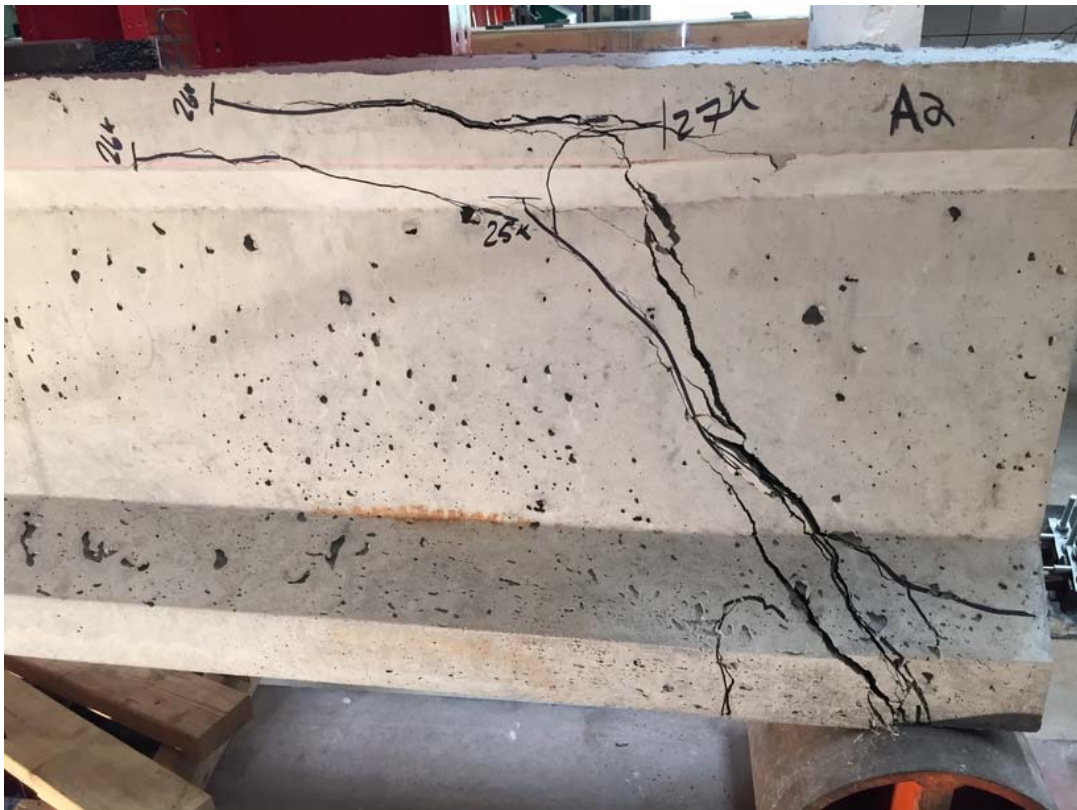
Figure 76. Cracking along the flange and web of A2N

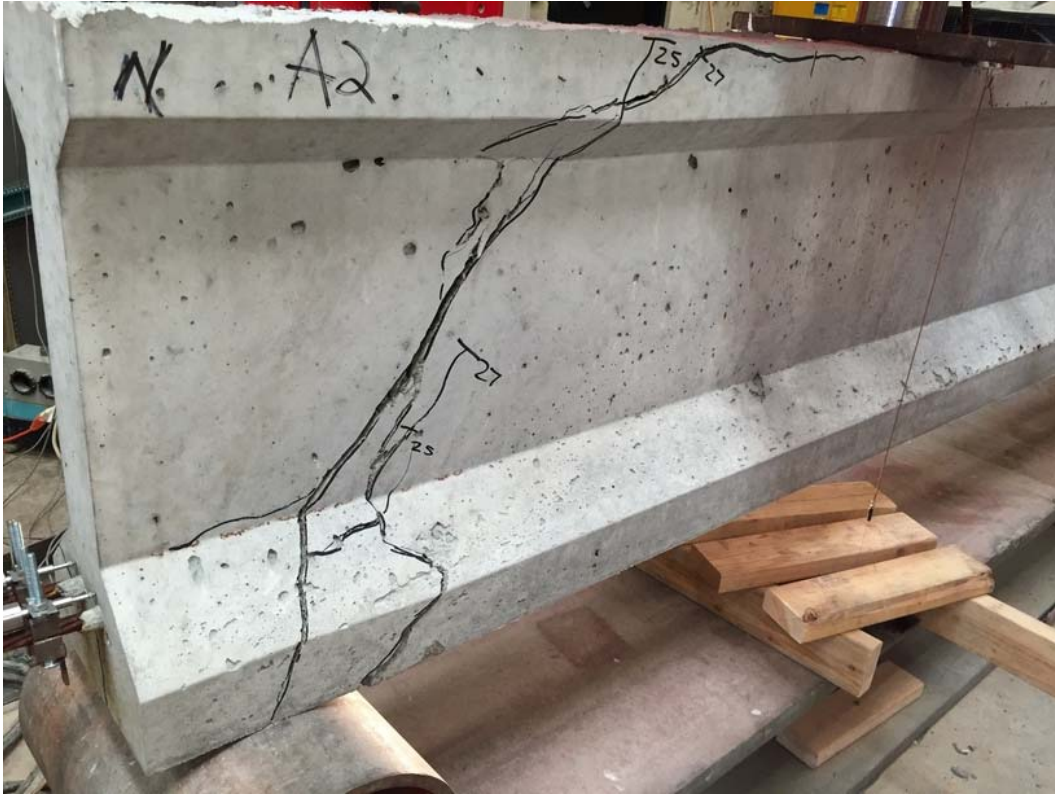
Figure 77. Cracking from bottom flange to top flange of A2N

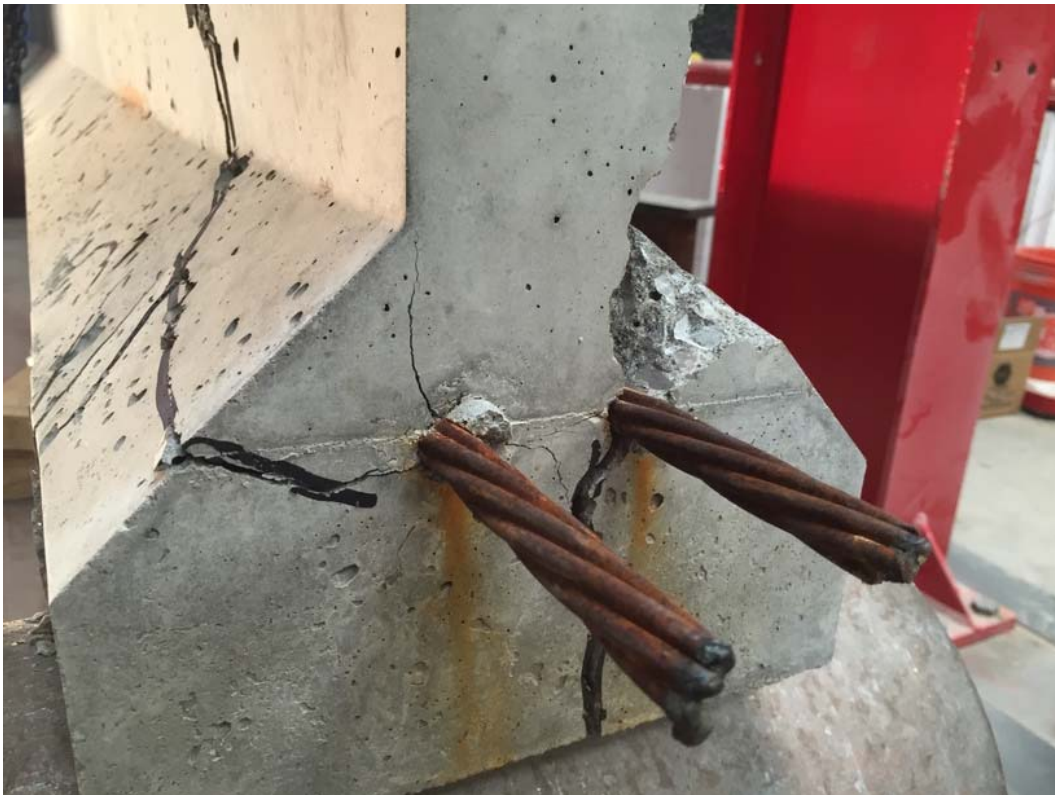
Figure 78. Cracking near prestressing strands

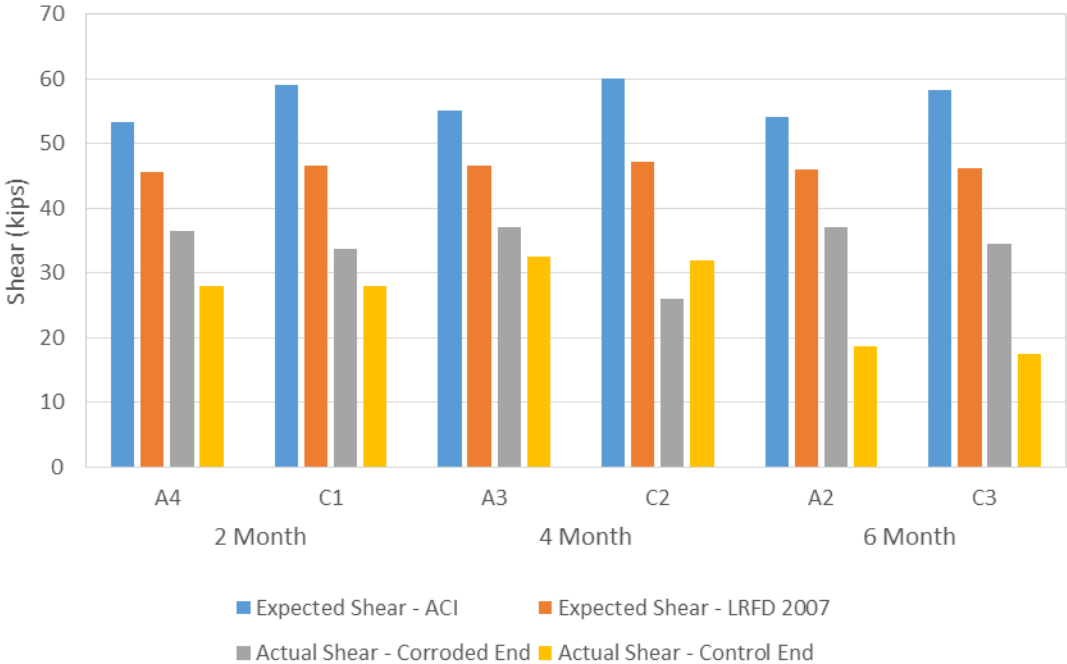
Figure 79. Design Shear Capacity vs. Measured Shear at Failure

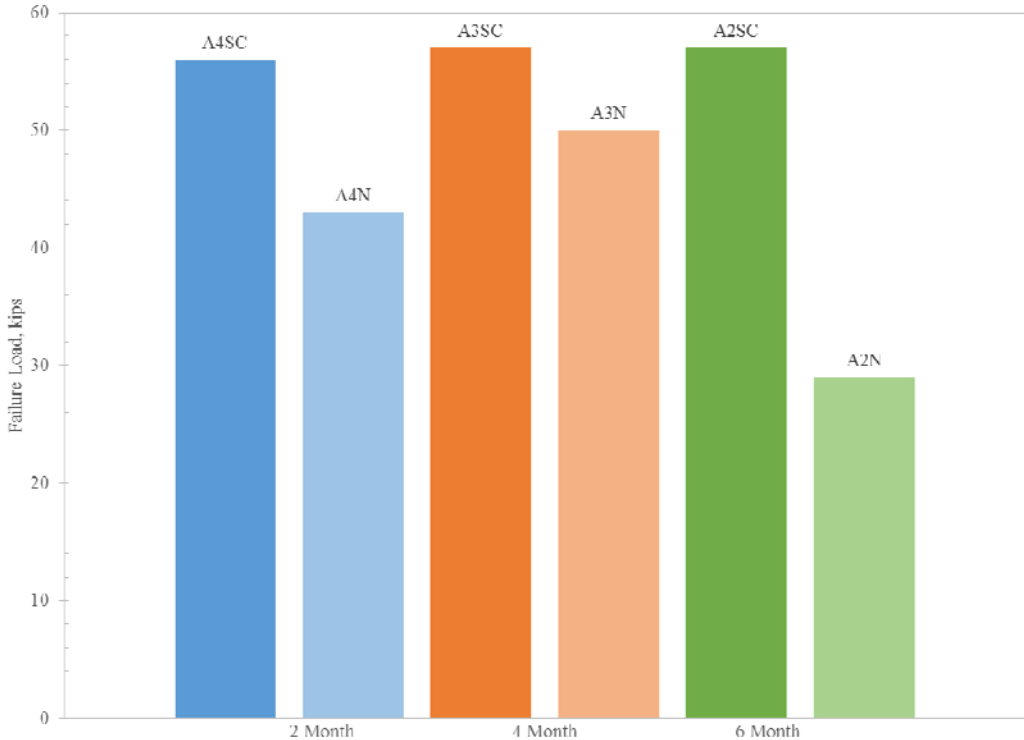
Figure 80. Failure Loads for Girder A Design

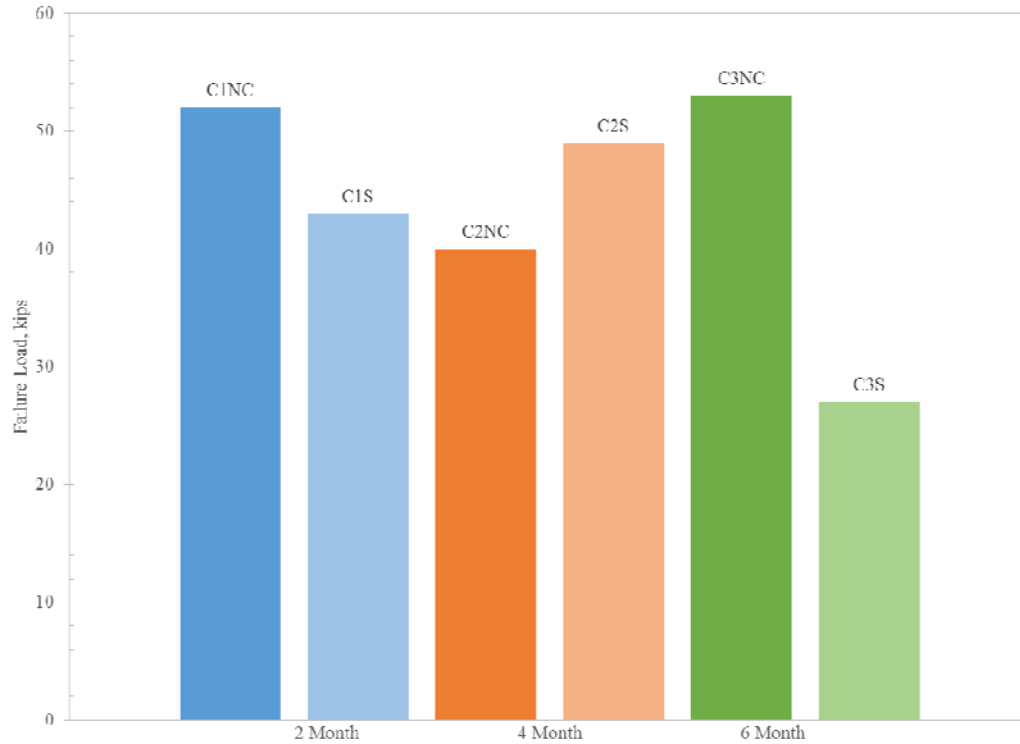
Figure 81. Failure Loads for Girder C Design

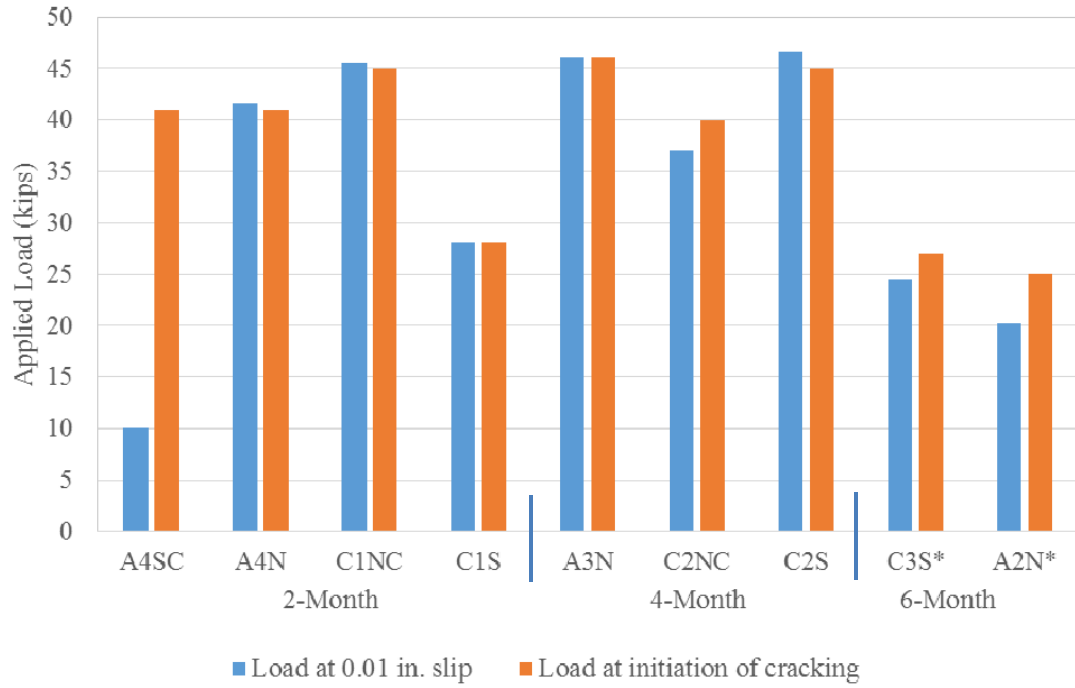
Figure 82. Comparison of load at 0.01 in. slip and initiation of cracking (*Note: C3S and A2N decreased in loading after cracking and then slip occurred at that decreased load)
