UNIVERSITY OF OKLAHOMA
GRADUATE COLLEGE

INVESTIGATION OF THE EFFECTS OF END REGION DETERIORATION IN
PRECAST, PRESTRESSED CONCRETE BRIDGE GIRDERS

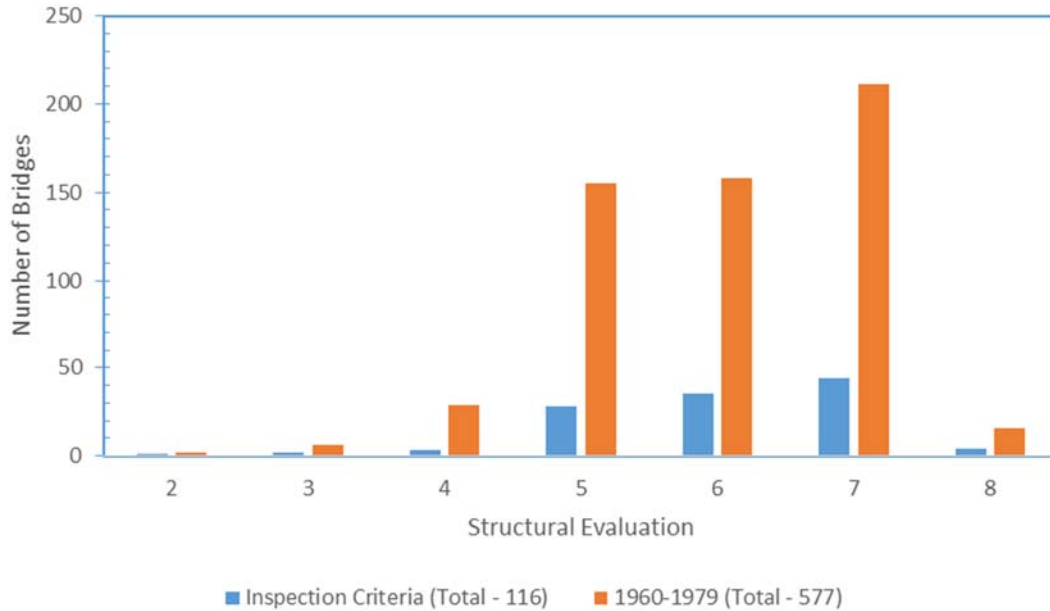
Figure 83. Oklahoma Prestressed Concrete Girder Bridges by Structural Evaluation

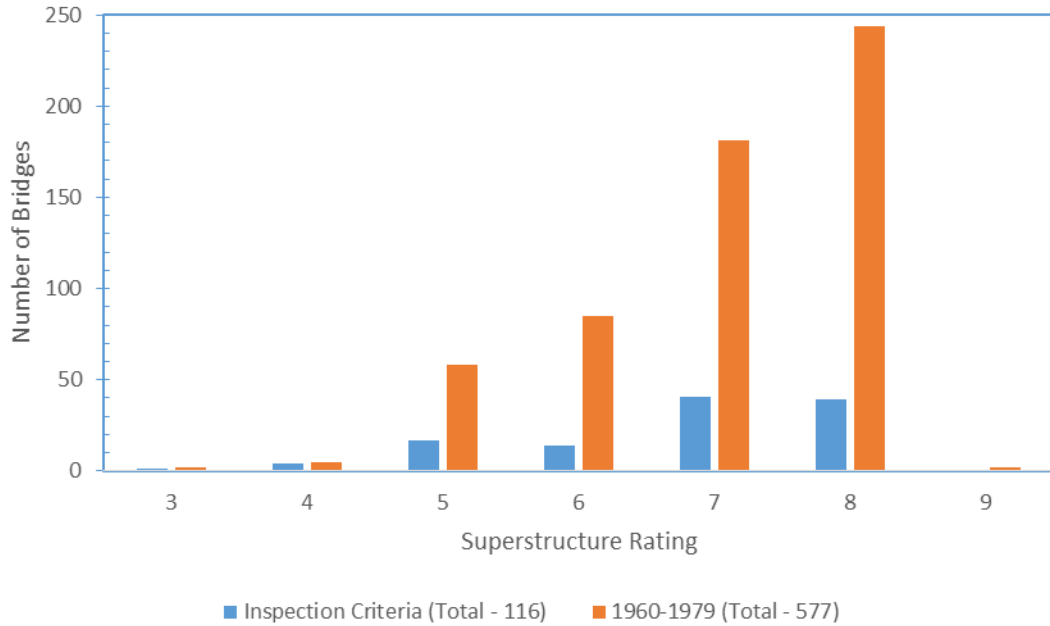
Figure 84. Oklahoma Prestressed Concrete Girder Bridges by Superstructure Rating

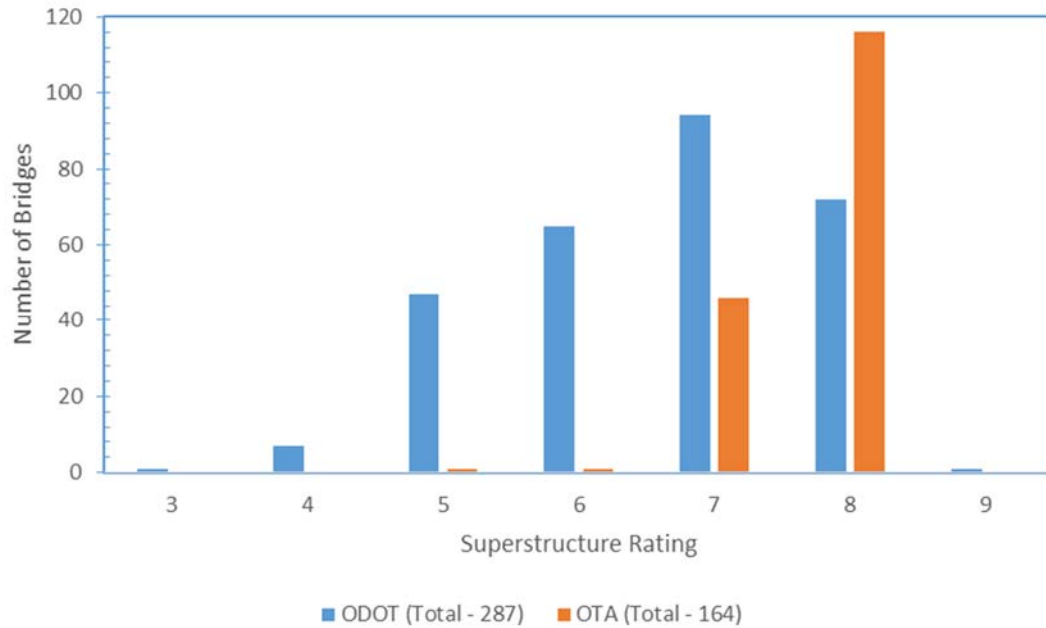
Figure 85. Oklahoma Prestressed Concrete Girder Bridges (1960-1979) by Superstructure Rating and Ownership

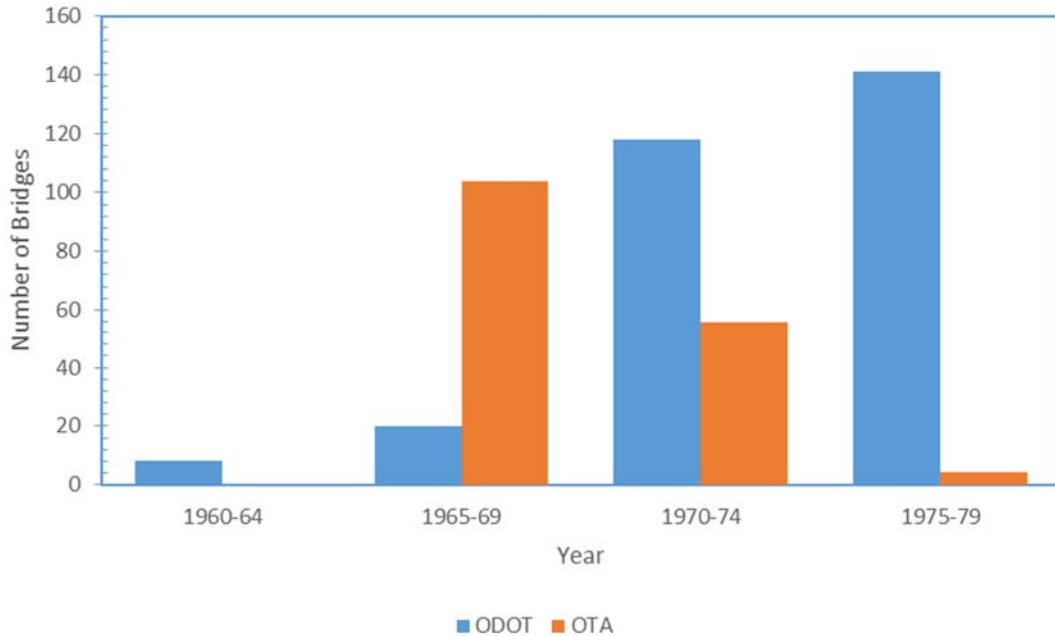
Figure 86. Oklahoma Prestressed Concrete Girder Bridges Ownership (1960-1979)

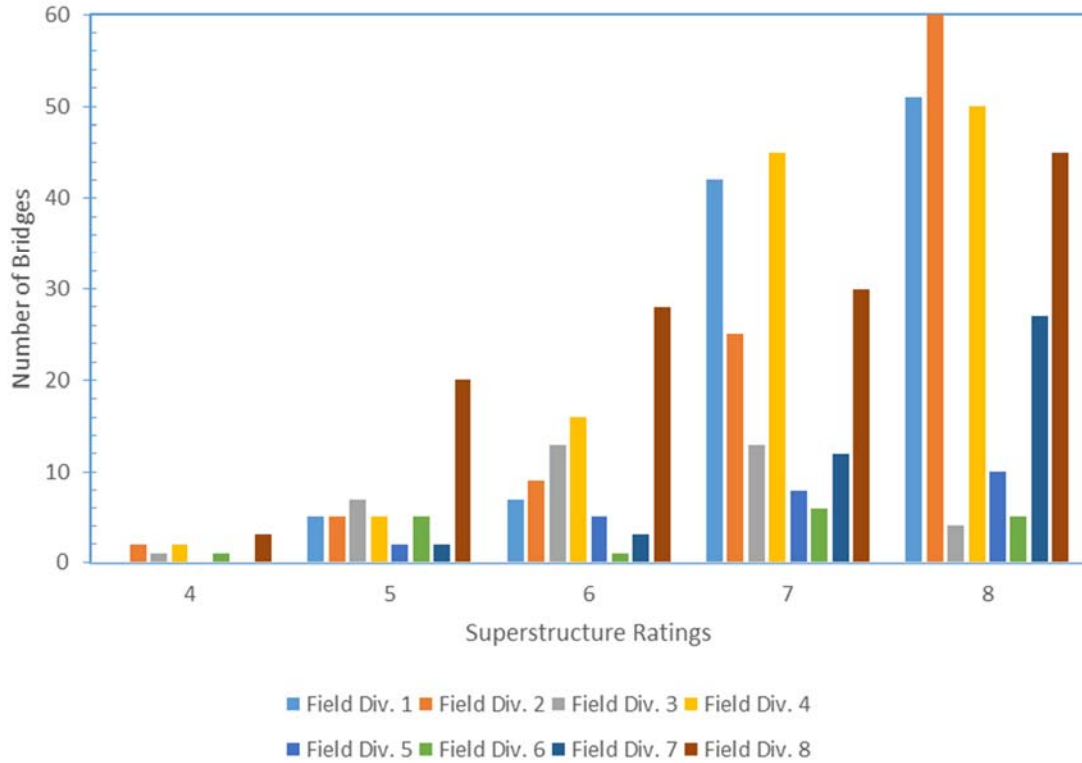
Figure 87. Oklahoma Prestressed Concrete Girder Bridges (1960-1979) by Superstructure Rating and Field Division

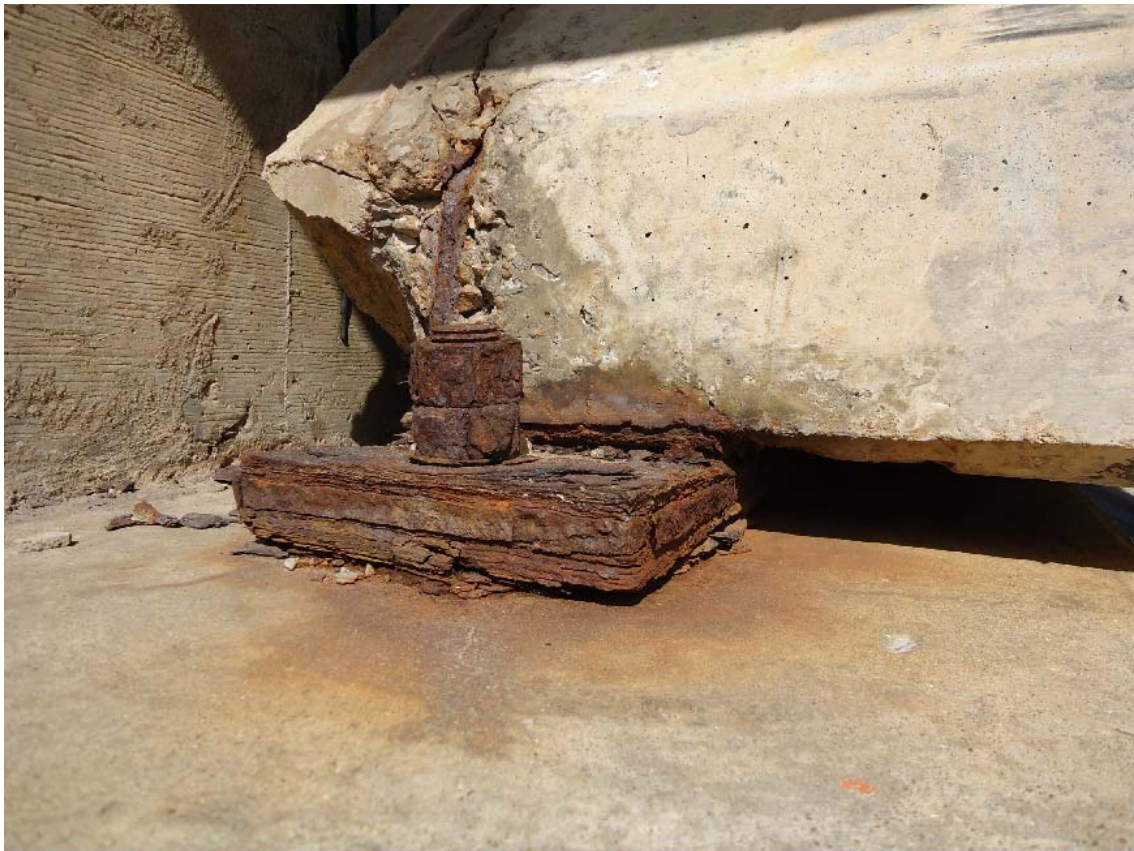
Figure 88. Example of corroded bearing plate

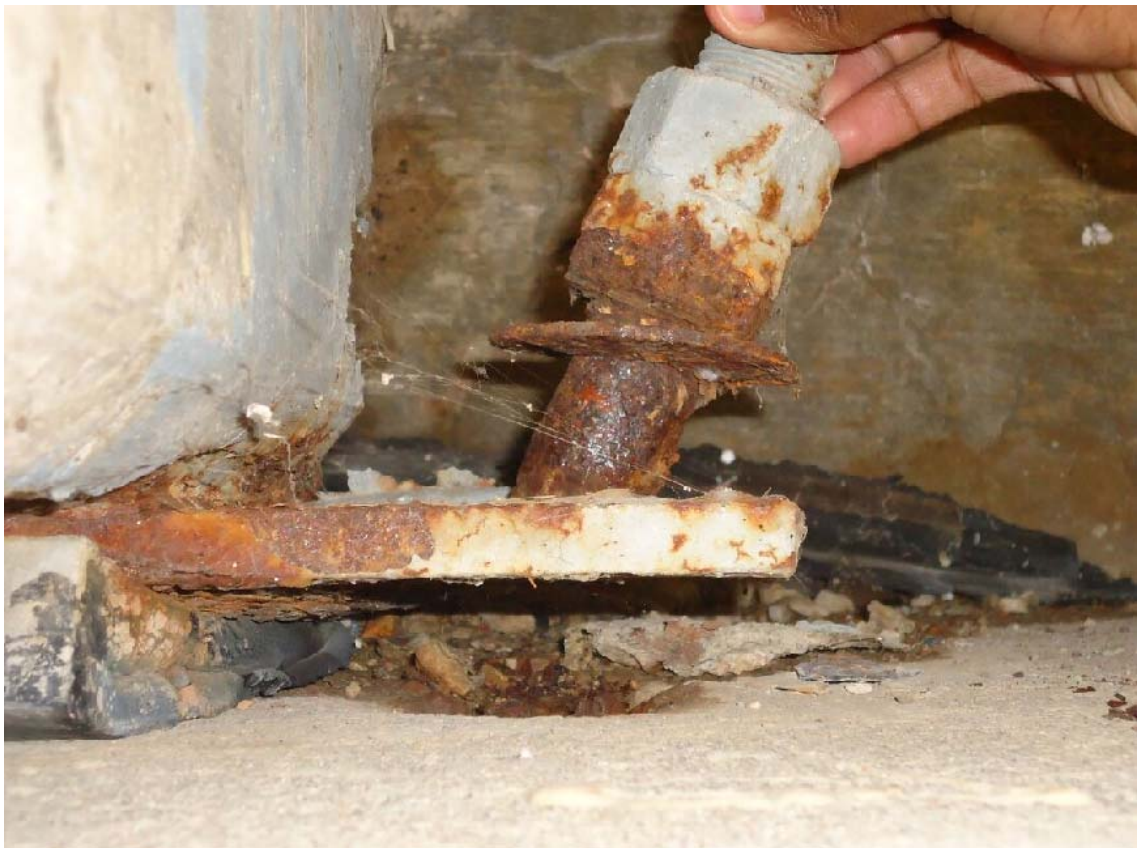
Figure 89. Example of corroded anchor bolt

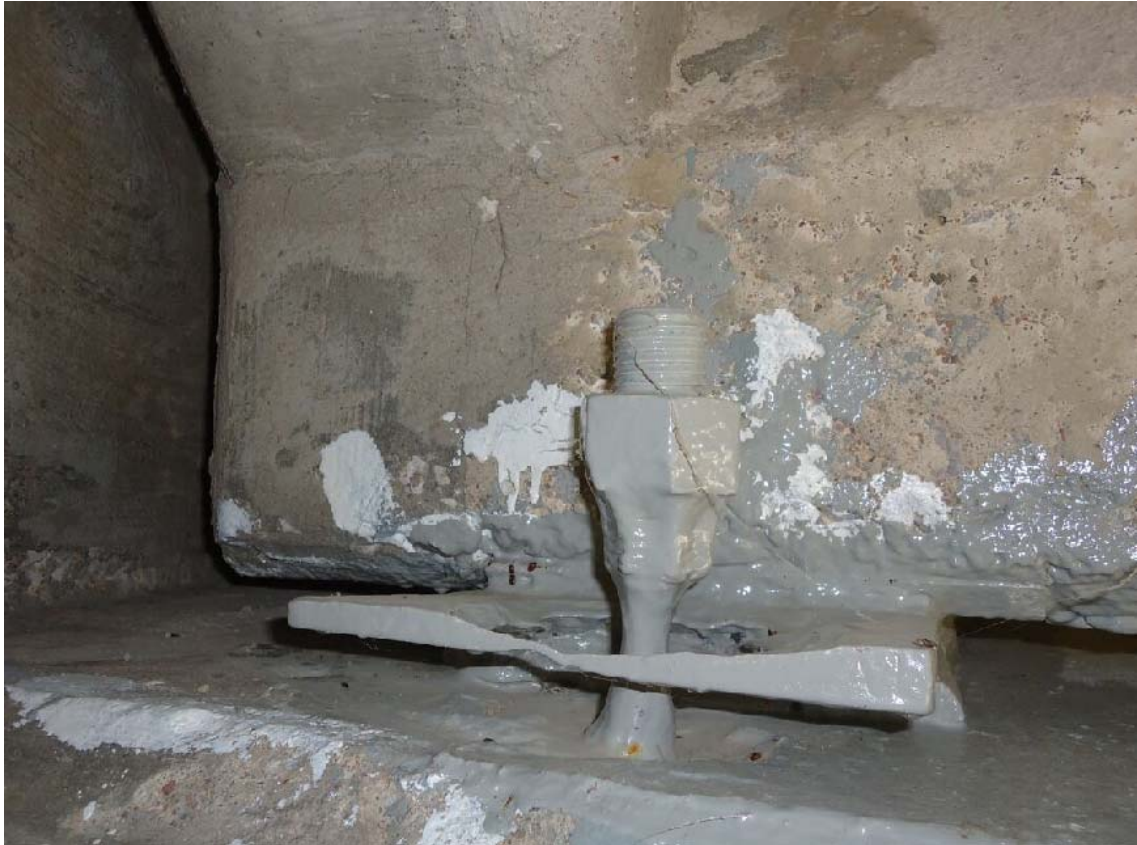
Figure 90. Example of coated, damaged anchor bolt and nut

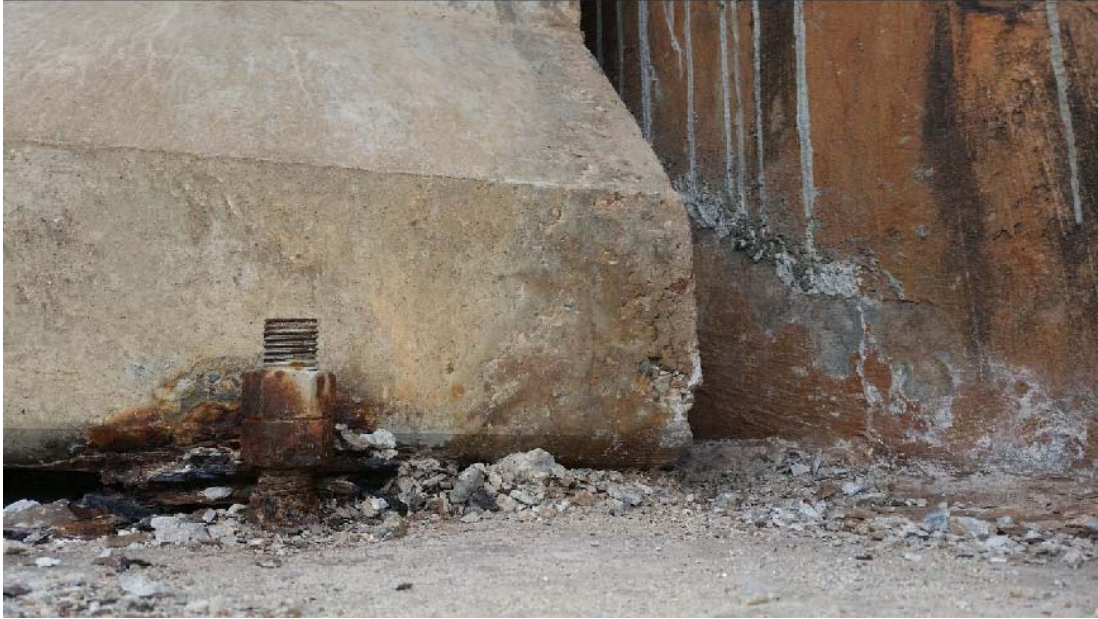
Figure 91. Example of spalling above bearing support

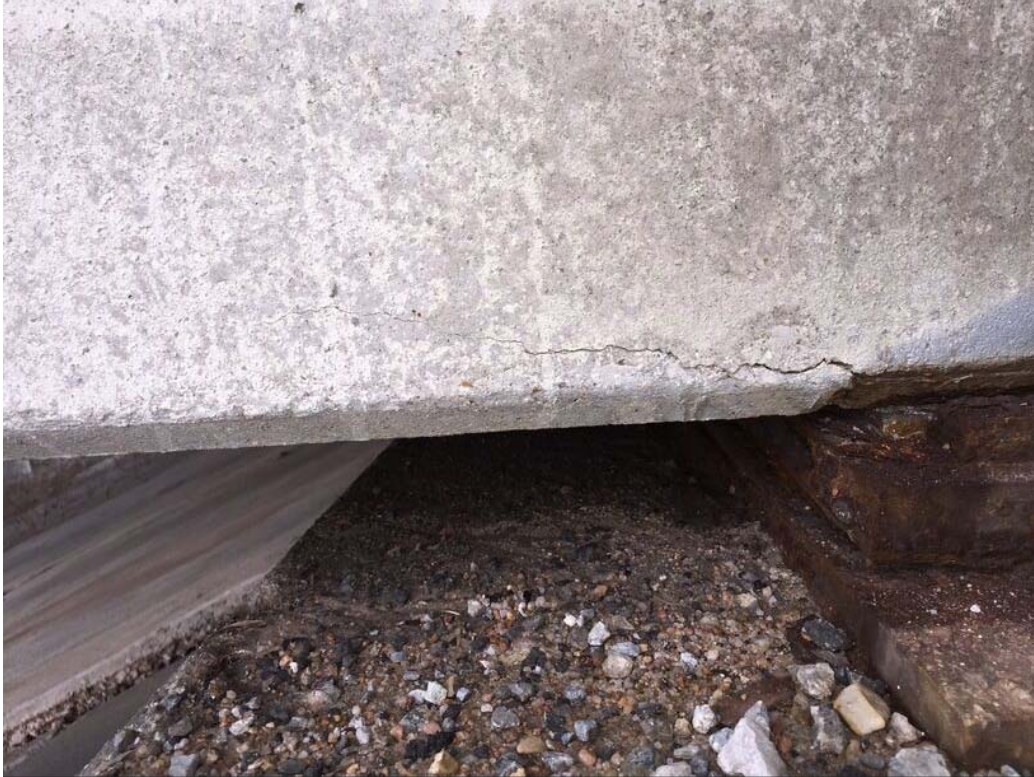
Figure 92. Example of crack from damage around the bearing plate

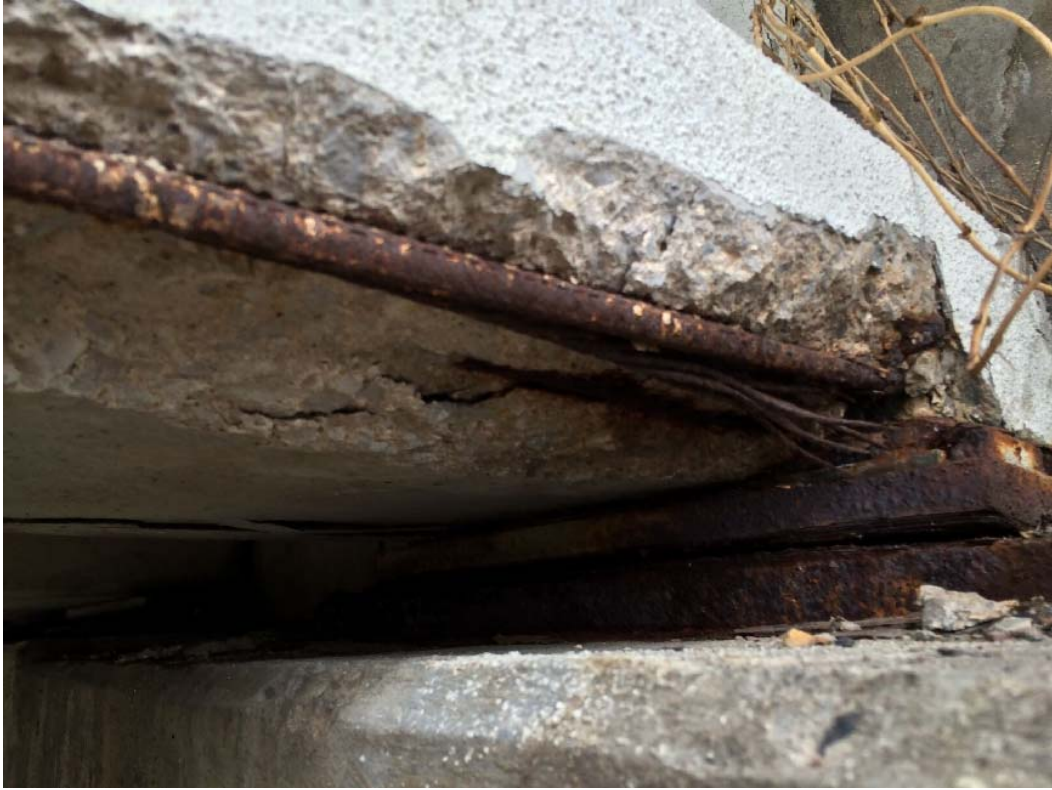
Figure 93. Example of exposed steel

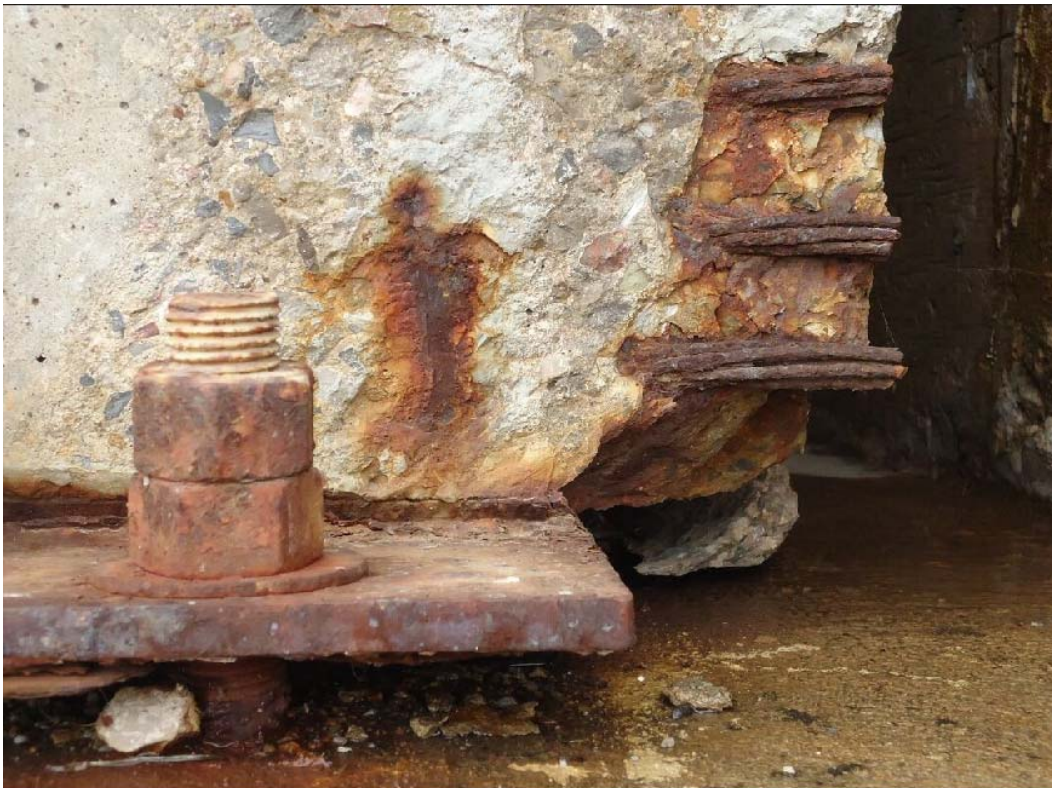
Figure 94. Example of exposed prestressing strands

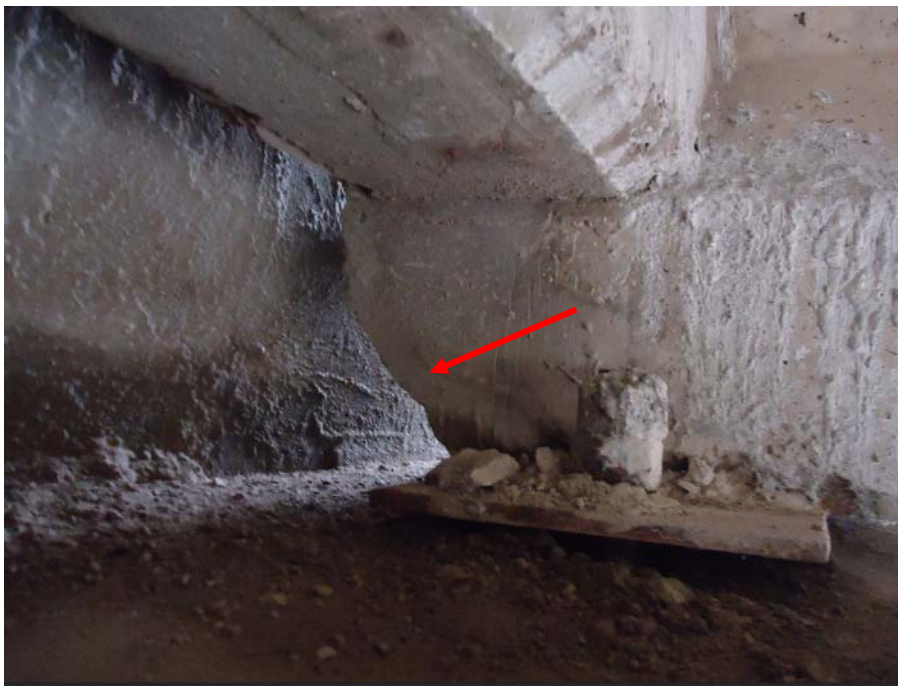
Figure 95. Example of back diagonal cracking/spalling

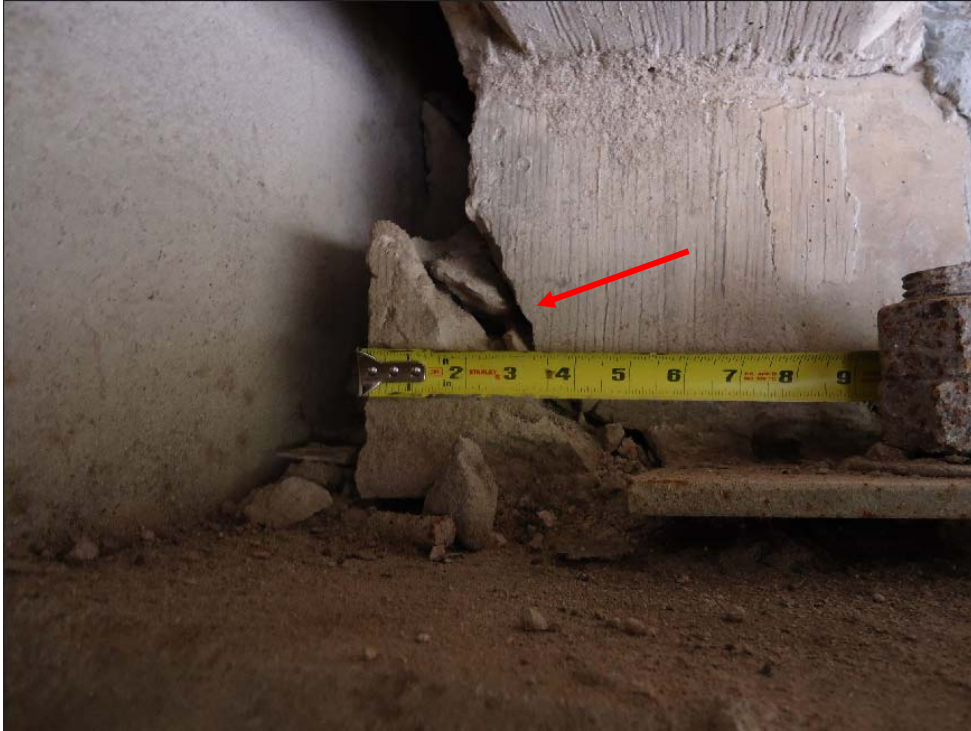
Figure 96. Example of back diagonal cracking

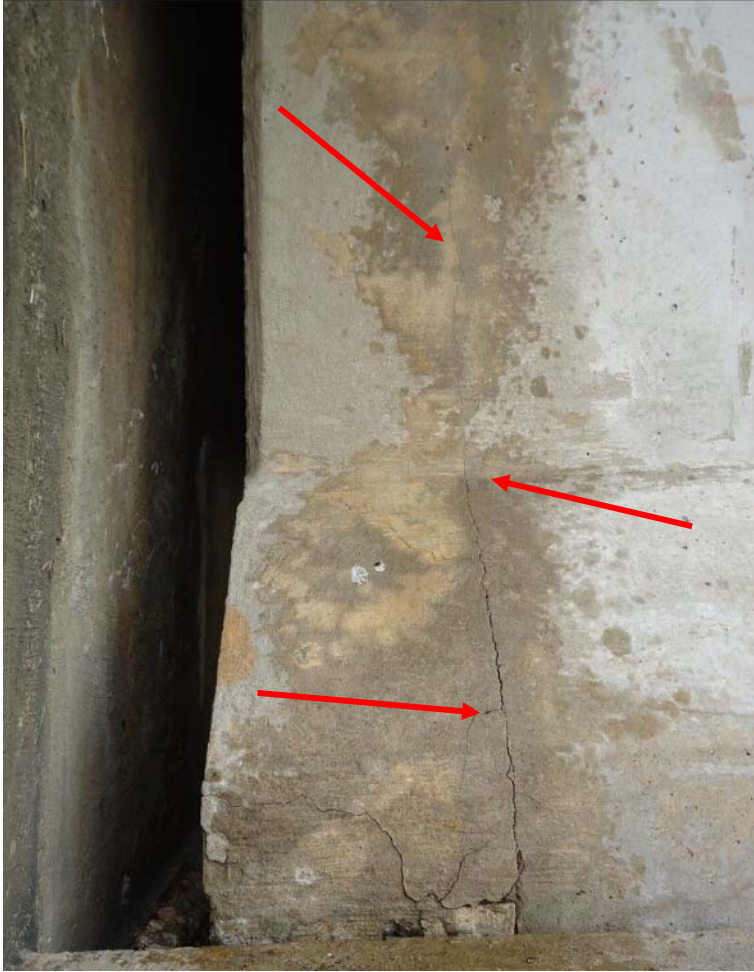
Figure 97. Example of vertical cracking along diaphragm and girder

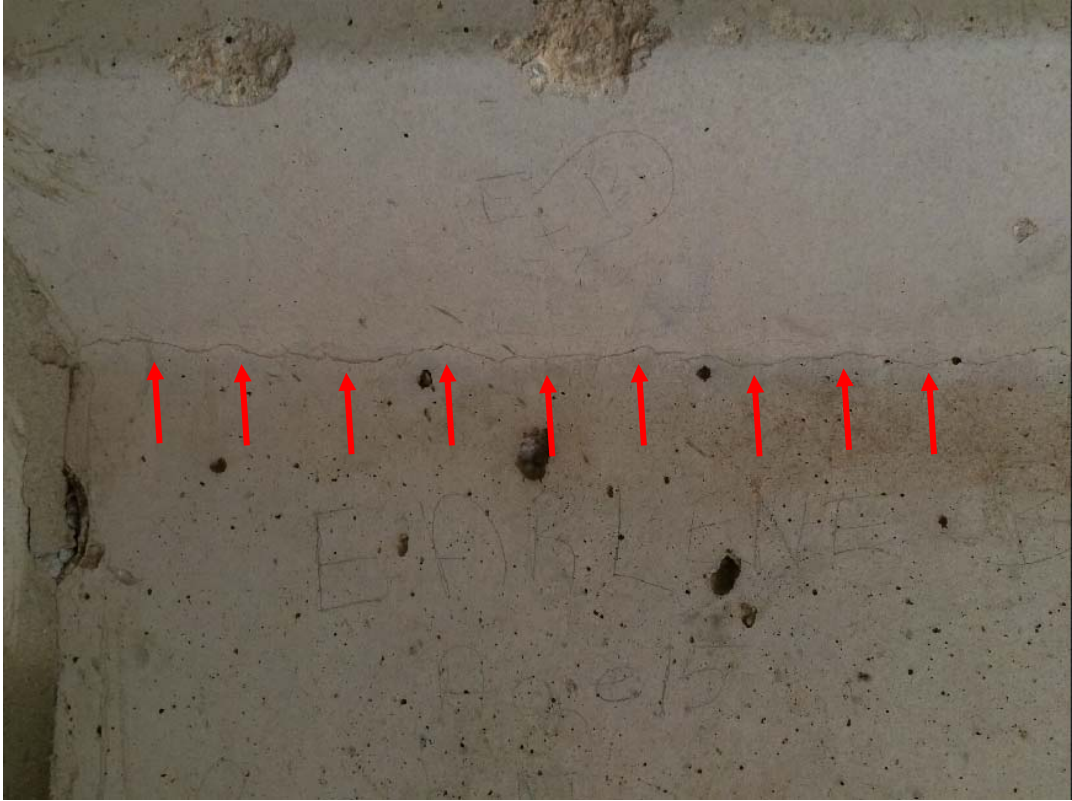
Figure 98. Example of horizontal cracking along the top flange and web interface

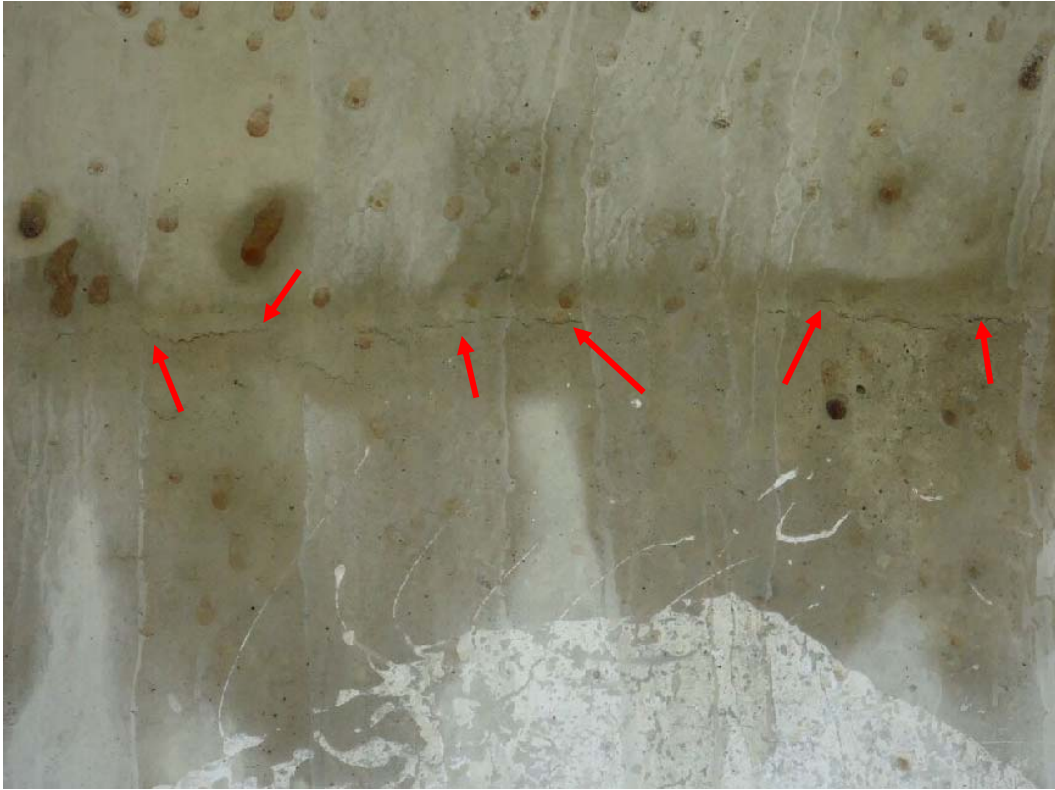
Figure 99. Example of horizontal cracking along the top flange and web interface

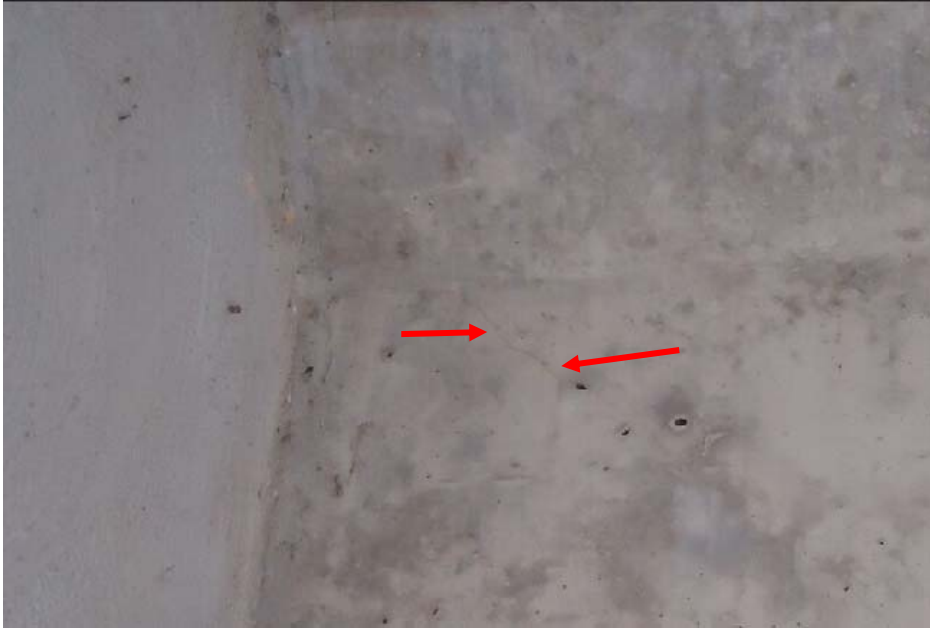
Figure 100. Example of diagonal cracking from the top flange and web interface

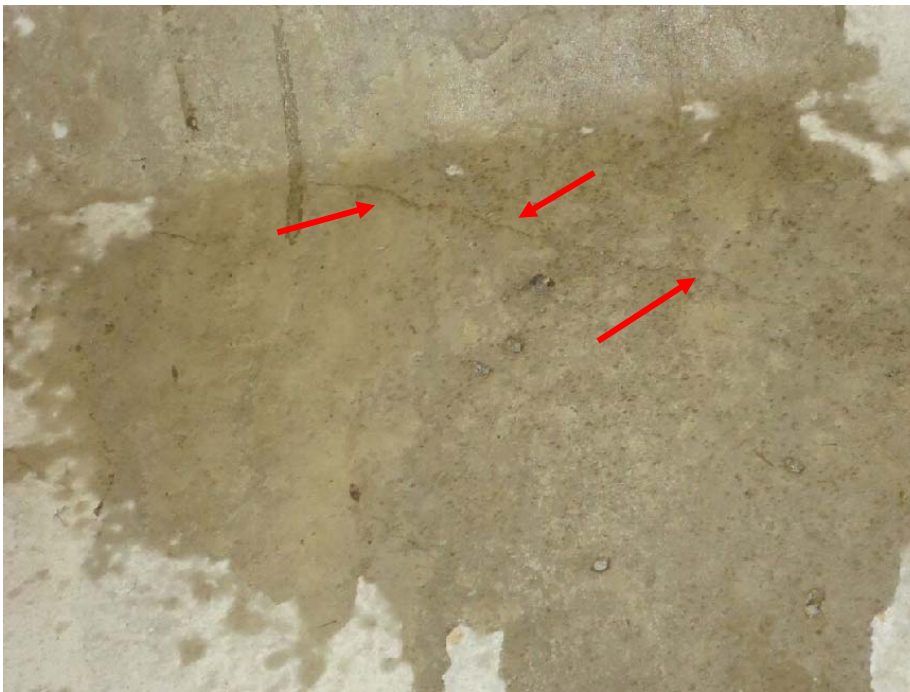
Figure 101. Example of diagonal cracking from the top flange and web interface

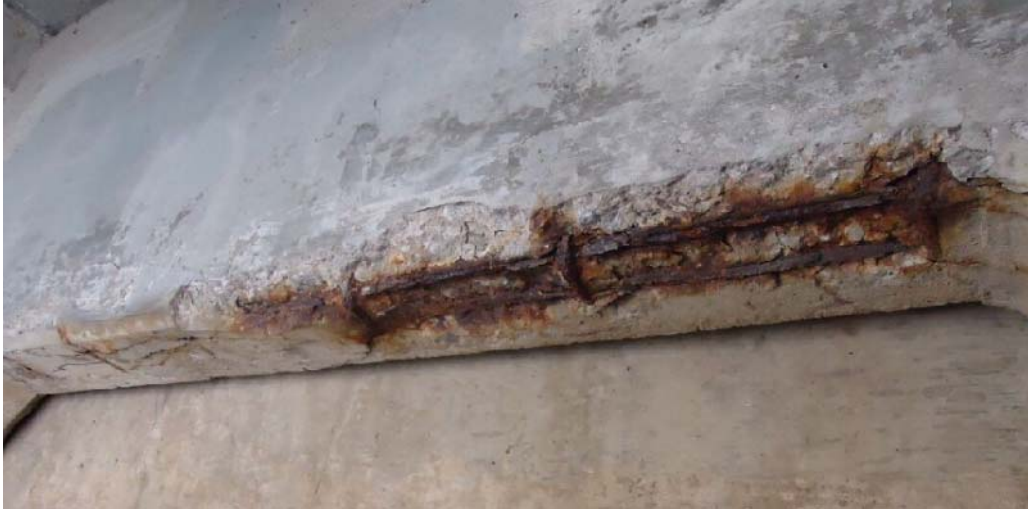
Figure 102. Example of Diaphragm deterioration

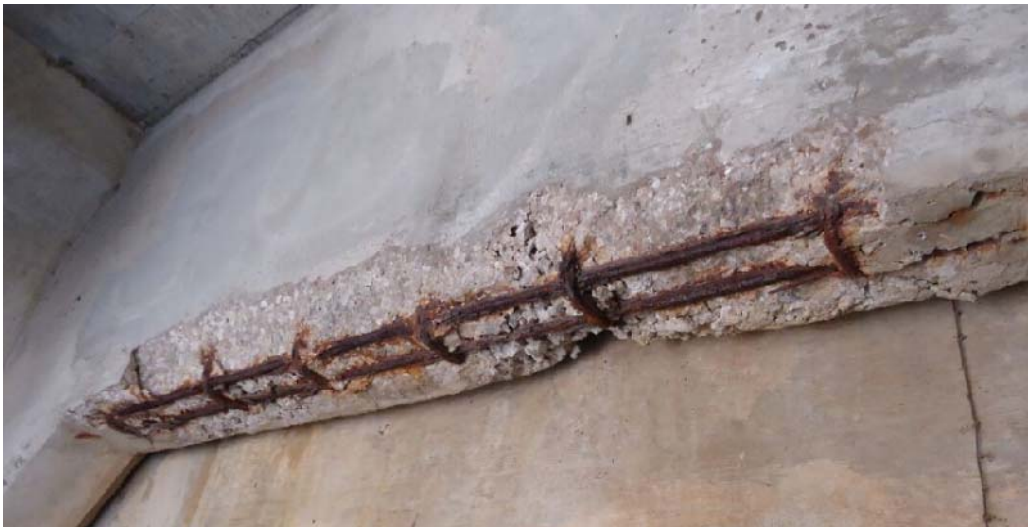
Figure 103. Example of Diaphragm deterioration

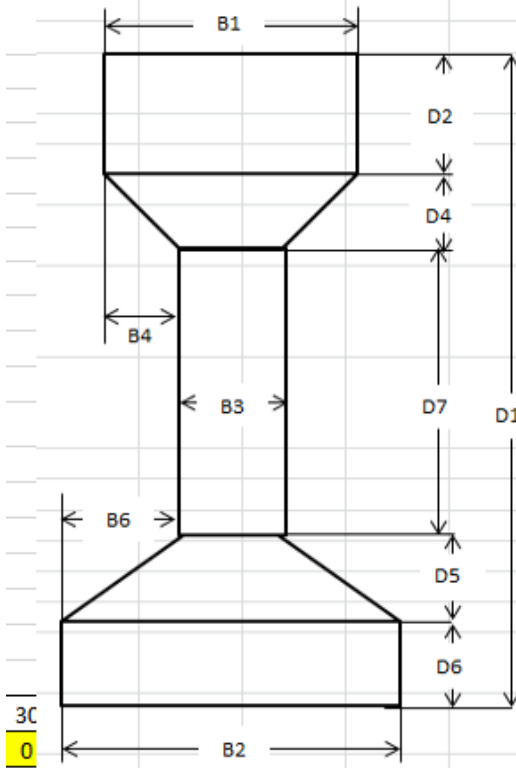
ACI Shear Capacity Calculation			
Properties		Loadings	
Type	2		
cgs (in.)	4		
h (in.)	22.5		
d _p (in.)	18.50		
d' (in.)	2.00		
b _w (in.)	3		
w _d (k/ft)	0.110		
w _l (k/ft)	0.000		
P (kips)	62.365	62.365	
A _g (in ²)	105.75		
A _{ps} (in ²)	0.33		
L (ft) supports	9	Simplified Shear	
l _c (ft)	3.083333333	V _c (kips)	41.43
a (ft)	3.083333333	V _{min} (kips)	8.60
b (ft)	5.92	V _{max} (kips)	21.50
V _{de} (kips)	0	Detailed Shear	
V _{d(-support)} (kips)	0.99140625	V _{ci} (kips)	26.14
V _{d(+support)} (kips)	0.991	V _{ci,min} (kips)	7
V _{dc} (kips)	-0.340	V _{cw} (kips)	23.7
M _{dc} (k-ft)	-0.523624674	Final	
V _{ue 1} (kips)	40.99921296	V _c (kips)	23.66
V _{ue 2} (kips)	21.36578704	V _s (kips)	30.525
V _{uc} (kips)	40.65956452546	V _n (kips)	54.18
M _{cu} (k-ft)	125.8906153	ϕV _n (kips)	40.63522
V _i (kips)	40.999	M _n (k-ft)	126.4149
M _{max} (k-ft)	126.41424

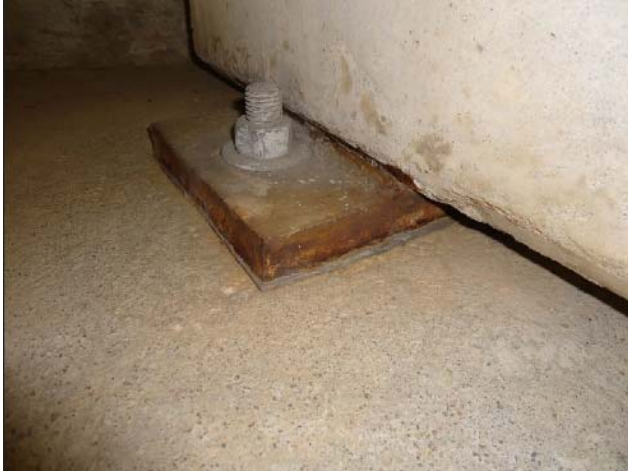
Figure 108. Example of corroding bearing plate (2W-S)

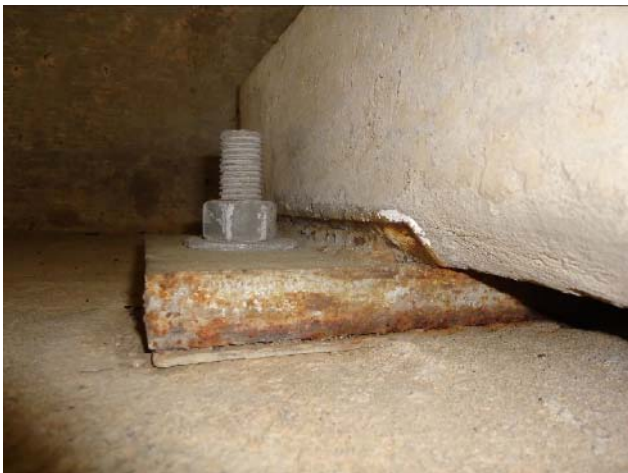
Figure 109. Another example of a corroding bearing plate (3W-S)

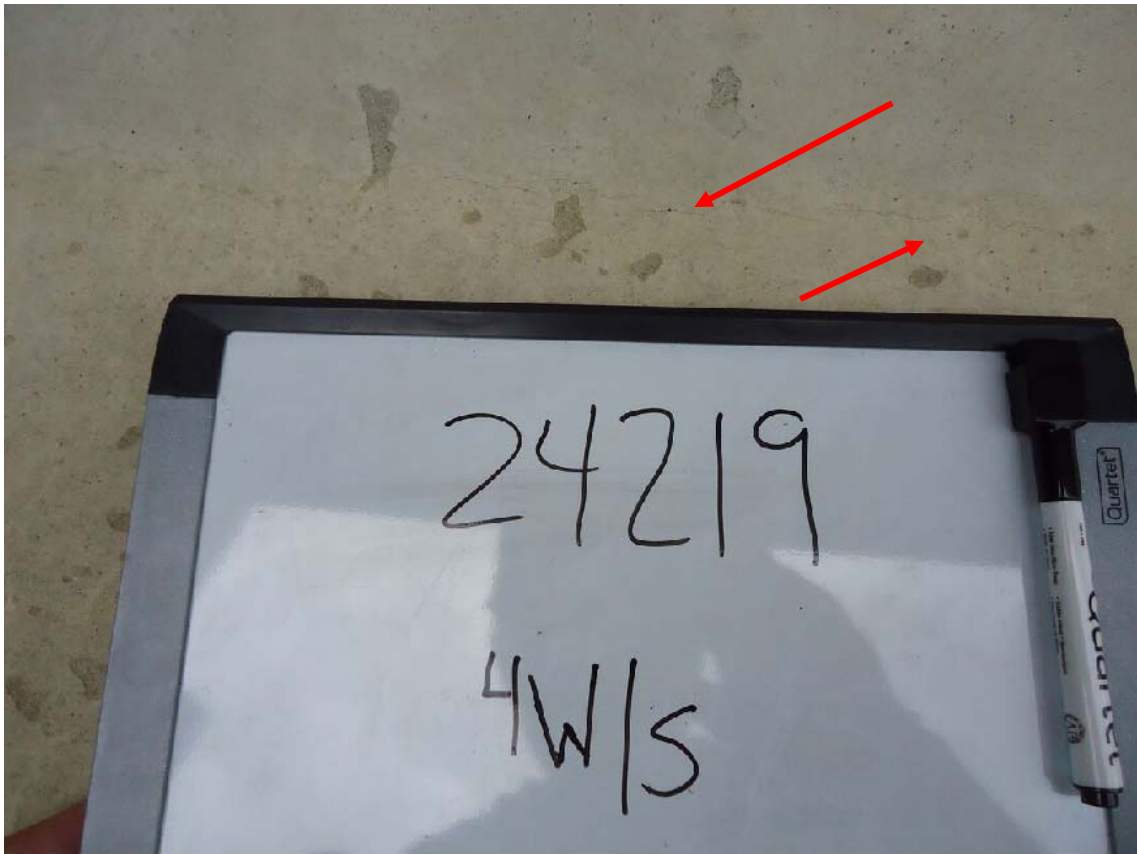
Figure 110. Horizontal Crack at Flange/Web Interface⁴(4W-S)

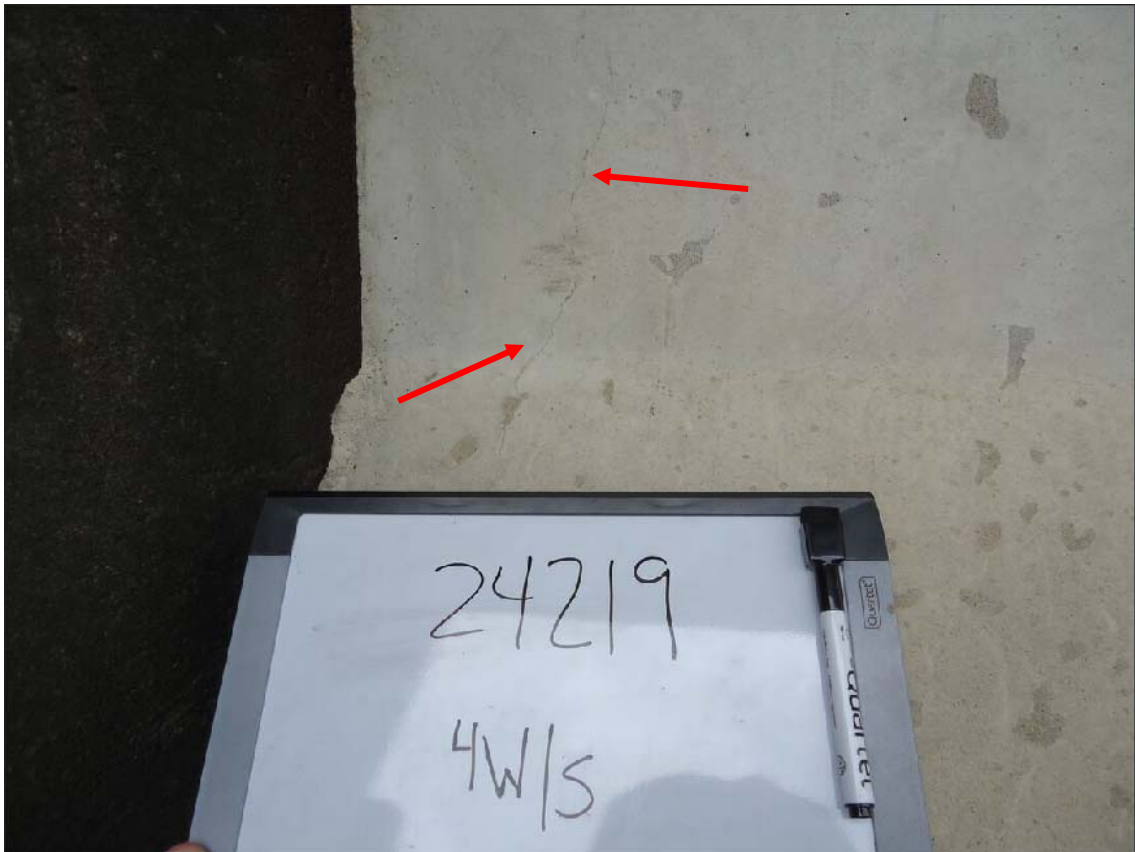
Figure 111. Vertical Crack from web through flange (4W-S)

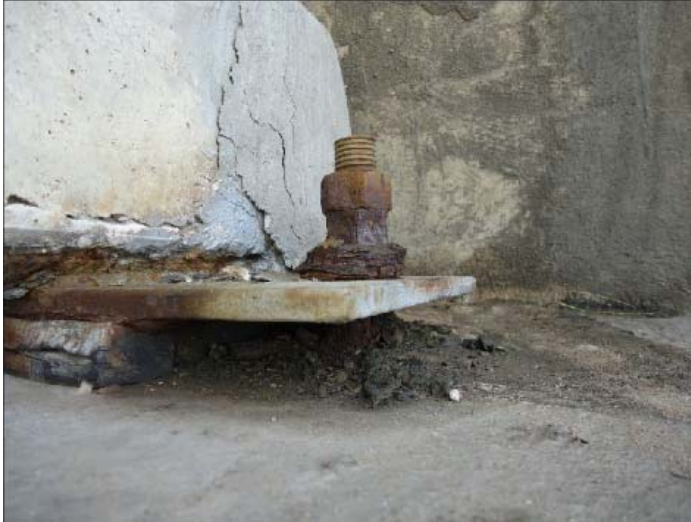
Figure 112. Corroded anchor bolt (IS-W)

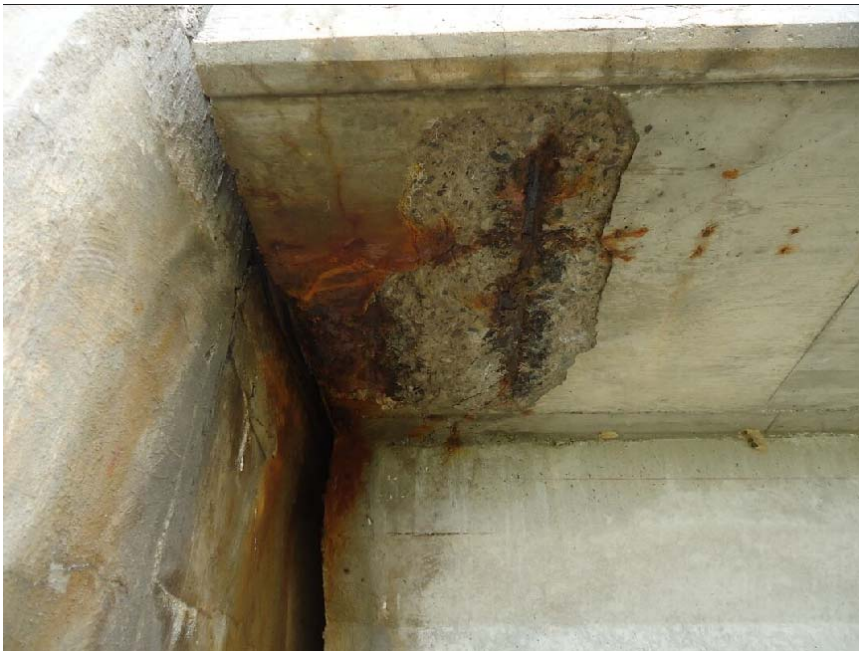
Figure 113. Exposed rebar, showing insufficient concrete cover at end of bridge deck (IN-W)

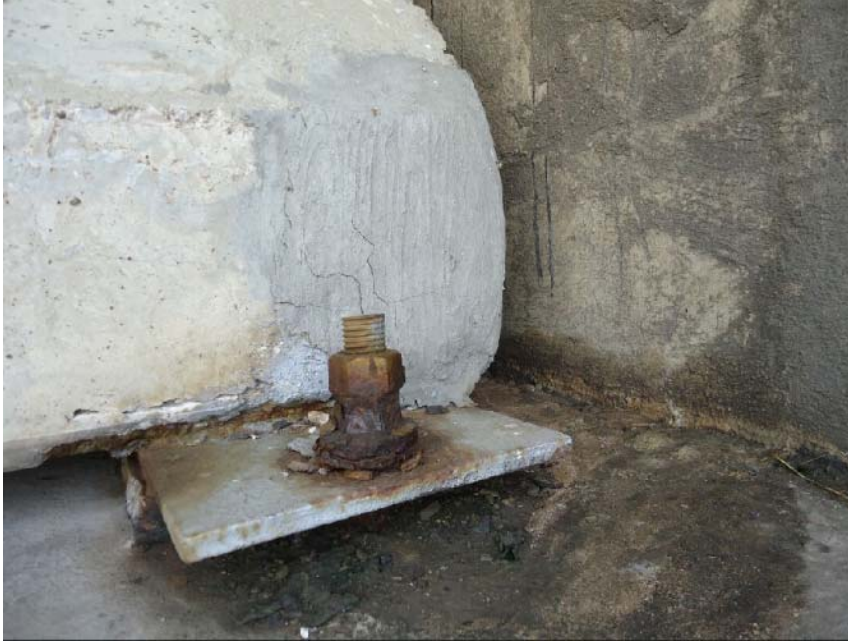
Figure 114. Repaired concrete on girder end and corroded bolt (IS-W)

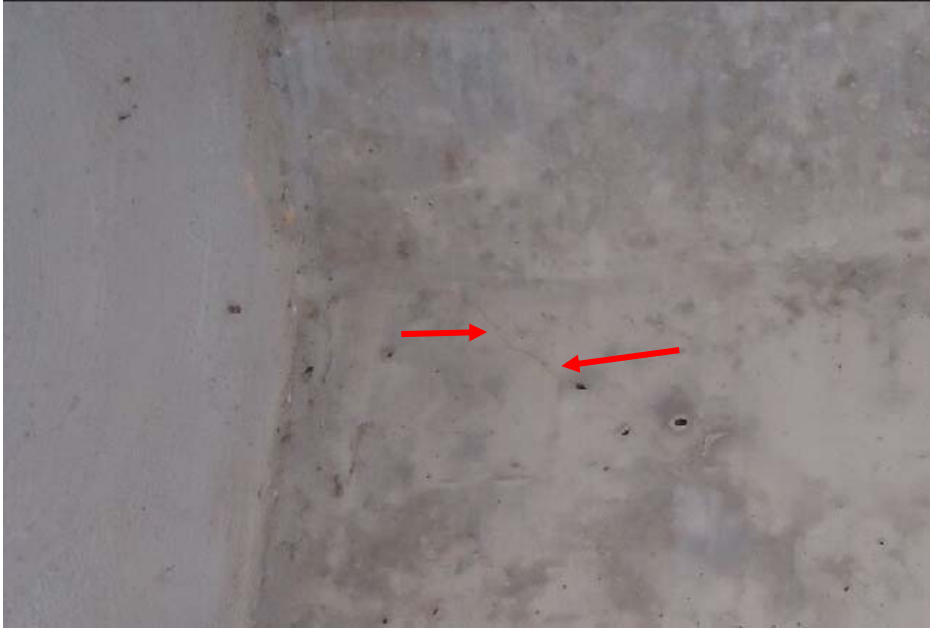
Figure 115. Diagonal cracking on the web of the beam (3N-W)

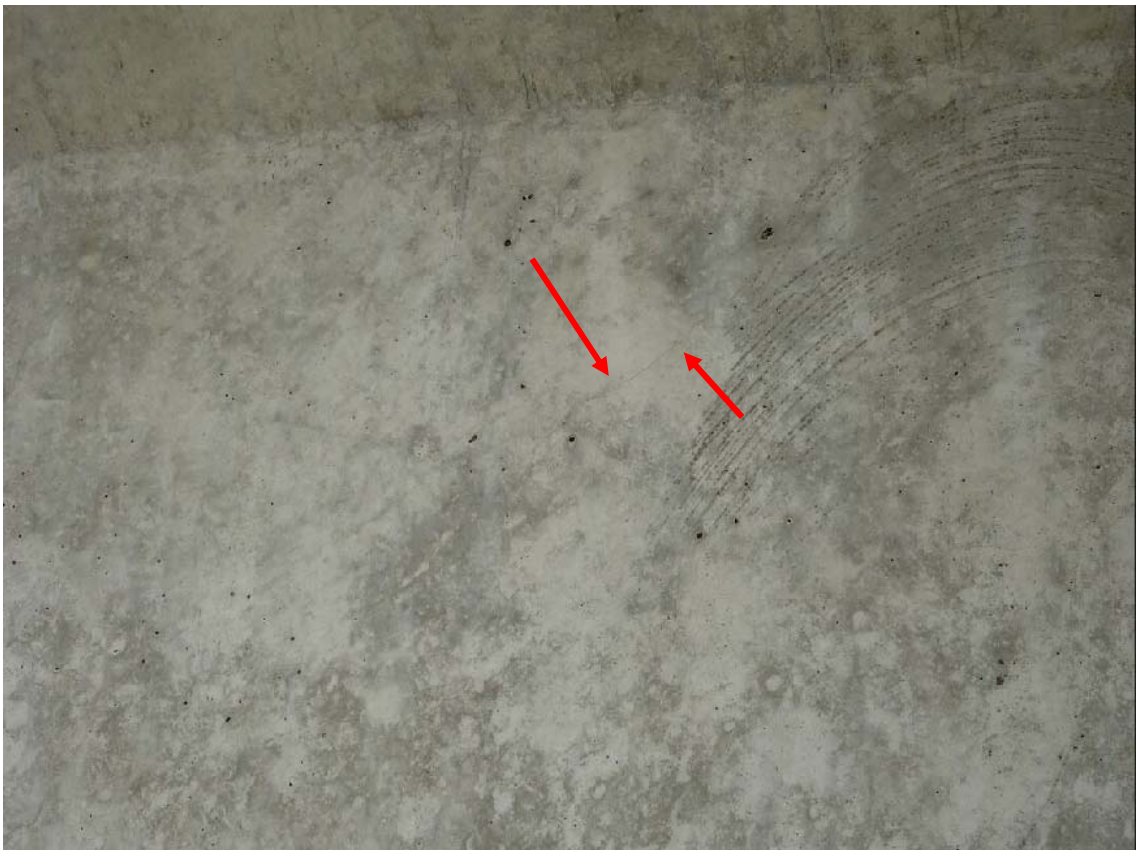
Figure 116. Diagonal cracking on the web of the beam, heading towards the bottom flange (1S-W)

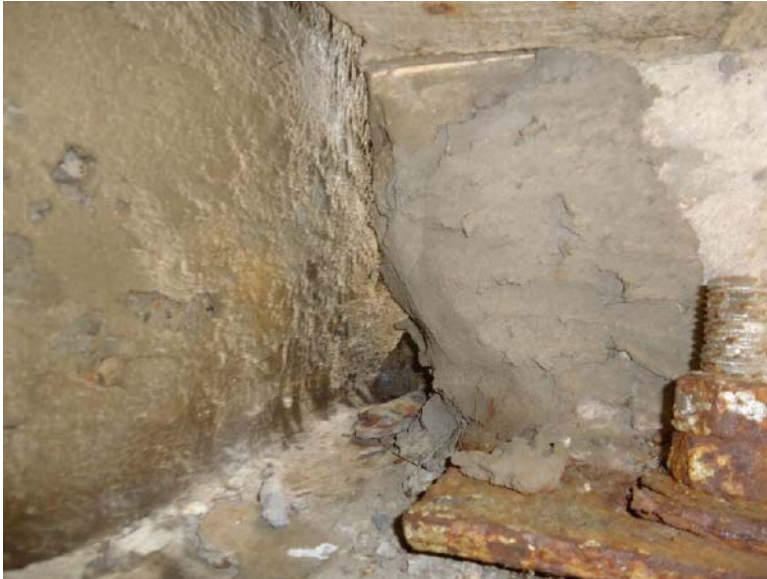
Figure 117. Repair to spalled back corner (6N-W)

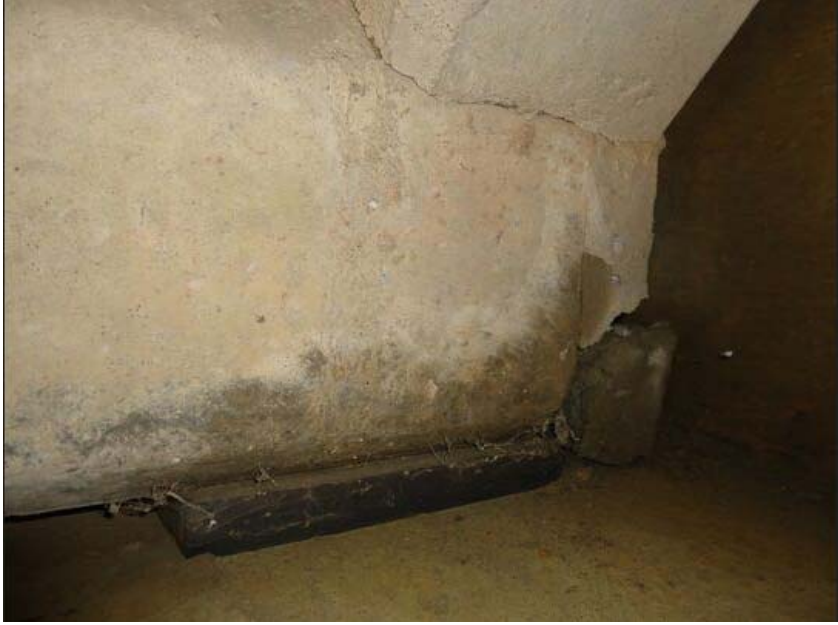
Figure 118. Back diagonal crack in the beam end (3N-E)
