UNIVERSITY OF OKLAHOMA
GRADUATE COLLEGE

INVESTIGATION OF THE EFFECTS OF END REGION DETERIORATION IN
PRECAST, PRESTRESSED CONCRETE BRIDGE GIRDERS

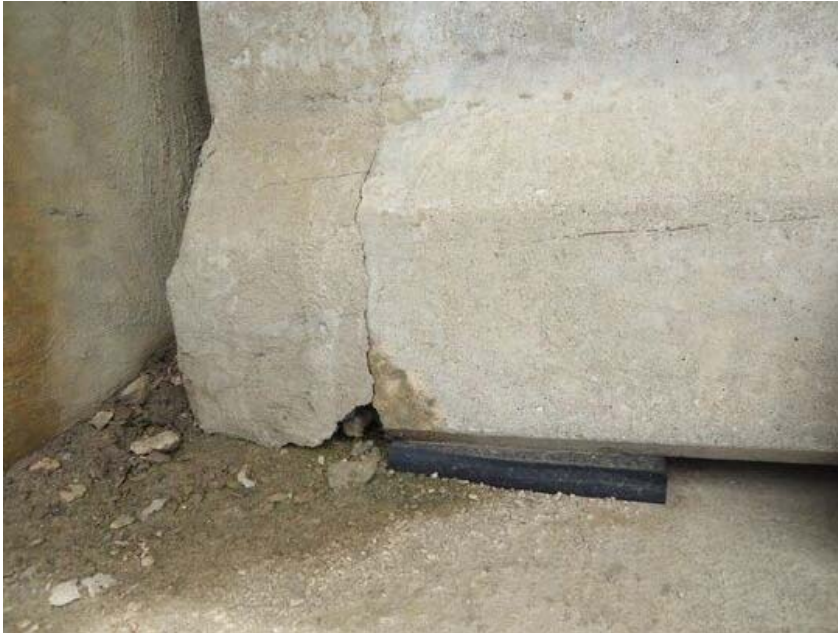
Figure 119. Separation at the diaphragm and girder end (1N-W)

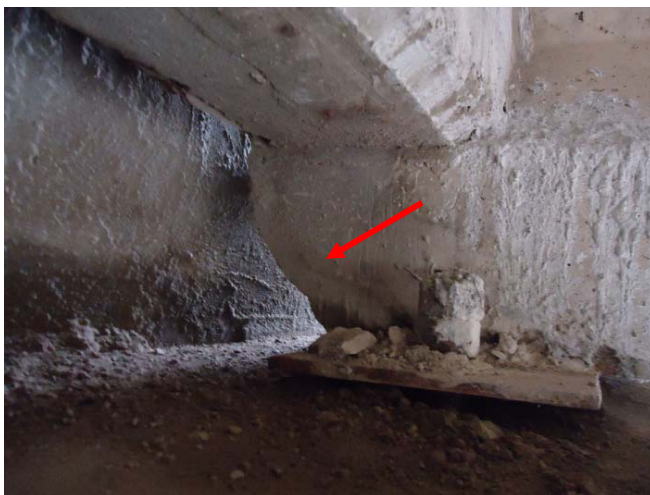
Figure 121. Spalled back corner of beam end (1W-S)

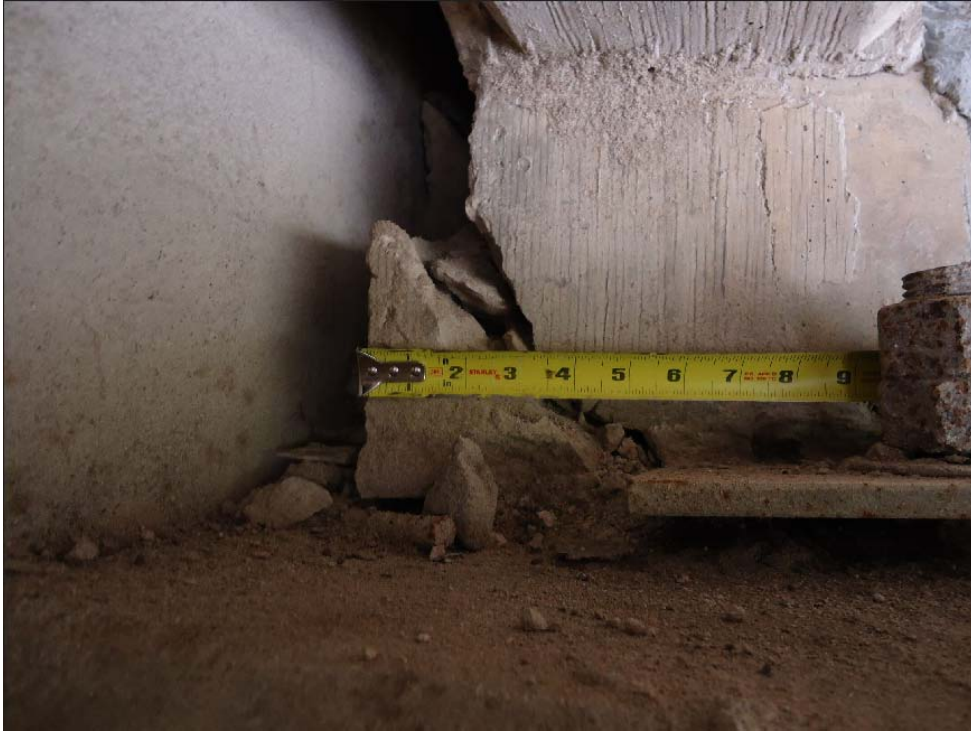
Figure 122. Spalled back corner of beam end (4E-N)

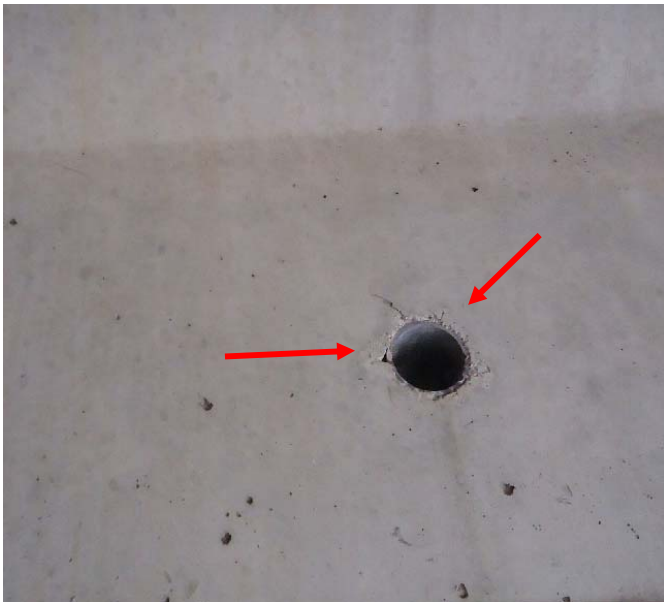
Figure 123. Crack from interior pipe that runs through web of beam (4E-N)

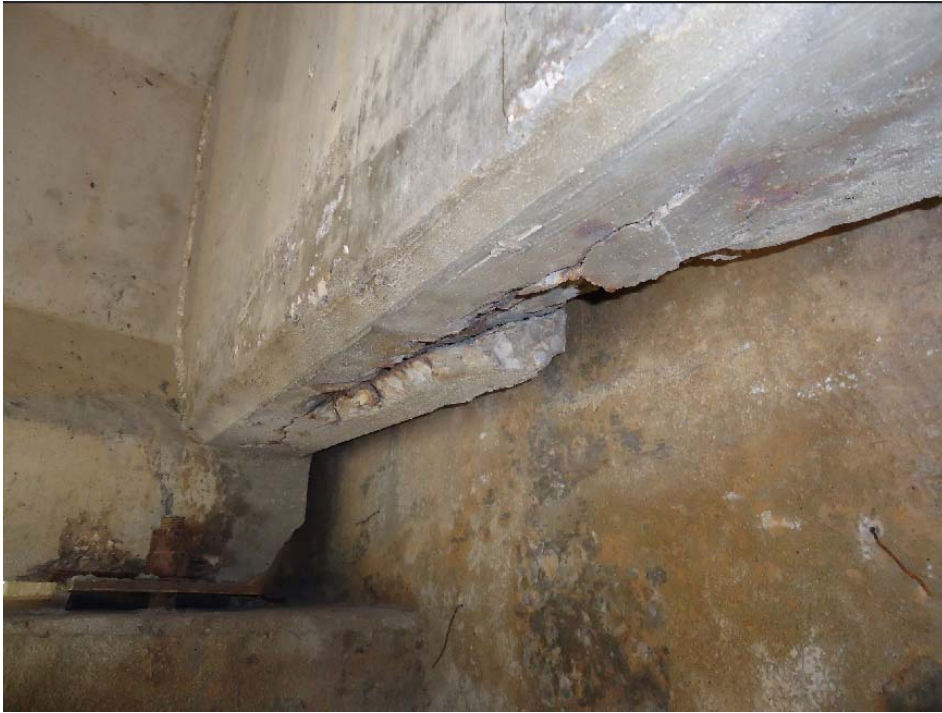
Figure 124. Deterioration of an interior diaphragm (6W-N); the diaphragm connects two interior beam ends

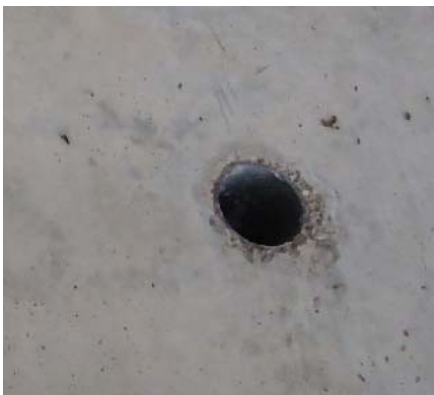
Figure 125. Spalling around pipe interface with exterior of concrete girder (3E-N)

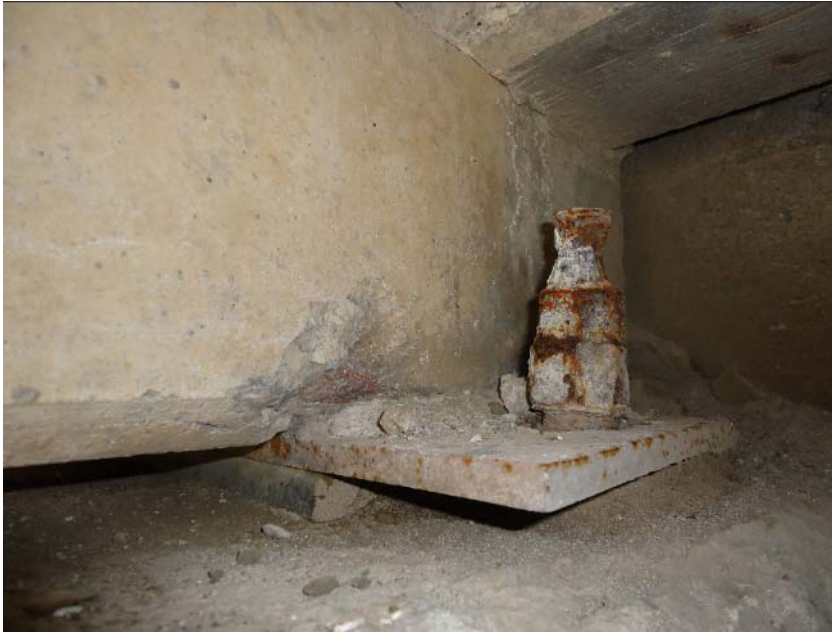
Figure 126. Anchor bolt with extreme deterioration, with necking of the anchor bolt at the top (4E-S)

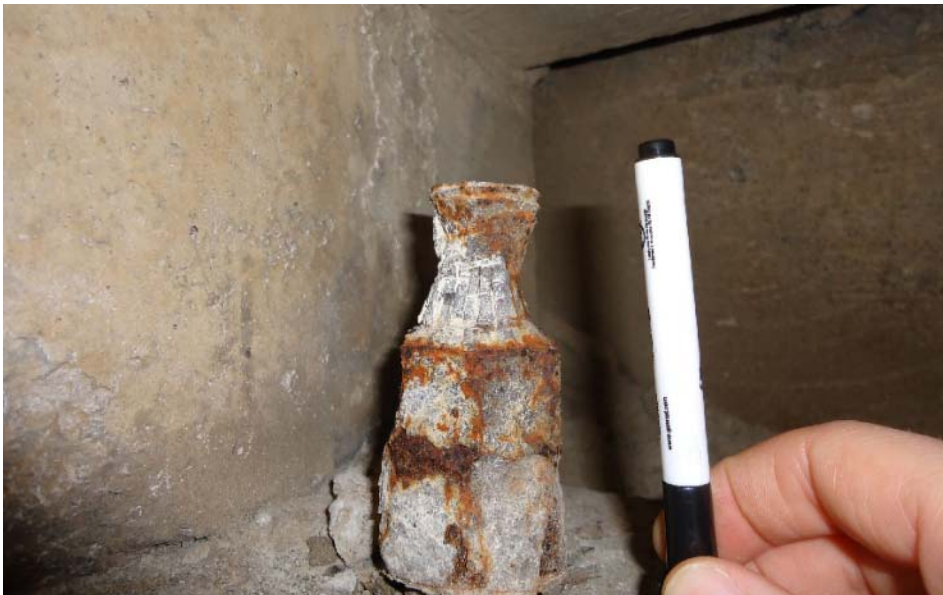
Figure 127. Close-up of deterioration of anchor bolt, with necking at the top (4E-S). The pen is shown in the picture to illustrate the amount of necking occurring to the steel member.

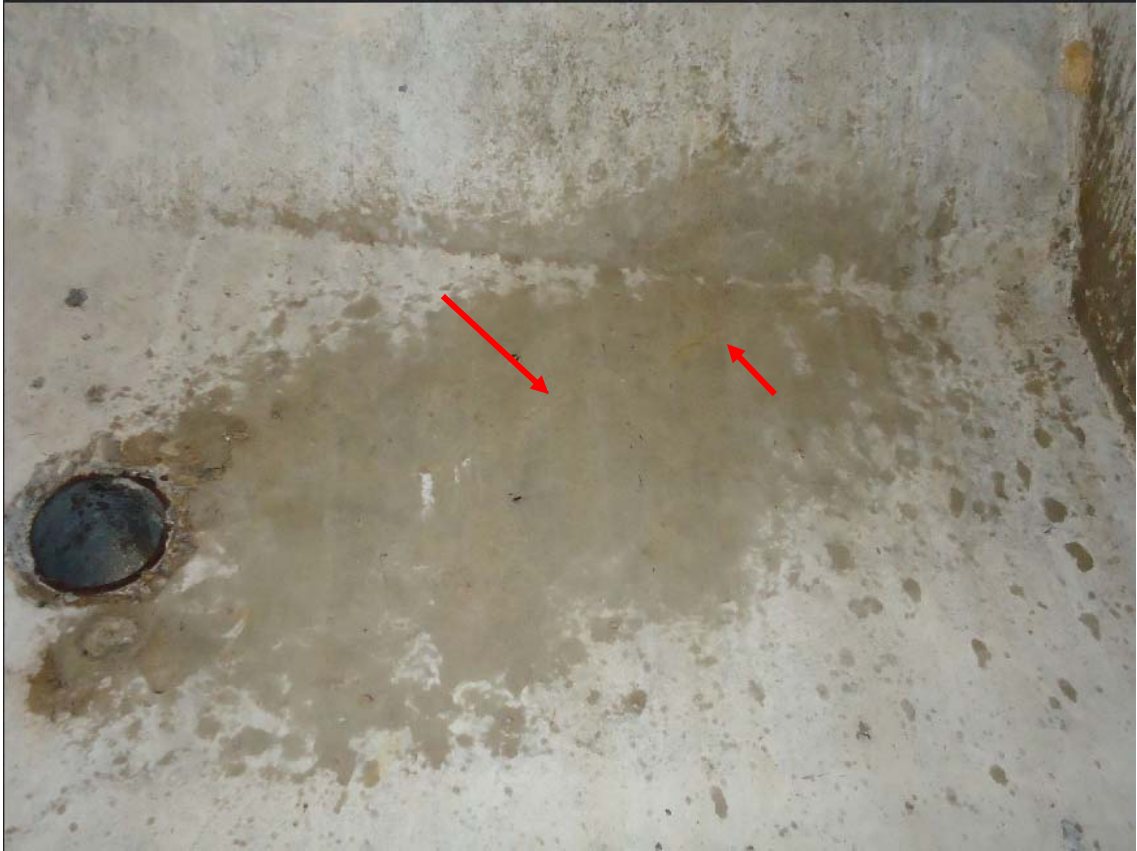
Figure 128. Diagonal cracks from top flange/web interface towards pipe on interior beam (5W-N)

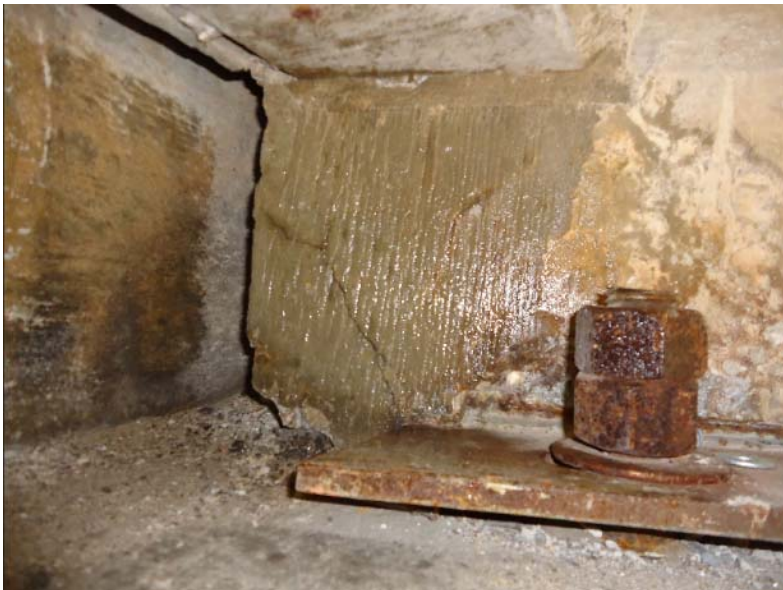
Figure 129. Back corner diagonal cracking of beam end (5W-S)

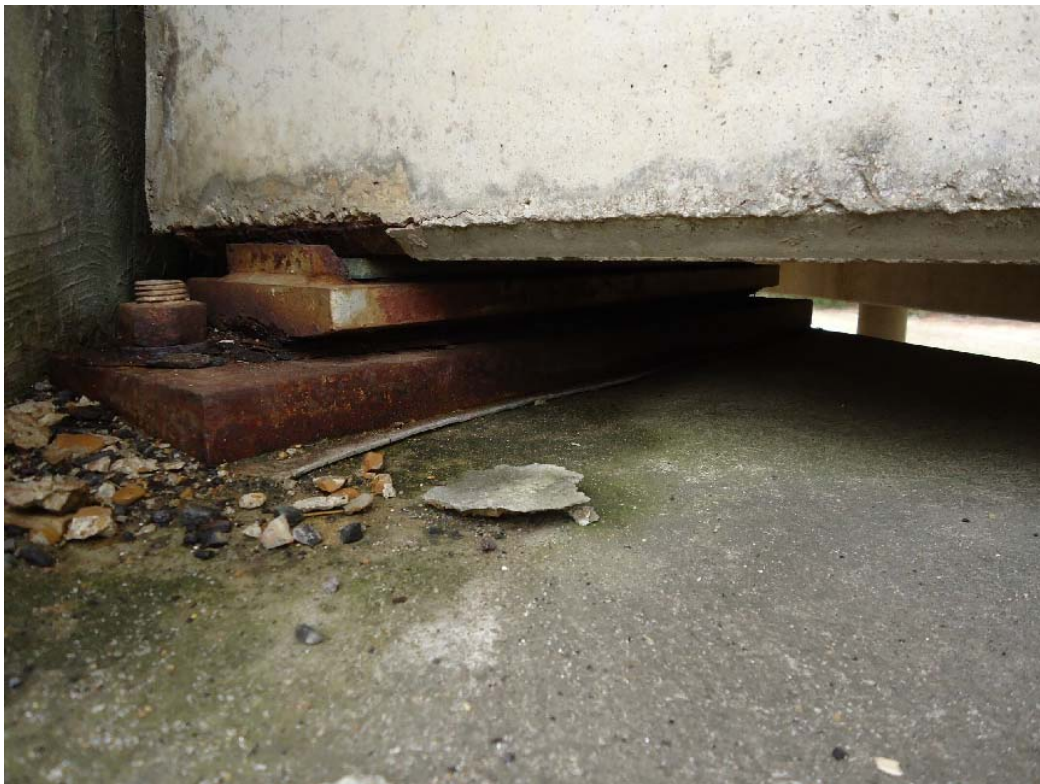
Figure 130. Spalling above corroded support of exposed, exterior girder (1E-N)

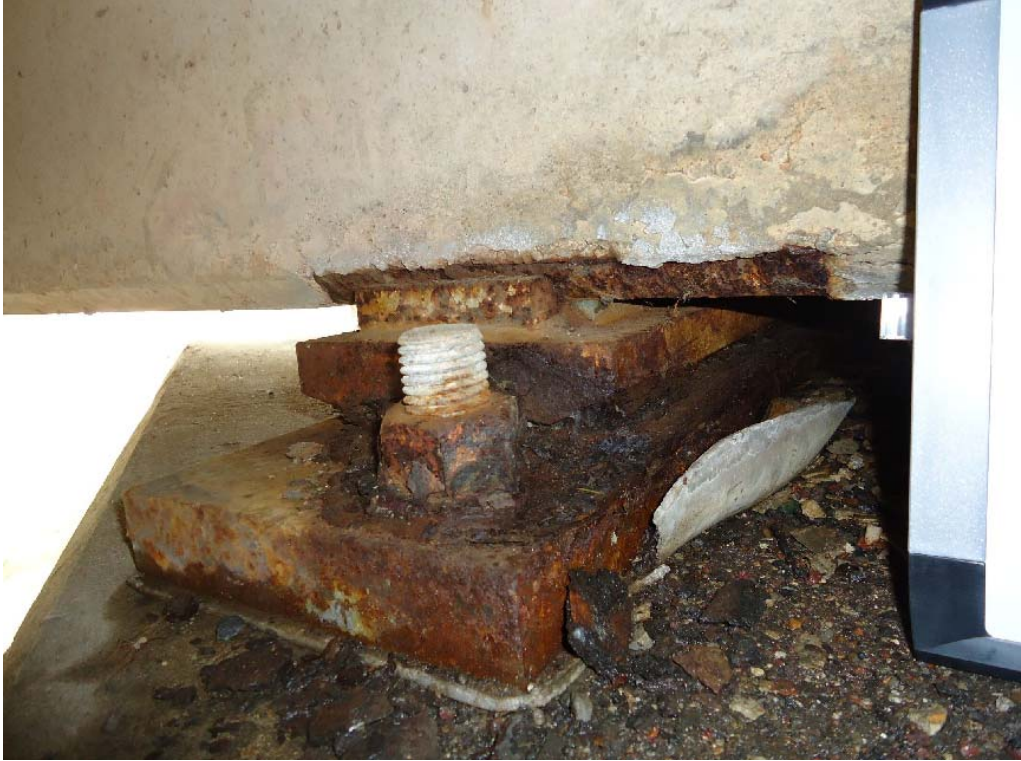
Figure 131. Corroded bearing plate (1E-S)

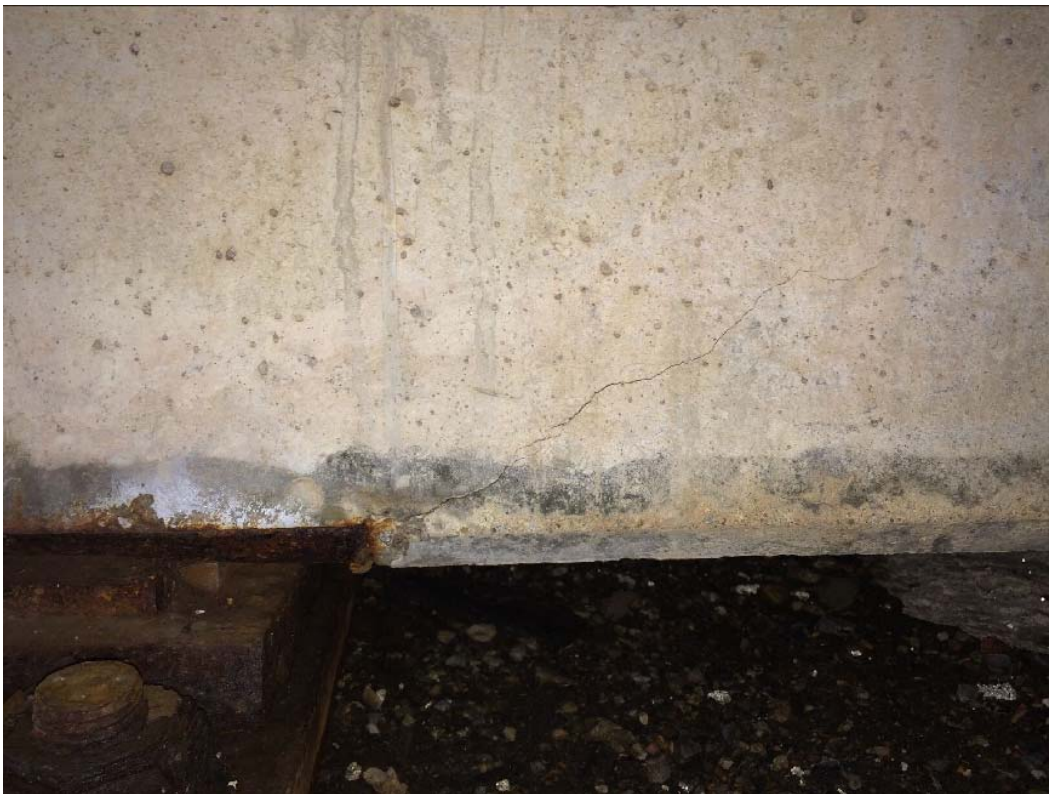
Figure 132. Diagonal crack in bottom flange of beam from corroding support (10W-N)

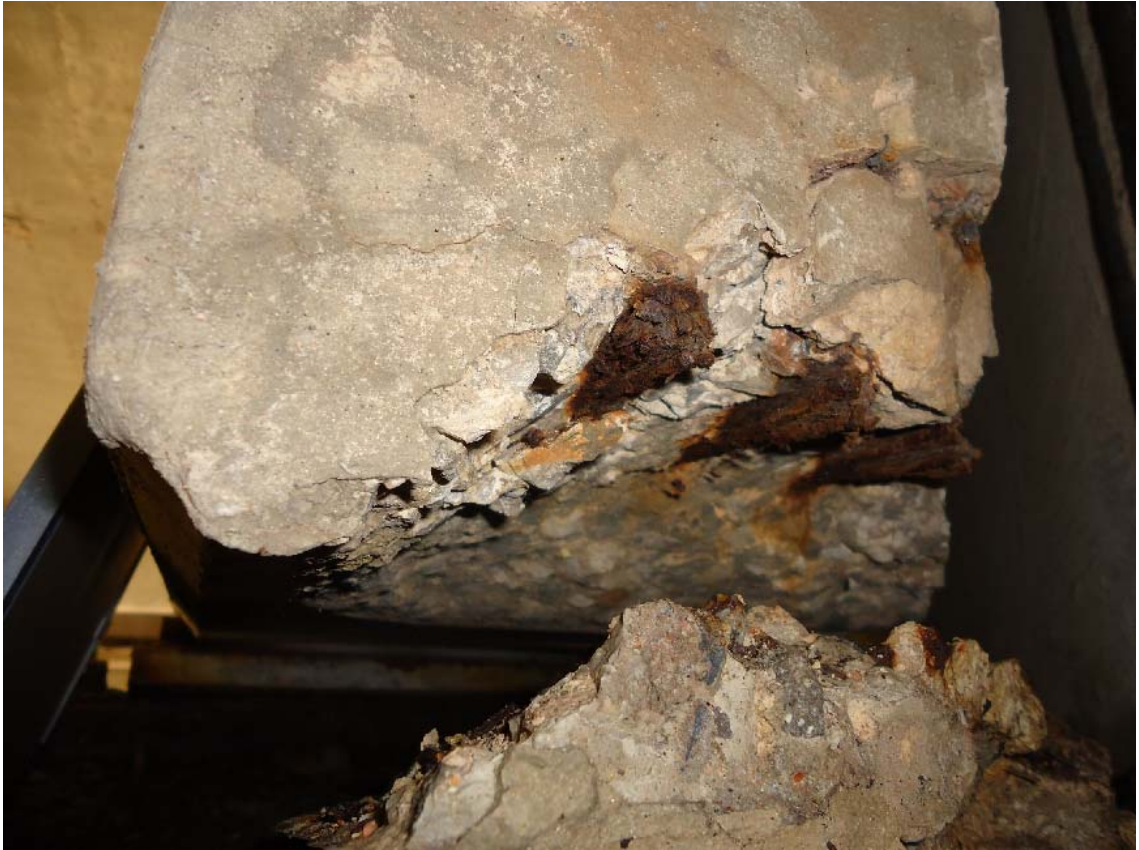
Figure 133. Spalled back corner and exposed prestressing strands

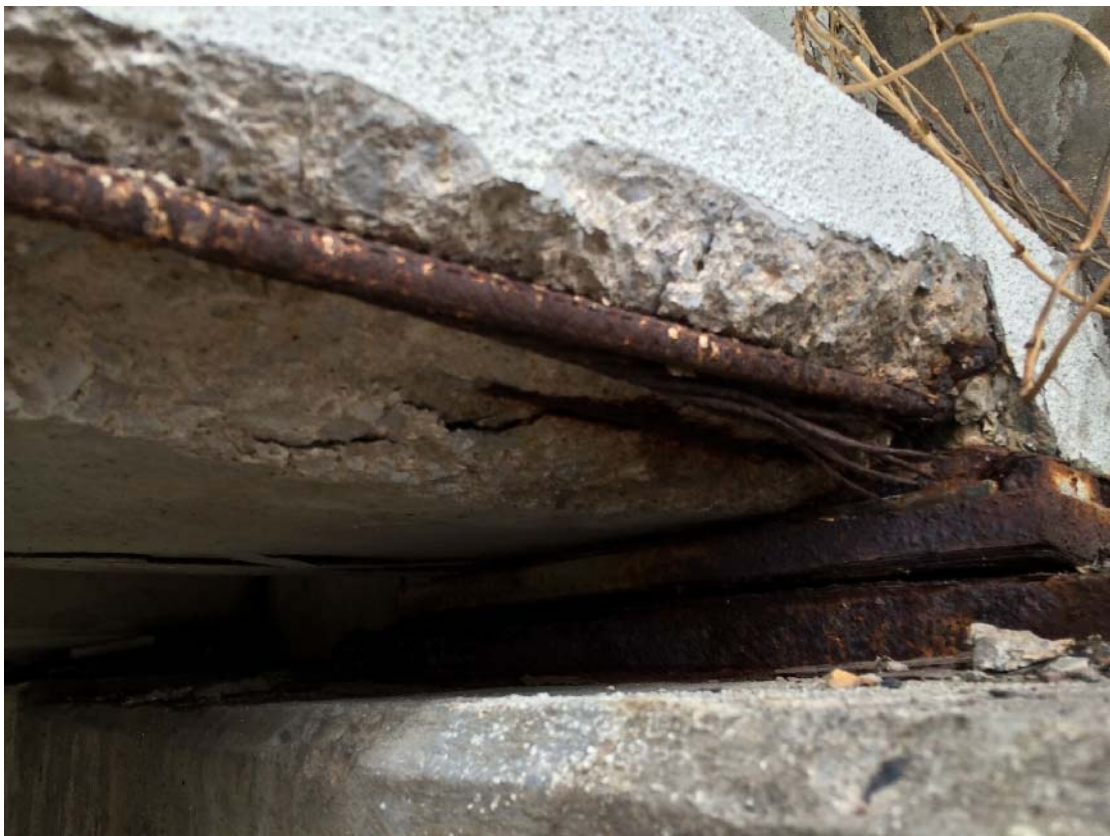
Figure 134. Exposed rebar due to spalled concrete on the bottom of an exposed, exterior girder (1N-E)

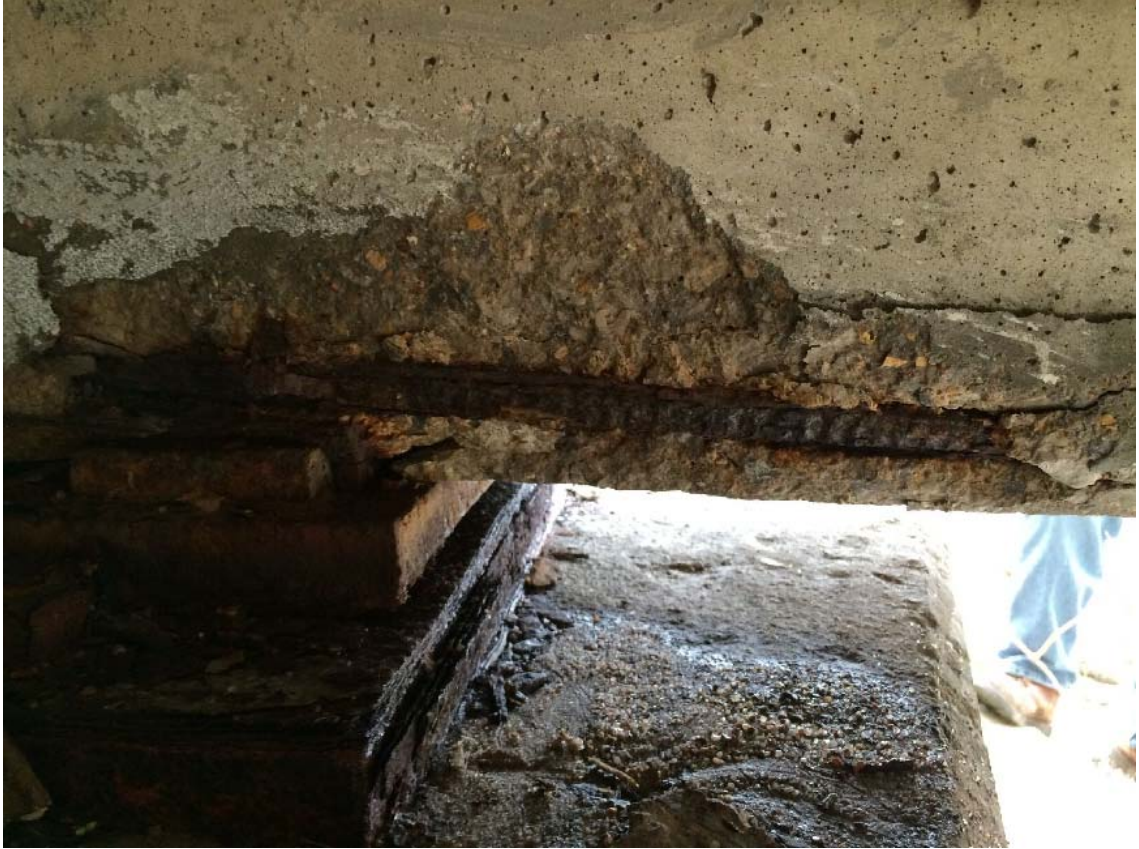
Figure 135. Exposed rebar due to spalled concrete (1N-W)

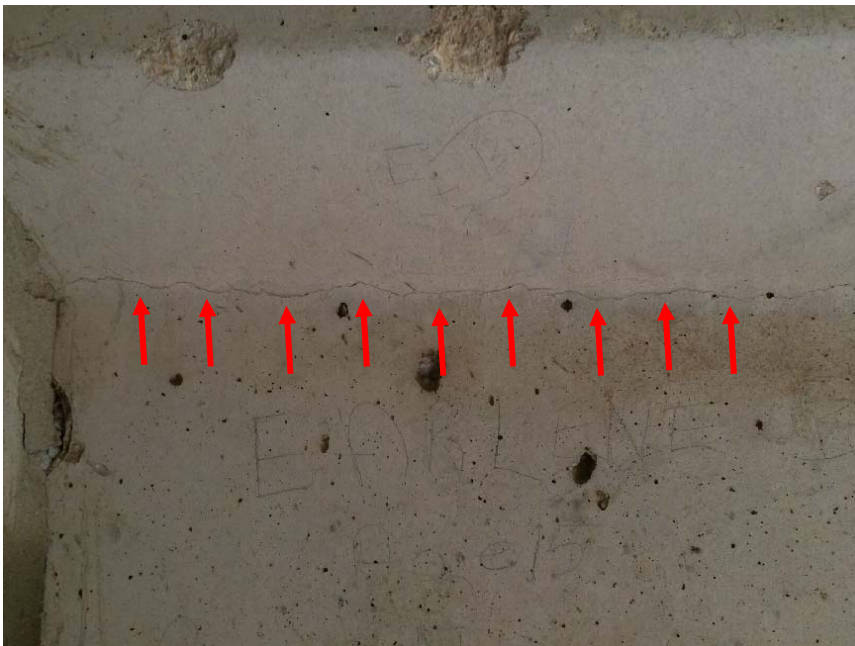
Figure 136. Crack along intersection of the top flange and web

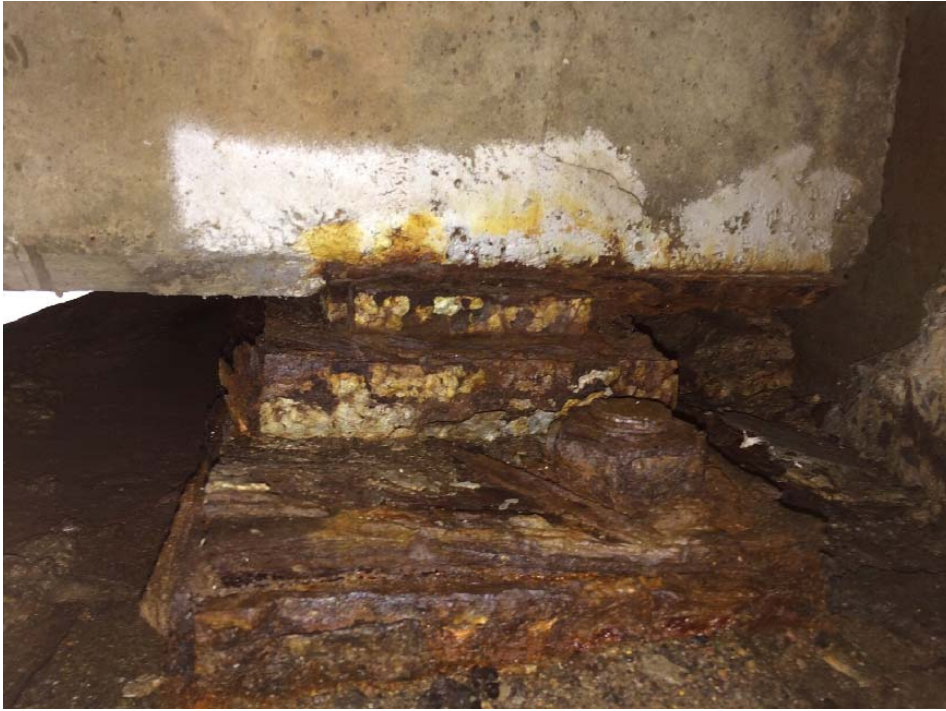
Figure 137. Corroded, and deteriorated bearing plate (8N-E)

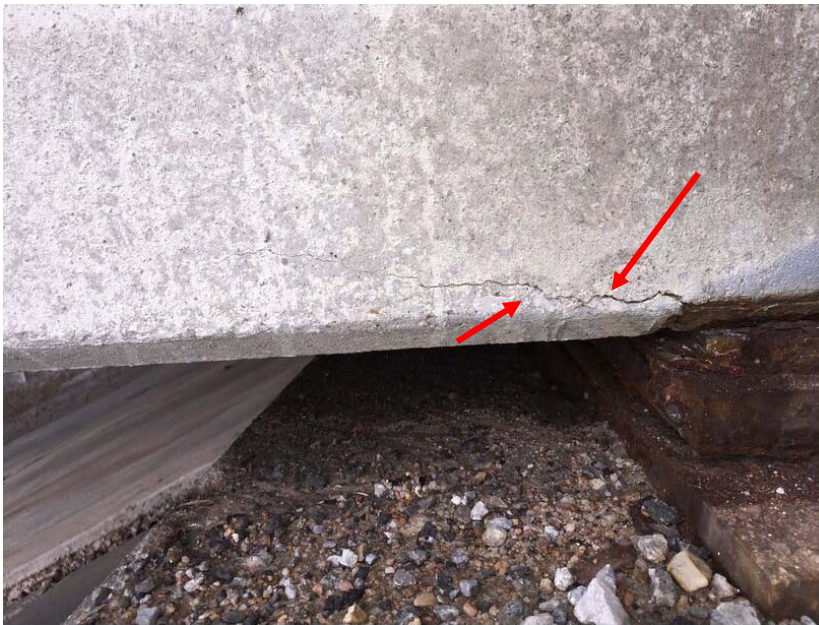
Figure 138. Cracking from corroded bearing plate into bottom flange (10S-W)

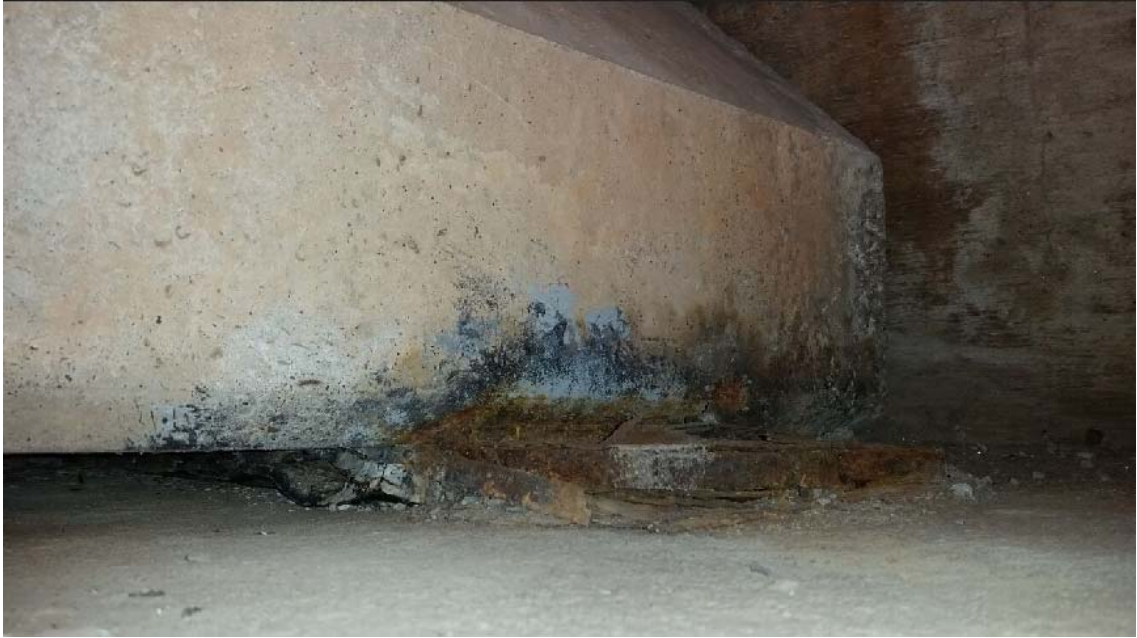
Figure 141. Corroded bearing plate, and spalling along bottom of girder and back of girder end (3S-W)

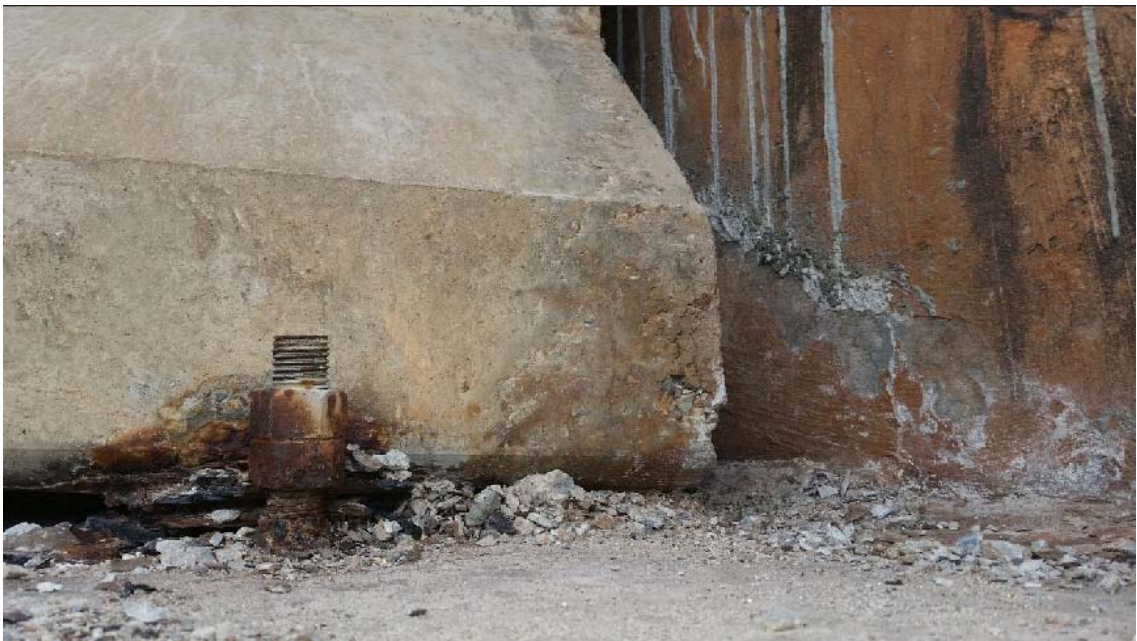
Figure 142. Corroded anchor bolt and spalling along bottom of girder and girder end (5N-E)

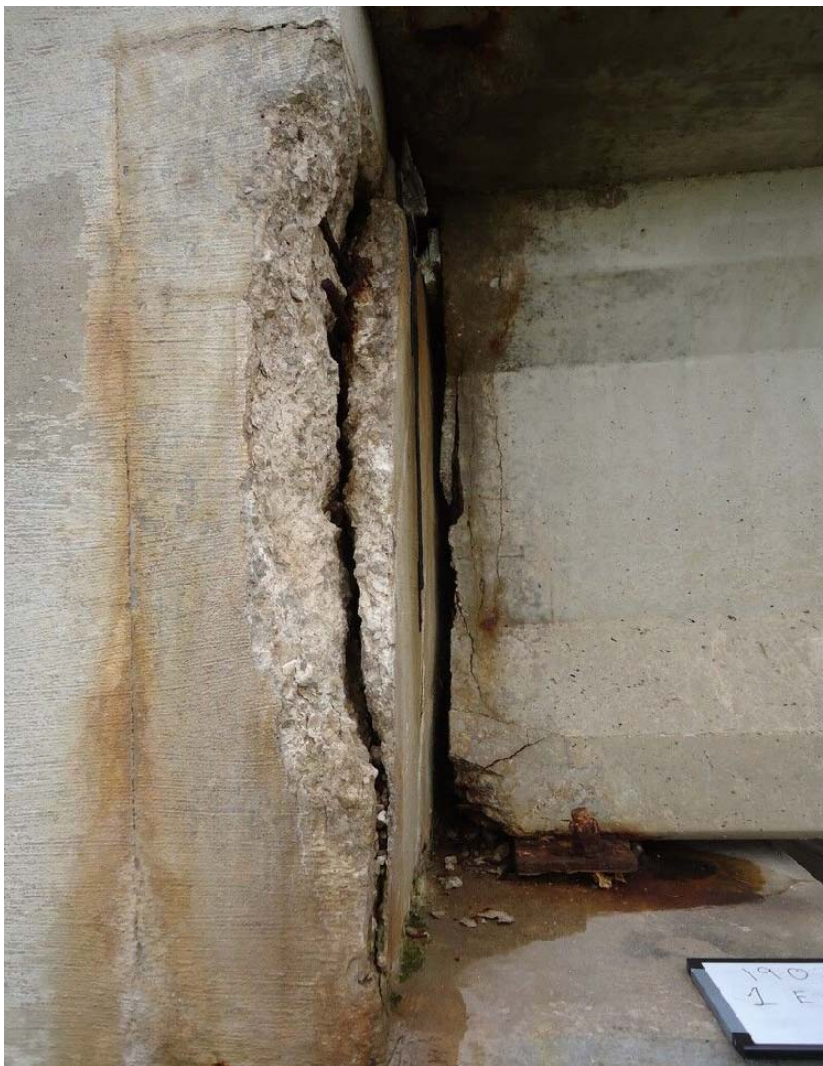
Figure 143. Extreme deterioration of back wall and girder end due to moisture/water (1E-N). The exposed, exterior girder has a corroded bearing plate and spalling occurring at the girder end.

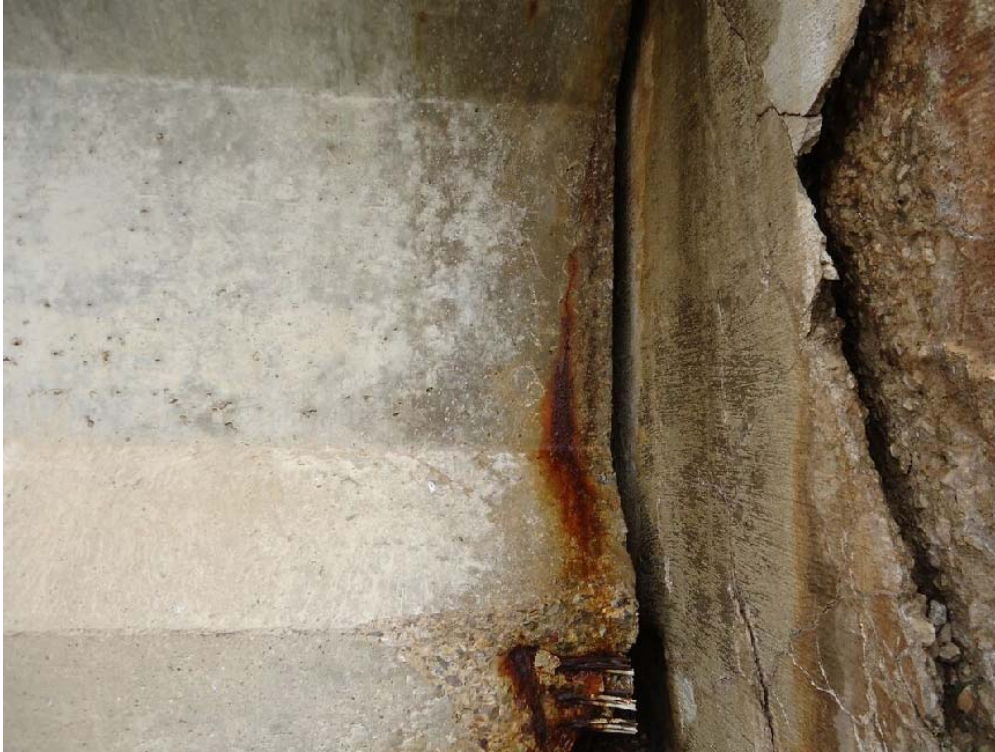
Figure 144. Vertical cracking with visible corrosion on exterior, exposed girder (12E-S)

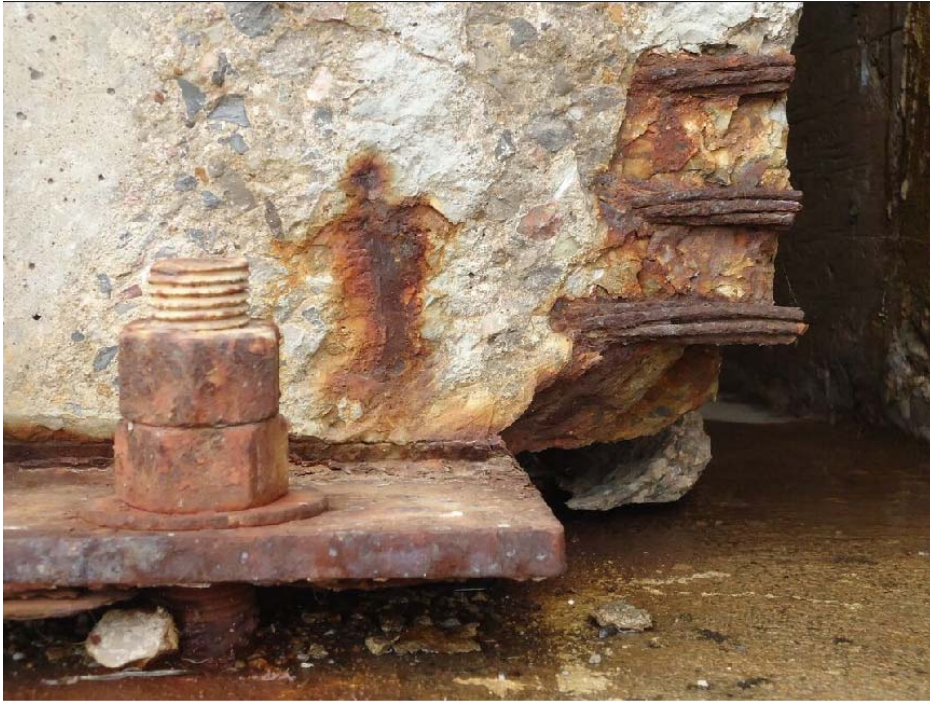
Figure 145. Exposed prestressing strands of an exposed, exterior girder (1W-N)

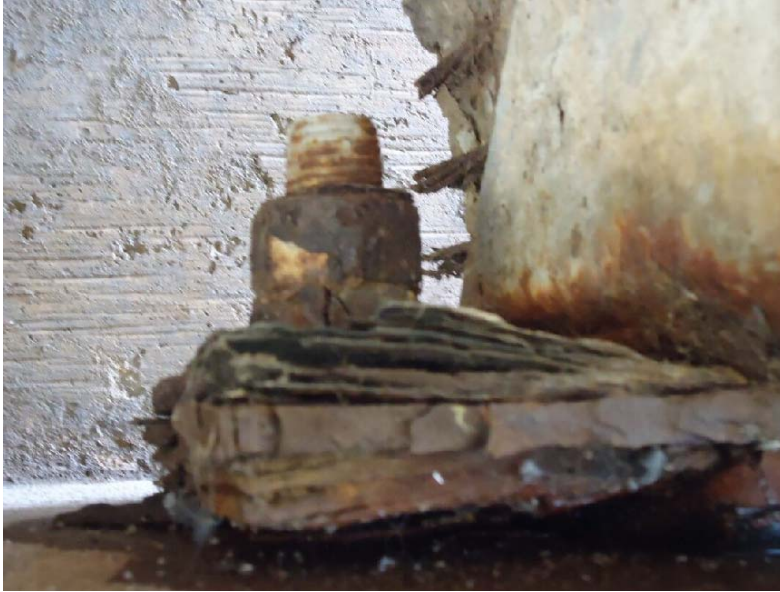
Figure 147. Corroded and flaky bearing plate, not providing much functionality as original designed (1W-S)

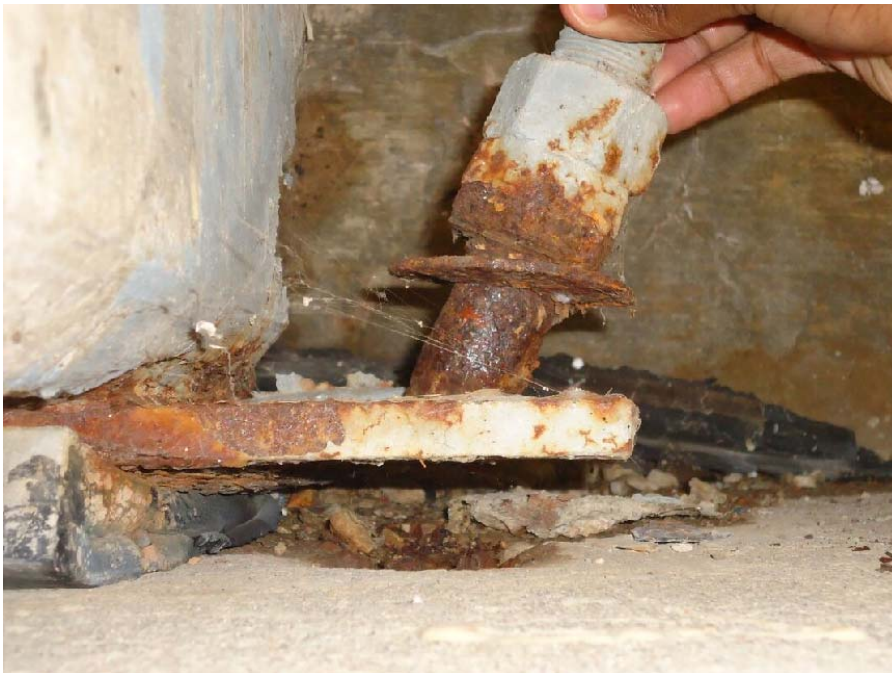
Figure 148. Corrosion at cavity of abutment and bolt interface (7E-S)

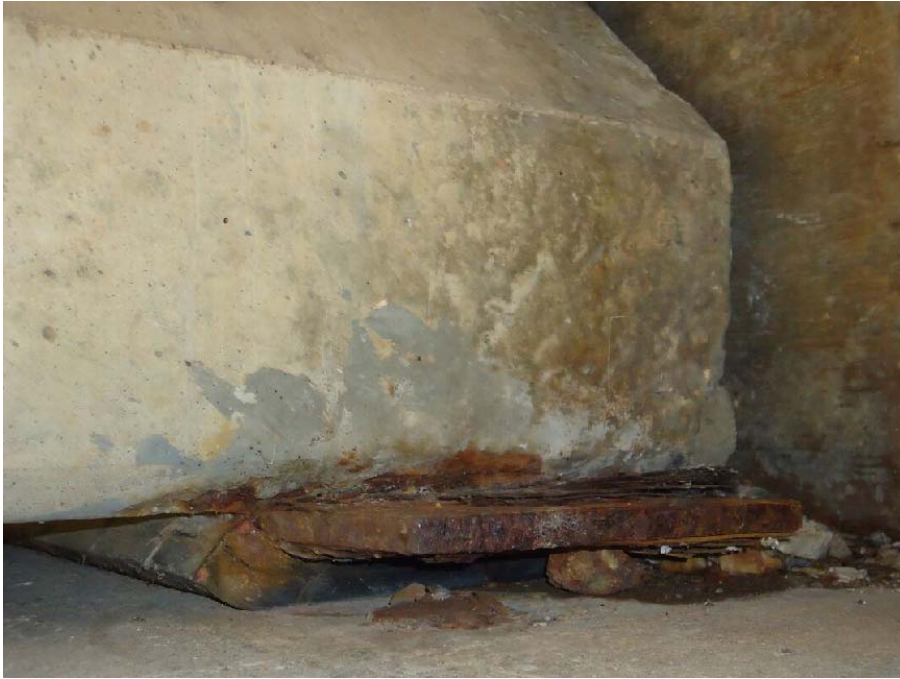
Figure 149. Spalling above corroded bearing plate, missing anchor bolt (10E-S)

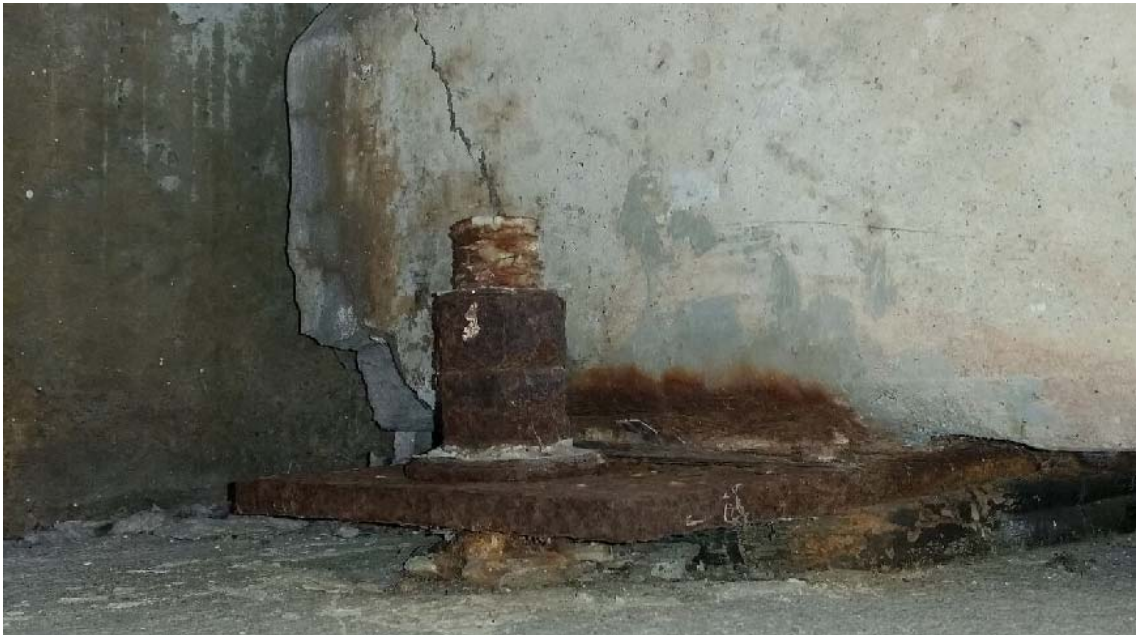
Figure 150. Back corner diagonally cracked on beam end (11W-S)

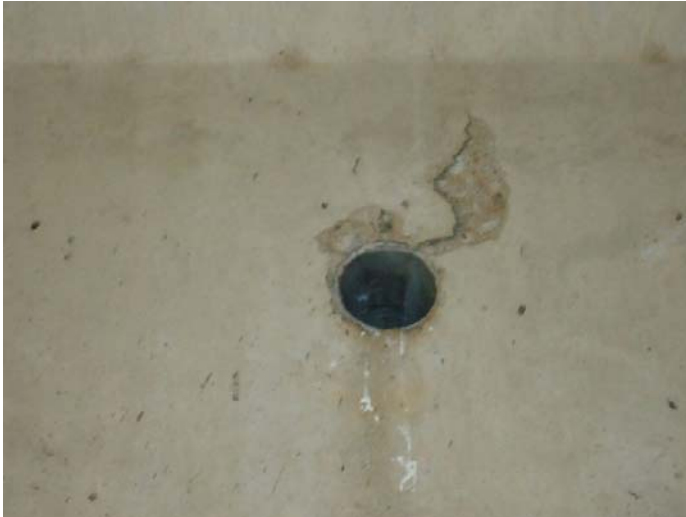
Figure 151. Spalling and cracking above pipe in web (1N-E)

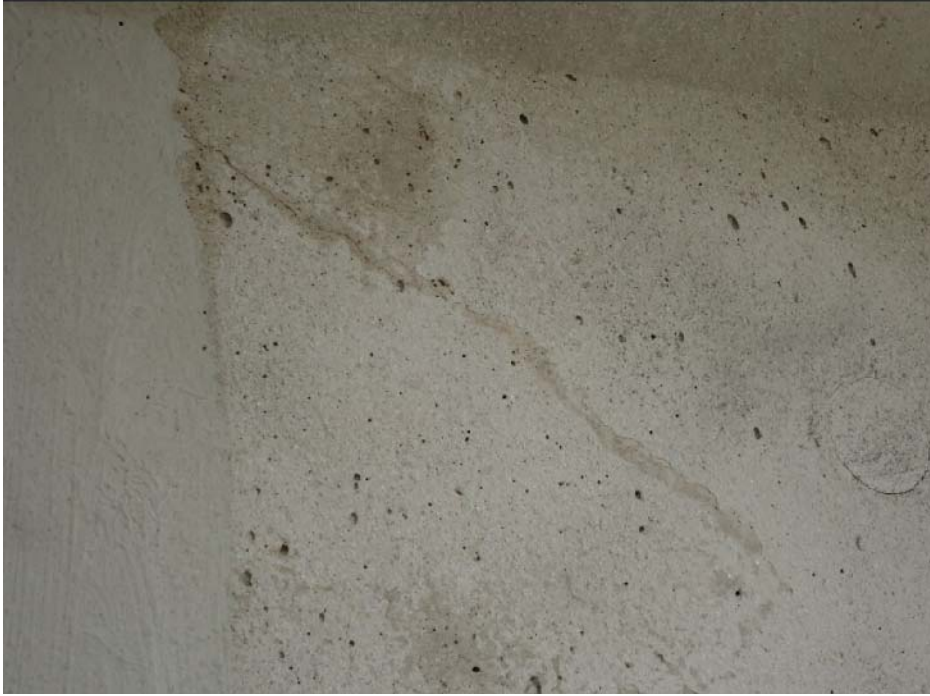
Figure 152. Diagonal crack in web from top flange towards bottom of beam (1N-W)

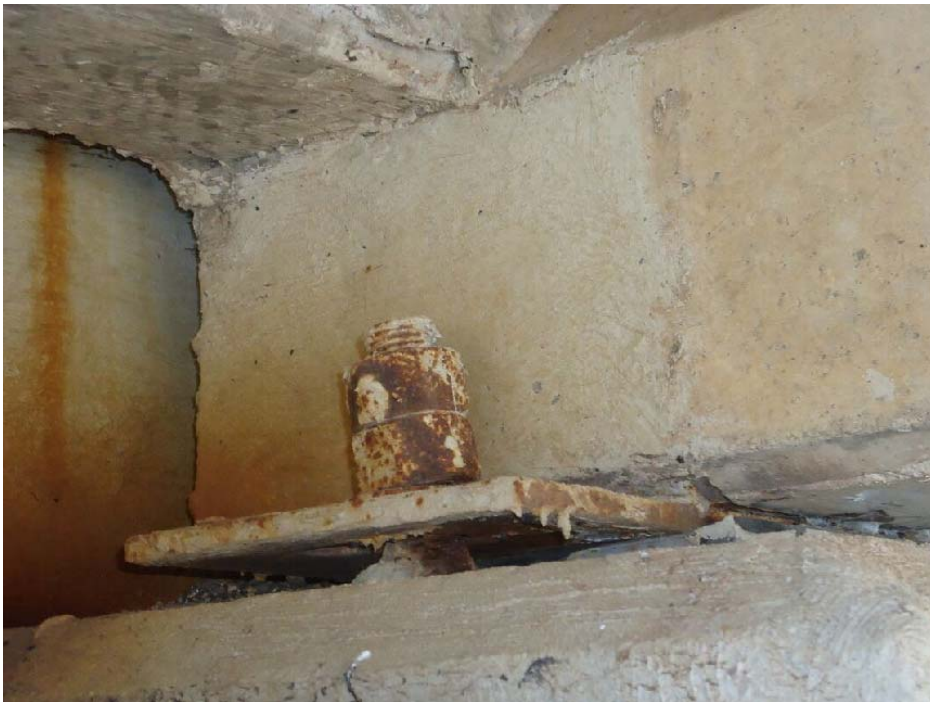
Figure 153. Corroding anchor bolt (4S-E)

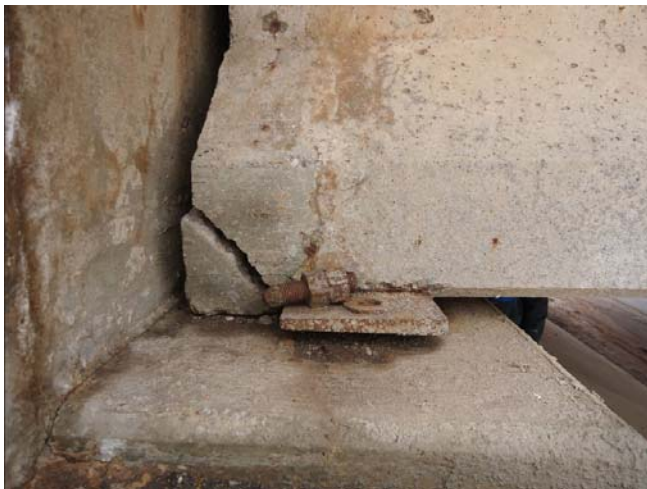
Figure 157. Back corner diagonal crack of exposed, exterior beam (1E-N)

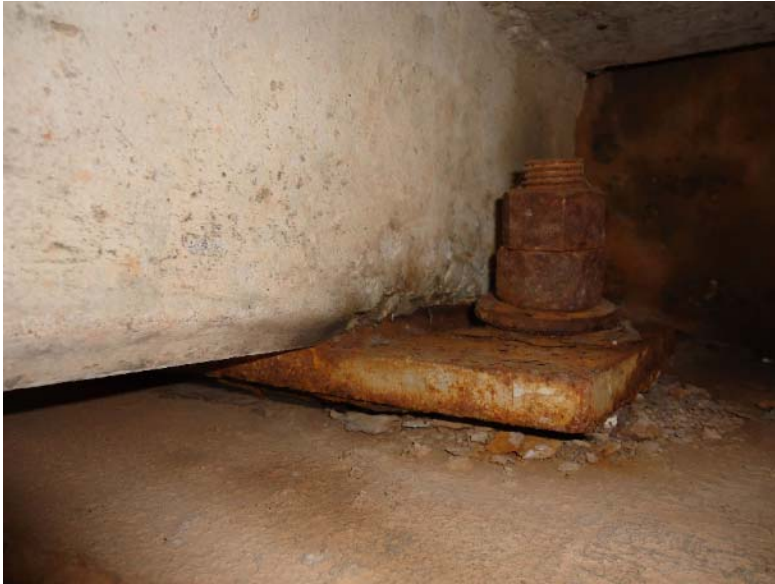
Figure 158. Corroded bearing plate and anchor bolt, with spalling above the support (5E-S)

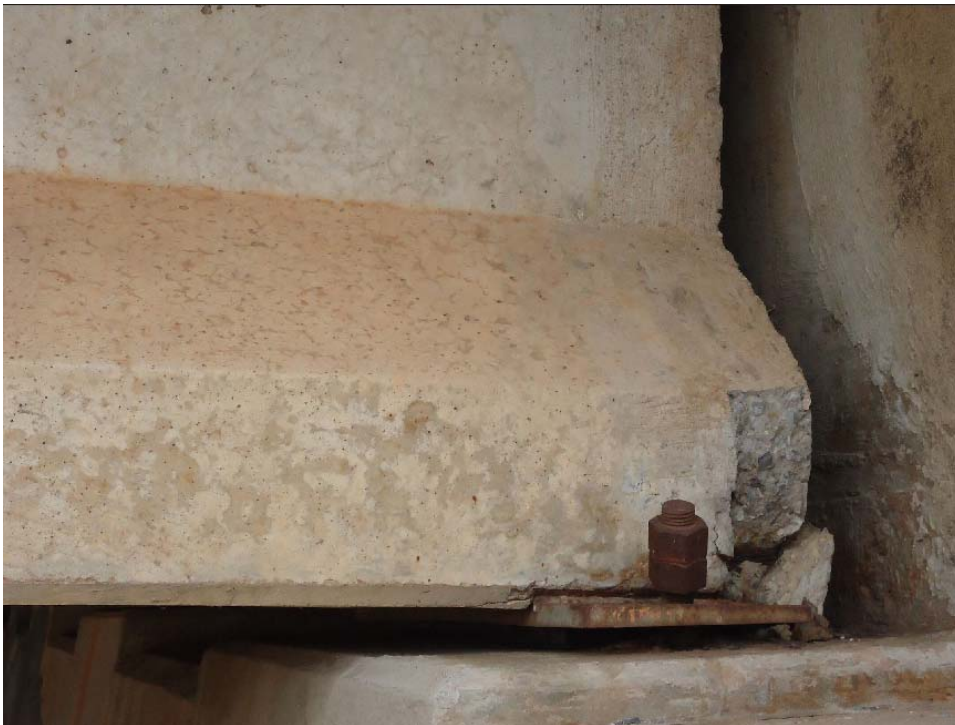
Figure 159. Back corner spalling of girder (9E-S)

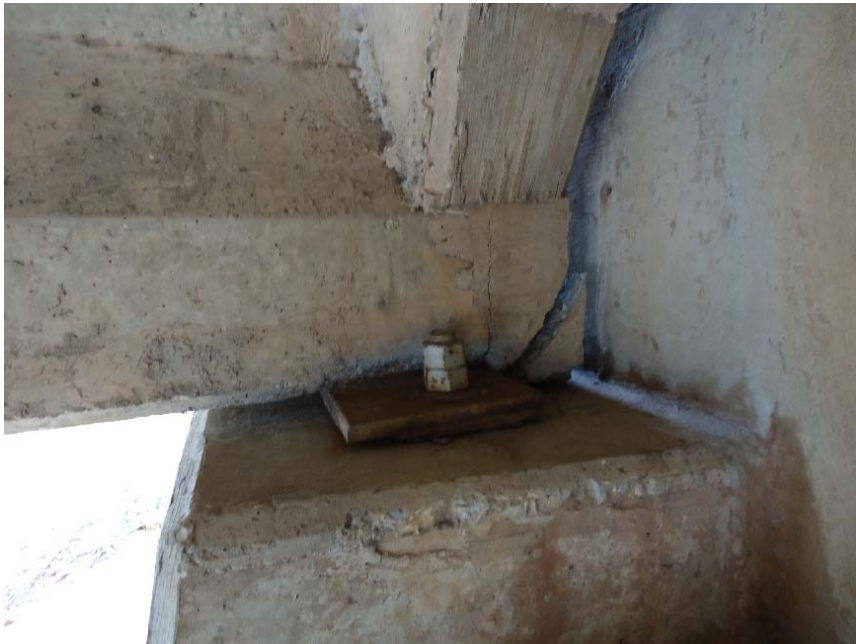
Figure 160. Back corner diagonal cracking of exterior beam (1E-S)
