UNIVERSITY OF OKLAHOMA
GRADUATE COLLEGE

INVESTIGATION OF THE EFFECTS OF END REGION DETERIORATION IN
PRECAST, PRESTRESSED CONCRETE BRIDGE GIRDERS

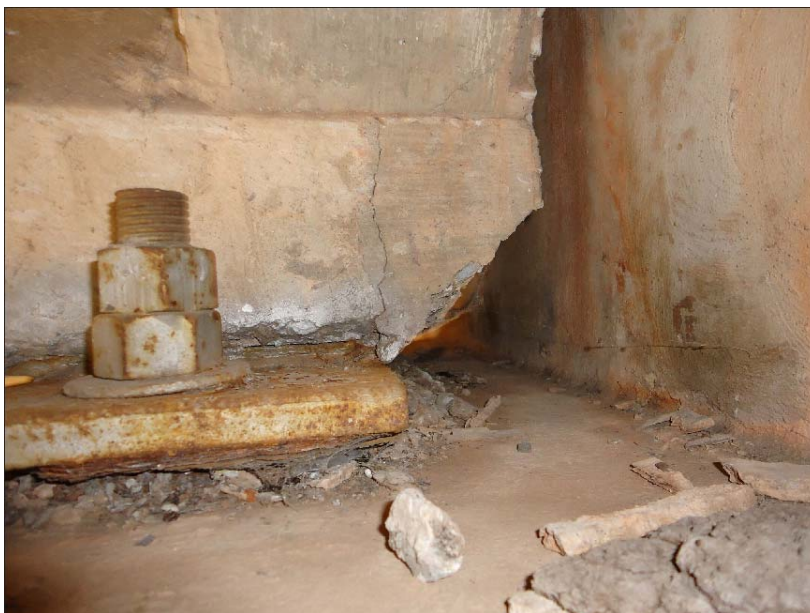
Figure 161. Similar back corner cracking (deformation) (2E-S)

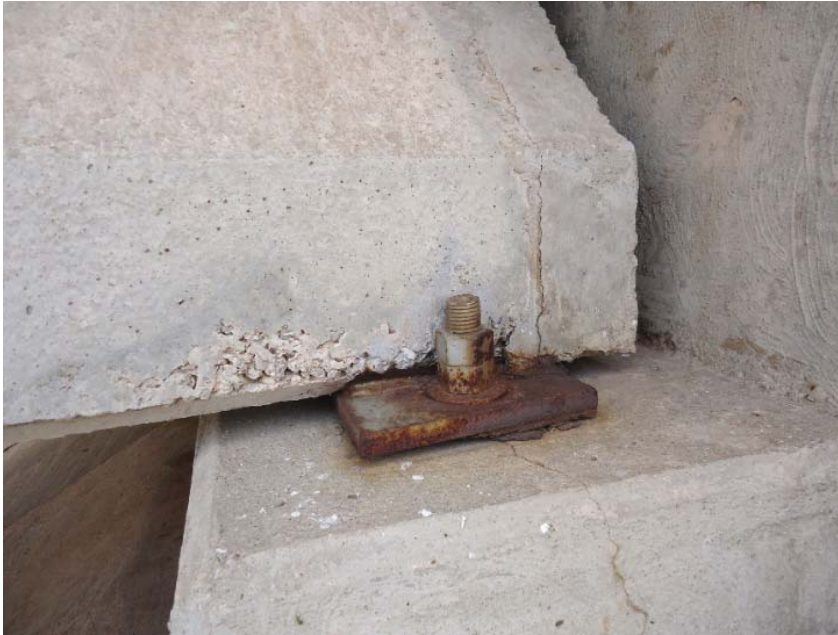
Figure 162. Spalling above the corroded bearing plate (1W-N)

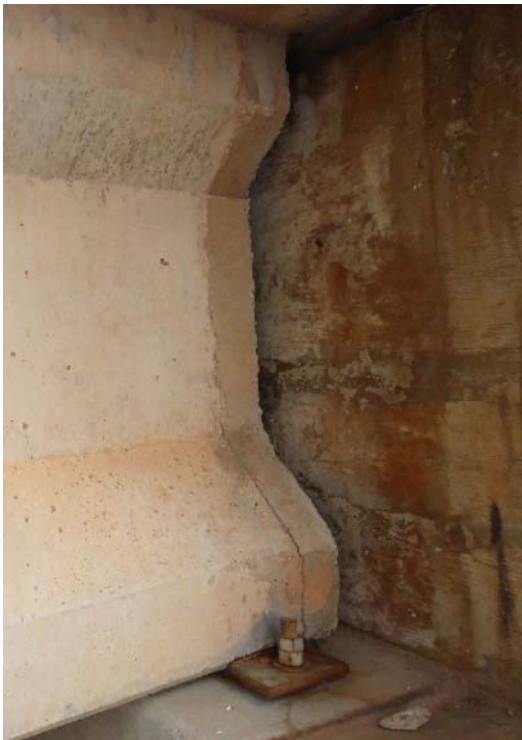
Figure 163. Vertical separation of diaphragm and girder at interface (5E-S)

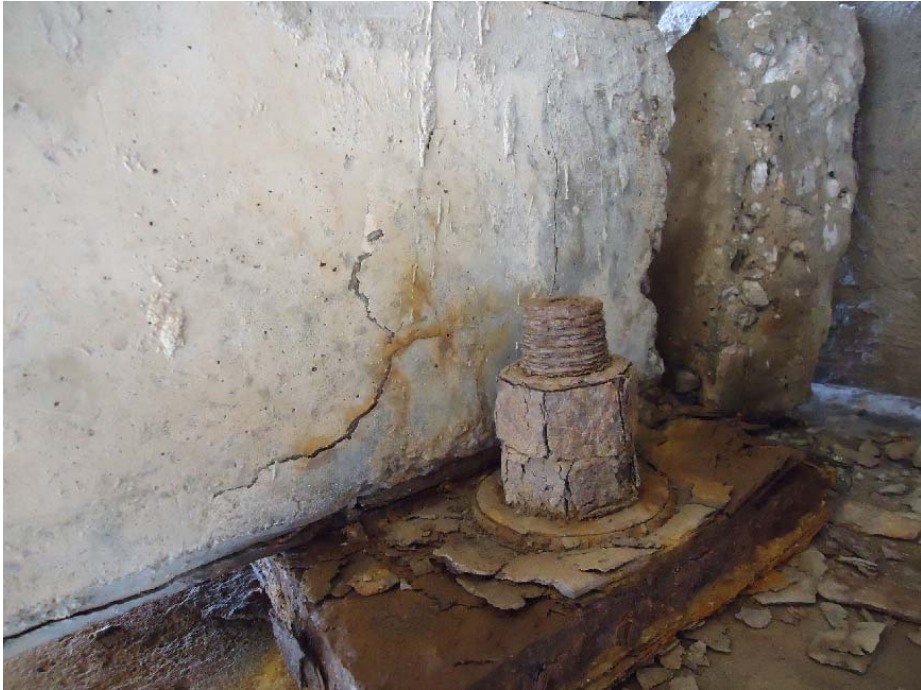
Figure 164. Corroded bearing plate and anchor bolt, with spalling and cracking above the corroded bearing plate (5W-N)

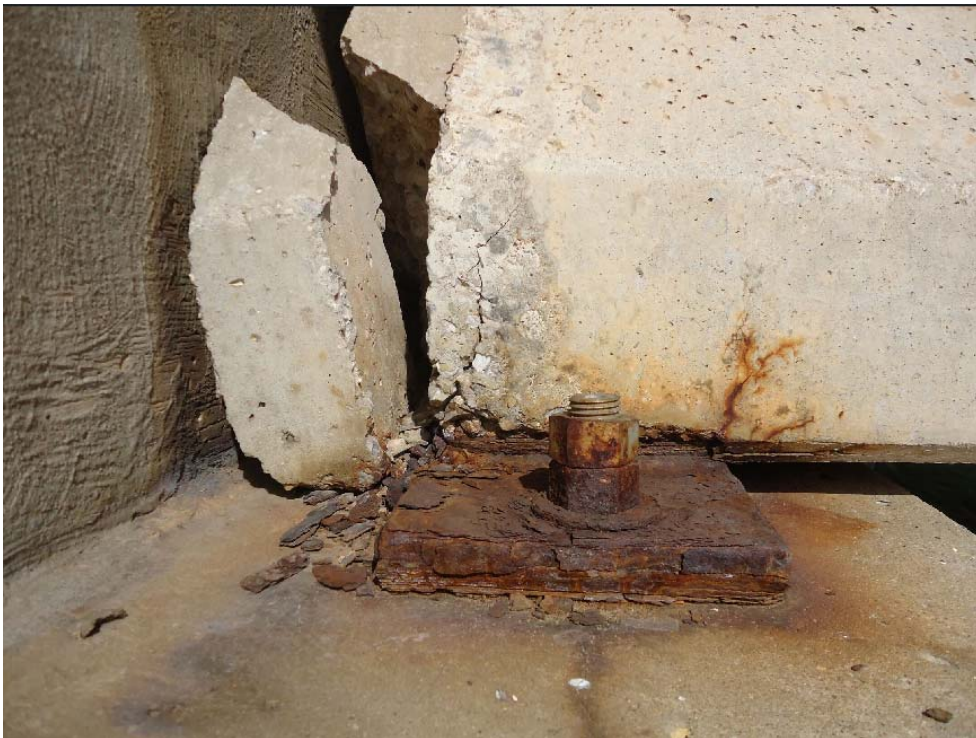
Figure 165. Spalling girder end and corroded bearing plate (5W-S)

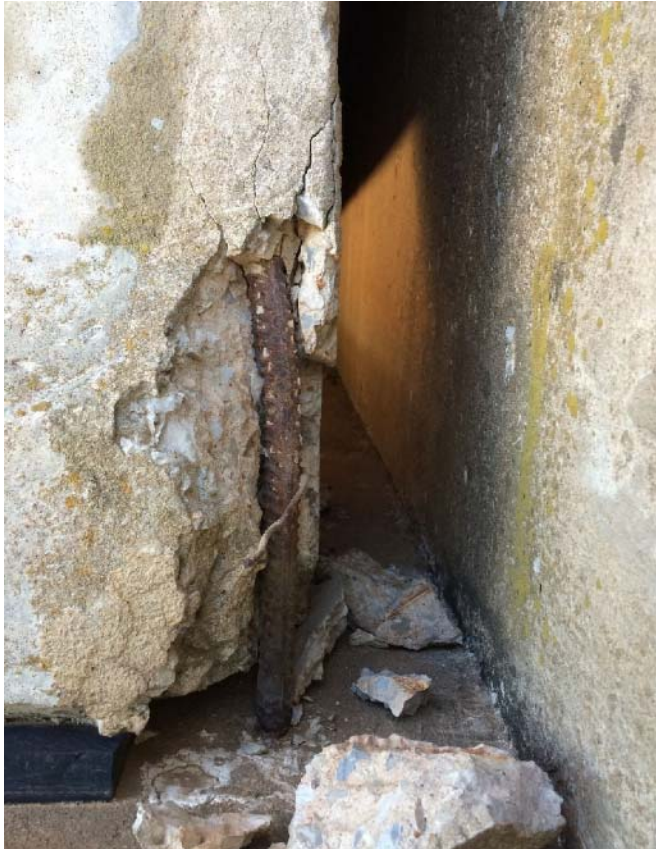
Figure 166. Exposed vertical rebar due to spalled girder end of exposed, exterior beam (1W-N)

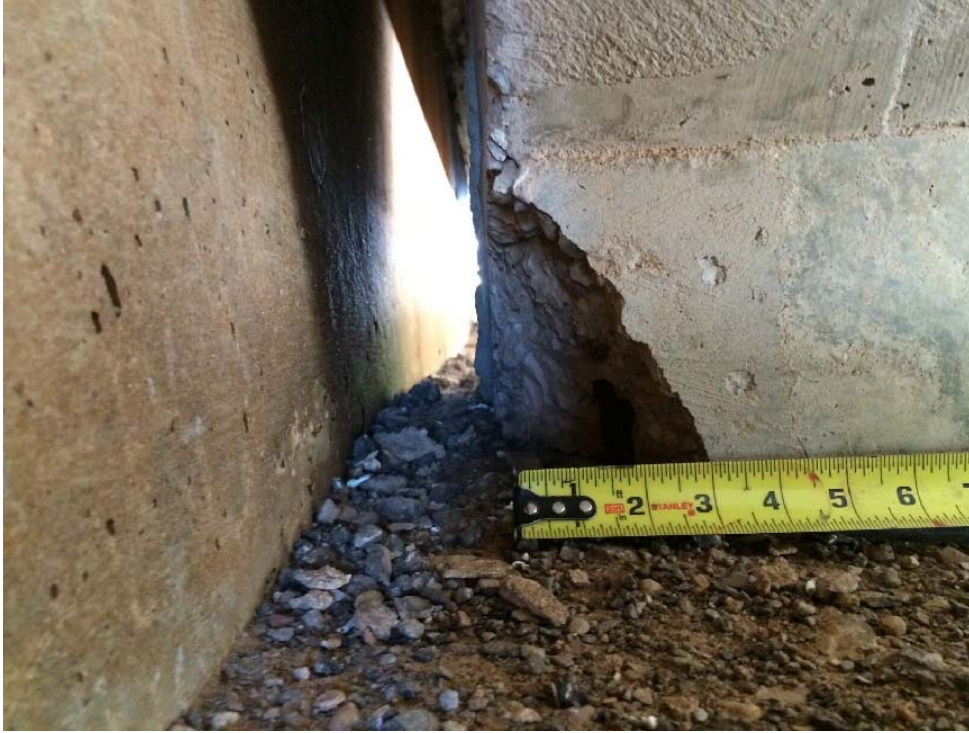
Figure 167. Back corner diagonal crack with a width at the base of approximately three inches (2E-N)

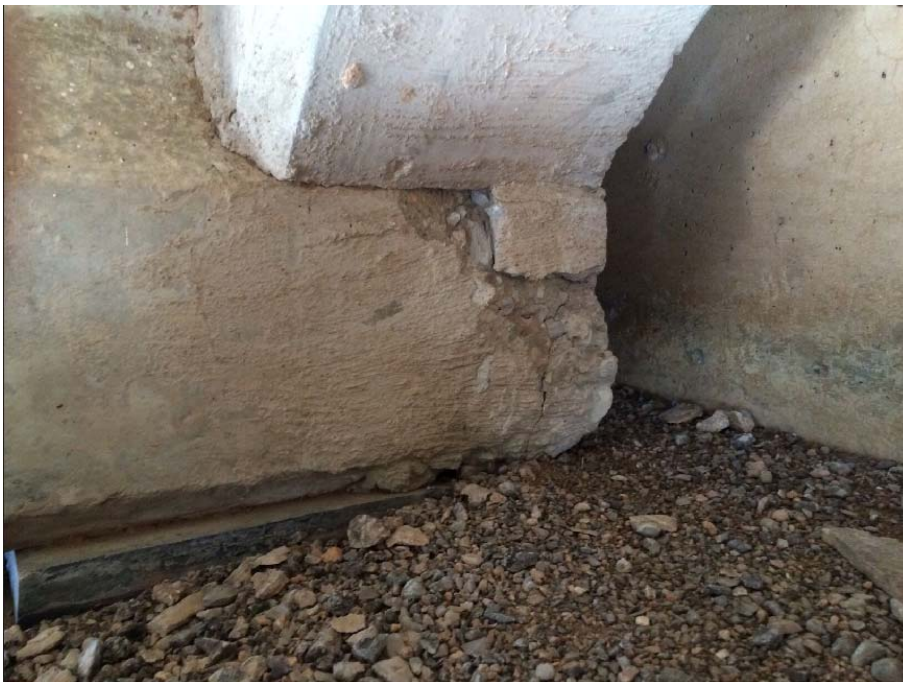
Figure 168. Spalling at diaphragm and girder interface (3W-N)

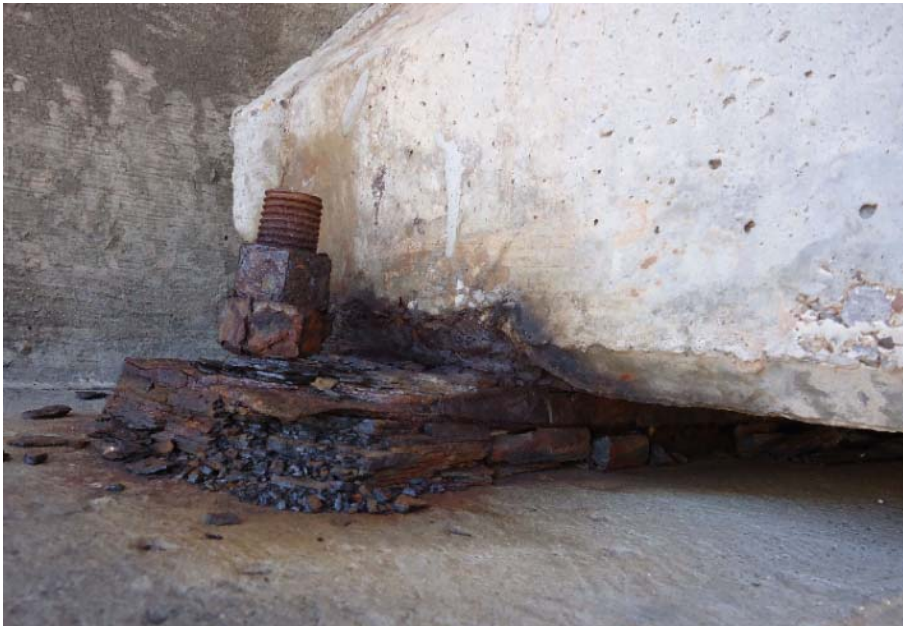
Figure 169. Corroded bearing plate, bolt, and nut along with spalling above the support of an exposed, exterior girder (1E-N)

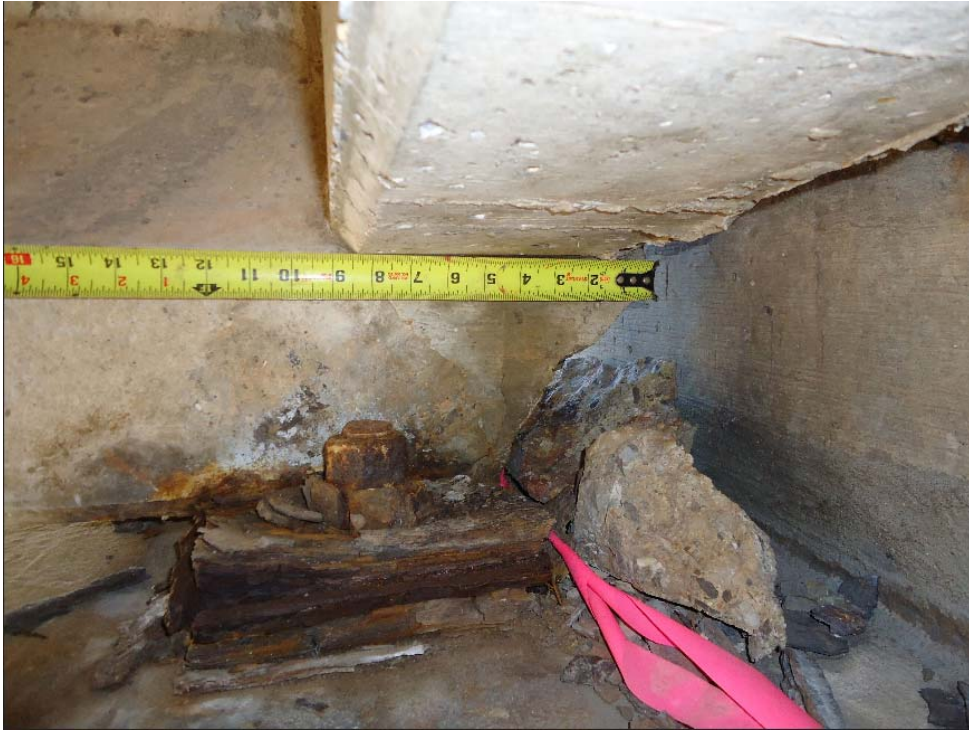
Figure 170. Corroded bearing plate and diagonal back corner crack with a maximum width of approx. four inches

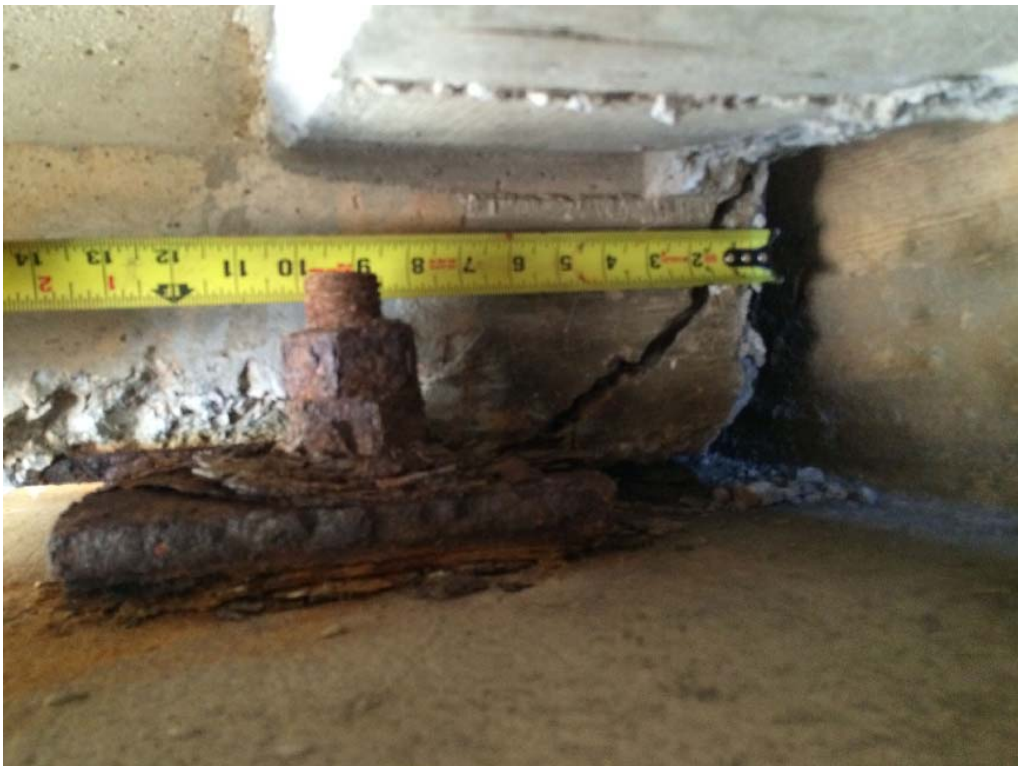
Figure 171. Corroded bearing plate and diagonal back corner crack with a maximum width of approx. five inches (2W-N)

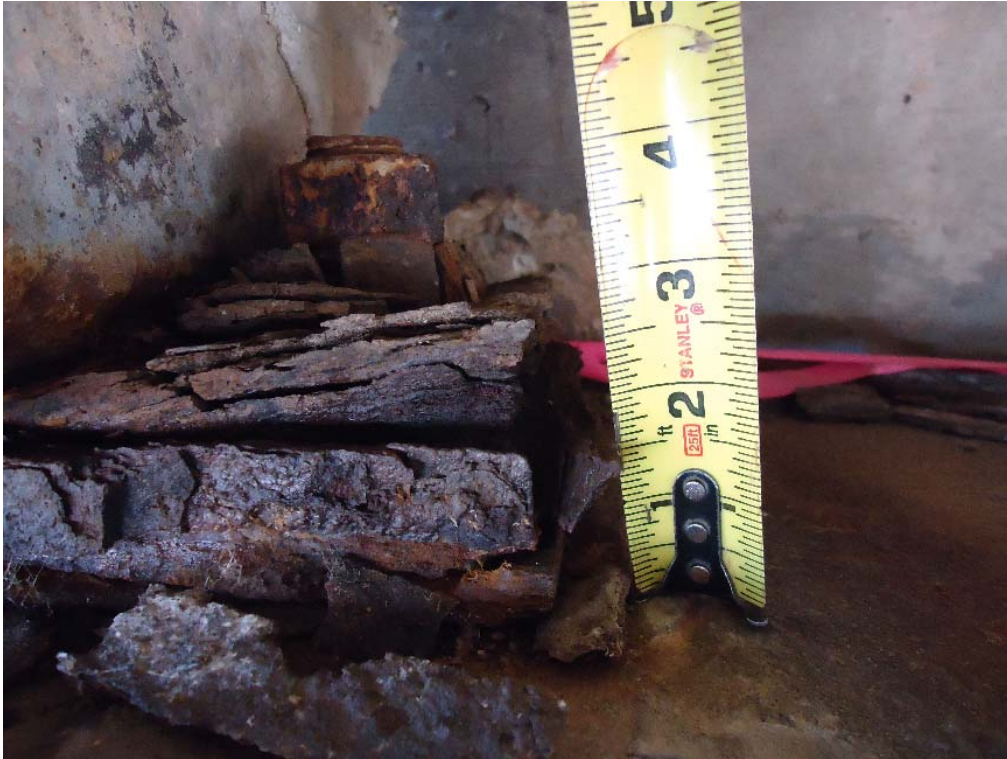
Figure 172. Corroded, flaky bearing plate

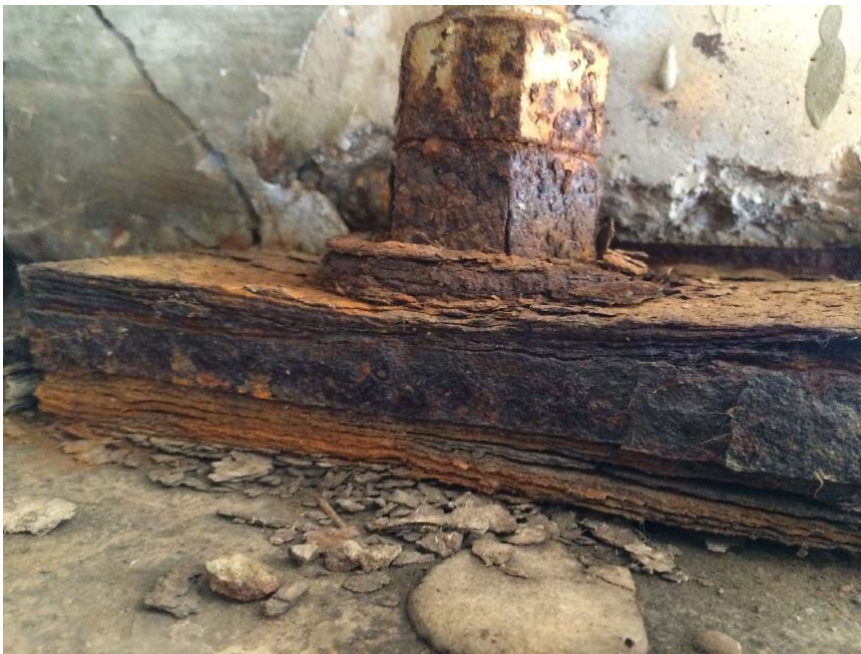
Figure 173. Corroded, flaky bearing plate

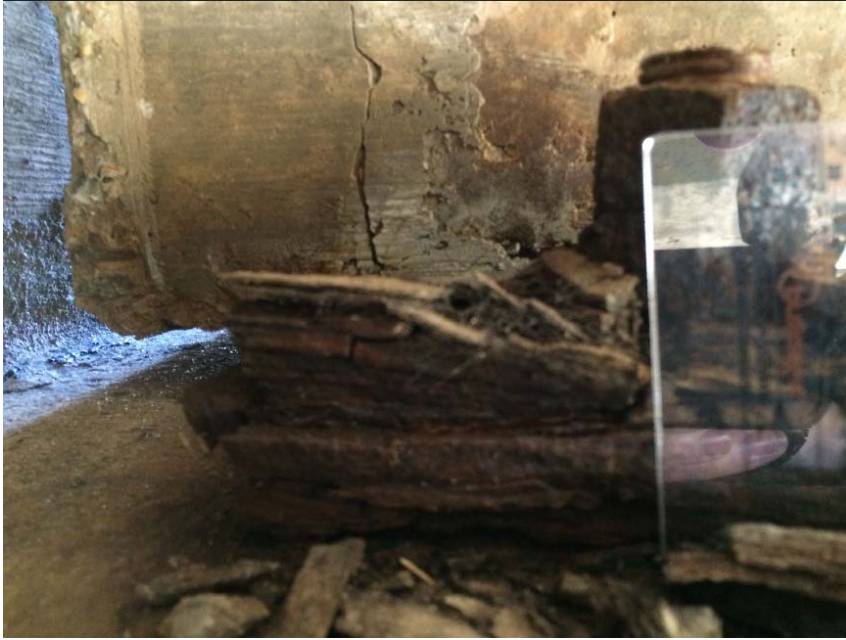
Figure 174. Vertical crack along interface of girder end and diaphragm (1W-S)

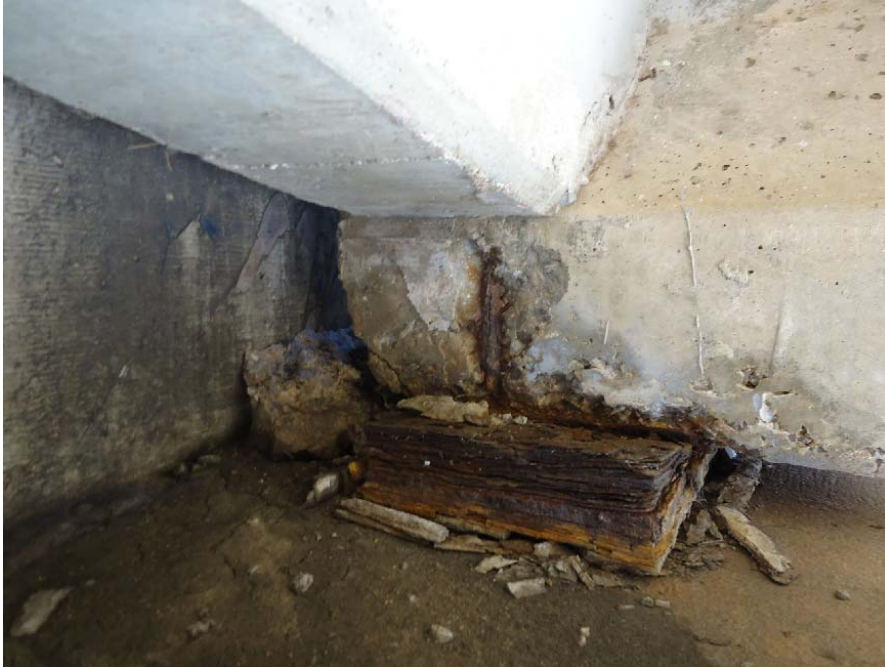
Figure 175. Exposed rebar, corroded, flaky bearing plate, and spalling of concrete (5E-N)

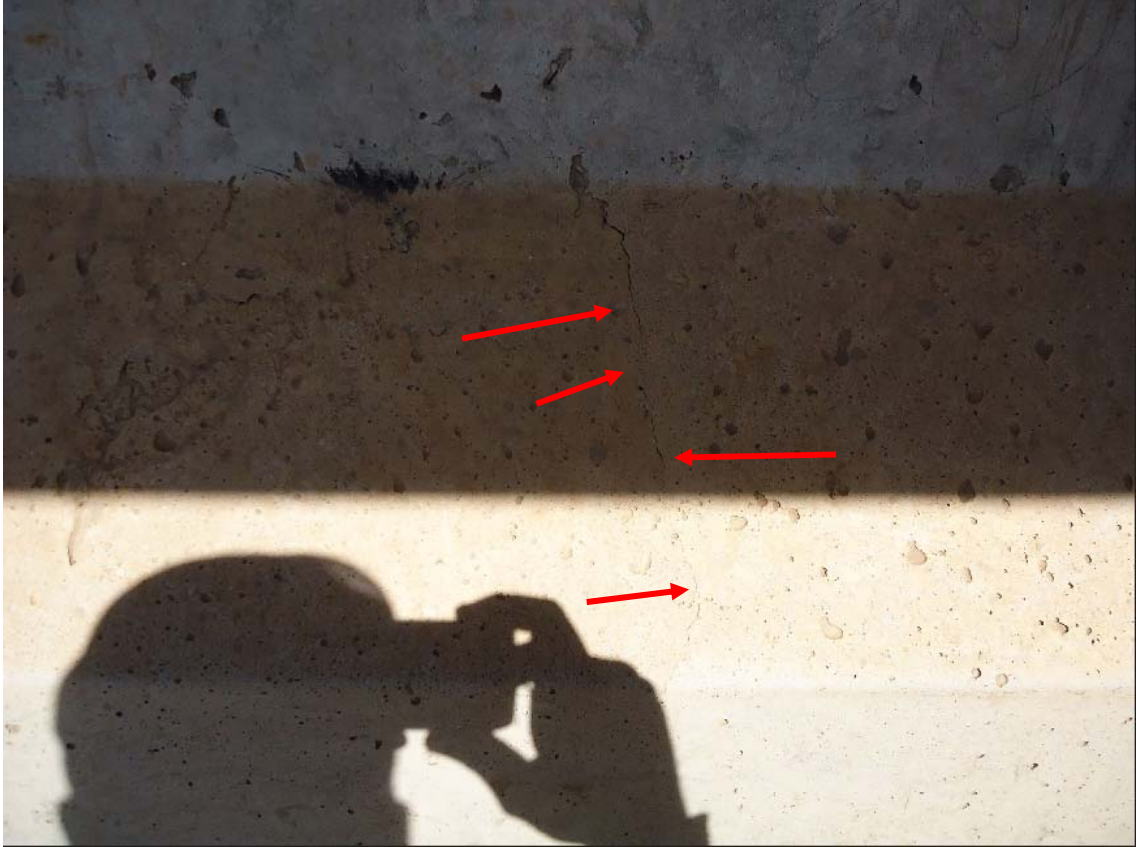
Figure 176. Crack along the web of girder (5E-S)

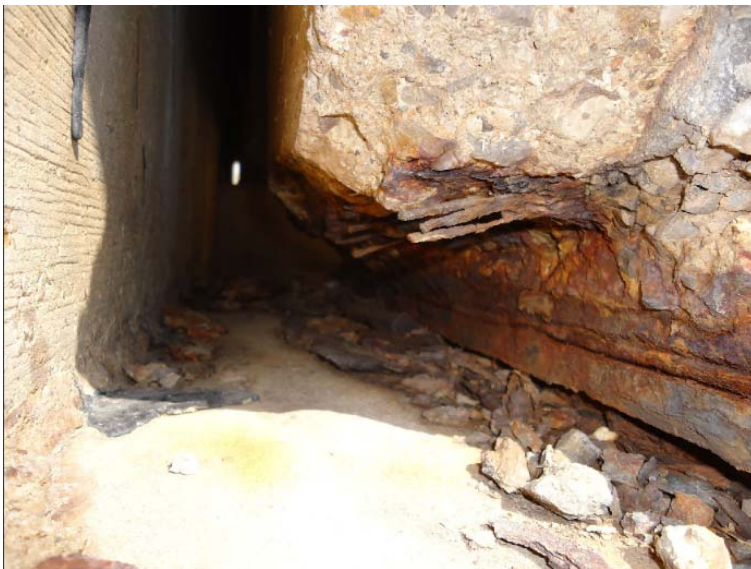
Figure 177. Diagonal back corner spalling and exposed prestressing strands (5W-S)

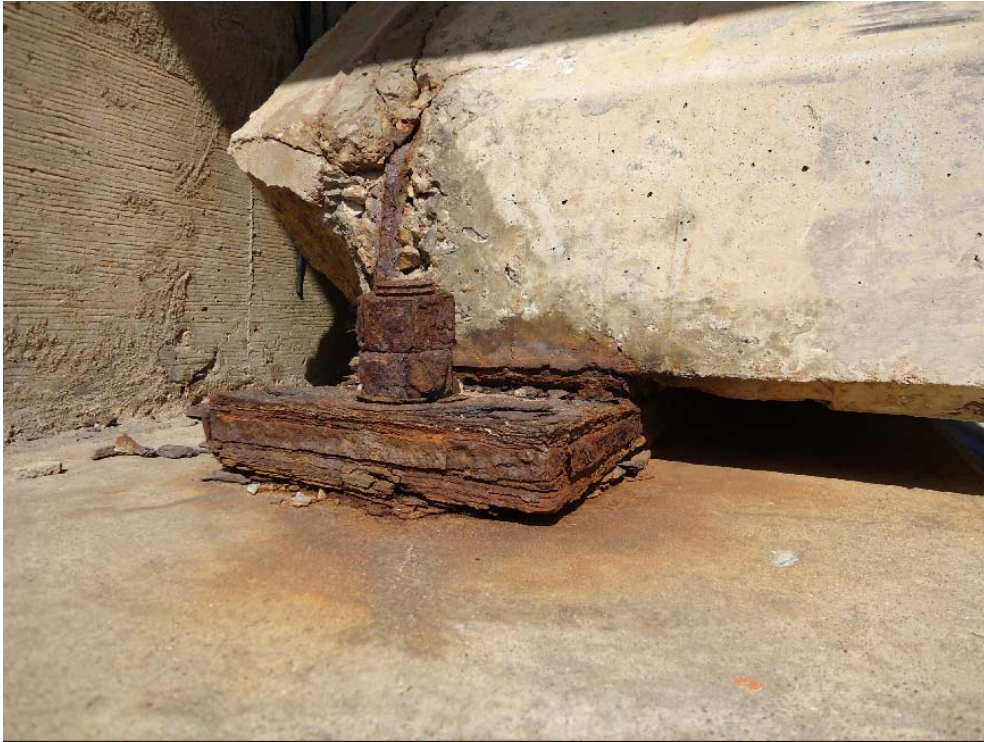
Figure 178. Corroded bearing plate, exposed rebar, and spalled back corner of girder (5W-S)

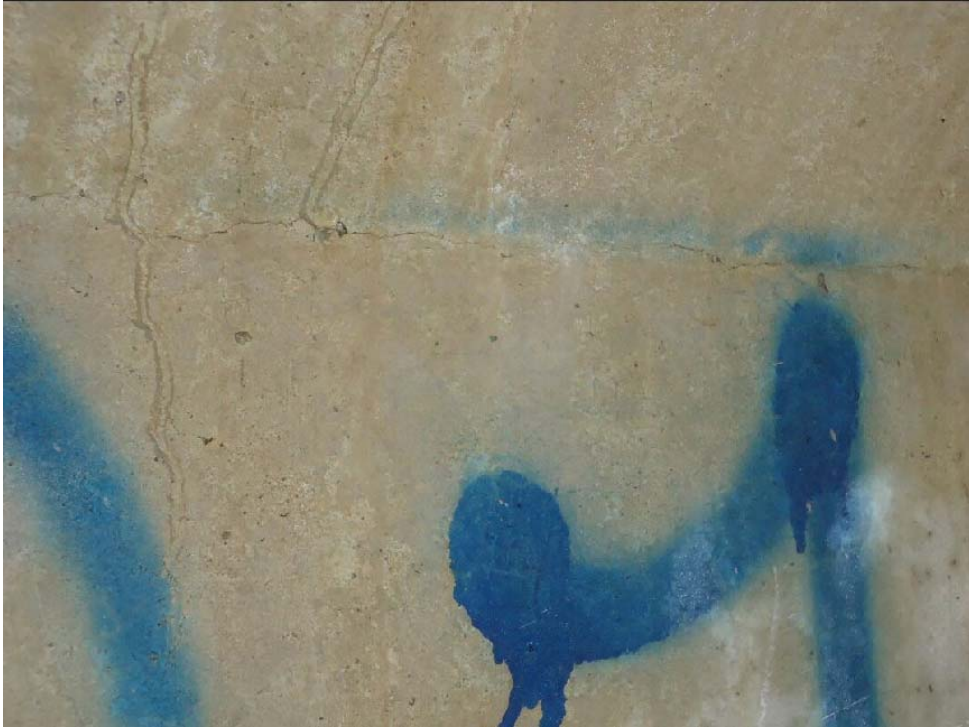
Figure 180. Horizontal crack at top flange and web interface for about one foot into the beam (1S-E)

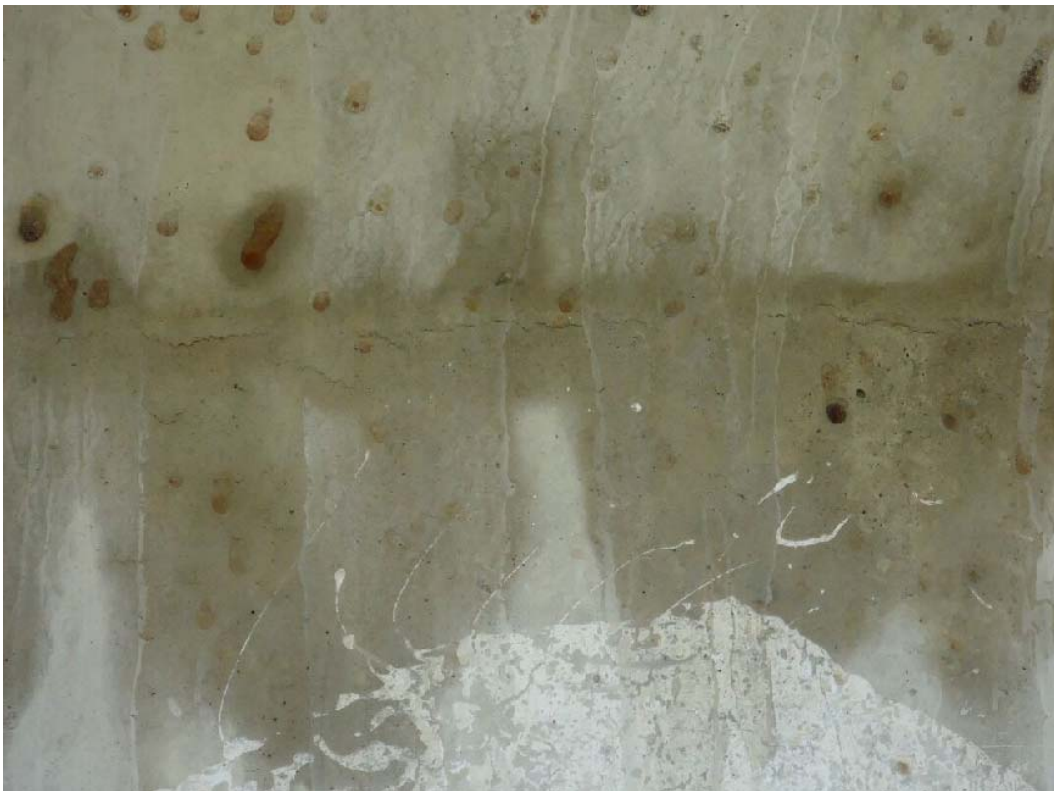
Figure 181. Horizontal crack at top flange and web interface for about one foot into the beam (5S-E)

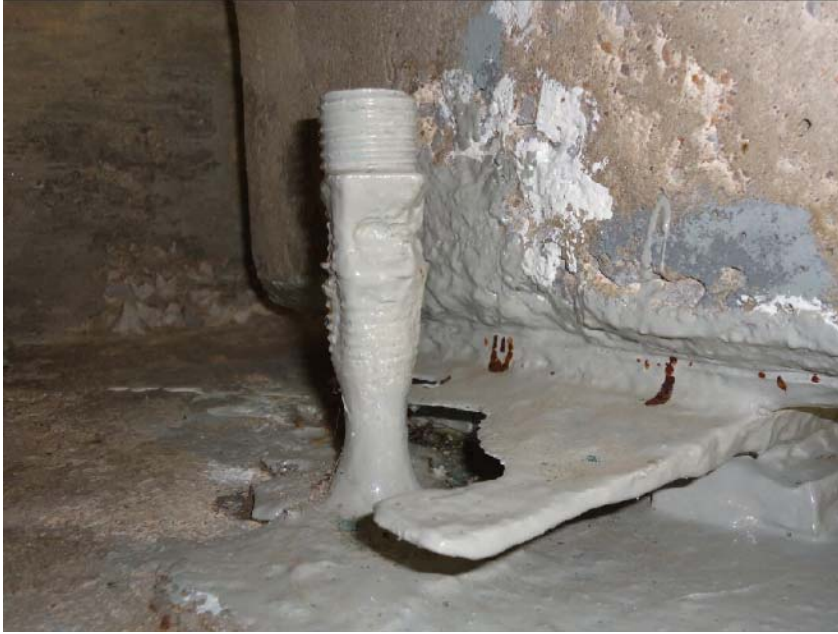
Figure 182. Anchor bolt and bearing plate coated (1S-E)

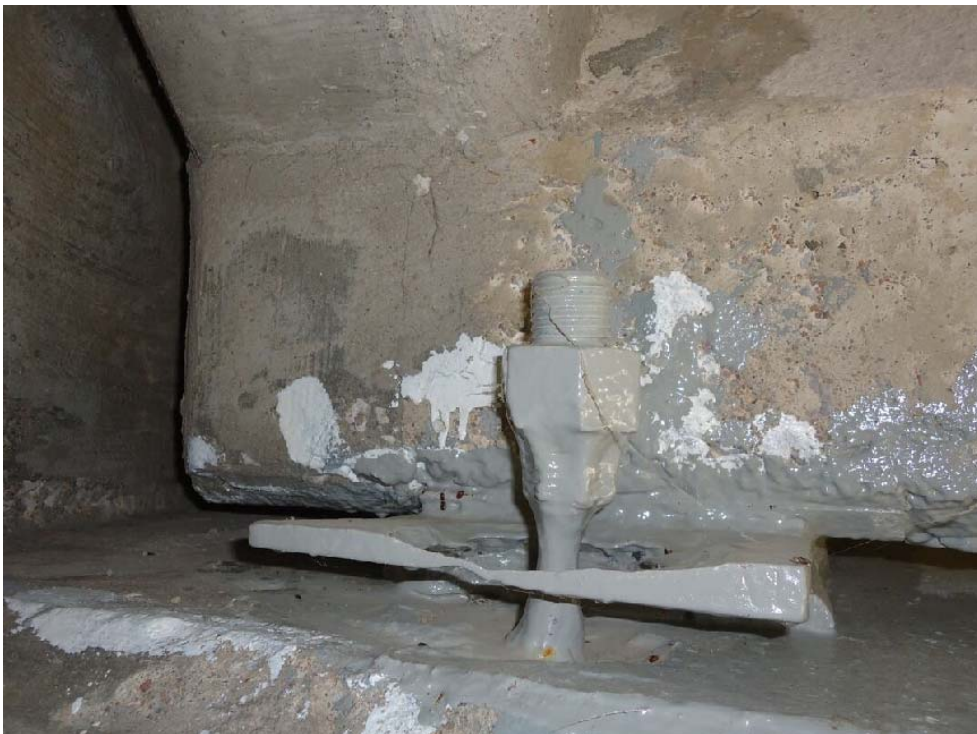
Figure 183. Necked anchor bolt and bearing plate both deteriorated and coated (2S-E)

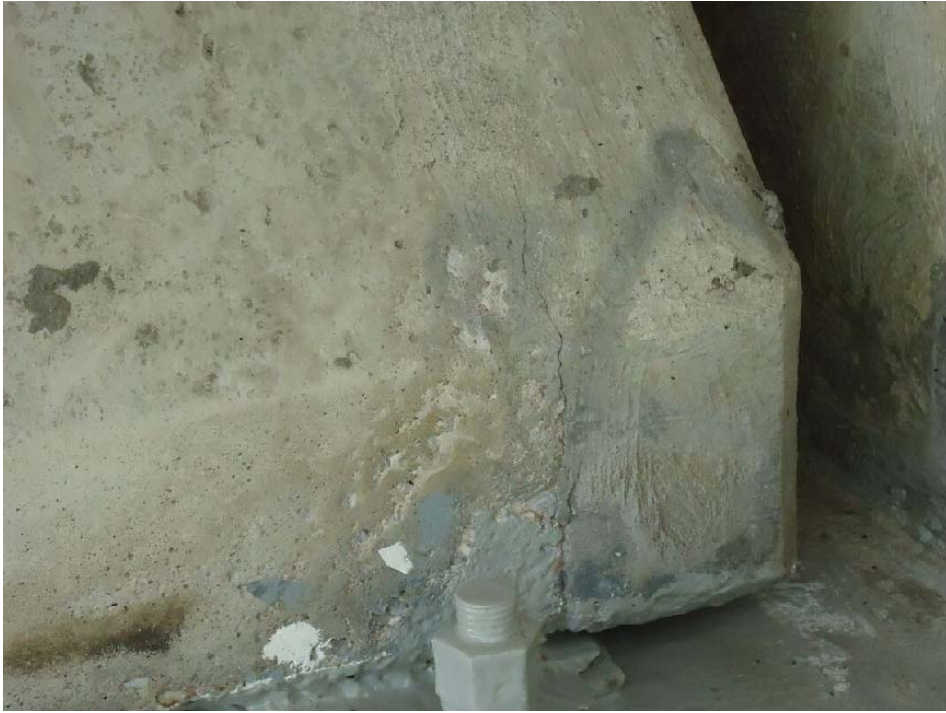
Figure 184. Crack at girder and diaphragm intersection (1S-W)

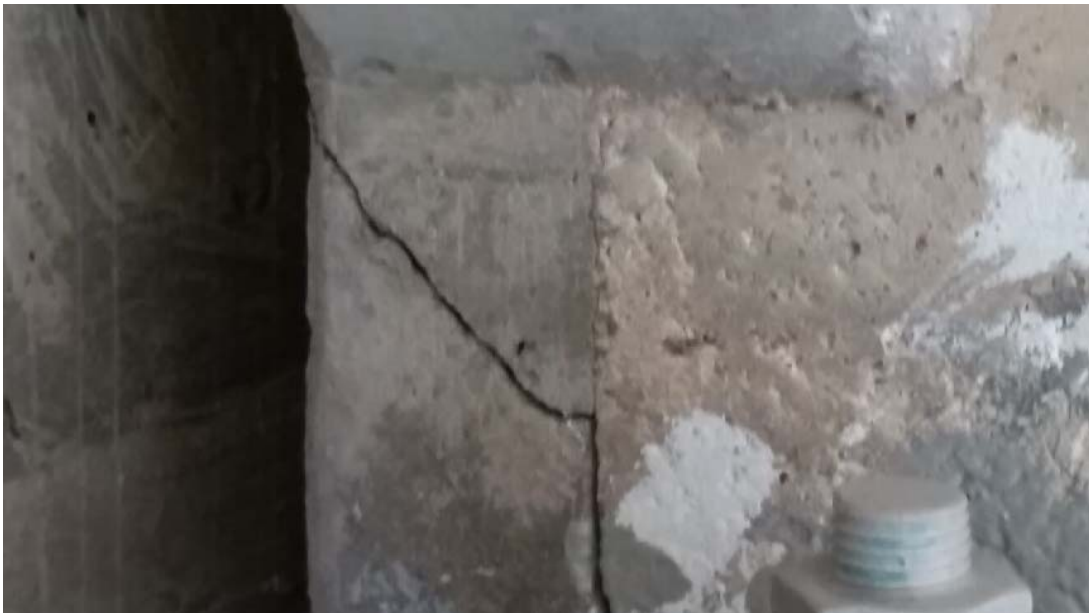
Figure 185. Back diagonal and vertical crack in girder end (2N-W)

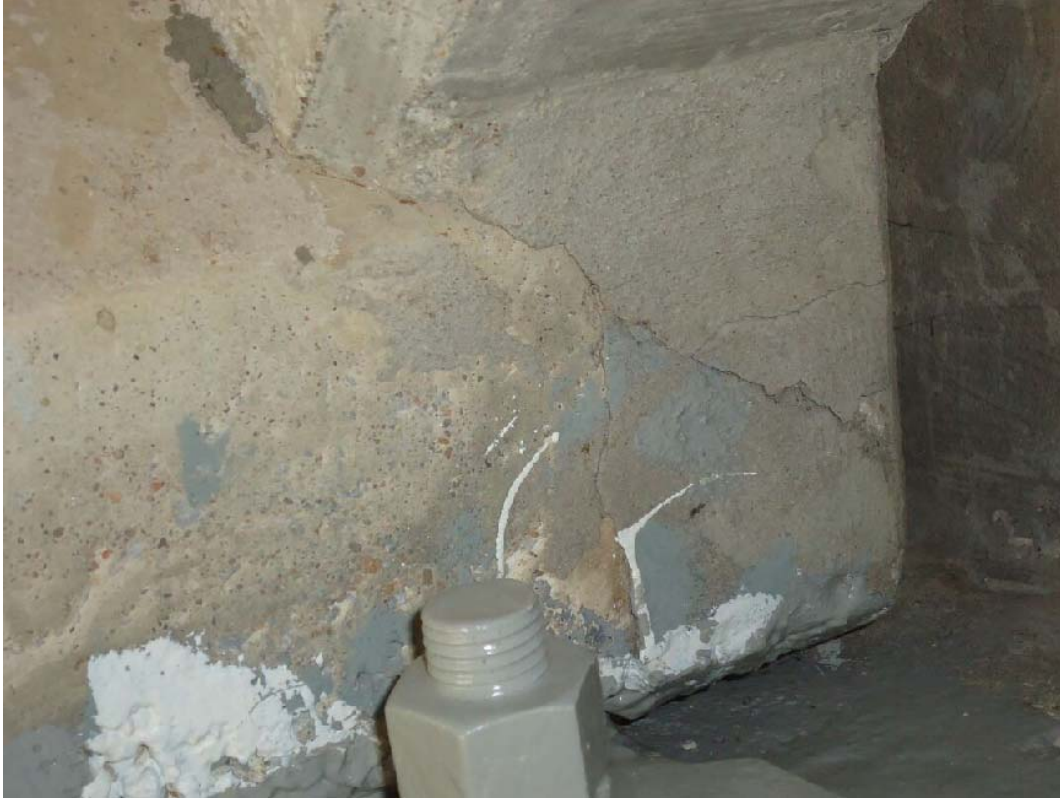
Figure 186. Diagonal crack at back corner of girder end (2S-W)

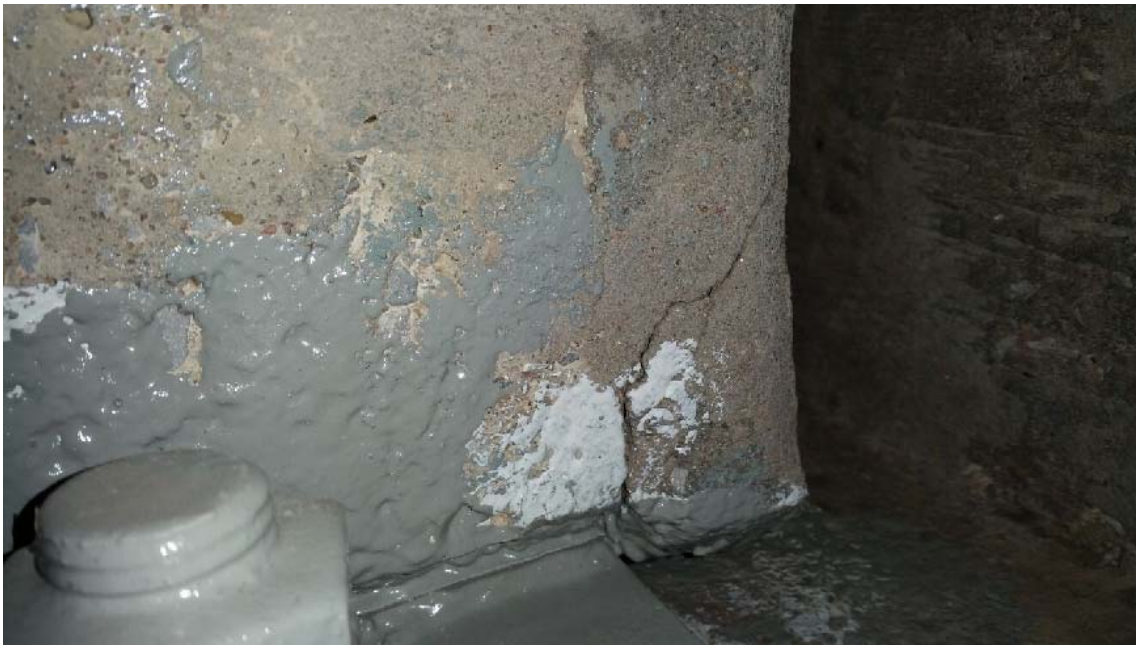
Figure 187. Diagonal crack in back corner of girder end (4N-E)

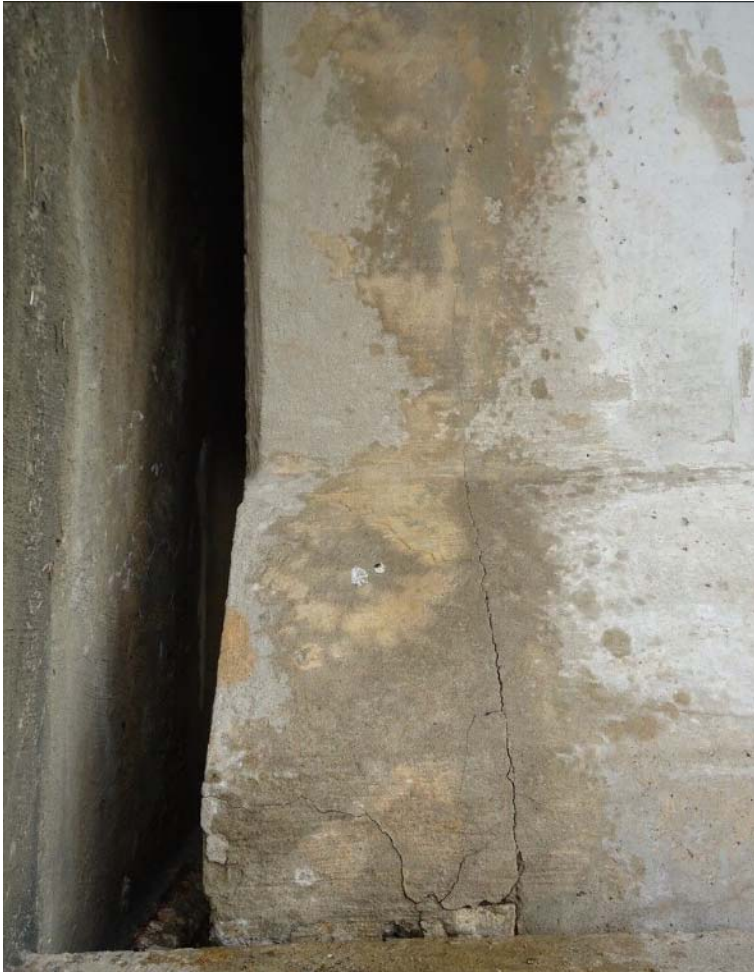
Figure 188. Vertical crack at girder/diaphragm interface (1N-W)

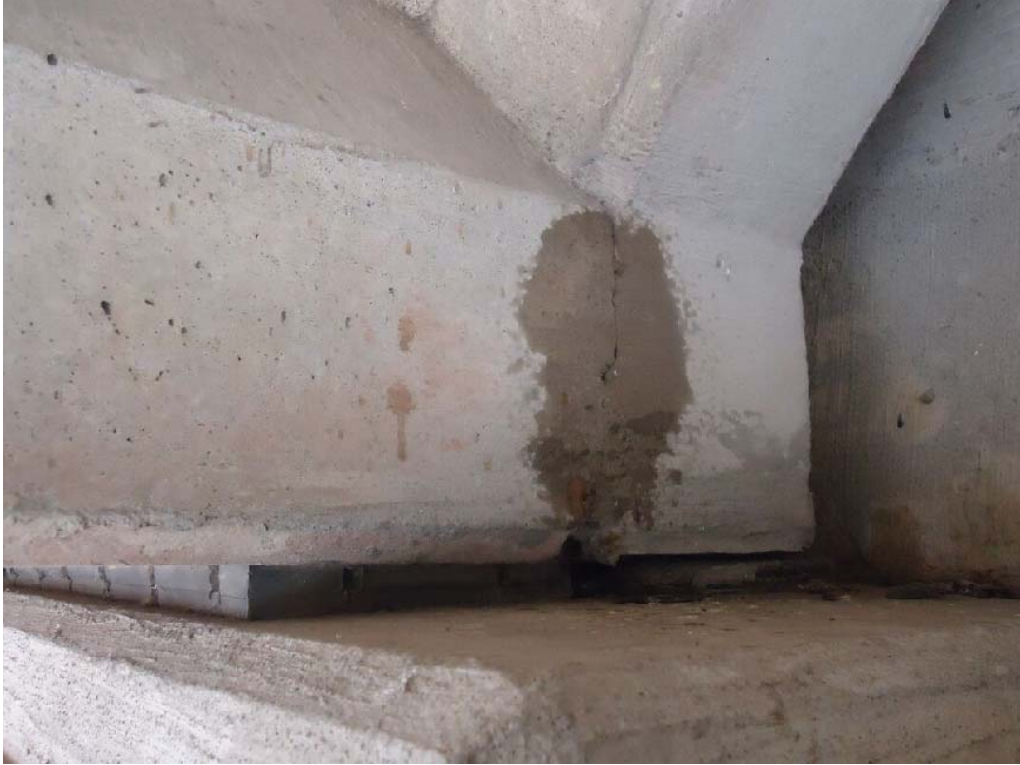
Figure 189. Vertical crack at bottom flange and diaphragm interface (3N-E)

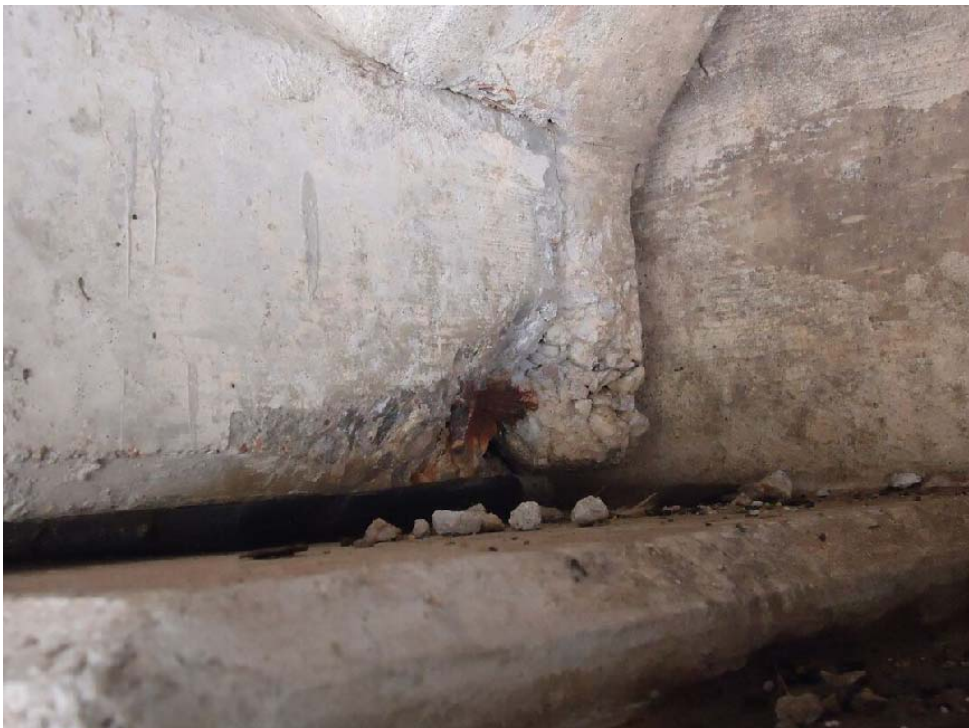
Figure 190. Exposed rebar, back corner spalled (2S-W)

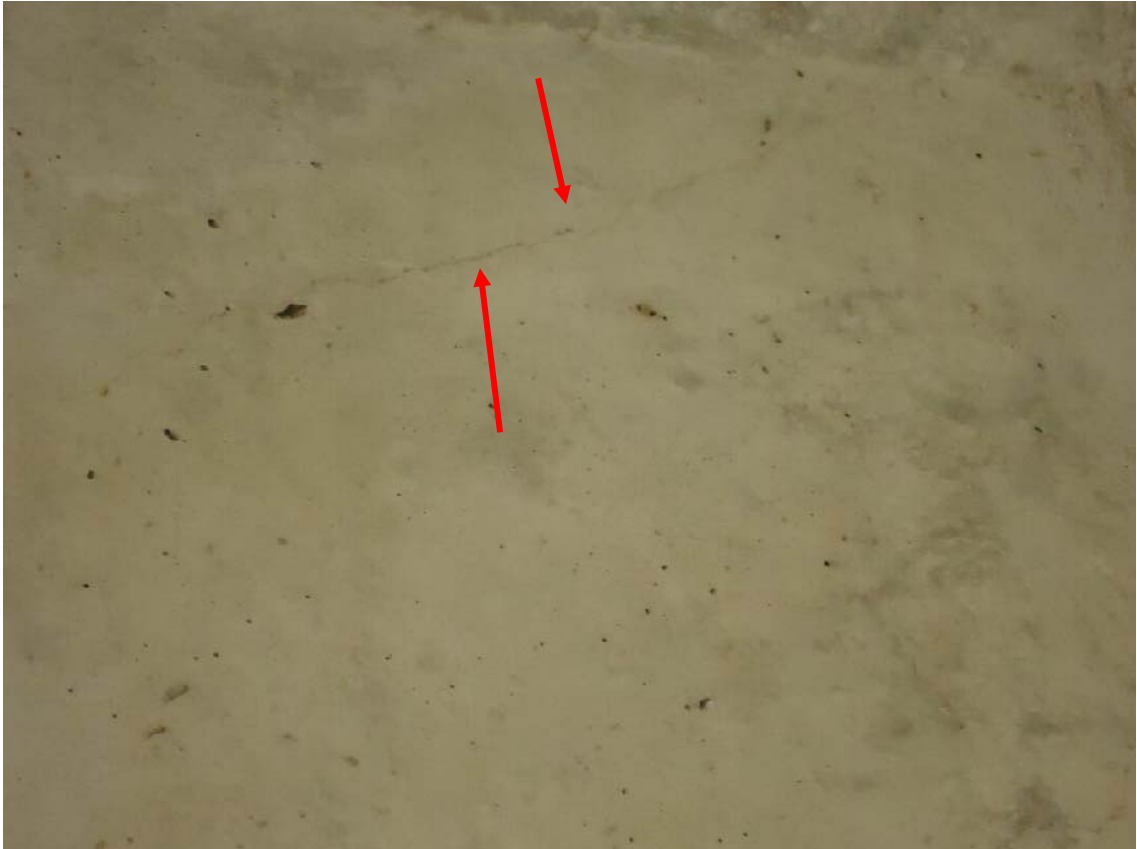
Figure 191. Diagonal crack from top flange and web interface (2S-W)

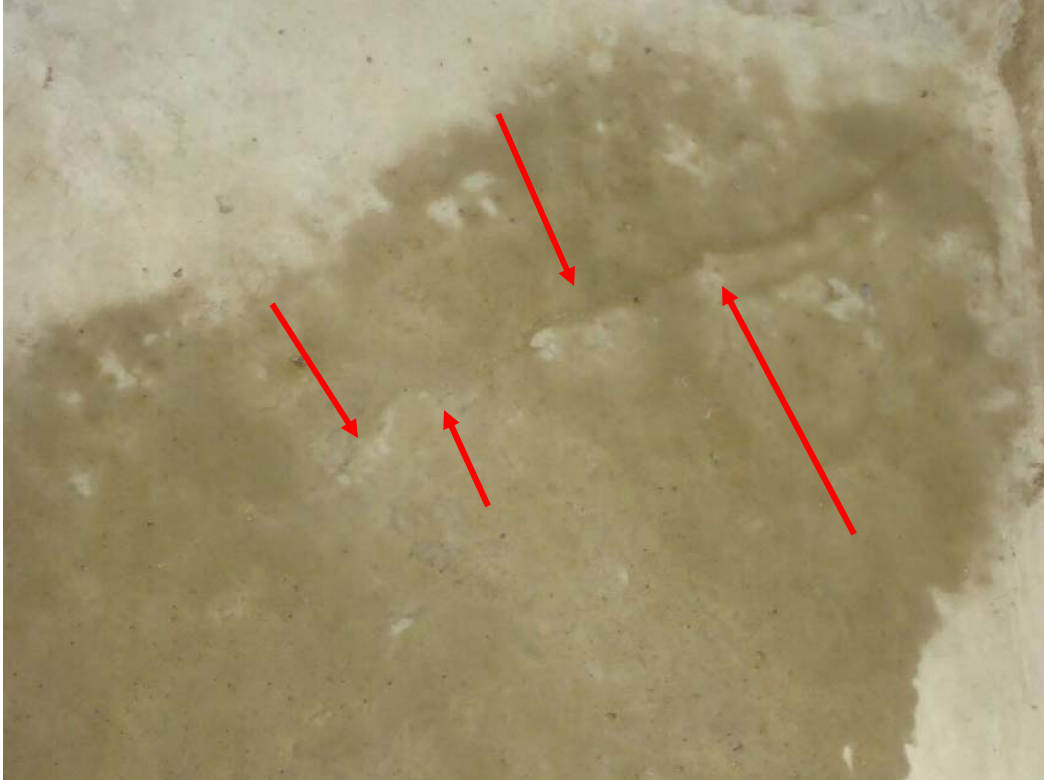
Figure 192. Diagonal crack from top flange and web interface

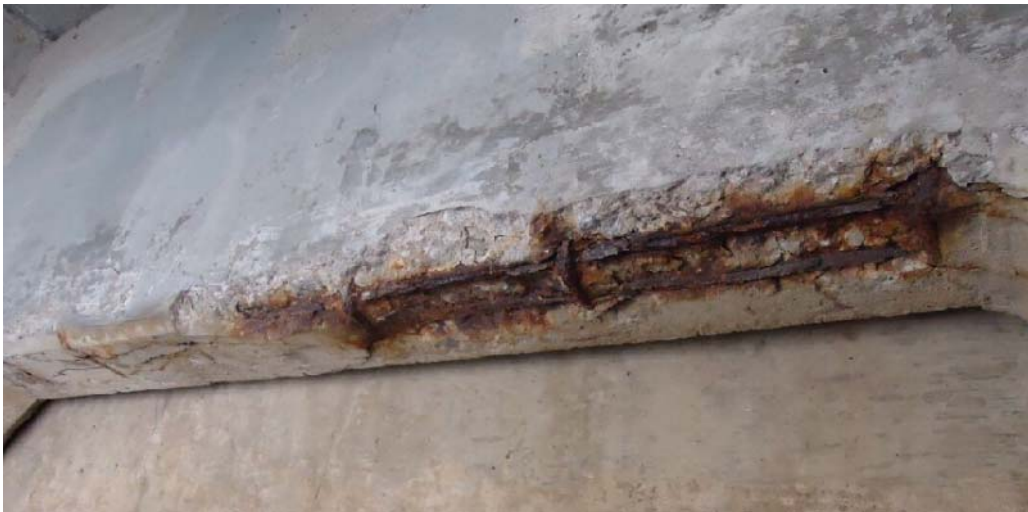
Figure 193. Corrosion and deterioration of underside of diaphragm

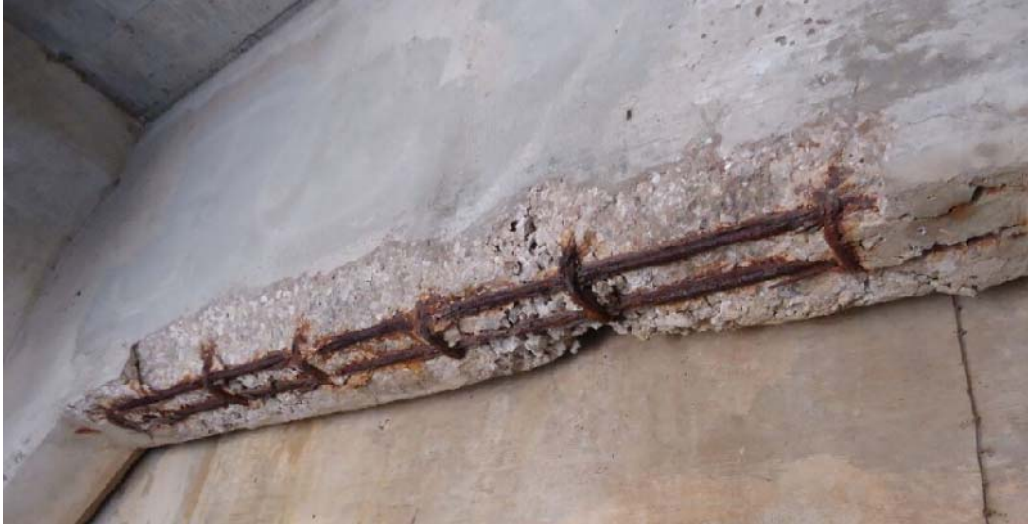
Figure 194. Similar corrosive underside of diaphragm, with exposed rebar cage

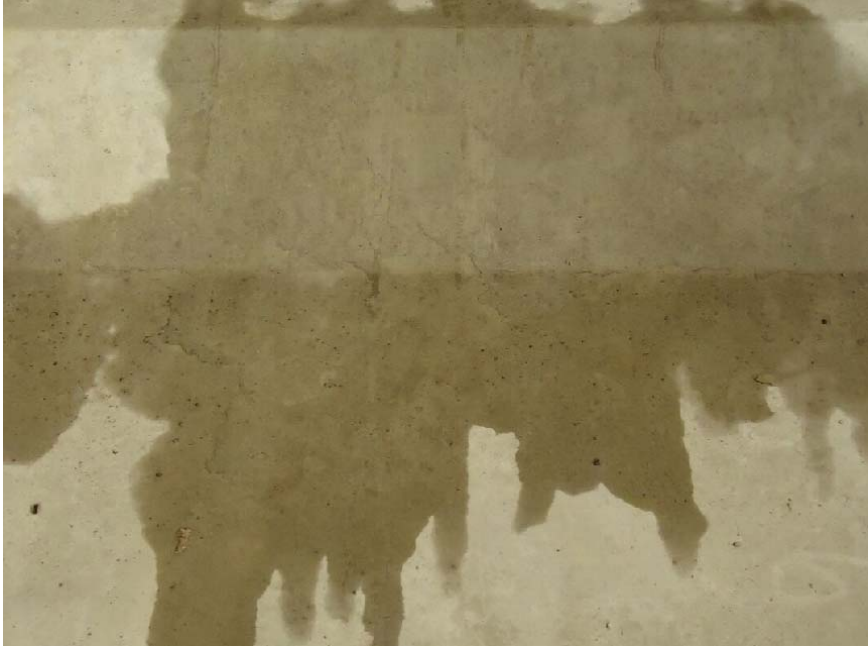
Figure 195. Horizontal crack along top flange and web interface (3N-E)
