UNIVERSITY OF OKLAHOMA
GRADUATE COLLEGE

INVESTIGATION OF THE EFFECTS OF END REGION DETERIORATION IN
PRECAST, PRESTRESSED CONCRETE BRIDGE GIRDERS

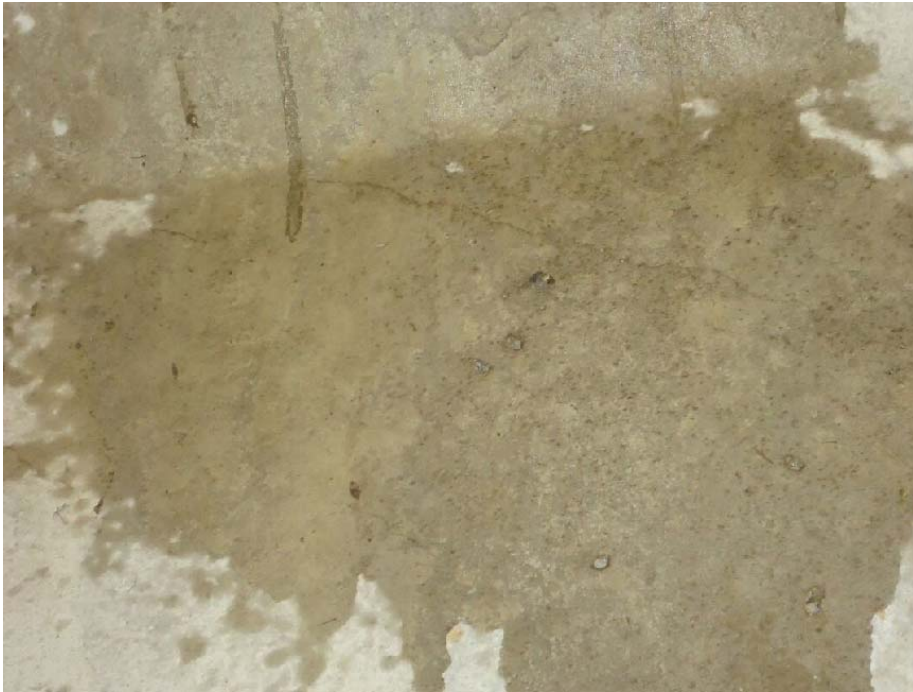
Figure 196. Diagonal crack from top flange and web intersection going further into the web (5N-W)

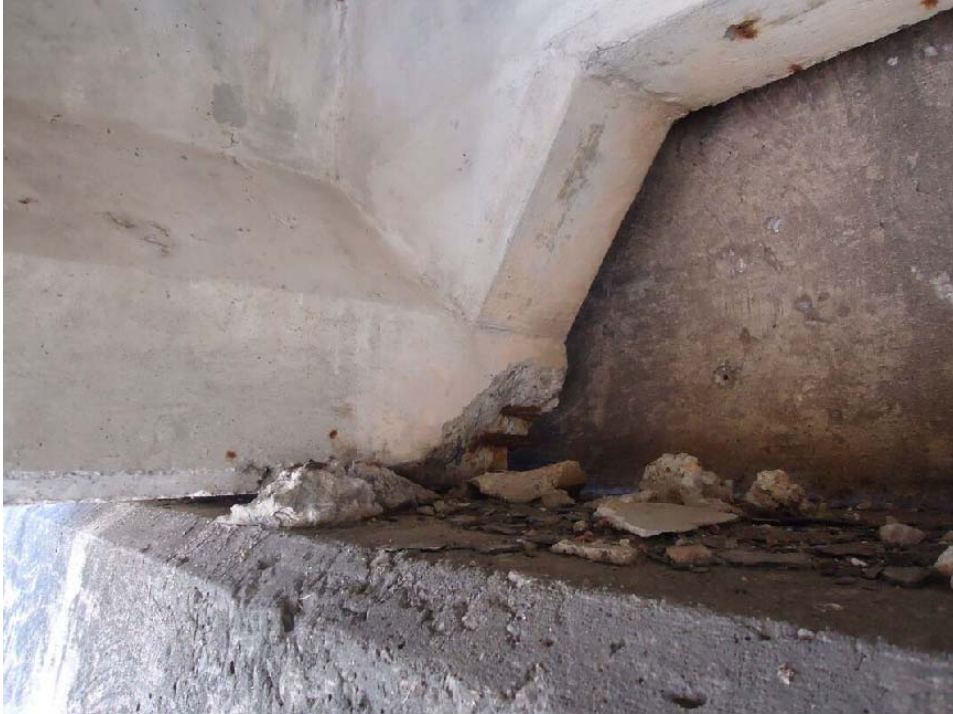
Figure 197. Diagonal back corner spalling of diaphragm and exposed prestressing strands (5S-W)
