The Seal Cove Shipwreck Project: Investigating an Historical Wooden Vessel on Mount Desert Island, Maine

Franklin H. Price, Stephen Dilk, and Baylus C. Brooks, Jr.

Two one-week field projects, carried out during the summers of 2011 and 2012, investigated an historical wooden shipwreck in the intertidal zone on the western side of Mount Desert Island, Maine. Salvage, tide, ice, and other environmental forces have reduced the wreck to a keel, frames, and outer hull planking. Despite this, some observations can be made from the limited surviving evidence. The vessel appears to have been heavily-built, with a full-bodied hull, and constructed in the mid to late 19th century. Its location, hull, and the wood shavings and brick chips found between its timbers suggest that it may represent a sailing vessel engaged in the coasting trade. Archaeological investigation of the site also served as an informal field school, providing experience in maritime site recording to Acadia National Park staff and members of the public.

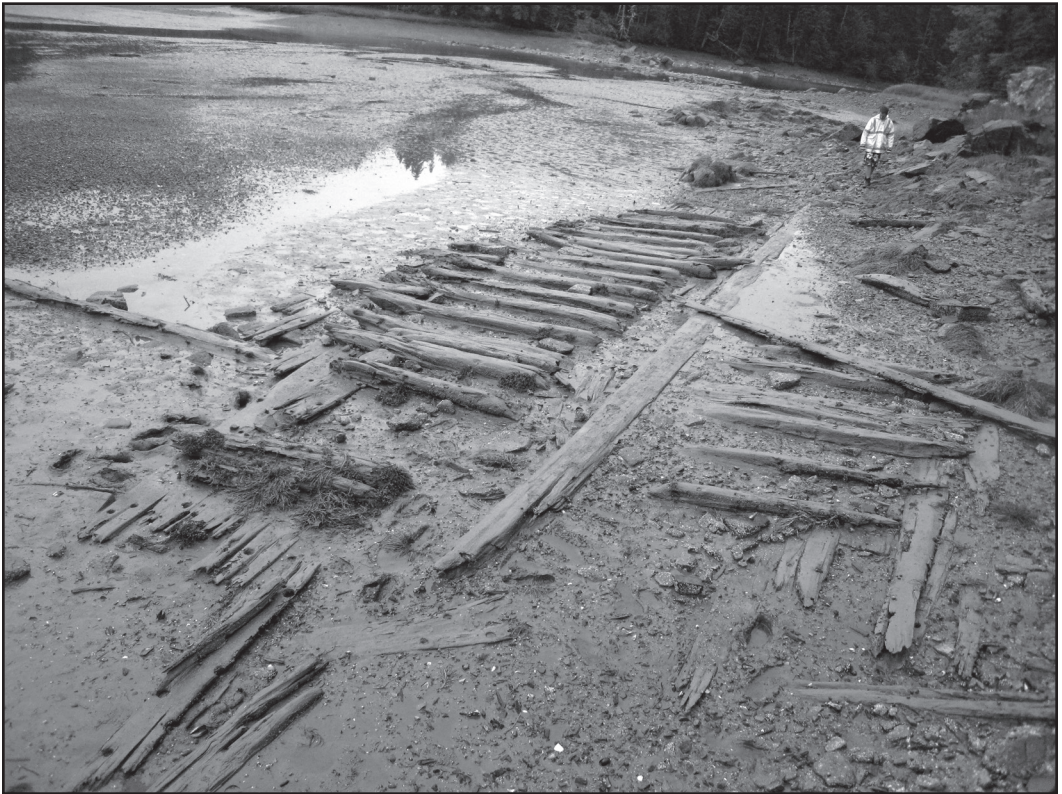
The shipwreck is located on the north shore of the eastern end of Seal Cove, on Mount Desert Island, in the intertidal zone (FIG. 5). East of the main part of the cove, the site is next to a narrow channel that is nearly dry at low tide, limiting the draft of vessels able to enter. The site was reported by local informants in 2006 and listed with the Maine Historic Archaeological Sites Inventory in July 2007 by Anthony Booth of Independent Archaeological Consulting (Maine Historic Preservation Commission 2007: 1–2; Price 2007).

Figure 5. The Seal Cove shipwreck, from north of the wreckage. (Photo by Franklin H. Price, 2011.)

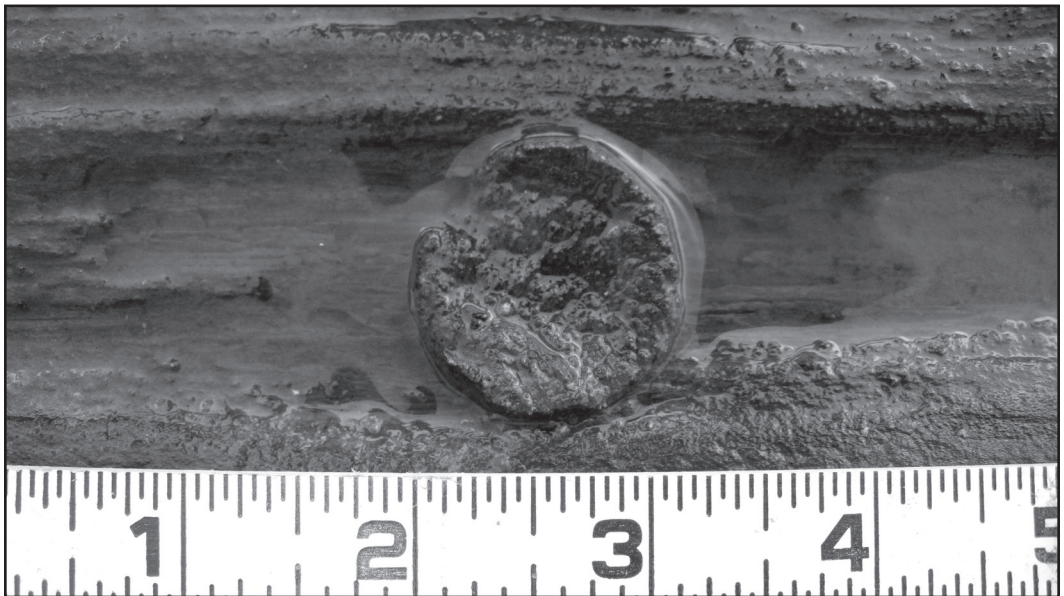
On the Seal Cove site treenails were employed for three uses. First, they acted as through-fastenings, running completely through both the outer hull planking and the frames (FIG. 7). Second, they pinned double frames together, as with the example of F25, F28, and a treenail between F16 and F17. Third, treenails were observed on the keel, driven vertically and horizontally, with at least two examples of each. This is not particularly surprising, as it was not uncommon for treenails to be used in the keel (Chapelle 1969: 178). The treenails might be defined as unwedged, since neither wedges nor pegs were conclusively observed locking the treenails in place. However, the lack of wedges could be a result of the eroded nature of the frames. In the

Figure 7. Treenail, scale in inches. (Photo by Franklin H. Price, 2011.)

“long” treenail type, the fastener runs through outer hull, frame, and ceiling planking (De Kerchove 1961: 860; McCarthy 2005: 68). The wedges, if these are “long” treenails, were removed by ice and tide along with the ceiling planking that they once held in place.

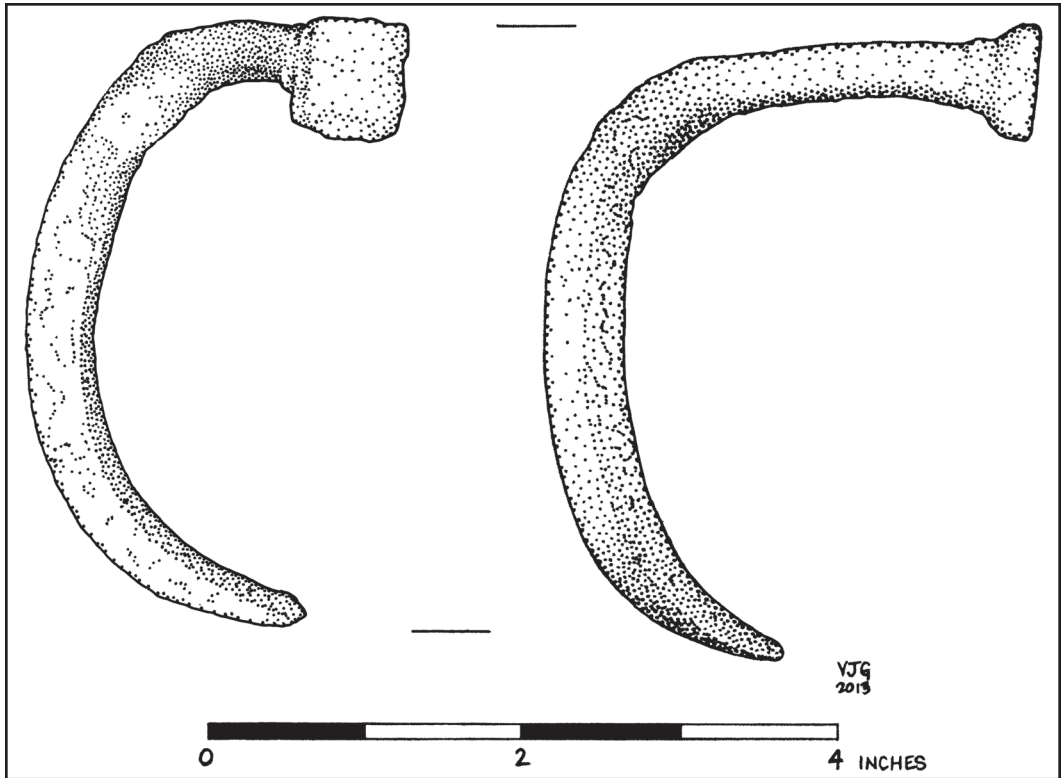
In addition to ferrous and wooden fasteners, a copper-alloy fastener might be associated with the wreck. A local informant provided investigators with a copper-alloy fastener that he found on the site. It is square, measuring ½

in. (1.3 cm) on a side (FIG. 8). The dimension matches some of the fastener holes in the outer hull planking, notably a well-preserved example on the western side of the wreck just north of frame F28. The fastener has been bent into a contorted shape, whether from stresses incurred as the vessel broke apart, from being pulled from the wreck, or from being clenched as part of vessel construction, is unknown. Degradation of the metal is considerably more pronounced toward the head, where it may have been exposed to the elements.

Figure 8. Copper-alloy fastener. (Drawing by Valerie J. Grussing, 2013.)
