South Dakota State University Agricultural
Experiment Station

5-1-1940

Paints and Plasters for Rammed Earth Walls

R. L. Patty

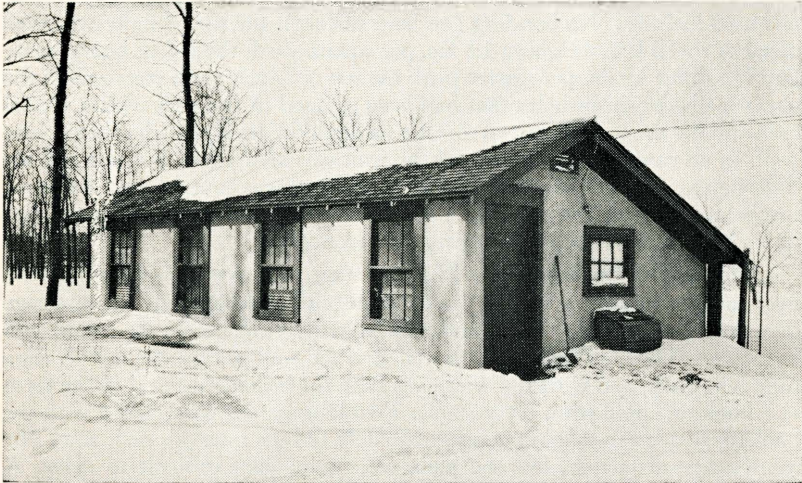
Fig. 3. Ordinary Stuccos Have Been Successful on Rammed Earth Walls.

The stucco on this poultry house has been on the walls for five years. The mixture used for the stucco was (1-4- $\frac{1}{2}$), 1 measure of portland cement, 4 measures of sand, and $\frac{1}{2}$ measure of cem-mix. The sand was high quality. These walls were first painted. After two years the paint failed and this stucco was put on. The earth walls are slightly below average in quality.

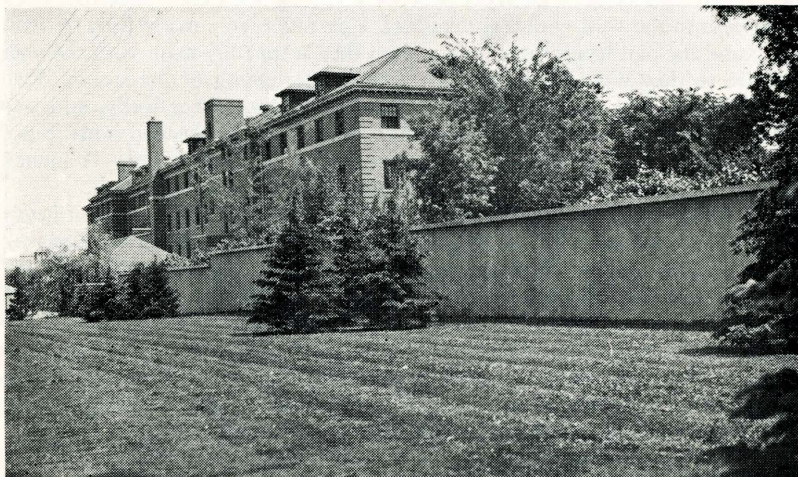
Fig. 4. A Section of Garden Wall Used For Trying Different Bonding Methods For Stucco on Rammed Earth Walls.

Twenty-eight bonding panels were used on this wall, including methods of nailing and joining bonding wire. Picture taken after four years.

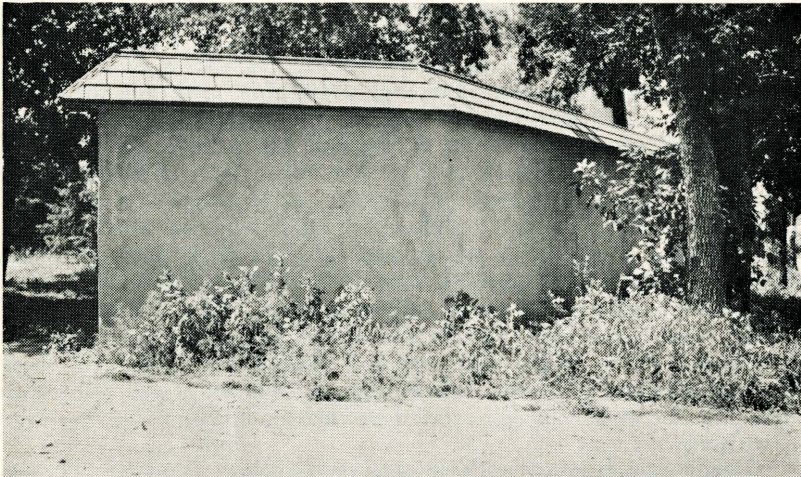
Fig. 5. Stucco Panels on a Section of Rammed Earth Wall.

The mixture used for the stucco panel in the foreground was ($1-3\frac{1}{2}-\frac{1}{2}$), 1 measure of portland cement, $3\frac{1}{2}$ measures of sand and $\frac{1}{2}$ measure of cem-mix. This was the mixture the plasterer liked best.

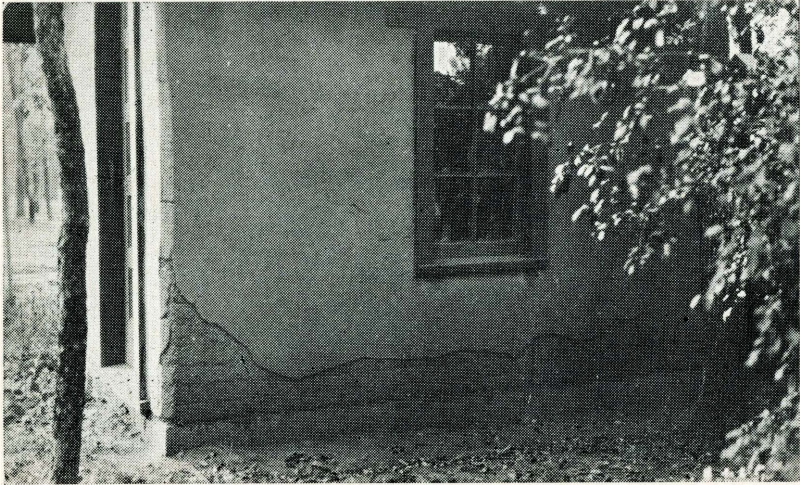
Fig. 6. Plain Dagga Plaster on Rammed Earth.

This plaster is made from sand and sandy clay mixed with water. It is a temporary covering, only. The picture was taken after two years. When painted with lead-oil paint, this dagga plaster is made quite durable. Panels are in excellent condition after five years.

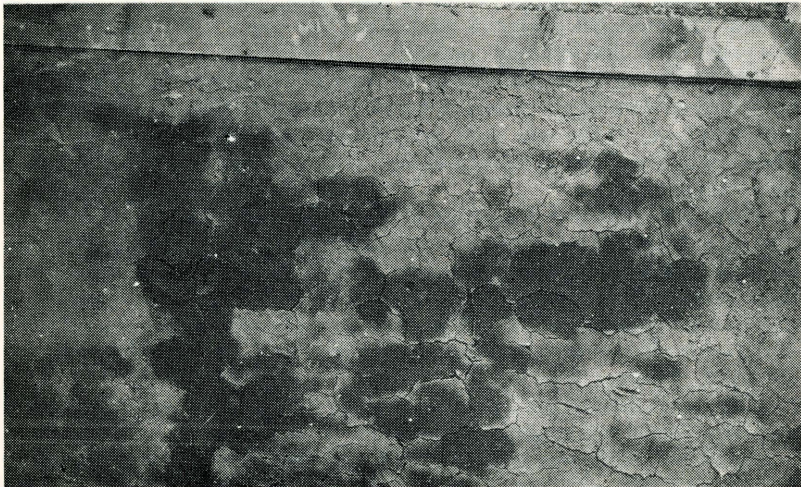
Fig. 7. An Example of Dagga Plaster Containing Too Much Clay and Not Enough Sand.

painted in the same way and at the same periods as panel 33M. A different clay was used in the dagga plaster on this panel, and the plaster proved to contain too low a percentage of sand. After two years, two large patches on this panel failed due to heavy cracking.

When dagga plaster checks like this, it must be removed and replaced with mortar containing more sand. Trial of a sample patch of plaster before using is advised.

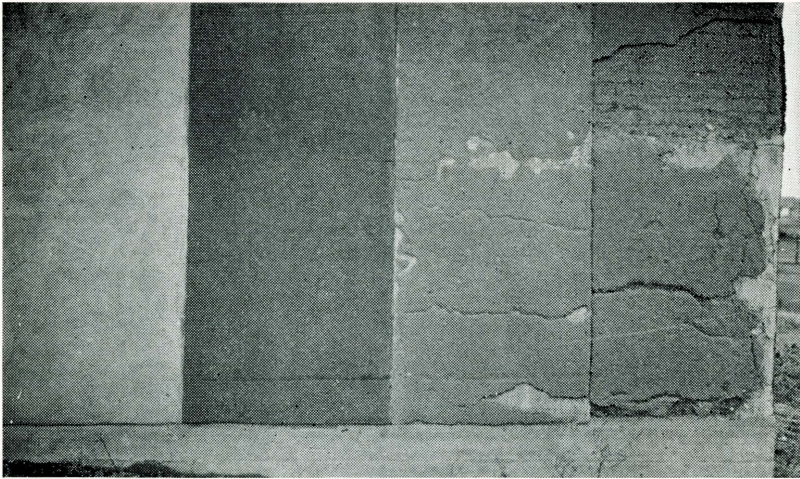
Fig. 8. Two Inexpensive Plasters Showing Excellent Results.

These plaster panels have been on for five years. The one at the left is dagga-cement plaster containing only 10 percent of portland cement. The dark panel is dagga plaster to which is added asphalt emulsion at the rate of $\frac{1}{2}$ gal. per 100 lbs. of dry dagga plaster. The two panels at the right failed, although the plaster contained more cement than the dagga-cement panel.

Panel No. 31M was 3 x 9 feet in size. The first coat was plastered on August 3, 1936 and nailed to the wall immediately with 10d common nails, 12 inches apart at random. The second coat was applied one day later. After three years and six months this panel is in perfect condition. The color is dark but the plaster promises to be a very durable one for the cost. The cost of the sand and clay was negligible, and asphalt used measured $1 \frac{1}{2}$ gals. per 100 sq. ft. of plaster. (See Fig. 8.)

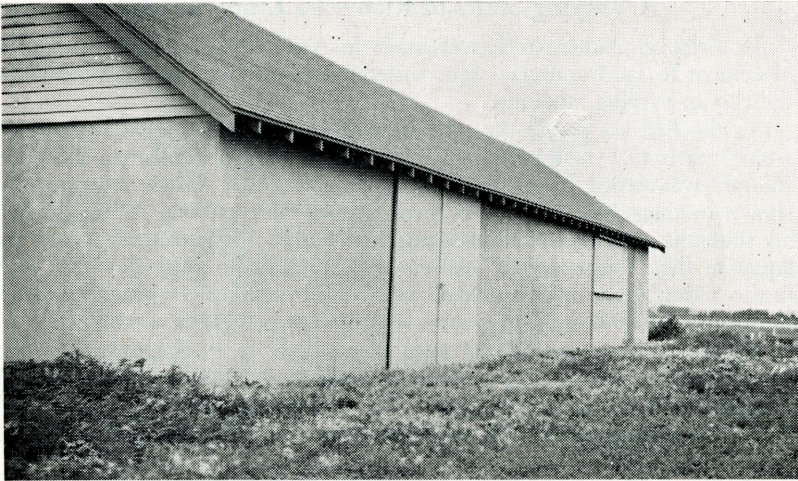
Fig. 9. Panels of Common Cement Stucco and of Dagga Plaster with the Surface Painted.

The section of wall between the doors of this machine shed is stuccoed with ordinary mixture of 1 measure of portland cement, $3\frac{1}{2}$ measures of sand and $\frac{1}{4}$ measure of cement. This section of wall was made of rammed earth blocks. The section close up is covered with dagga plaster with the surface painted.

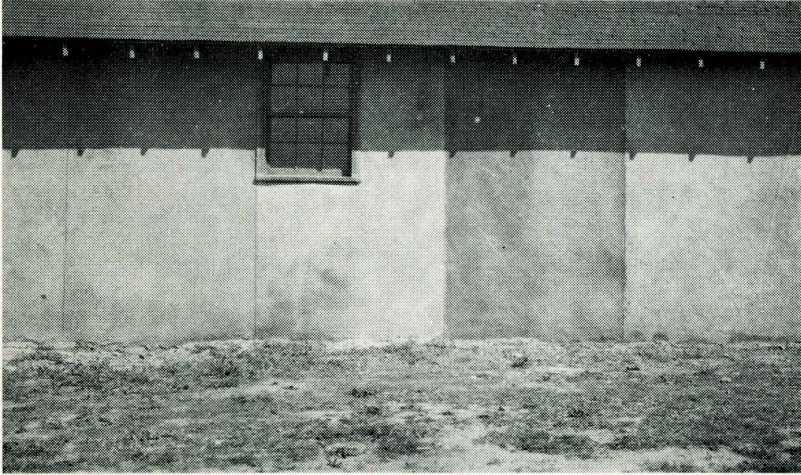
Fig. 10. Panels of Rich to Very Lean Cement Plasters Reported in Table No. 1.

7Mb	6' x 9'	south	Both Coats Apr. 30, 1938	Portl'd cement-Sand-Cem-mix (1-3½-¼)	Sound, but with slight hair checks
8Mb	6' x 9'	south	Both Coats Apr. 30, 1938	Portl'd cement-Sand-Cem-mix (1-3½-½)	Good. This panel is fine.
9Mb	6' x 9'	south	Both Coats Apr. 30, 1938	Portl'd cement-Sand-Cem-mix (1-3½-1)	Good. Same as panel 8Mb
10Mb	6' x 9'	south	Both Coats Apr. 30, 1938	Portl'd cement-Sand-Cem-mix (1-3-1)	Sound, but not quite as good as 9Mb. Mixture too rich.

Beginning at the right, these panels are No. 4Mb, 5Mb, 6Mb and 7Mb as shown in the table.

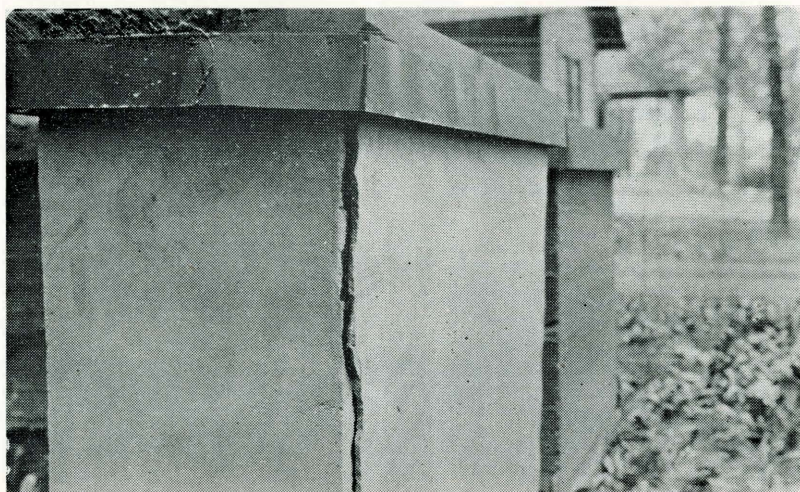
Fig. 11. Stuccos Will Fail on Heavy Clay Walls.

This stucco failed in less than a year's time. On a heavy clay soil that is unfit to use for rammed earth walls, even stucco will fail. It is not necessary to have high quality walls, however, as stucco will be satisfactory on average quality walls containing 30 percent or less total clay.

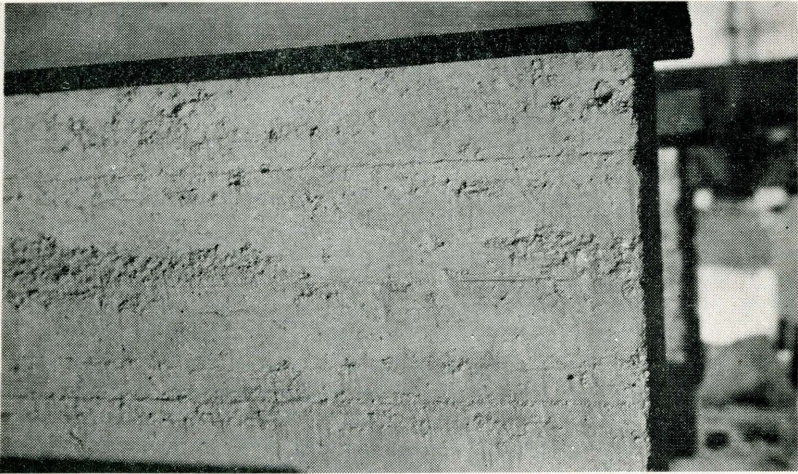
Fig. 12. Paints Are Satisfactory Only on the Highest Quality Walls.

This is wall panel No. 76, a high quality wall containing 77.2 percent sand on which lead-oil paint has been satisfactory. After four and one-half years the first coat of paint showed a trace of checking and the wall was repainted.

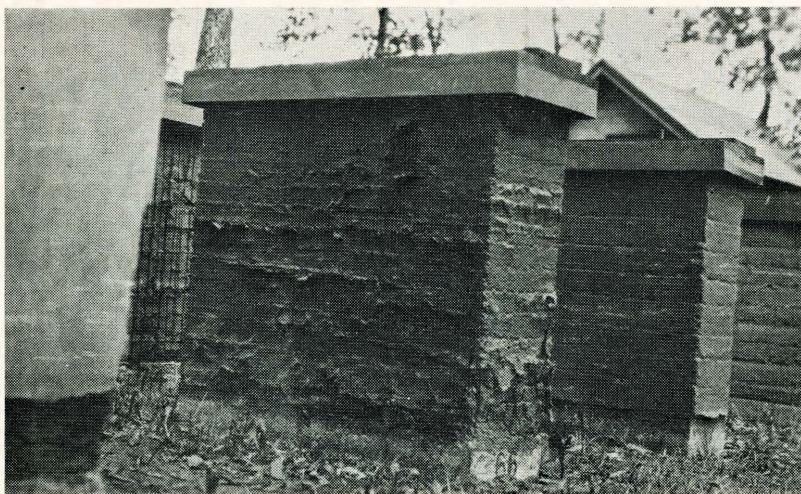
Fig. 13. A Failure of Paint on a Low Quality Wall.

First failure sign appeared May 1, 1934 after 8 months; failed rapidly; total sand content in wall 19.8 percent.

This picture was taken one year after painting. The wall is of very low quality containing only 19.8 percent total sand and 51.5 percent total clay. The poorer the quality of the wall, the sooner the failure of paints on its surface.

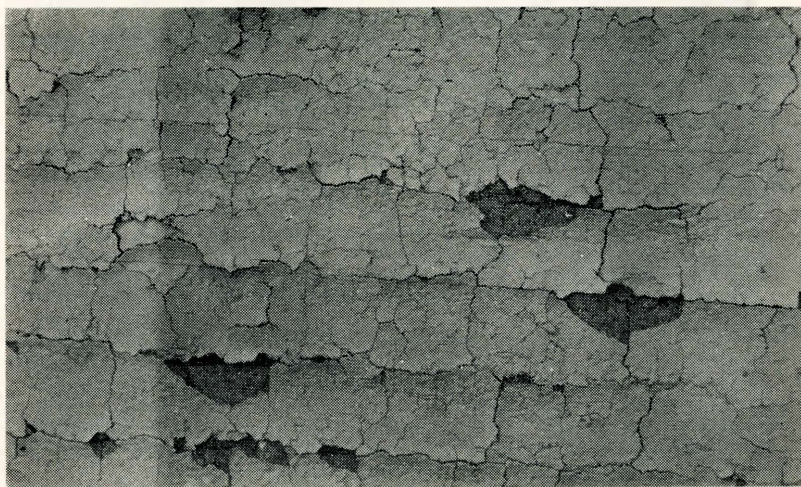
Fig. 14. A Section of the Paint Failure on the Poultry House Shown in Fig. 2.

This paint was applied over linseed oil with a paint spray machine. The reason for the failure was the low quality wall. A paint spray machine is convenient for applying the priming coat for painting. Although brushing the priming coat on is quite satisfactory, it is somewhat tedious.

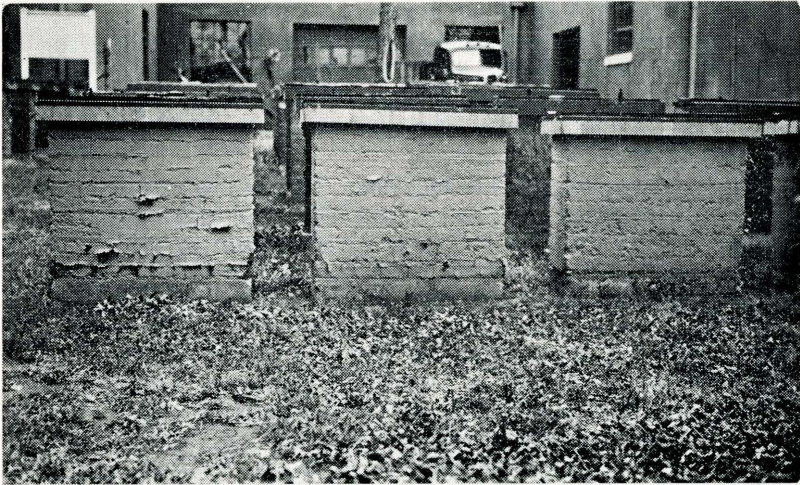
Fig. 16. The Success of Paint Coverings Varies Directly with the Sand Content in the Wall.

In wall panel No. 71 was a total sand content of 35 percent; in wall panel No. 79, 50 percent; in wall panel No. 84, 65 percent; and in wall panel No. 87, 80 percent. These four walls were given a coat of thin paint (2 volumes of standard paint to 1 volume of linseed oil) on November 25, 1935. A second coat of pale green lead-oil house paint was applied after 18 days. The weather was cool but above freezing, except at night, when they were protected with a tent. These panels were observed closely.

First failure signs appeared in these panels at the following intervals: panel 71 containing 35 percent sand, after 1 year and 7 months; panel

This picture was taken in November, 1939, just four years after the walls were painted. Wall No. 71 at the left has a sand content of 35 percent. Wall No. 79 in the center has a sand content of 50 percent. Wall No. 84 at the right has a sand content of 65 percent. Wall No. 87 with the end barely showing in the picture has a sand content of 80 percent.

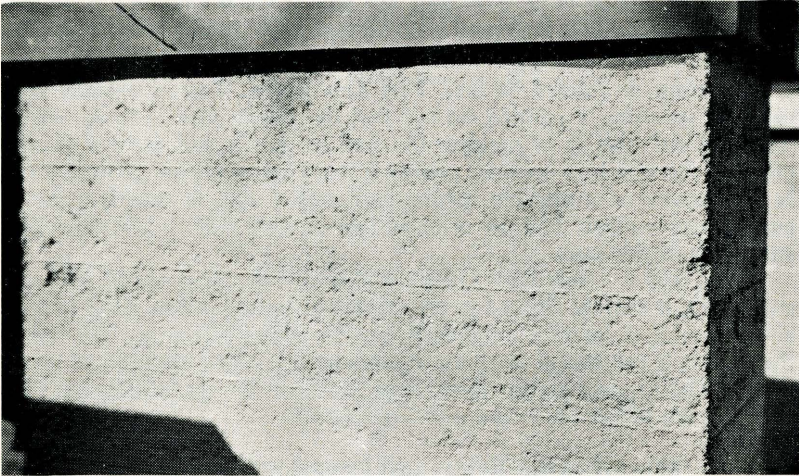
Fig. 17. An Admixture of Sand to the Soil Made This Wall Satisfactory for Painting.

This wall panel No. 70 had a coat of white lead-oil paint well brushed out over a priming coat of linseed oil just seven years ago. This is the best panel of the study. There is no check in the paint as yet. The wall has a sand content of 83.8 percent.

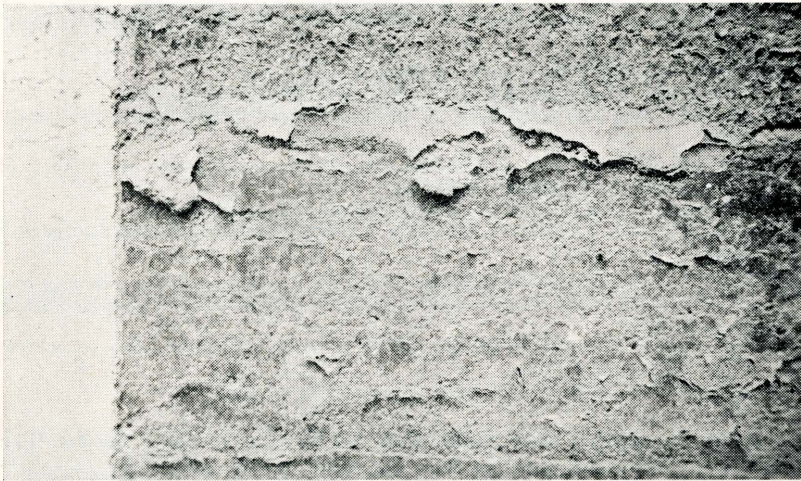
Fig. 19. A Typical Failure of a Transparent Paint.

This is a close-up of panel No. 103T, a transparent paint. No successful transparent covering has been found to date, and most of the transparent paints damage the wall surface severely. Stucco is the only covering that will correct a wall surface that has been damaged as shown here.

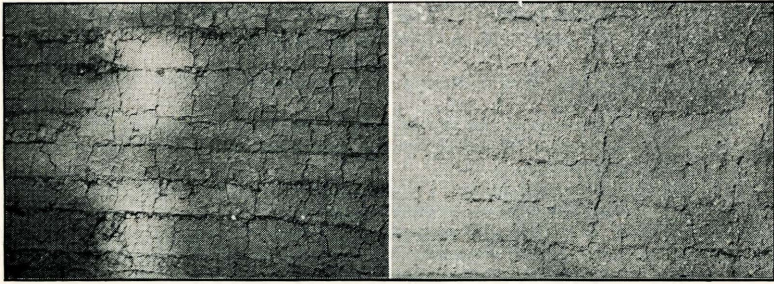
Fig. 21. Showing An Average Soil As It Is Improved By A Sand Admixture.

The wall at the left is not better than average soil with a sand content of 27.9 percent. The wall to the right is made from the same soil with sand added to bring the total sand content up to 59.6 percent. This increases the quality of the soil. If still more sand were added, bringing the total up to 75 to 80 percent, this wall might be painted successfully. If the soil is right, it might stand successfully as a bare earth wall.

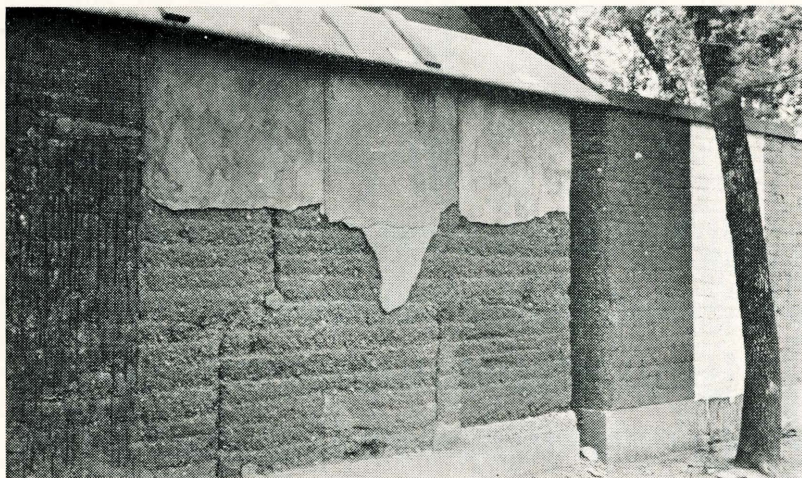
Fig. 21. Plaster Panels Applied Without Any Bond.

Plasters did not prove satisfactory on rammed earth walls without some method of bonding. These panels were intact for more than two years but failed completely, as shown.
