# The Fall and Rise of “Owl”

Robert Oddy

To my knowledge, only one of my windows, Owl, has suffered a really devastating accident. Owl is a 22" x 39" residential stained glass window (figure 1) that I made in 1988, three years after I began working in this medium. However soundly we construct our stained glass artwork, we cannot avoid the simple fact that glass is a fragile medium. Like Humpty Dumpty, Owl did not respond well to falling a few feet to the floor. The window's owner had moved house and taken the window with him. It was temporarily displayed on a window sill in the new home, awaiting a decision on where to re-install it, when a draft caught it and tipped it onto the floor. Fortunately, the distressed owner called me instead of depending on all the king's horses and all the king's men!

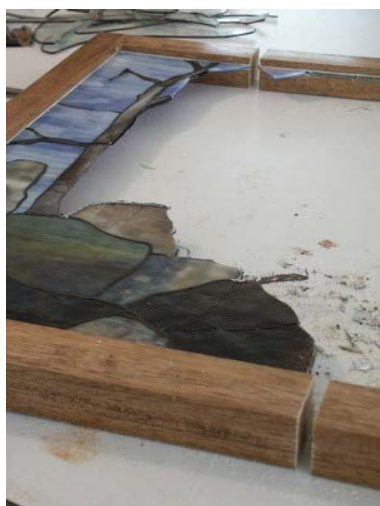
Figure 4: Old frame cut into pieces

The first task was to remove the glass from the frame. The old frame was made to fit the window opening in the original site and would not be needed for the new installation in a light box. The easiest way to remove glass that I wished to salvage was to cut up the frame (figures 4 & 5). I then separated the owl from most of the surrounding glass.

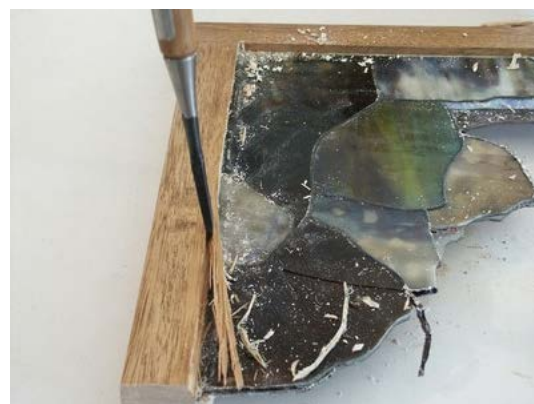
Figure 5: Wood removed to release glass

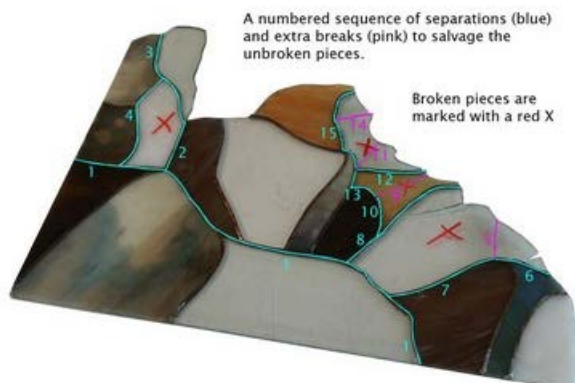
Figure 6: Separation lines for a damaged section

Sometimes I first separated undamaged pieces, and sometimes I made extra breaks in already cracked pieces to make the separation easier (figure 6).

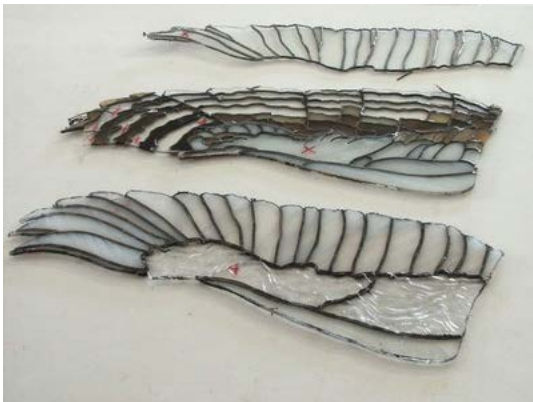
Figure 10: Three layers of a wing separated

Working this way all around the plated section, eventually the layers came apart (figure 10). More important than skill is patience!

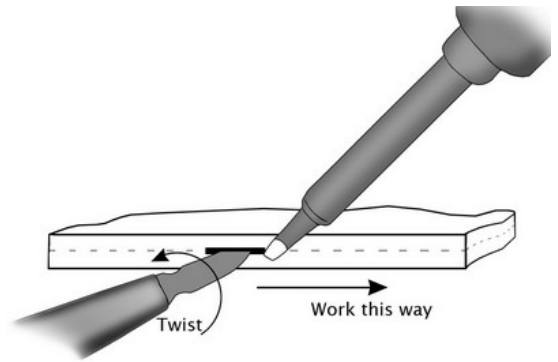
Figure 9: Prizing plated layers apart

This meant that the glass layers were not interlocked where the wings met the body, and the solder joining them did not penetrate beyond the surface. I examined the sections carefully for cracks, to determine which plates would need to be separated (figure 8). In this case, they all needed to be separated. I melted off as much as possible of the old solder from the edges of the plated section (holding the section vertically), then looked for a place where I could insert a thin blade between the layers as a wedge. Gently twisting the blade to provide outward pressure, I melted the solder close to the blade to widen and lengthen the gap (figure 9).

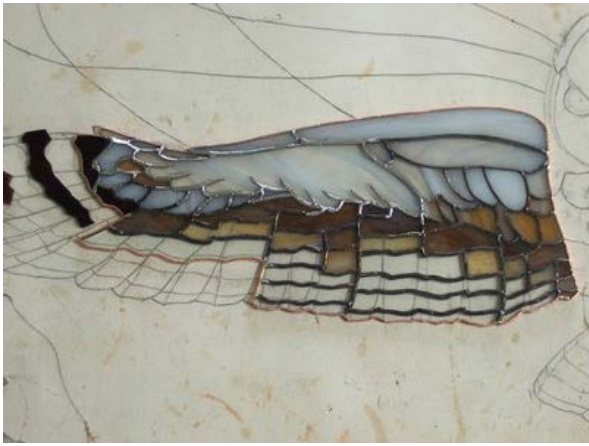
Figure 12: Parts salvaged from the middle layer of wing

When the undamaged parts were separated from the broken pieces, the old copper foil was scraped away from the edges with a knife. Then the edges were thoroughly cleaned, the old adhesive was removed, and the pieces were refoiled (figures 11 & 12).

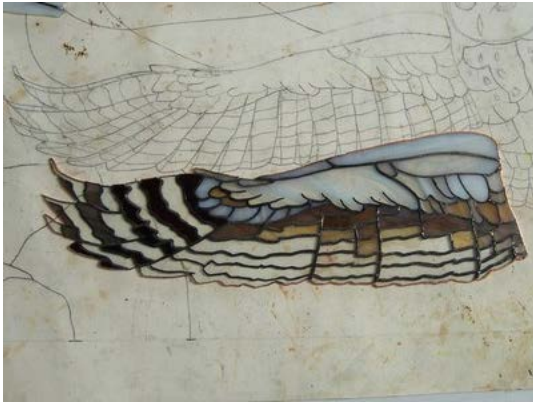
Figure 14: Rebuilt middle layer of wing

I began with the middle of the three layers in the wing (figure 14). This is the most intricate and has all the color. I made new pieces to fit with the old and soldered them together.

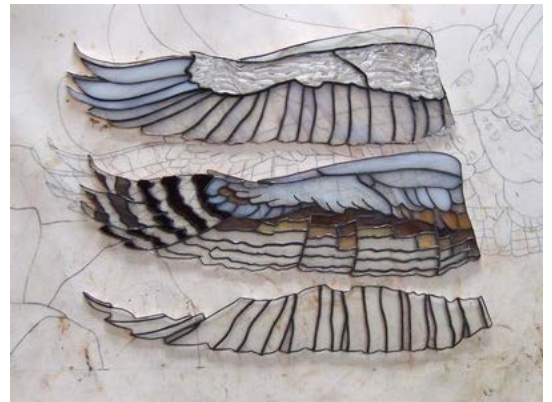
Figure 15: Rebuilt three layers of wing

The other two layers were rebuilt in the same way, with additional care given to making sure that they matched the middle layer closely (figure 15). (This was one aspect of the work

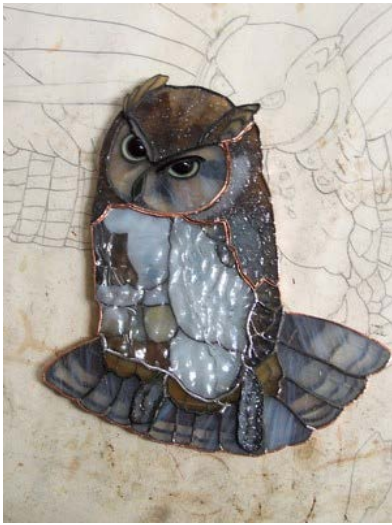
Figure 16: Rebuilding head and body

where my performance has improved over the years!) Each layer was finished, patina'd and cleaned thoroughly, and the three were joined together by tacking around the edges. Finally the wings were attached to the body (figure 16), thus completing the bird (figure 17).

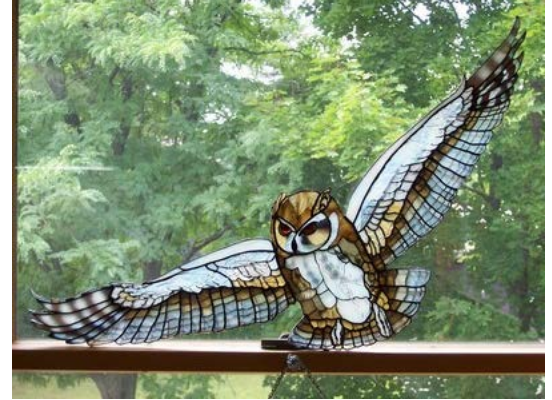
Figure 17: Owl rebuilt

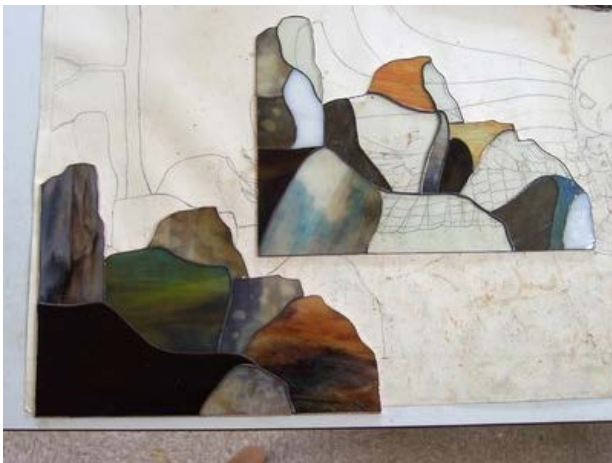
Figure 18: Rocks rebuilt with two layers yet to be joined

The rocks in the lower left corner are made in two layers of glass to give the impression of 3-dimensionality by shading. Some of the glass in the second layer is plain window glass where I did not wish to change the appearance of the front layer glass (figure 18). Several pieces needed to be replaced, and since I could not find exact matches for all of these pieces, the new rocks look slightly different from the original ones. As the original artist I felt free to do this!

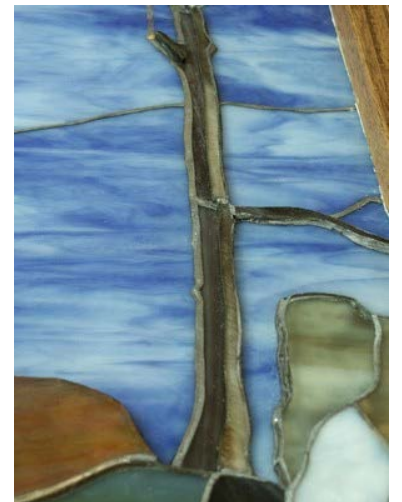
Figure 19: Tree, reverse side, before repair showing plated shading

produced by adding a thin strip of light brown glass along the back (figure 19). In the repair, I decided that I could get the same effect more simply by putting a copper foil overlay on the reverse

side of the tree trunk and branches.

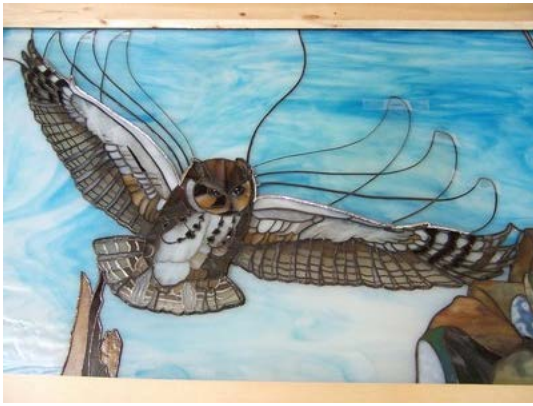
Figure 20: Reverse side of the panel showing phantom wings

The phantom wings are made in plain window glass. These had to be completely rebuilt. They were soldered along the reverse side of the tops of the real wings. The wing tips are glued to the back of the sky glass with tiny dabs of two-part epoxy adhesive. Notice that the copper foil lines get narrower as you go further away from the real wings (figure 20).

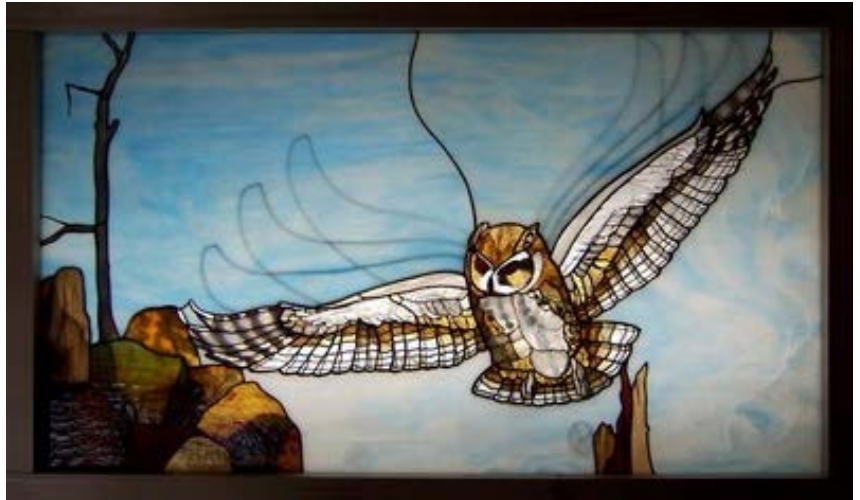
Figure 21: The restored Owl window

joined them together. In the repair, the line from the owl's tuft to the top of the panel was necessary, because the glass sheets were not wide enough in the direction of the streaks to reach from tree to right wing tip (figure 21).
