MLM-1180
M-3679 (32nd Ed.)
C-92a, Isotopic
SNAP Program

DESTRUCTIVE EXAMINATION OF A SNAP HEAT SOURCE

Date: November 25, 1963

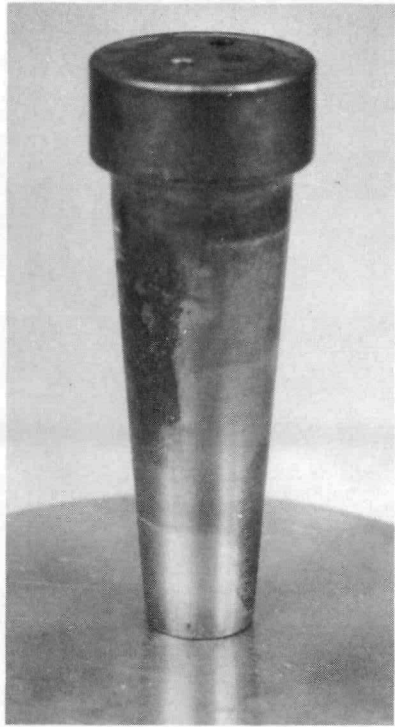
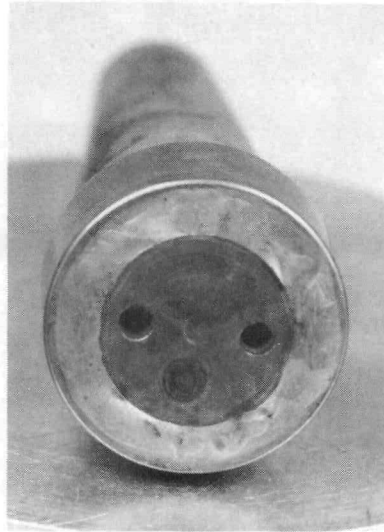
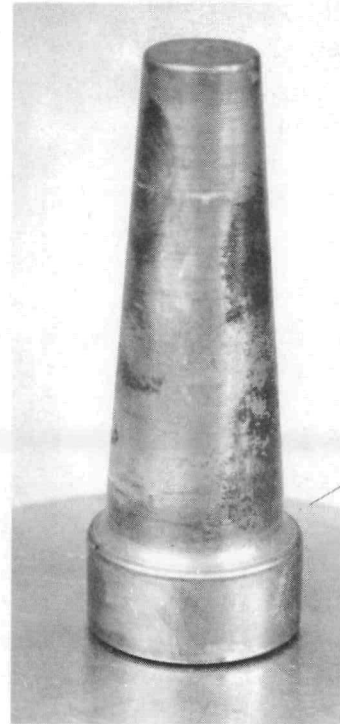
Figure 1

The external appearance of the source indicated that it was not subjected to any physical abuse during use. Slight stains on the tapered surface, shown in Figure 1, were found which were carbonaceous residues left by gloves and other materials used in handling the source during examination. The tool marks on the surface of the specimen are clearly visible and well defined. This indicated that no significant amount of oxidation took place on the outer container during use.

SNAP 3 Heat Source as Returned in May, 1963

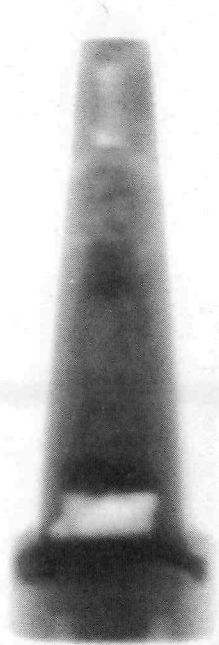
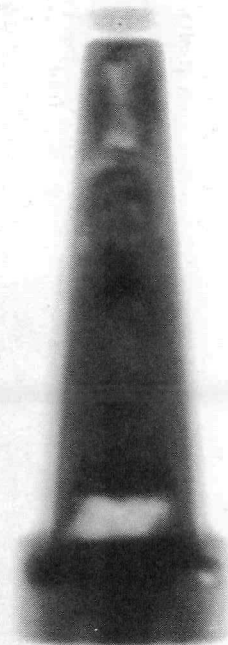
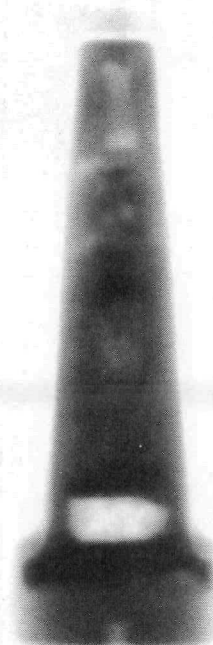
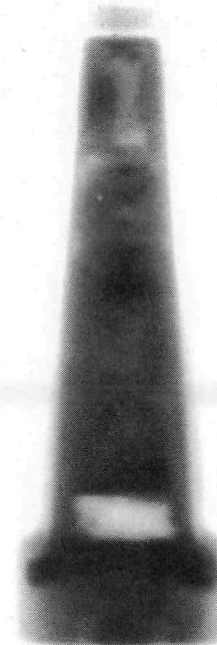
Figure 2

Four radiographs were taken at 45° intervals around the longitudinal axis and are shown in Figure 2. The radiographs show that at some time after fabrication the plutonium, which was originally inserted as four individual precast slugs, had melted. The radiographs suggest that the space between the tantalum inner lid and the outer Haynes Alloy 25 cap became filled with the plutonium metal. The figures also indicate a large void in the top of the source just below the tantalum lid.

The radiographs also suggest that the Haynes Alloy 25 reacted with the plutonium. Portions of the sharp inside circular shoulder in the head of the outer container disappeared into a hazy line in the 0°, 45°, and 135° radiographs.

RADIOGRAPHS OF THE SNAP 3 HEAT SOURCE AT VARIOUS RELATIVE POSITIONS AROUND THE LONGITUDINAL AXIS OF THE SOURCE

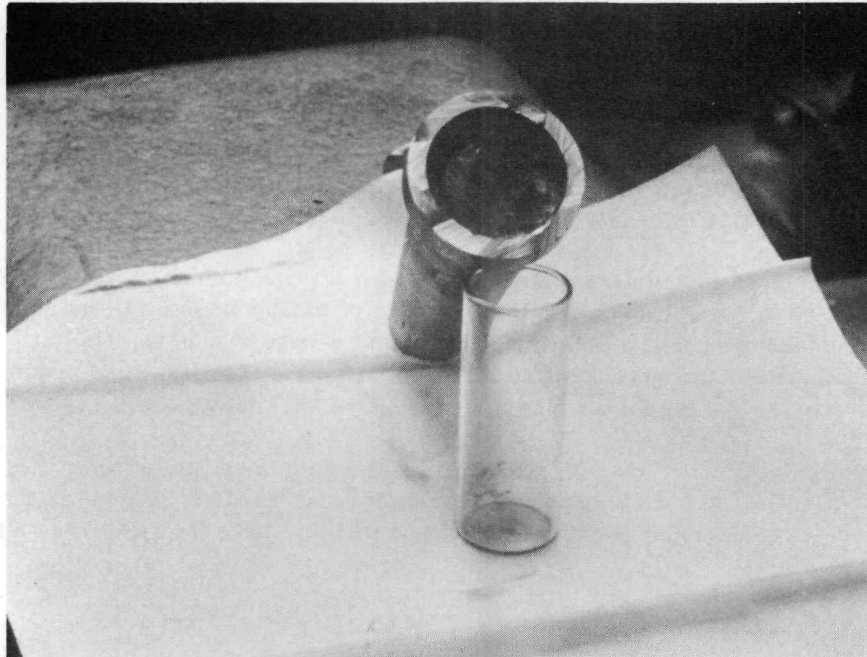
a. Note corrosion inside outer container

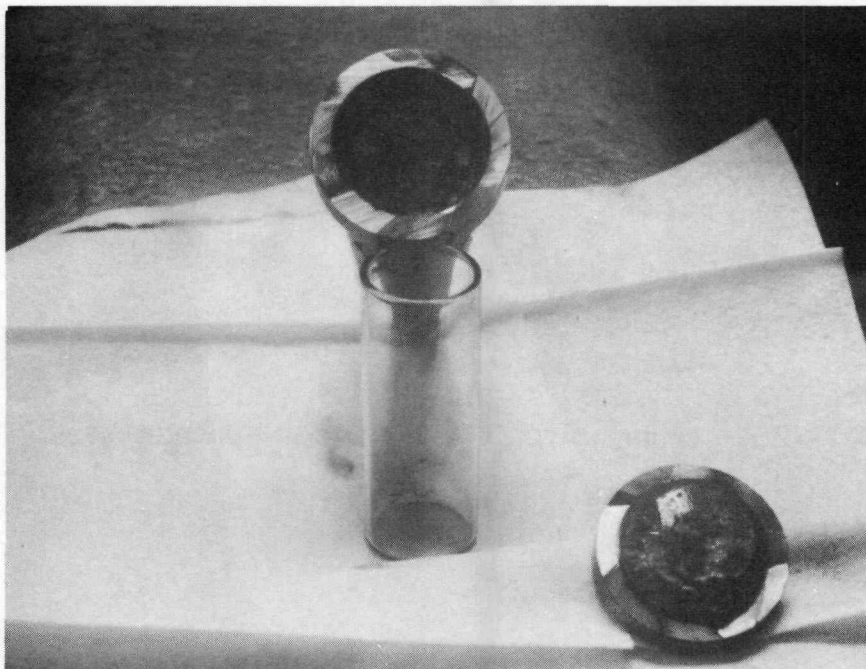
b. Note corrosion of outer container cap

All of the cap was not wetted by the plutonium, and hence the cap was not corroded over the entire surface. The source had to be removed from the pressure measuring device to remove the cap, to examine the cap and contents, and to take the desired photographs. After returning the source to the pressure device, it was noted that gas was slowly leaking out. As will be discussed later, a discrepancy exists between the measured and calculated helium accumulation which was caused from this operation. After returning the source to the measuring device, the pressure increased from three to 193 torr in 110.5 cc, equivalent to 25.5 cc (STP) of gas.

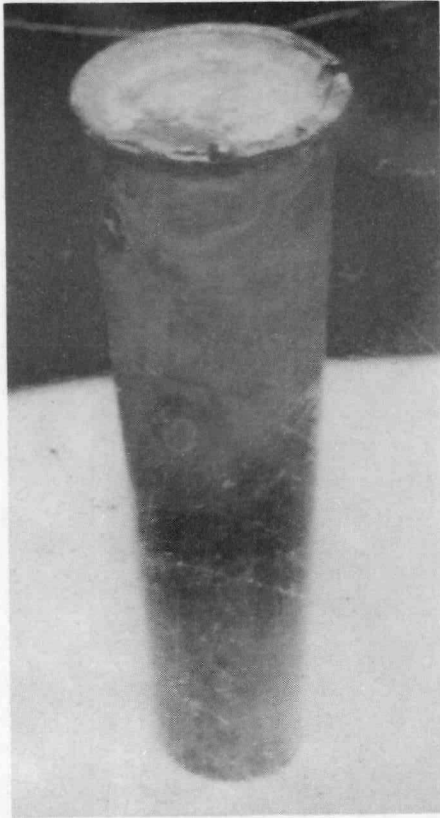
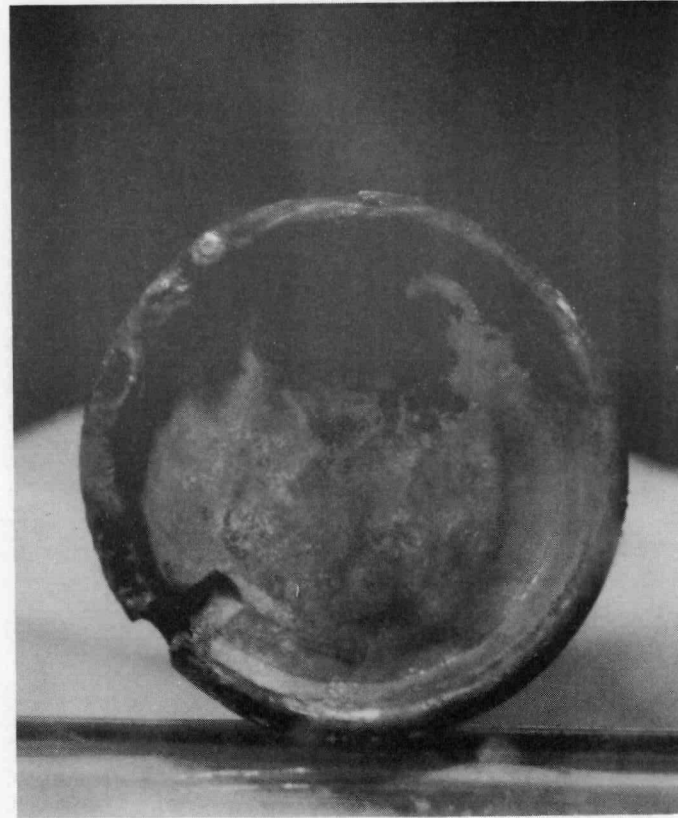
Figure 5

As expected, the first solution contained significant amounts of the constituents of Haynes Alloy 25*. The fact that only a trace amount of tantalum was found indicates that the closure weld on the tantalum container was poor, and that corrosion was not the primary cause of failure of the weld.

The failure of the tantalum weld can be seen quite clearly in Figure 5. Half of the weld was in good condition. The plutonium metal penetrated the weld in several places without lifting the cap. Figure 6 shows the extent of corrosion to the Haynes Alloy 25 container.

TANTALUM LINER OF SNAP 3 HEAT SOURCE
(NOTE BAD WELD ON HALF OF CIRCUMFERENCE OF CAP)

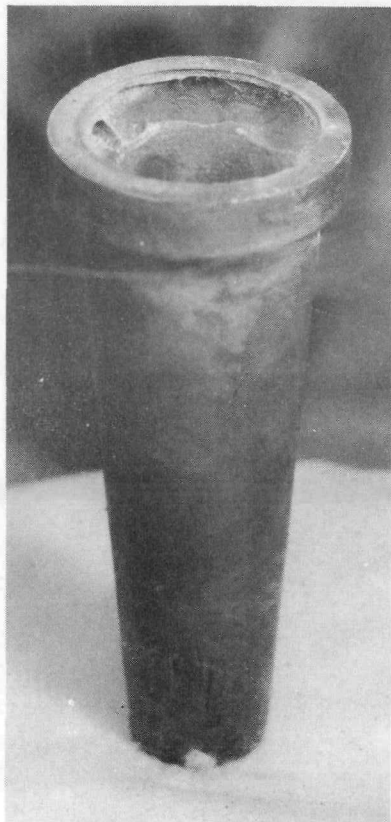
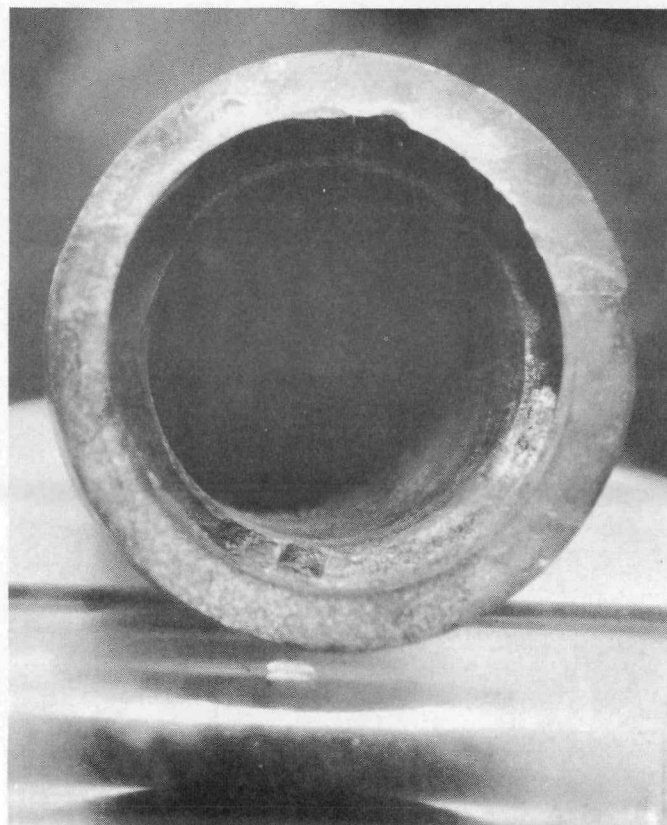
Figure 6

HAYNES ALLOY 25 OUTER CONTAINER OF SNAP 3 SOURCE
(NOTE CORROSION ON INSIDE OF CONTAINER)

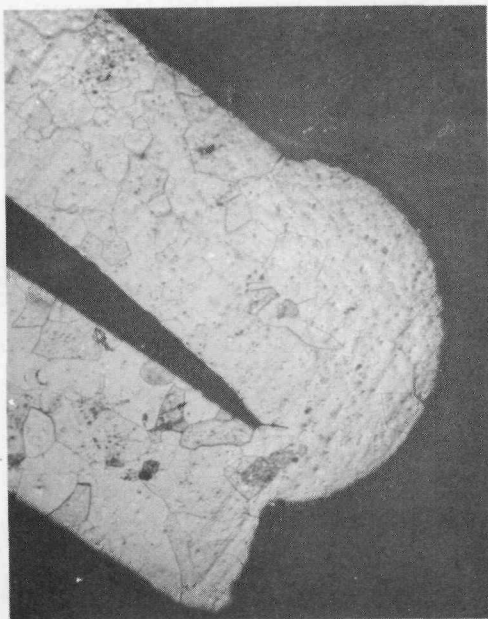
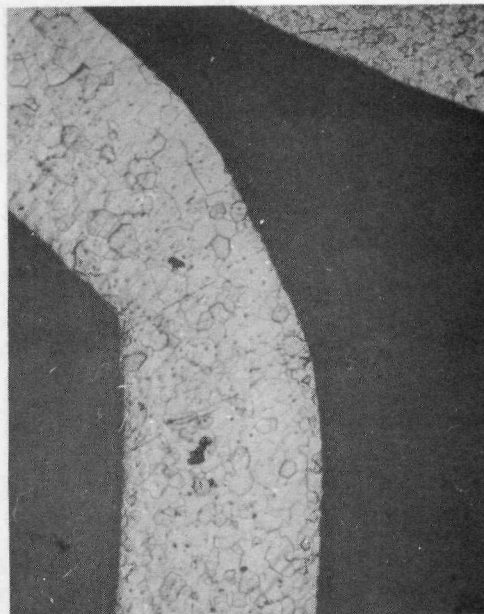
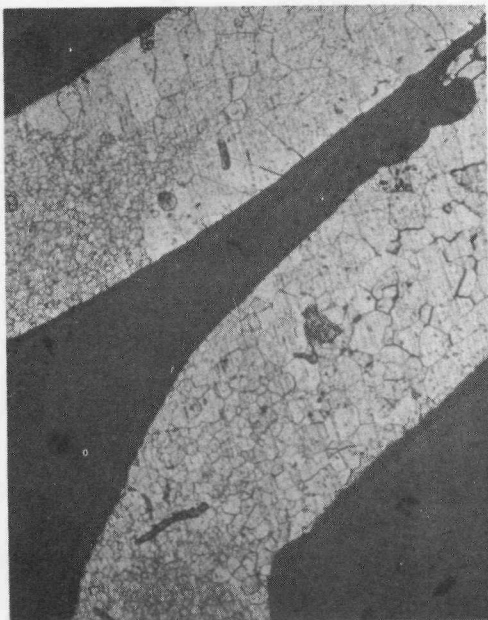
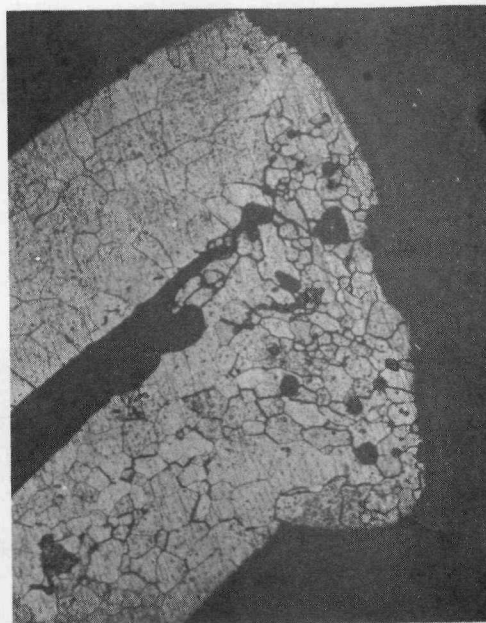
Figure 7

Metallographic sections were taken of various parts of the tantalum and Haynes Alloy 25 containers. These sections were polished, etched, and photographed, as shown in Figures 7 and 8. Inspection of these photographs confirm the poor quality of the weld in the tantalum container. Figure 7A is a photograph of the sound

MICROMETALLOGRAPHS OF WELD ON TANTALUM
LINER OF THE SNAP 3 SOURCE

portion of the weld. Here the weld penetration is only 0.010 inch. Figure 7B shows the tantalum wall and inside cap surfaces where no corrosion is evident. Figures 7C and 7D are two views of the same weld area which show evidence that there was plutonium in the vicinity of the tantalum lip prior to welding. The plutonium inclusions in the weld were responsible for the poor quality of the seal. Figures 8A and 8B are photographs of the sound and corroded portions of the Haynes Alloy 25. As mentioned previously, the section shown in Figure 8B was adjacent to the part of the tantalum container where weld failure occurred.

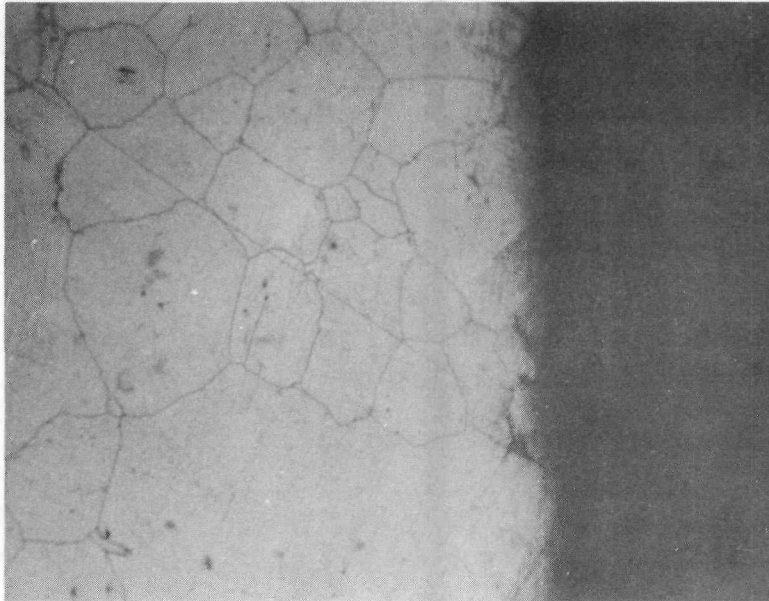
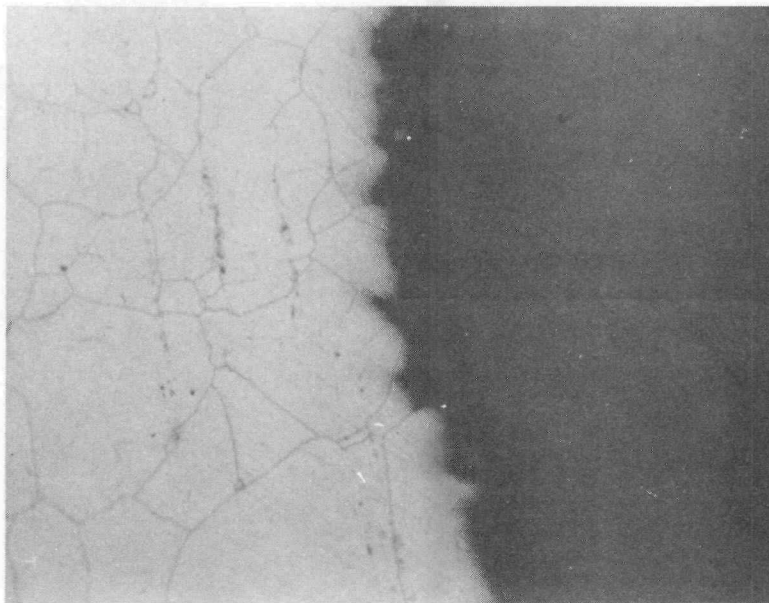
Figure 8

MICROMETALLOGRAPHS OF (a) THE SOUND PORTION AND
(b) THE CORRODED PORTION OF THE HAYNES ALLOY 25 OUTER CONTAINER
