DATE: November 27, 1956

SUBJECT: Summary of Corrosion Sample Data for HRT Mockup Operational, Period Ending July 28, 1956.

#### SUMMARY OF CORROSION SAMPLE DATA FOR HET MOCKUP PERIOD ENDING JULY 28, 1956.

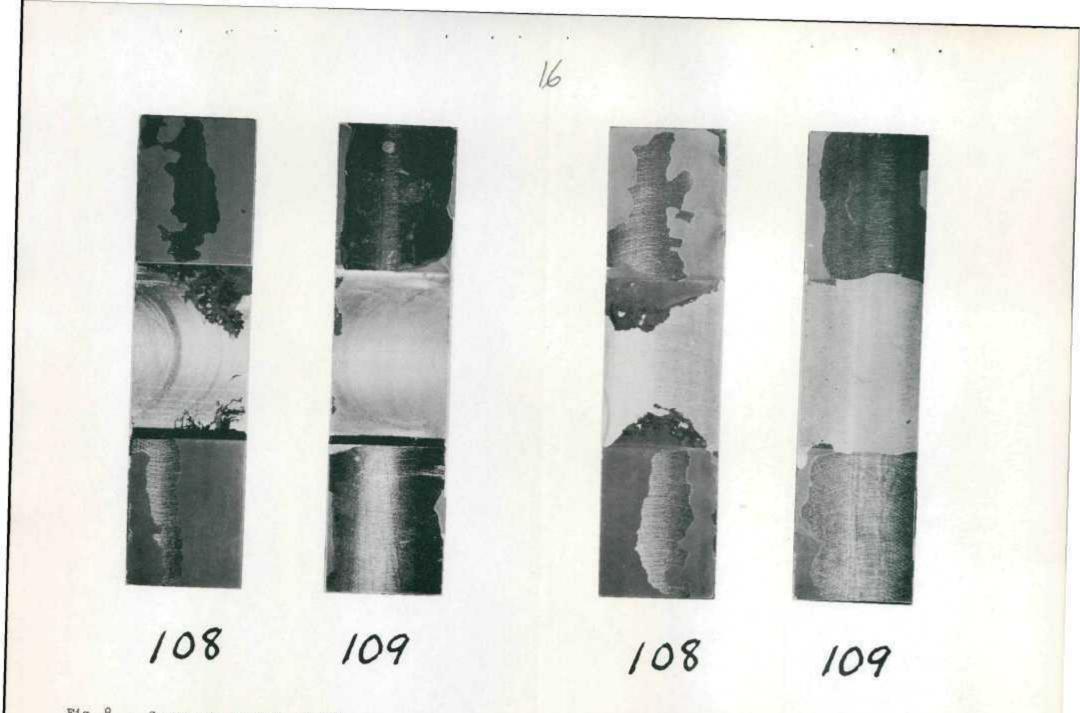
Samp]	le	Coupon Position from Flange End	Sample Areg	Weight Chan	uge,mg/cm <sup>2</sup>	Corrosion Rate, mpy			,		
Form	No.	Туре	of Holder	<u></u> cn <sup>2</sup>	As Removed	Defilmed	Defilmed			Appears	ance	<u></u>
Coupon	<b>H-108</b>	T1-75A	l	20.7	+ 3.90	- 0.12	0.04	Gold	-colored	film.	Patches	of blue.
Coupon	<b>H-10</b> 9	T1-75A	8	20.7	+ 4.07	- 0.23	0.07	Ħ		11	11	<b>H</b> II
Coupon	H-99	Zircaloy-2	2	20,7	+ 8.12	Gain	*	Gray	-black,t:	ightly	adherent	t film.
Coupon	н-100	Zircaloy-2	7	20.7	+10.97	Gain	*	*	6	11	H	41
Coupon	H-102	347 58	3	20.7	+ 6.78	- 0.86	0.15	Rust	-coloređ	scale.	. Unifo	ru attack.
Coupon	H-103	347 88	6	20.7	+ 5.94	- 0.84	0.15	()	Π	ta	2	н
Coupon	H-81	309 SCb	4	20.7	+ 7.85	- 1.08	0.19	Ħ	"		11	PT
Coupon	н-85	309 806	5	20.7	+ 8.73	- 1.05	0.18	Ħ	#1	*	μ	*
Screw	MUA	Ti RC-55		4.3		0.51	0.16					
Screw	MUC	. T1 RC-55		4.3		- 0.88	0.27			-

Fig. 8 - Coupons As Removed. (2.6X)

Fig. 9 - Coupons As Removed. (2.6x)

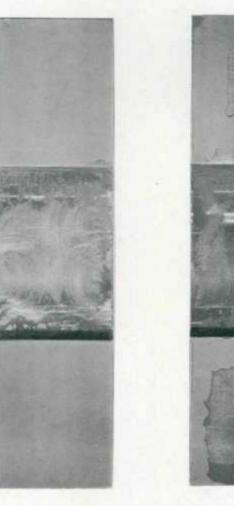
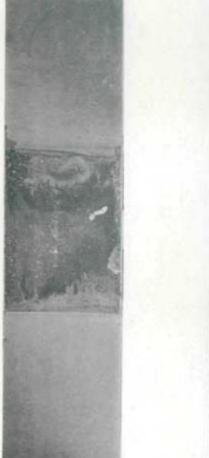
Fig. 10 - Coupons as Removed. (2.6X)

Fig. 11 - Coupons as Removed. (2.6x)

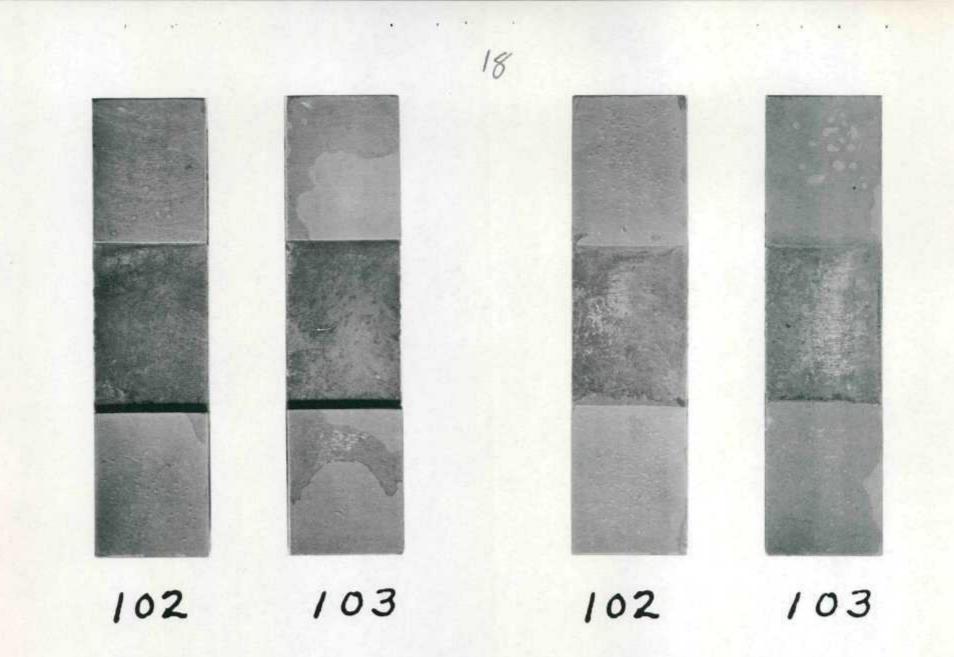
Fig. 13 - Coupons as Removed. (2.6X)

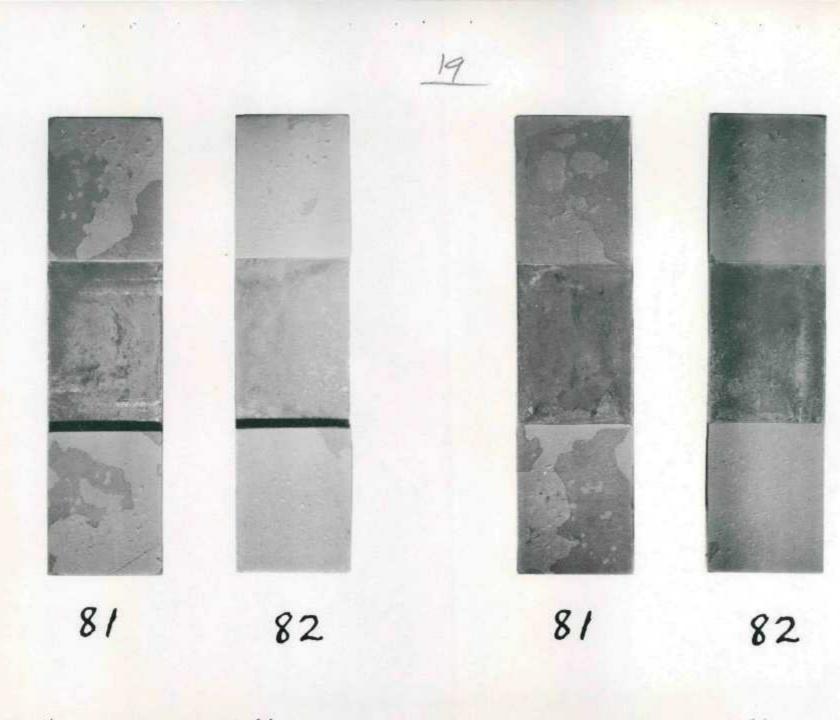
Fig. 14 - Coupons as Removed (2.6X)

Fig. 15 - Coupons as Removed. (2.6X)

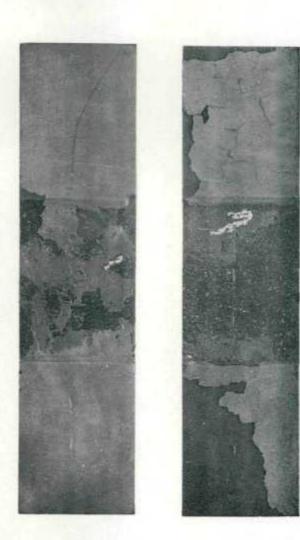
H99 H100

Fig. 18 - Coupons Partially Defilmed. (2.5X) Fig. 19 - Coupons Partially Defilmed. (2.5X)

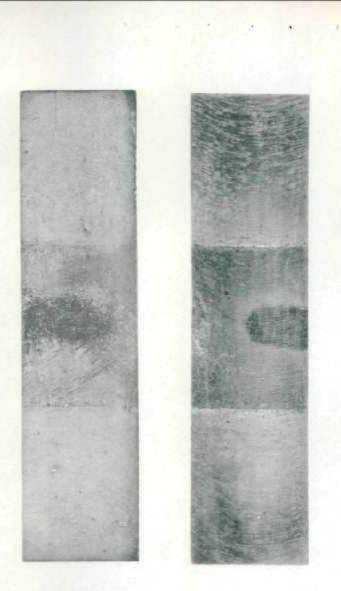
H102 H103

Fig. 20 Coupons Defilmed. (2.5X)

Fig. 21 Coupons Defilmed. (2.5X).

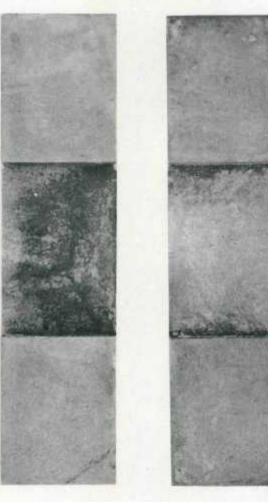
H81 H82

Fig. 22 Coupons Defilmed. (2.5X)

Fig. 23 - Coupons Defilmed. (2.5X)

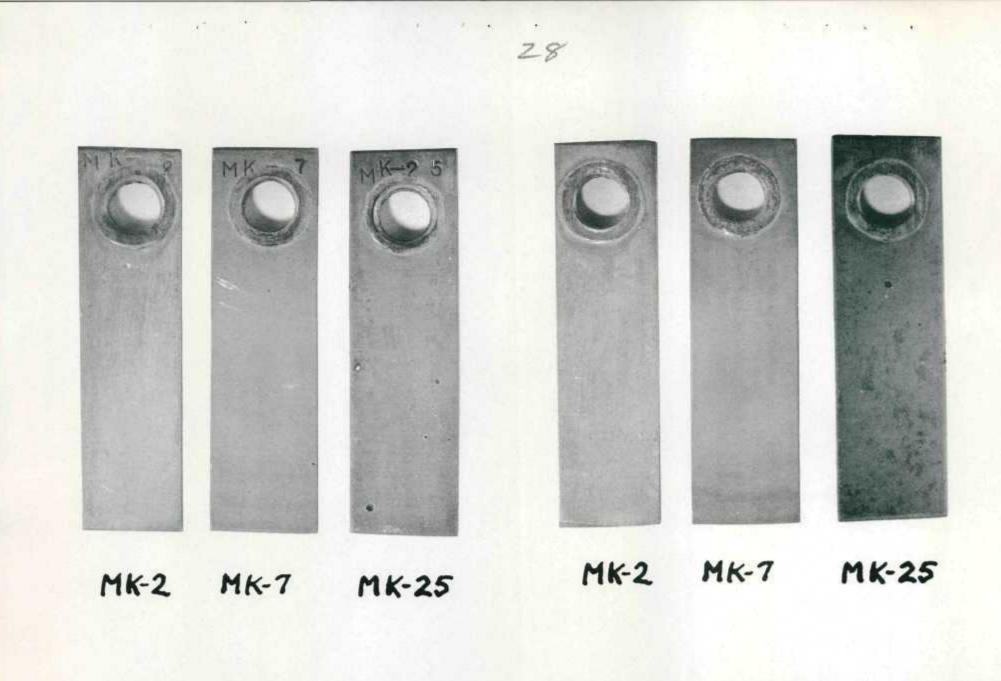
Fig. 33 Coupons as Removed. (2.3X)

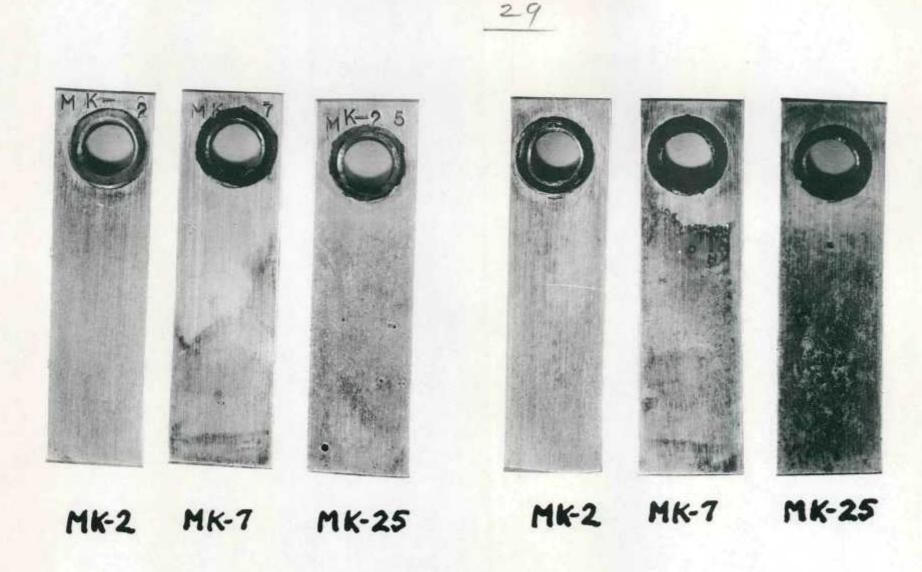
Coupon No.	Position <sup>#</sup> from Top of Pressurizer	Weight Chang As Removed	ge, mg/cm <sup>2</sup> Defilmed	Corrosion <u>Rate, mpy</u> Defilmed	Appearance
MK-20	1	+0.04	-0.24	0.04	Dark gray stain. Moderate pit attack near drilled hole where fastened.
MK-2	2	+0.07	-0.45	0.08	Dark gray stain. Few pits. Heavy attack at drilled hole where fastened.
MK-21	3	+0.04	-0.25	0.04	Dark gray stain. Moderate pit attack near drilled hole where fastened.
МК-4	4	+0.06	-0.25	0.04	Dark gray stain. Few pits. Heavy attack at drilled hole where fastened.
MK-22	5	-0.01	-0.35	0.06	Dark gray stain. Moderate pit attack near drilled hole where fastened.
MK-23	6	-0.16	-0.95	0.17	Dark gray stain. Heavy pit attack over-all.
MK-7	7	+0.37	-0.62	0,11	Dark gray stain. Few pits. Heavy attack at drilled hole where fastened.
MK-24	8	+0.33	-0.35	0.06	Bark gray stain. Moderate pit attack over-all.
MK-25	9	+2.33	-1.38	0.24	Dark gray stain. Heavy pit attack over-all. Few large deep pits. Cracks on ends and edges.

Fig. 35 Coupons Defilmed. (2.3X)

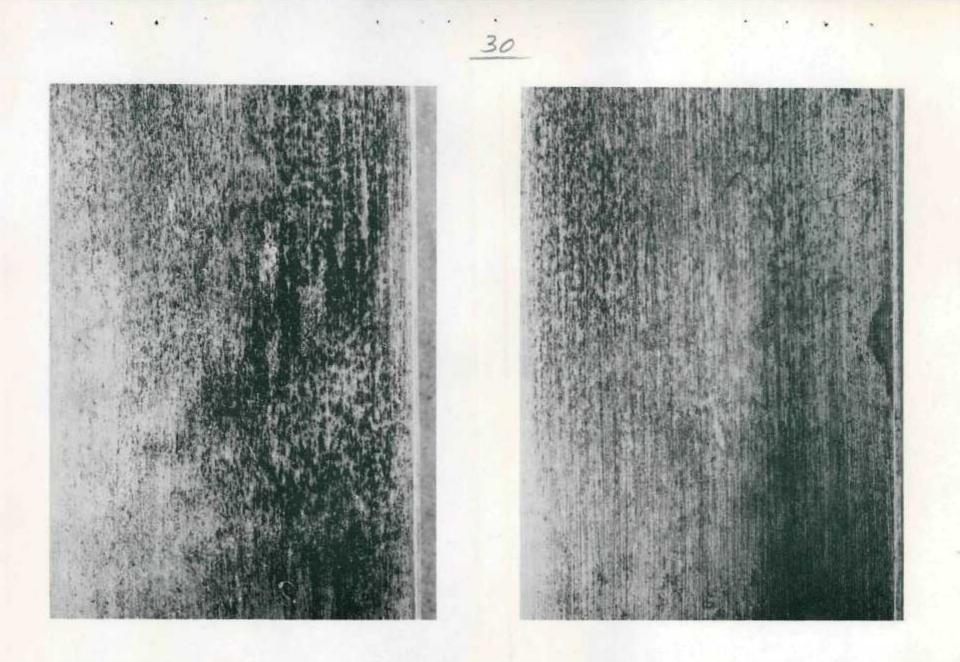
Plate-1670-1 Plate-1670-2

Fig. 36 Coupon MK-20 Defilmed. (10X) Fig. 37 - Coupon MK-20 Defilmed. (10X)

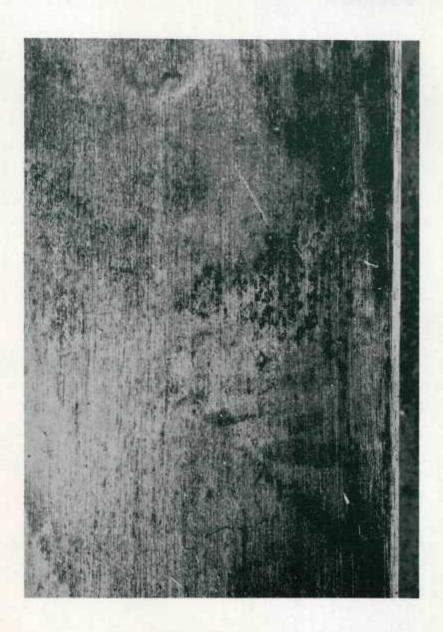
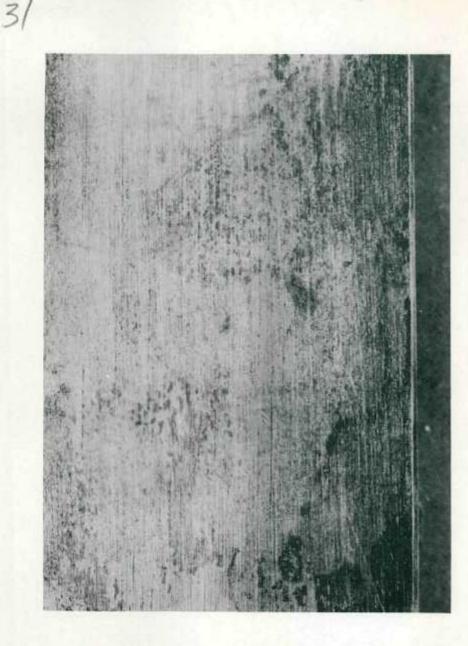
Plate-1671-1 Plate-1671-2

Fig. 38 - Coupon MK-23 Defilmed. (10X)

Fig. 39 - Coupon MK-23 Defilmed. (10X)

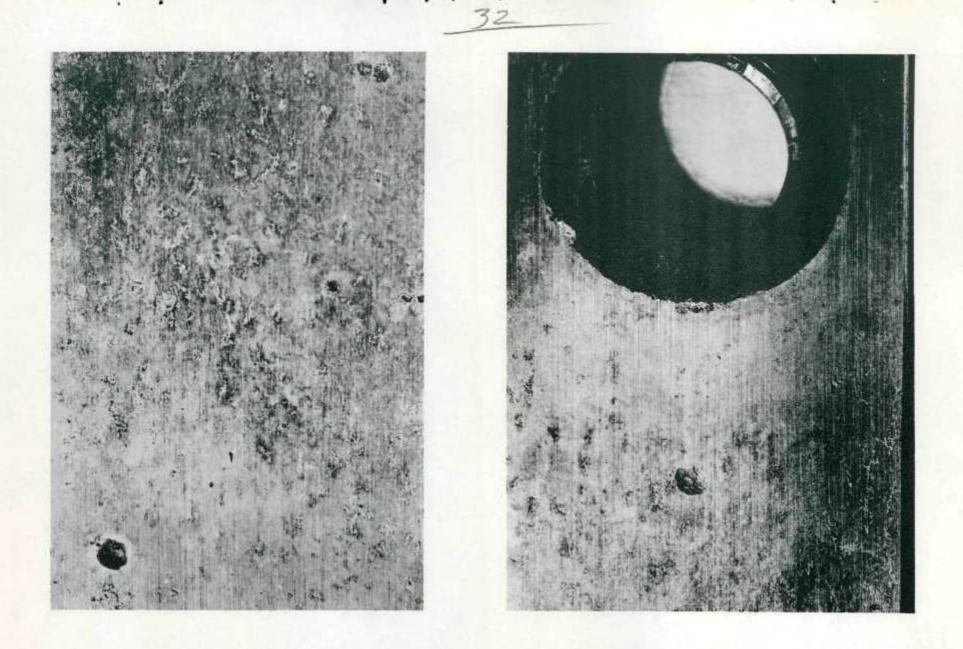
Plate-1672-1 Plate-1672-2

Photographs of the sample holders as removed, as well as photographs of the individual coupons both before and after defilming, are shown in the accompanying photographs. Figures 1 through 4 show the holder in the circulating line as removed. Figures 5 through 7 show the bottom half of the pressurizer leg holder as removed. The large deposit of solids on the bottom of the holder and bottom coupon are easily seen. Figures 8 through 15 show the top and bottom of the circulating line samples as removed. Figures 16 through 31 show all surfaces of these coupons after defilming. Figures 32 through 35 show the pressurizer leg coupons after defilming. Figures 36 through 41 are enlarged views of the pressurizer leg coupons, showing the localized attack which occurred.

Fig. 40 - Coupon MK-25 Defilmed. (10X)

Fig. 41 - Coupon MK-25 Defilmed. (LOX)
