### ASSESSMENT OF EXTENT AND DEGREE OF THERMAL DAMAGE TO POLYMERIC MATERIALS IN THE THREE MILE ISLAND UNIT 2 REACTOR BUILDING

N. J. Alvares

Published February 1984

Lawrence Livermore National Laboratory  
Livermore, California

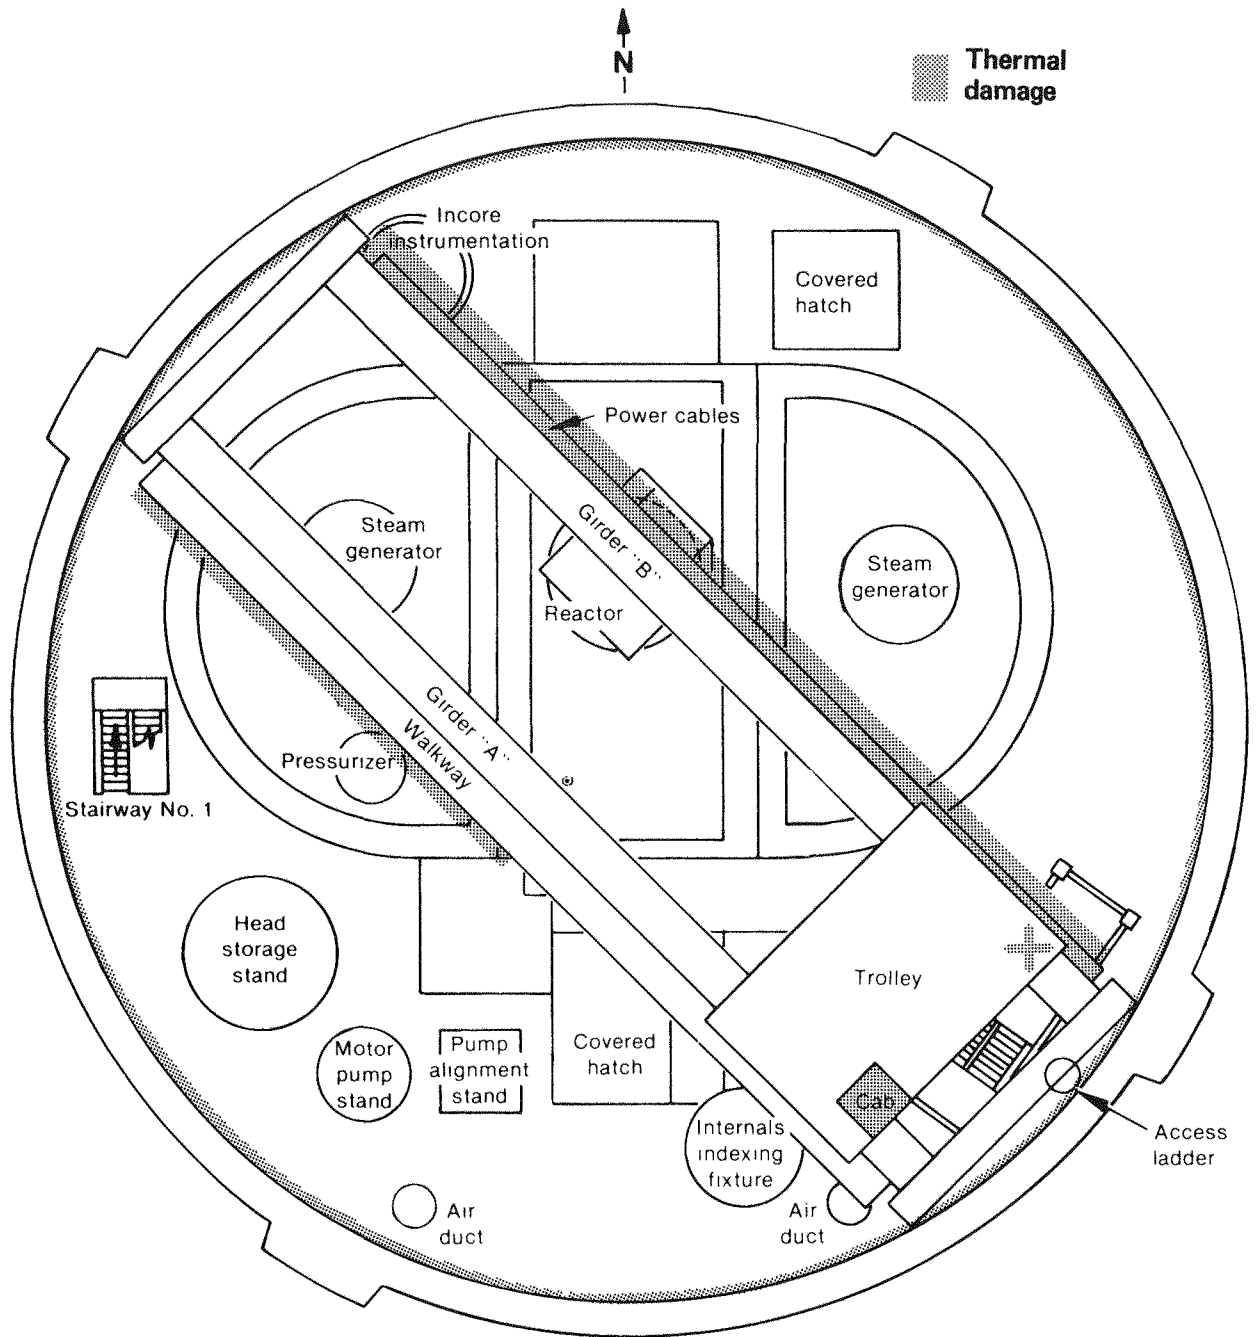
Figure 2. Thermal damage on the 347-ft level (with polar crane superimposed).

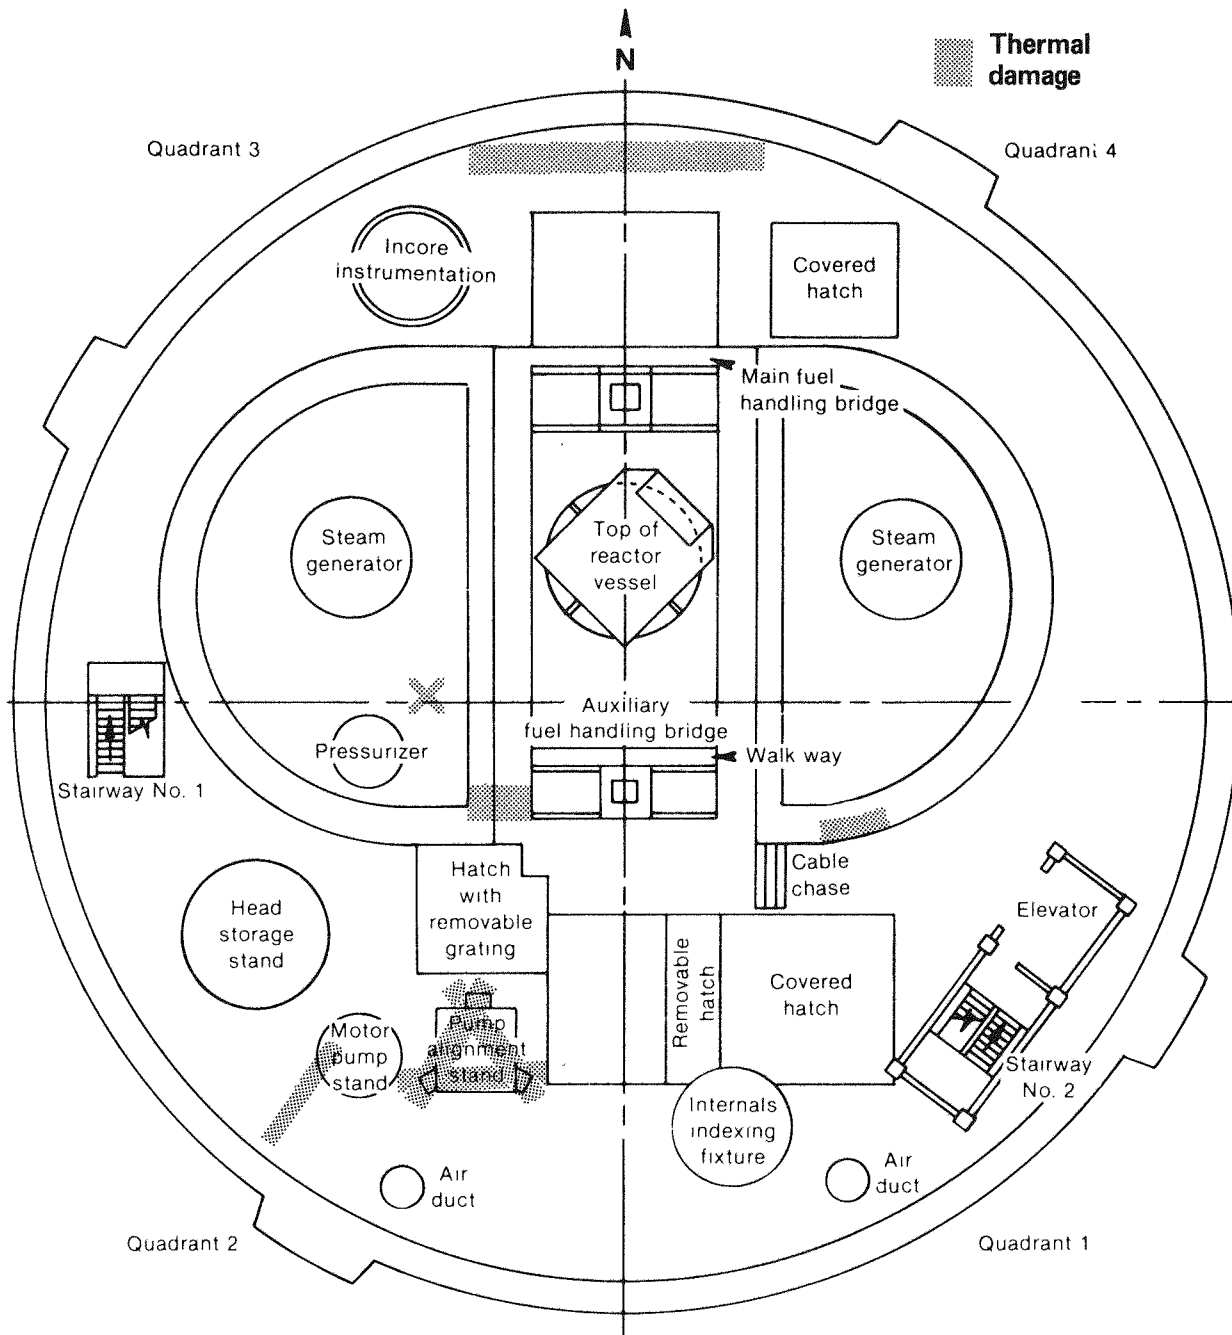
Figure 3. Thermal damage in the same plane as the D-rings.

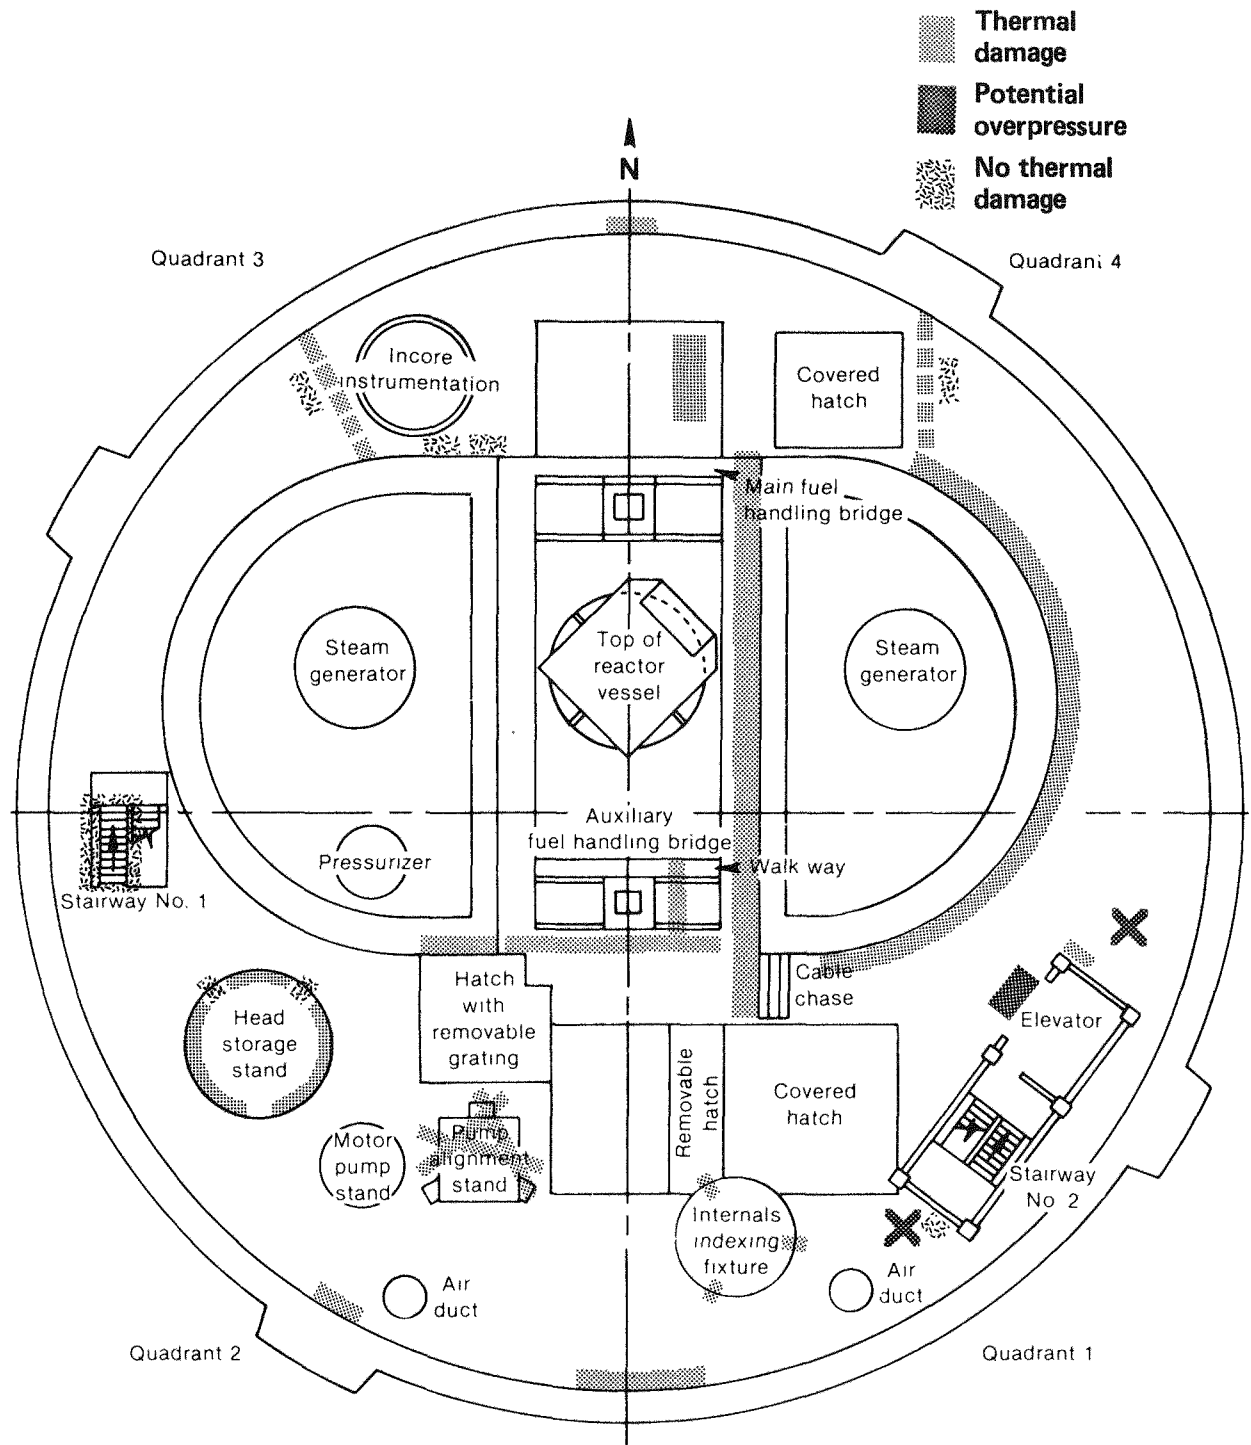
Figure 4. Thermal damage and potential overpressure on the 347-ft level.

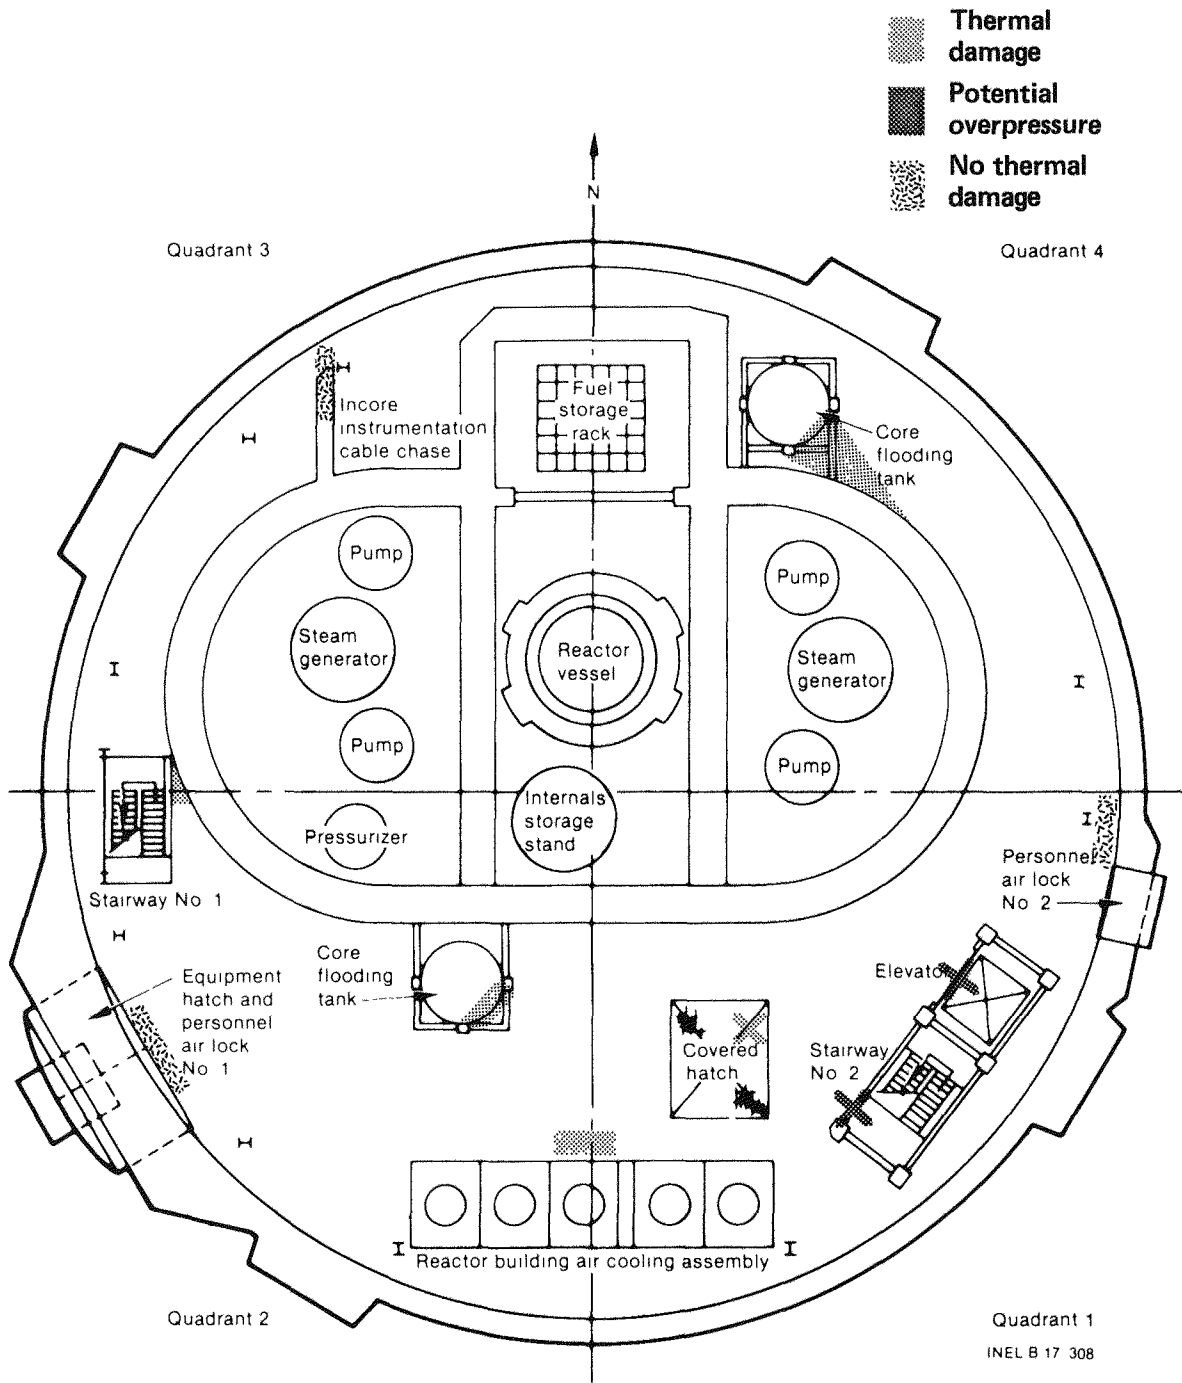
Figure 5. Thermal damage and potential overpressure on the 305-ft level.

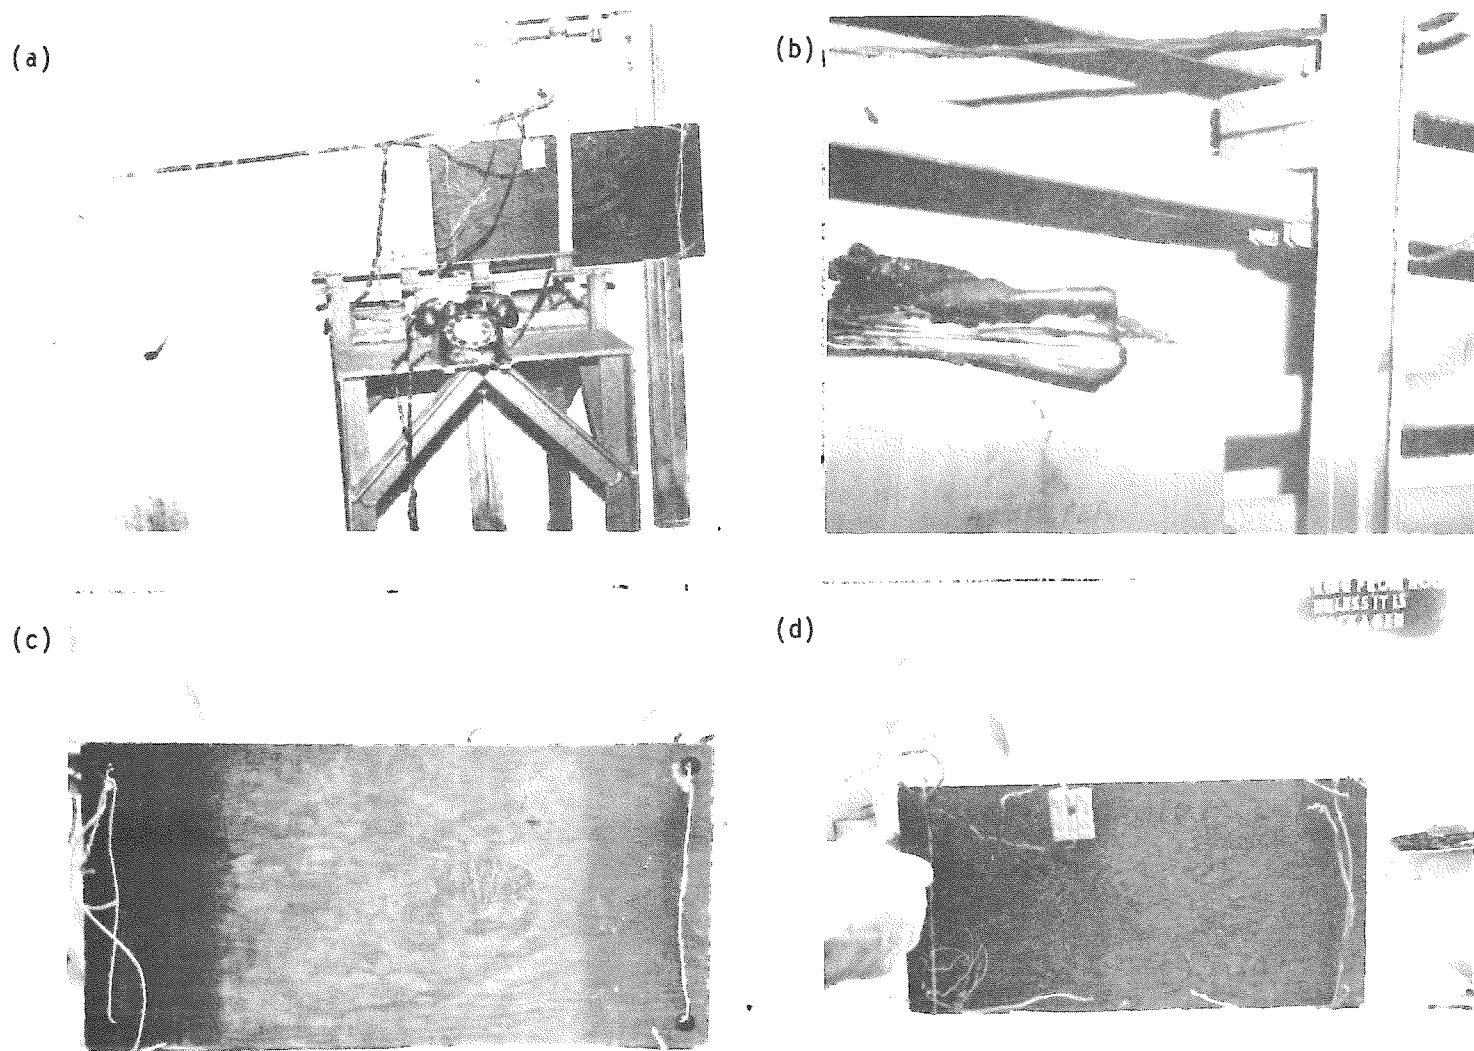
Figure 6 shows photographs of plywood on the reactor building south wall and remains of an instruction or maintenance manual located on the reactor building north wall, both ignited by fire propagation through the seismic gap. Note in Fig. 6a that wires along the wall also exhibit burn trauma. Figures 6c and 6d show the front and rear surface of the plywood panel after it was extracted from the reactor building. Both sides are charred, as are edges and holes through which wire ties penetrate. Surface char condition indicates that the panel ignited to flaming combustion for a short period before self-extinguishing or being quenched by the reactor spray system.

8. The total burn pattern of the plywood board back for the south-wall telephone on the 347-ft level indicates flame propagation through the seismic gap.

Figure 6. Hydrogen-burned in-containment materials: (a) Bell telephone. (b) Charred manual on electrical box. (c) Back of plywood panel. (d) Front of plywood panel.

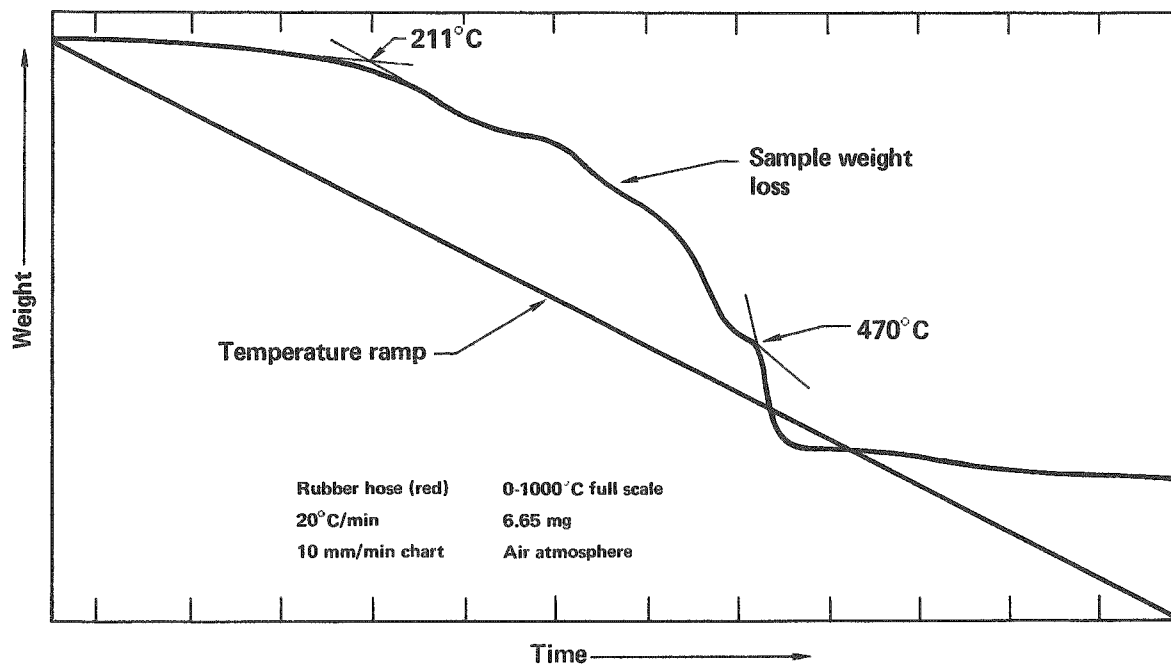
Figure 9 illustrates the thermal degradation pattern for red rubber fire hose. This material begins slow degradation at 211°C, ultimately forming an inert char at 470°C. We would expect that this material would be difficult to ignite because of low pyrolyzate production.

Figure 9. Thermogram of red rubber fire hose.

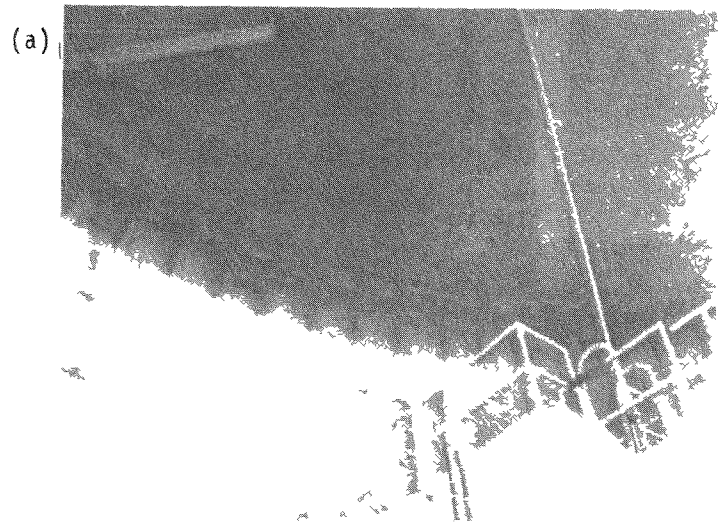
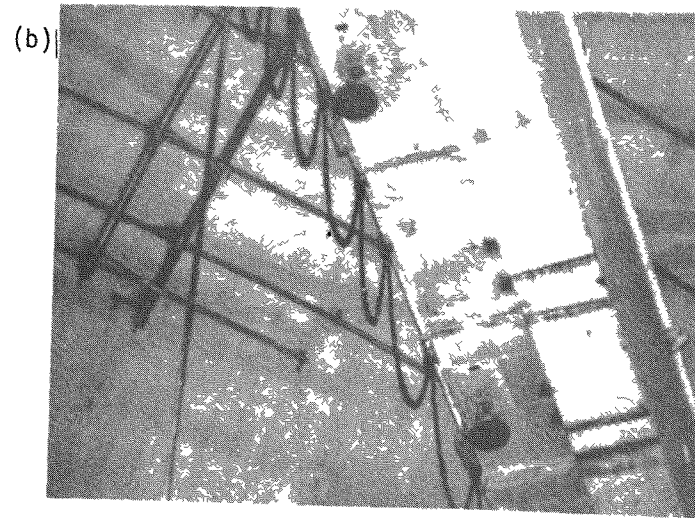
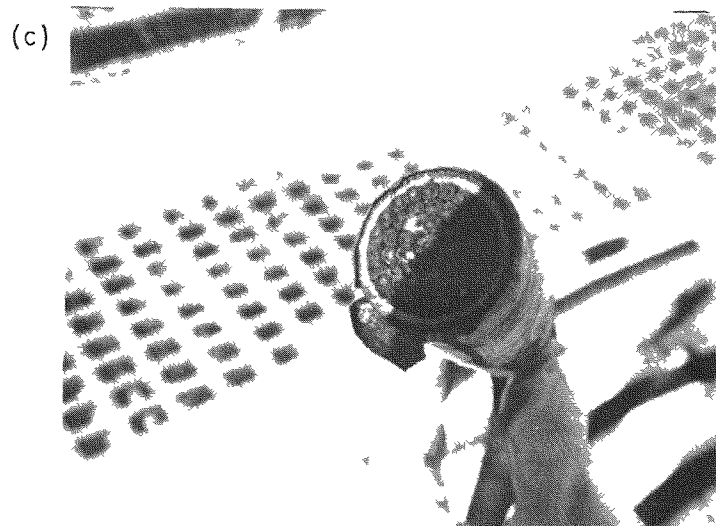
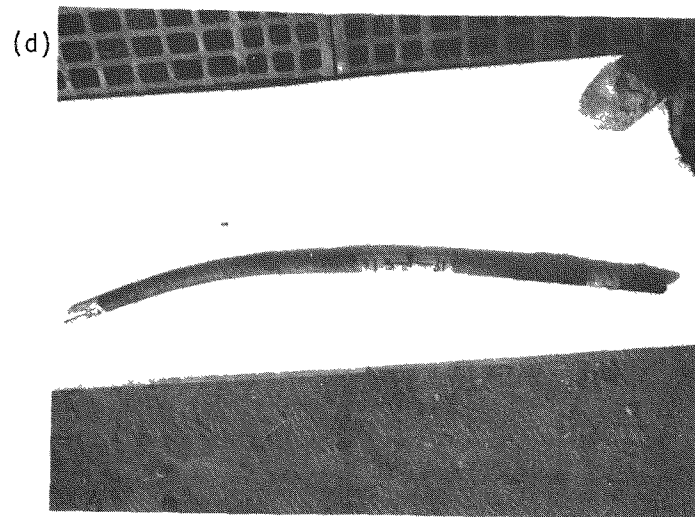
One item that possibly received the most intense energy exposure was the pendant and festoon for the polar crane. Figures 10a and 10b show the lower polar crane pendant, and upper polar crane pendant and festoon along the A girder in the reactor building. Figures 10c and 10d, and all plates in Figs. 11, 12, and 13, show the relative thermal damage of cable sections extracted from the reactor building.\* These are illustrative photographs starting from the festoon support of the polar crane and extending to the position of the control box resting on the east side of the west D-shield. A detailed description of thermal damage on each section is contained in Table 3. The figures and tables show that all sections received thermal exposure, including those coiled on the D-shield catwalk. The degree of thermal degradation decreased from the polar crane level to the D-shield top, and, in fact, was only apparent on the bottom pieces where cuts in insulation projected free surfaces of poor heat transfer. Thermal degradation is also apparent on light lenses of the pendant control box (Fig. 13c).

Figure 10. In-containment views and sectional pieces of the polar crane pendant: (a) Jib crane; D-ring A is in lower right. (b) Girder A of the polar crane. (c) North side of cable is ash; plastic tape is charred all around; no degradation under the tape. (d) Half of circumference is ash, half char (ash is gray, char black).

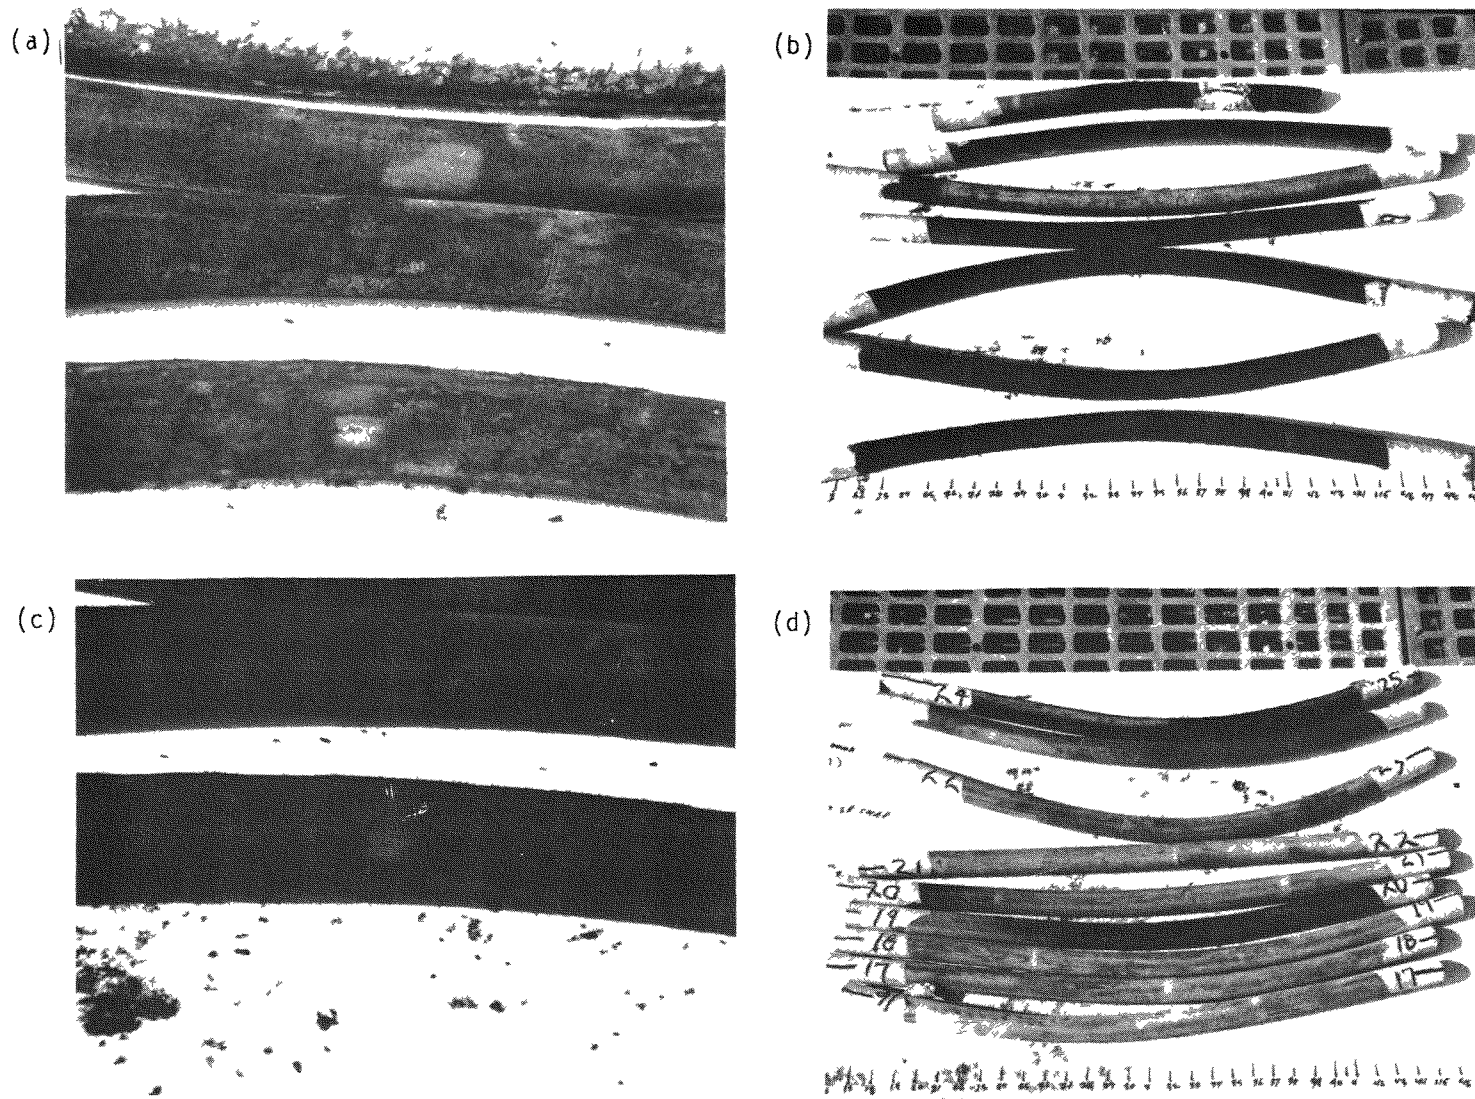
Figure 11. Sections from the top part of the polar crane pendant: (a) Low end is complete char; remainder is one side char, one side ash. (b) Cables 31-26; the higher the cable number, the higher it was on the polar crane pendant. (c) Char around complete circumference. (d) Cables 25-17.

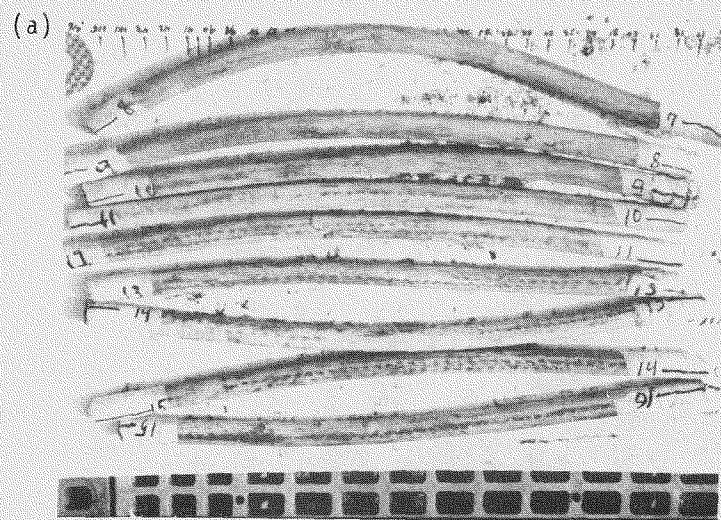
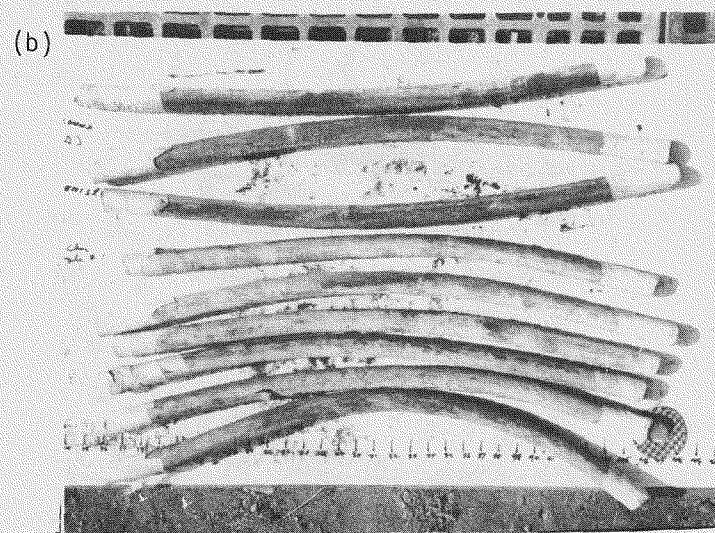
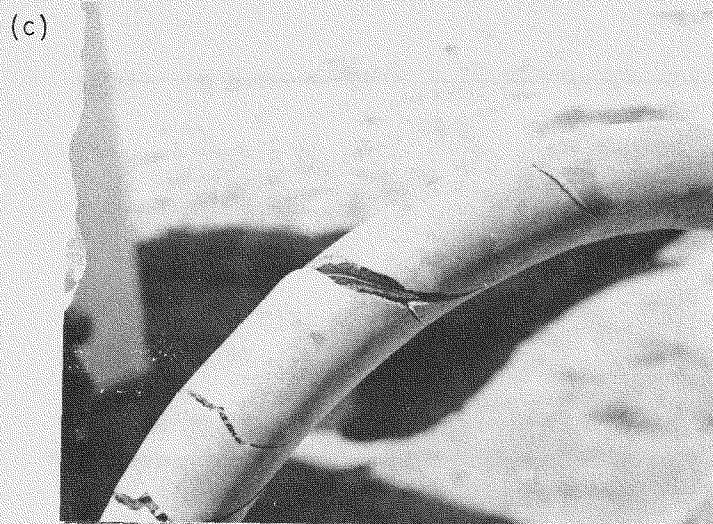
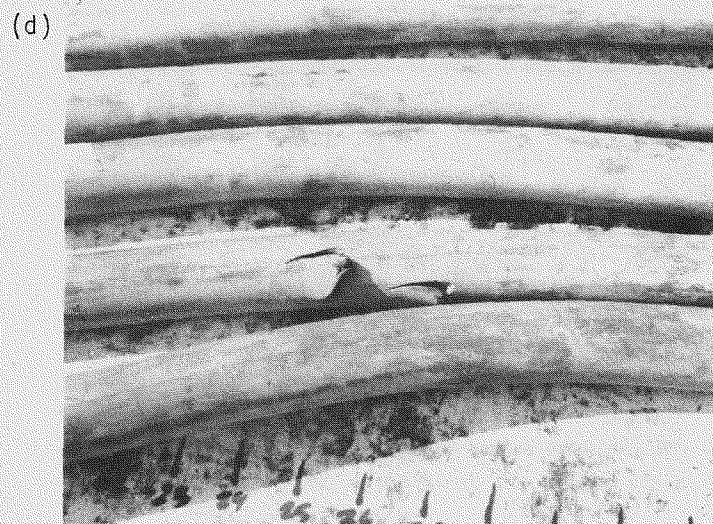
Figure 12. Sections from the bottom part of the polar crane pendant: (a) Cables 16-8. (b) Reverse sides of cables in (a). (c) Lengths 3-5, showing insulation cuts and checks. (d) Lengths 8-9, showing charred cut.

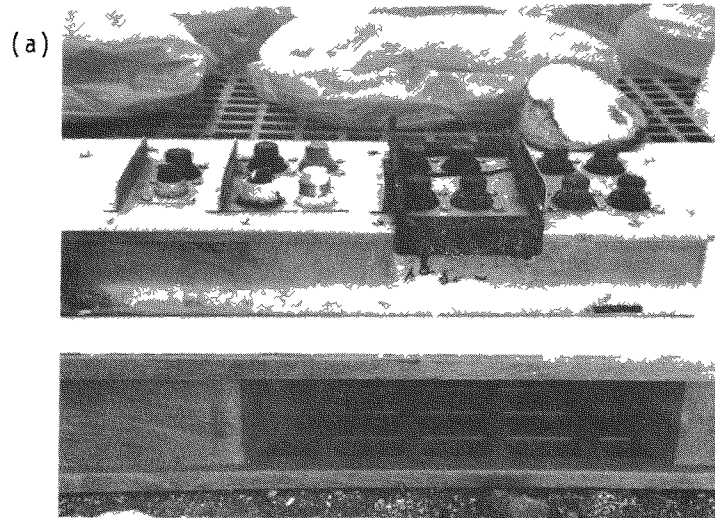
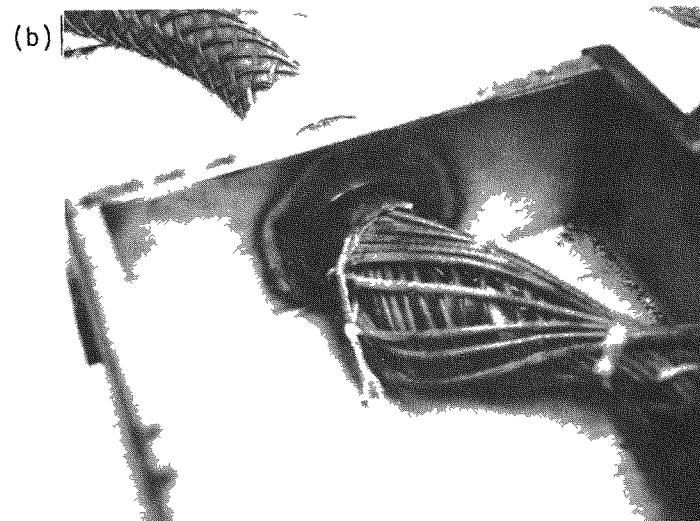
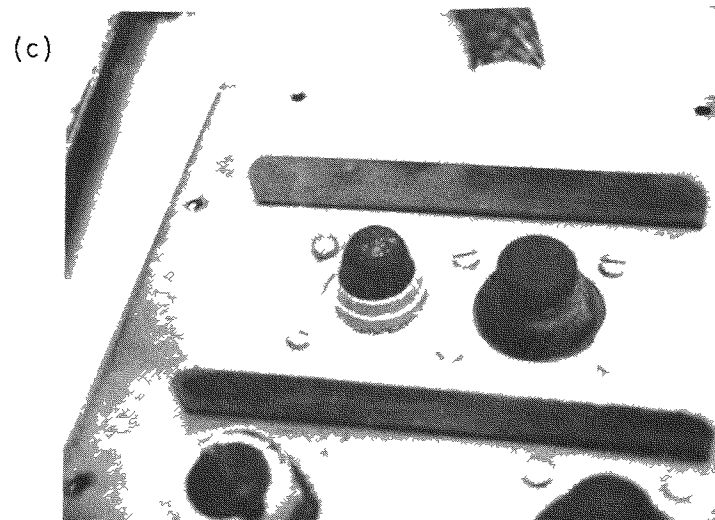
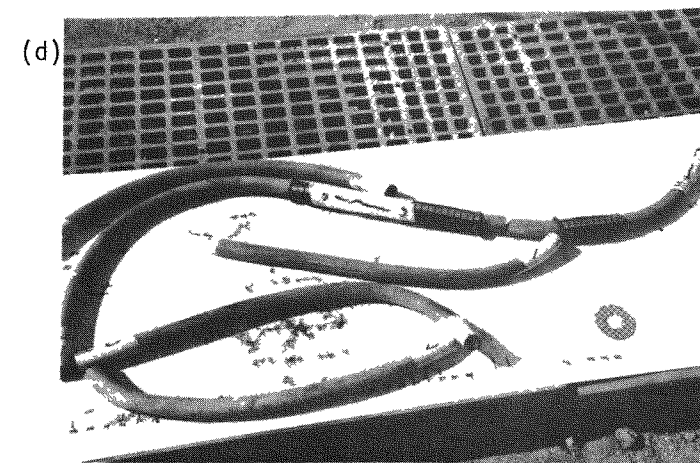
Figure 13. Details of control box and proximate cable.

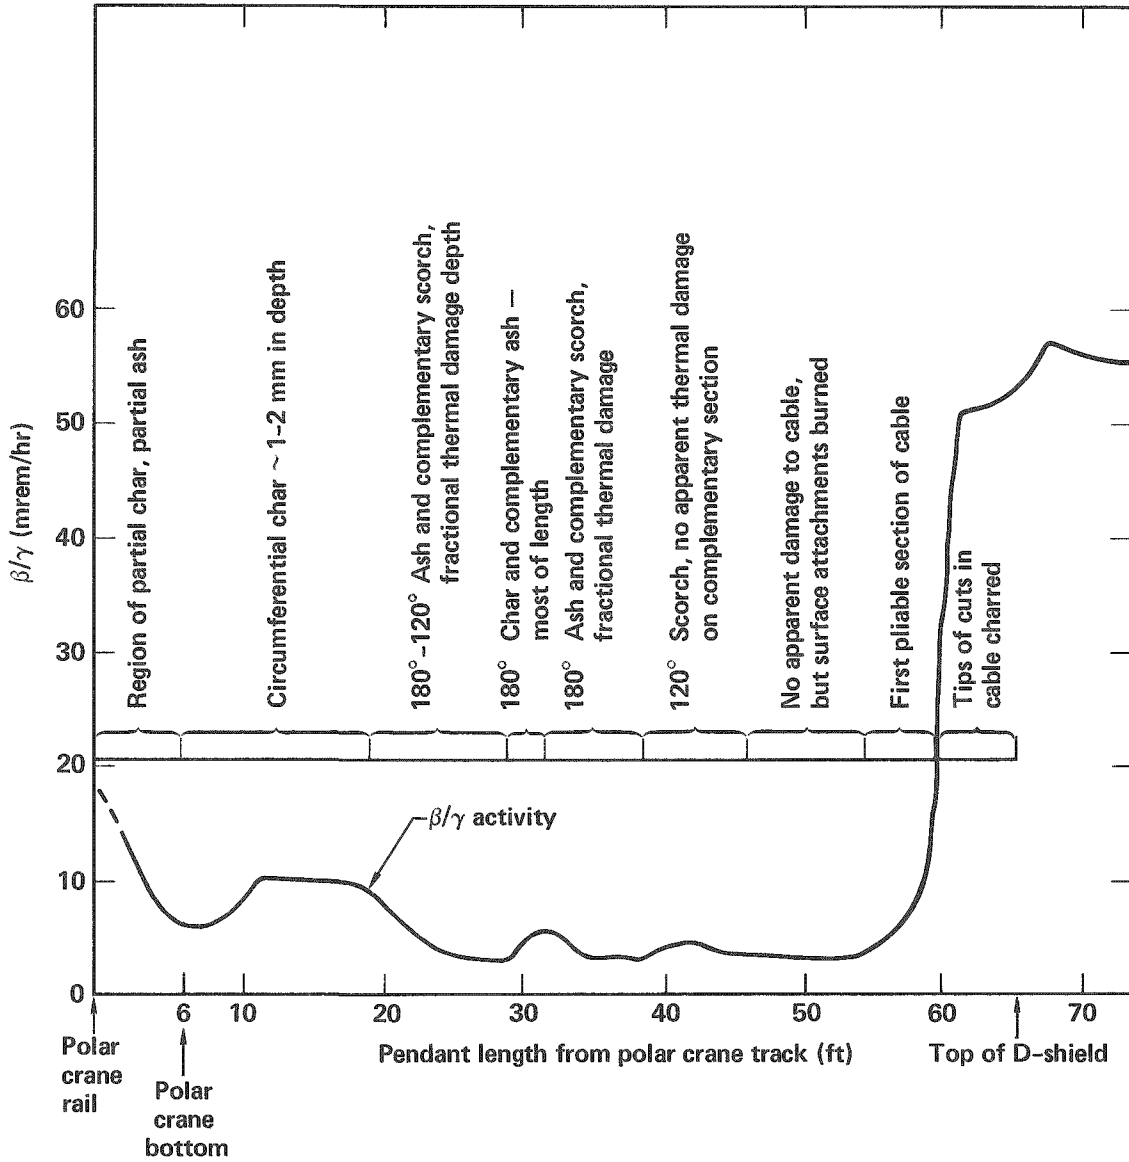
Figure 14 plots thermal damage with pendant length from polar crane level to the top of the D-shield level. Superimposed is the level of  $\beta/\gamma$  radiation (as determined and constructed by Mr. Trujillo). Maximum thermal damage occurs in the region from 6 to 10 ft below the polar crane girder (from about the 420-ft level down to about the 406-ft level). This region shows locally high  $\beta/\gamma$  activity, which may correlate to physical absorption by porous, charred insulation. Thermal damage is severe and circumferentially equal in this region. Char depth on the polymer surface averages 1 to 2 mm. We have no clue as to the composition of the insulating cover for the pendant, so we cannot define the intensity of exposure. However, it was definitely intense and uniform, an indication that this region was bathed for a substantial period in an intense combustion zone.

Figure 14. Distribution of residual radiation and burn damage along pendant length from the polar crane track.

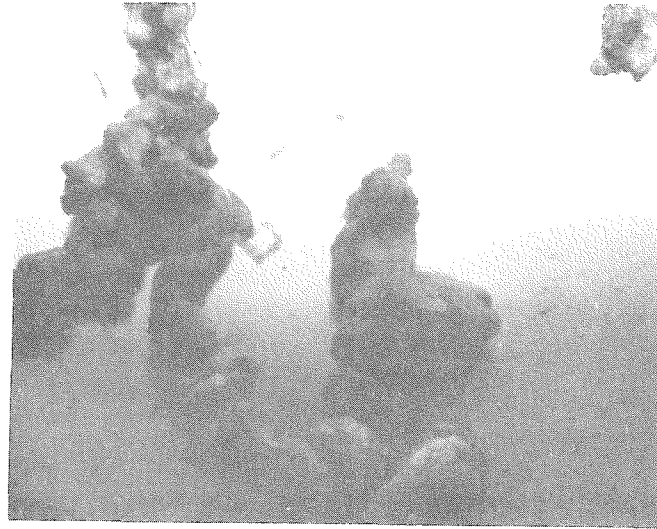
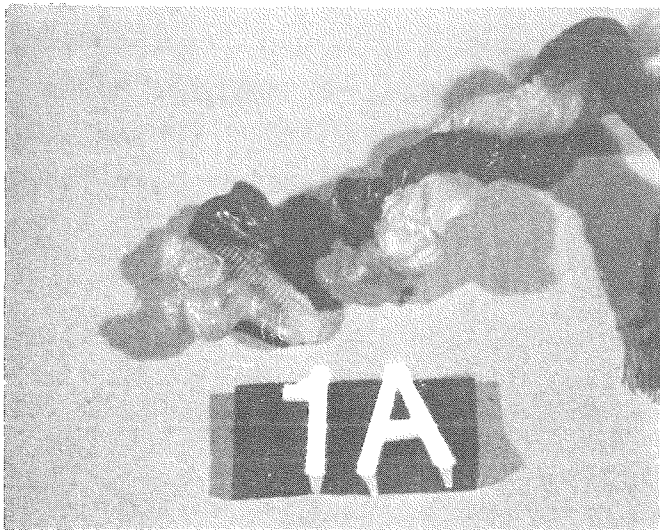
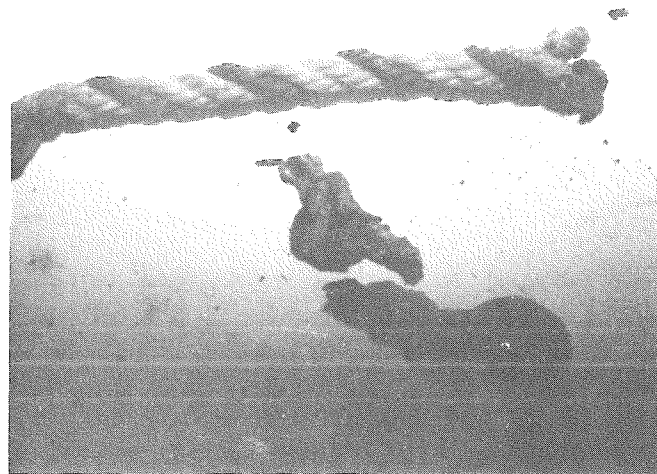
Figure 16. Comparison of exemplar polyethylene rope exposed to  $180 \text{ J/cm}^2$  for 30 s (left) and TMI-2 polyethylene rope (right).

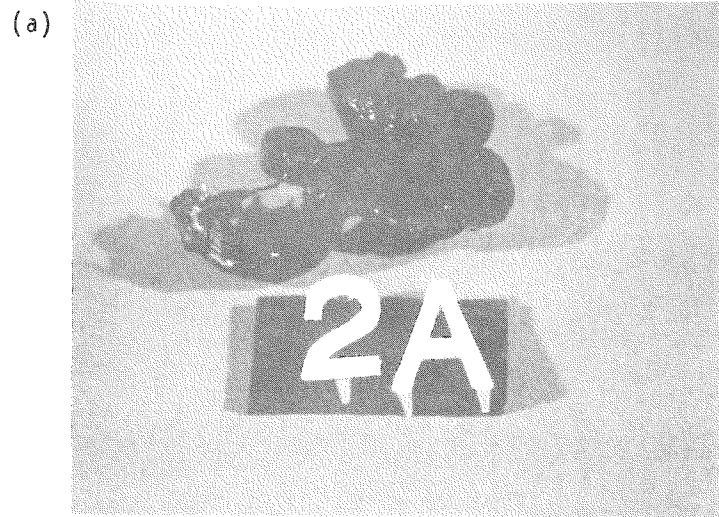
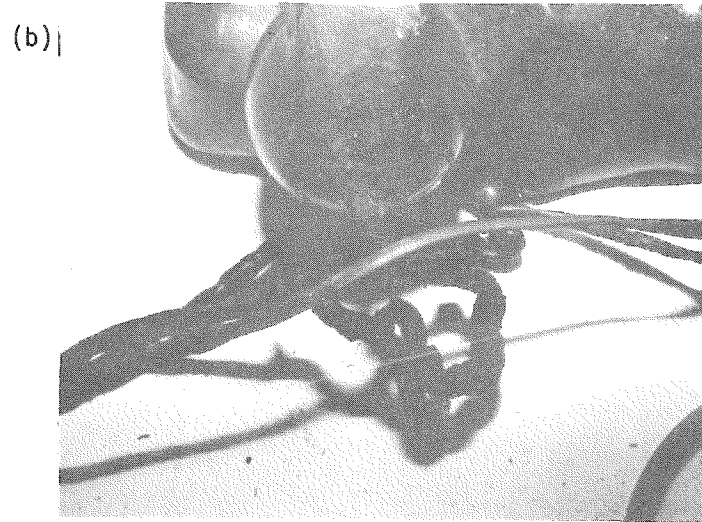
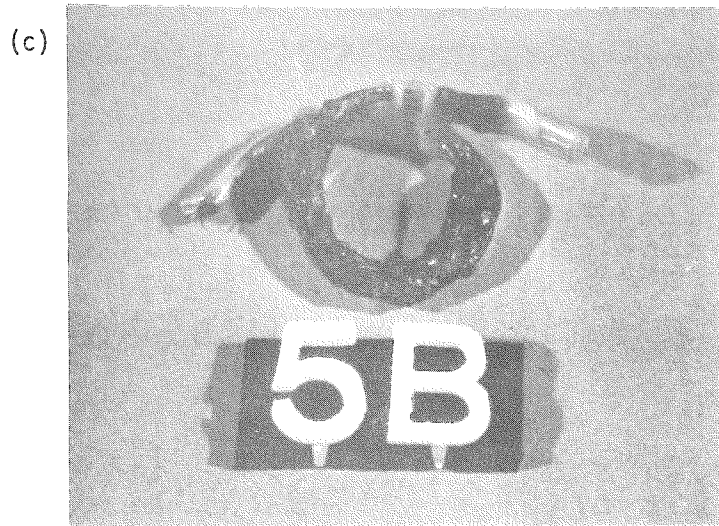
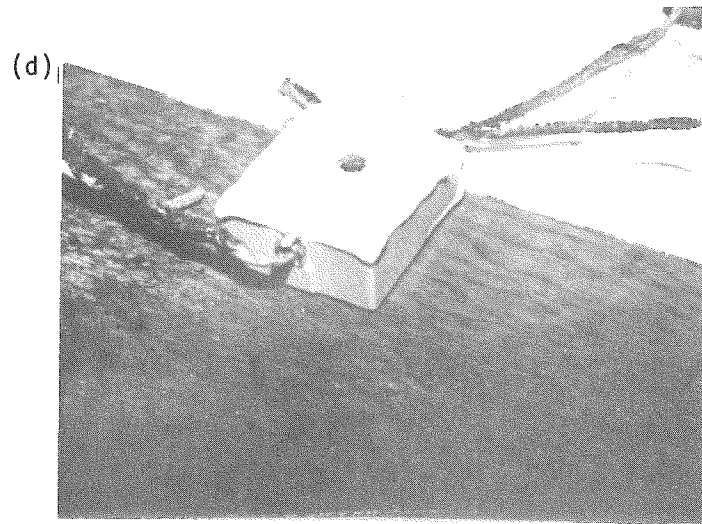
Figure 17. Comparison of exemplars exposed to  $180 \text{ J/cm}^2$  for 30 s and TMI materials: (a) Exemplar telephone receiver cord. (b) TMI receiver cord. (c) Exemplar extension cord. (d) TMI extension cord.

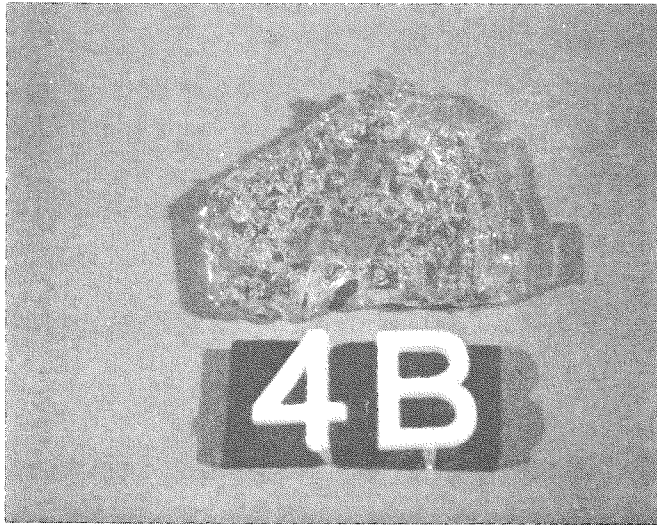
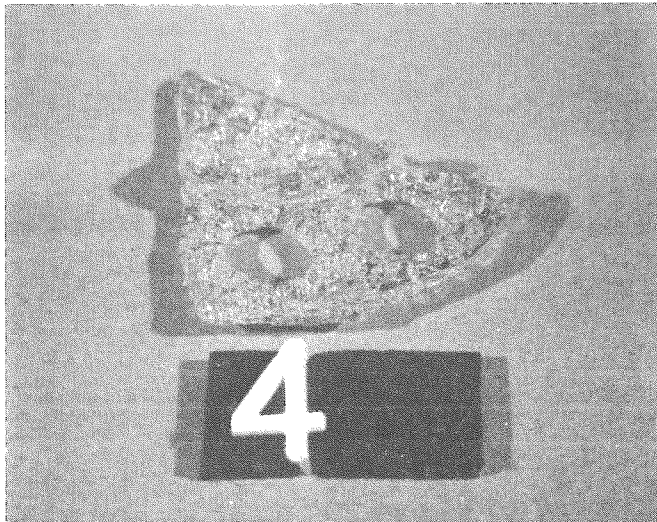
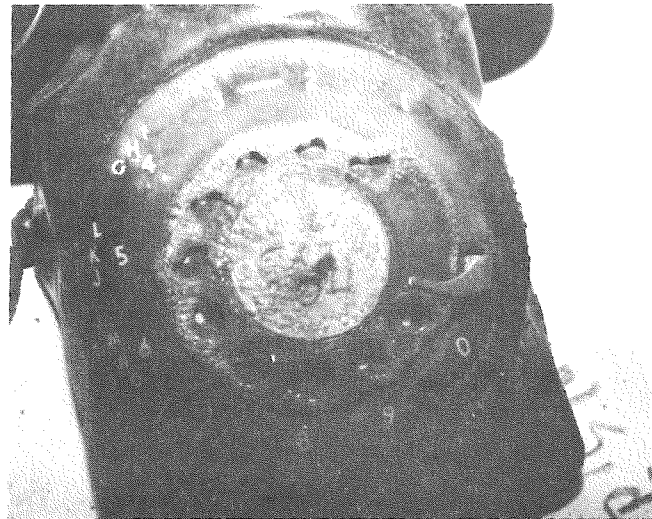
Figure 18. Comparison of exemplar acrylic exposed to  $180 \text{ J/cm}^2$  for 30 s (left) and TMI-2 telephone dial.

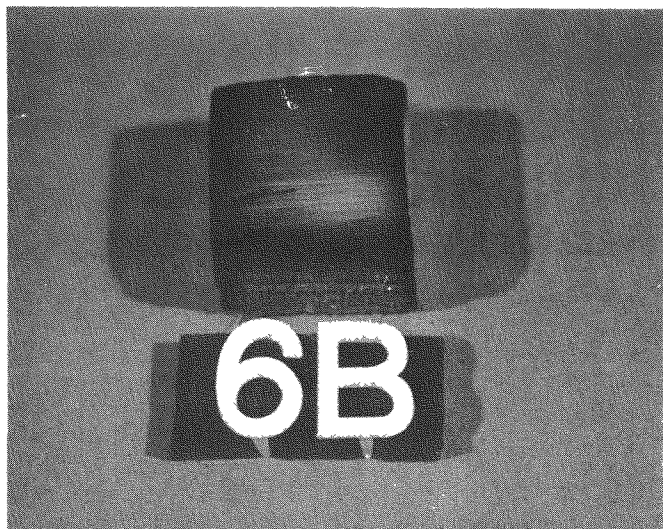
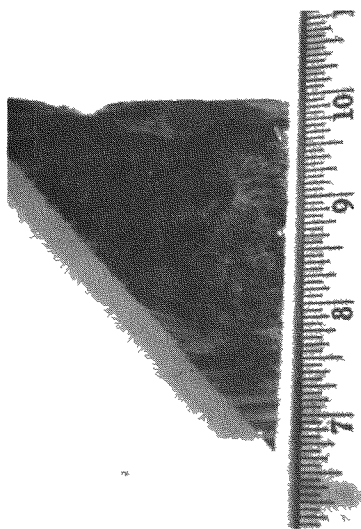
Figure 19. Comparison of exemplar plywood (fir) exposed to  $180 \text{ J/cm}^2$  for 30 s (left) and plywood from TMI.

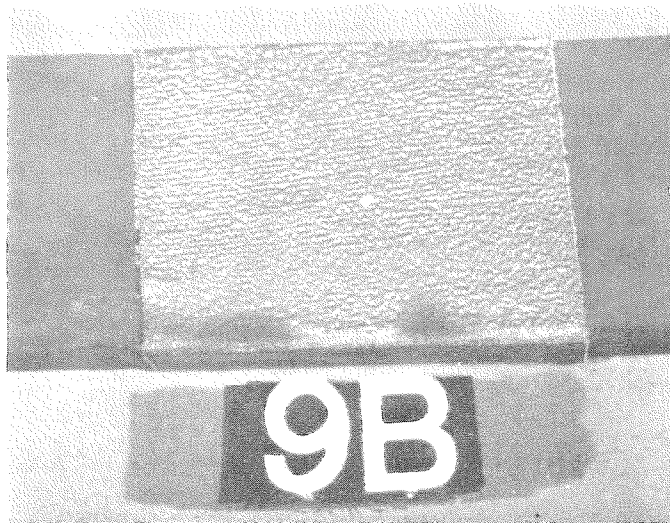
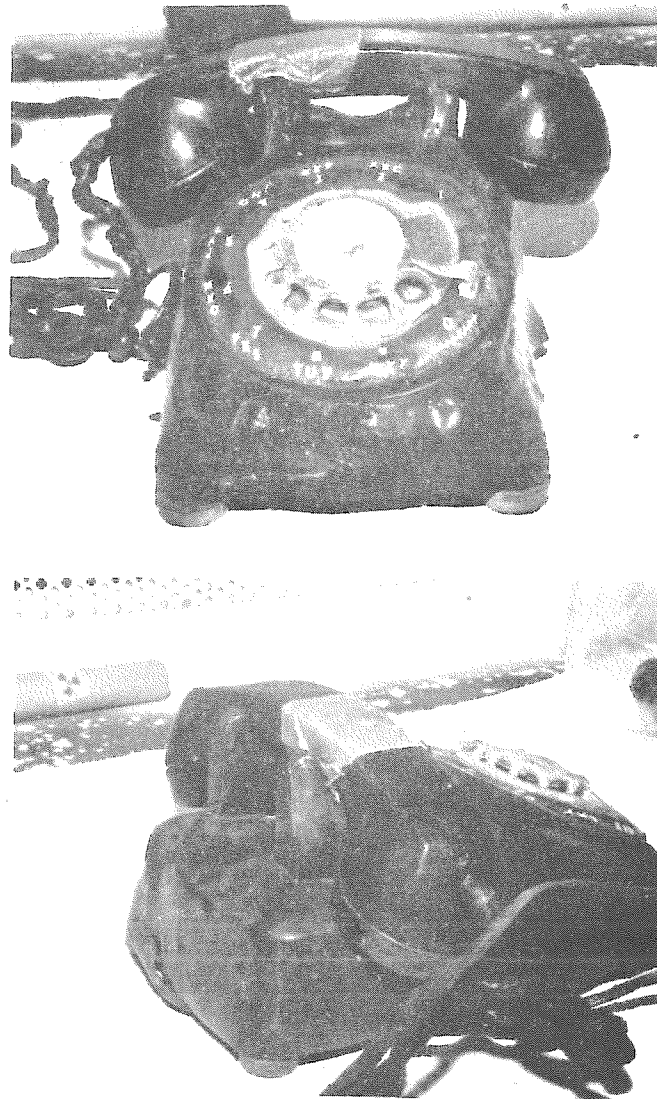
Figure 20. Comparison of exemplar duct tape exposed to  $120 \text{ J/cm}^2$  for 20 s (left) and TMI-2 duct tape.
