### ASSESSMENT OF EXTENT AND DEGREE OF THERMAL DAMAGE TO POLYMERIC MATERIALS IN THE THREE MILE ISLAND UNIT 2 REACTOR BUILDING

N. J. Alvares

Published February 1984

Lawrence Livermore National Laboratory  
Livermore, California

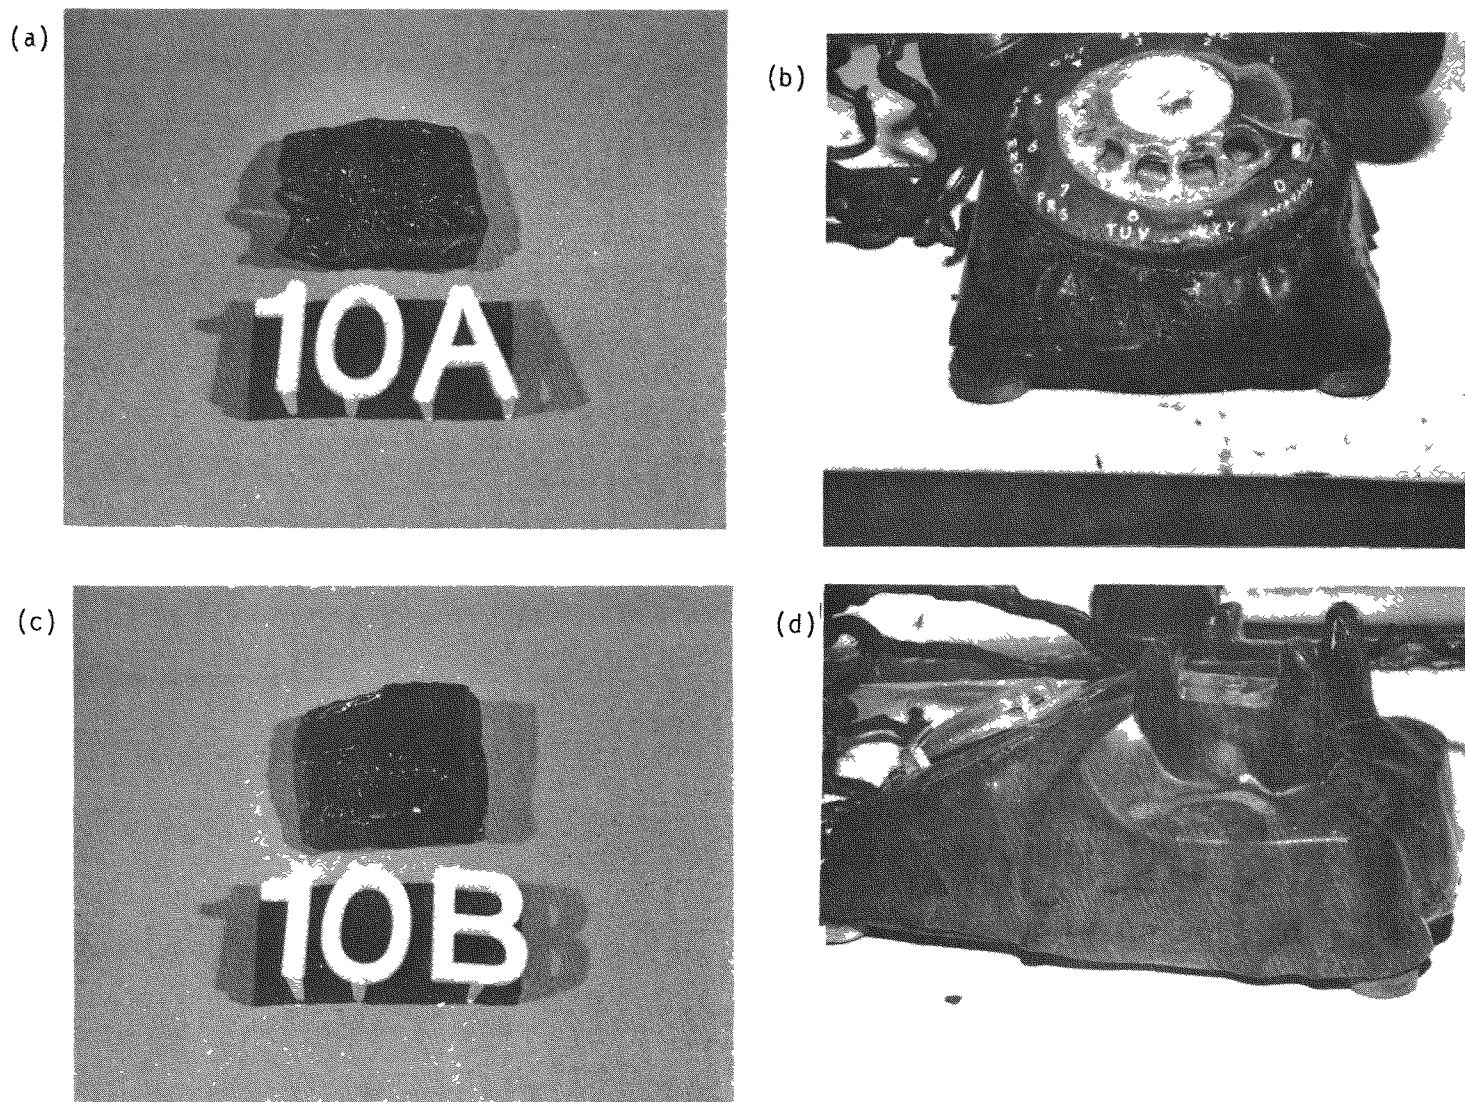
Figure 21. Comparison of exemplar telephone body pieces and TMI-2 ABS telephone body: (a) Exemplar exposed to  $120 \text{ J/cm}^2$  for 20 s. (b) Telephone from TMI. (c) Exemplar exposed to  $72 \text{ J/cm}^2$  for 12 s. (d) Telephone from TMI.

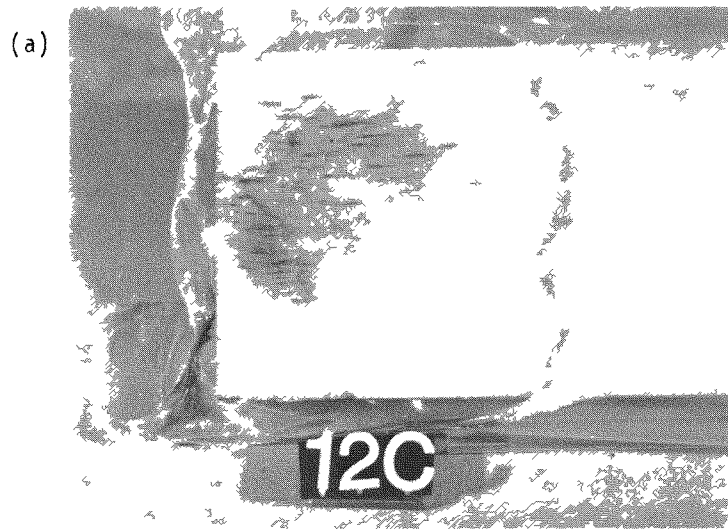
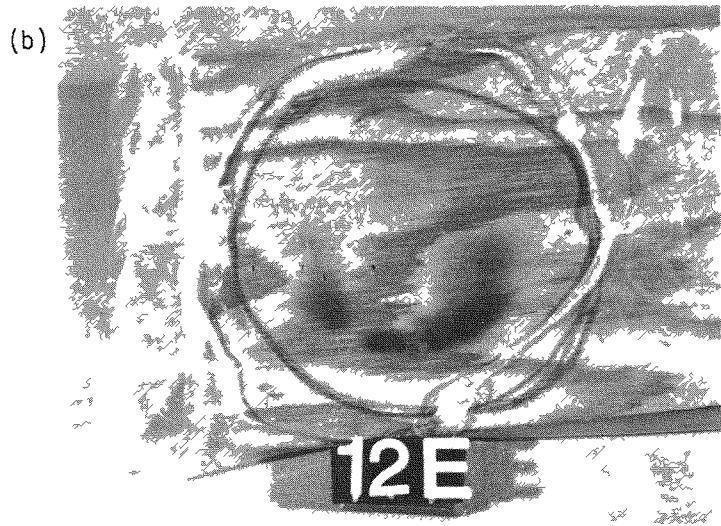
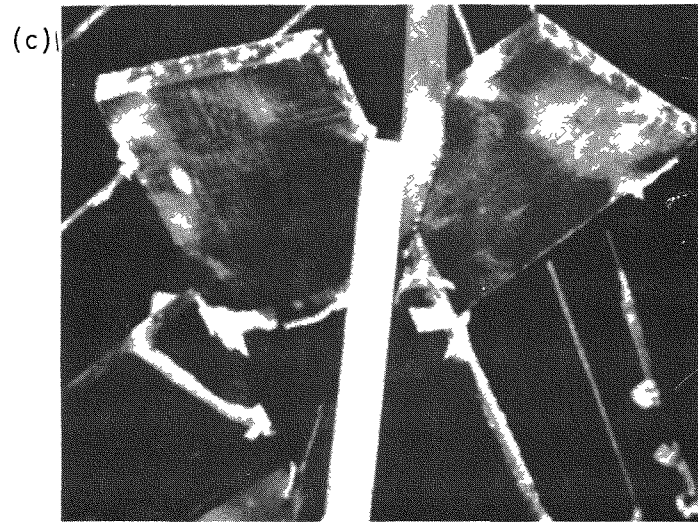
Figure 22. Comparison of exemplars and TMI-2 polyethylene-wrapped plywood: (a) Exemplar exposed to  $75 \text{ J/cm}^2$  for 12.5 s. (b) Exemplar exposed to  $78 \text{ J/cm}^2$  for 13 s. (c) Scaffolding at TMI.

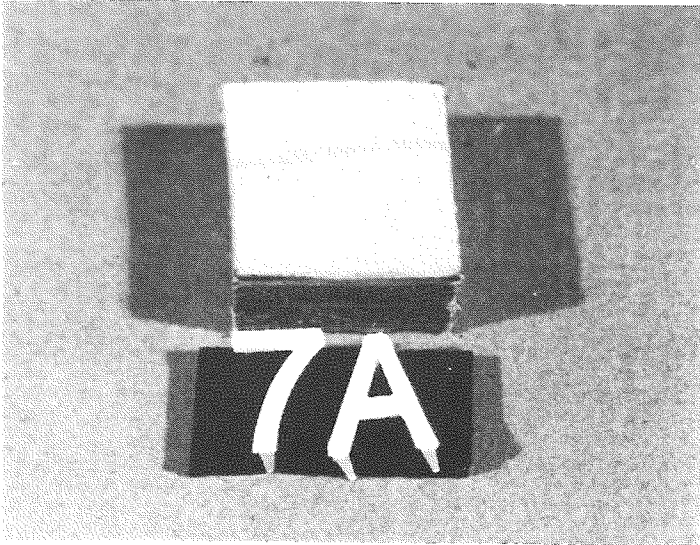
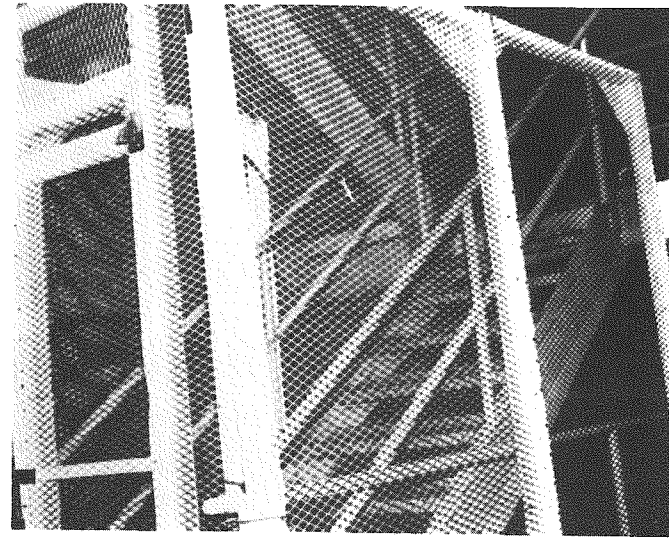
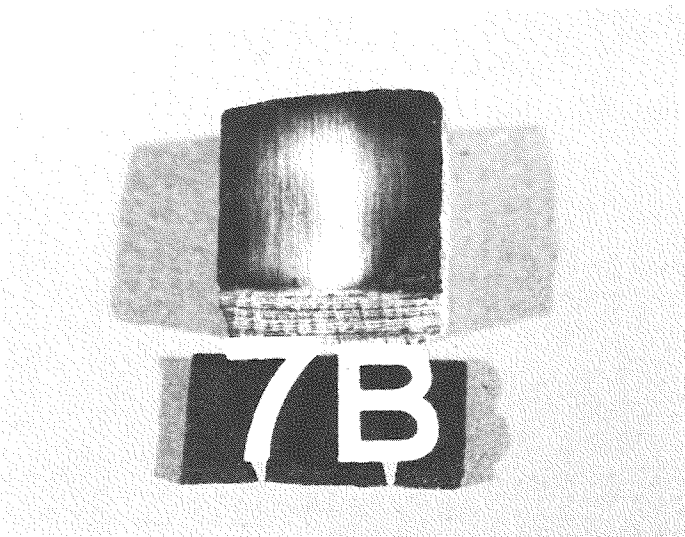
Figure 23. Comparison of exemplar wet plywood and TMI-2 wet plywood: (a) Exemplar exposed to  $180 \text{ J/cm}^2$  for 30 s. (b) Exemplar exposed to  $360 \text{ J/cm}^2$  for 1 min. (c) Plywood-framed cage at TMI.

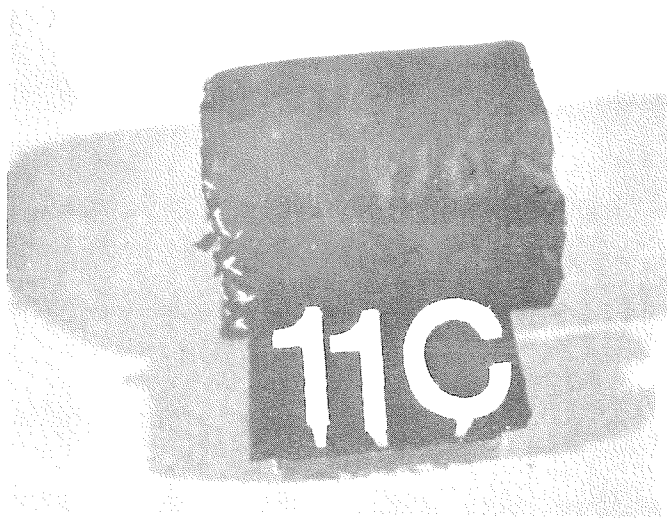
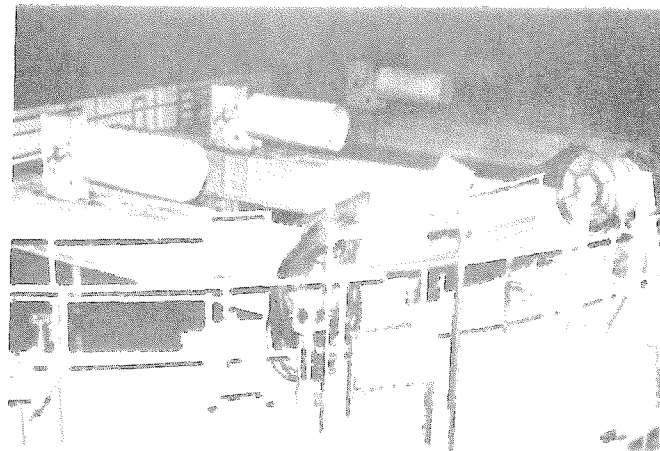
Figure 24. Exemplar red rubber fire hose exposed to  $360 \text{ J/cm}^2$  for 1 min (left) and fire hose at TMI (right).
